**STATE OF VERMONT  
AGENCY OF TRANSPORTATION**

**Scoping Report**

**FOR  
Plymouth BF 013-3(13)**

**VT ROUTE 100, CULVERT 115 OVER RESERVOIR BROOK**

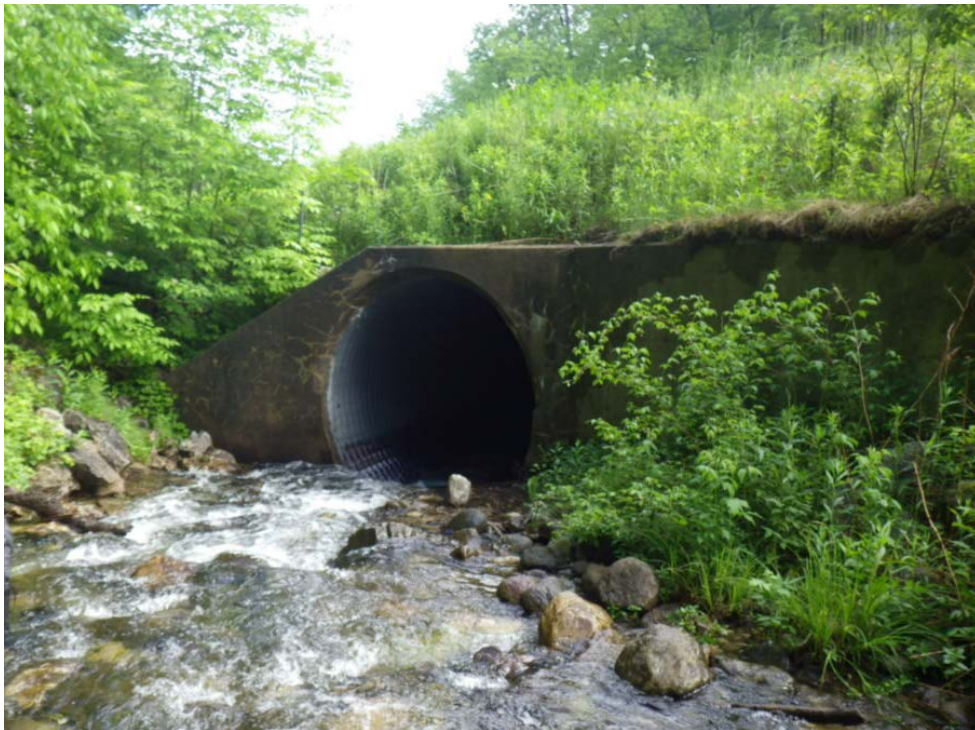
**Picture 4:** Inlet of Culvert, Stream Bed Steps Down into Culvert

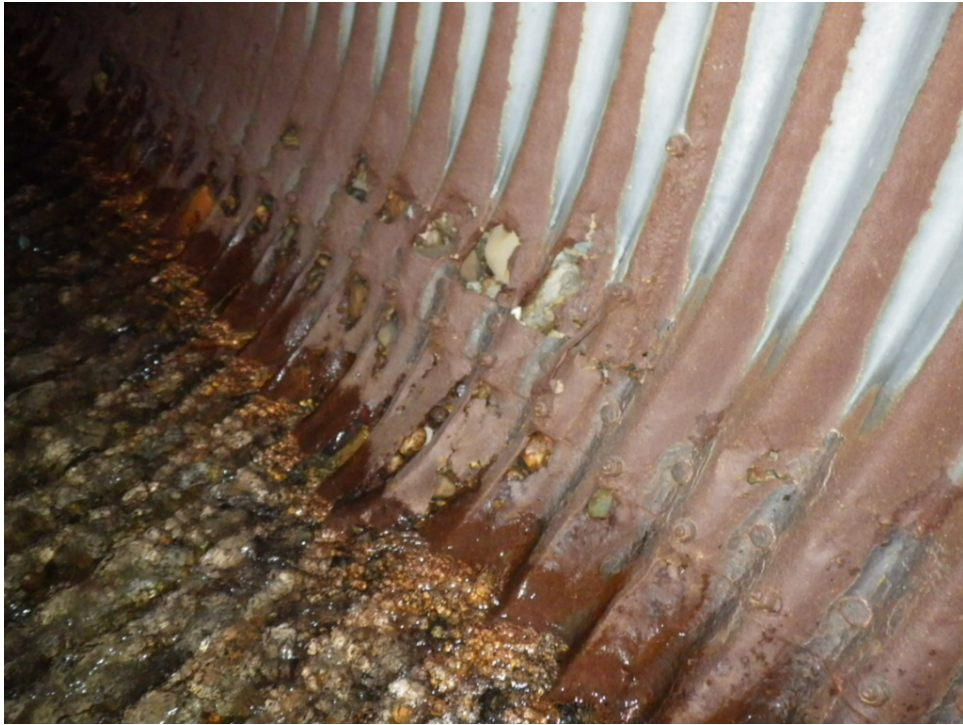
**Picture 5: Holes Forming on Invert**

12/3/2013 – The invert has extensive deterioration with large holes scattered along the water line. A concrete invert should be installed in the near future. JWW/JDM

10/18/12 – Poor Condition. There are large 2+ holes numerous throughout the pipe at about 2' up the pipe from the bottom of invert...1' of undermining is occurring at outlet end. JM MK

The pipe is in poor condition with large holes scattered along the waterline. There is a drop at the outlet with water undermining here.

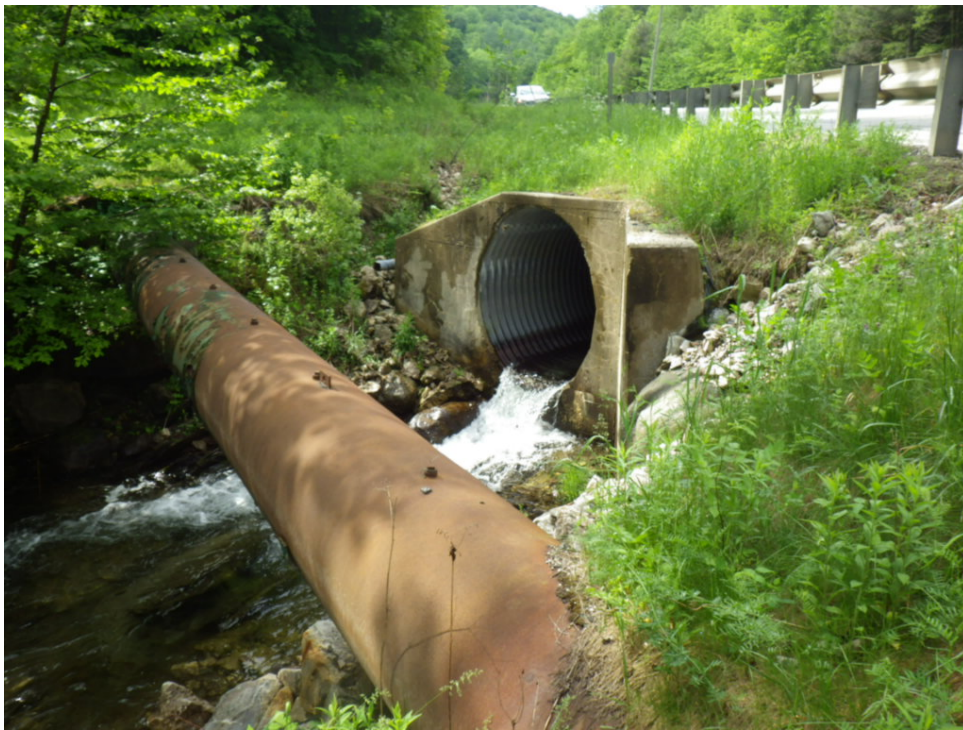
**Picture 6: Outlet of Culvert, Water Pipe in Foreground**

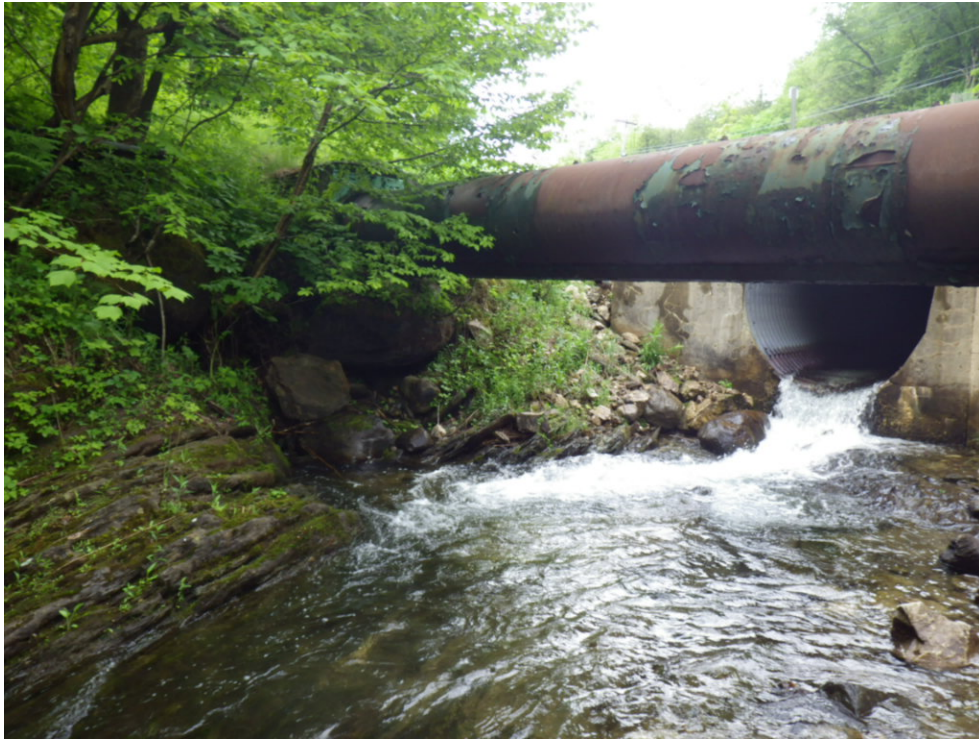
**Picture 7:** Outlet of Culvert, Exposed Bedrock in Streambed on Left

Exposed bedrock was observed at the outlet of the culvert as seen in Figure 4 and denoted with the red arrows. The river bed contained cobbles and small to medium boulders, as seen in Figure 5.

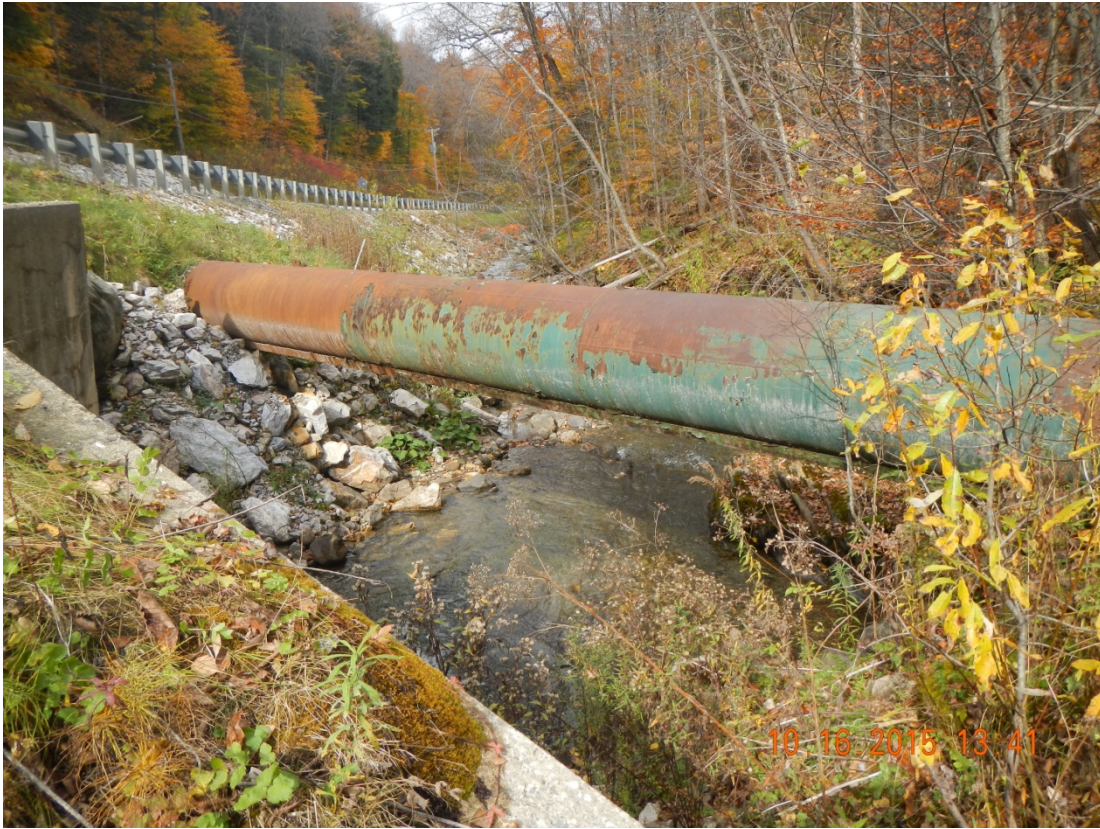
**Figure 2:** Water pipe Northeast of the Culvert Outlet

A preliminary site visit was conducted on October 16, 2015 to determine possible obstructions inhibiting boring operations and to make any other pertinent observations about the project. This visit revealed a large water pipe in close proximity to the outlet of the culvert, as seen in Figure 2. Overhead power lines cross Route 100 above the culvert and run over the inlet of the culvert, west of Route 100. The utility lines can be seen in Figure 3. The embankment slopes above the inlet and outlet of the culvert are steep, and this coupled with limited access for drill rigs could make boring operations at the inlet and outlet locations difficult.

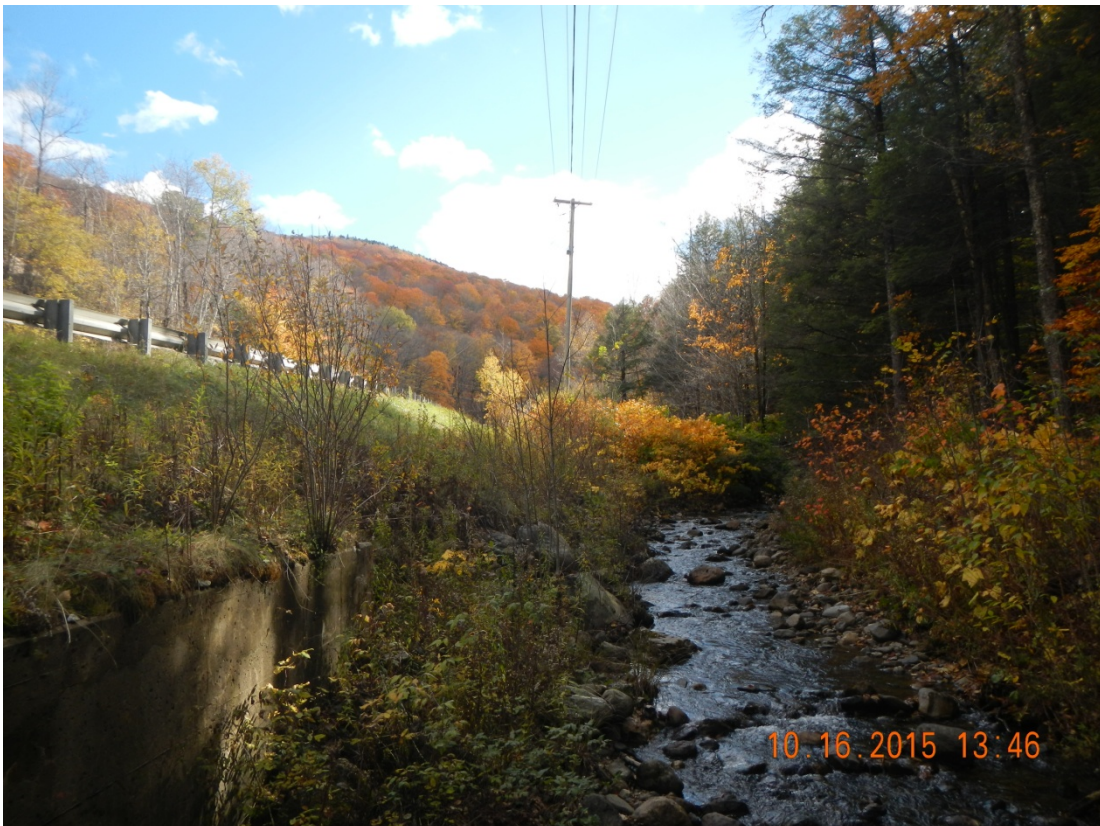
**Figure 3:** Utility Lines above Culvert Inlet

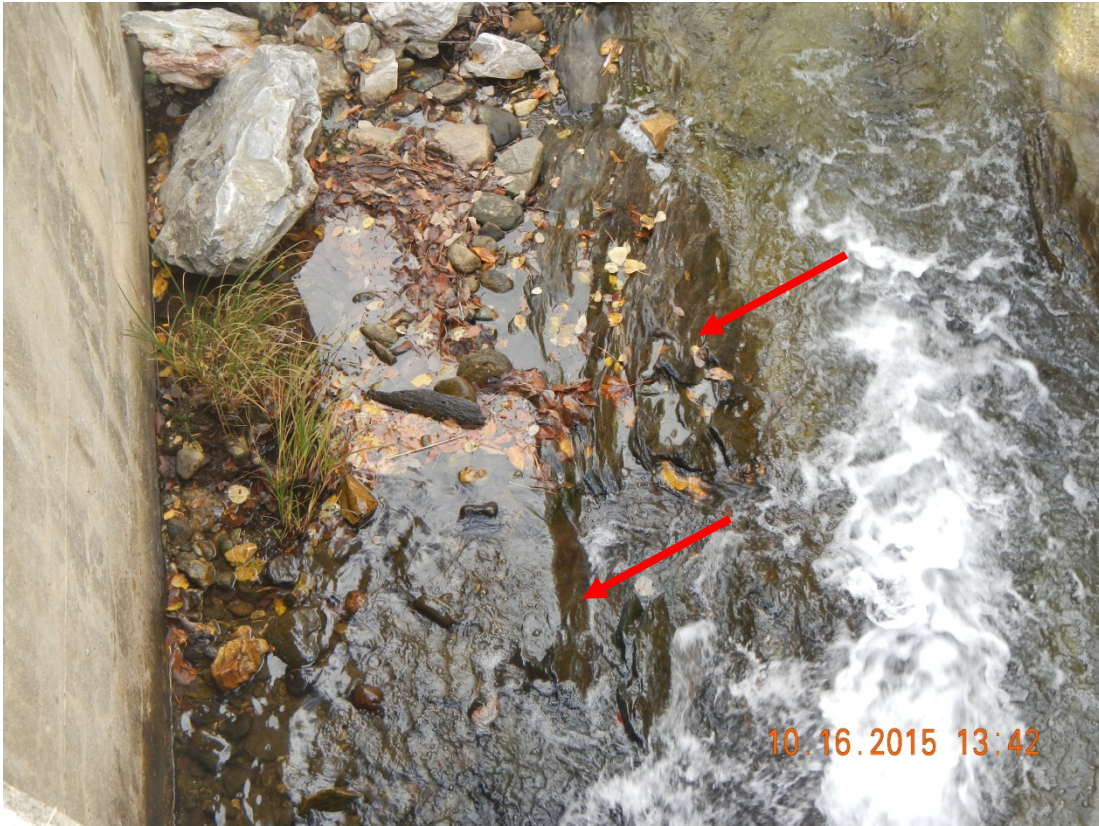
**Figure 4:** Exposed Bedrock in Stream

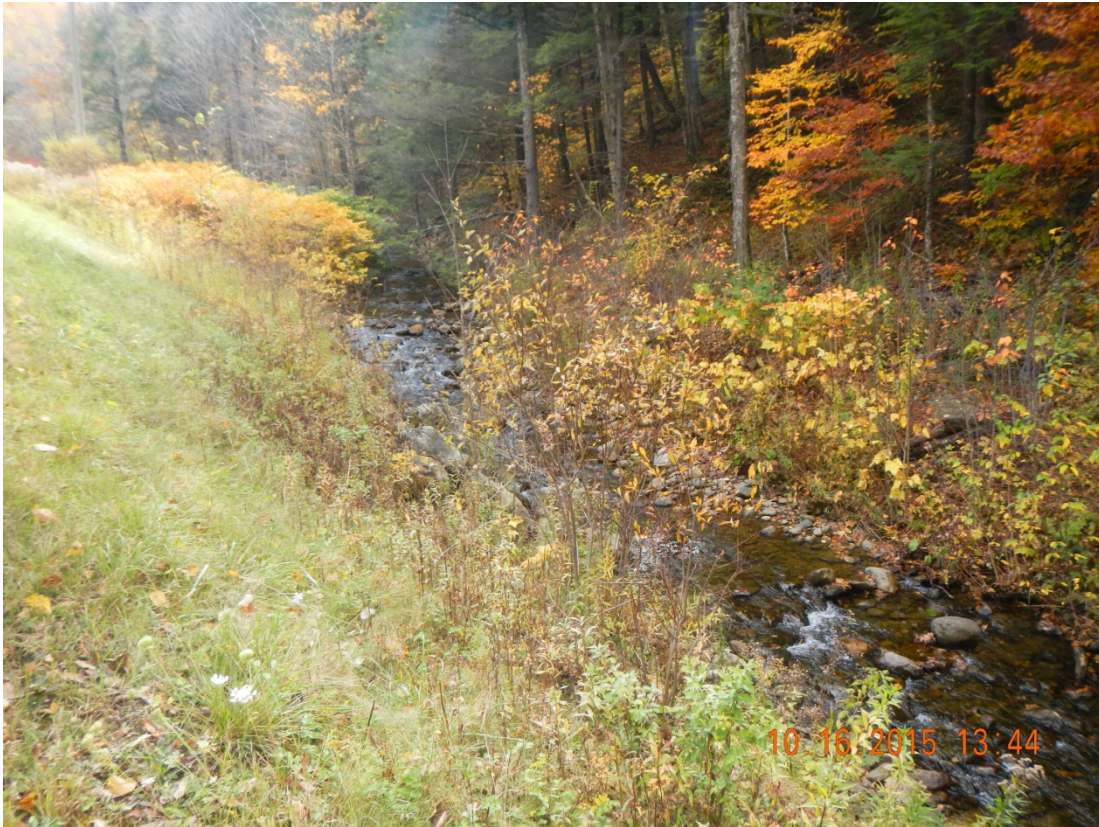
**Figure 5:** Boulders Upstream of the Culvert

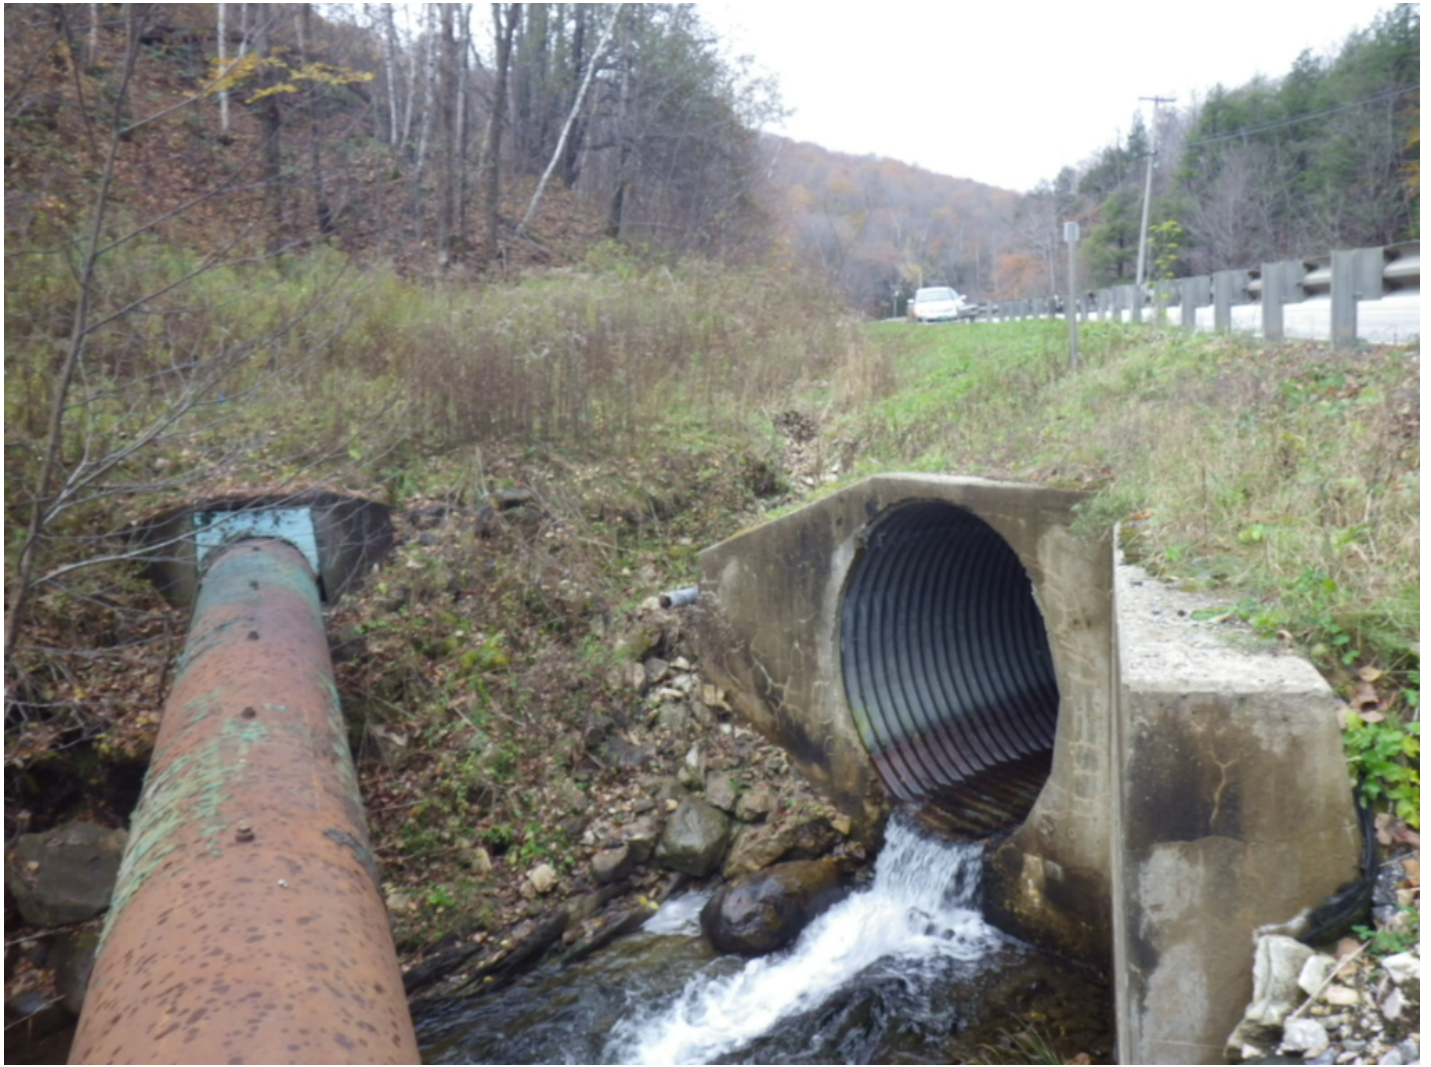
Figure 2. Bridge (Culvert) 115 at right with reinforced concrete head and wing-walls.

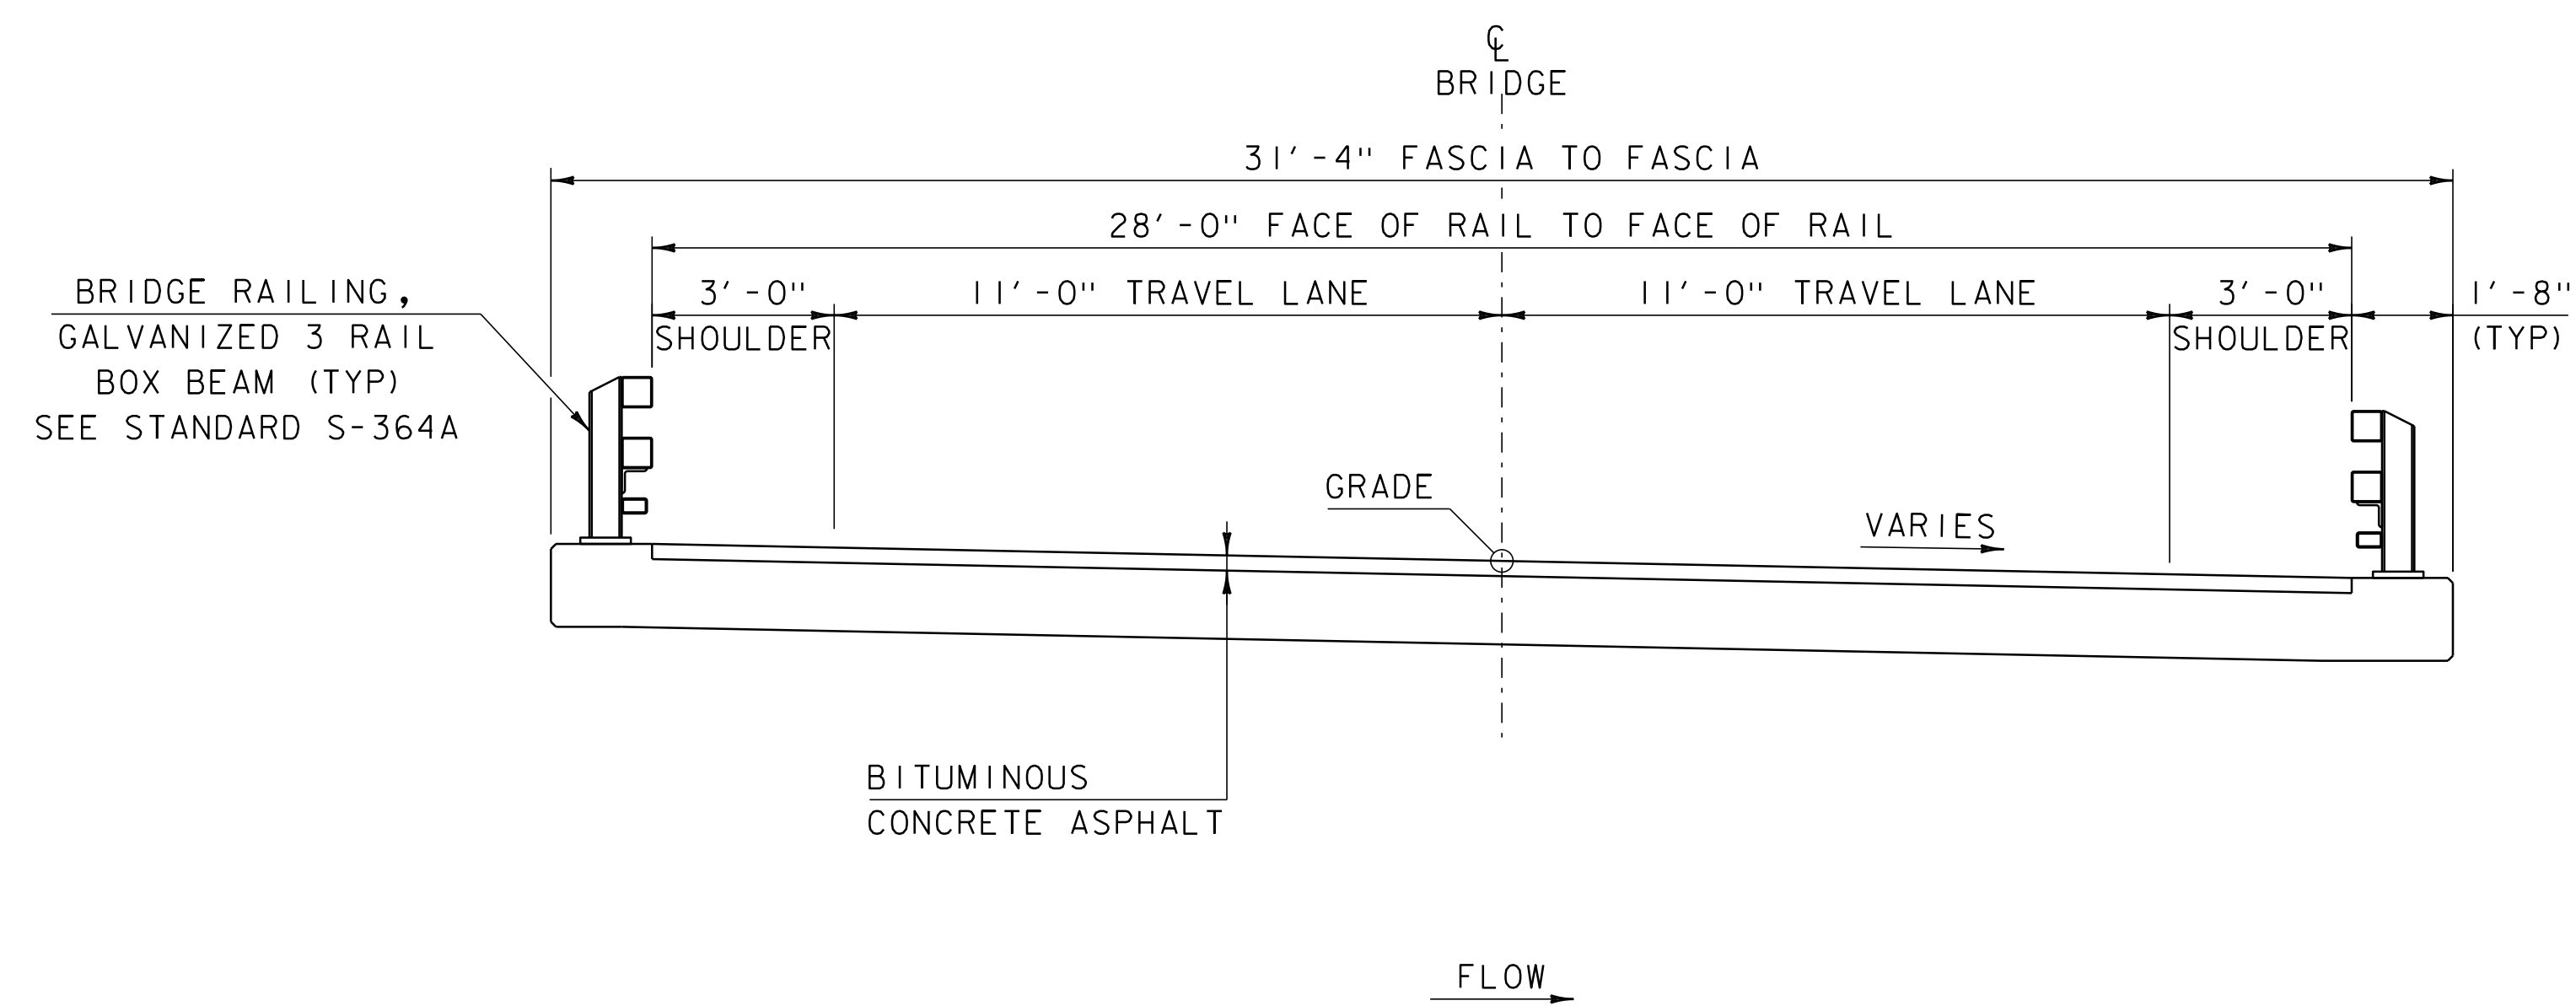
**ALTERNATIVE #3 & #4 TYPICAL SECTION**  
SCALE  $\frac{3}{8}$ " = 1'-0"  
SUPERSTRUCTURE TO BE DESIGNED LATER

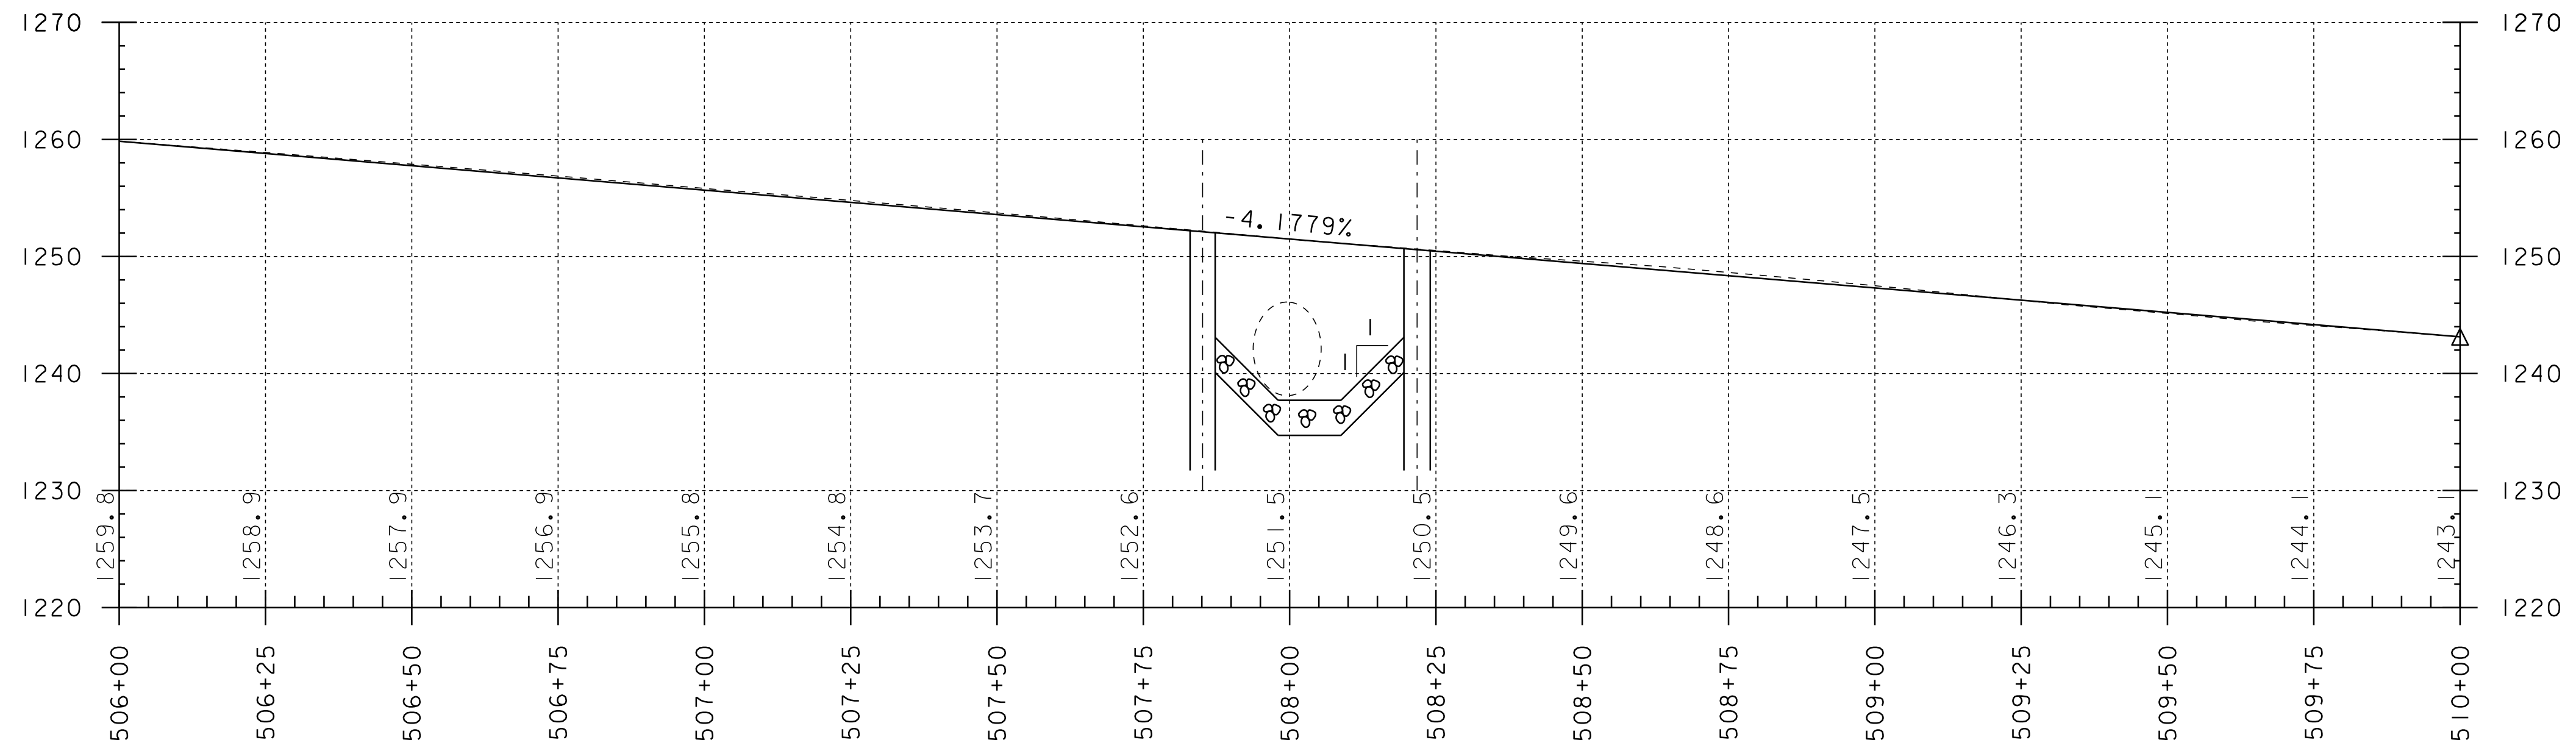
**ALTERNATIVE #3 & #4 VT ROUTE 100 PROFILE**

SCALE: HORIZONTAL 1"=20'-0"  
 VERTICAL 1"=10'-0"  
 SUPERSTRUCTURE AND SUBSTRUCTURE  
 TO BE DESIGNED LATER
