Plymouth BF 013-3(13)

Public Presentation

Vermont Route 100 – Culvert 115 over Reservoir Brook

August 7, 2017

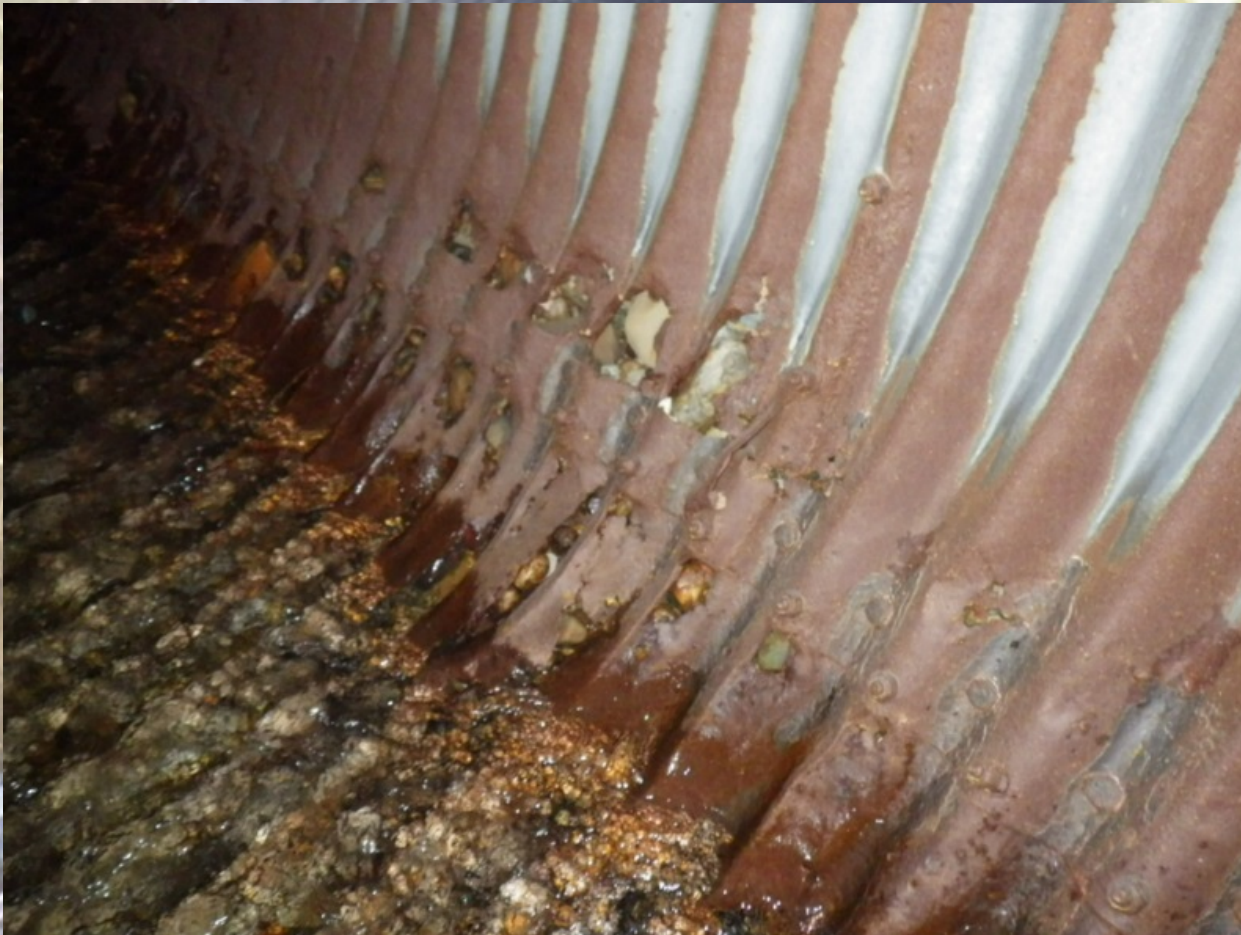
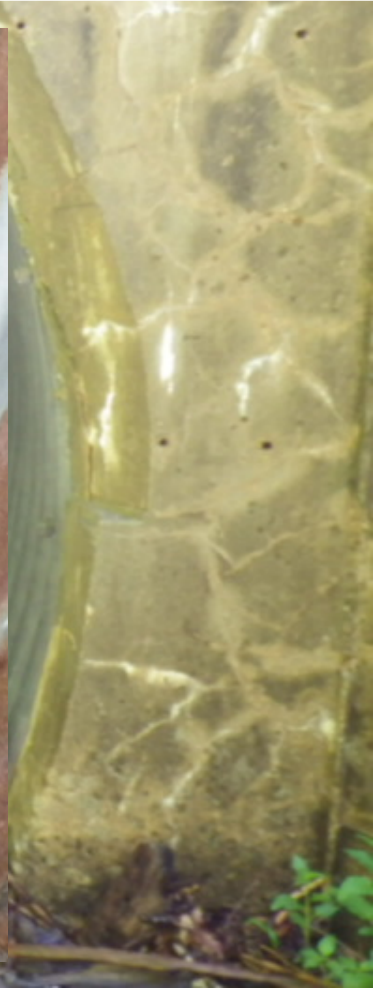
- This culvert has a rating of 4, "Poor"
- There are large perforations through the entire length of the culvert.
- The existing culvert does not meet hydraulic standards.

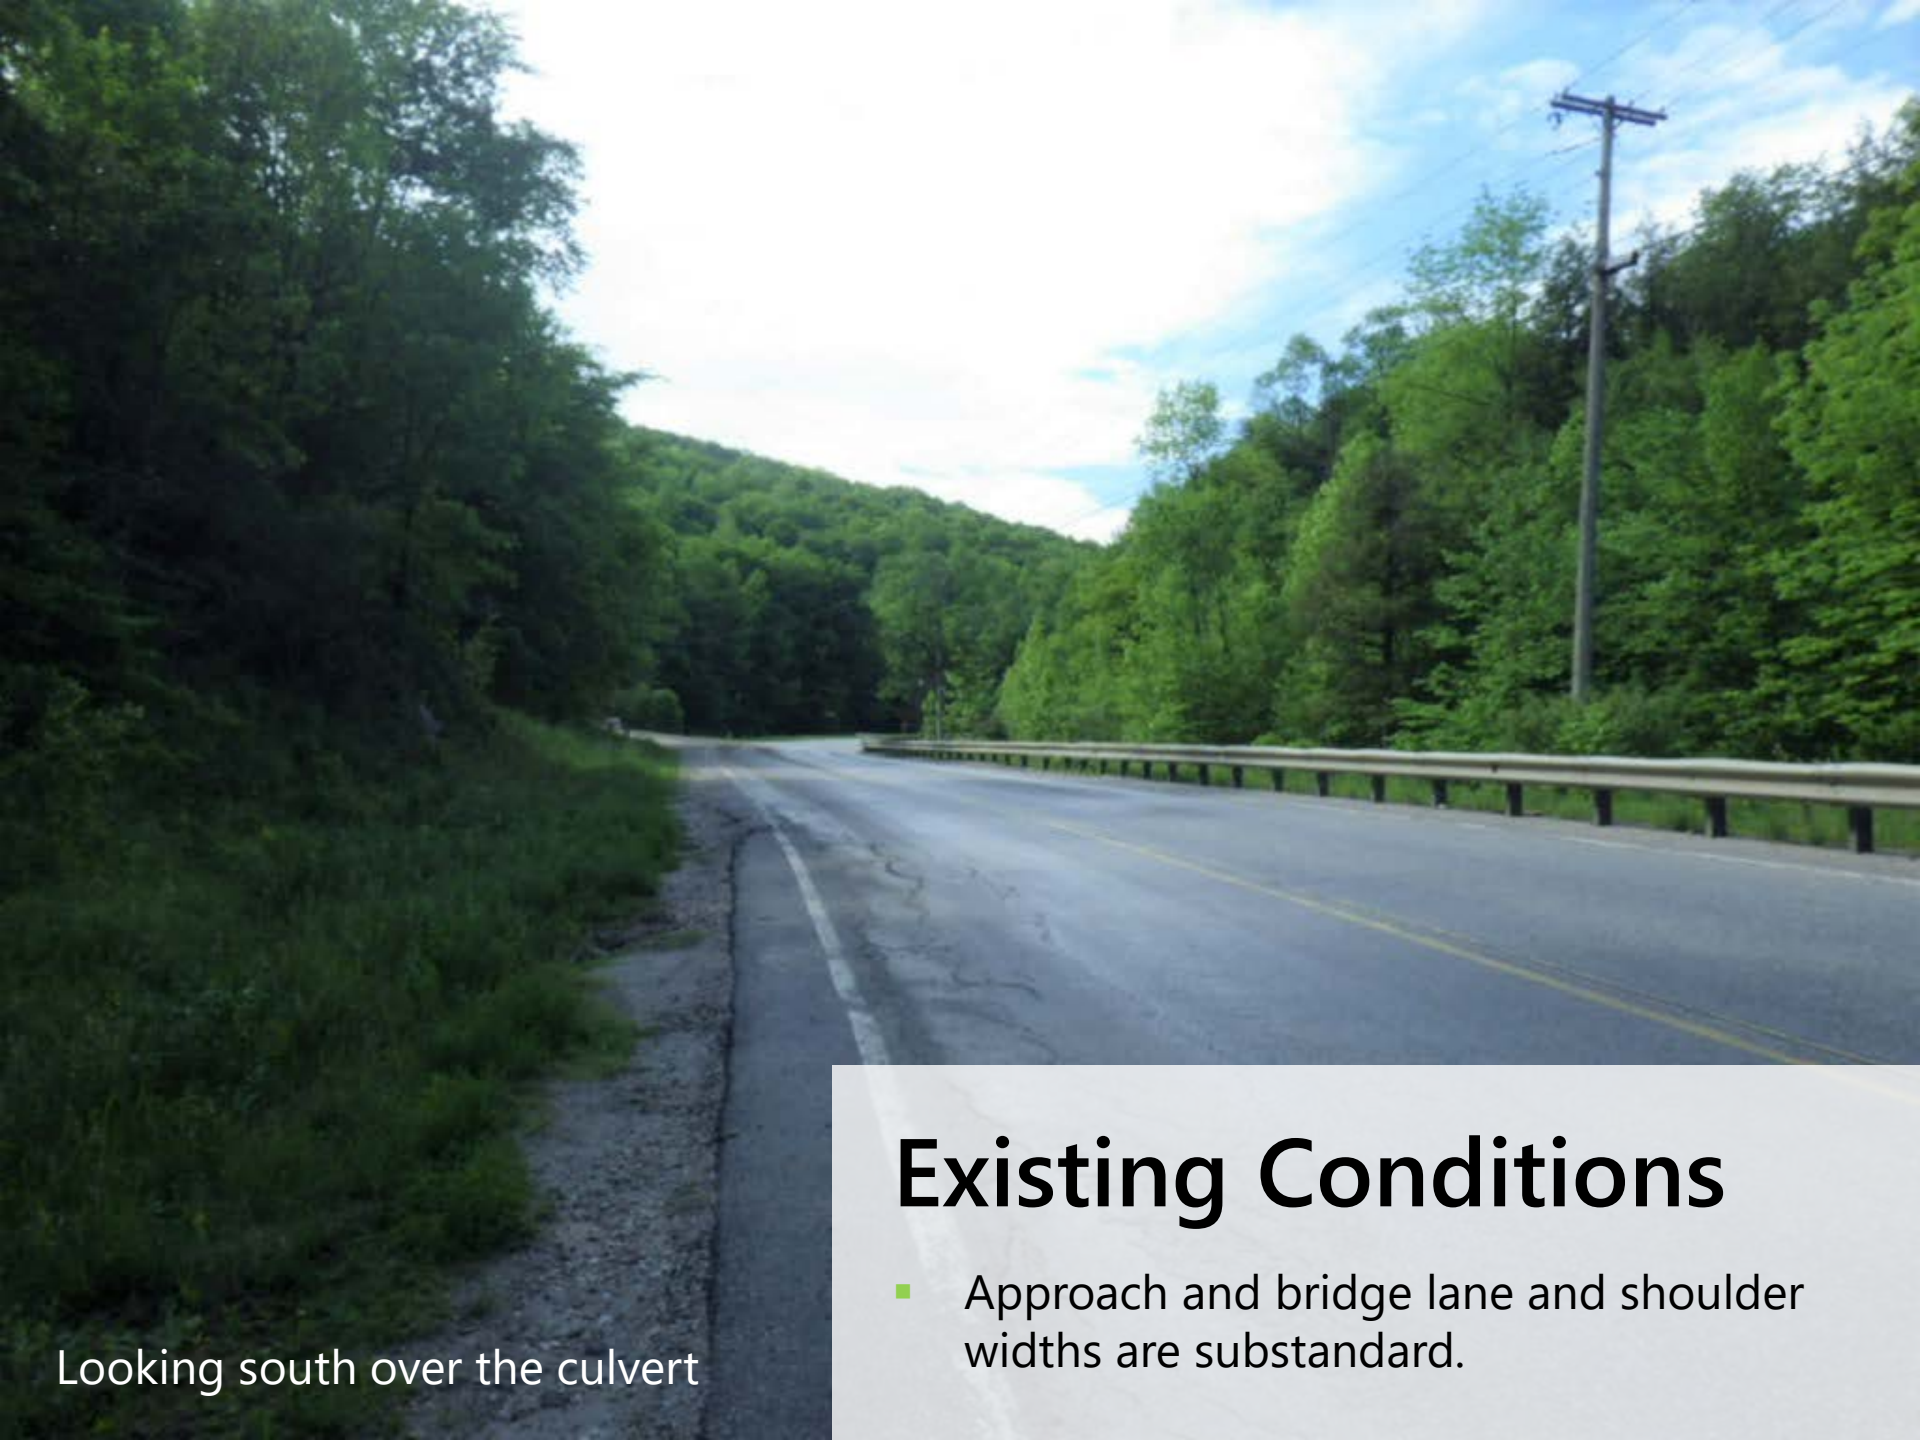
Looking south over the culvert

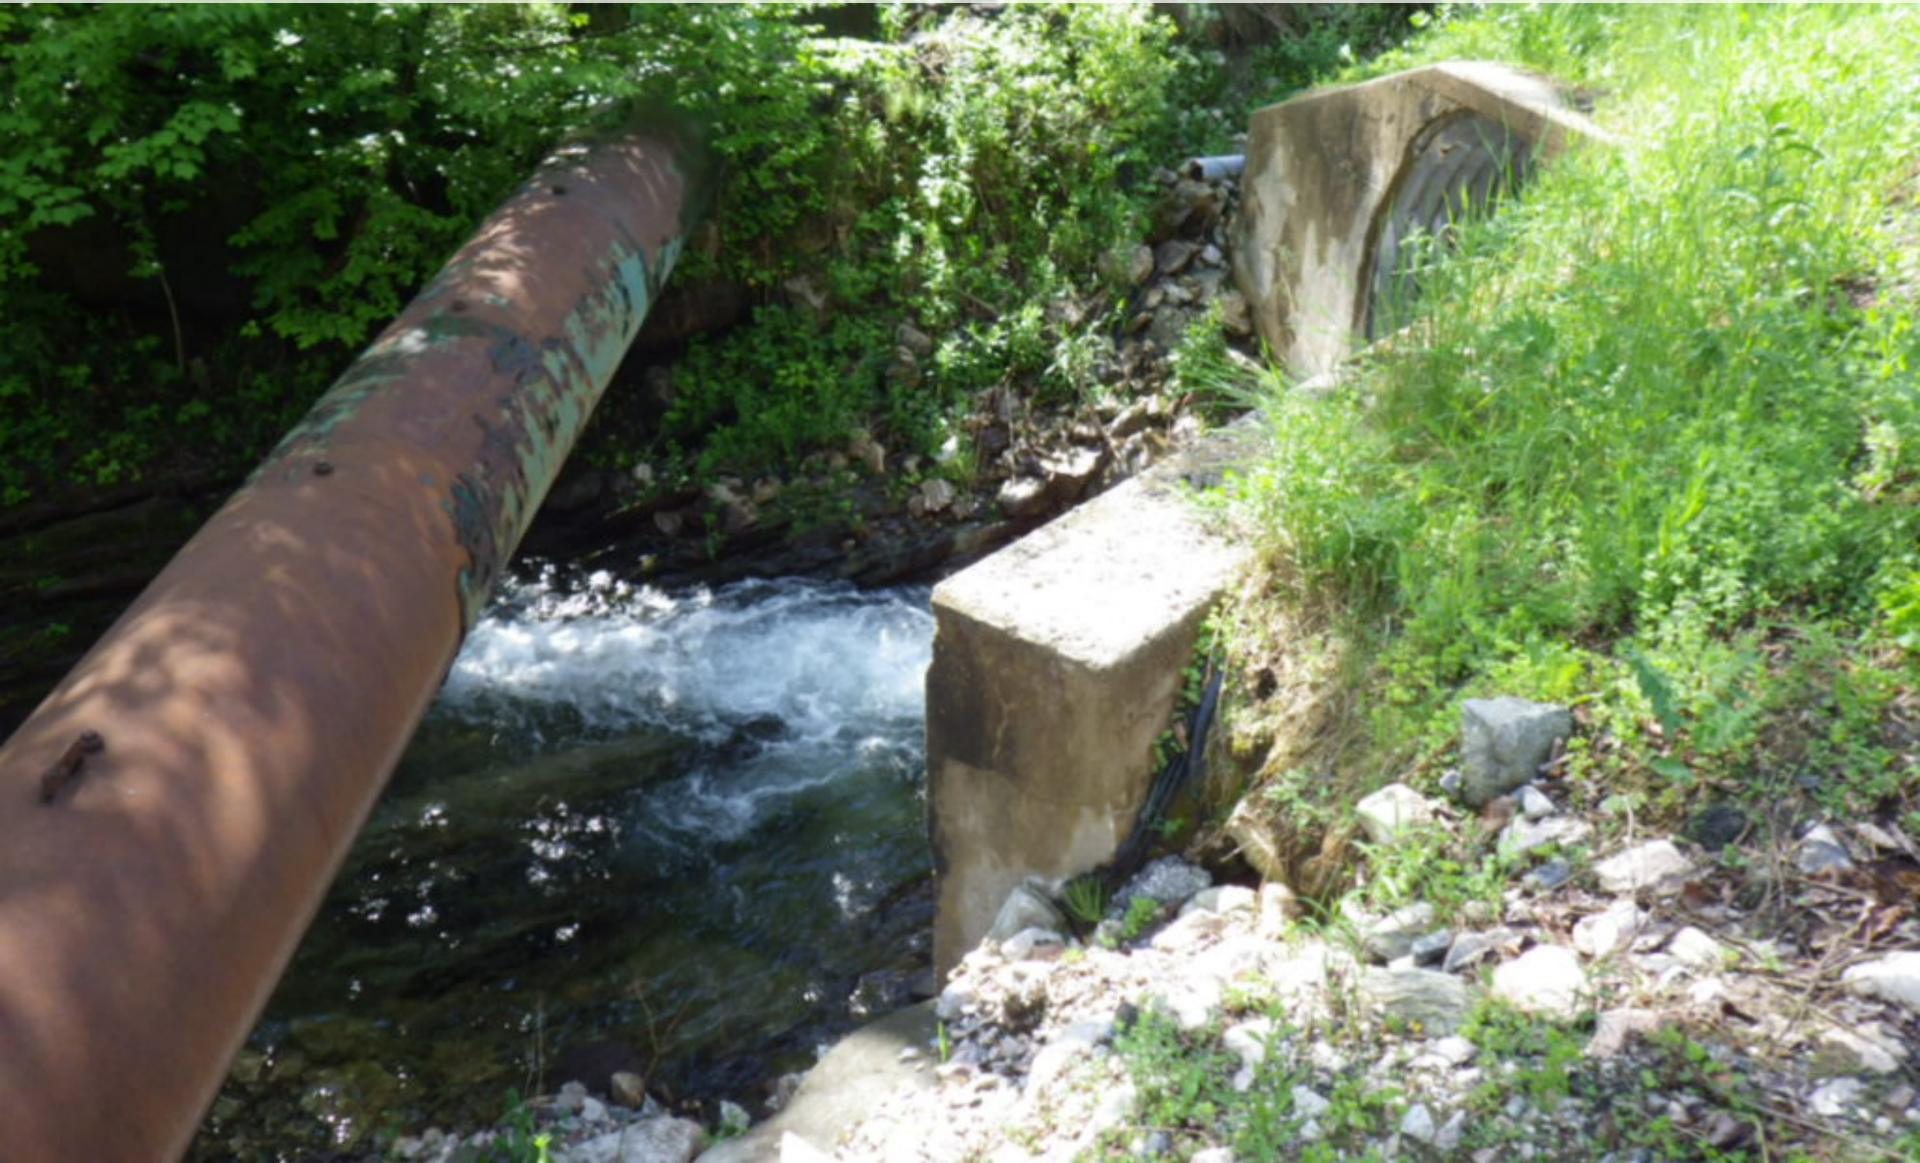
Close proximity of Killington water pipe

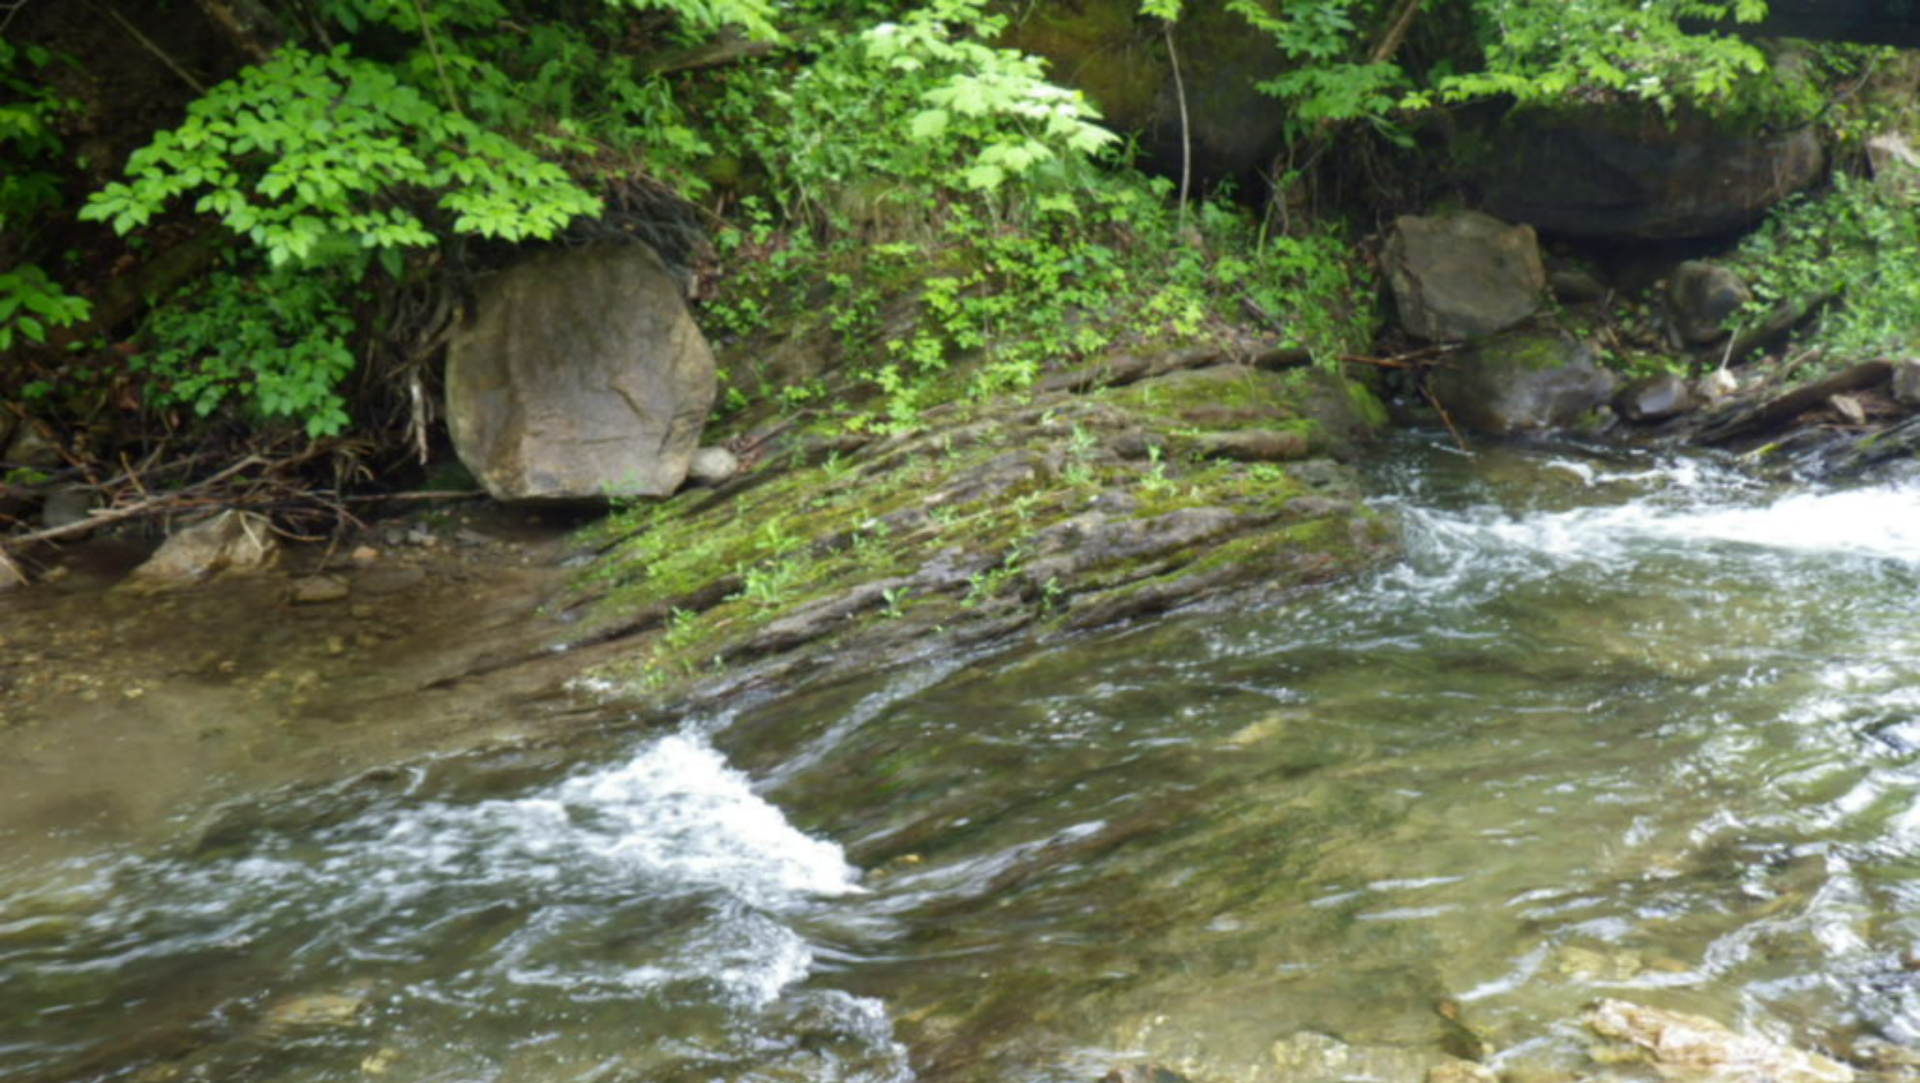
Exposed bedrock

- Not recommended because of observed high levels of bedrock.

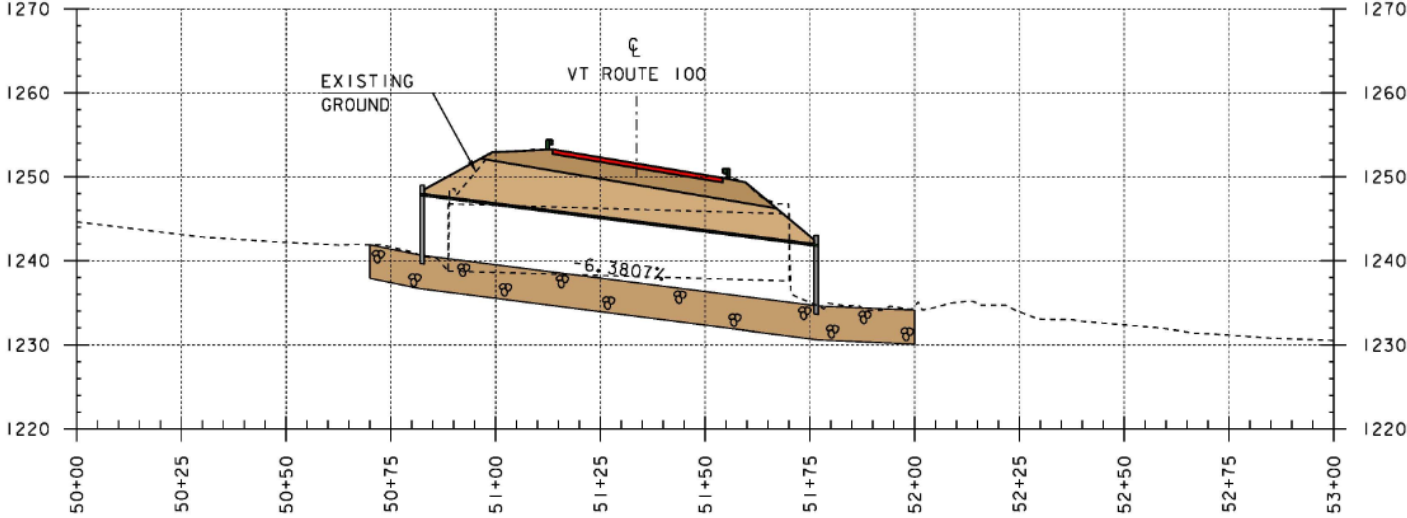
SCALE: HORIZONTAL 1"=20'-0"
VERTICAL 1"=10'-0"

CULVERT 115 PROFILE

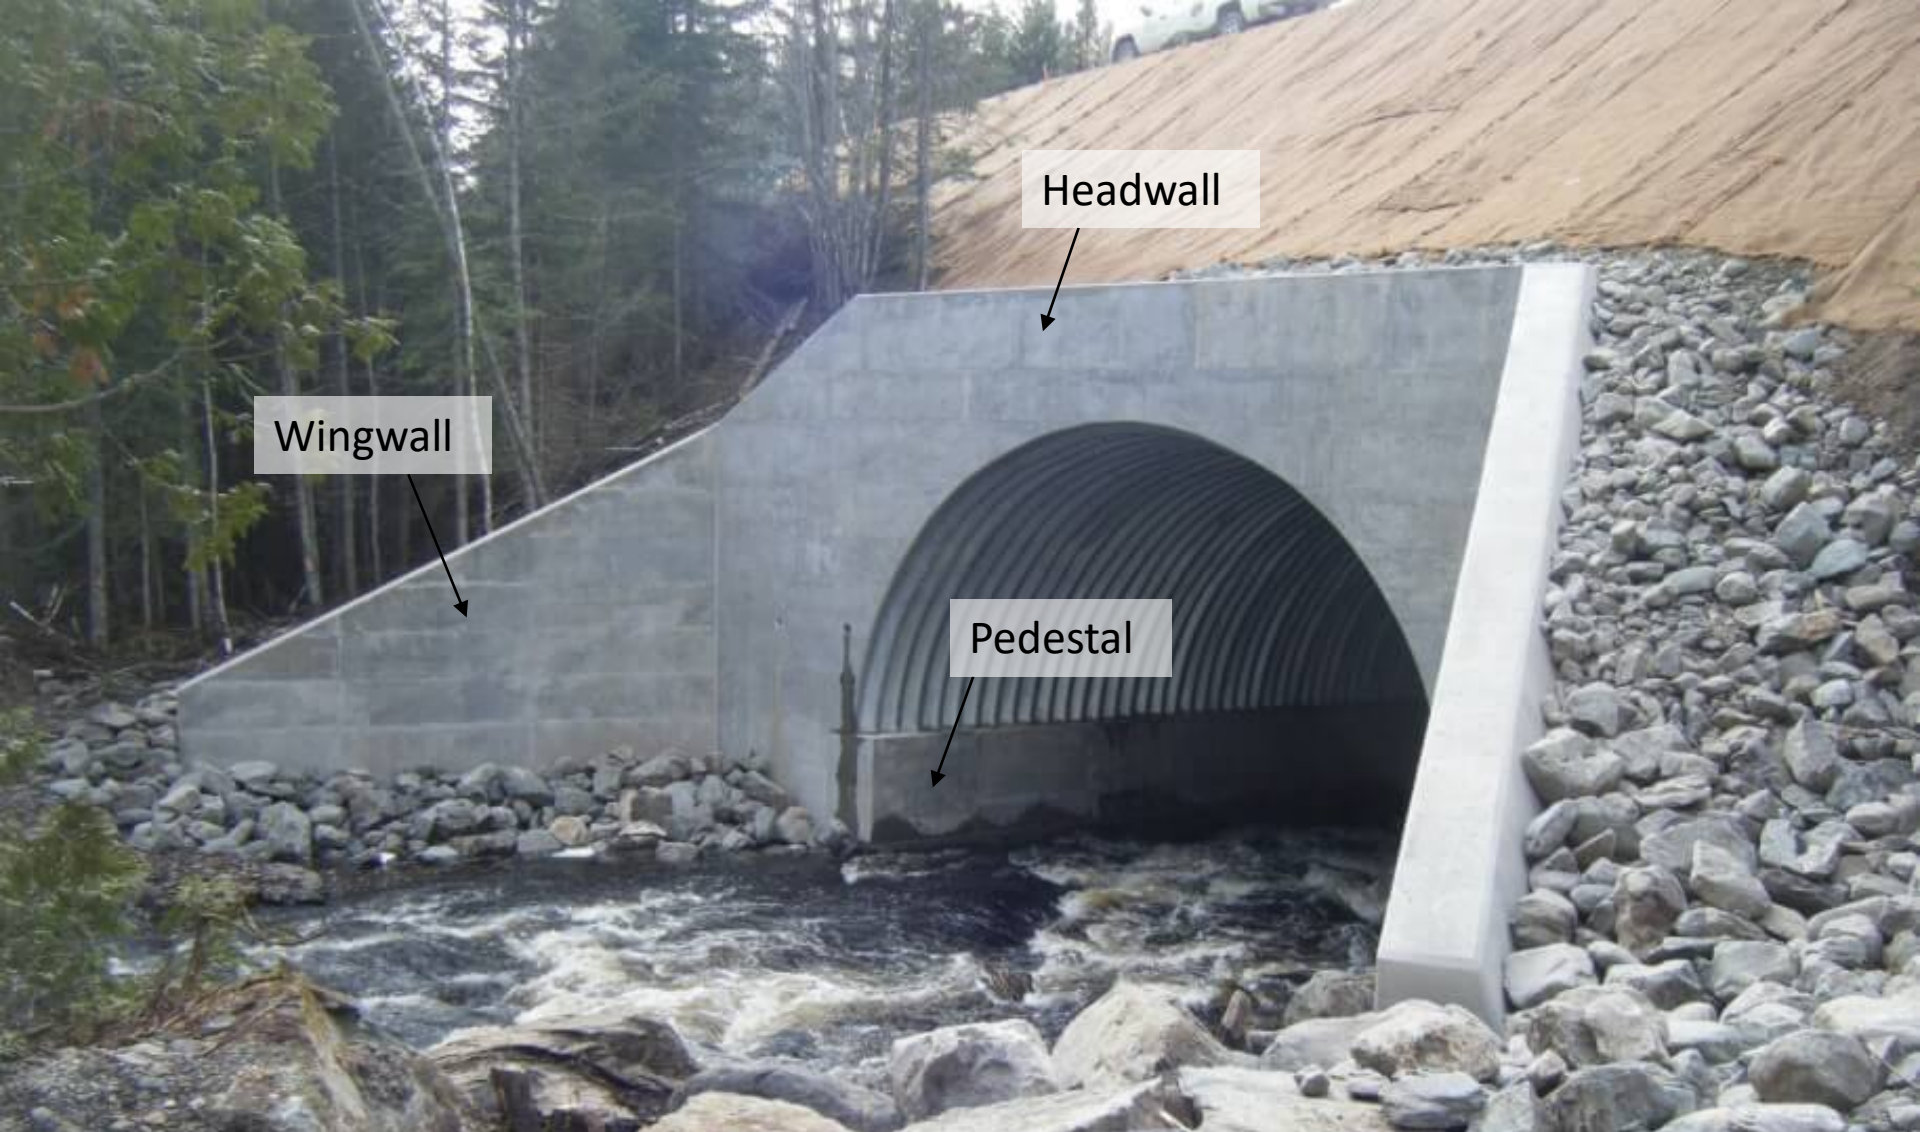
Example of Proposed Alternative

- New Metal Arch Concrete Pedestal Combination Structure
 - 20' span arch, 6'-4" height, 45° skew to roadway
 - Concrete pedestals founded on bedrock
 - Lowest up front and annualized cost
 - 75 year design life
 - Improved aquatic organism passage
 - Shorter construction schedule
