Barre Town BF 0169(12)
Regional Concerns Meeting
VT Route 110 – Bridge #21 over Jail Branch

January 14, 2020

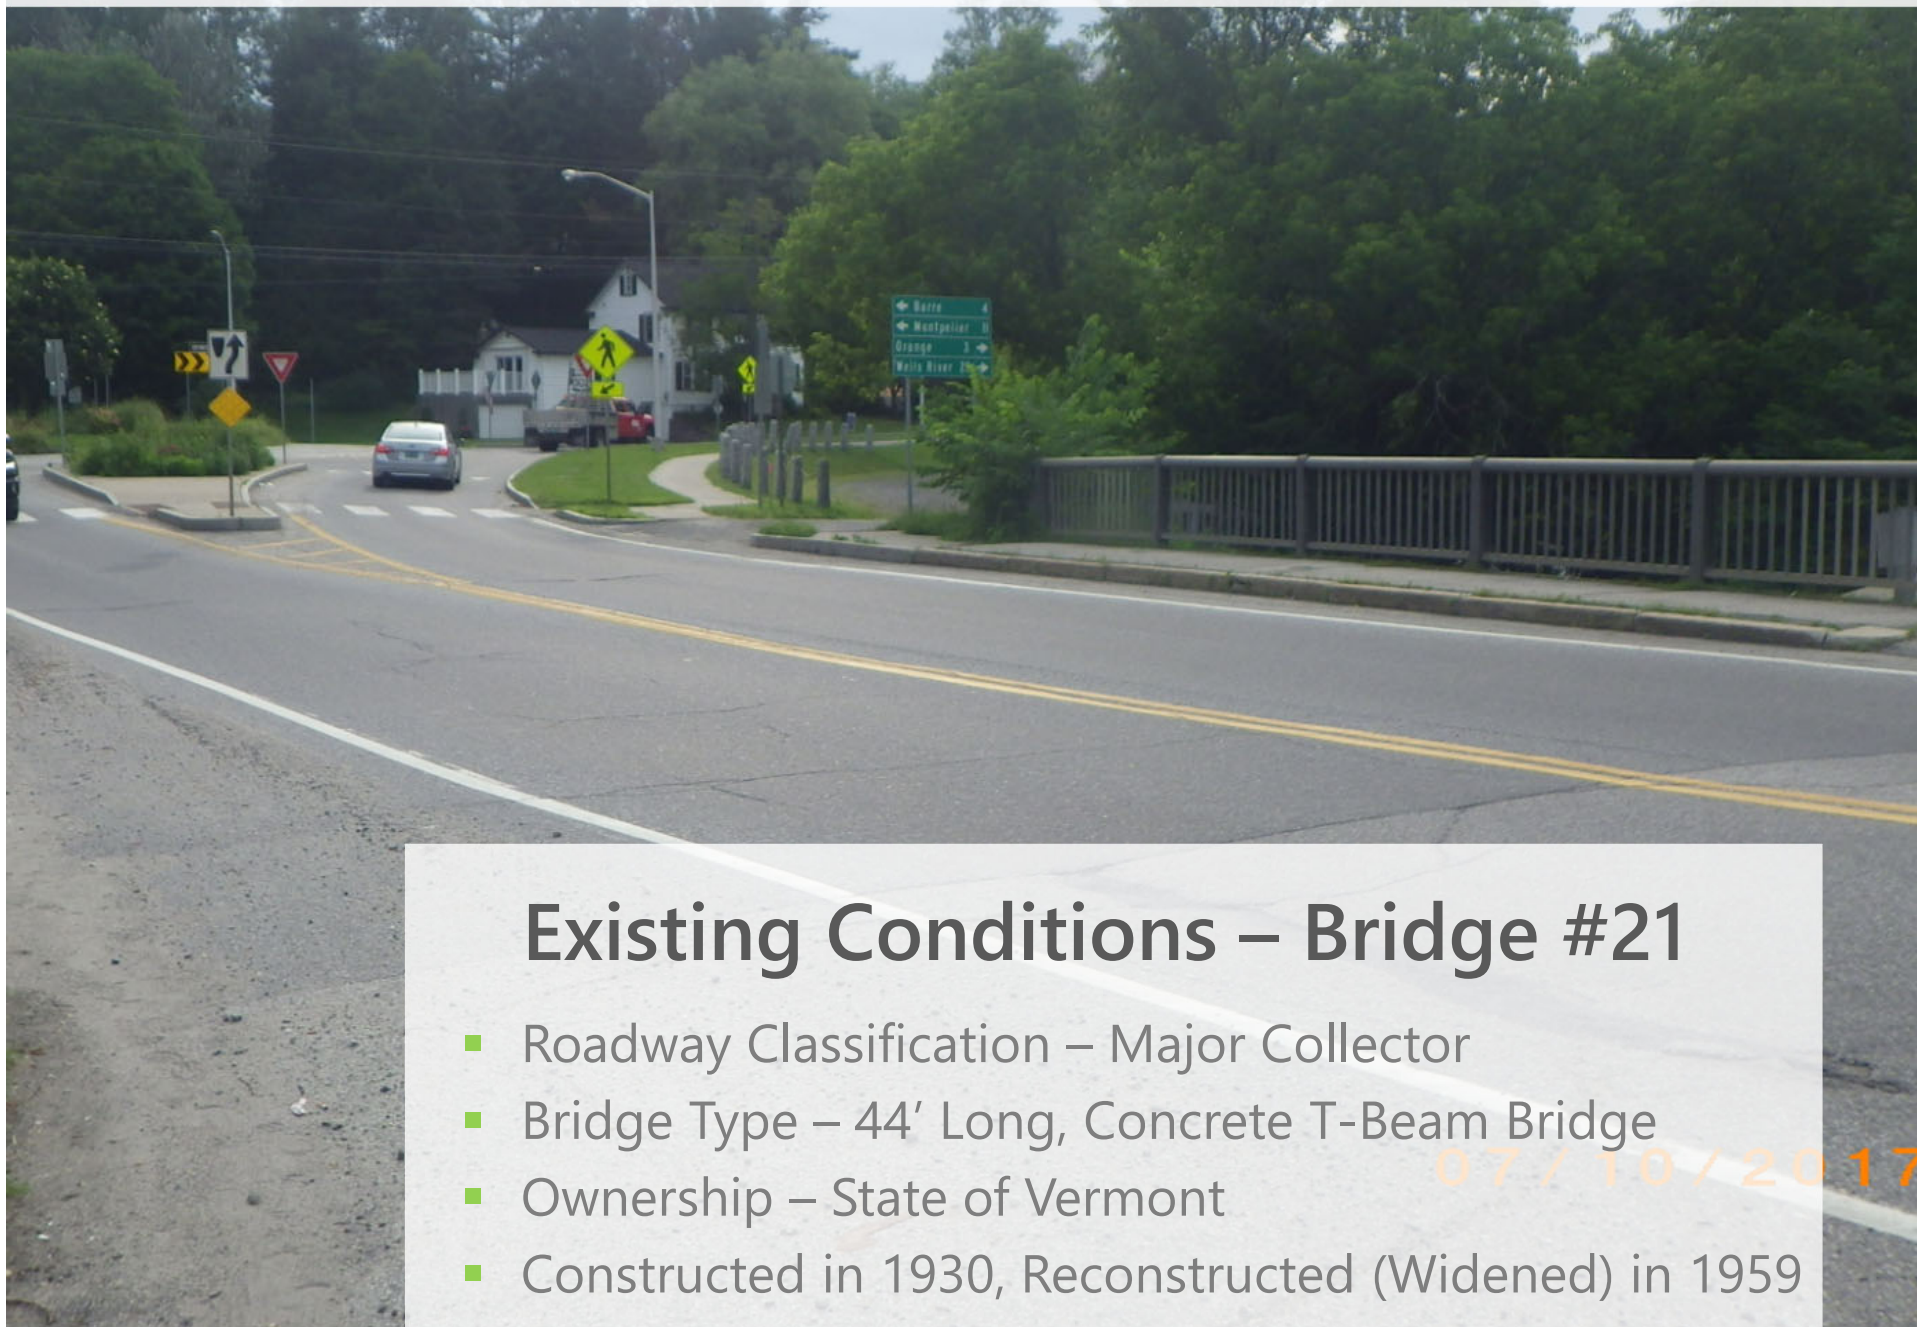
Looking North over Bridge 21

- Roadway Classification – Major Collector
- Bridge Type – 44' Long, Concrete T-Beam Bridge
- Ownership – State of Vermont
- Constructed in 1930, Reconstructed (Widened) in 1959

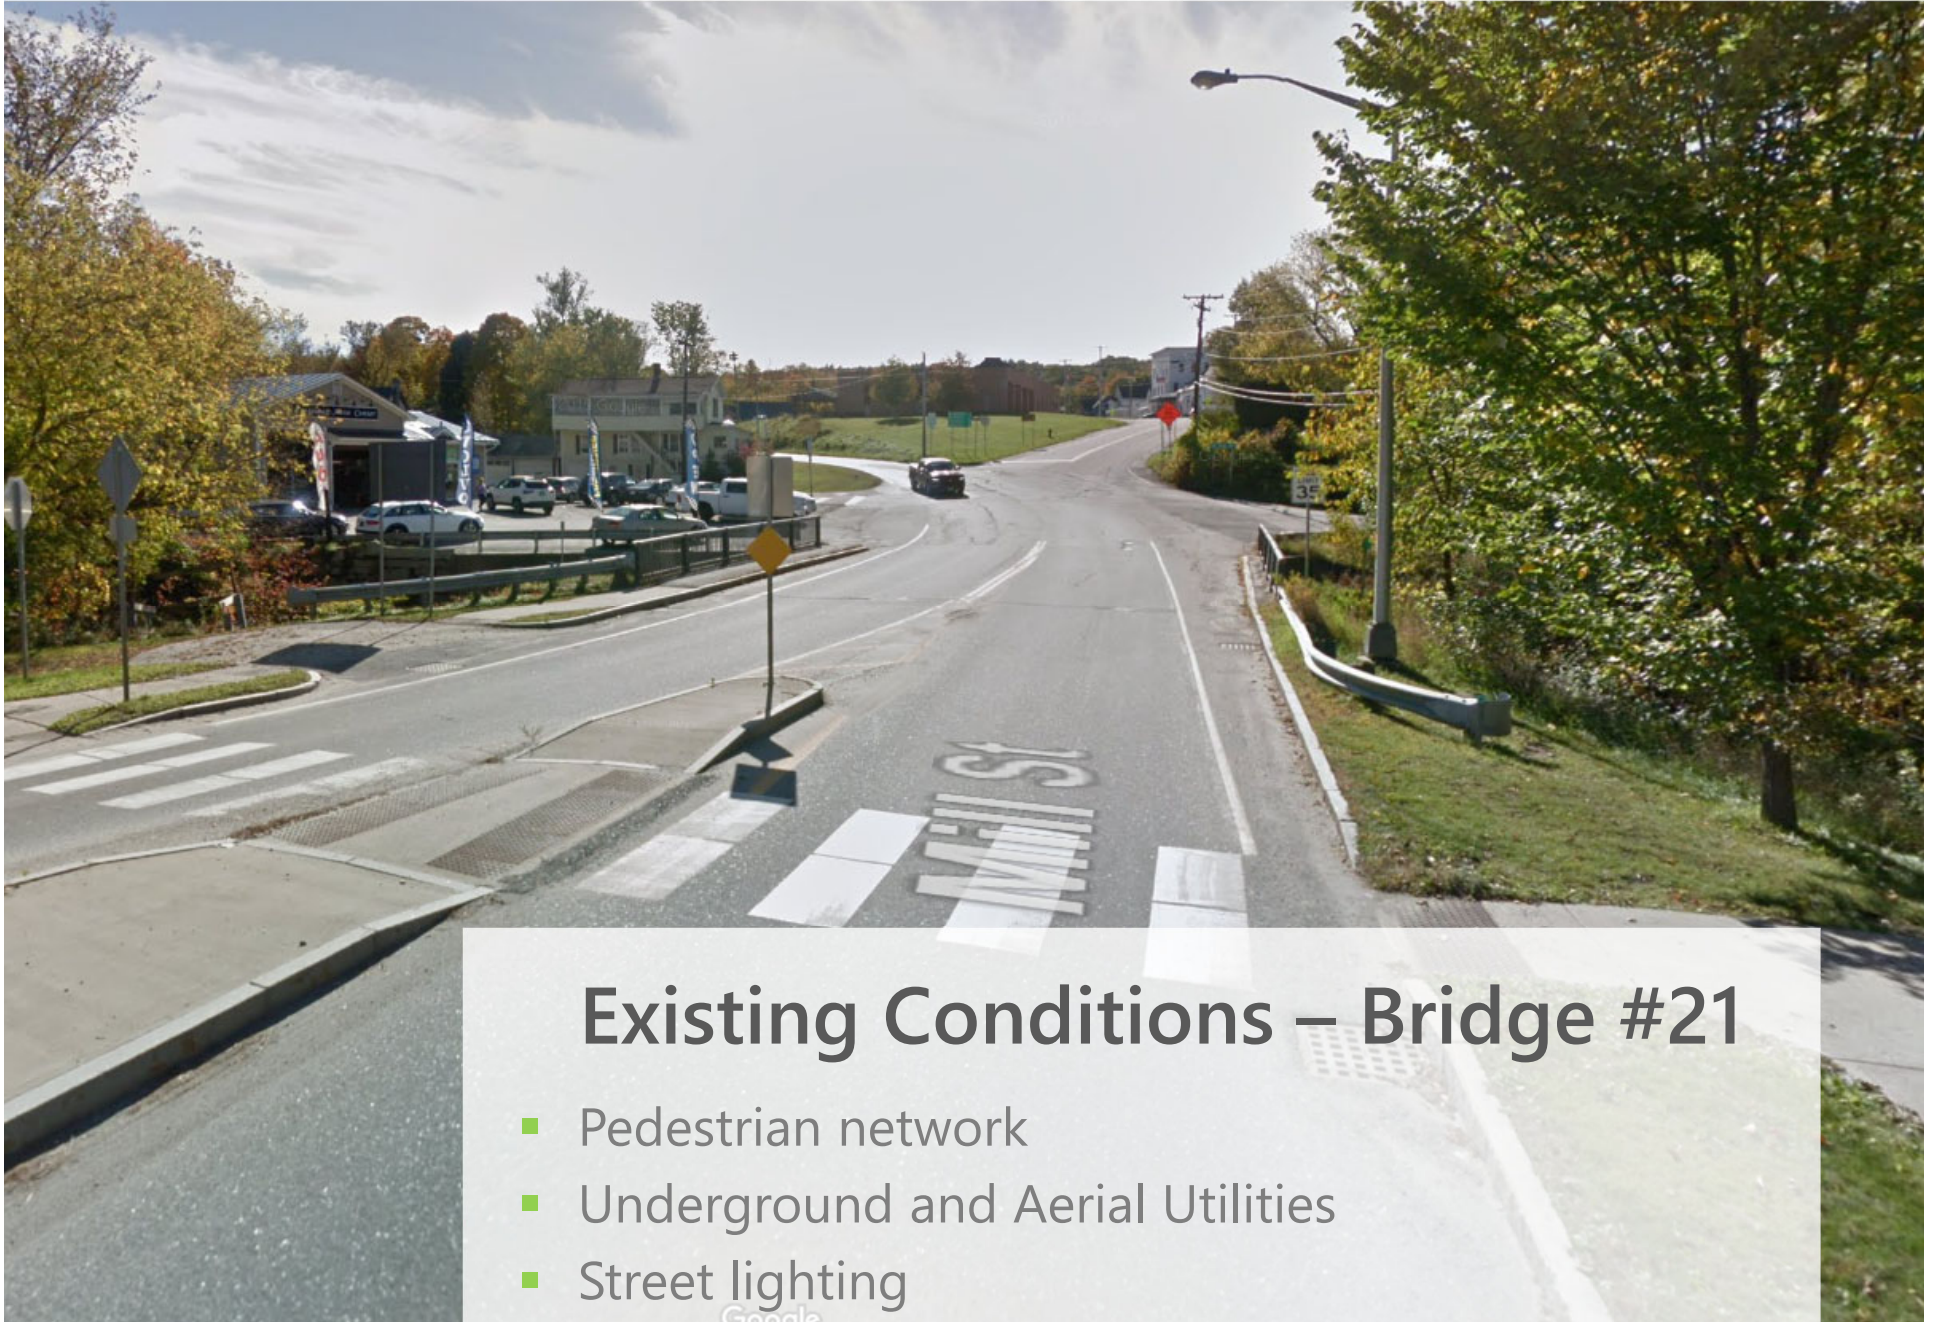
Looking South over Bridge 21

- Pedestrian network
- Underground and Aerial Utilities
- Street lighting

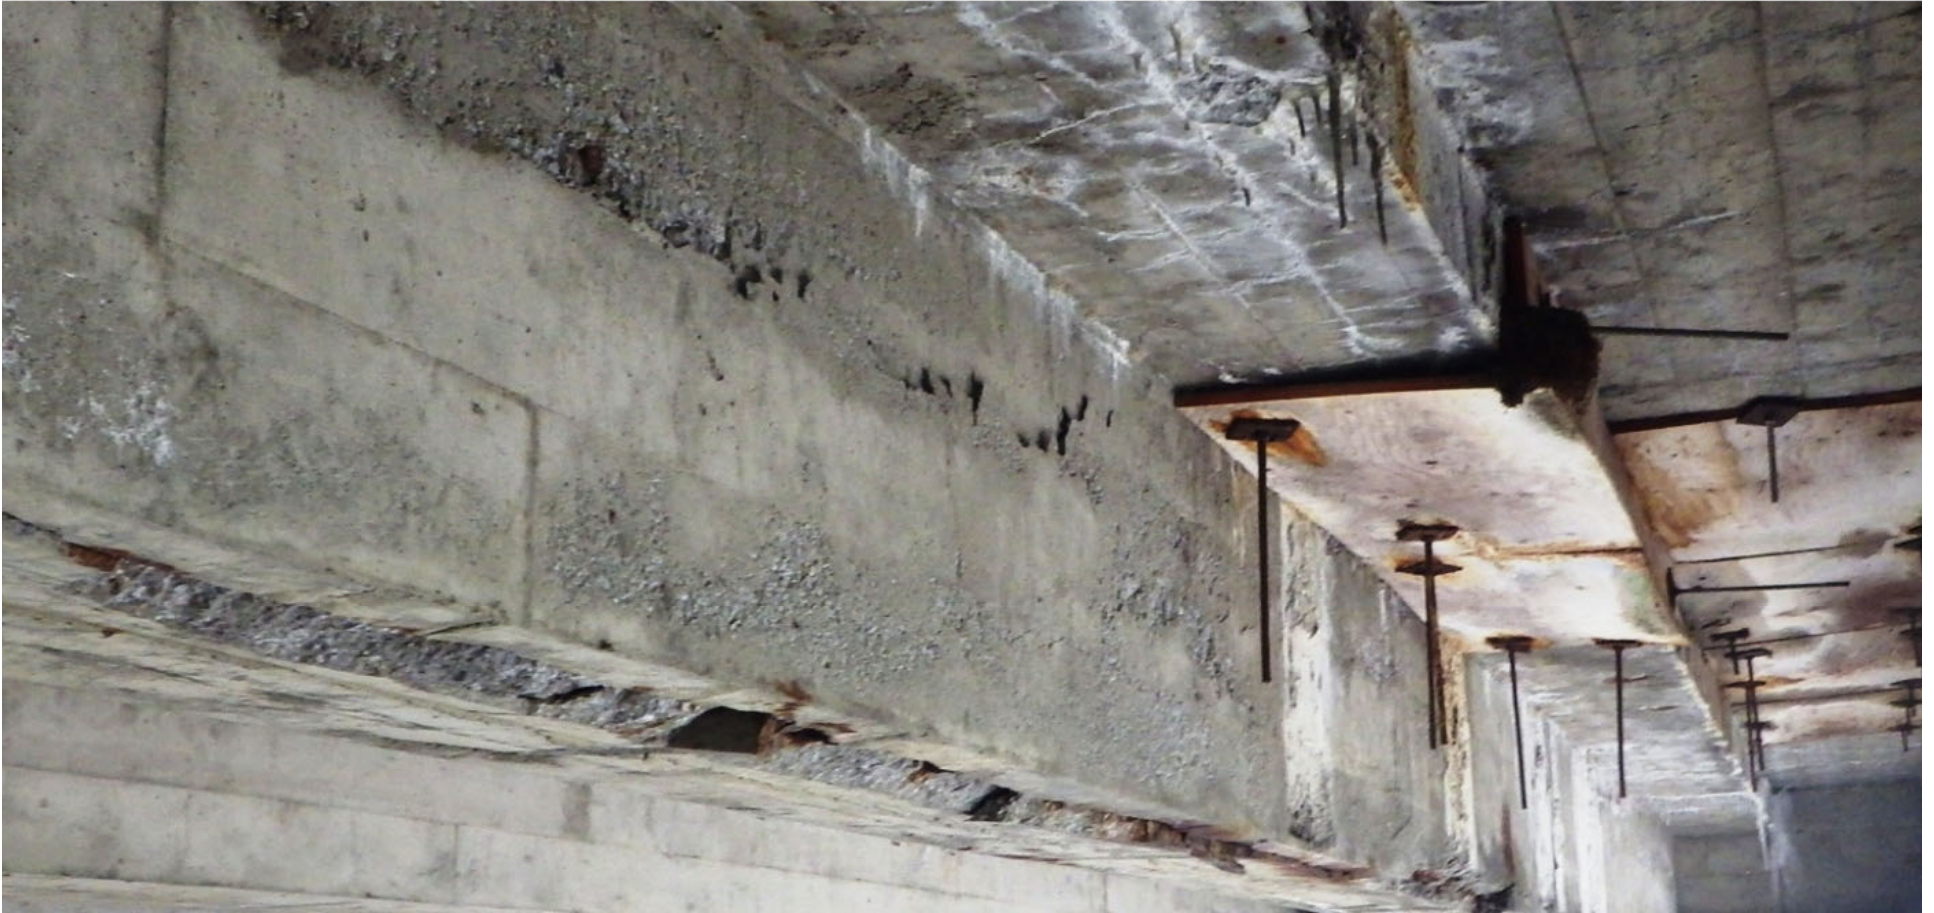
Condition Ratings

- Deck Rating 5 (Fair)
- Superstructure Rating 5 (Fair)
- Substructure Rating 6 (Satisfactory)

- Wearing Surface: There is transverse and longitudinal cracking in the wearing surface due to a potential full depth failure of the deck.
- Deck: There are areas of heavy saturation, cracking, delaminations and staining in the deck. A full depth failure is eminent at any time in Bay 2.
- Beams: There are nine T-Beams. Four of the beams have spalling. The abutting beams have spalling with rusted rebar exposed and minor section loss in the reinforcing bars. The remaining T-beams have cracking and some saturation at their ends.
- Abutments: There are voids in the laid-up stone portions. There are cracks and some scaling in the concrete portions.

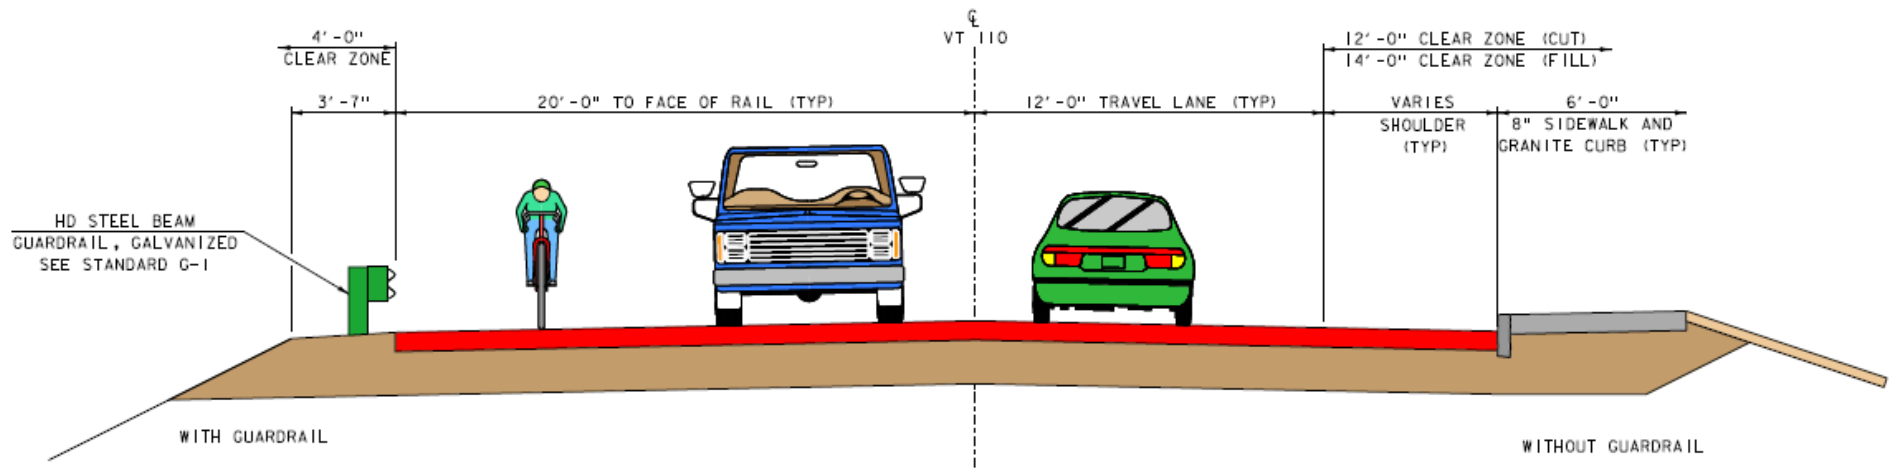
Proposed Typical Section - Roadway

PROPOSED VT 110 TYPICAL SECTION

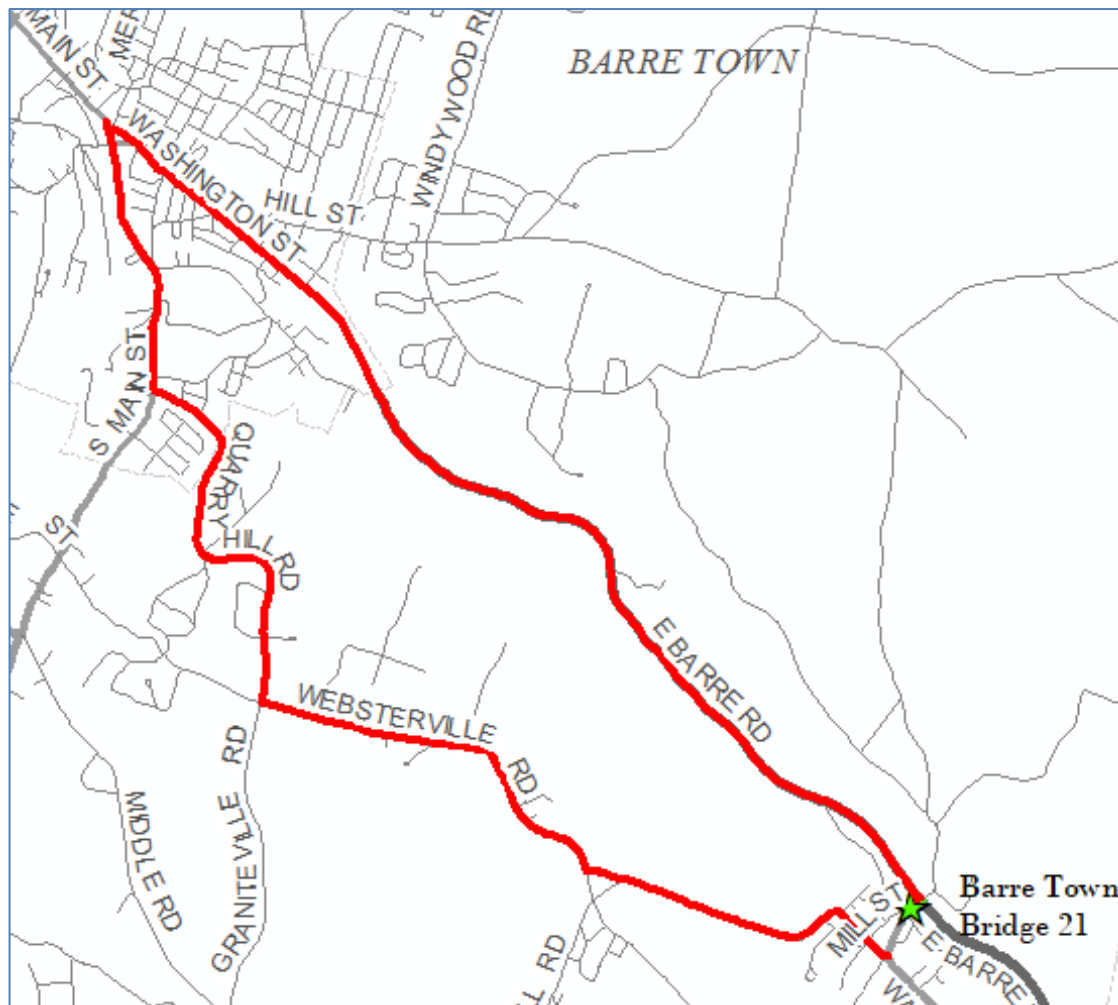
Traffic Control – Offsite Detour

- VT Route 110, to Websterville Road, Quarry Hill Road, Quarry Street, South Main Street (VT Route 14), and US Route 302, back to VT Route 110

- Through Route: 0.2 miles
- Detour Route: 8.4 miles
- Added Distance: 8.2 miles
- End-to-End Distance: 8.6 miles
