**STATE OF VERMONT
AGENCY OF TRANSPORTATION**

Scoping Report

**FOR
Braintree BF 0241(51)**

VT Route 12, BRIDGE 47 OVER AYERS BROOK

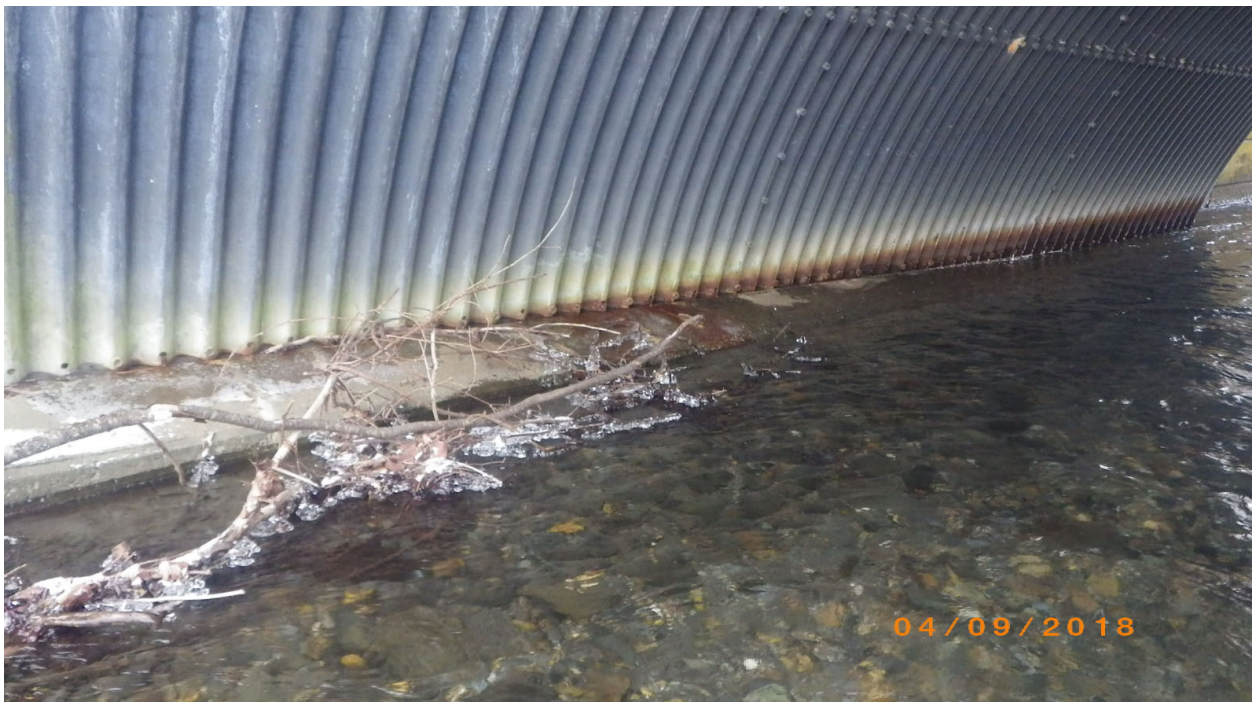
Picture 6: Rust Staining on metal pipe along water line

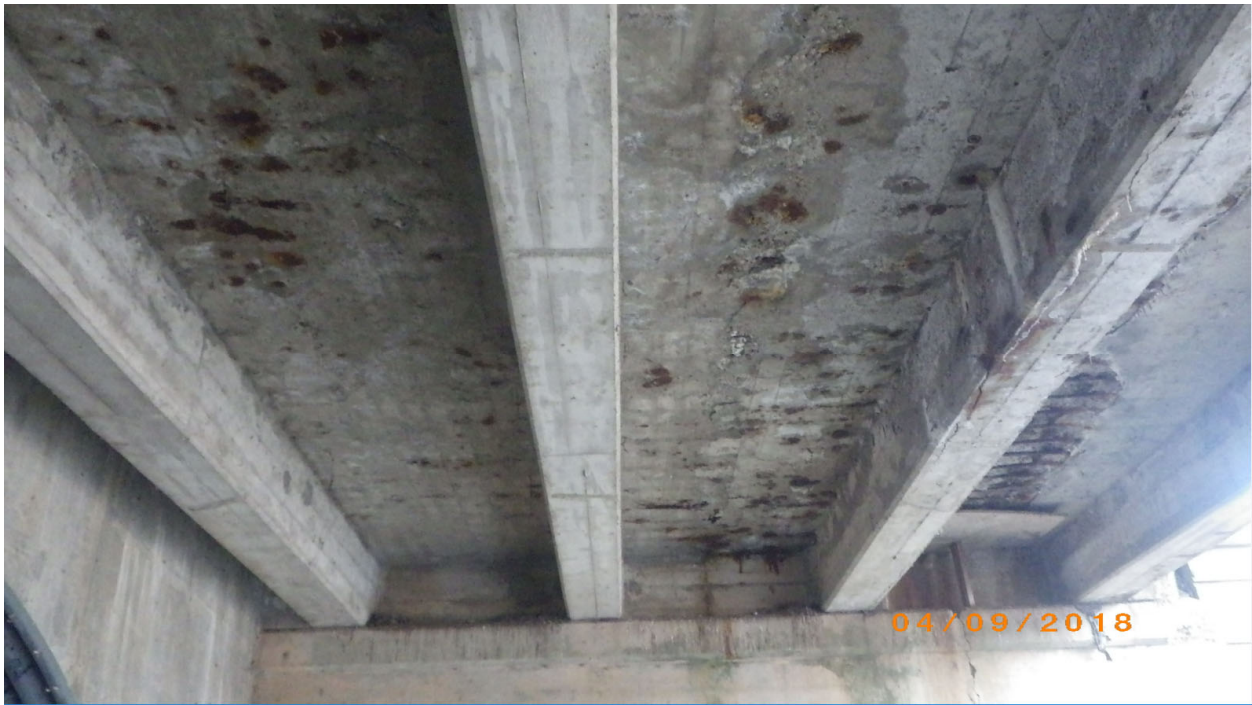
Picture 7: Rust Staining on underside of T-Beam deck

1. The bridge deck on the T-Beam portion of the bridge is in poor condition and has widespread deterioration and saturation on the soffit. The T-Beams have scattered longitudinal cracking with large delaminations. Additionally, there is saturation and scattered small areas of rust staining throughout. There is minor spalling at the center of beam 1 with exposed reinforcing. Some of the spalling has reached the pavement, and full depth holes may occur at any time.
2. The abutments and wingwalls have fine map cracking throughout with light staining. The downstream, wall of abutment 1 has extensive spalling with loose granular concrete.
3. There are substandard horizontal curves at both approaches and a substandard vertical sag curve at the approach on the North end of the bridge.

Due to the extent of deterioration of the existing T-Beams and rust staining and exposed rebar throughout the T-Beam sections, concrete patching of the beams and soffit is not recommended. Due to the saturation and amount of deterioration, concrete patching would be expected to last less than 10 years.

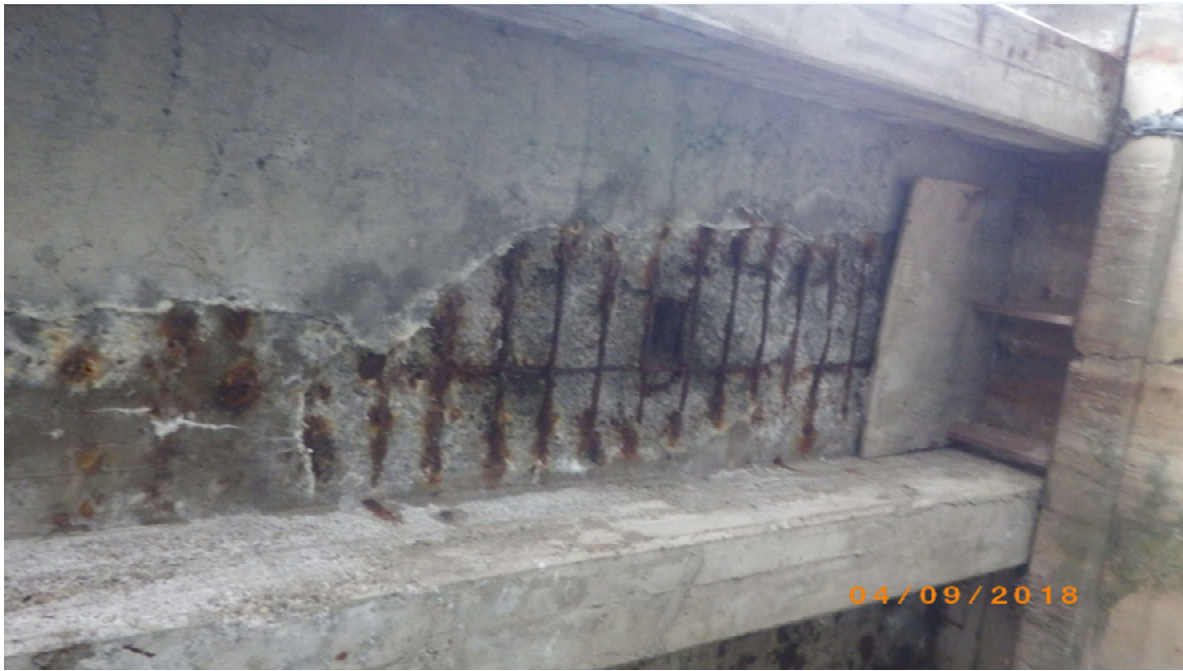
Picture 11: Deck Deterioration

4/25/2017 – Due to wide spread deterioration and saturation, a new deck should be considered or have an extensive rehabilitation project. The spalling in the downstream bay near abutment 1 has now reached the asphalt layer, penetrating 14" +/- beyond the soffit. A full depth hole could occur at any time and preventive measures need to be taken. ~JW/AC

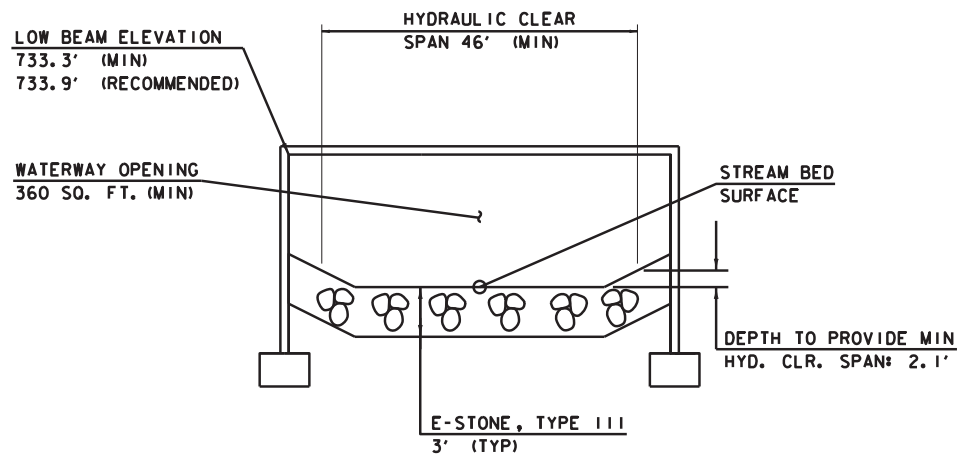
TYPICAL SECTION
TRAPEZOIDAL OPENING

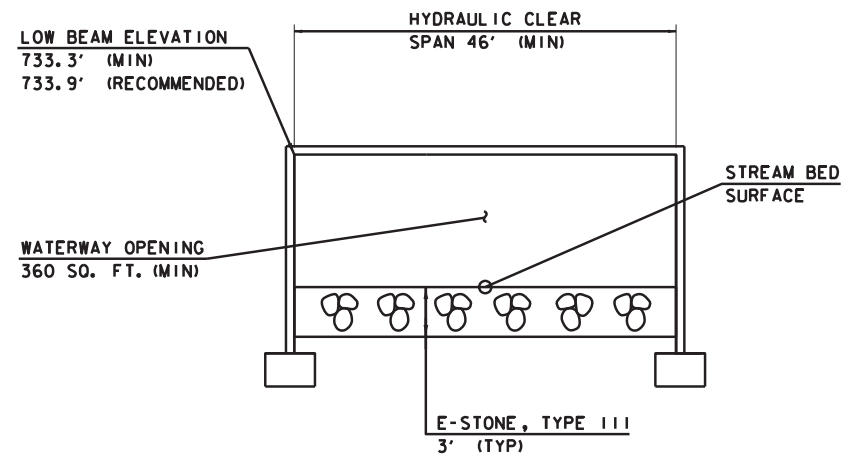
TYPICAL SECTION
RECTANGULAR OPENING

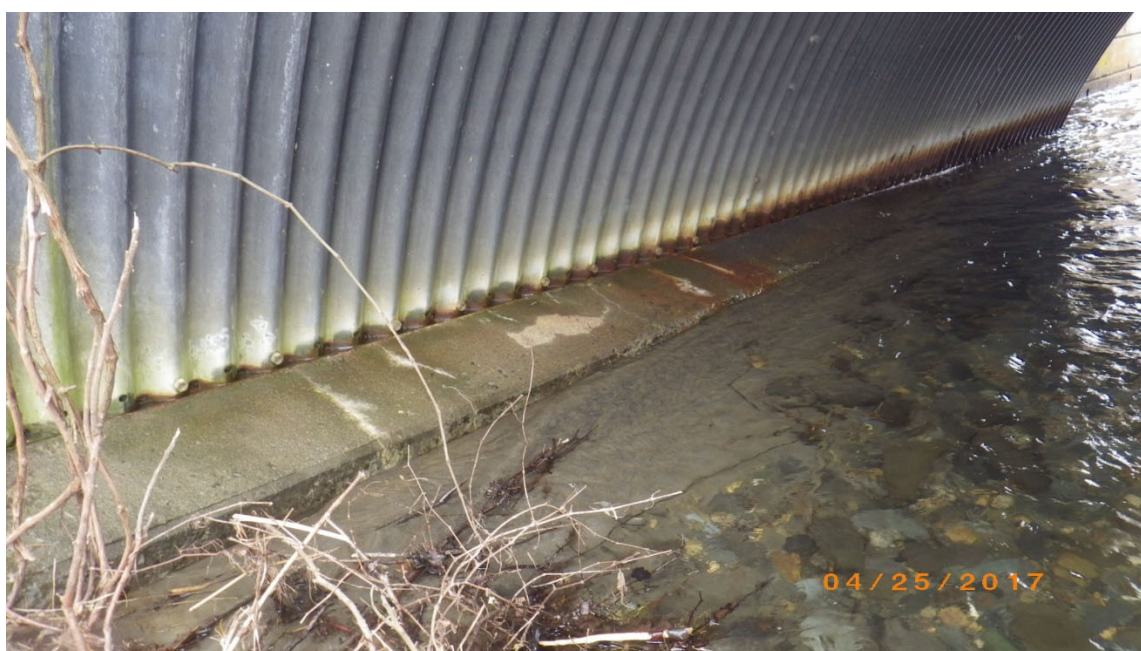
Figure 3.1: Cobbles within streambed and sediment deposition at abutment foundation of the pipe arch.

A preliminary site visit was conducted on September 24, 2018 to assess possible obstructions inhibiting boring operations and to make any other pertinent observations about the project. The structure consists of two bridge types, a concrete T-beam span and a corrugated metal pipe arch. All sections of the abutments appear to be founded on spread footings. The streambed material appears to contain a significant amount of cobbles with some sediment deposits along the abutment foundations shown in Figure 3.1. There are occasional boulders and no bedrock visible in the streambed or in the vicinity of the bridge. There are overhead utilities that cross over the road at the project site, shown in Figure 3.2, however these are not anticipated to impact boring operations.

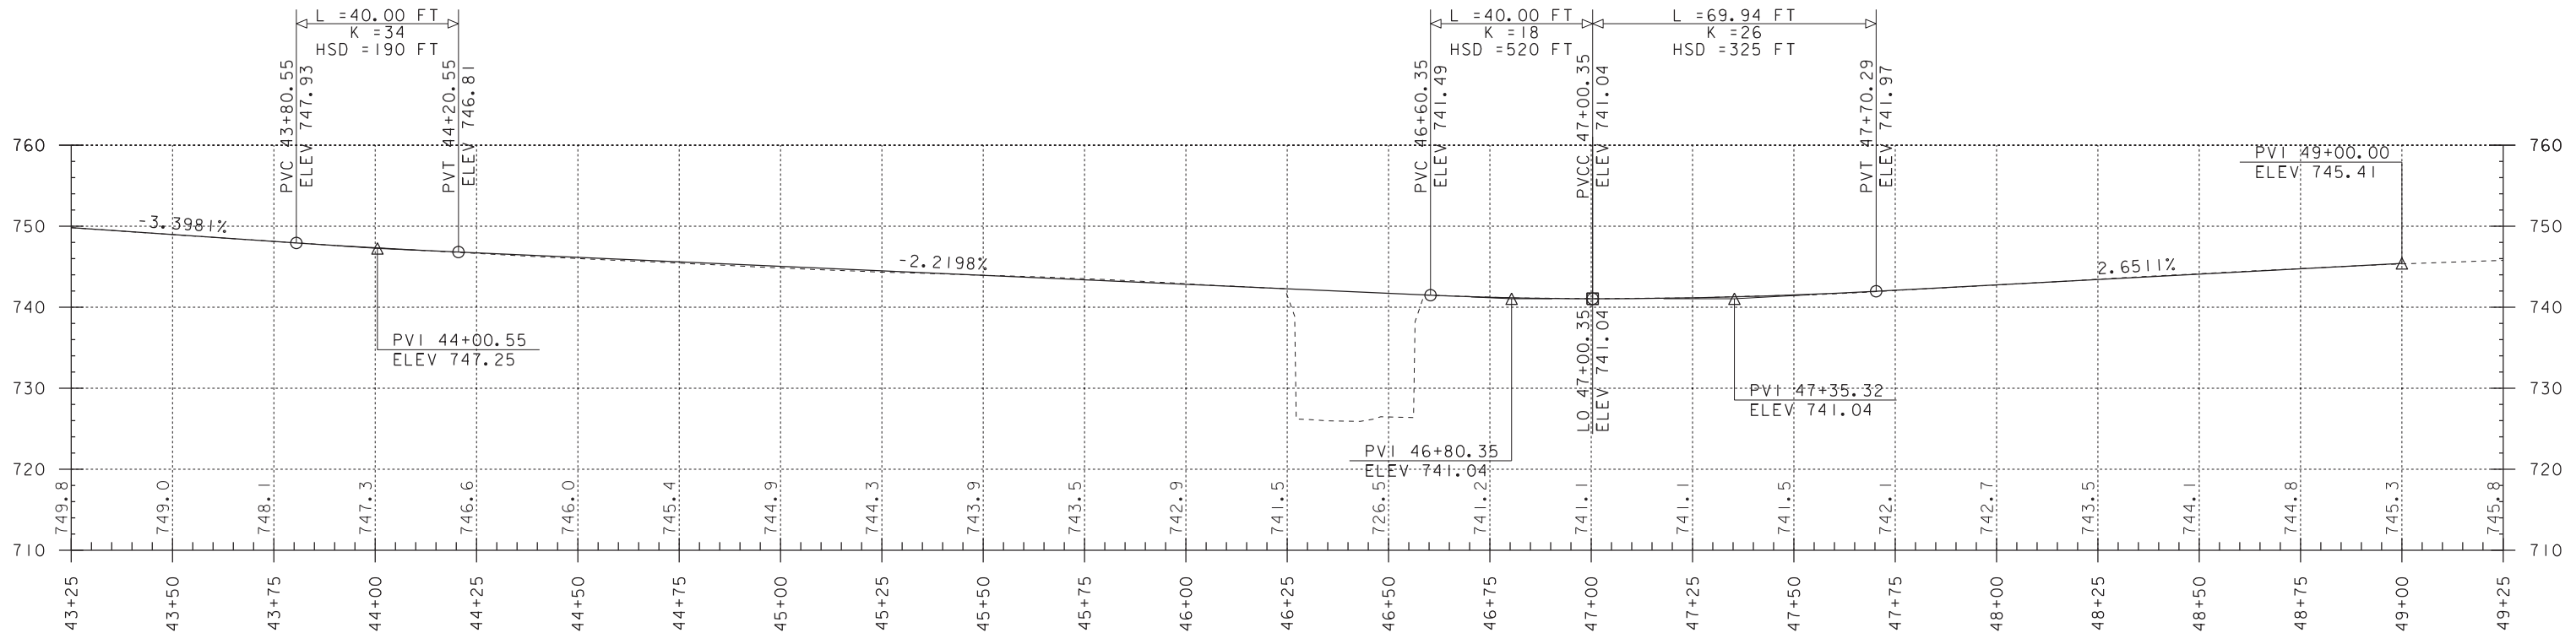
VT ROUTE 12 PROFILE

SCALE: HORIZONTAL 1"=20'-0"
VERTICAL 1"=10'-0"

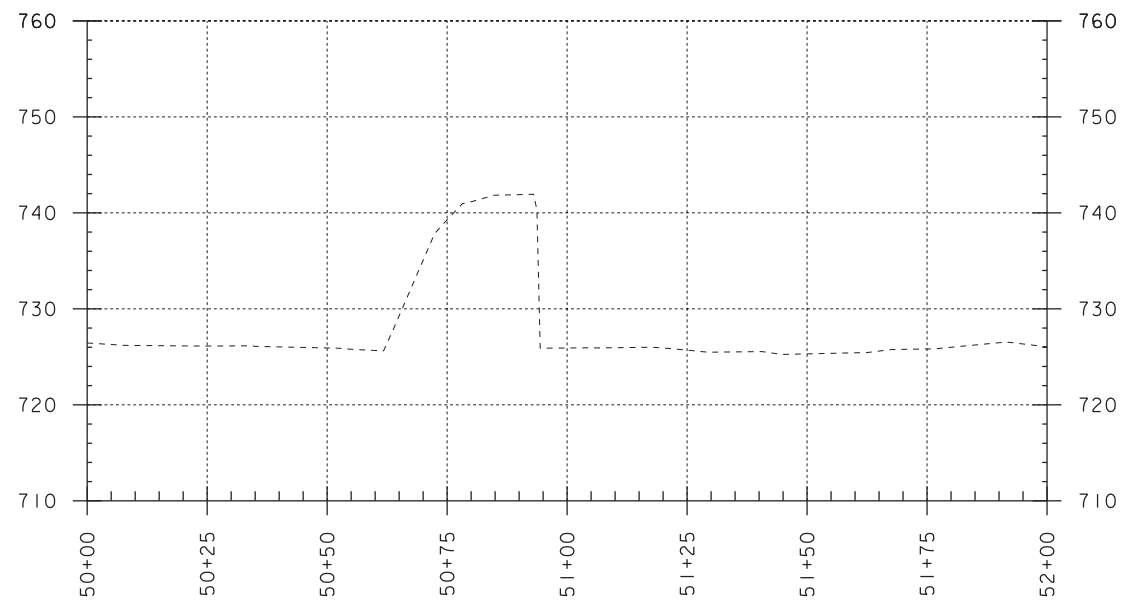
AYERS BROOK PROFILE

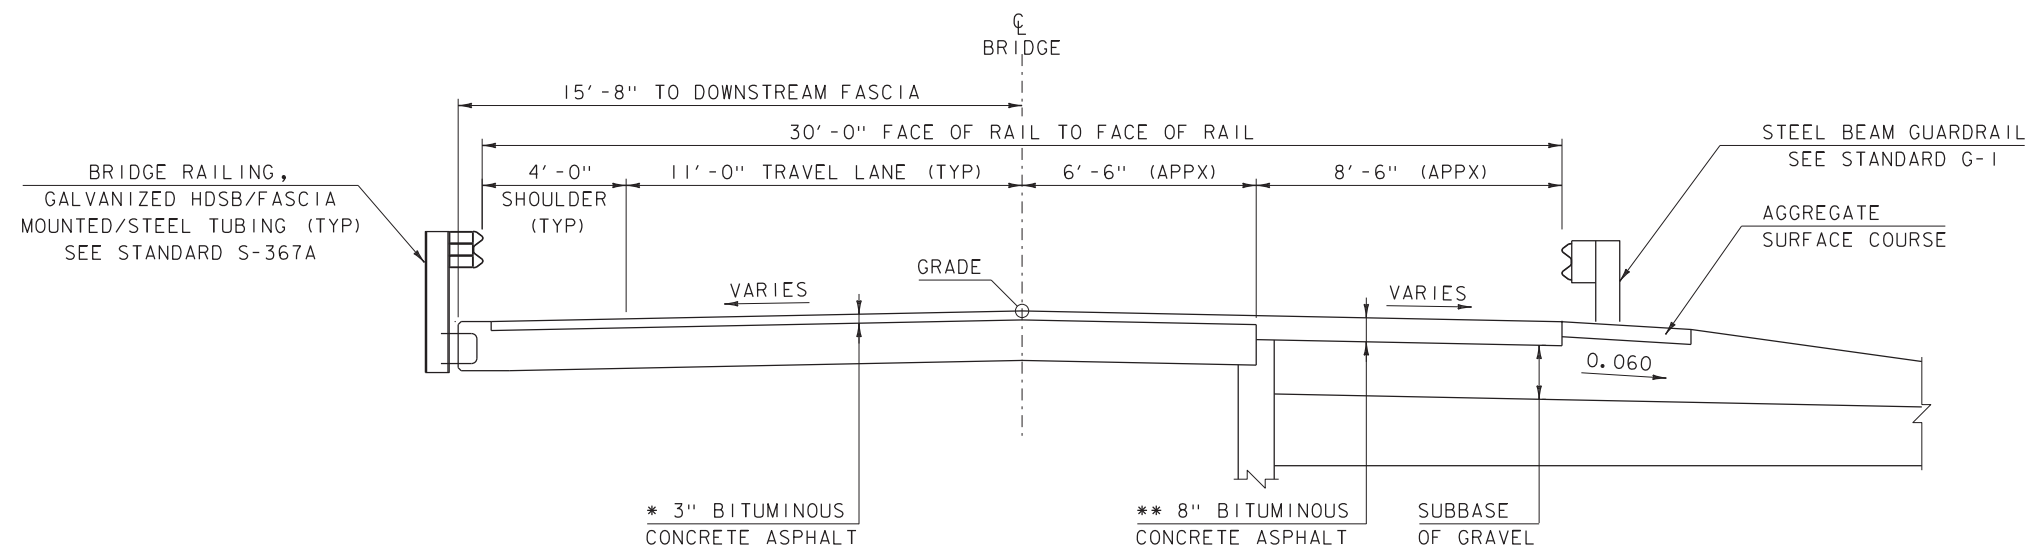
PARTIAL SUPERSTRUCTURE REPLACEMENT TYPICAL SECTION

A partial superstructure replacement would include replacement of the T-Beams with a new superstructure on the existing abutments. Replacement of the deck portion only would not be considered as the T-Beams were cast integrally with the deck and removing the deck from the beams would be cost prohibitive. For this option, the concrete footing for the multi-plate arch should be extended up along the face of the metal arch to above the ordinary highway water mark.

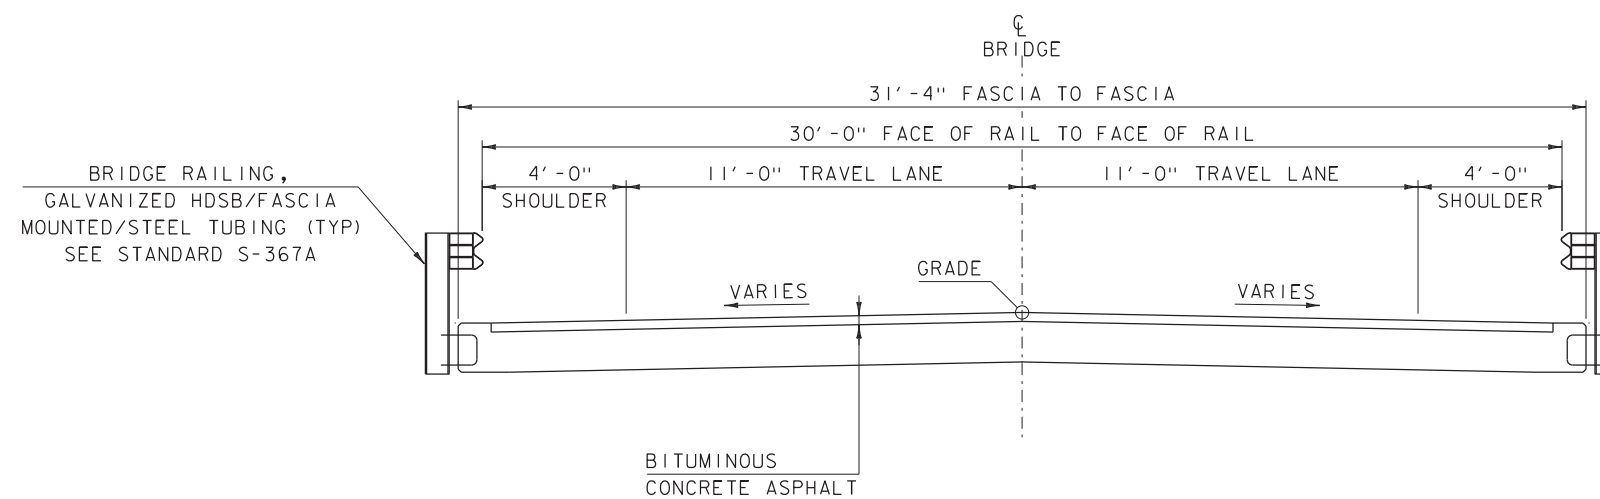
FULL BRIDGE REPLACEMENT BRIDGE TYPICAL SECTION

The minimum standard roadway width is 28 feet. However, the current bridge provides a rail-to-rail width of 30 feet. It is recommended that the new bridge width matches the existing 30-foot approaches and bridge width. This would include two 11-foot travel lanes with 4-foot shoulders.

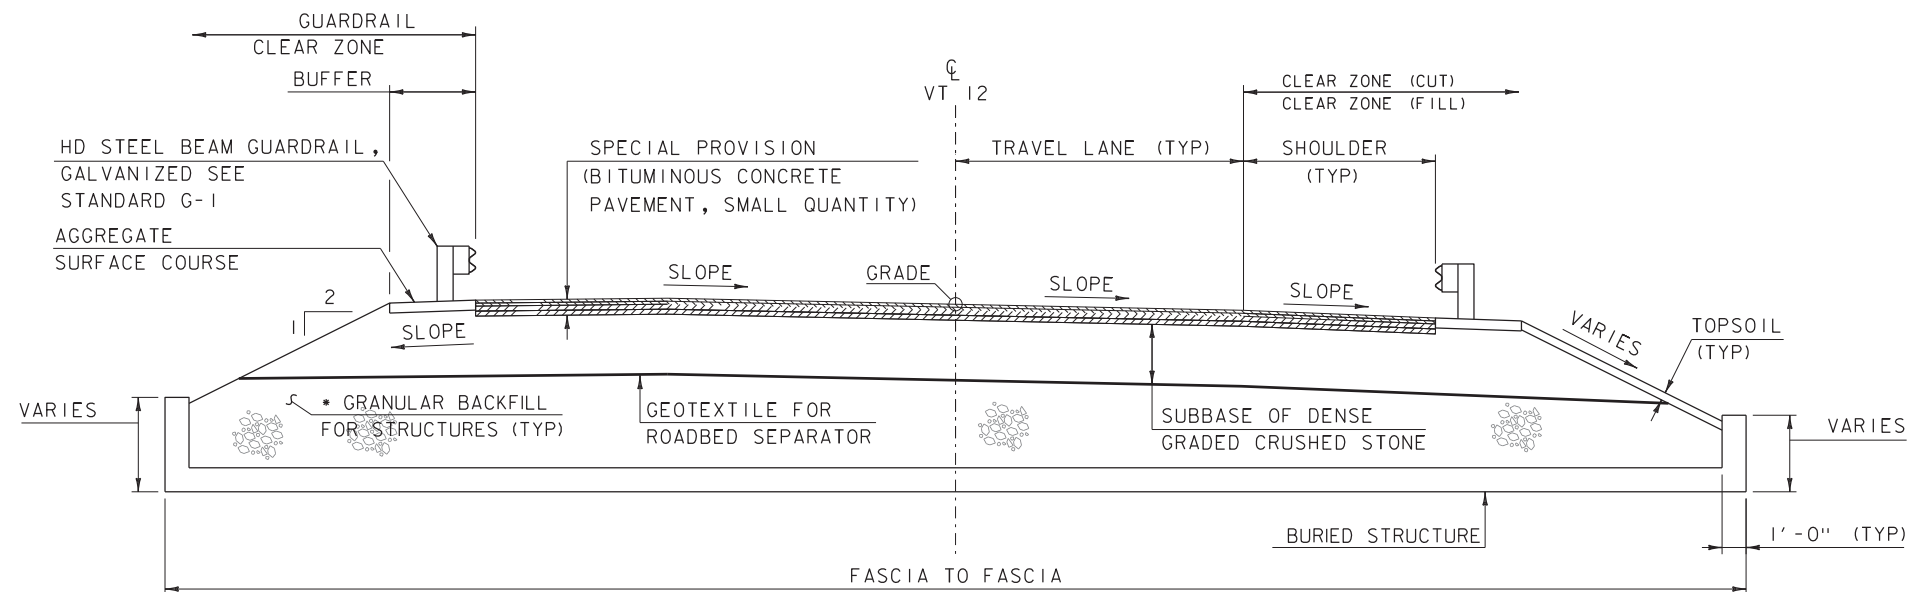
BURIED STRUCTURE REPLACEMENT TYPICAL SECTION

The minimum standard roadway width is 28 feet. However, the current bridge provides a rail-to-rail width of 30 feet. It is recommended that any new structure provide a rail to rail distance of 30-feet to match the existing bridge and approaches. This would include two 11-foot travel lanes with 4-foot shoulders. In order to accommodate a 30-foot traveled way, and new culvert would need to be approximately 60-feet long. This length could be reduced if headwalls are constructed at the inlet and outlet.

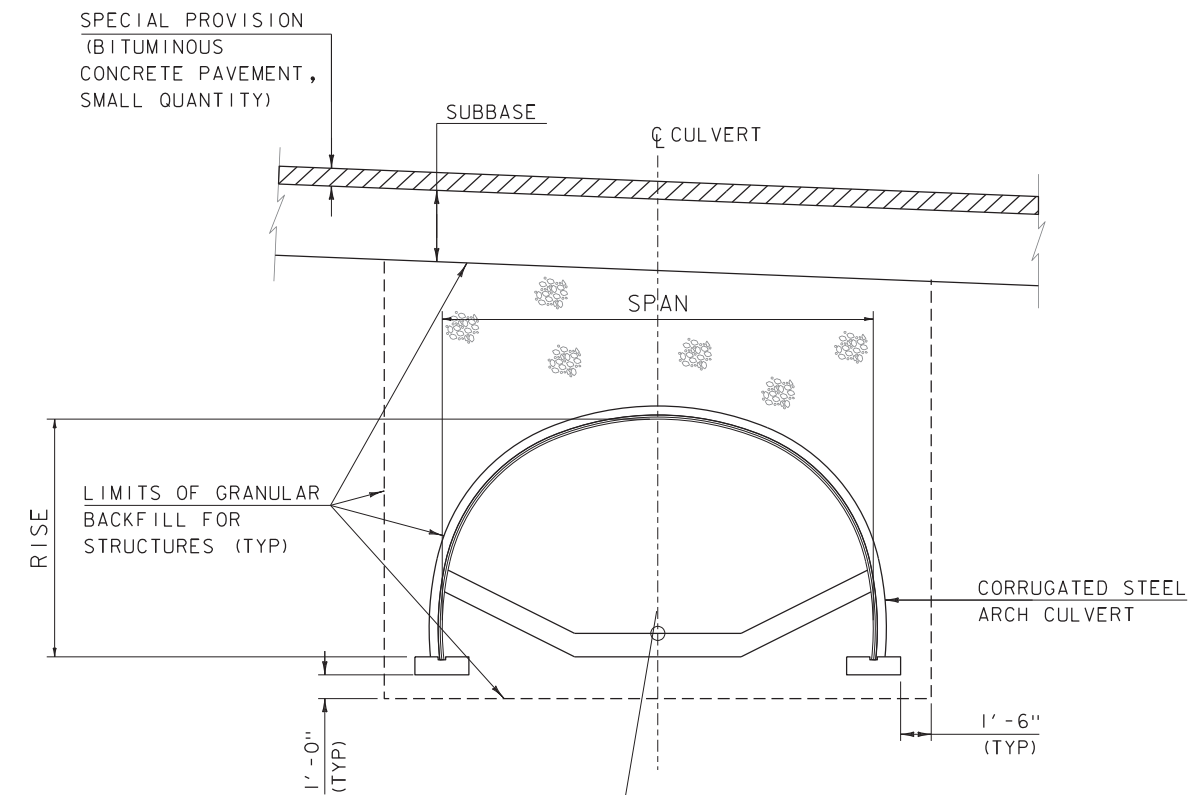
SPAN	54'-4"
RISE	27'-2"
LENGTH	77'-0"

ARCH CULVERT TYPICAL SECTION

The existing bridge is 34 feet in length with no skew. This provides a clearspan normal to the channel of approximately 25.5 feet. This clearspan does not meet the minimum recommended bankfull width. If a new buried structure is constructed it is recommended that it meet the minimum clearspan requirement of 46 feet. The new culvert span would be approximately 50-feet and would be aligned with the stream channel.

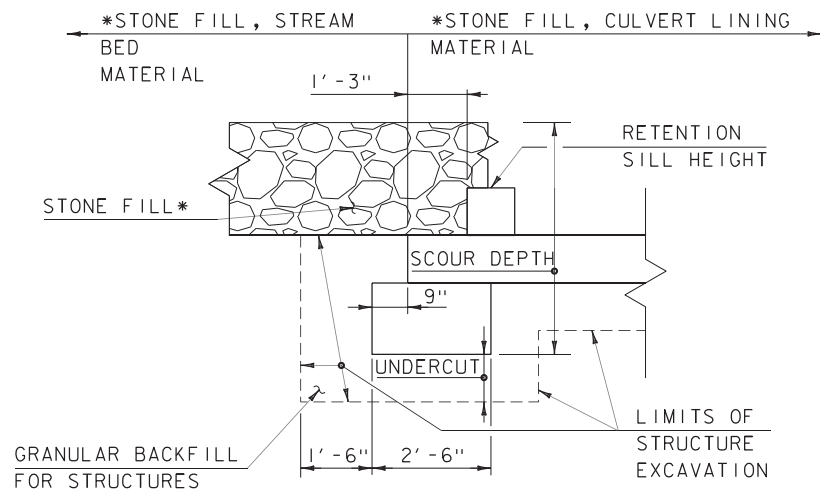
CUTOFF WALL TYPICAL SECTION

CUTOFF WALL - CRITICAL DIMENSIONS

DIMENSION
SCOUR DEPTH	4'-0"
RETENTION SILL HEIGHT	1'-0"
UNDERCUT	1'-0"

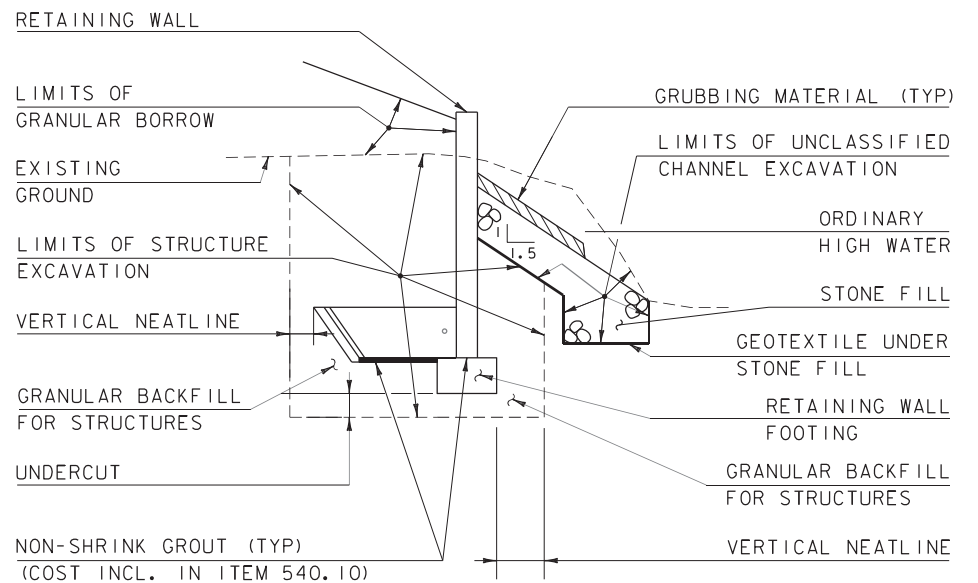
RETAINING WALL EARTHWORK TYPICAL SECTION

TOP OF RETAINING WALL FOOTING SHALL BE AT OR BELOW BOTTOM OF BOX CULVERT.

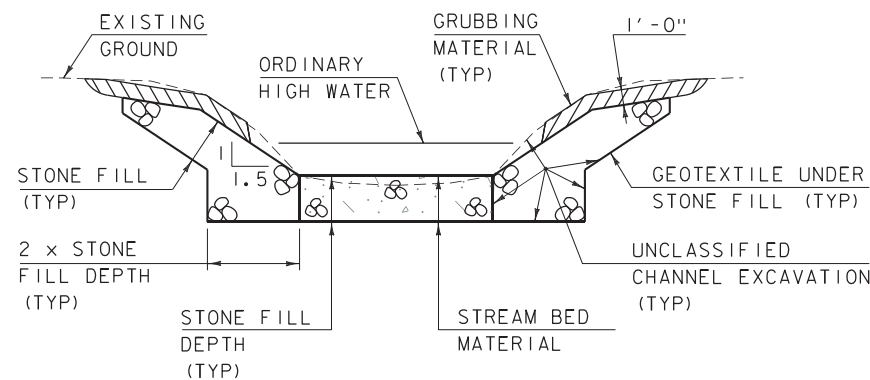
TYPICAL CHANNEL SECTION
