**Braintree BF 0241(51)**  
**Regional Concerns Meeting**  
**VT Route 12 – Bridge #47 over Ayers Brook**

June 18, 2019

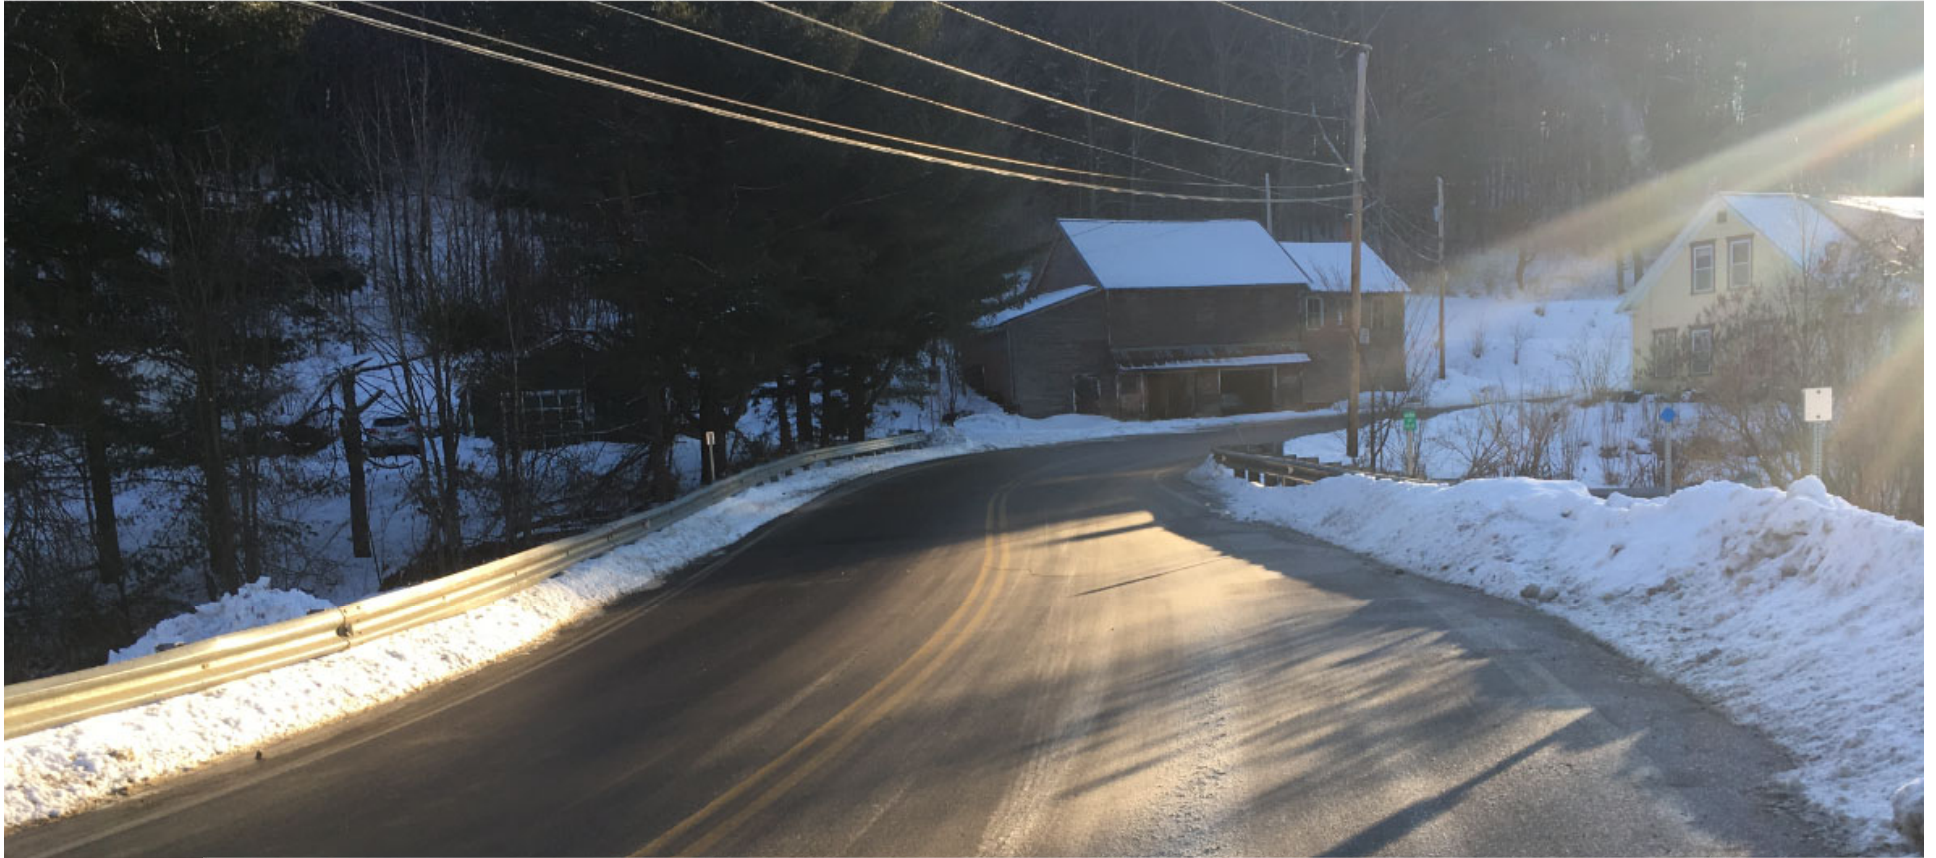
Looking South over Bridge

## Existing Conditions – Bridge #47

- Roadway Classification – Major Collector
- Bridge Type – 33' Long T-Beam Bridge/Multi-Plate Arch
- Ownership – State of Vermont
- Constructed in 1928, reconstructed in 1969

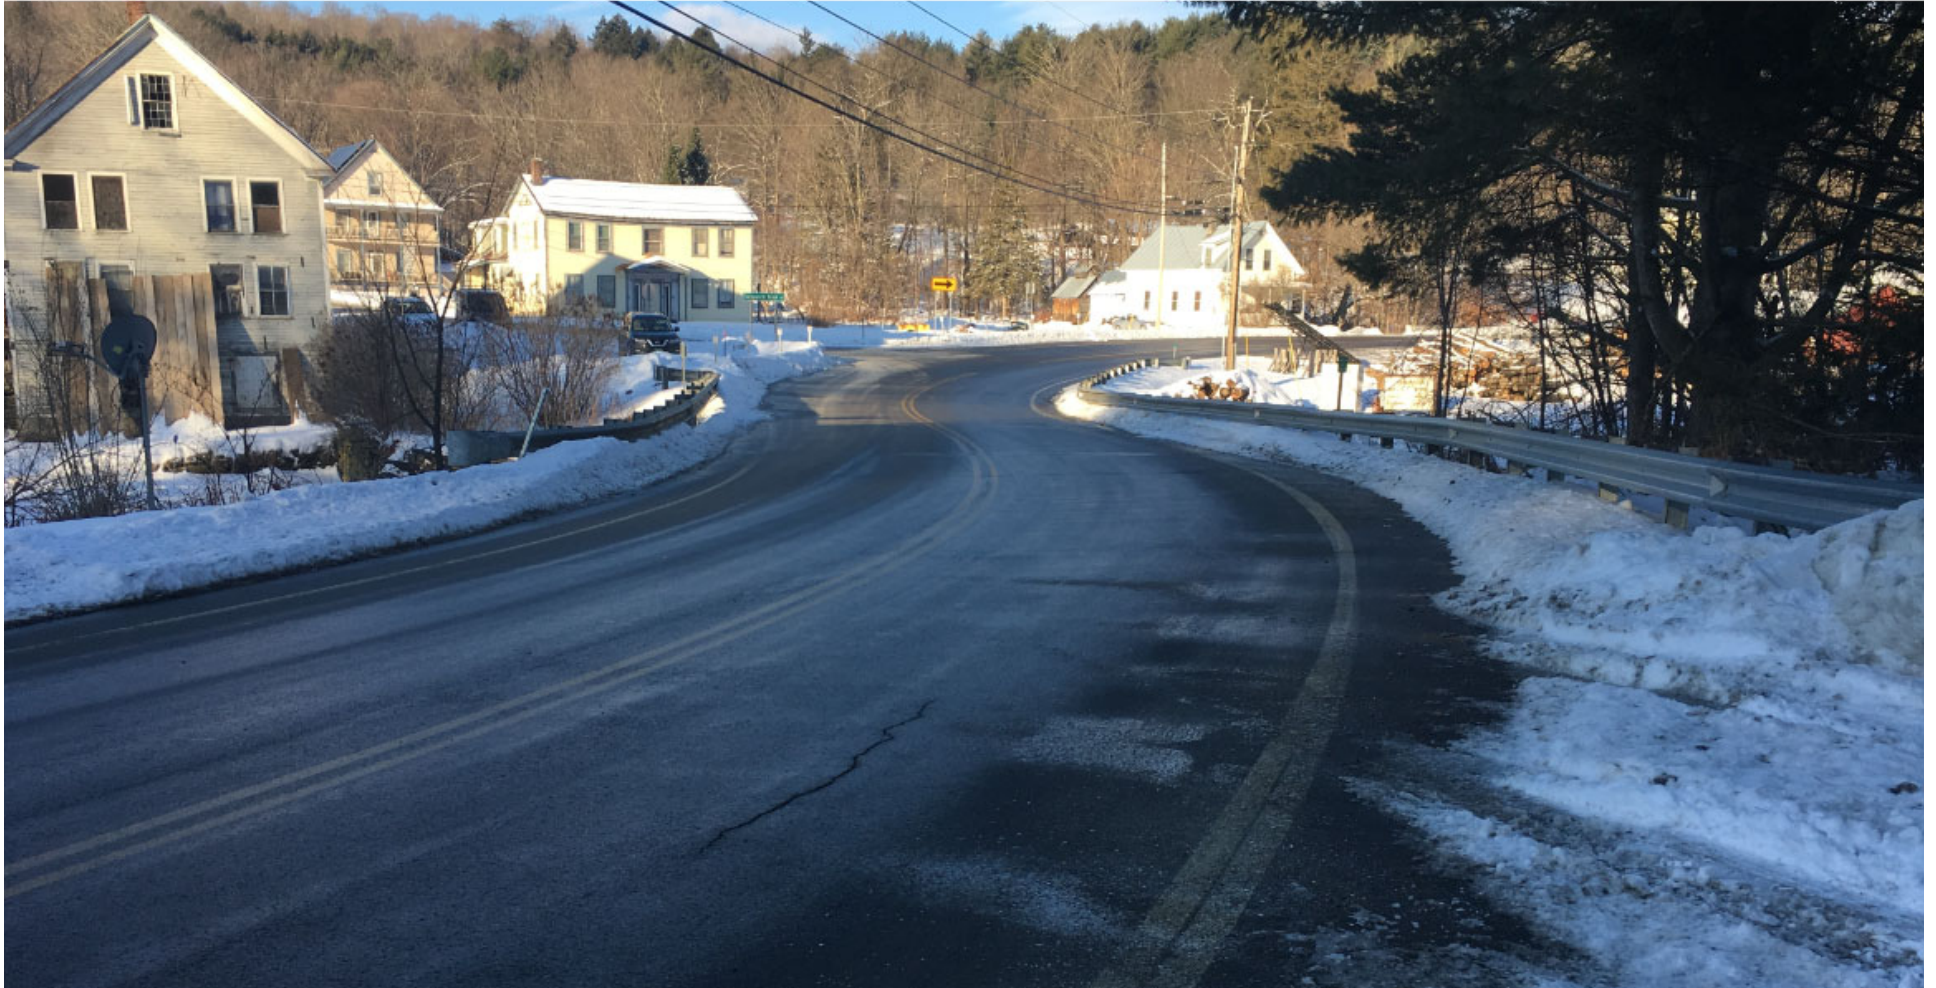
Looking North over Bridge

## Existing Conditions – Bridge #47

- Sharp S-Curve
- Located at Intersection

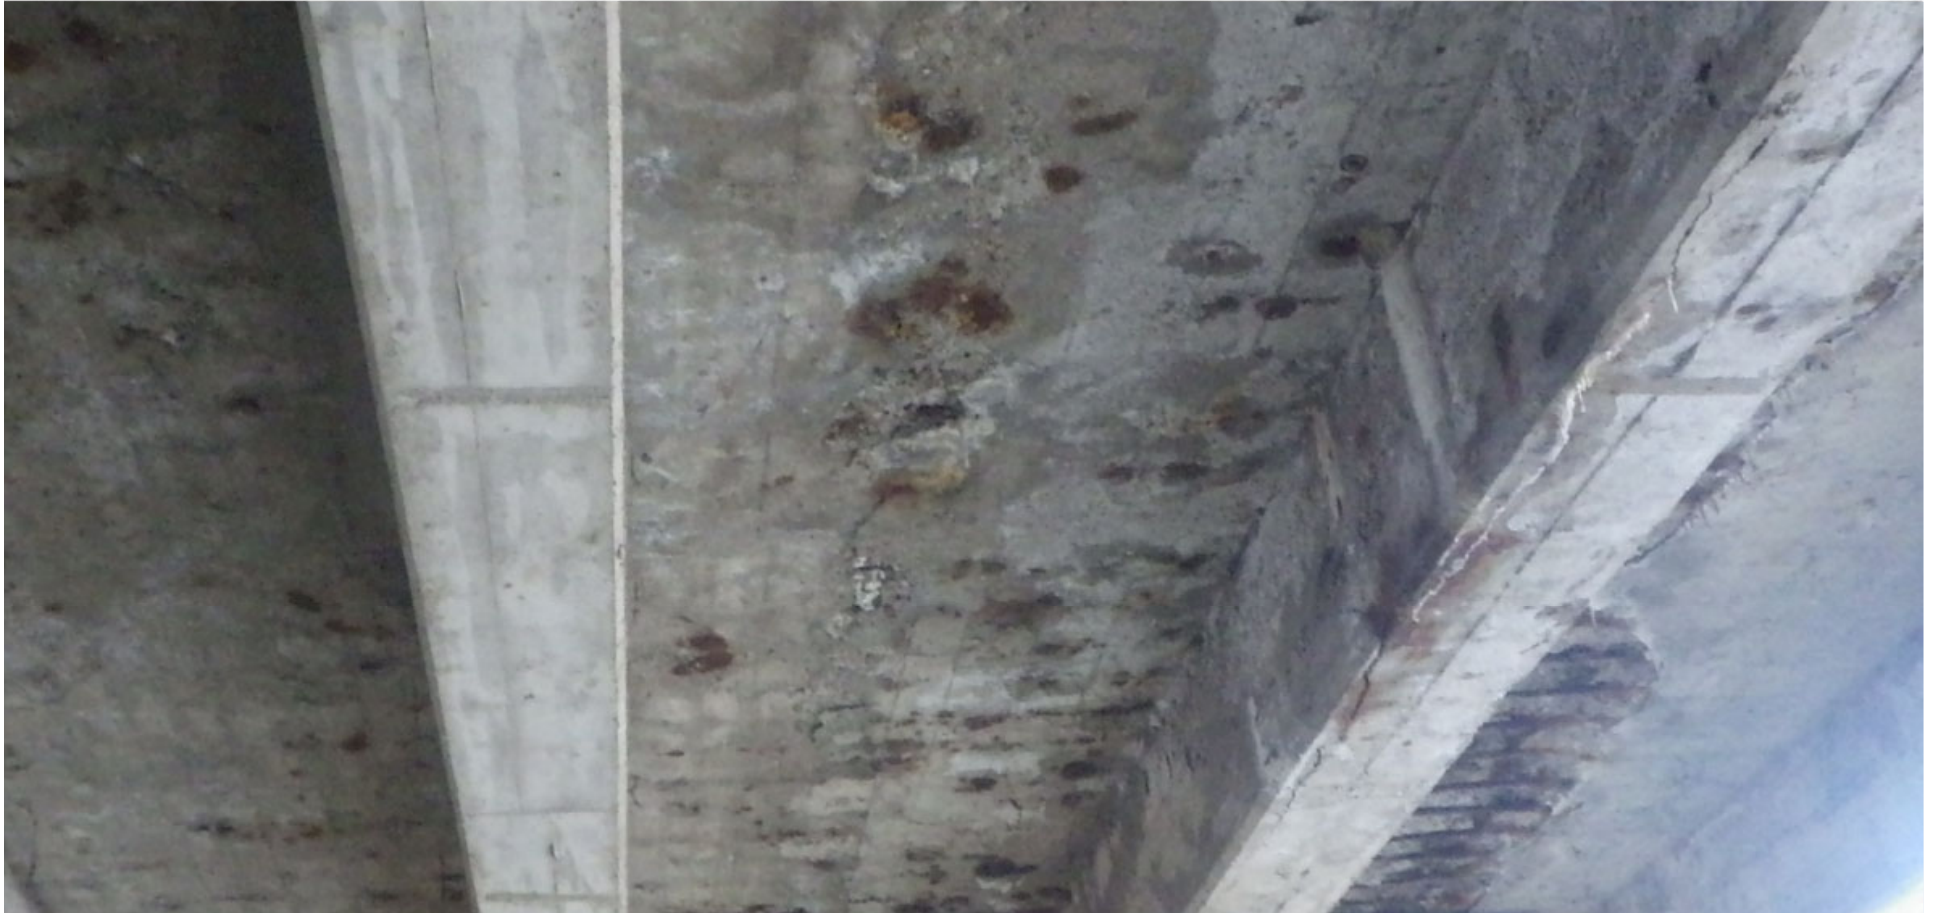
## Condition Ratings

### Existing Conditions - Bridge #47

- Deck Rating 4 (Poor)
- Superstructure Rating 6 (Satisfactory)
- Substructure Rating 6 (Satisfactory)

- The bridge deck on the T-Beam's has widespread deterioration and saturation on the soffit.
- The T-Beams have scattered longitudinal cracking with large delaminations.
  - Some of the spalling has reached the pavement, and full depth holes may occur at any time.
- The abutments and wingwalls have fine map cracking throughout with light staining.
- There are substandard horizontal curves at both approaches and a substandard vertical sag curve at the approach on the North end of the bridge.
- The bridge does not meet the minimum Bank Full Width requirements.

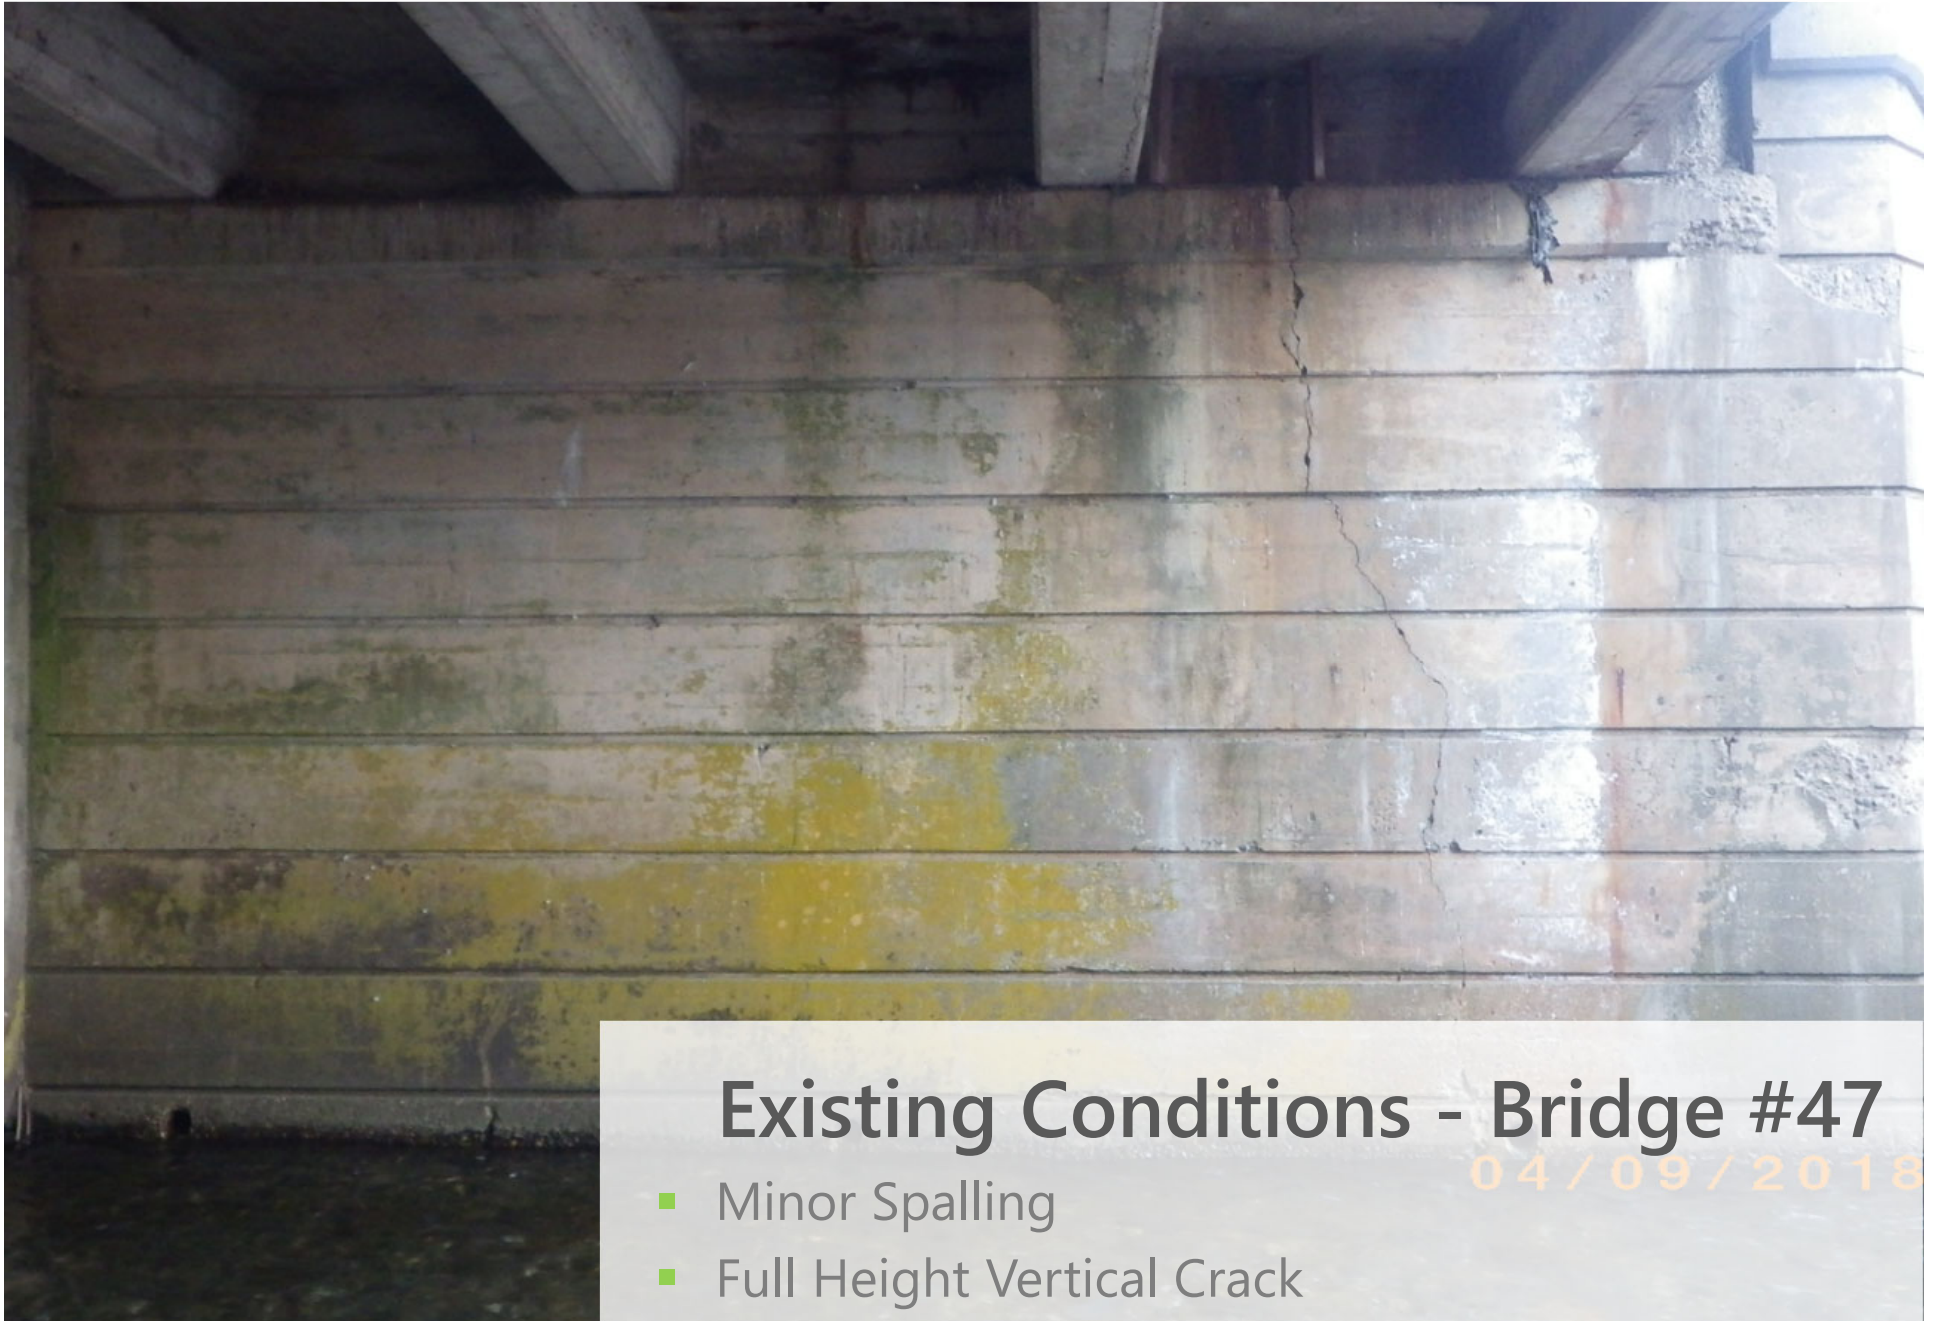
## Southern Abutment

- Minor Spalling
- Full Height Vertical Crack

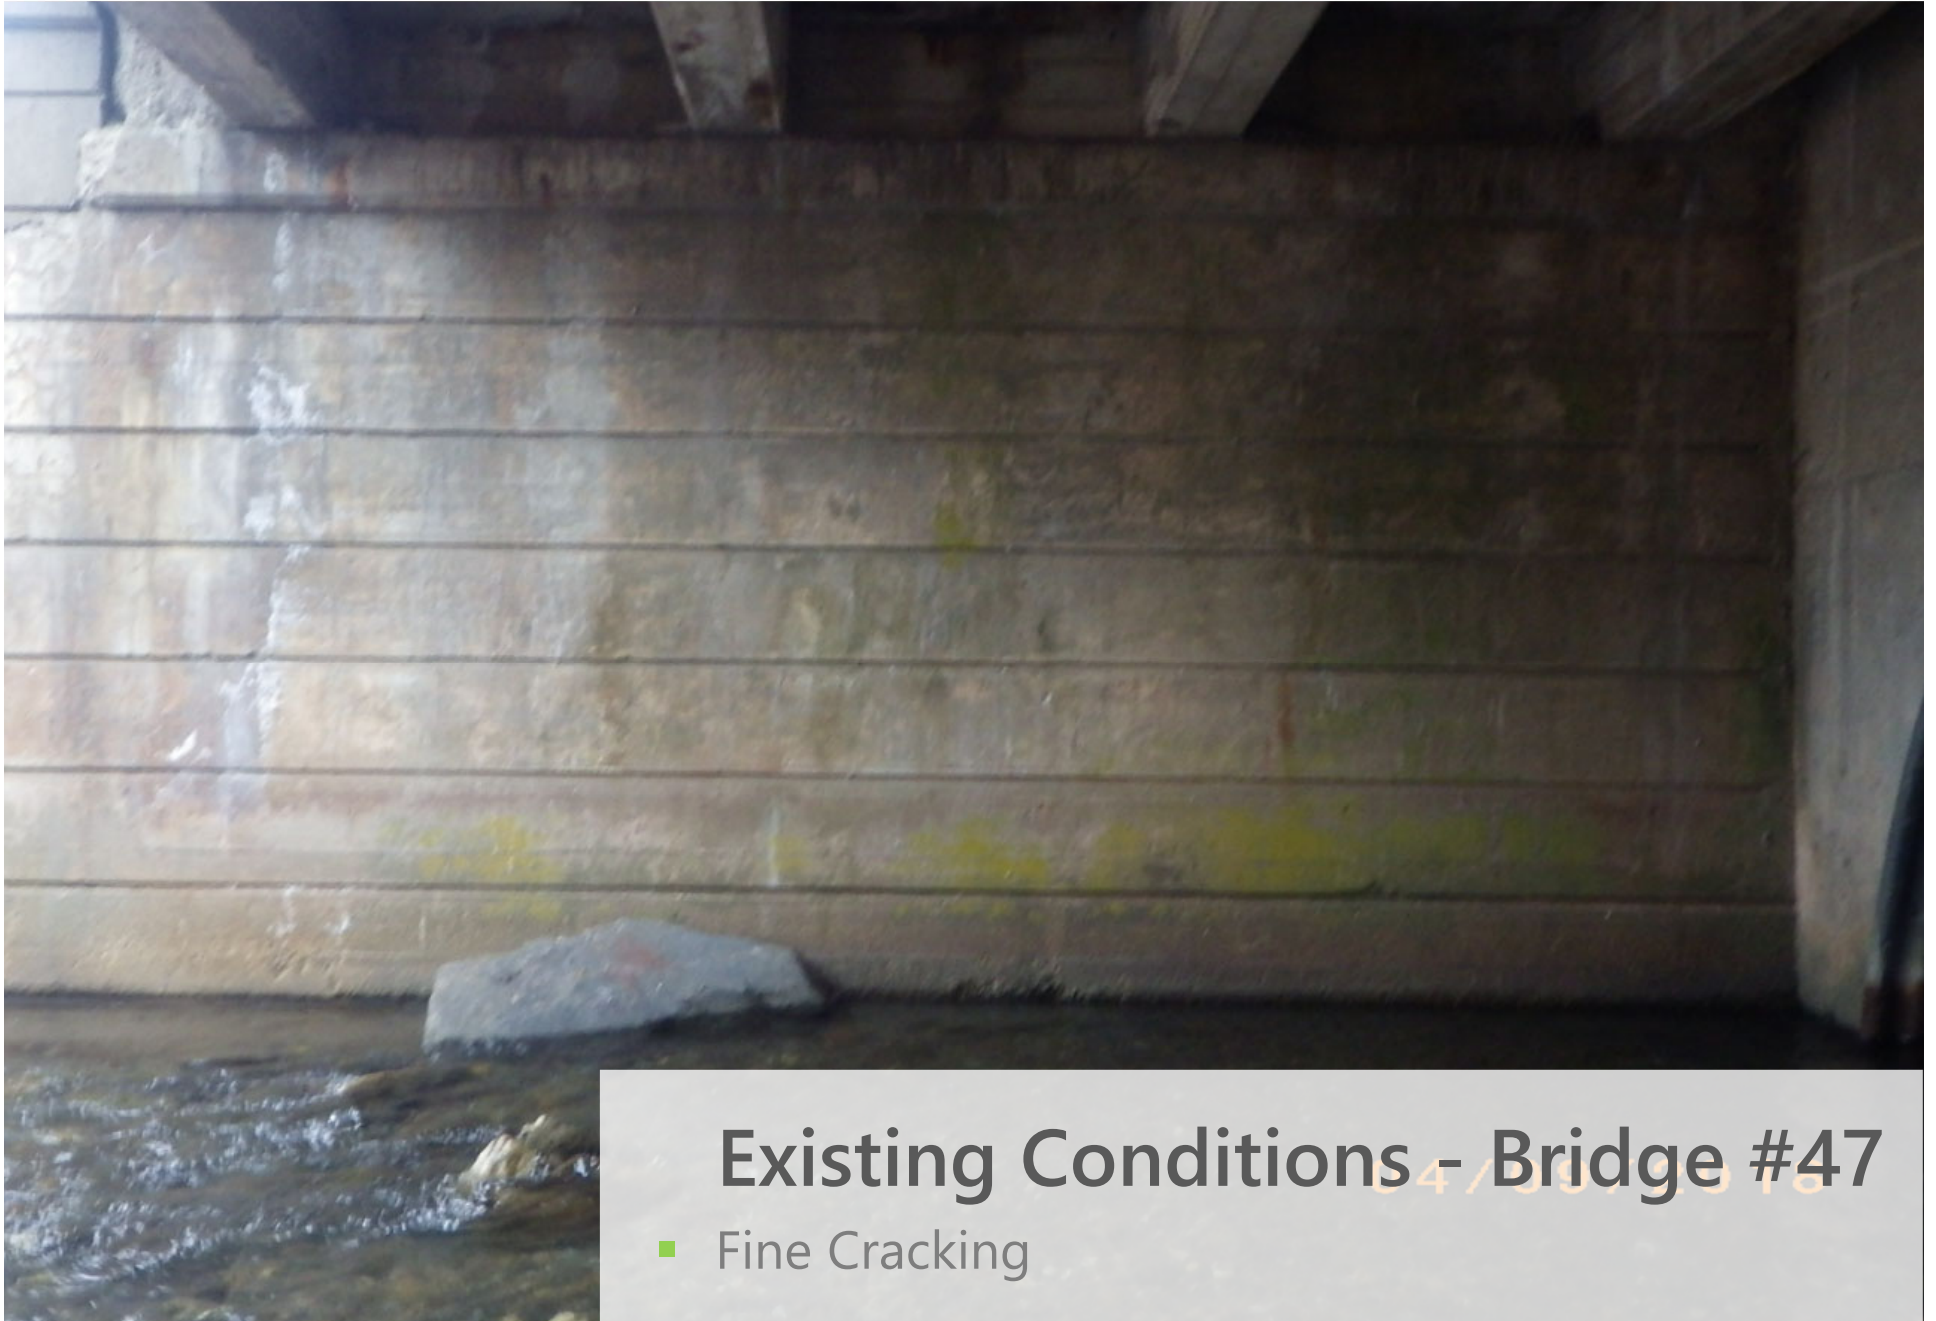
## Northern Abutment

- Fine Cracking

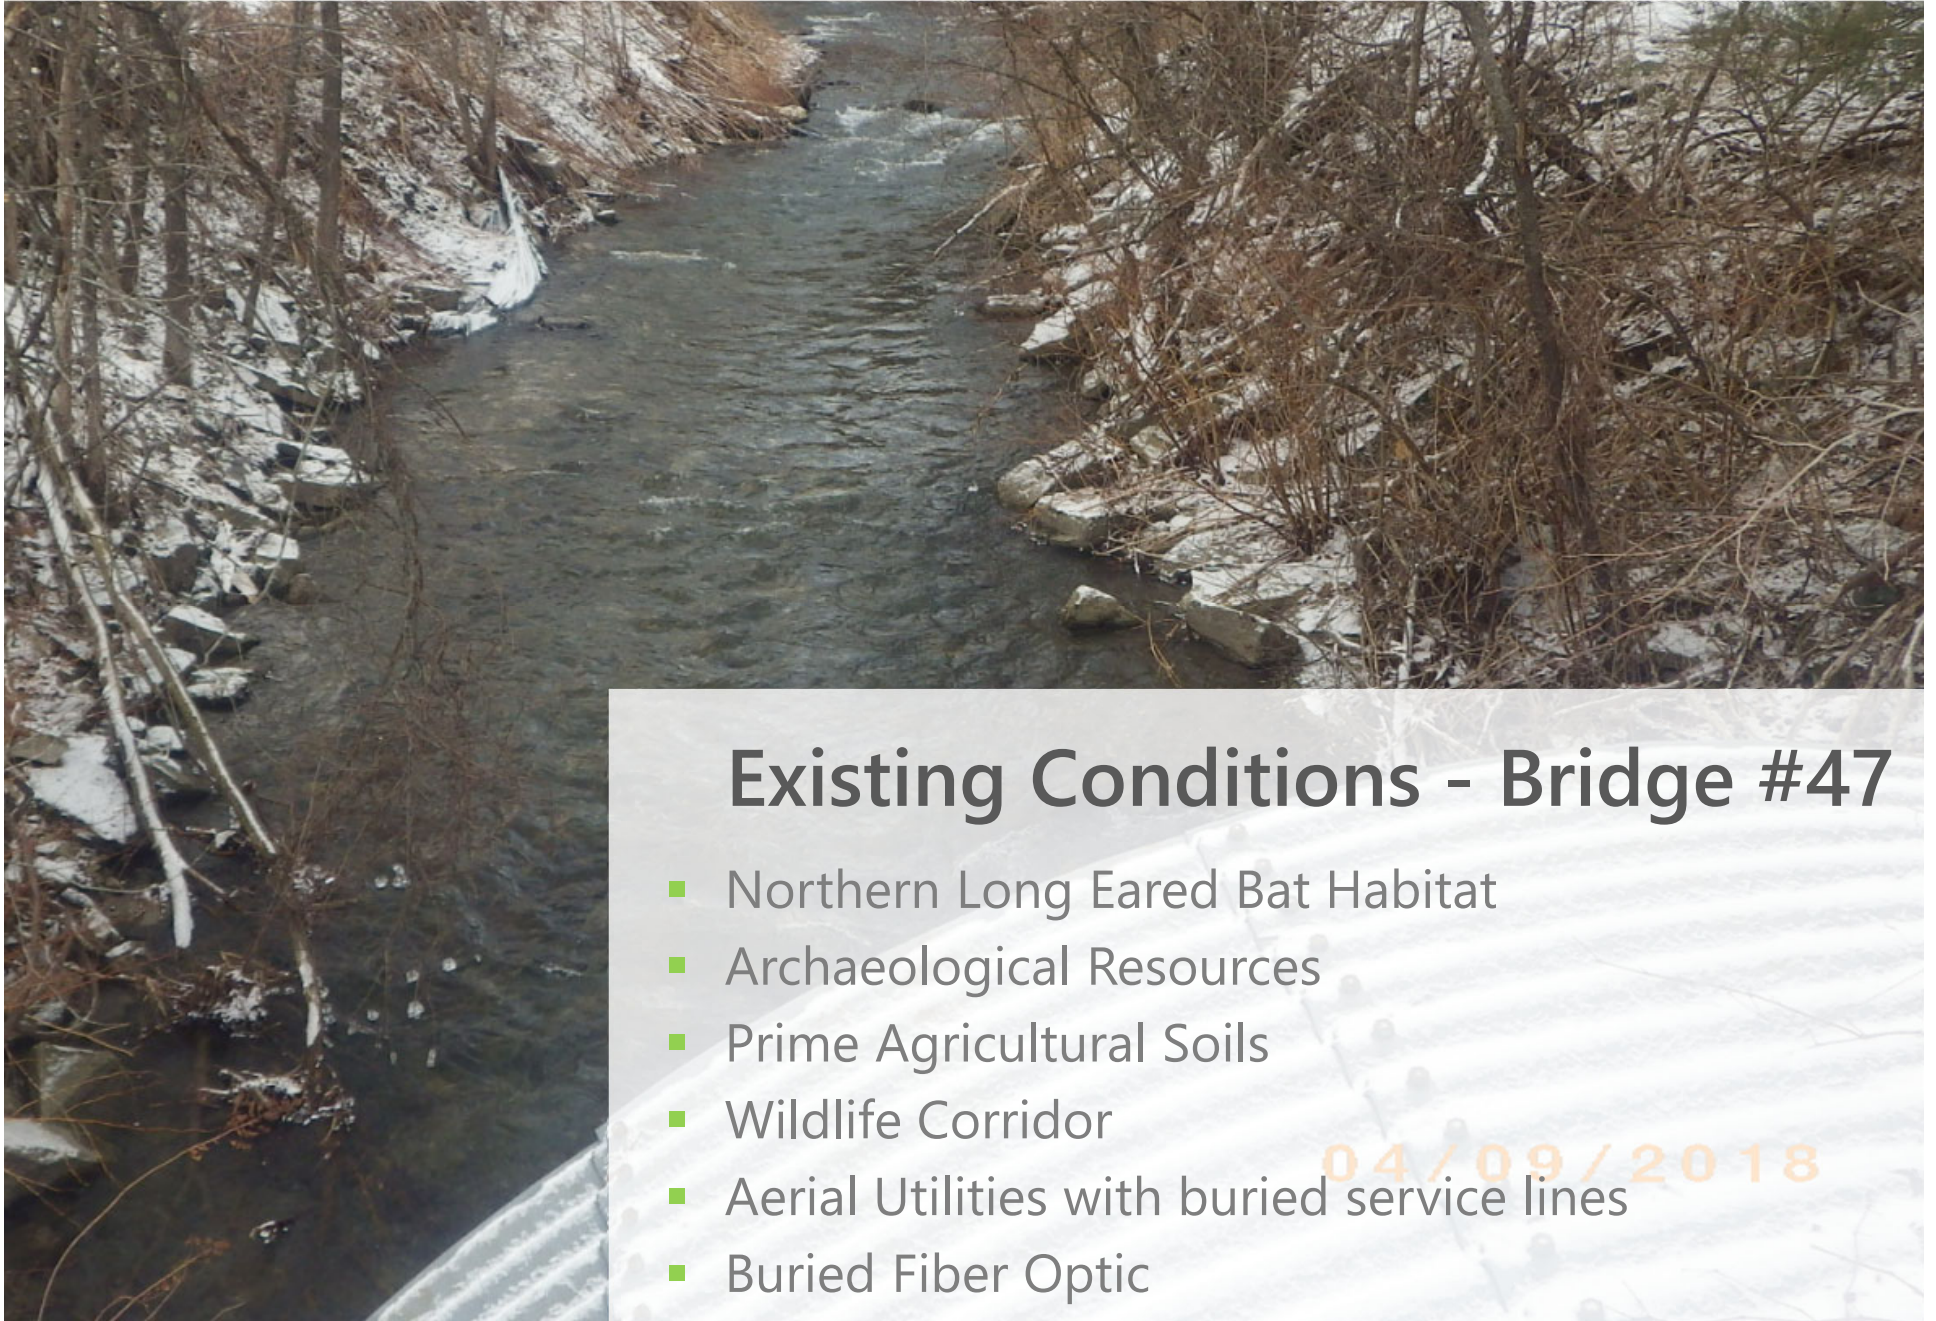
## Resources – Looking Upstream

- Northern Long Eared Bat Habitat
- Archaeological Resources
- Prime Agricultural Soils
- Wildlife Corridor
- Aerial Utilities with buried service lines
- Buried Fiber Optic
