Enosburg BF 0283(42)
Regional Concerns Meeting
VT Route 118 – Bridge #24 over Unnamed Brook
April 15, 2019

Enosburg BF 0283(42)

VT Route 118 – Bridge #24 over Unnamed Brook

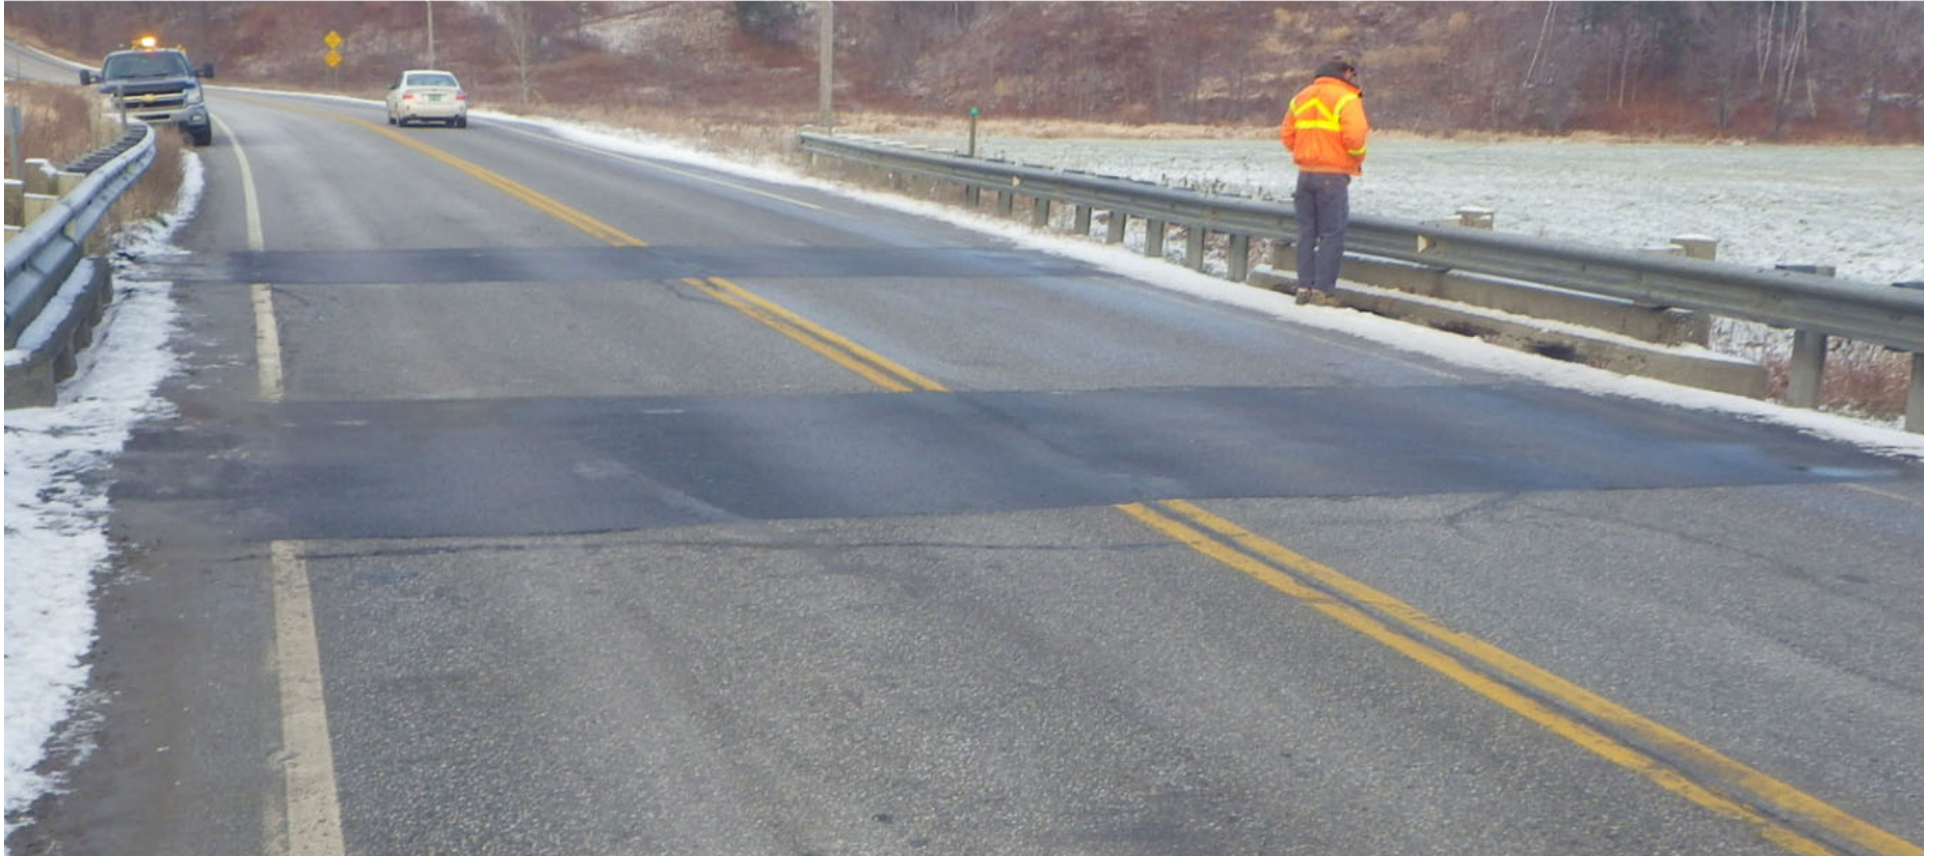
Looking West over Bridge

Existing Conditions – Bridge #24

- Roadway Classification – Major Collector
- Bridge Type – 20' Concrete Slab
- Ownership – State of Vermont
- Constructed in 1921

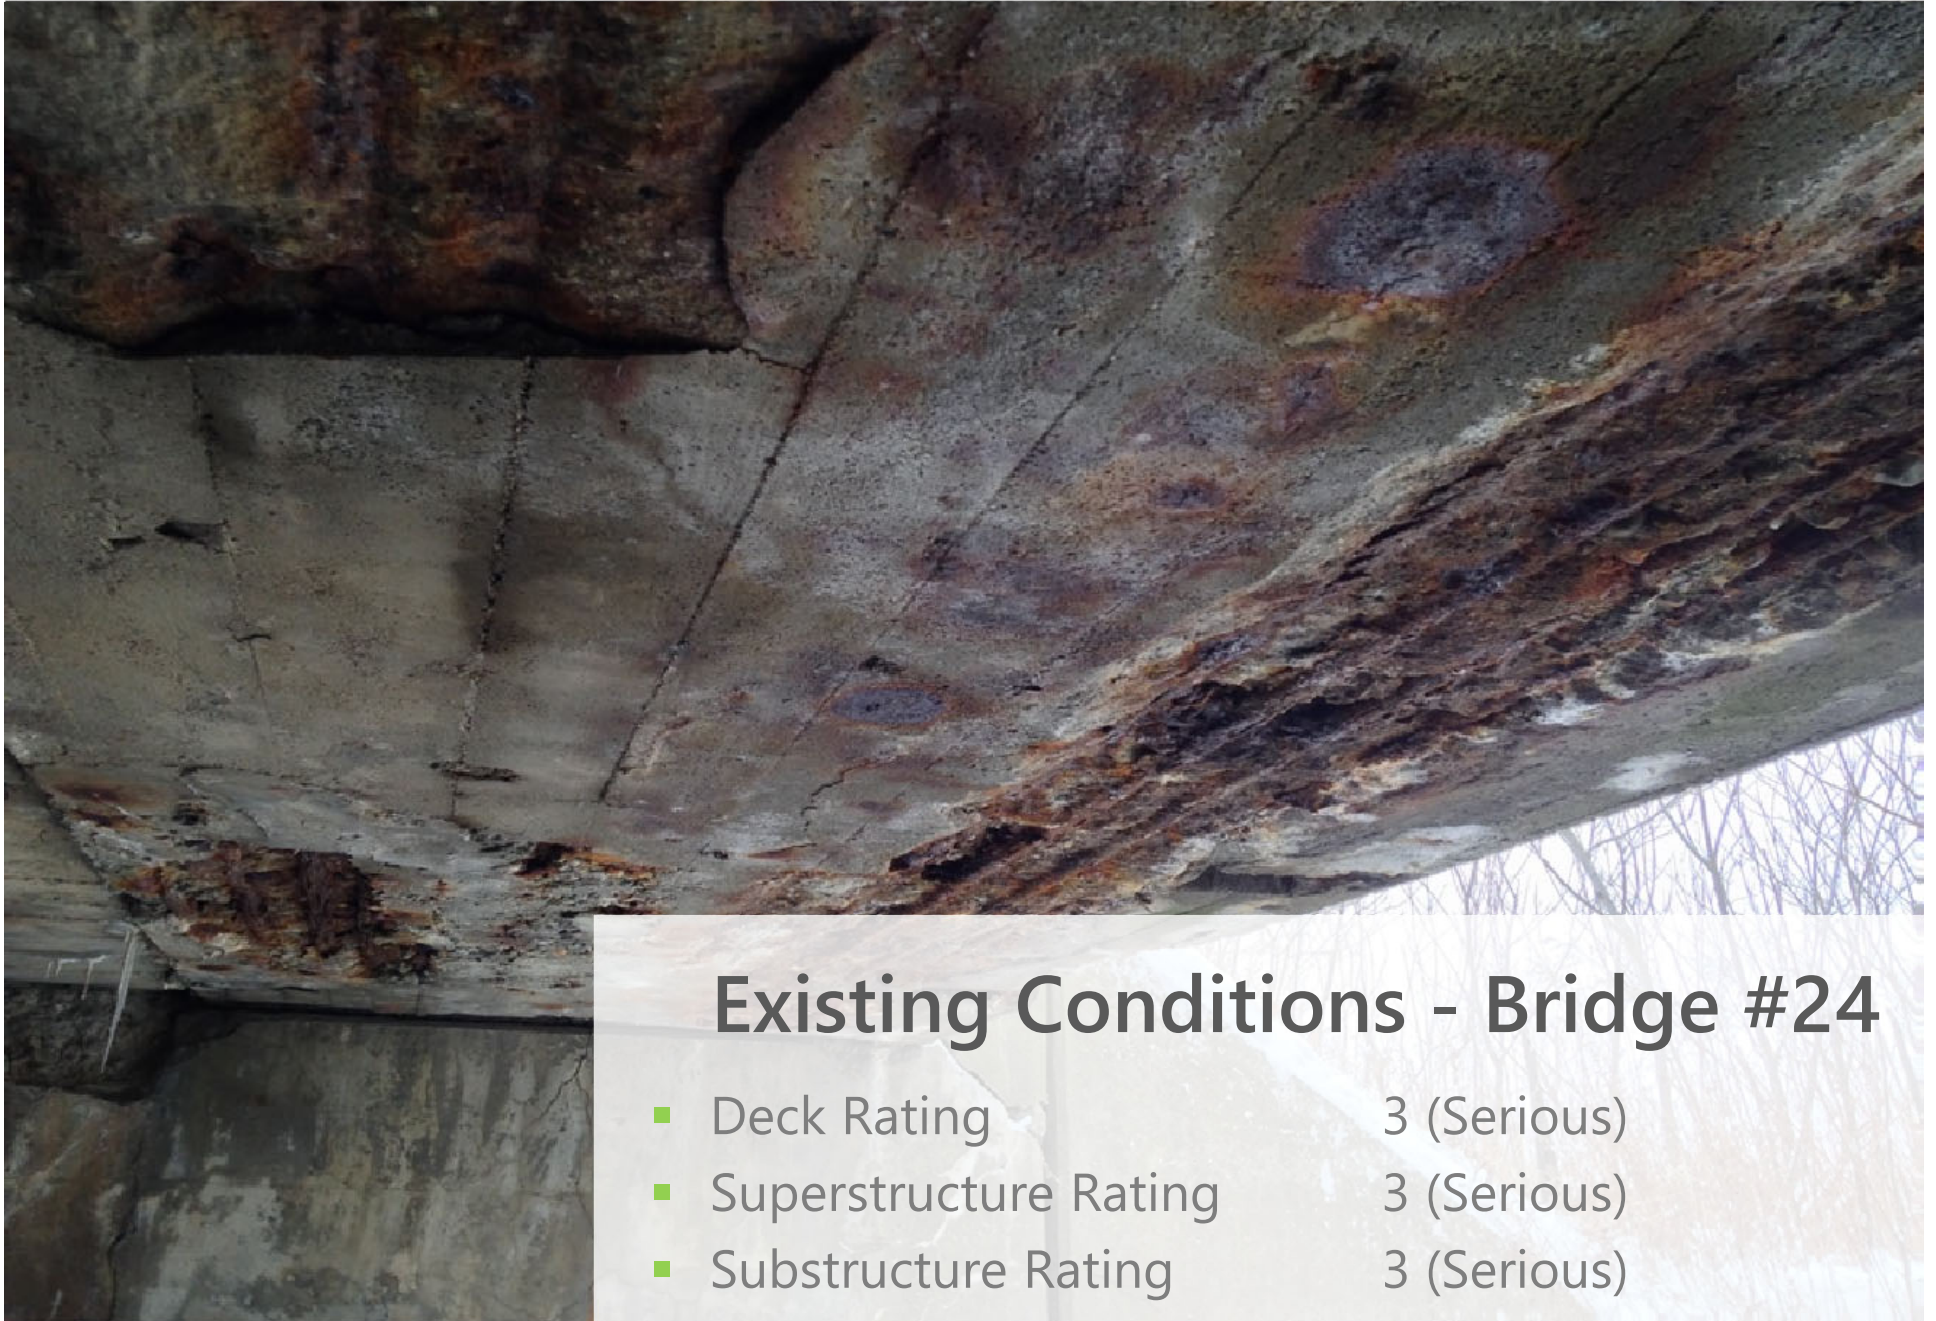
Condition Ratings

Existing Conditions - Bridge #24

- Deck Rating 3 (Serious)
- Superstructure Rating 3 (Serious)
- Substructure Rating 3 (Serious)

- The bridge is structurally deficient with all components rated in serious condition
 - The soffit of the concrete slab has heavy spalling with exposed reinforcing steel
 - The slab has a 1-inch wide full depth crack at the center line of the roadway
 - Both abutments have settlement and rotation
 - The abutment concrete along the water line has extensive spalling.

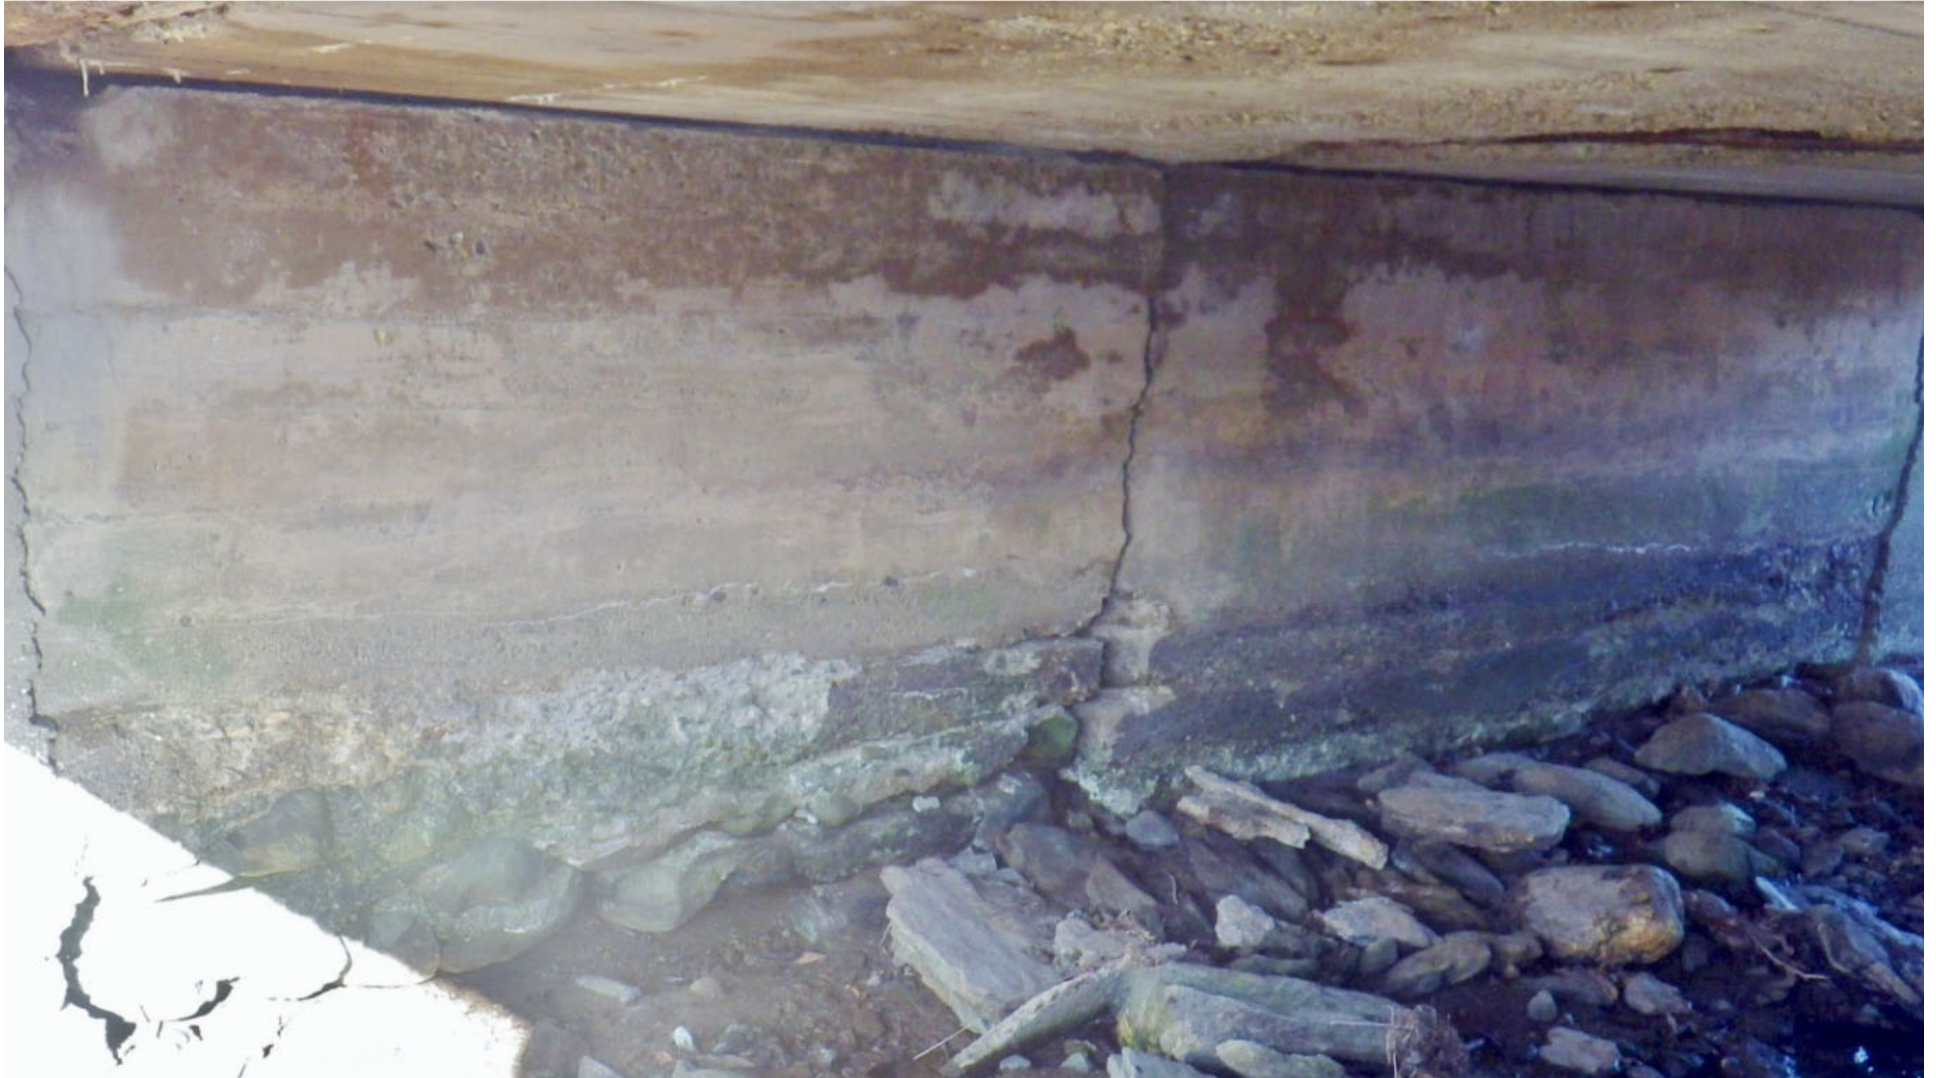
Western Abutment

- Full Height Cracks

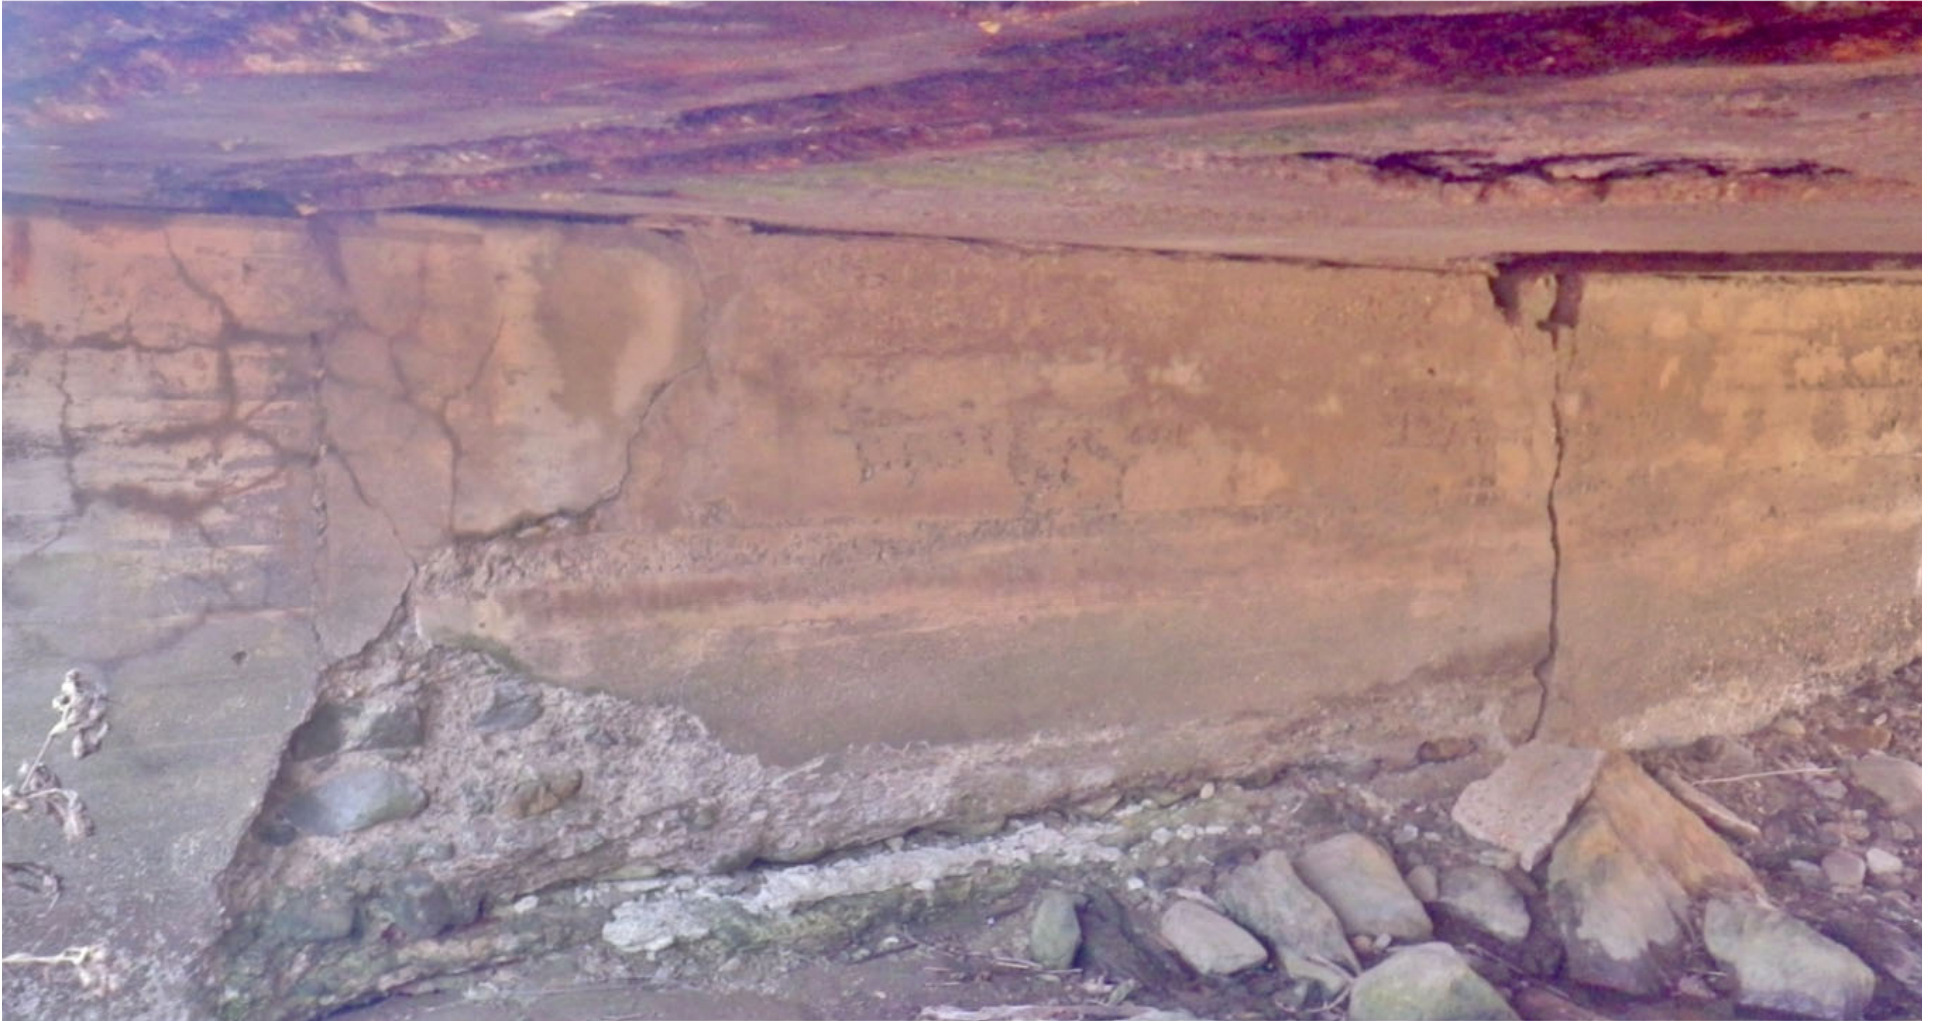
Eastern Abutment

- Spalling
- Undermining

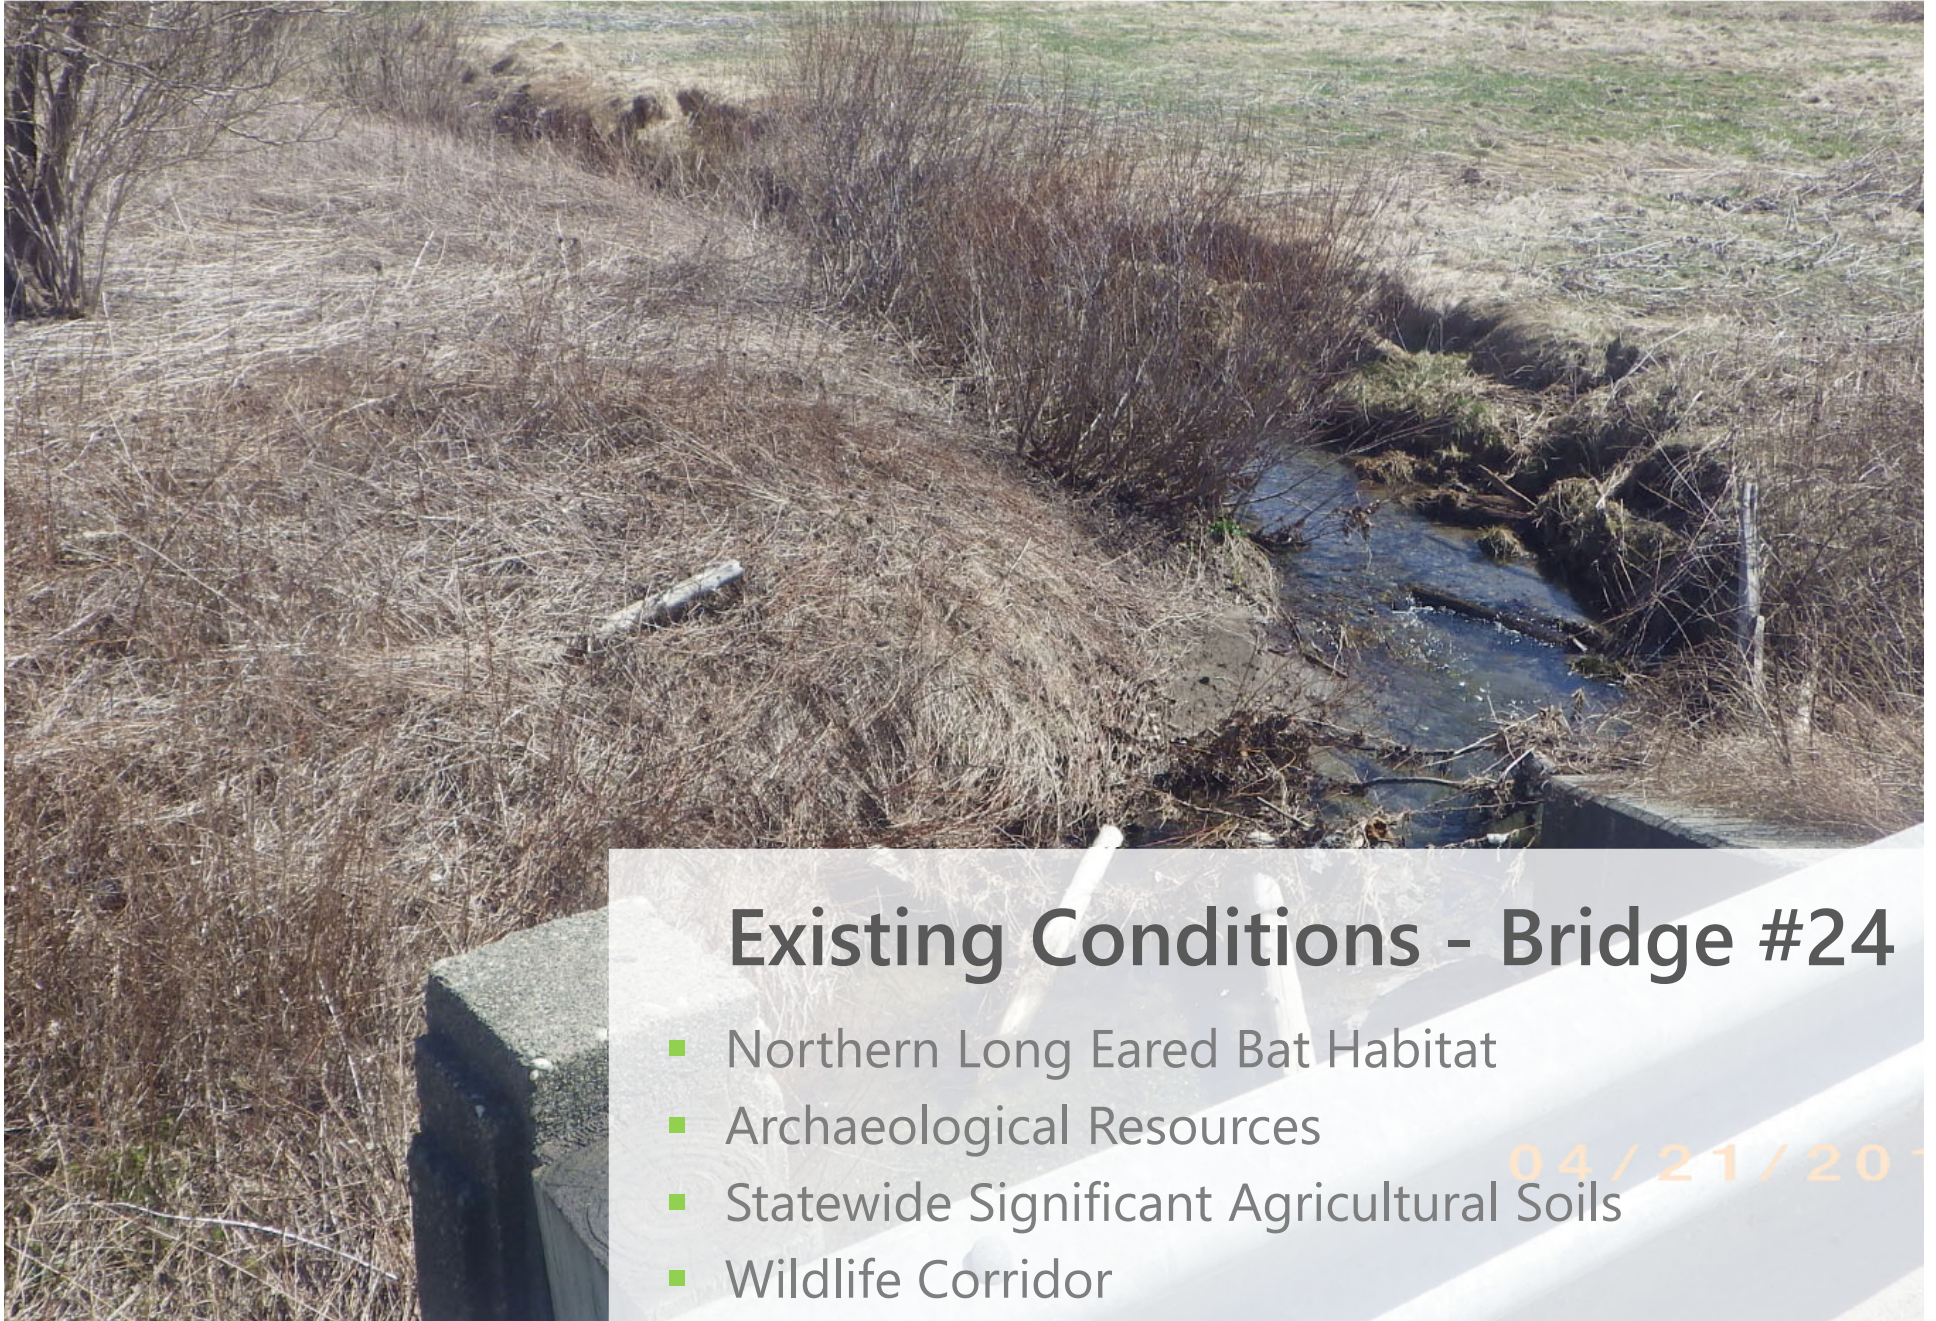
Resources – Looking Upstream

- Northern Long Eared Bat Habitat
- Archaeological Resources
- Statewide Significant Agricultural Soils
- Wildlife Corridor

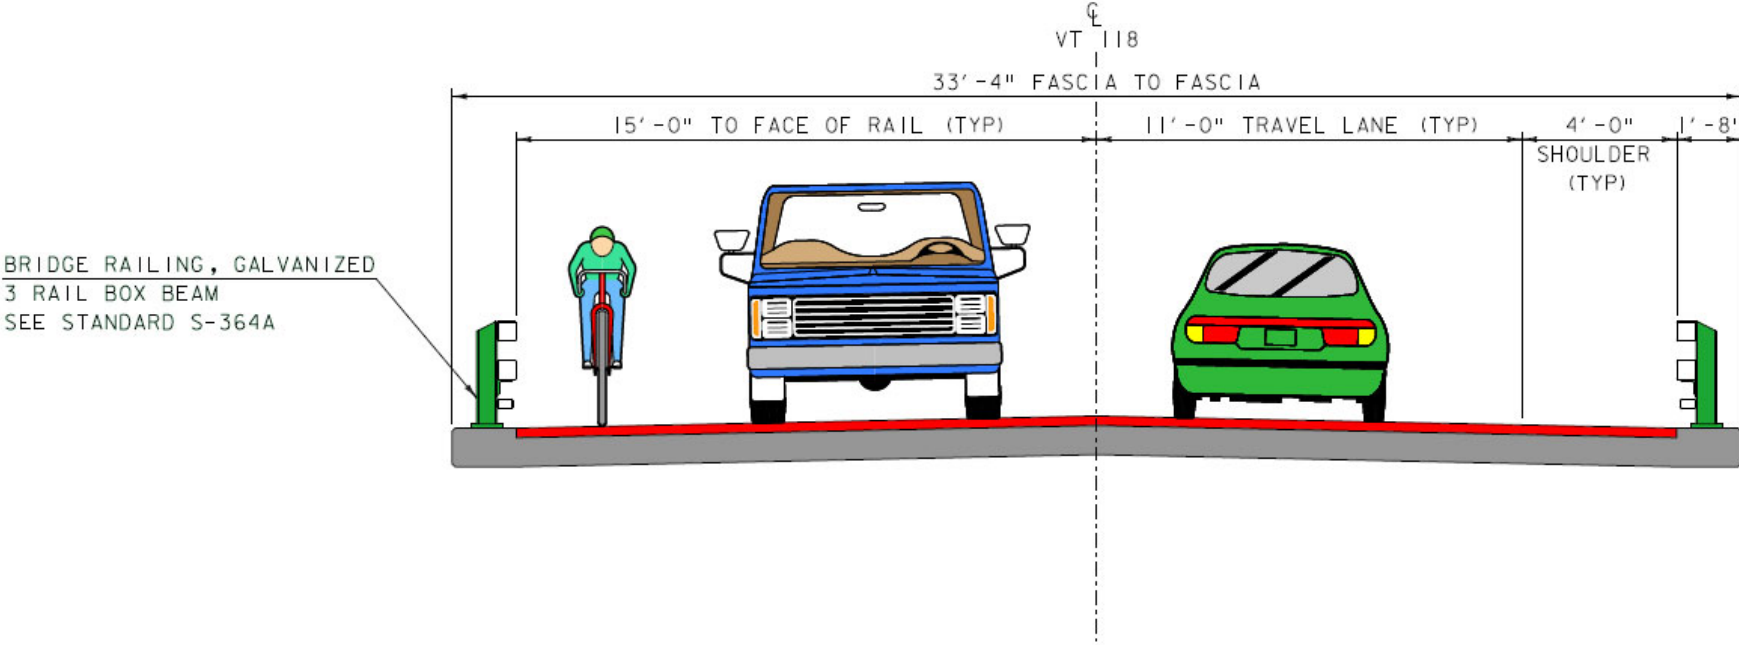
Proposed Typical Section - Bridge

BRIDGE 24 TYPICAL SECTION

- Full Bridge Replacement with New Integral Abutment Bridge
 - 11'4' typical
 - 75 year design life
 - Bedrock approximately 60 feet below FG
 - 38'-span slab bridge

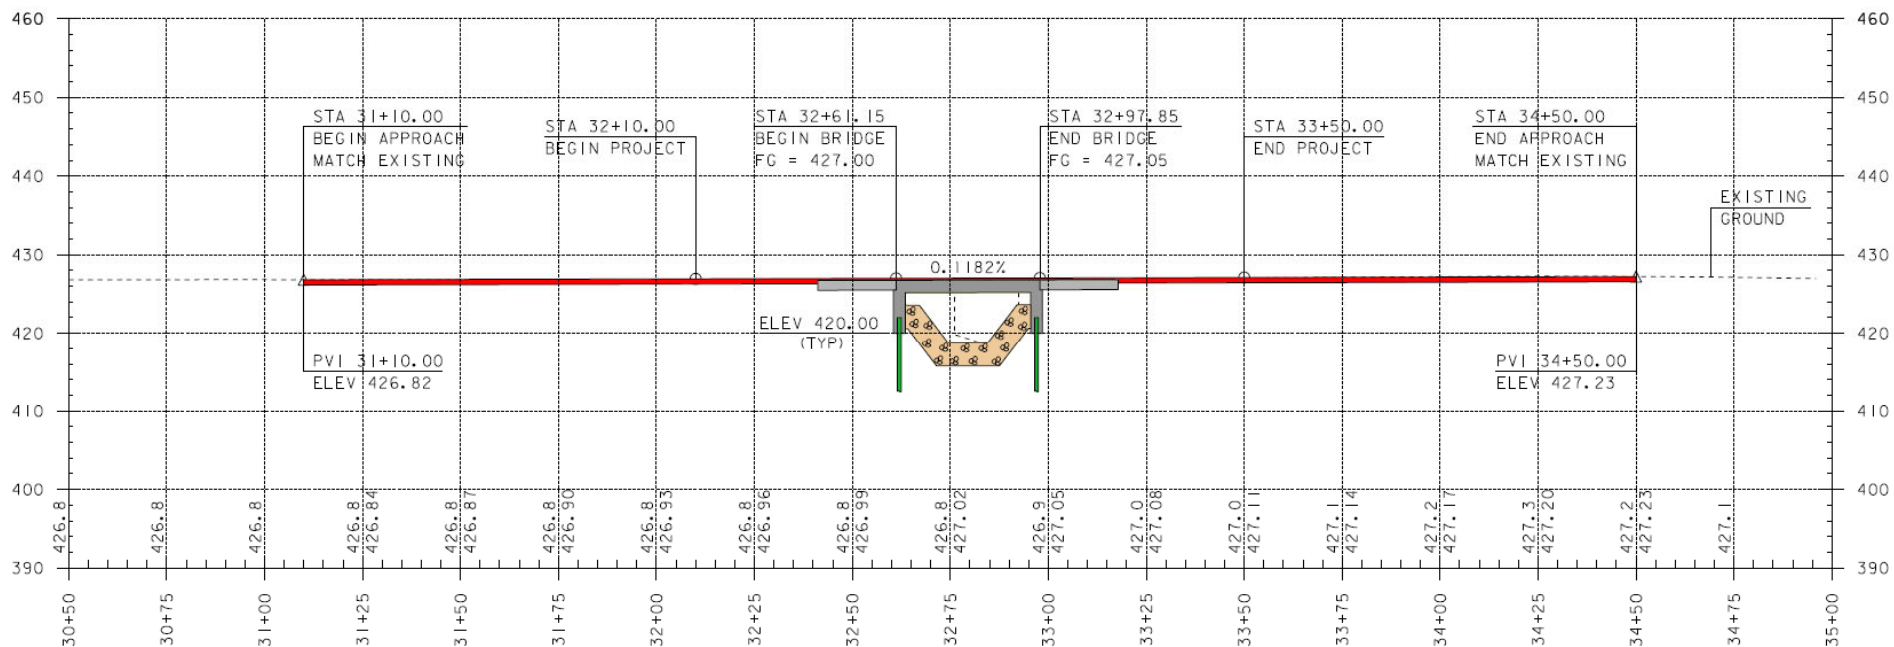
Proposed Profile

PROFILE ALONG VT 118

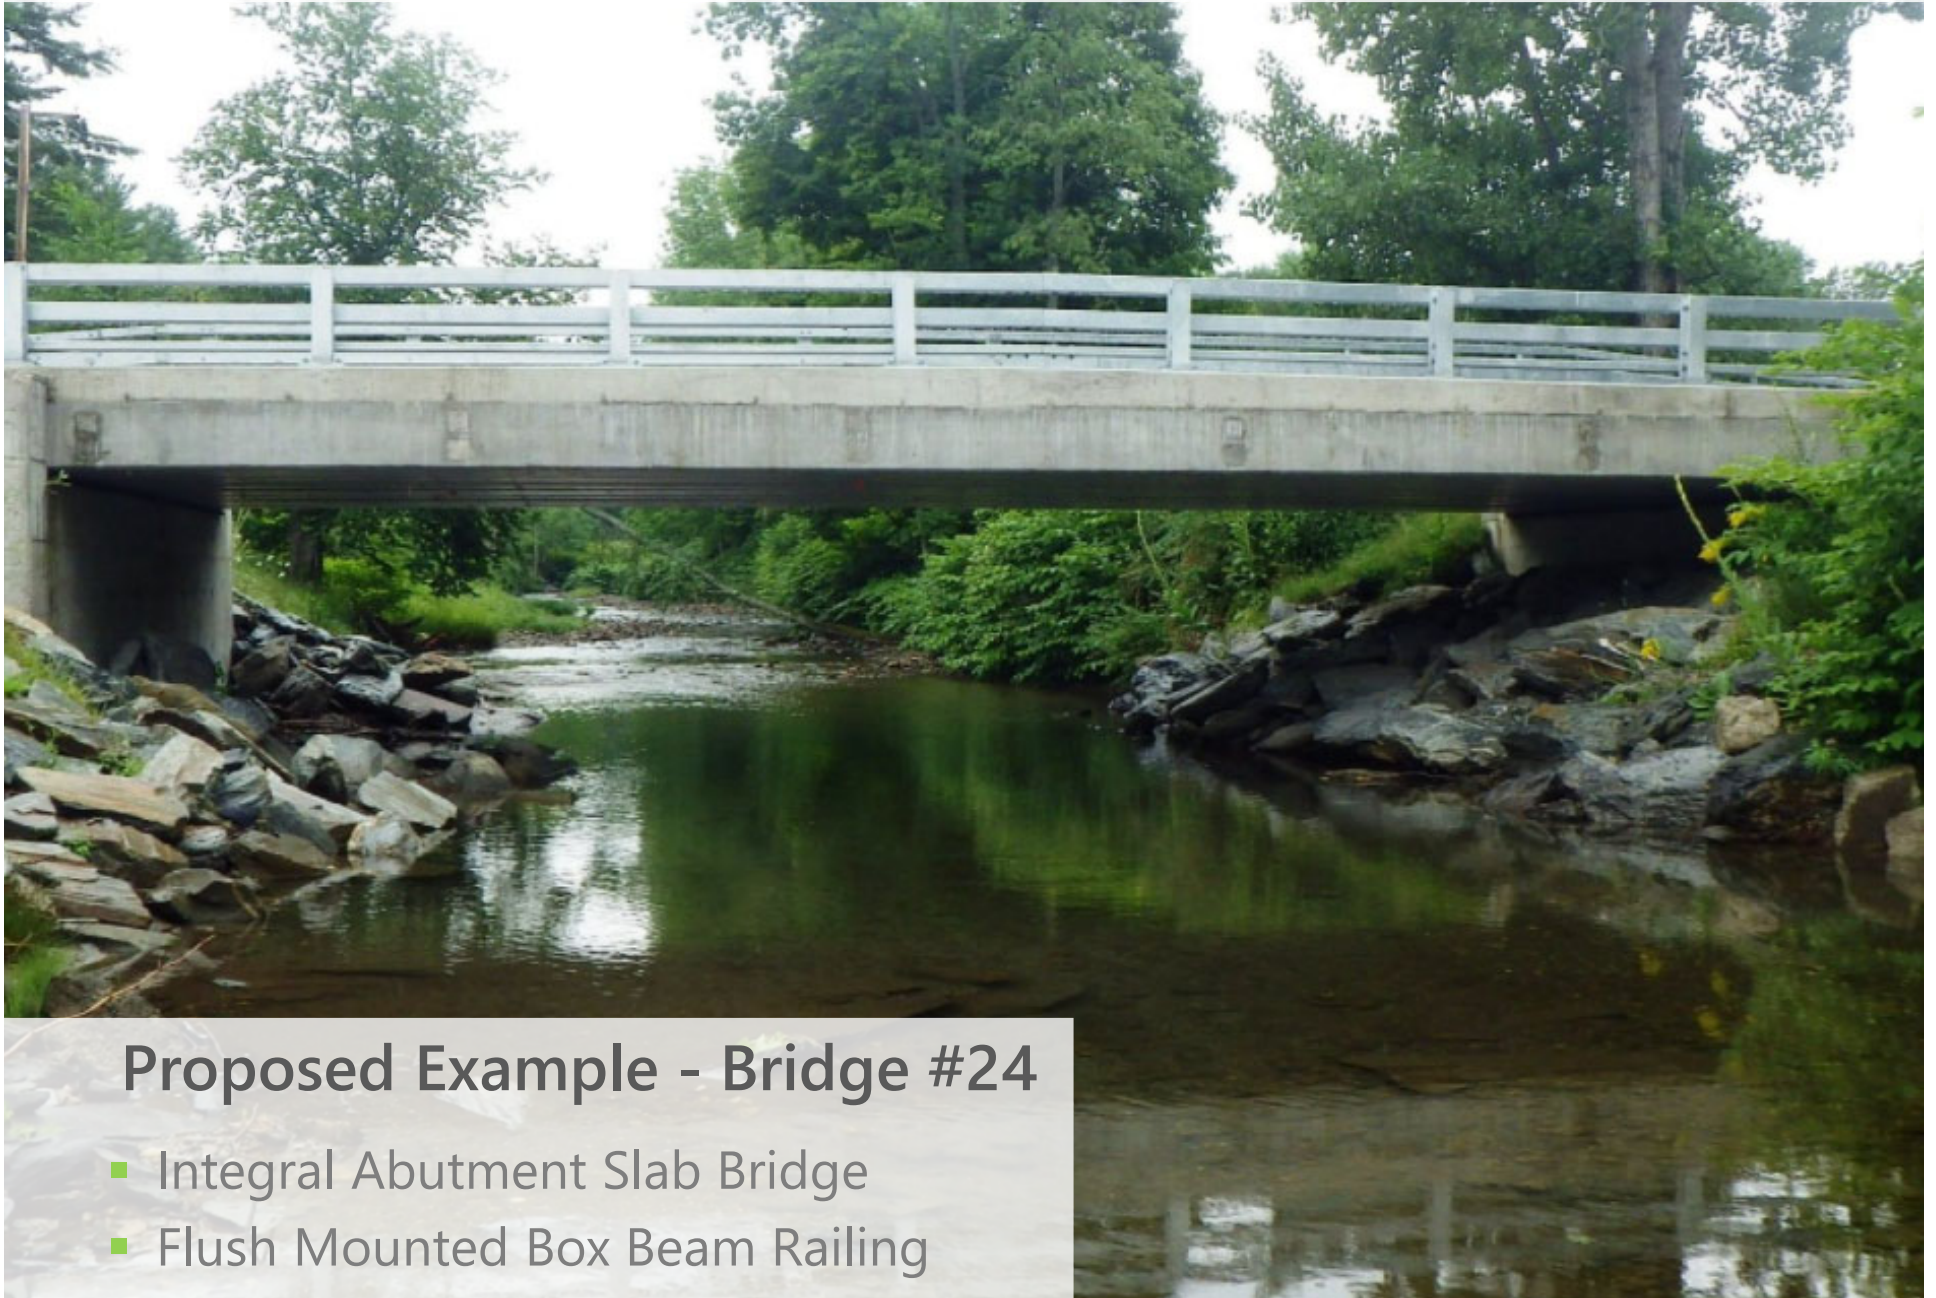
What Will the New Bridge Look Like?

Proposed Example - Bridge #24

- Integral Abutment Slab Bridge
- Flush Mounted Box Beam Railing

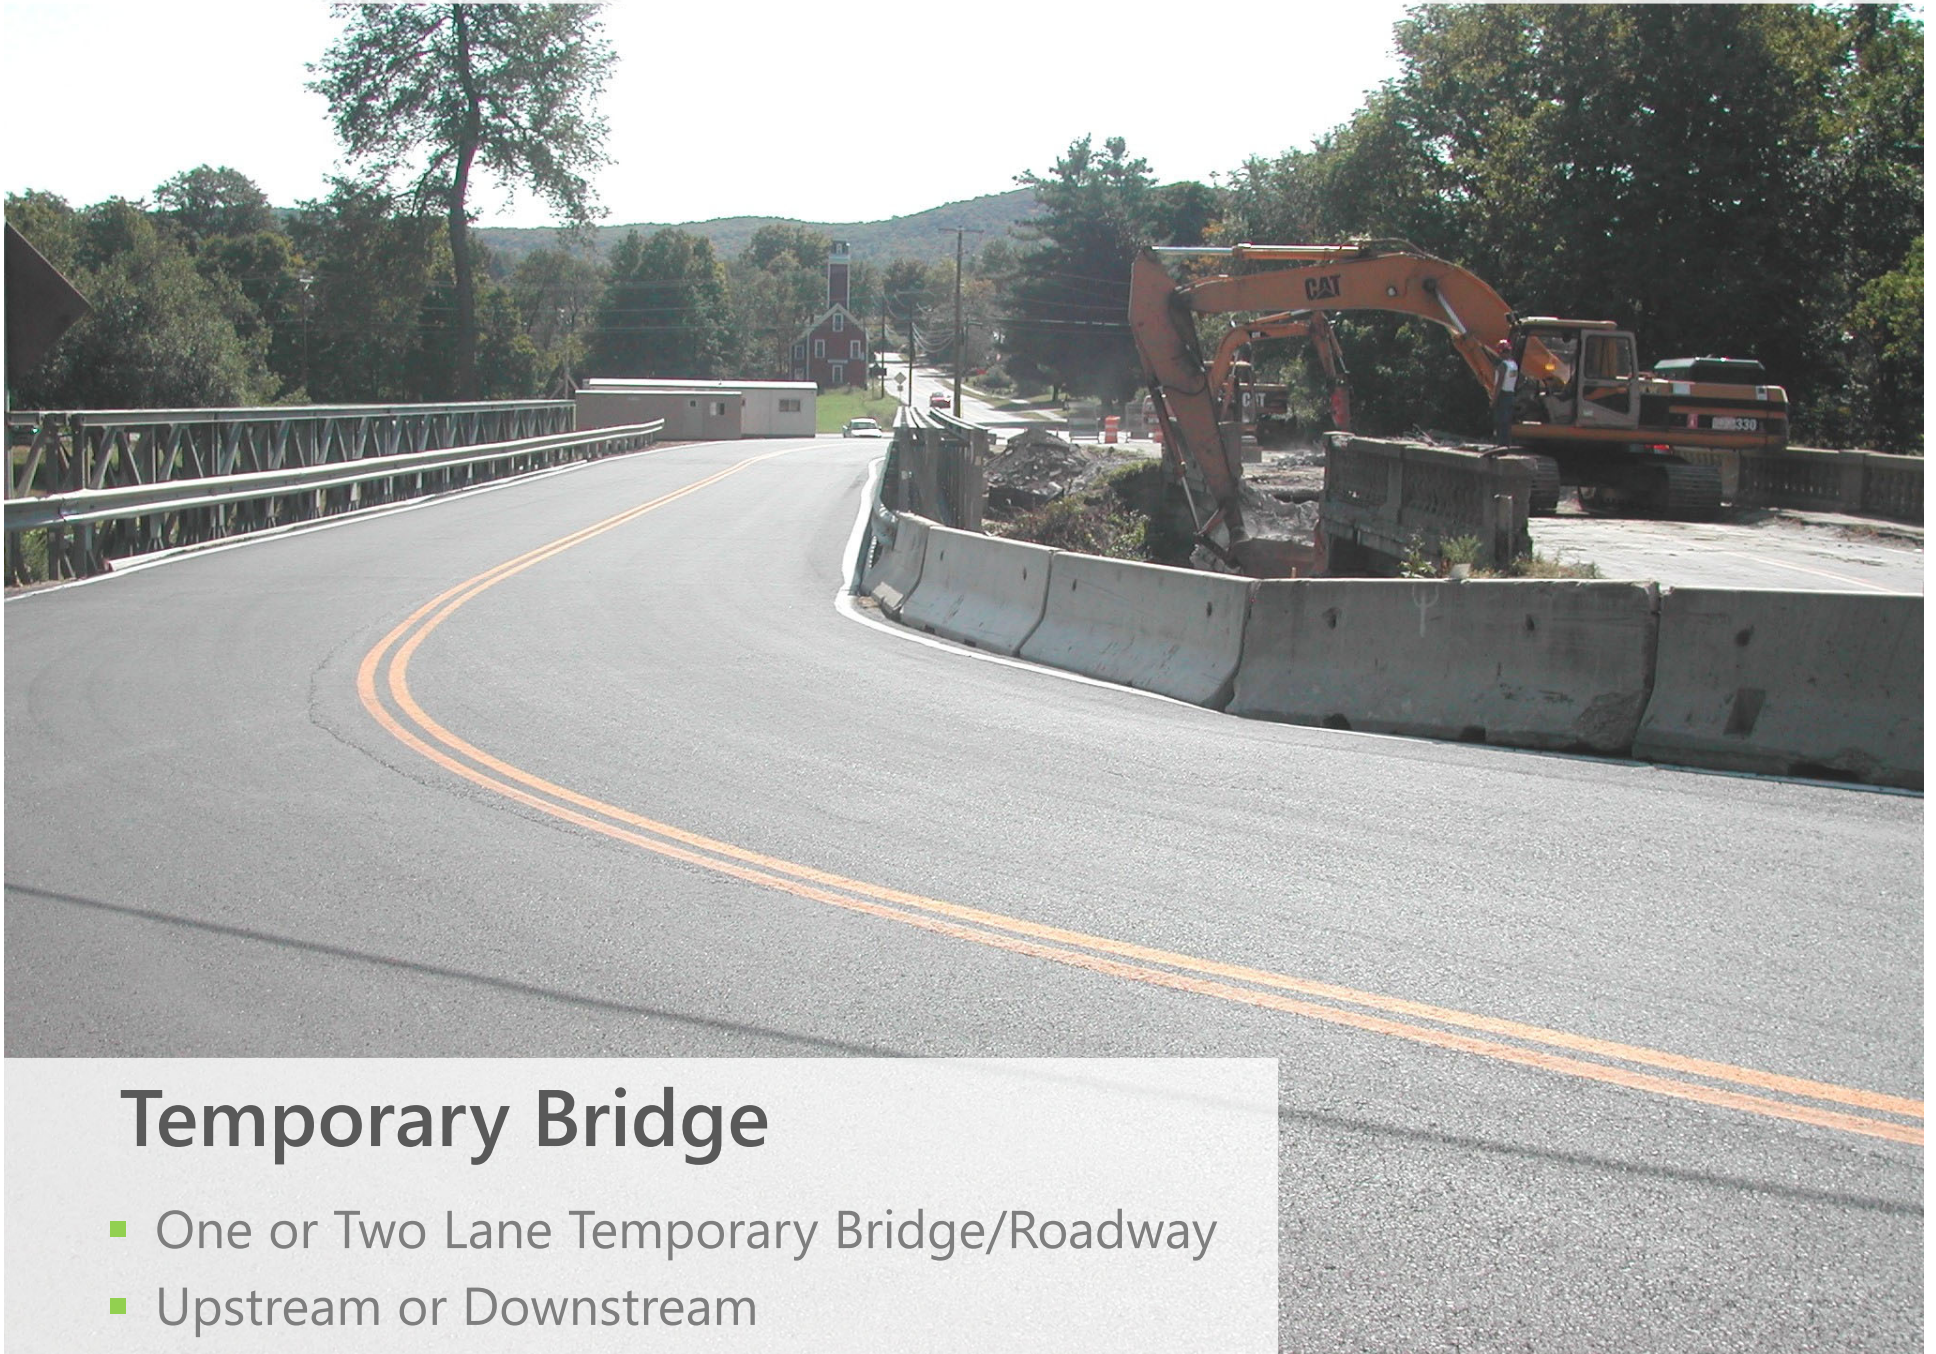
Selected Method of Traffic Maintenance

Temporary Bridge

- One or Two Lane Temporary Bridge/Roadway
- Upstream or Downstream
