STATE OF VERMONT
AGENCY OF TRANSPORTATION

Scoping Report

Bennington BF 1000(20)
Town Highway 2, Bridge 6 over the Walloomsac River

September 10, 2019

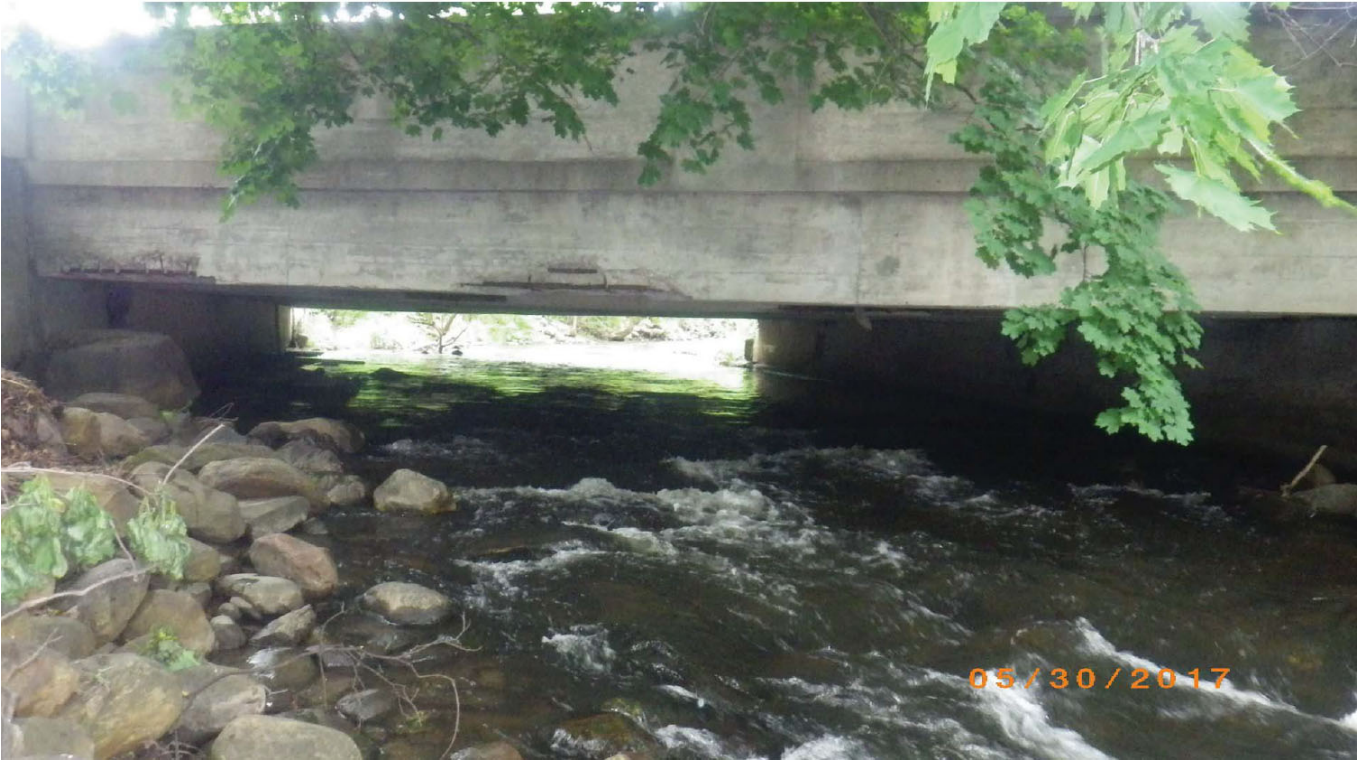
Picture 3: Looking at Upstream Fascia

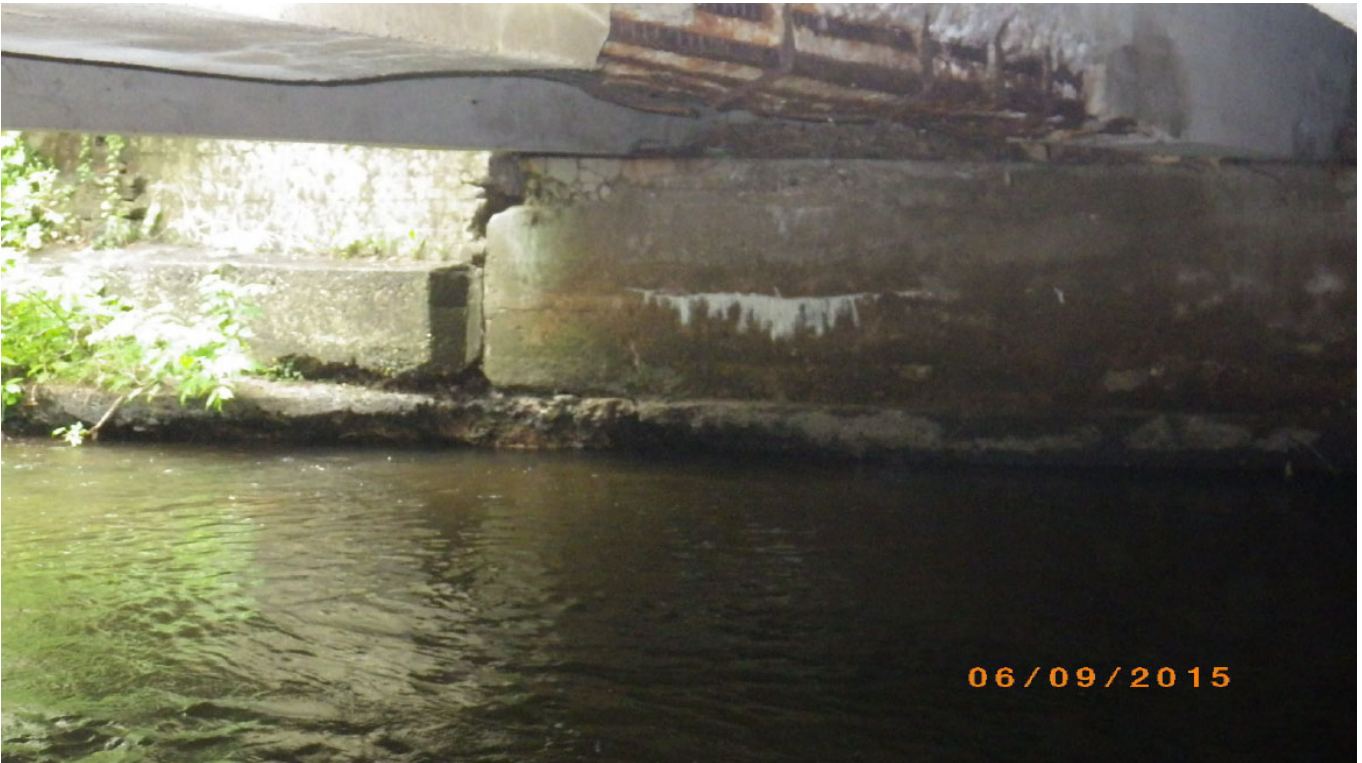
Picture 4: Abutment Scour and Deterioration

5/30/2017 – Concrete repairs are needed throughout. The abutments continue to spall out around the drain openings and along the footings. Voids have developed due to spalling along the stemwall ends and the wingwalls. Scattered settlement cracks in abutment 2 that stem from the drainage openings have ¼" +/- of separation. The spalling around beam 10 at abutment 2 has narrowed the bridge seat and penetrated into the beam end. Drainage in the deck also affects beam 10 with continued saturation and spalling that penetrates beyond the second layer of reinforcing. ~JW/SP

6/9/2015 – Extensive concrete repairs are needed throughout. The abutments continue to spall out around the openings of the old drainage pipes and there are large voids with cracking along the wingwalls. There are scattered full height vertical settlement cracks in abutment 2. The bridge seat area under beam 10 at abutment 2 has become a concern. This is due to continued spalling and saturation that penetrates down through the bridge seat and up from the drainage opening below. The area continues to “neck” down and could eventually lead to a failure in the bridge seat. The old weep tubes continue to saturate and cause spalling in the beams below. ~JWW/JDM

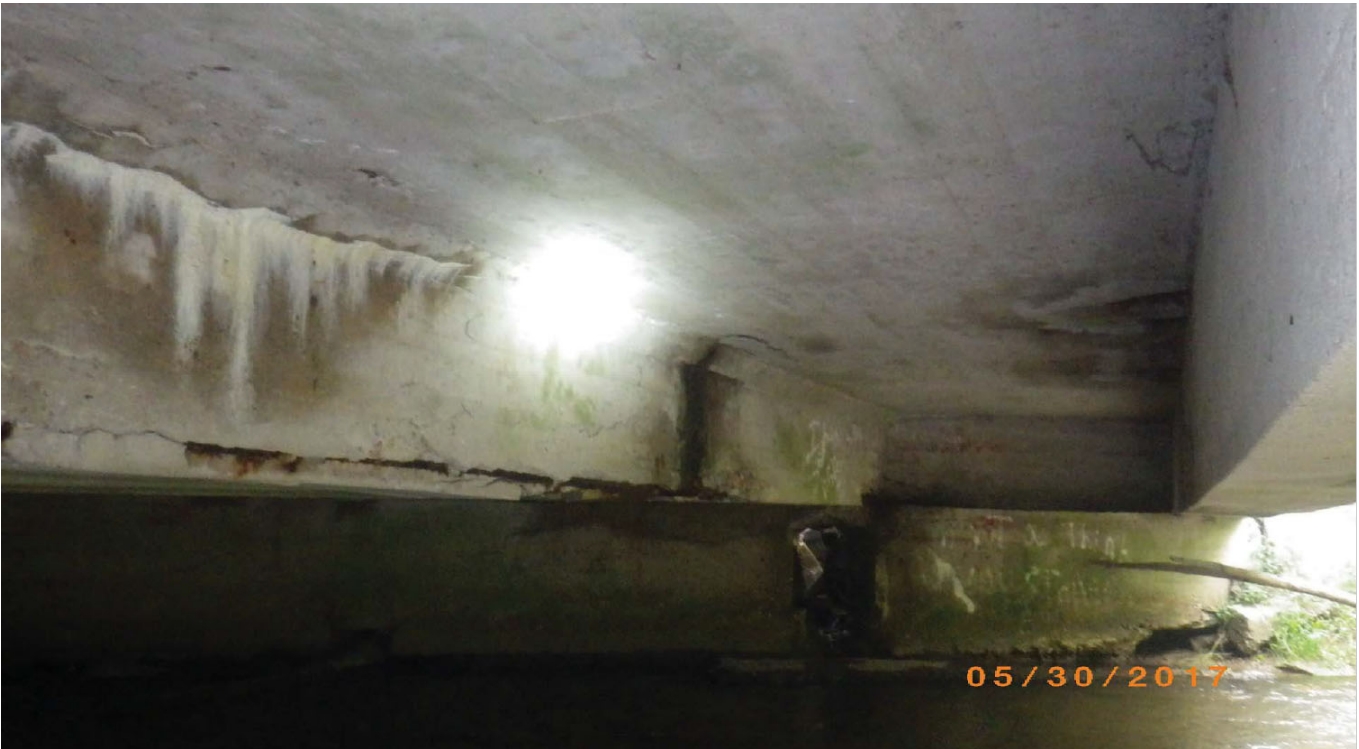
Picture 5: Beam and Abutment Deterioration

Bridge 6 is not considered structurally deficient; however, the existing T-beams are only in fair condition and continue to deteriorate, with large areas of delaminations on the T-beams and continually saturated areas on the deck soffit. Additionally, the hydraulic opening is substandard.

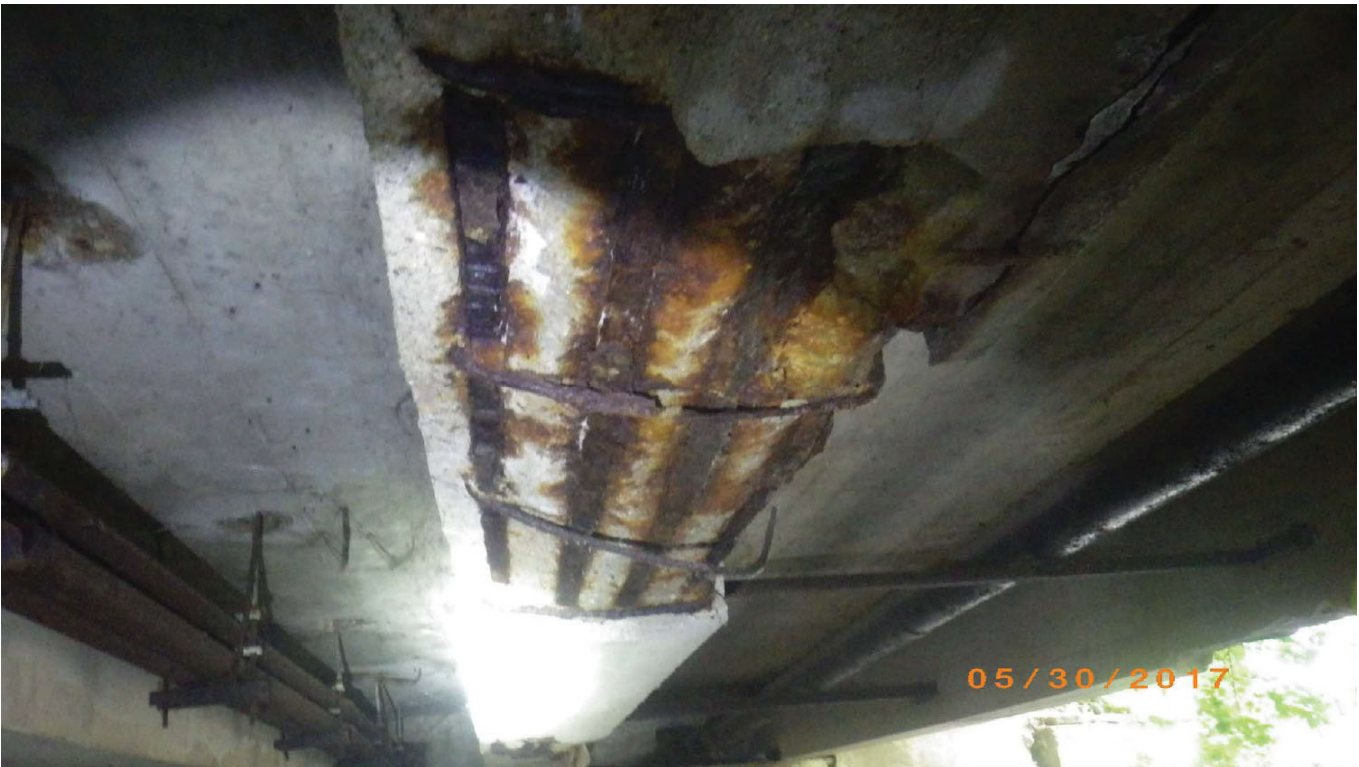
Picture 6: T-Beam Deterioration and Utilities

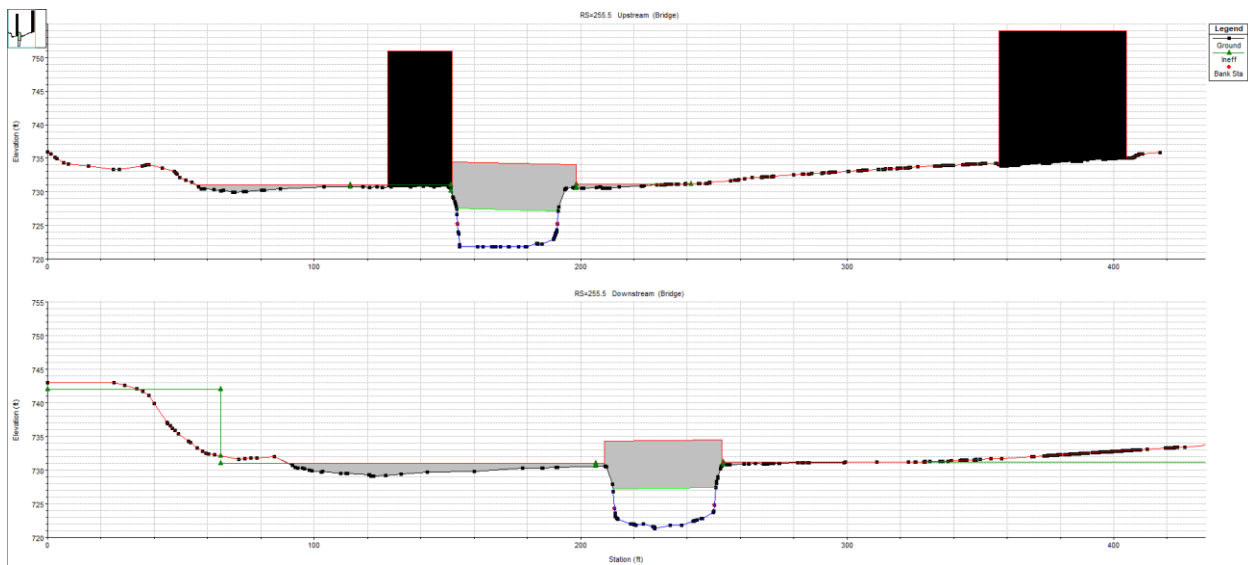
The existing bridge does not meet the VTrans hydraulic requirement to pass the Q_{50} flow with 1.0 foot of freeboard. The model predicts that for Q_{50} that the bridge is overtopped, with water surface elevation at 731.3-feet and -4.3-feet of freeboard. The existing bridge has a clear span of 37 feet and does not span the measured BFW of 40 feet.

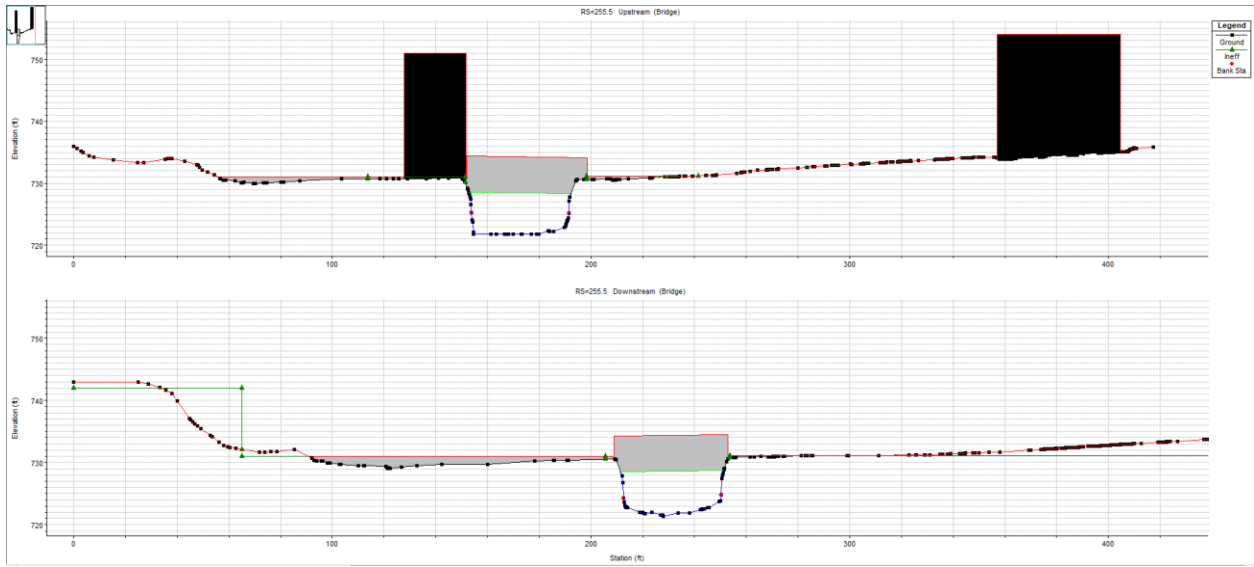
PROPOSED BRIDGE: ALTERNATIVE 1 REDUCED SUPERSTRUCTURE DEPTH

This replacement bridge alternative is located on the same roadway alignment as the Existing Bridge with the center of the bridge at approximately River Station 255.5. Due to existing buildings and retaining walls which form the stream banks upstream and downstream of the bridge, widening the bridge profile was not seen as a feasible option. Additionally, building and driveway entrances along the approach roadway constrain the roadway profile from increasing, limiting a substantial increase in low chord elevation. For this reason, VTrans recommended a proposed bridge with a reduced superstructure depth to improve the hydraulic performance of the bridge. This option would maintain a single span bridge but decrease the superstructure depth from a depth of approximately 3.1-3.3 feet to 2-feet to improve conveyance of South Stream during large storm events. The proposed abutments remain in the same location as the existing abutments with a clear span length of 37 feet. All input parameters for this Proposed Conditions model were the same as the Existing Conditions model (i.e. contraction/expansion coefficients, Manning's n, etc.).

While the low chord of the bridge is raised to 728.7 feet, the hydraulic design requirements of passing the Q_{50} flow with 1.0 foot of freeboard are still not met but yields improved results. The water surface elevation for Q_{50} is reduced from 731.3-feet to 730.5 feet with -2.2-feet of freeboard and no is longer predicted to flood the roadway. This alternative does not span the BFW of 40 feet but, as mentioned previously, nearby obstructions limit the widening of the bridge profile.

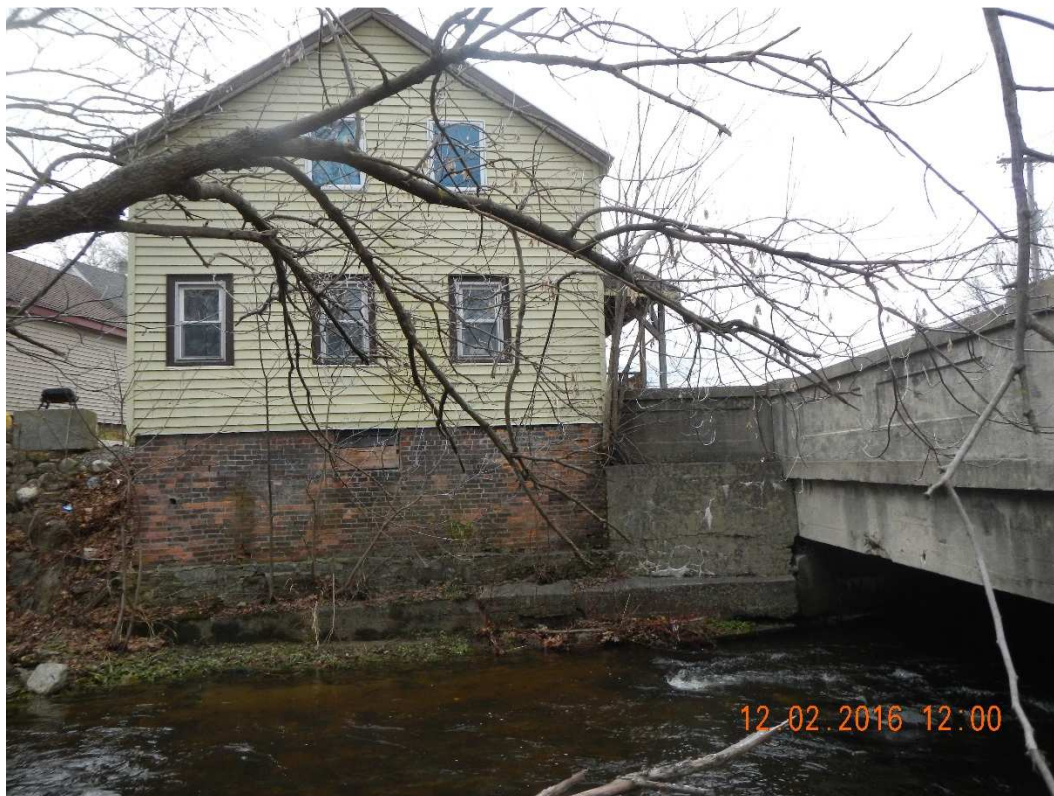
Figure 3: Structure Foundation in Contact with Bridge

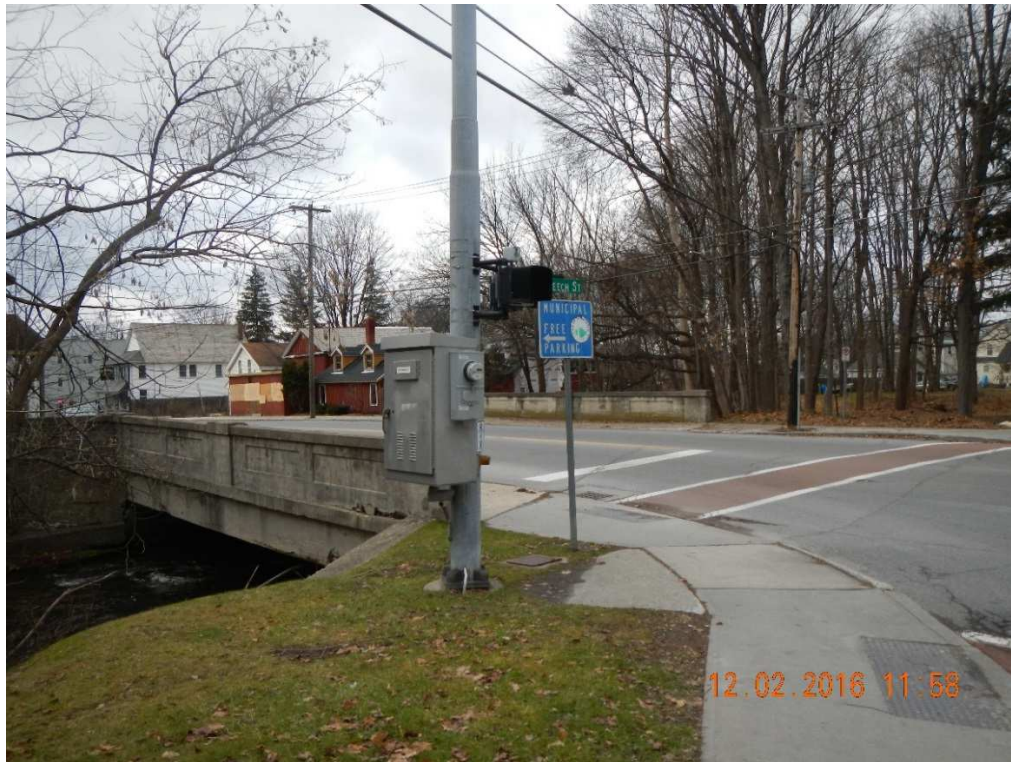
Figure 4: Utility Lines Above and Parallel to Bridge

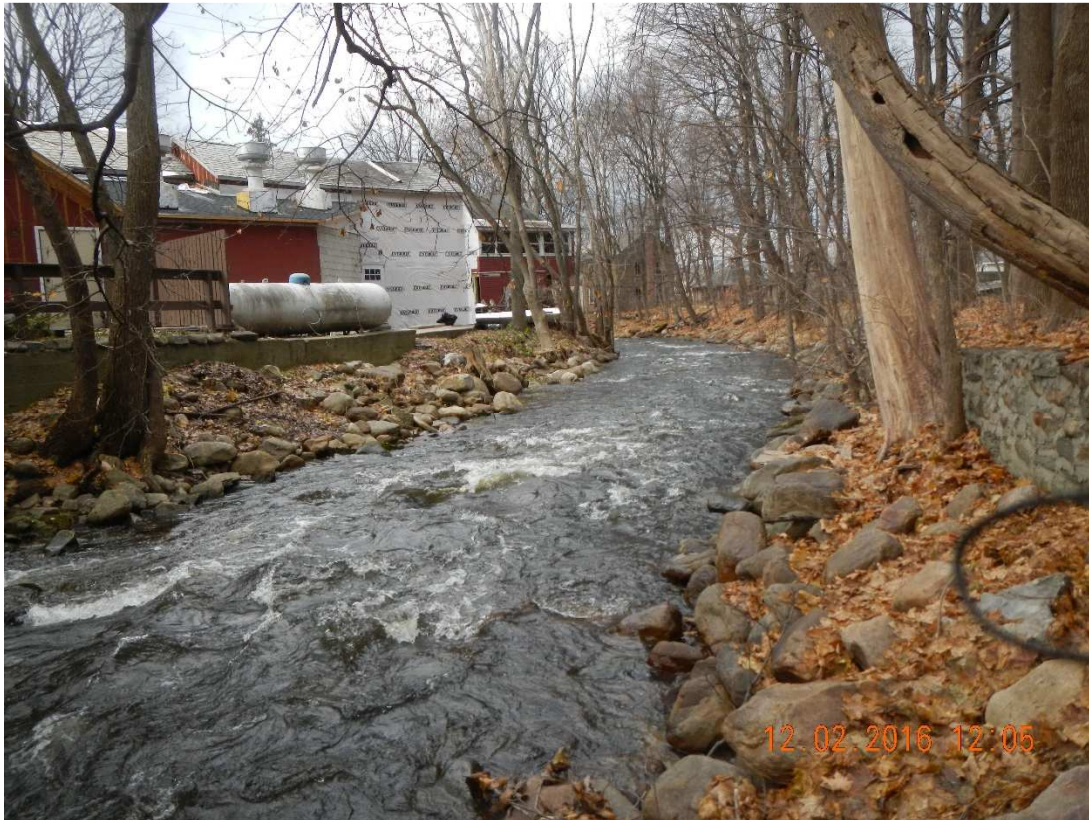
A preliminary site visit was conducted on December 2, 2016 to determine possible obstructions inhibiting boring operations and to make any other pertinent observations about the project. This visit revealed structures in close proximity to the bridge, including a building foundation in contact with one of the wingwalls on the west side of the bridge, as seen in Figure 3. Overhead powerlines cross Route 9 above the bridge on the east side, and run parallel to the bridge on the north side. The utility lines/poles can be seen in Figure 4 and Figure 5. There was no visible bedrock in the stream, but there were many boulders and cobbles visible throughout the stream and stream bank which can be seen in Figure 6.

Figure 6: Boulders and Cobbles in Stream

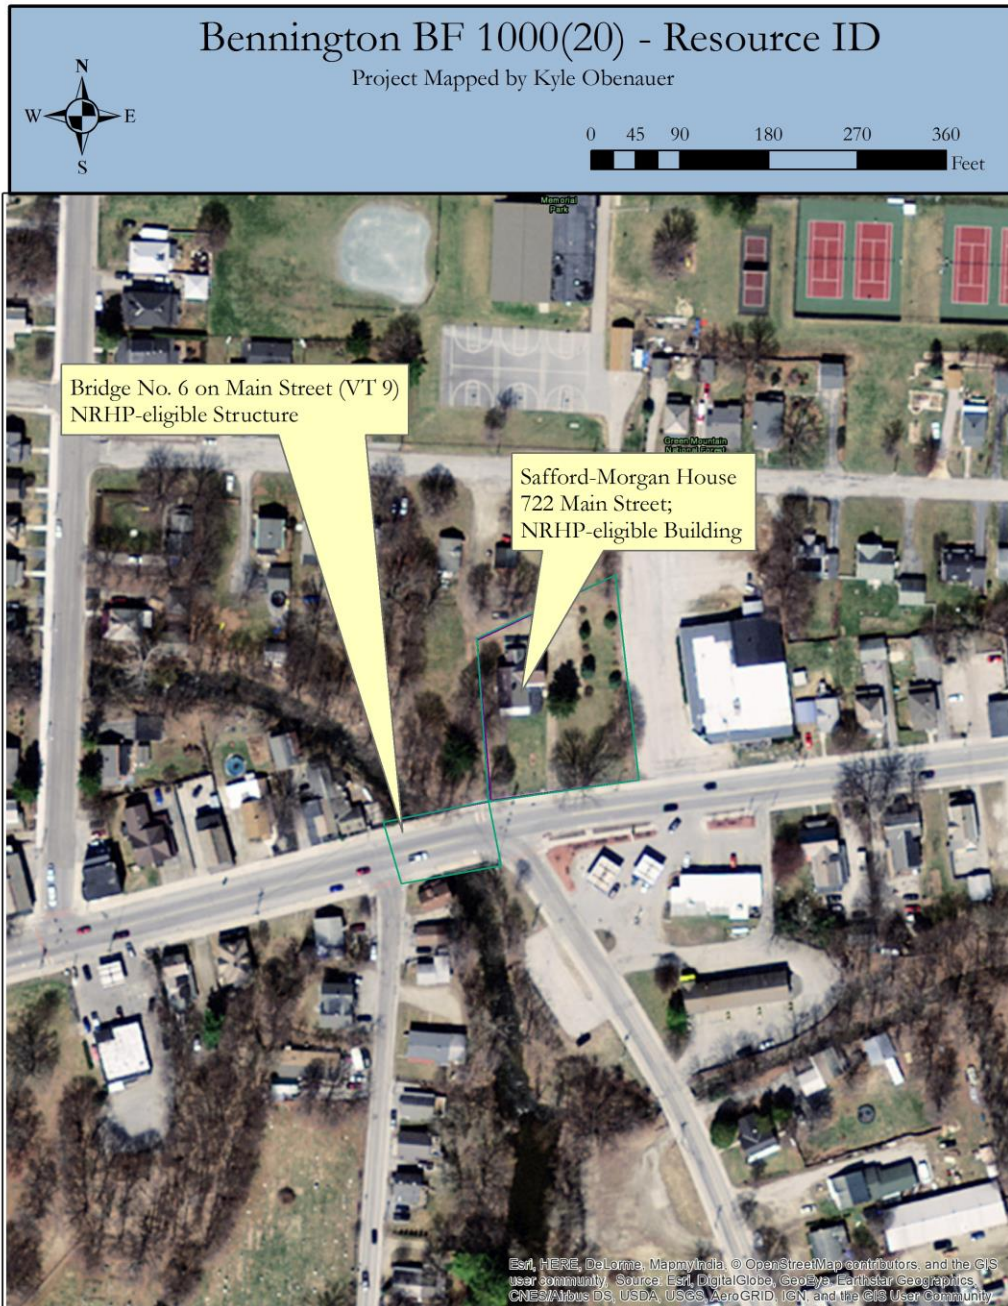
Figure 1. Historic Resources within a Possible Project APE for Rehabilitation of Bridge No. 6

Within a likely project Area of Potential Effect (APE), two historic resources were identified as eligible for inclusion in the National Register of Historic Places (NRHP): Bridge No. 6 and the former Safford-Morgan House at 722 Main Street (Figure 1). Both historic resources have been mapped in ArcGIS and are considered Section 4(f) property types.

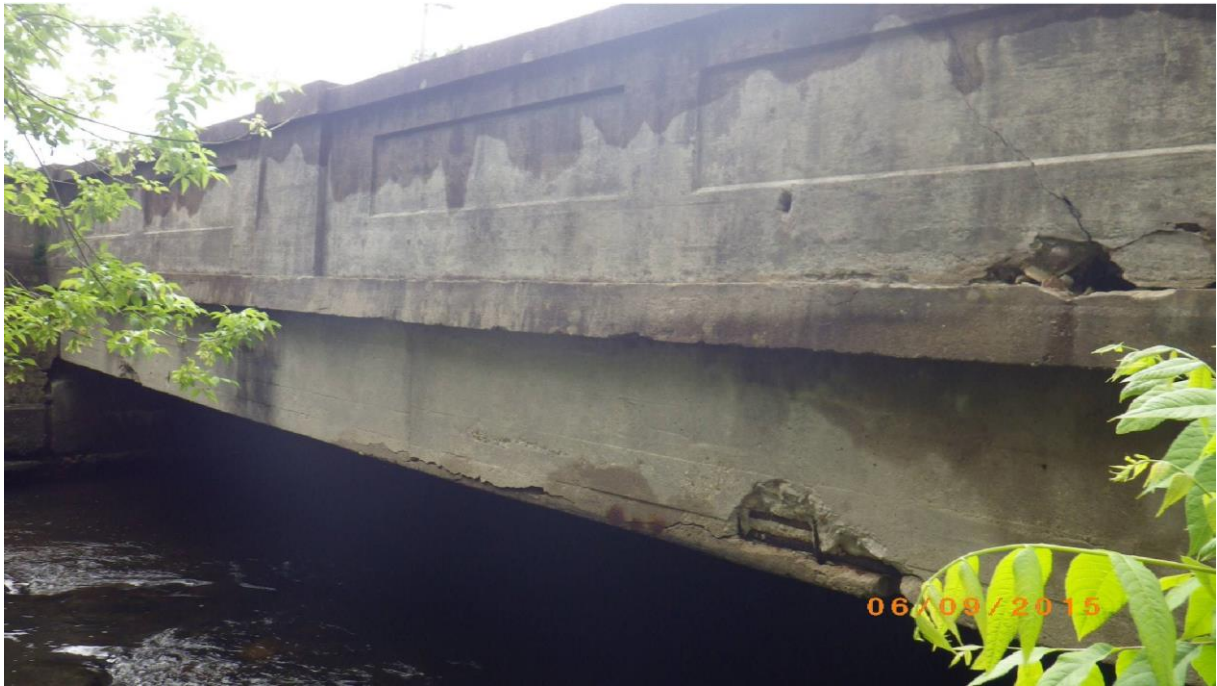
Figure 2. Bridge No. 6 Beam and Rail

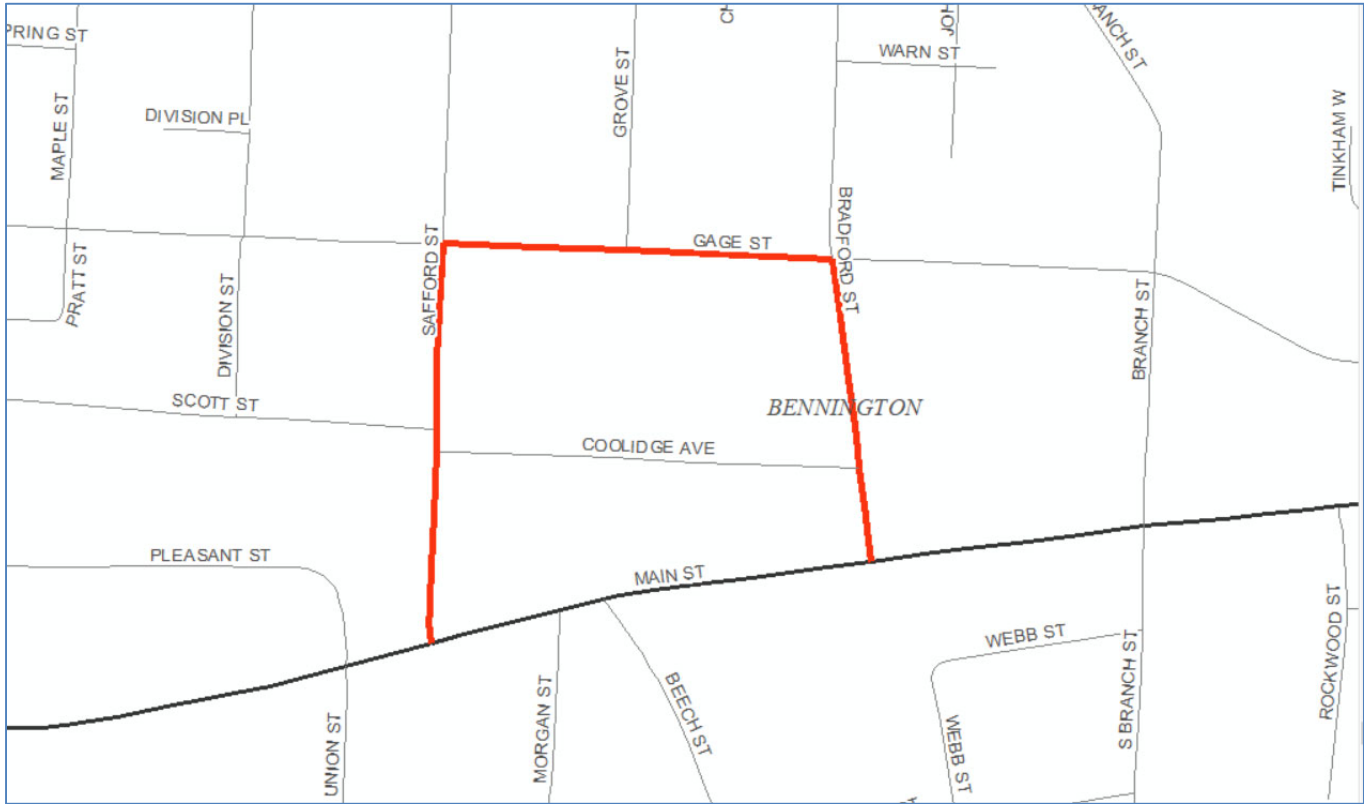
Pedestrian Detour Route: VT Route 9, to Safford Street, Gage Street, and Bradford Street back to VT Route 9

- Through Route: 0.25 Miles
- Detour Route: 0.55 Miles
- Added Distance: 0.3 Miles
- End-to-End Distance: 0.8 Miles

Since there is a sidewalk on the existing bridge, a pedestrian detour is necessary. The above passenger car route does not have sidewalks for the entire length and as such would not be recommended for pedestrians. The pedestrian detour route is as follows:
