Bennington BF 1000(20) Alternatives Presentation Meeting

VT Route 9– Bridge #6 over Walloomsac October 28, 2019

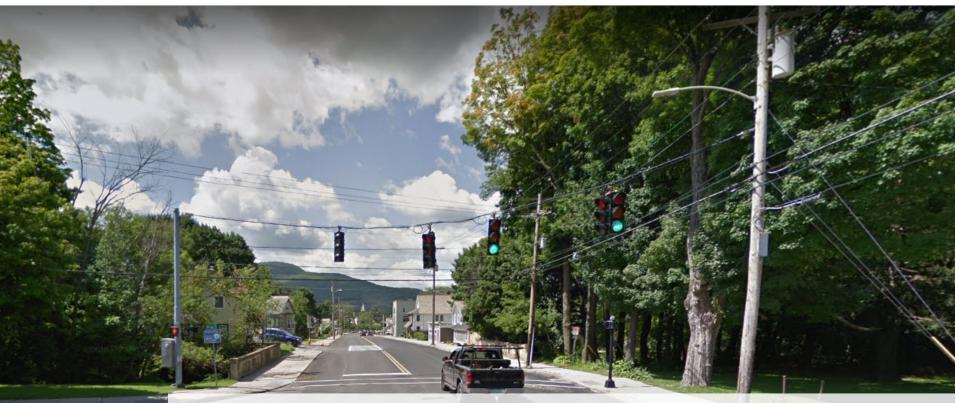
Looking West over Bridge

- Roadway Classification Principal Arterial, National Highway System, Urban (Class 1 Town Highway)
- Bridge Type 46' Span Reinforced Concrete T-Beam Bridge
- Ownership Town of Bennington
- Constructed in 1923

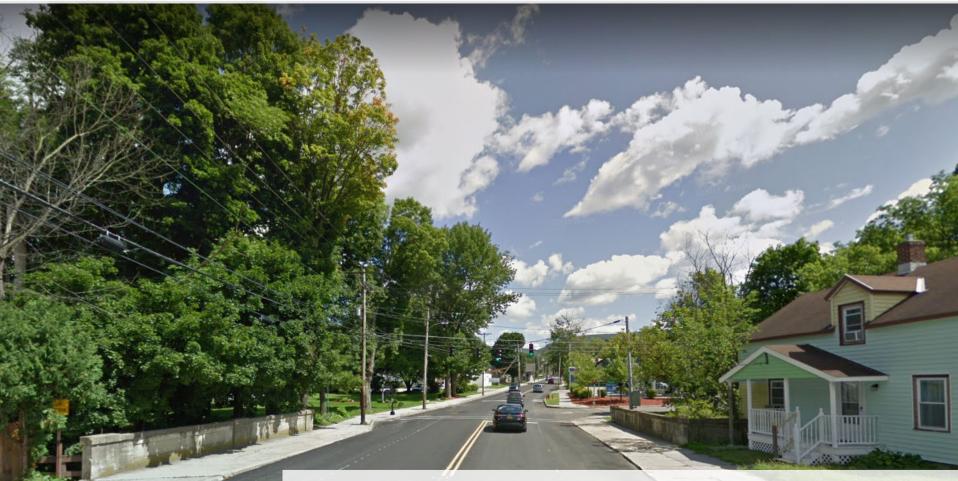
Looking East over Bridge

- Wide sidewalks over bridge
- Located in densely populated area
- Bridge is skewed

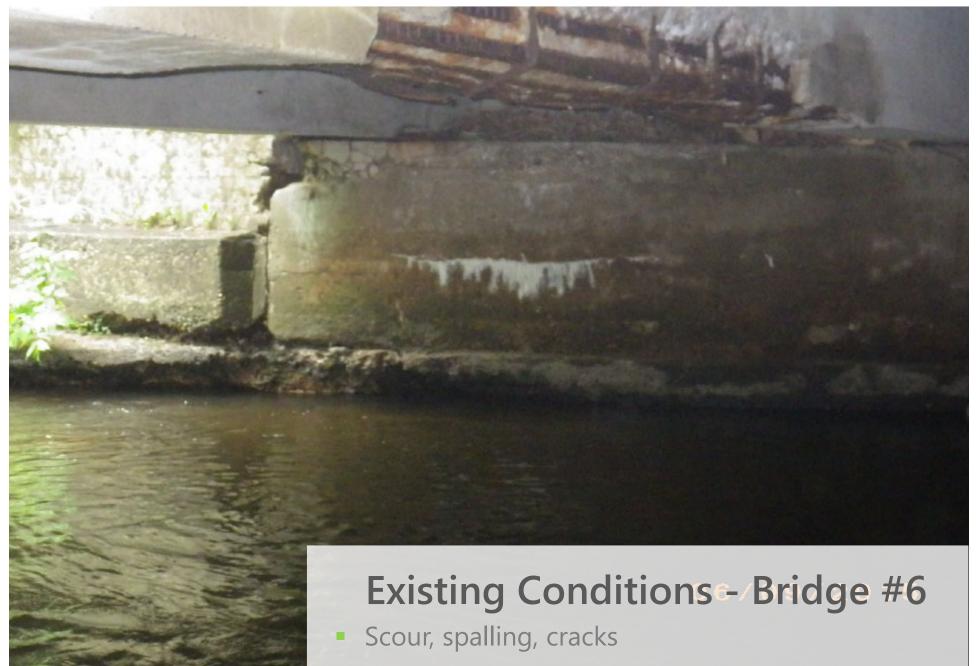
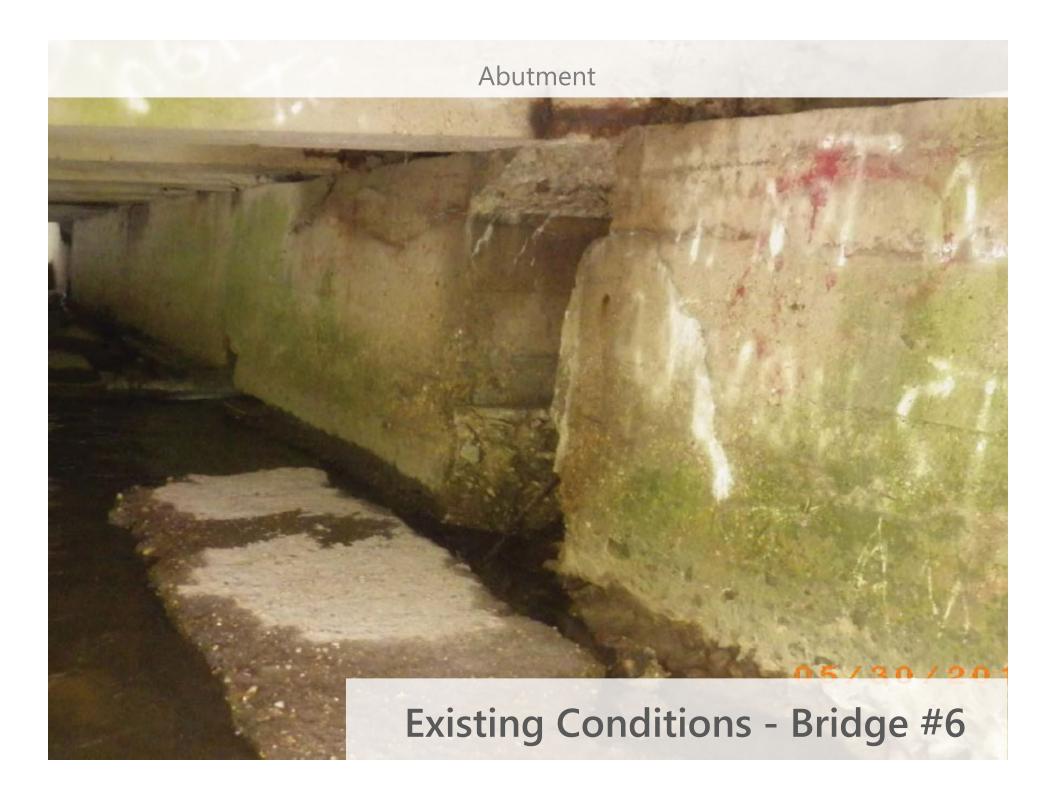
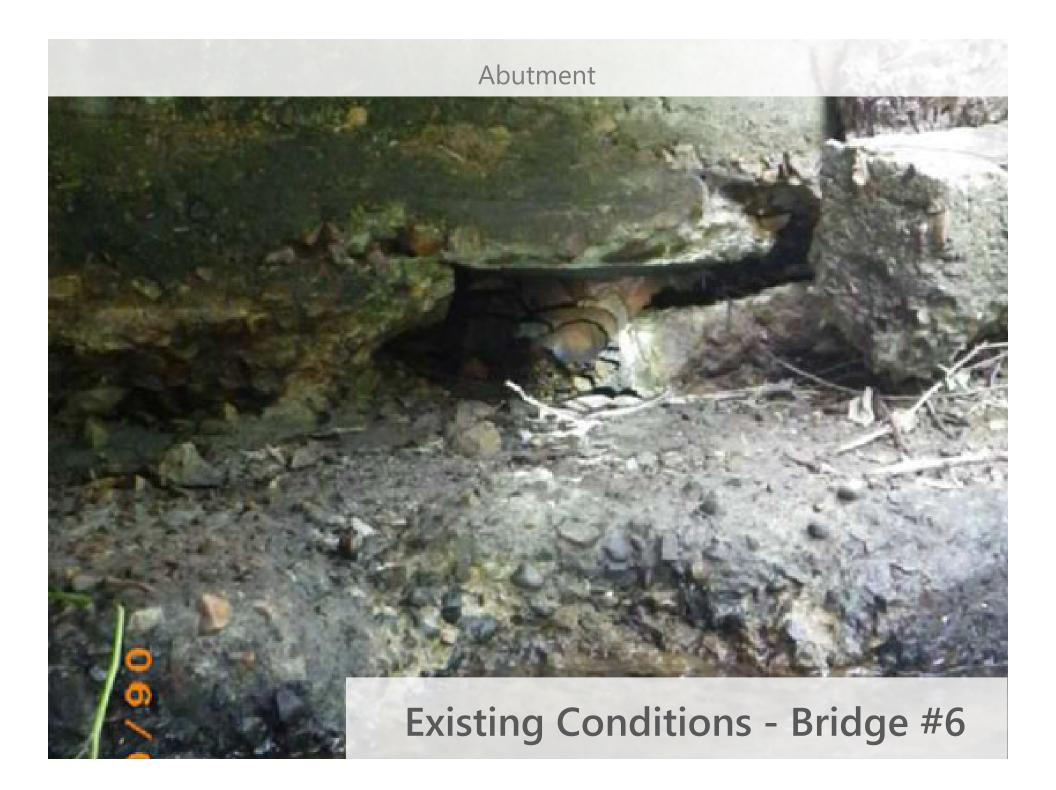
Substructure

- The substructures and superstructure are in fair condition with a rating of
 5. There is significant deterioration of the concrete and bridge seats.
 - Spalling, voids, and cracks in the abutments.
- Settlement cracks in Abutment 2.
- There are drainage features on the bridge that are leaking and saturating concrete members, accelerating deterioration.
- The bridge does not meet the minimum hydraulic requirements and is located within a flood insurance study area.
 - Negative 4-feet of freeboard at the design storm

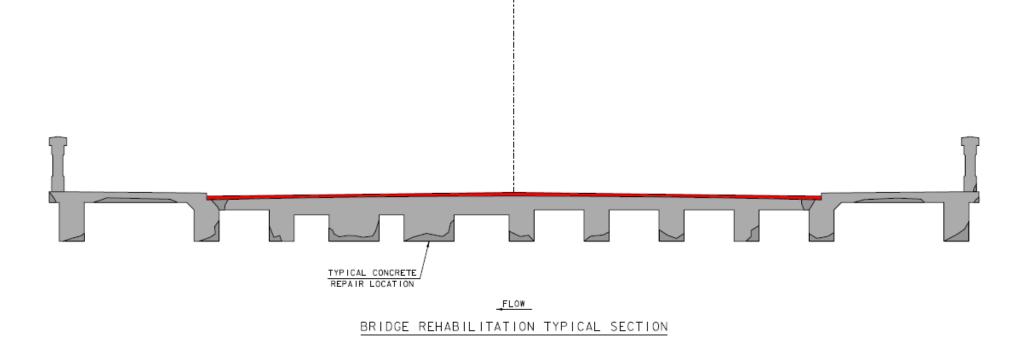
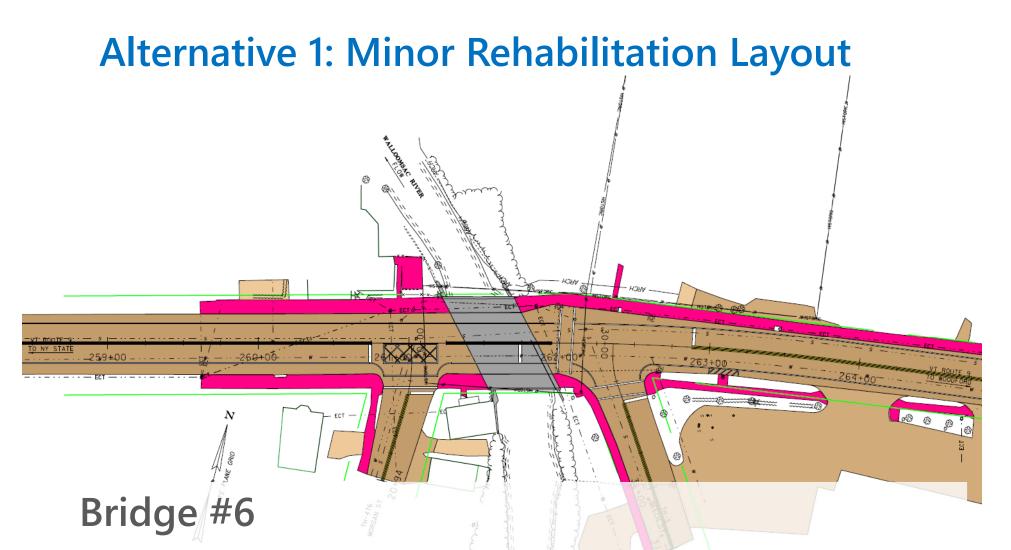
Alternative 1: Minor Rehabilitation Typical Section

- Concrete Repair: Superstructure and Substructure
- New Bridge Joints and Membrane and Pave
- 8'-12'-12'-8' Typical with 9' wide sidewalks on both sides of the bridge
- 15-year design life

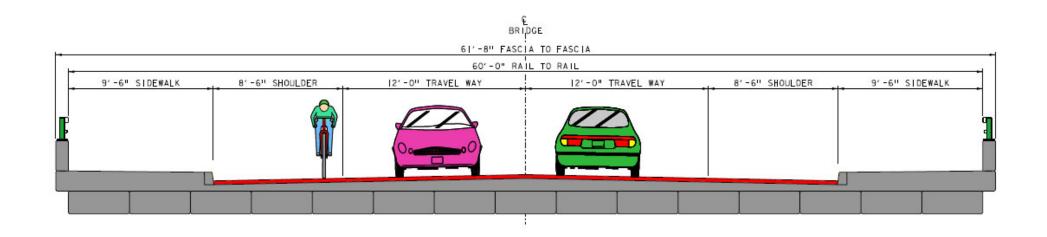
Alternative 2: Superstructure Replacement Typical Section

- New deck and beams on existing substructures
- Concrete repair as needed for substructures
- 8'-12'-12'-8' Typical with 9' wide sidewalks on both sides of the bridge
- 30-year design life based on current condition of substructures

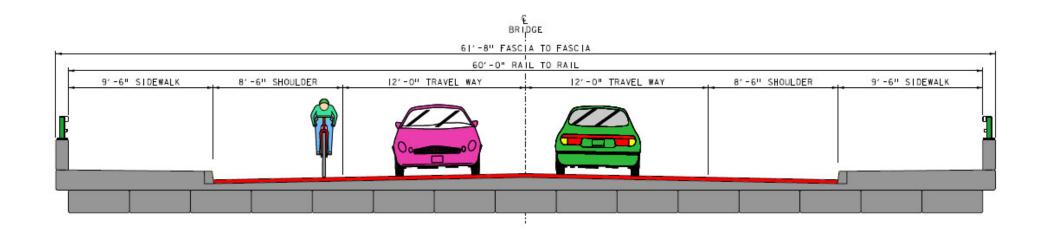
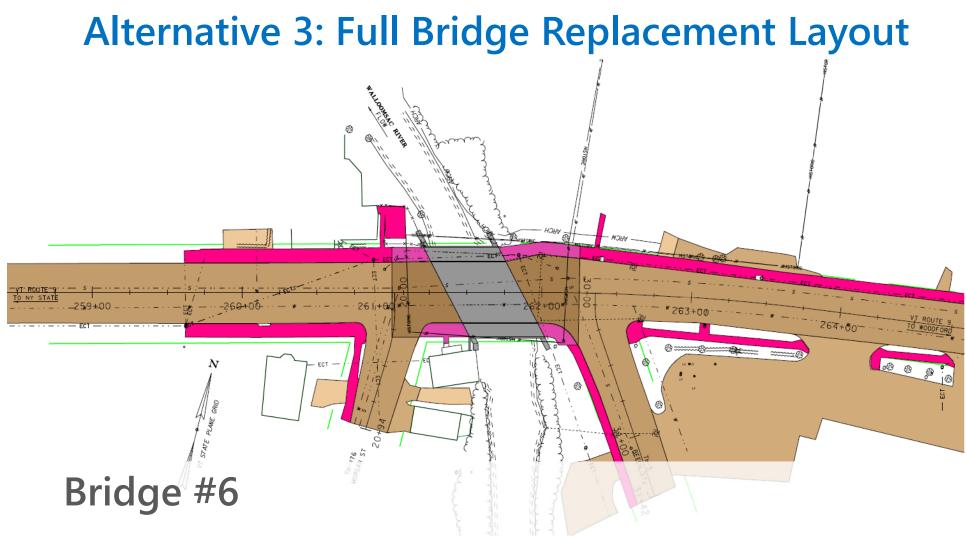
Alternative 3: Full Bridge Replacement Typical Section

- All new bridge components
- 8'-12'-12'-8' Typical with 9' wide sidewalks on both sides of the bridge
- Does not meet minimum hydraulic standard
- 100-year design life

- Full Bridge Replacement
 - 12'/8' typical with 9-foot wide sidewalk on both sides
 - Span length of approximately 50'
 - Remains Hydraulically Inadequate
 - Shallow superstructure type to be chosen
 - 100-year design life

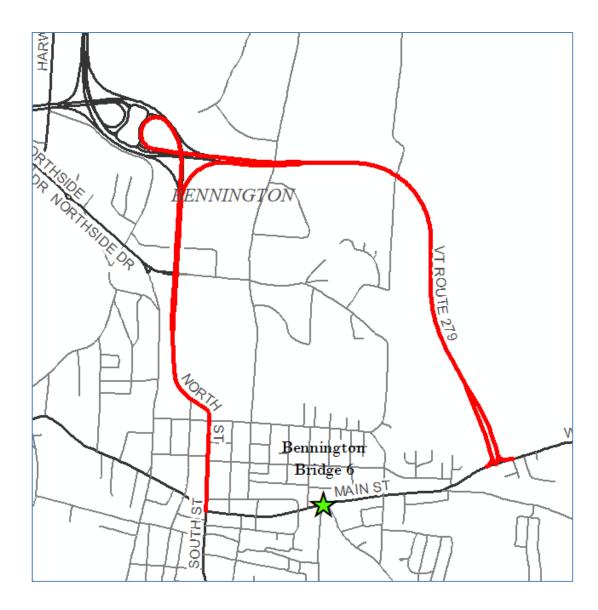
Traffic Control – Offsite Detour: Trucks

- Detour: VT Route 9, to US Route 7, and VT Route 279, back to VT Route 9 (5.4 miles endto-end)
 - Appropriate for large trucks
 - Adds 2.7 miles to the through route

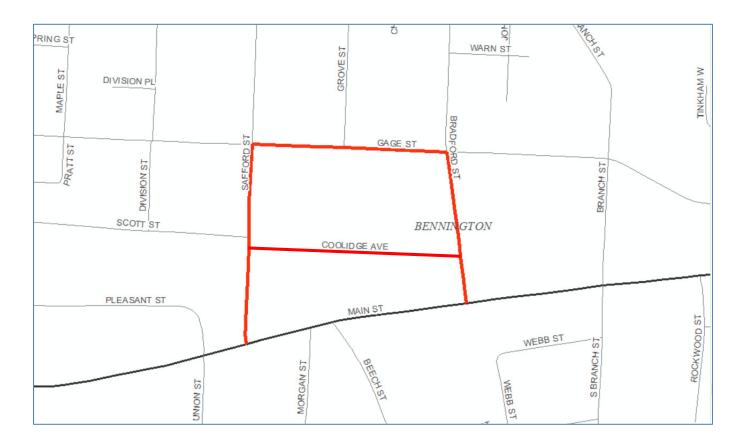
Traffic Control – Offsite Detour: Passenger Cars and Pedestrians

Passenger Car and Pedestrian Detour Routes: VT Route 9, to Safford Street, (Gage Street or Coolidge Street), and Bradford Street back to VT Route 9 (0.6 to 0.8 miles end-to-end)

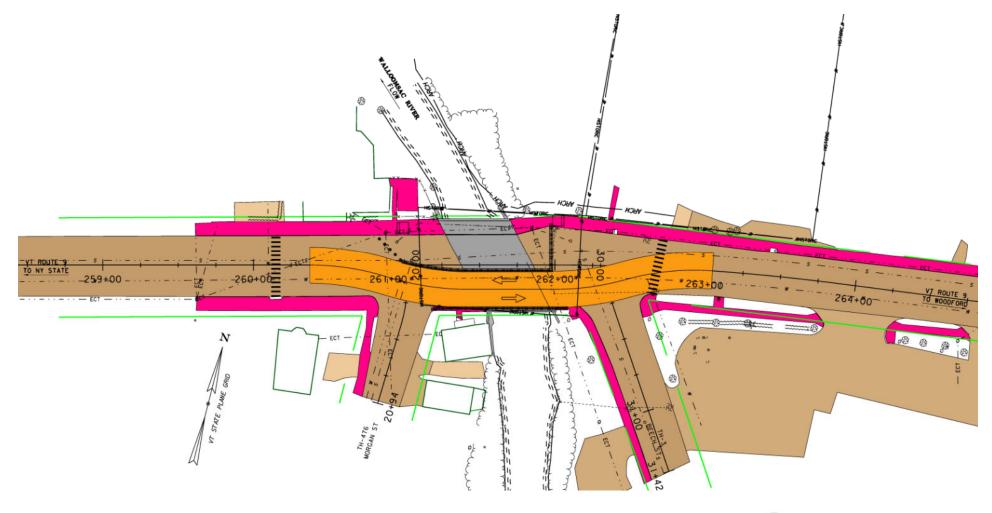
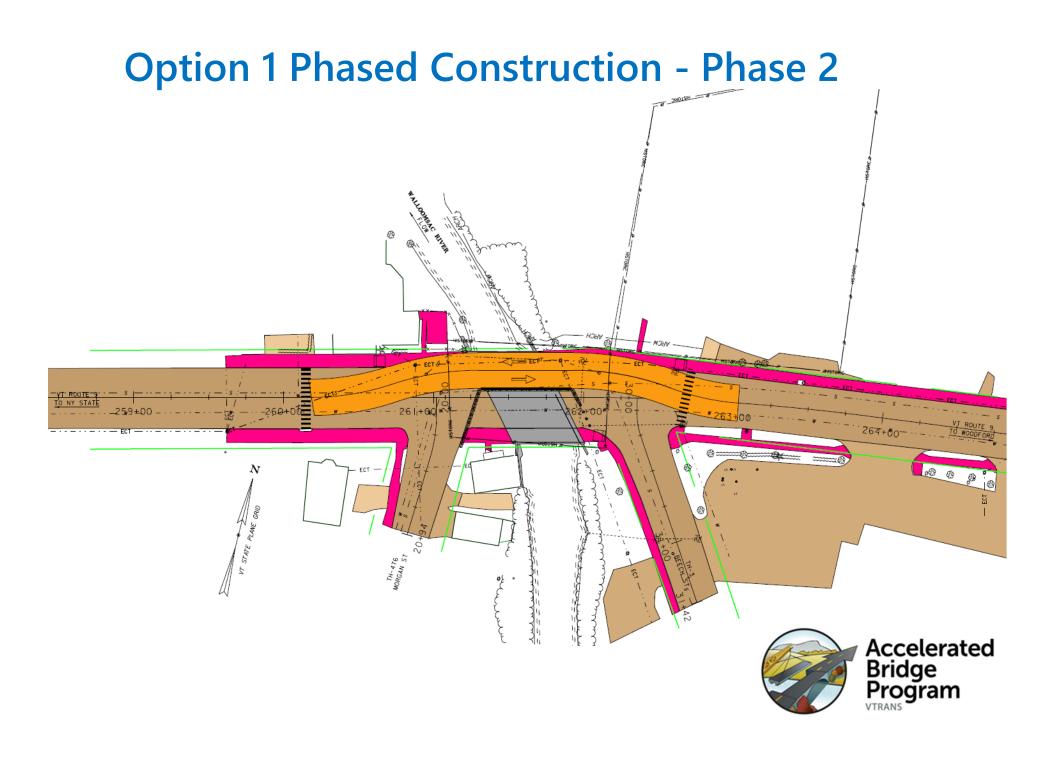
Option 1 Phased Construction - Phase 1

- Two-way traffic maintained
- Bridge closed to pedestrians offsite pedestrian detour for construction season

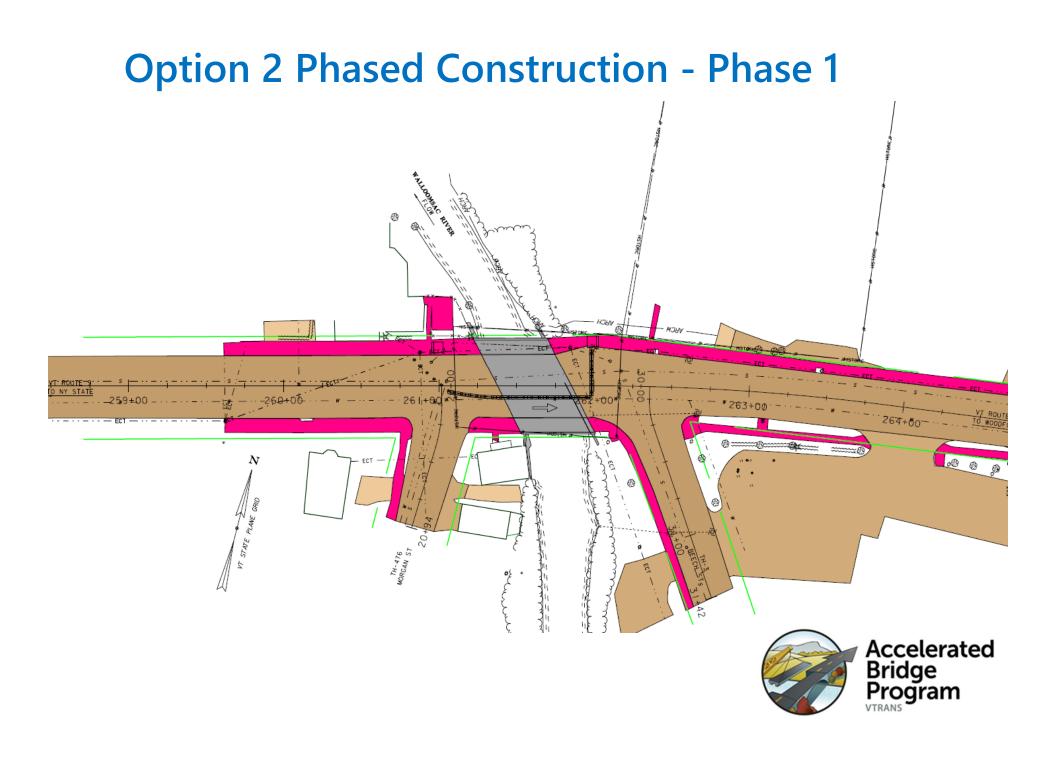
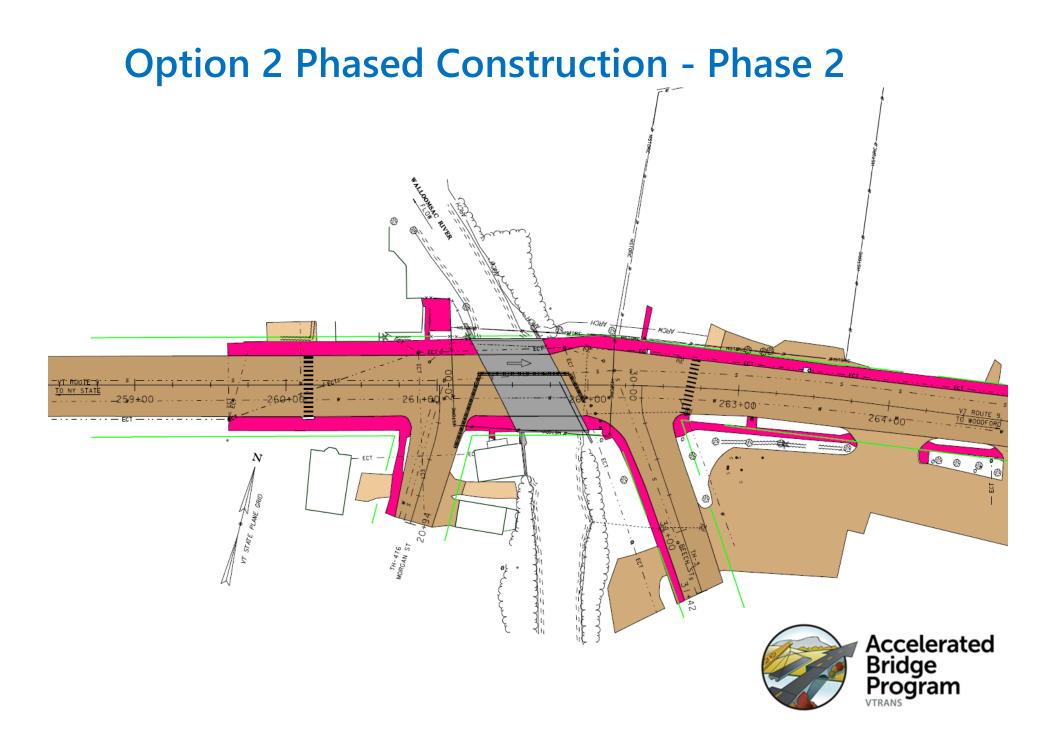
Phased Construction – Option 2

- Pedestrian and 1-way eastbound vehicular traffic maintained
- Offsite detour for westbound traffic
