**STATE OF VERMONT
AGENCY OF TRANSPORTATION**

Scoping Report

Brattleboro BF 2000(28)

VT Route 9, Bridge 54 Over Whetstone Brook

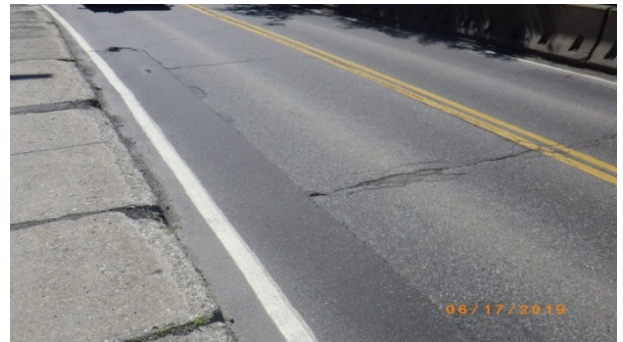
- a. There is longitudinal map cracking in the bituminous pavement along the outer edges with depressions throughout and patching on the downstream side.

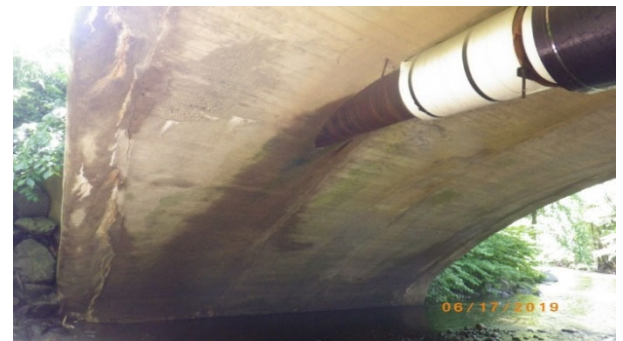
- c. The barrel of the arch has scattered fine longitudinal and map cracks below the fascia areas with efflorescence staining.

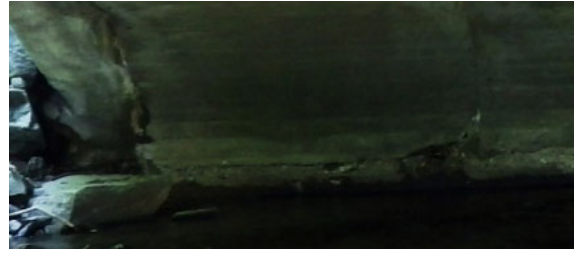
- f. There is heavy abrasion along the water line at both abutments.

6/17/2013 – Structure is in fair to good condition. Stone should be added to the south end of the arch to help stop the scour. ~FRE/DAK

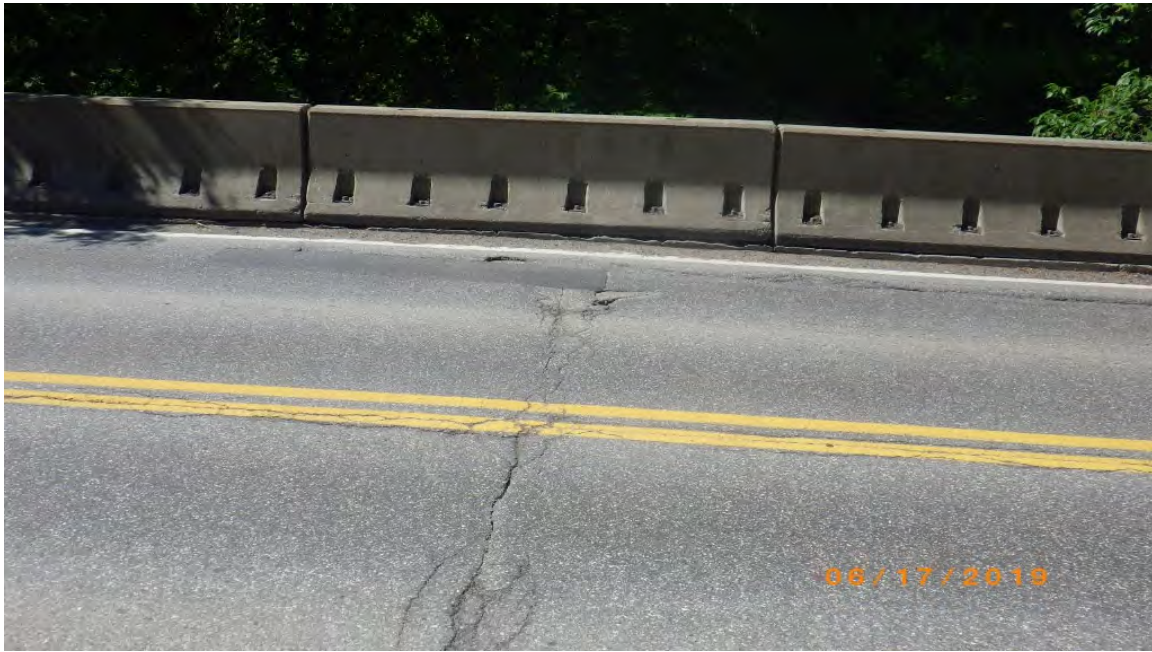
Picture 5: Concrete Barrier Railing

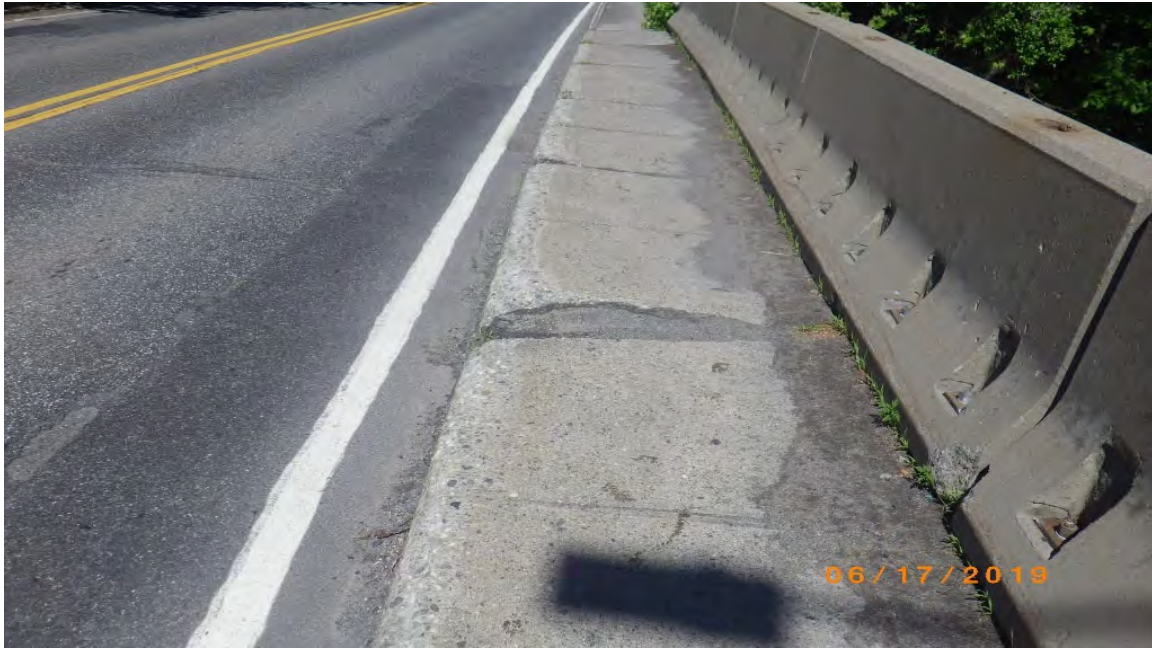
Picture 6: Poor Sidewalk Condition

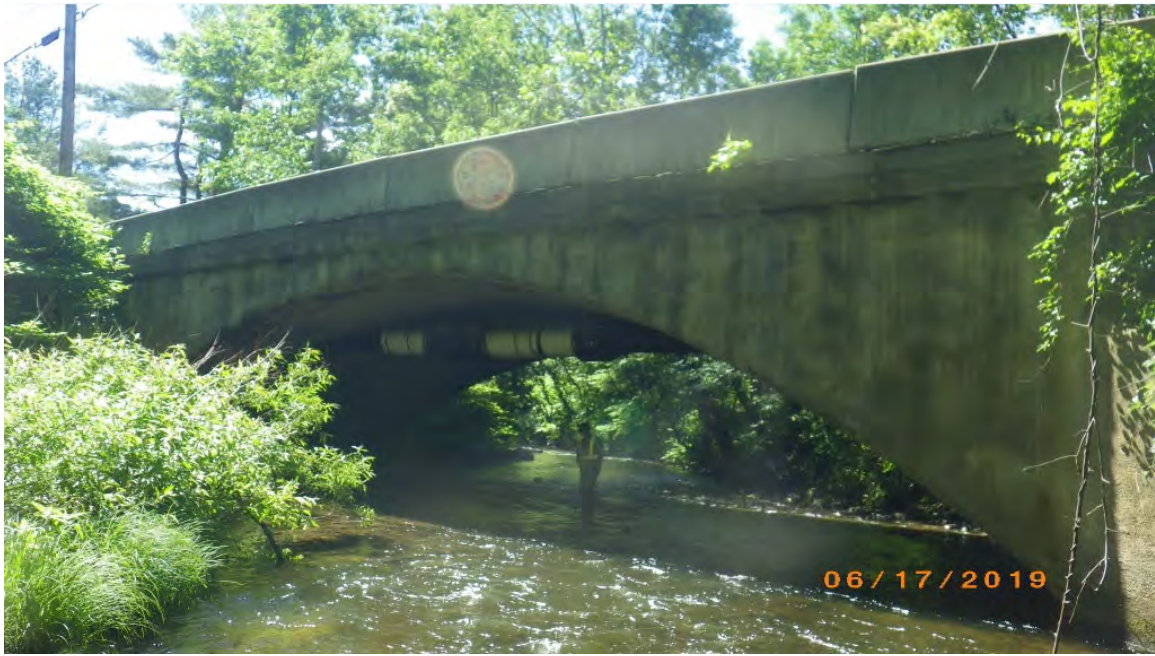
Picture 7: Upstream Fascia

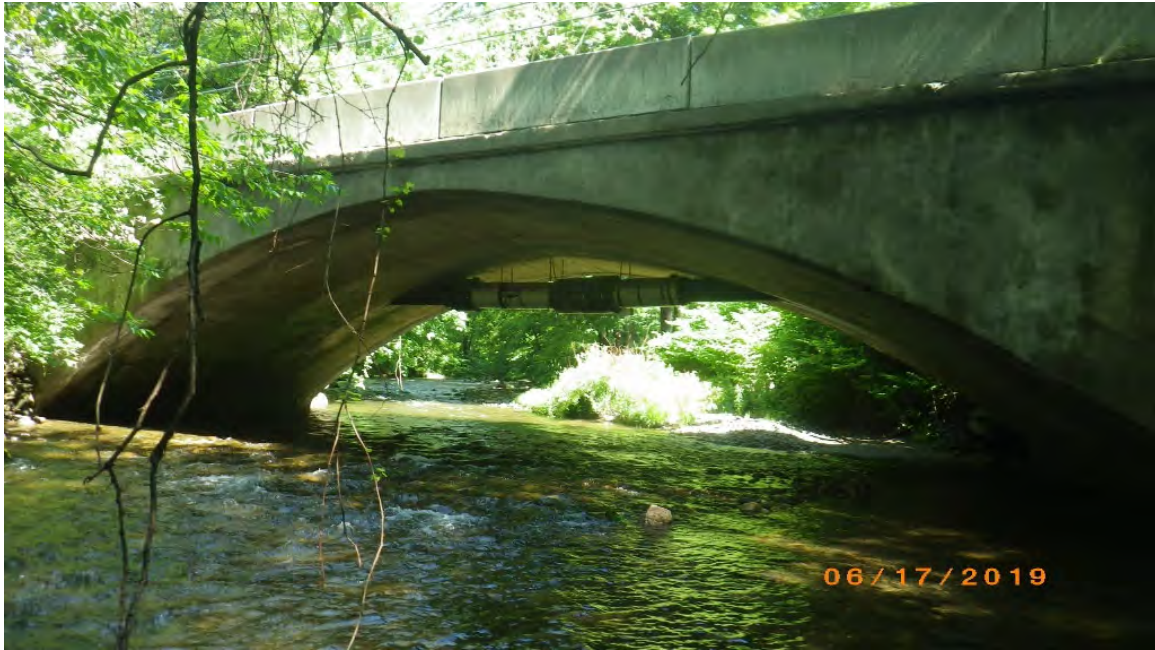
Picture 8: Downstream Fascia

- d. The headwalls have scattered fine map cracks with areas of efflorescence staining.

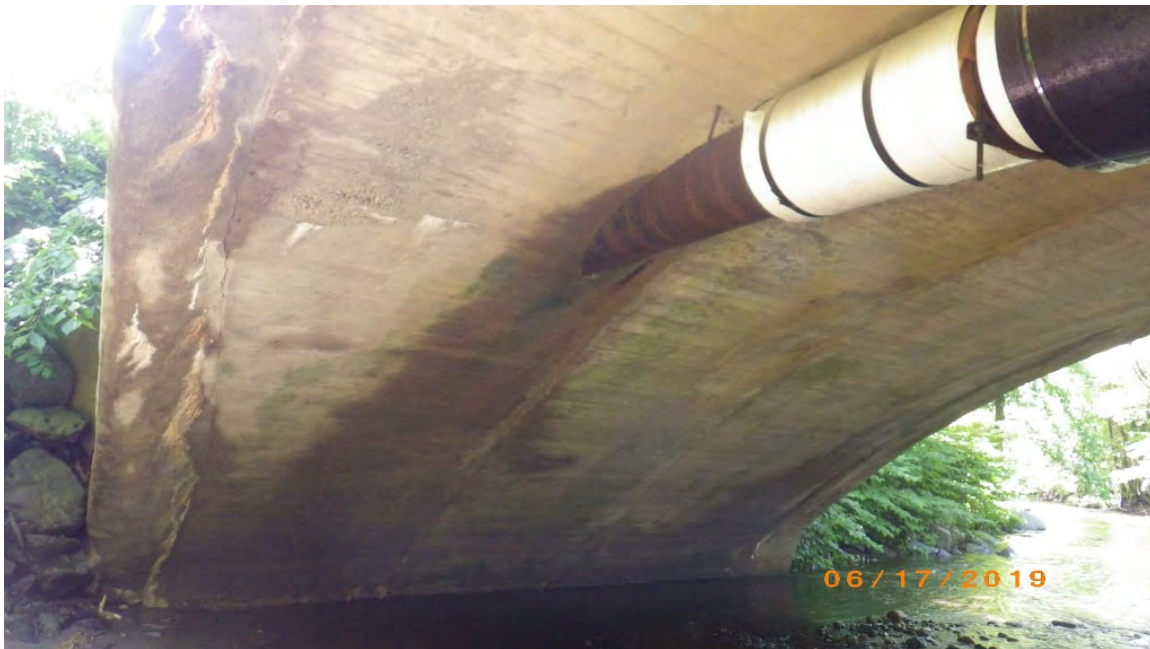
Picture 9: Arch Ring – Note cracking, seepage and efflorescence at fascia and seepage at the embedded waterline

An arch rehabilitation would include repairs or replacement to the outer portions of the arch ring and spandrel walls, new bridge railing, and repairs to the foundation. Additionally, there is leakage and saturation in the concrete immediately surrounding the embedded waterline. This waterline has a history of catching debris during large storm events, reducing the hydraulic capacity. The waterline should be relocated, and the existing exposed pipe should be removed. New pavement and a new sidewalk would also be included for a rehabilitation.

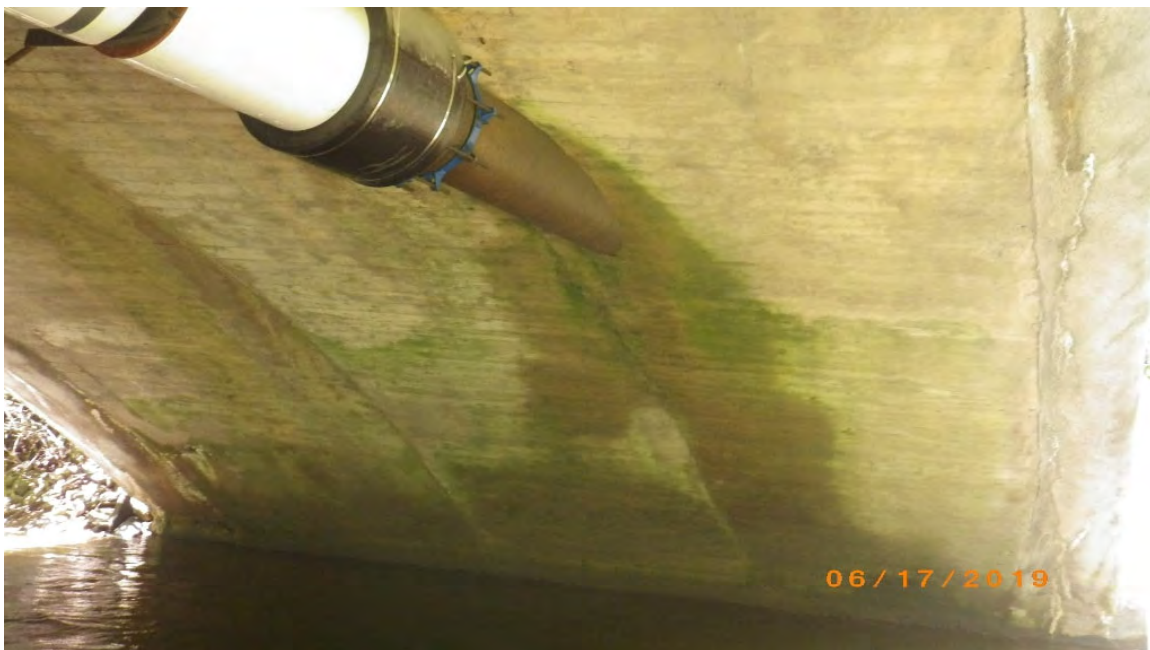
Picture 10: Arch Ring – Note cracking, seepage and efflorescence at fascia and seepage at the embedded waterline

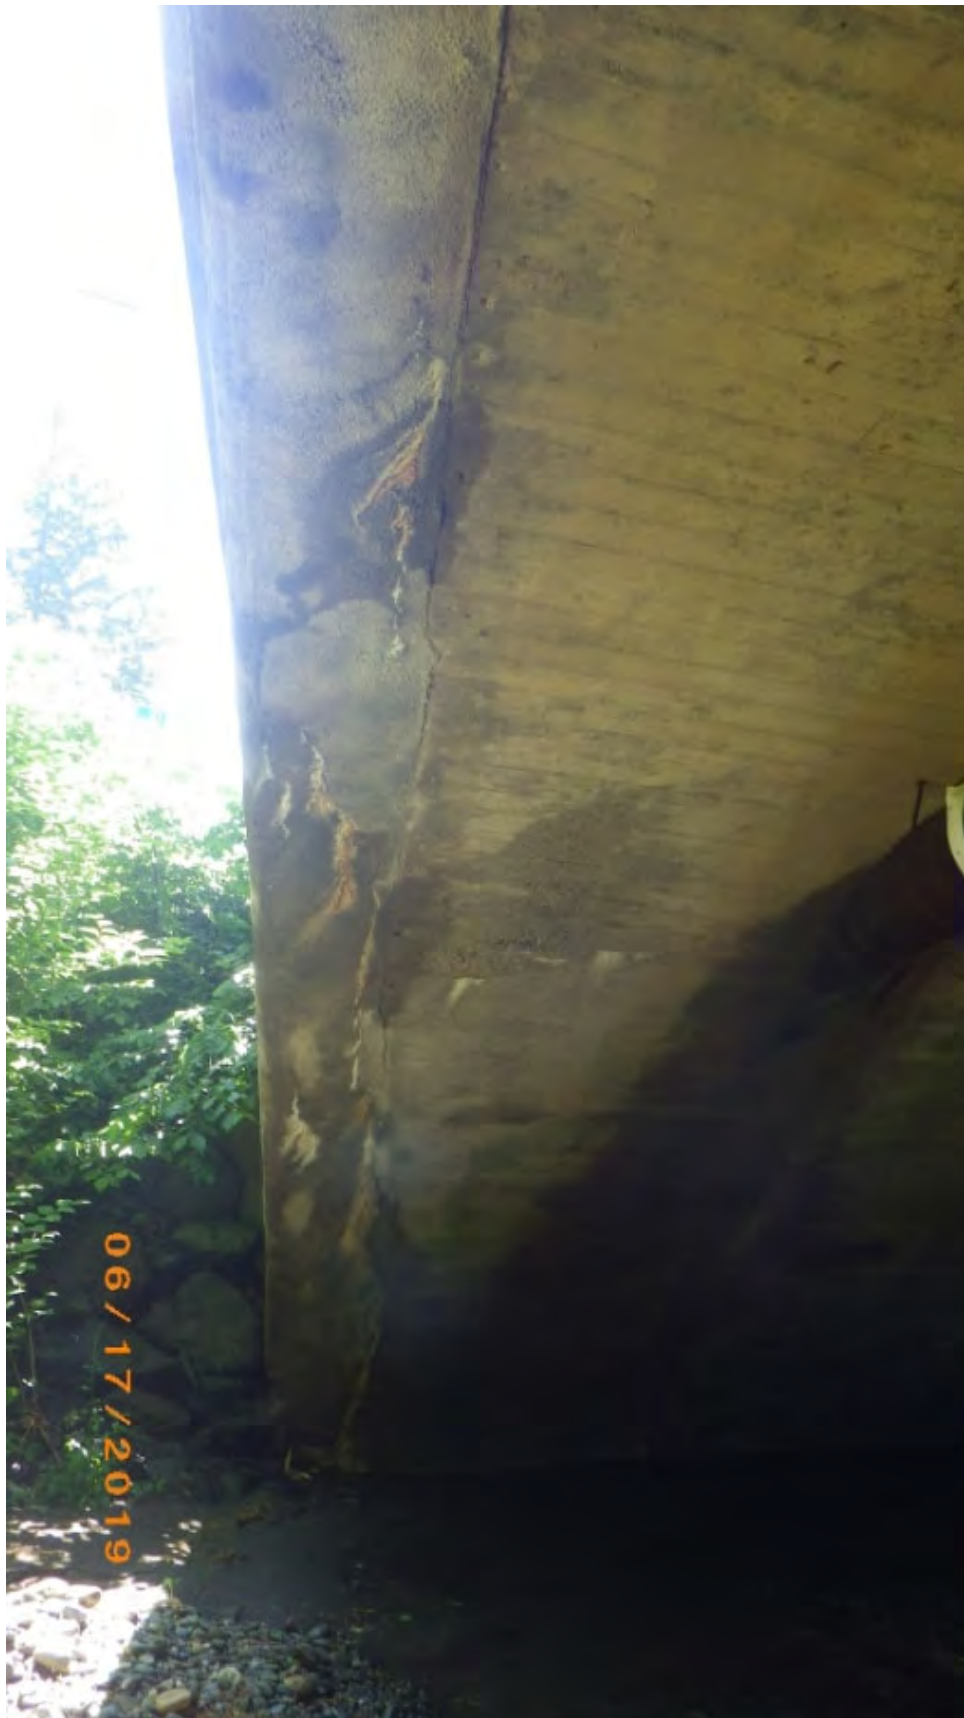
Picture 11: Barrel of the arch - note scattered fine longitudinal and map cracks below the fascia areas with efflorescence staining

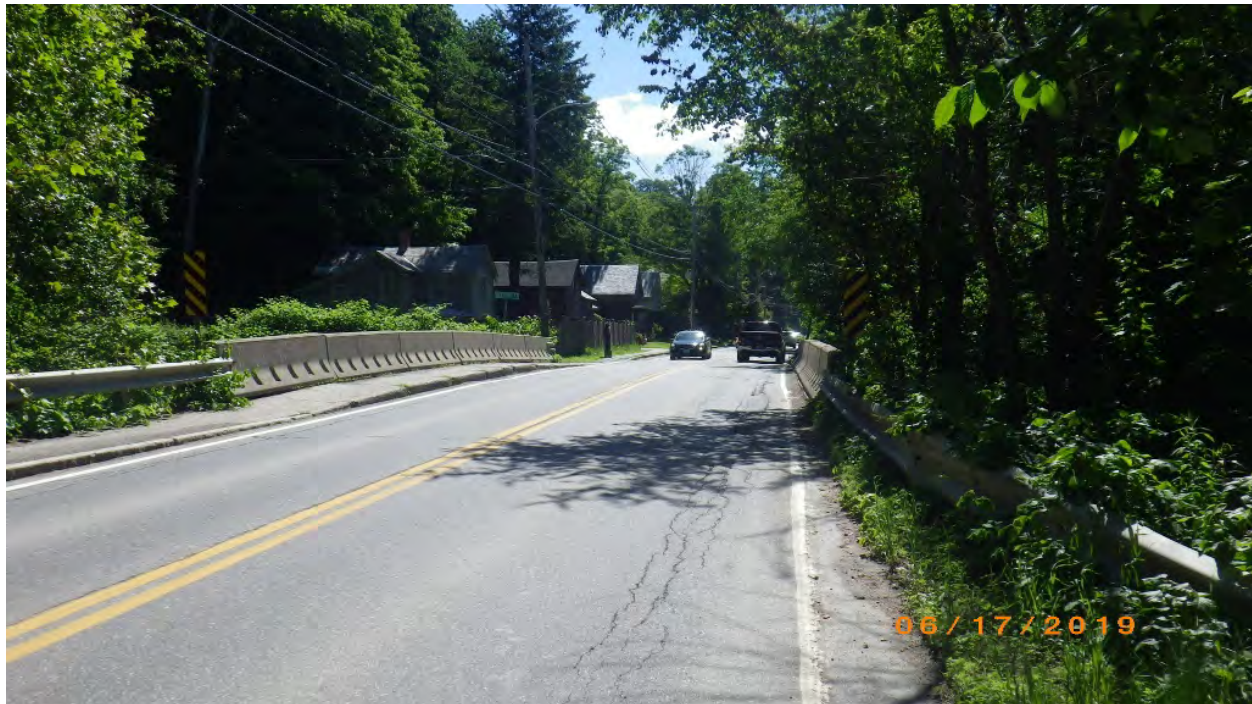
Figure 3.1 *Looking eastbound on VT Route 9; notice overhead utilities present running parallel to westbound travel lane. [Inspection photo dated 2019].*

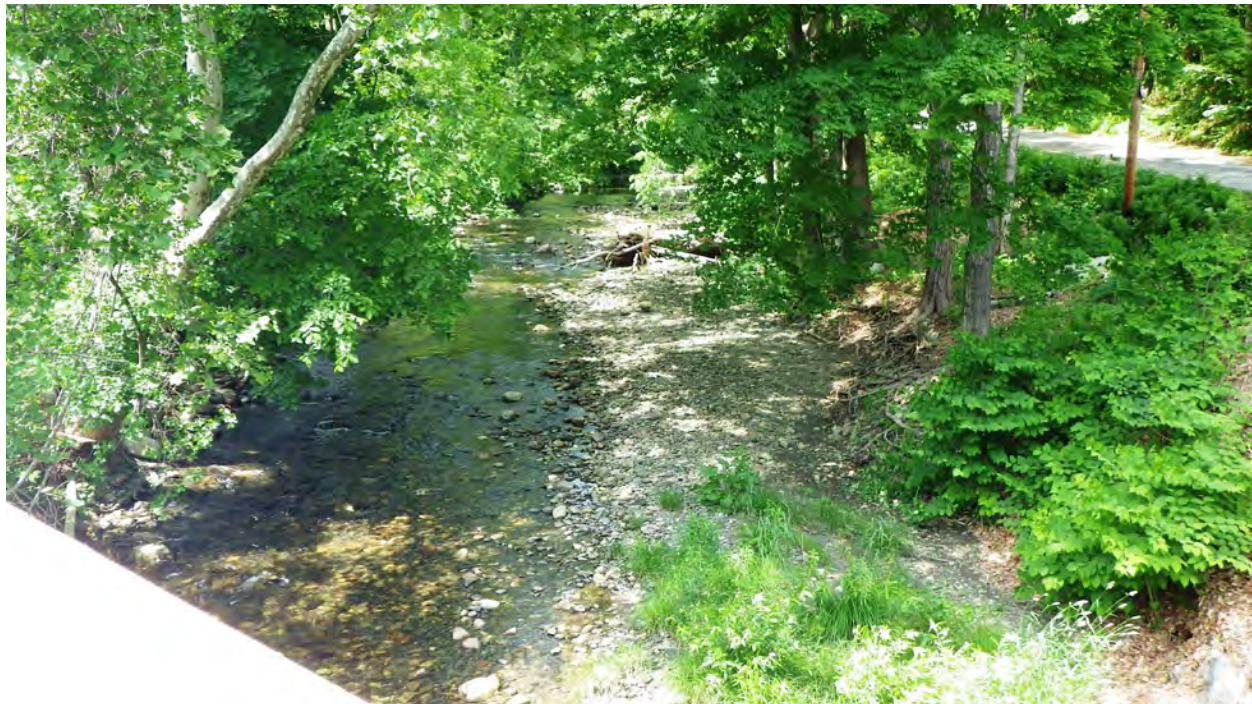
Figure 3.2 *Looking upstream of Whetstone Brook; notice cobbles in the streambed. [Inspection photo dated 2015]*

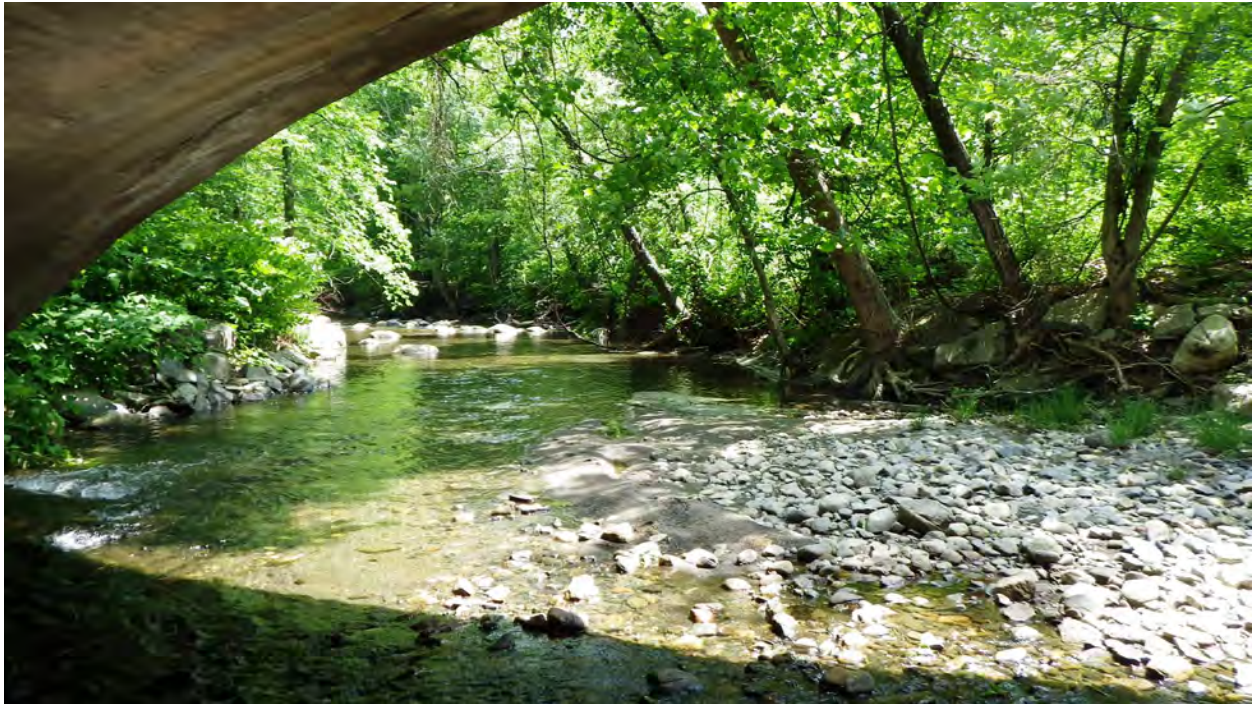
Figure 3.3 *Looking downstream from underneath bridge; note cobbles and boulders in streambed and along embankments. [Inspection photo dated 2015]*

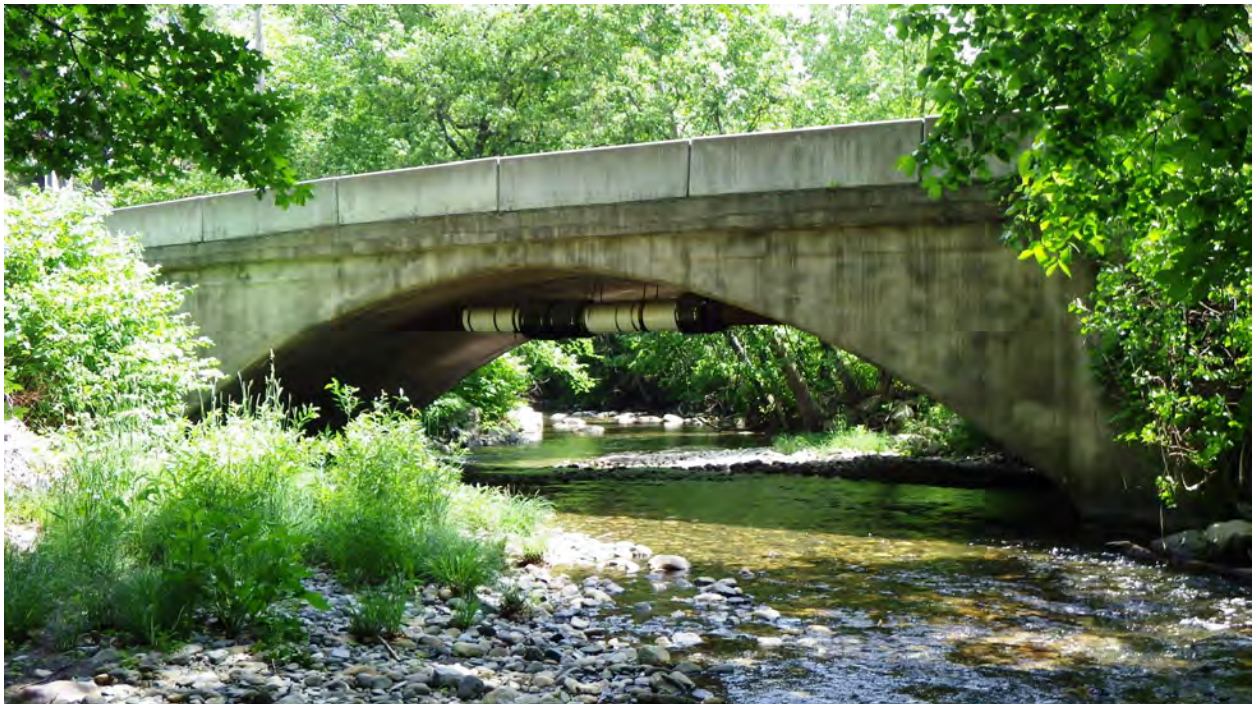
Figure 3.4 *Looking upstream at bridge; note cobbles in streambed and utility pipe on underside of bridge. [Inspection photo dated 2015]*

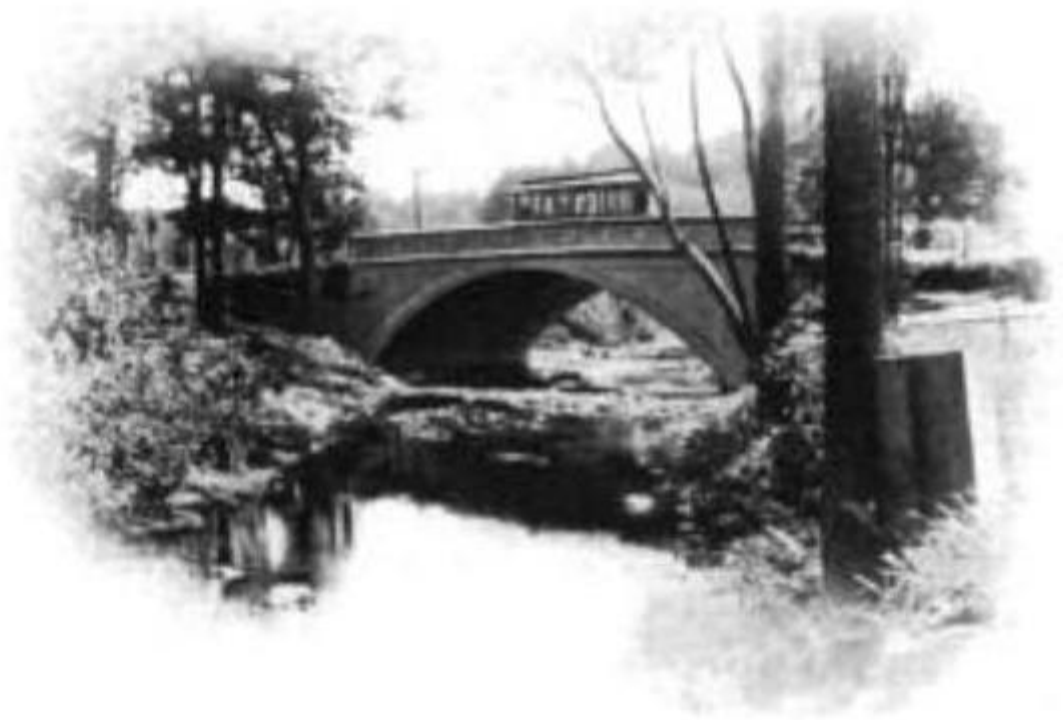
Figure 7: Bridge Illustration Ca. 1912.

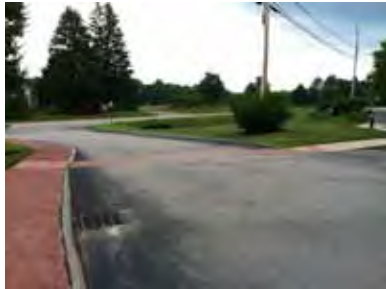
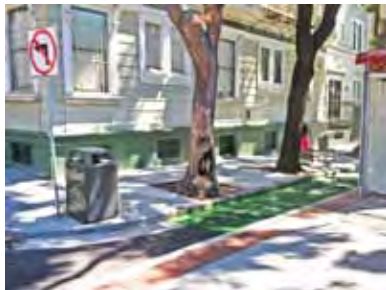
FIGURE 4.2: ALTERNATIVE 1 PLAN

Top: Colored and textured pavement at crossing for graphical purposes, may be replaced with state design standards.

Bottom: Buffered bike lane, with bus boarding island.

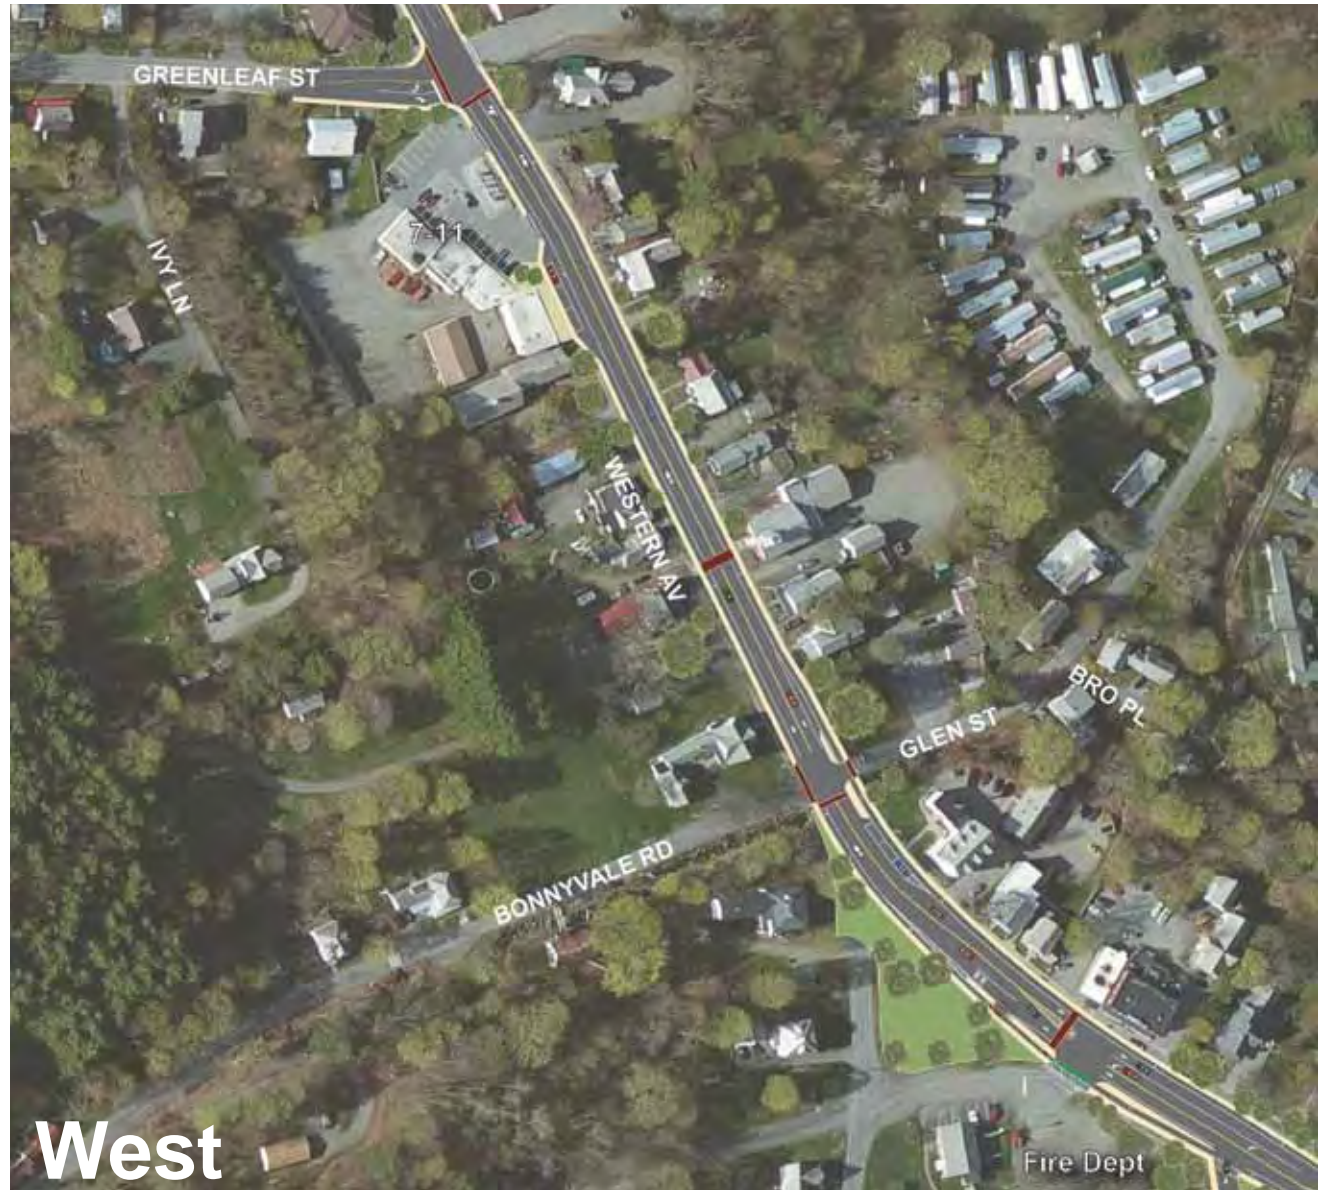
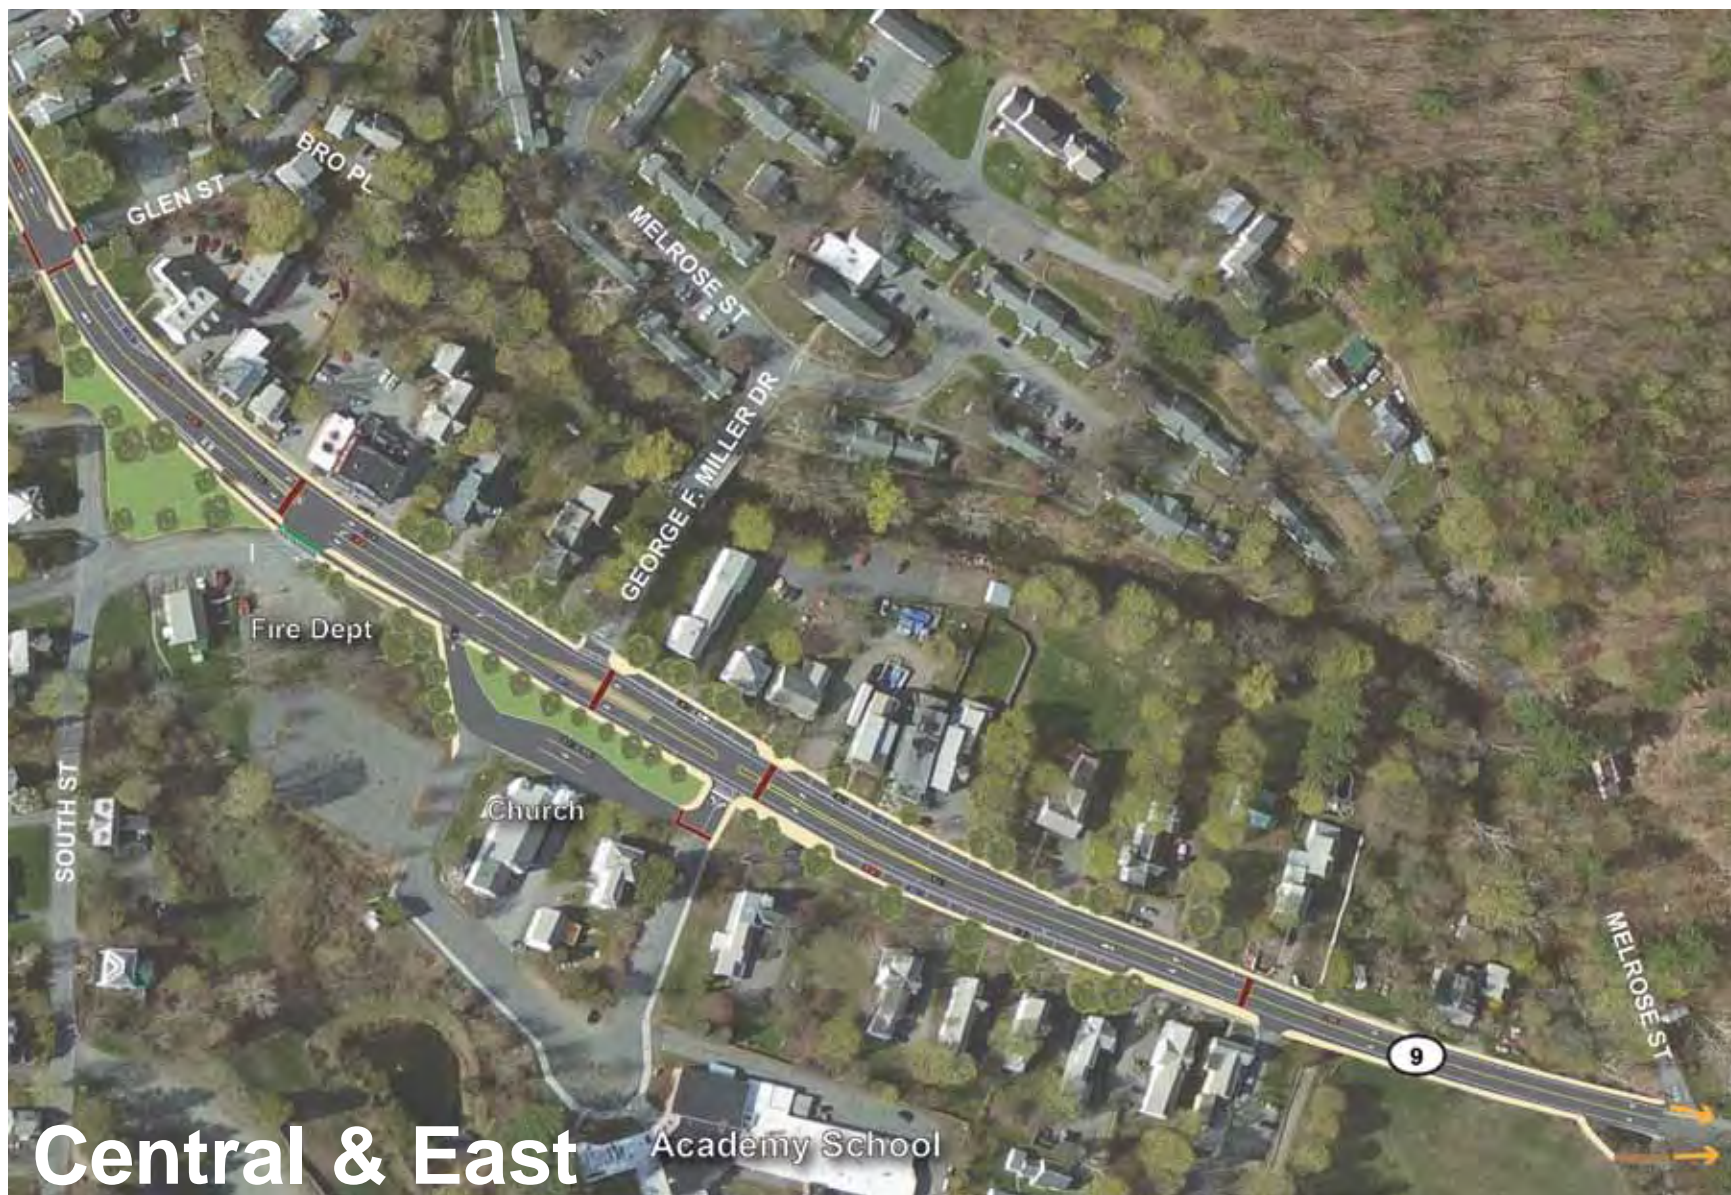
This page shows the proposed improvements for the western segment of Alternative 1. The opposite page shows the improvements for the central and eastern segments.

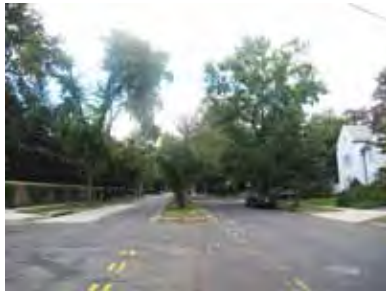
FIGURE 4.6: ALTERNATIVE 2 PLAN

Top: Landscaped curbed median

Bottom: Shared lane markings indicating shared use of bicycle and vehicles in the travel lane

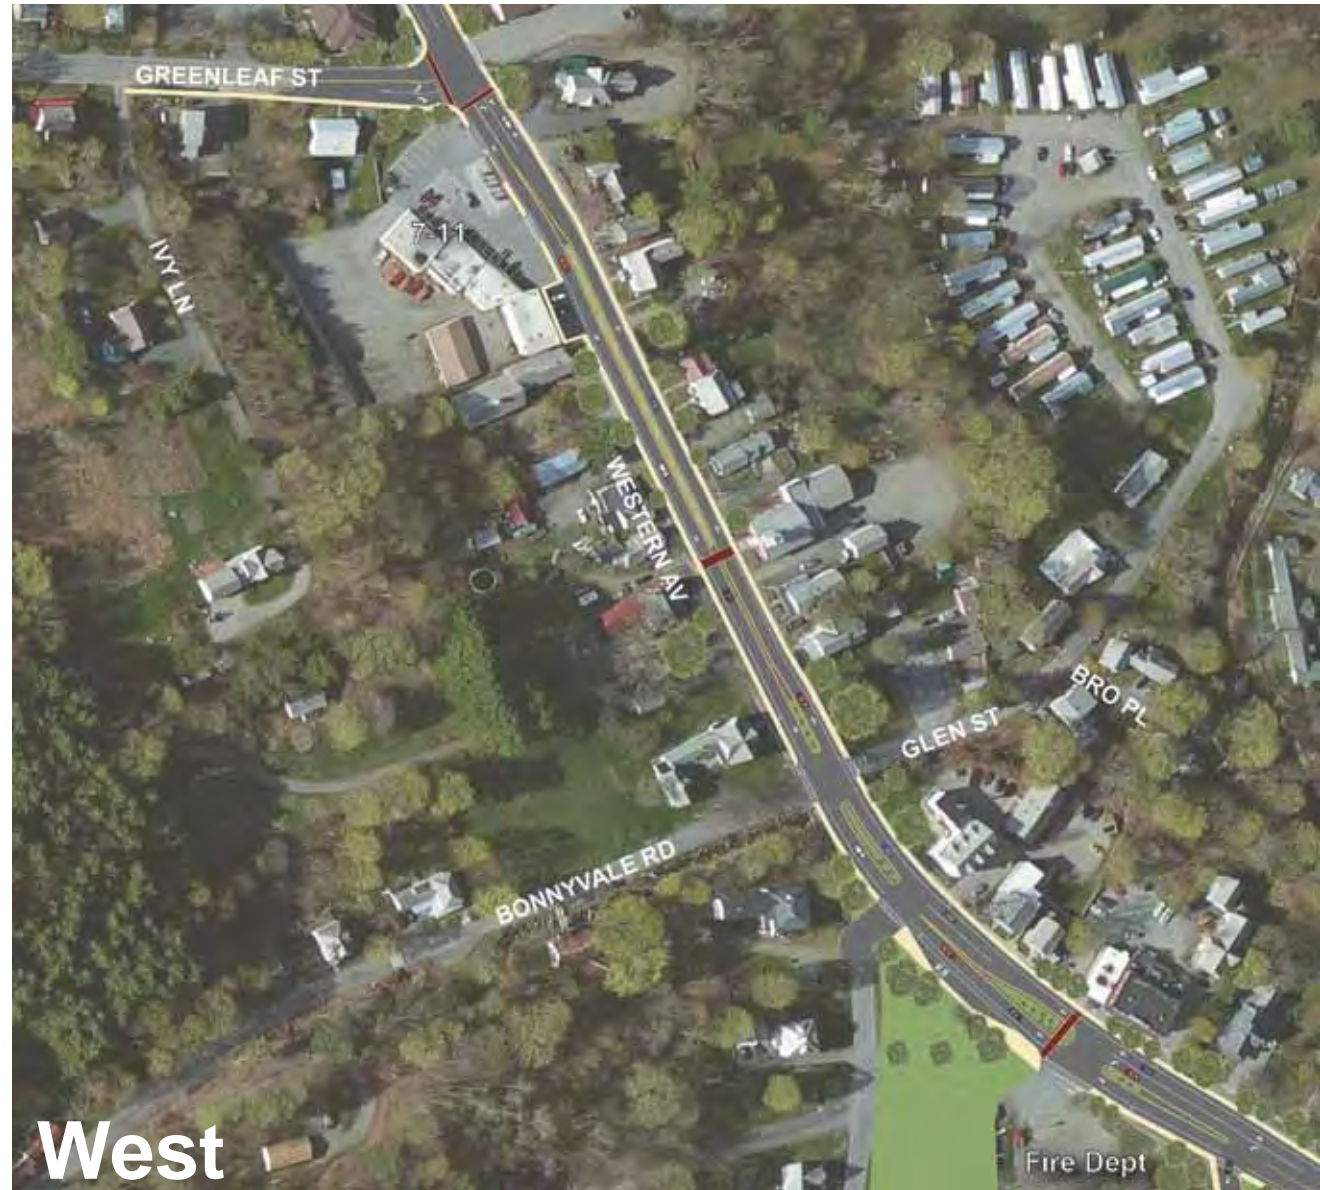
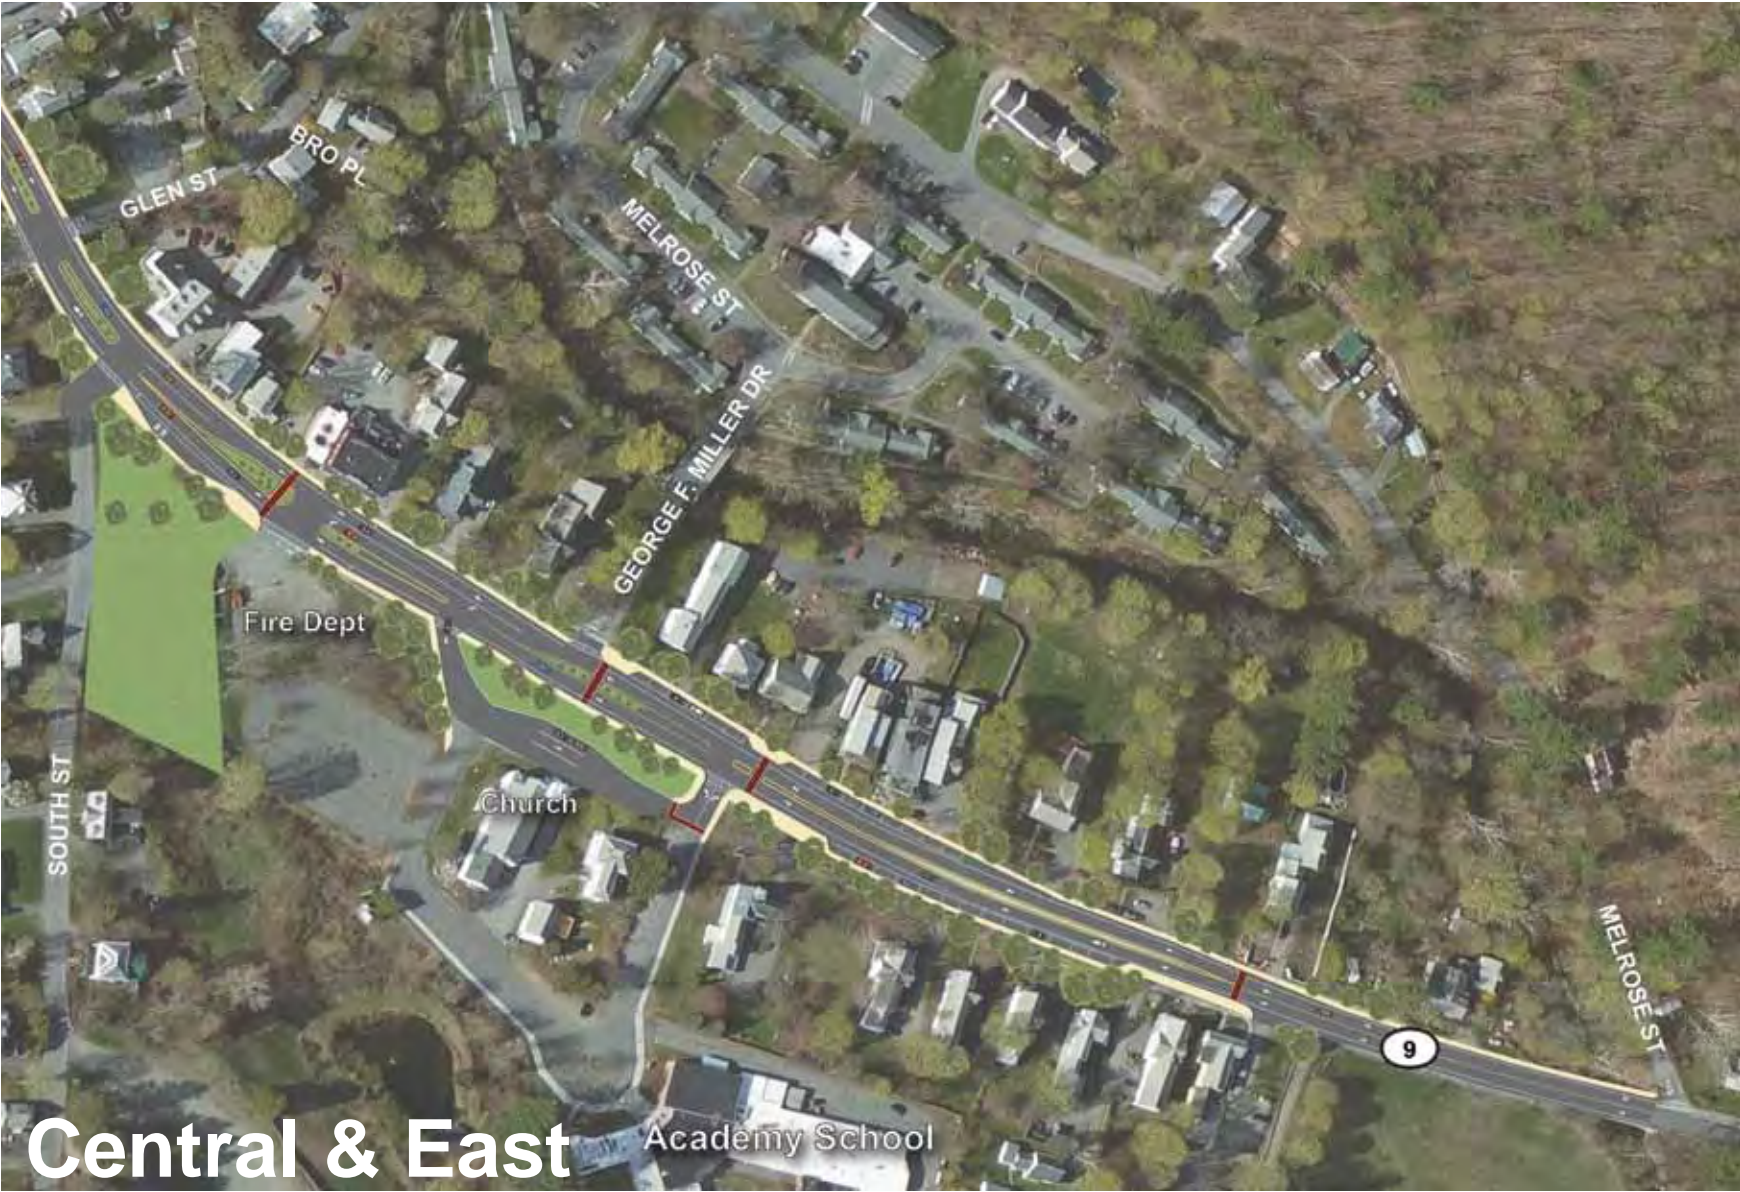
This page shows the proposed improvements for the western segment of Alternative 2. The opposite page shows the improvements for the central and eastern segments.

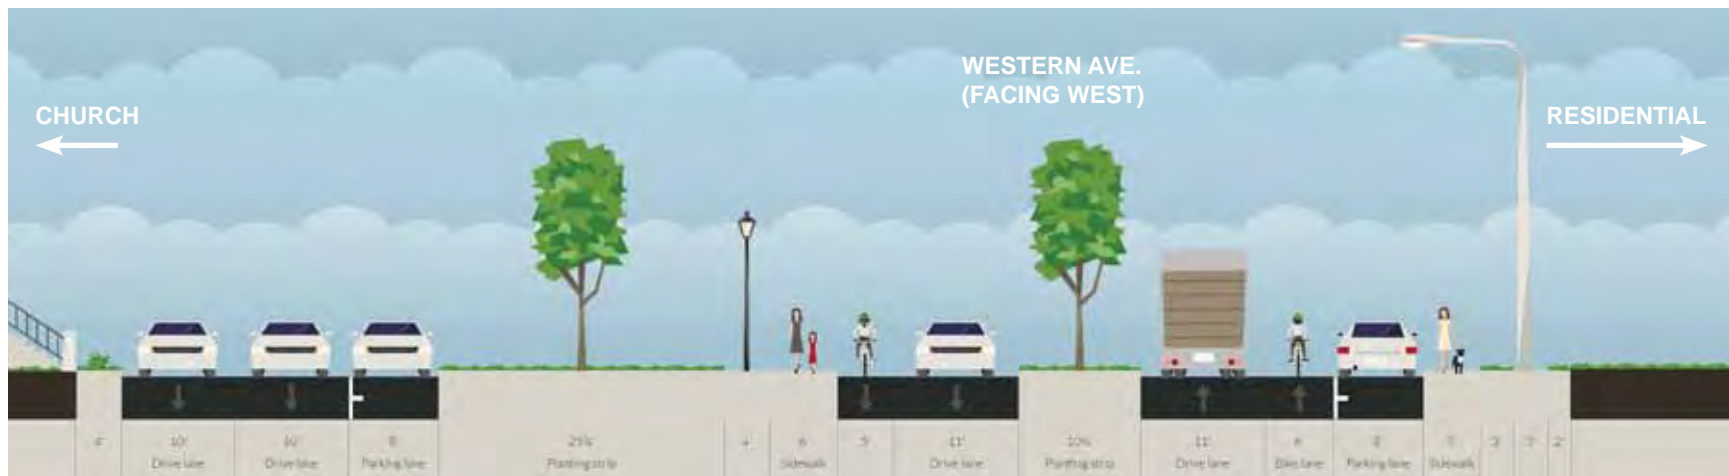
FIGURE 4.9: CROSS-SECTION ON WESTERN AVE AT THE FIRST CONGREGATIONAL CHURCH

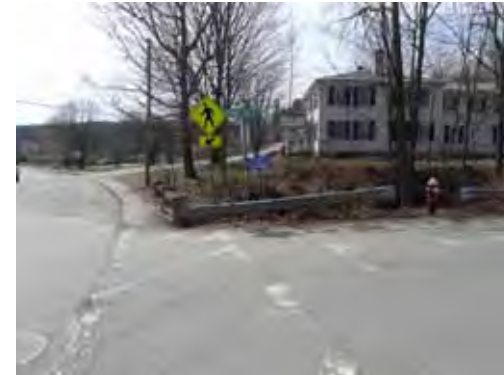
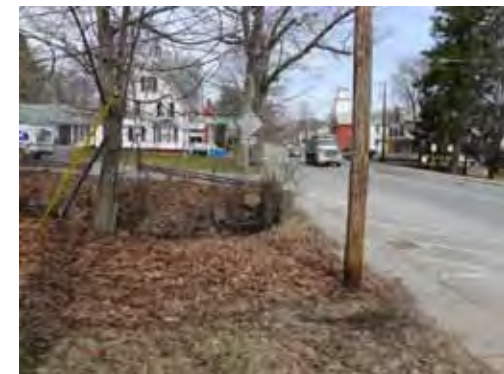
Figure 4. Photographs looking southeast (a) and northwest (b) at the stream crossing along the western side of VT Rte 9 in West Brattleboro for the proposed Brattleboro STP Bike (59) Project, Brattleboro, Windham County, Vermont.

A field inspection of the project area was carried out on April 14, 2014 by Charles Knight, Assistant Director of the UVM CAP. Knight walked the entire project alignment. As mentioned, the project alignment crosses an unnamed tributary of the Whetstone Brook. The crossing however, has been fully developed as the tributary passes underneath VT Rte 9 through a cement culvert (Figure 4). Further south, near the intersection of South Street, a wide green space exists between VT Rte 9 and the sidewalk and between South Street and the exit drive for the Unitarian church (Figure 5). Nonetheless, this area is not located near any water and has been disturbed by street and adjacent parking lot construction. The area near the northern terminus of the project alignment, where VT Rte 9 intersects with Greenleaf Street, has been extensively disturbed as a result of the construction of a parking lot and several commercial buildings (Figure 6). The eastern side of VT Rte 9 is dominated by residences, none of which contain areas of archaeological sensitivity in their front lawns. In general, any widening of VT Rte 9 to incorporate the proposed project will not disturb archaeologically sensitive areas. The proposed alignment is too far from Whetstone Brook to be archaeologically sensitive and the crossing of a tributary of Whetstone Brook has already been completely disturbed.

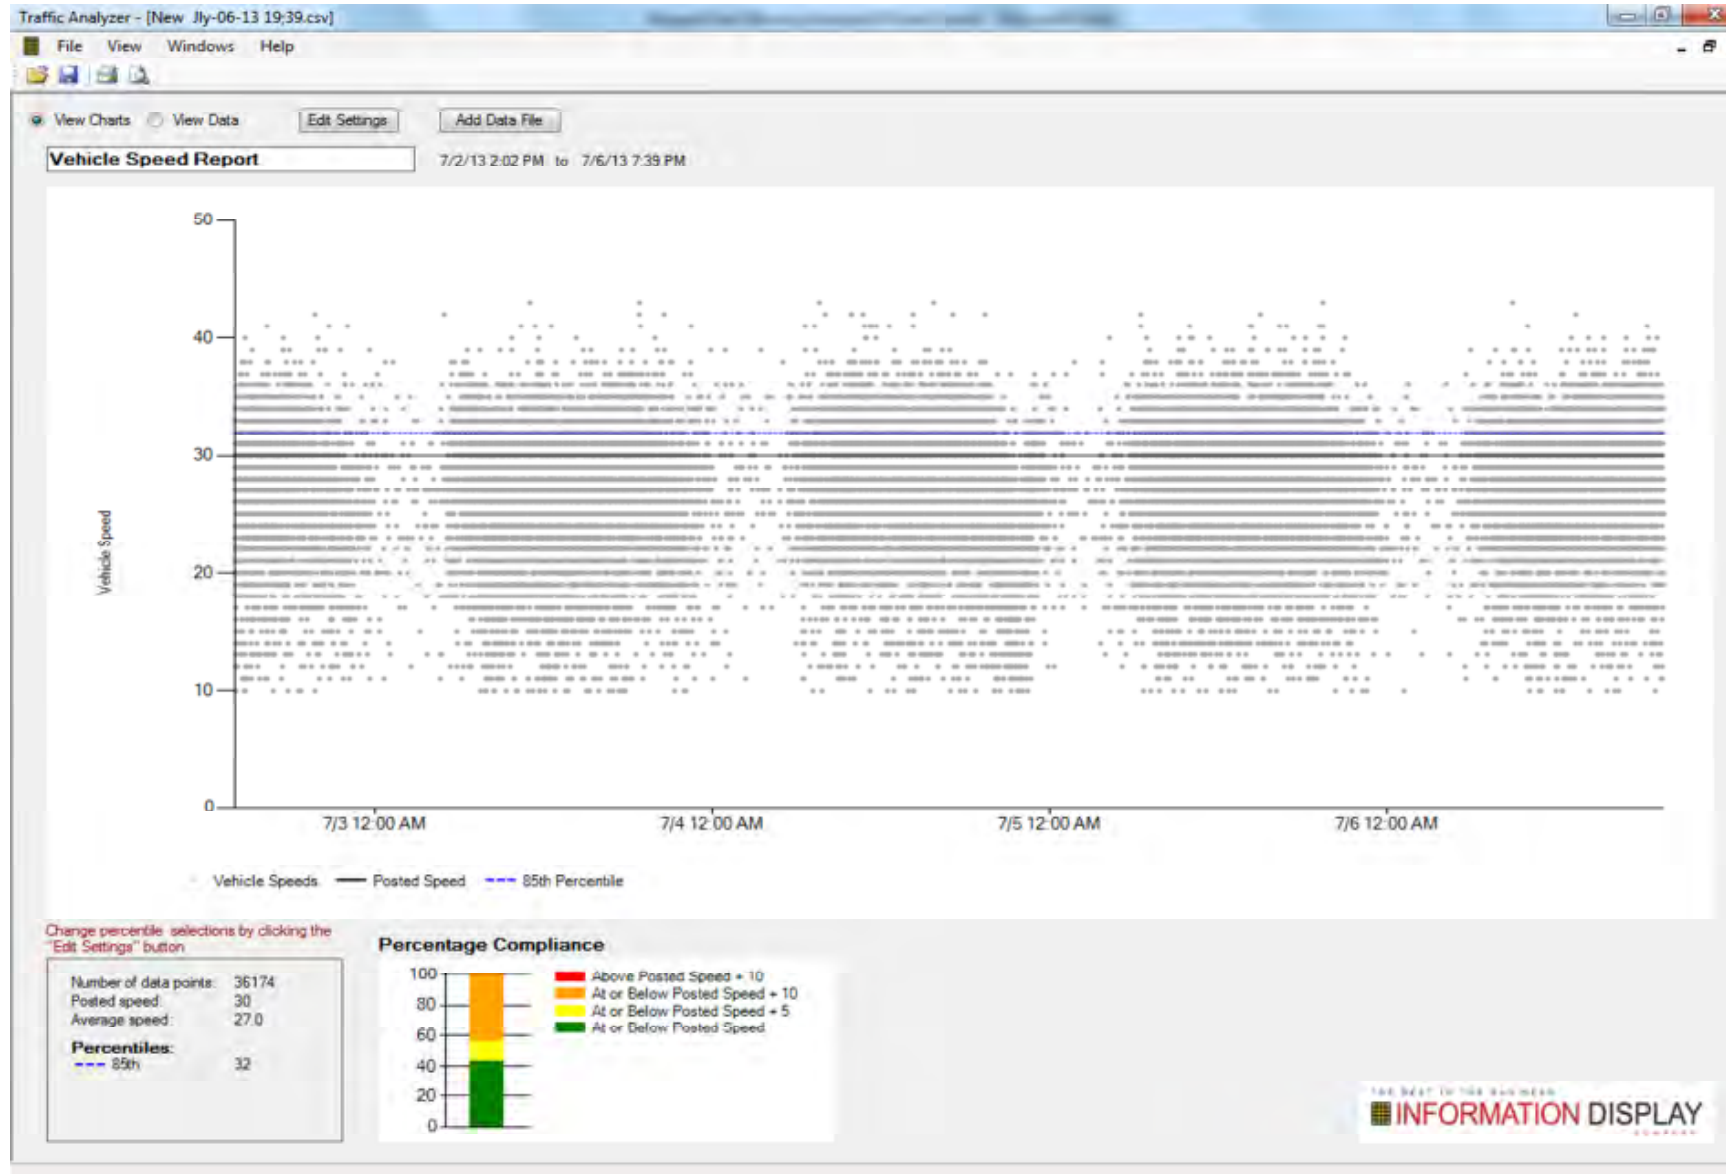
Bagged Data: Individual Targets with Posted Speed.

File	Traffic Data 9-9-2014.tdf
Date Range	9/5/2014 to 9/9/2014
Total Days of Data	5
Speed Limit	25
Time Range	12:00 AM to 11:59 PM
Average Speed	26.00
85% Speed	33
50% Speed	26
10 mph Pace Speed	26 to 35
High Speed	100
Low Speed	5
Display On/Off	On
Average Volume per Day	7562
