**STATE OF VERMONT
AGENCY OF TRANSPORTATION**

Scoping Report

Brattleboro BF 2000(28)

VT Route 9, Bridge 54 Over Whetstone Brook

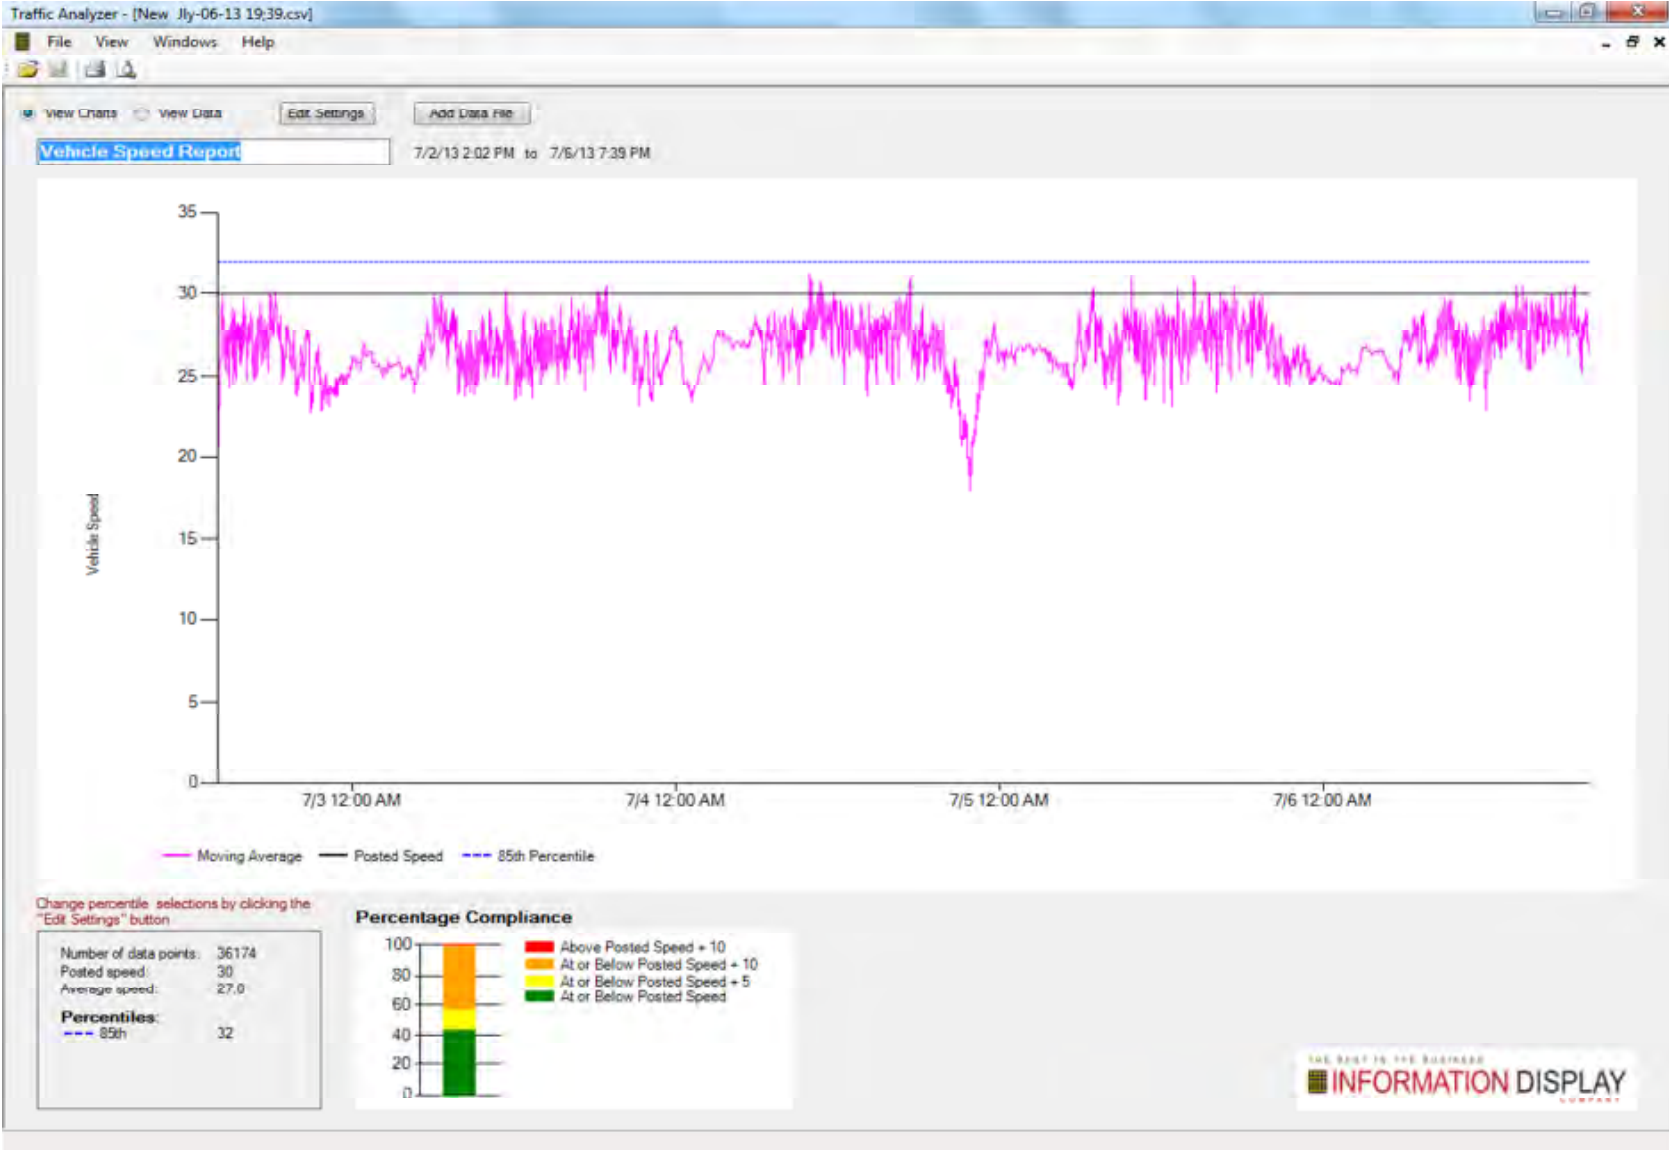
Bagged Data: Moving Average with Posted Speed.

File	Traffic Data 9-9-2014.tdf
Date Range	9/5/2014 to 9/9/2014
Total Days of Data	5
Speed Limit	25
Time Range	12:00 AM to 11:59 PM
Average Speed	26.00
85% Speed	33
50% Speed	26
10 mph Pace Speed	26 to 35
High Speed	100
Low Speed	5
Display On/Off	On
Average Volume per Day	7562
