**Brattleboro BF 2000(28)**  
**Alternatives Presentation Meeting**  
**VT Route 9– Bridge #54 over Whetstone Brook**

September 21<sup>st</sup>, 2021

### Existing Conditions – Bridge #54

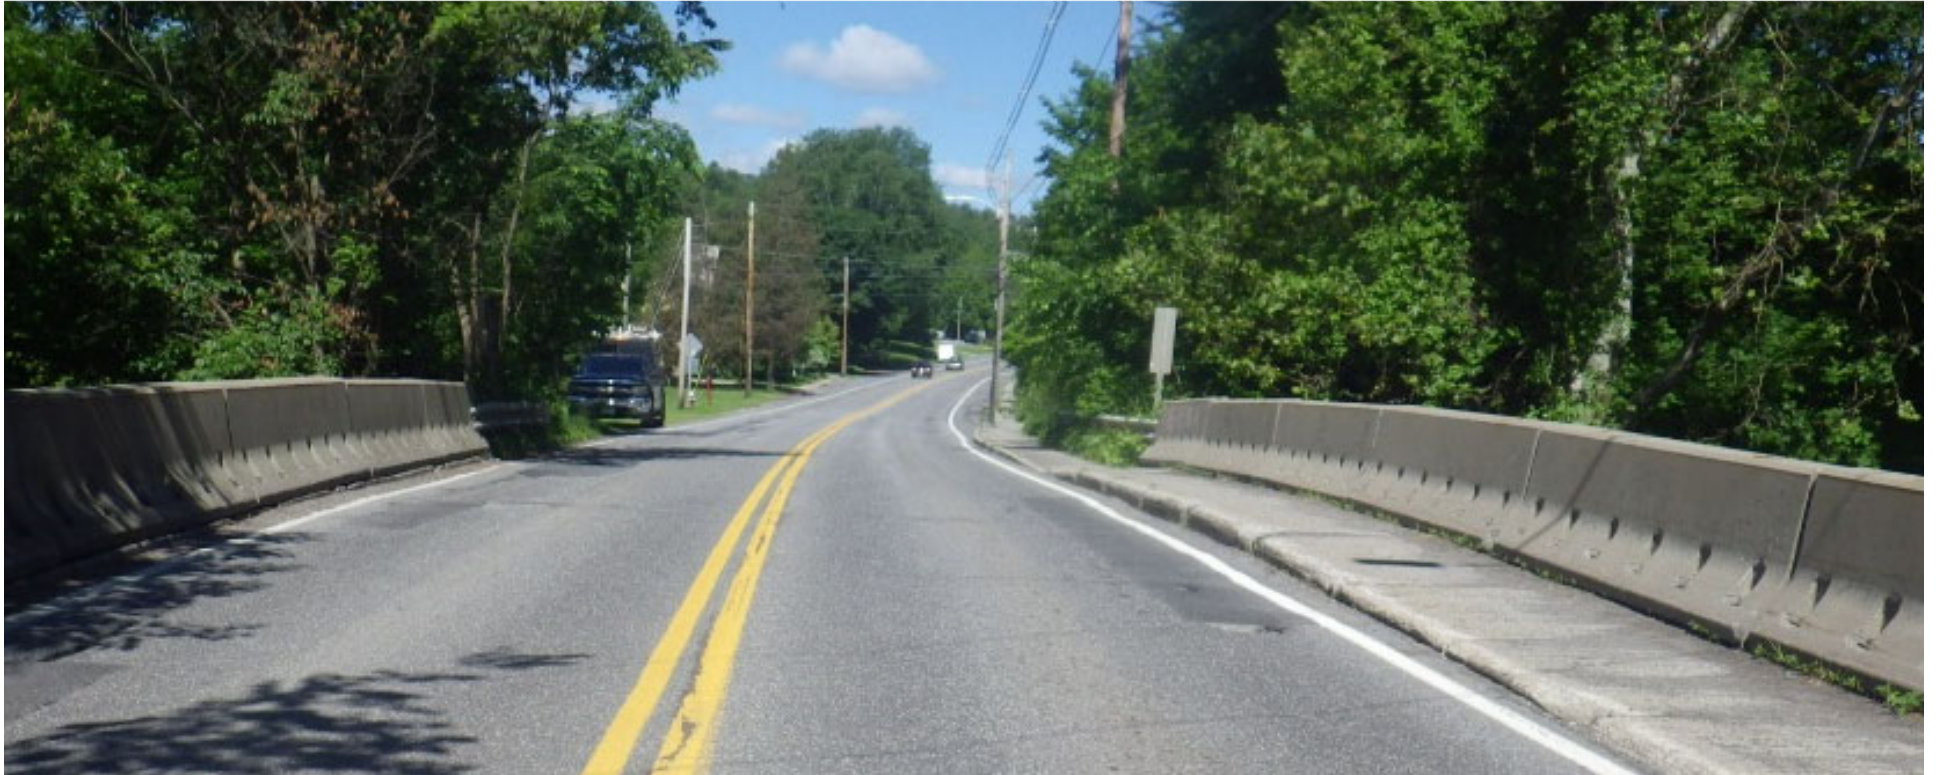
## Looking West over Bridge

- Roadway Classification – Principal Arterial, National Highway System, Urban (Class 1 Town Highway)
- Bridge Type – 60' Span Single Span Cast-in-Place Concrete Arch
- Ownership – Town of Brattleboro
- Constructed in 1914

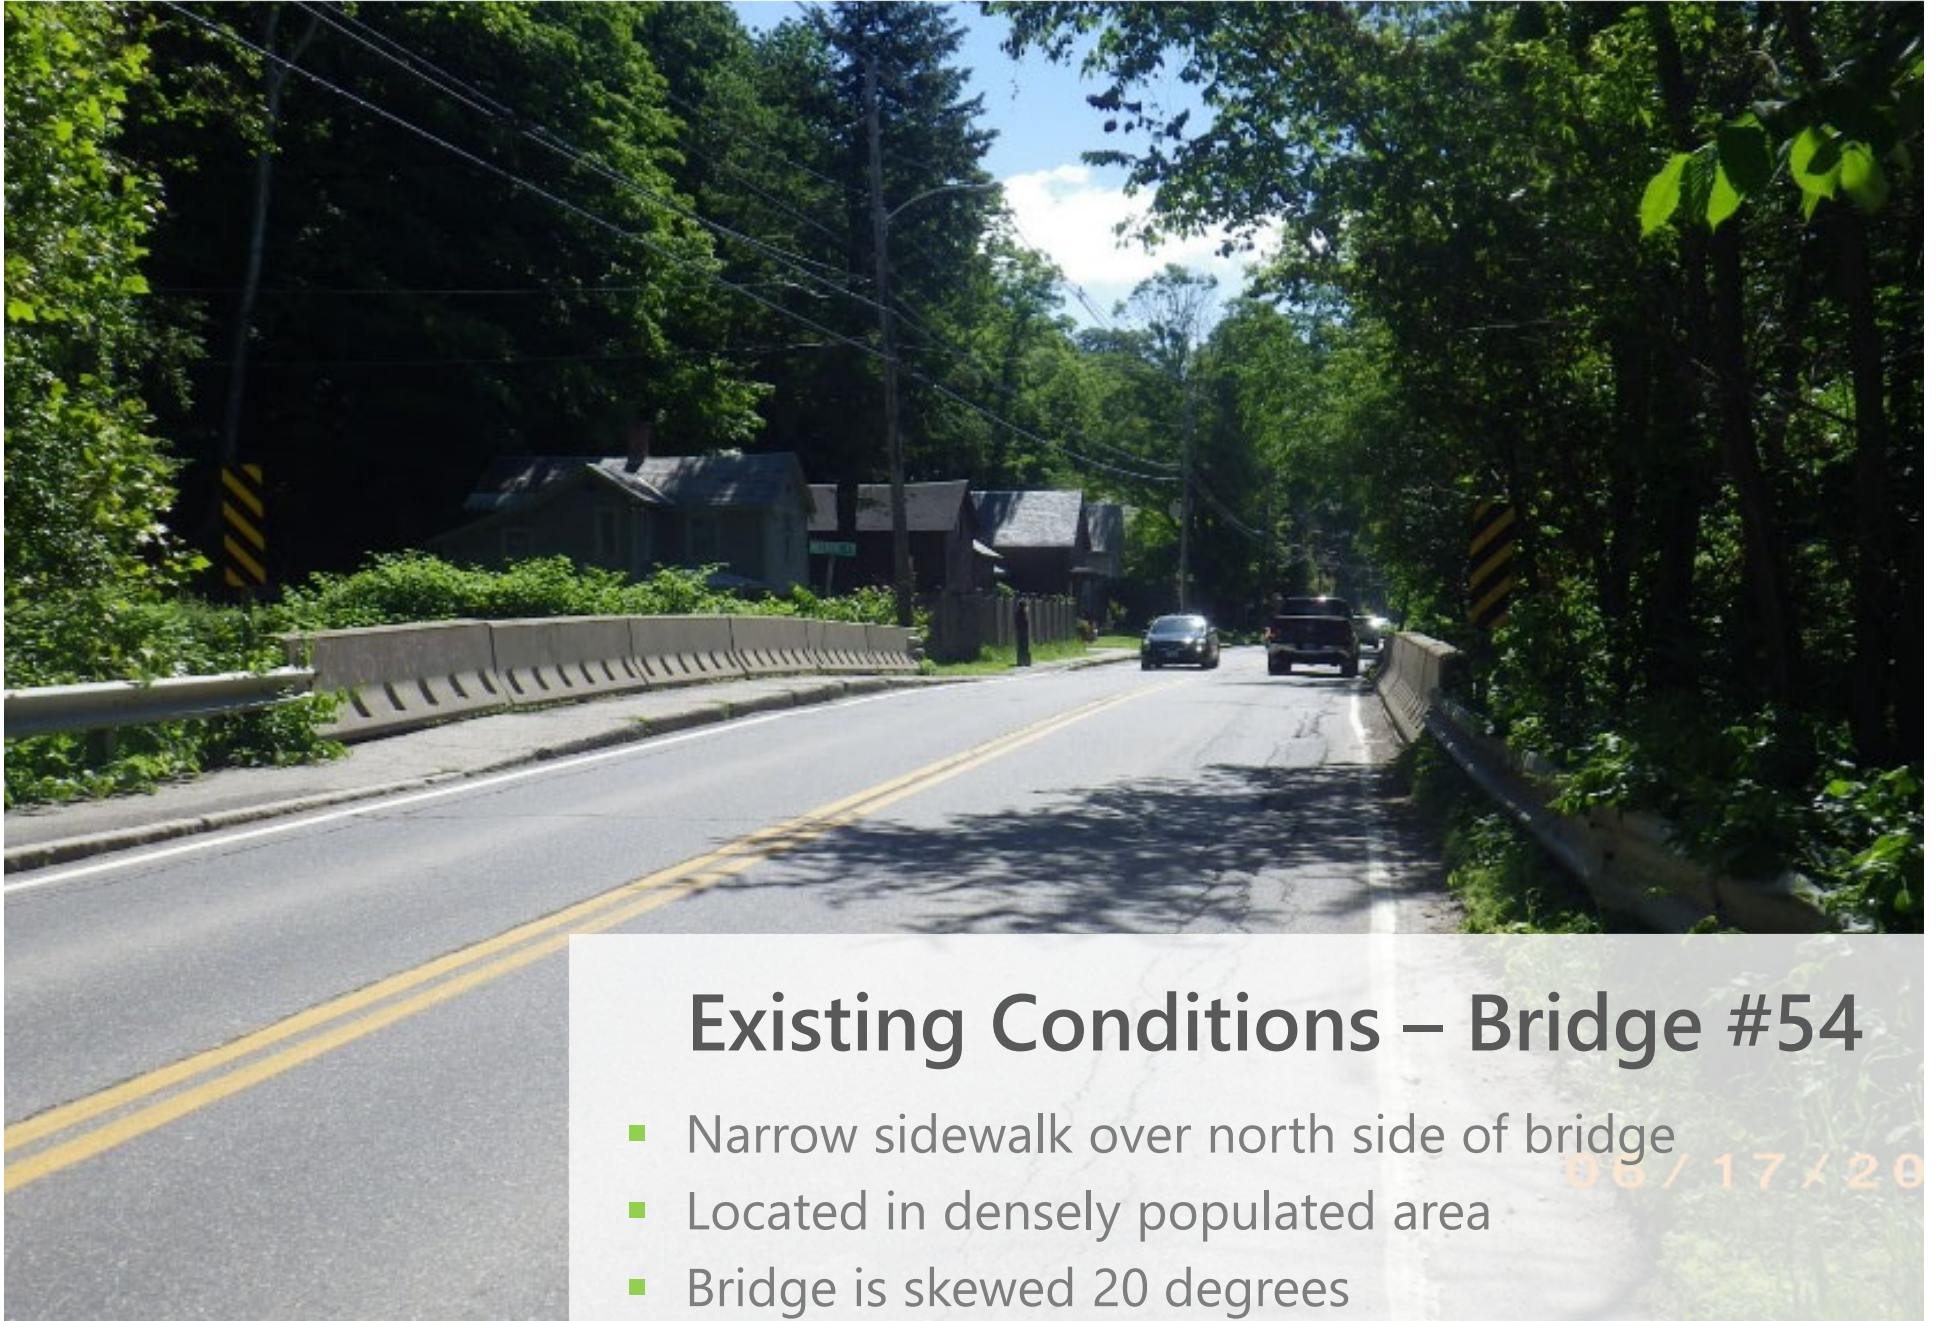
## Looking East over Bridge

- Narrow sidewalk over north side of bridge
- Located in densely populated area
- Bridge is skewed 20 degrees

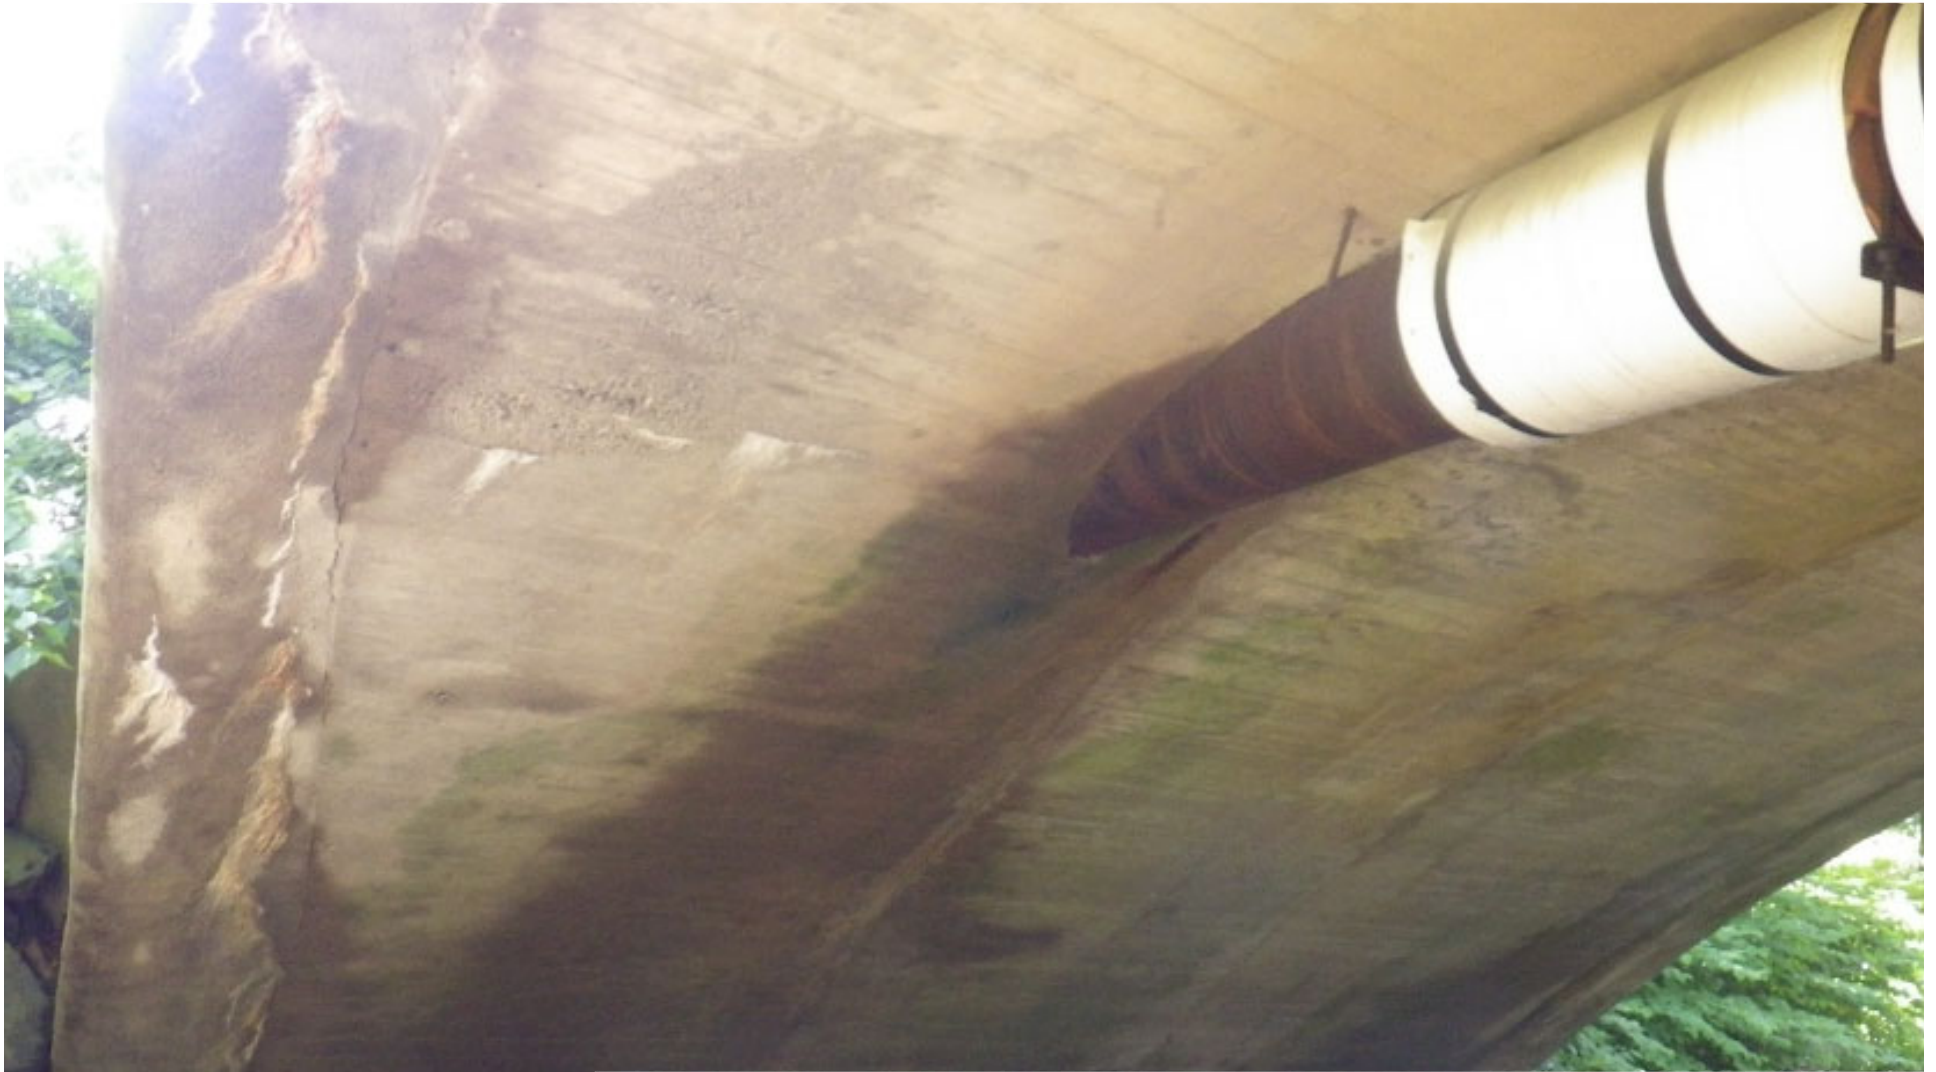
## Condition Ratings

- Culvert Rating 6 (Satisfactory)

- The sidewalk is in poor condition and does not meet the standard width.
- The barrel of the arch has scattered fine longitudinal and map cracks below the fascia areas with efflorescence staining.
- The headwalls have scattered fine map cracking with efflorescence.
- There is leakage and saturation in the concrete immediately surrounding the embedded waterline.
- There is heavy abrasion along the water line at both abutments.
- The paved width over the bridge is substandard by 18-feet.
- The embedded exposed waterline blocks high flood flows and catches debris. The arch is located within a flood insurance study area.

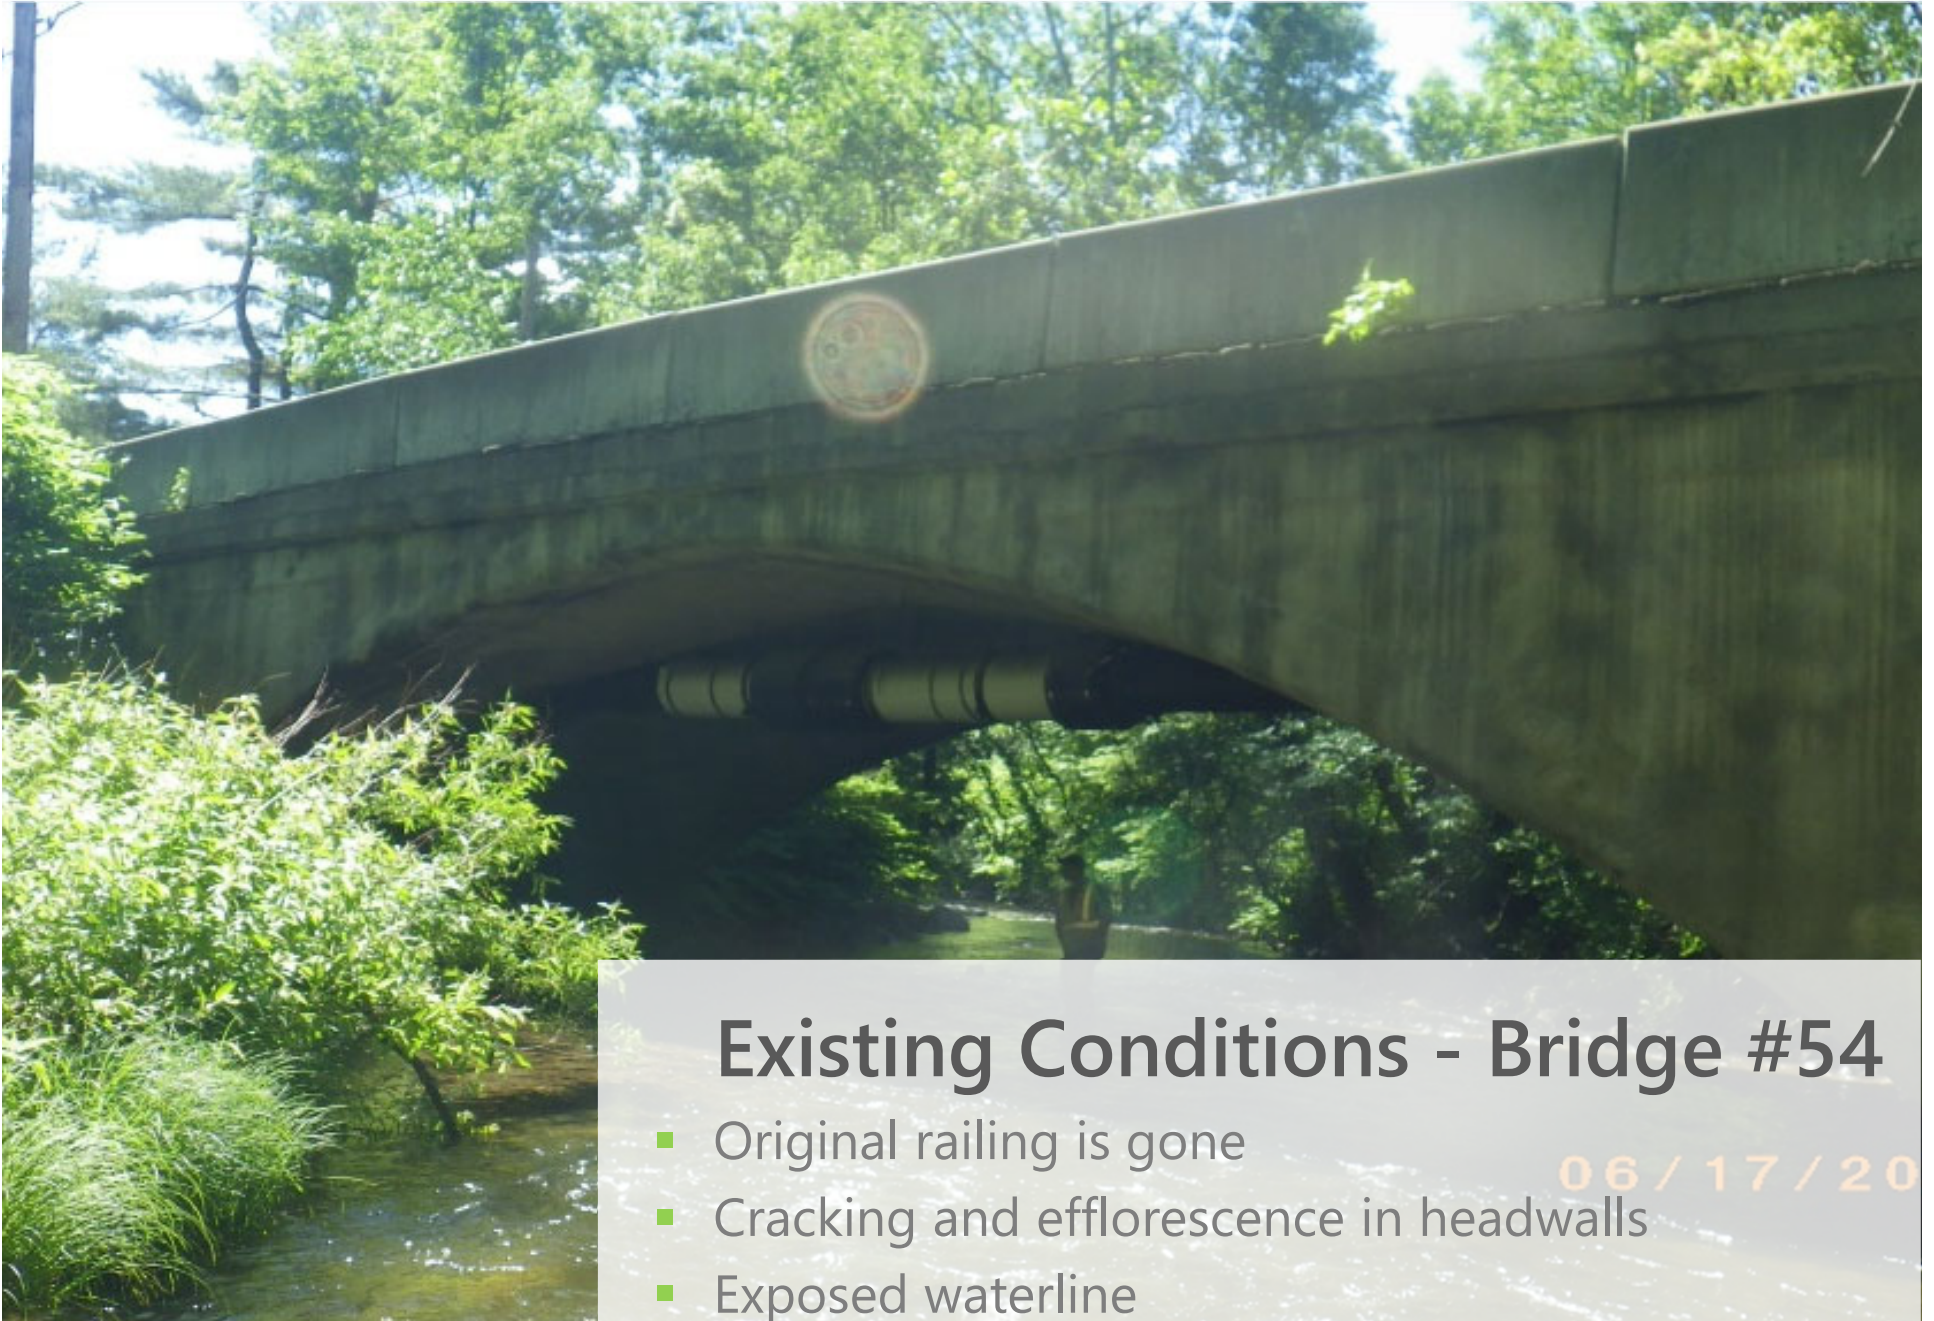
## Bridge Fascia

- Original railing is gone
- Cracking and efflorescence in headwalls
- Exposed waterline

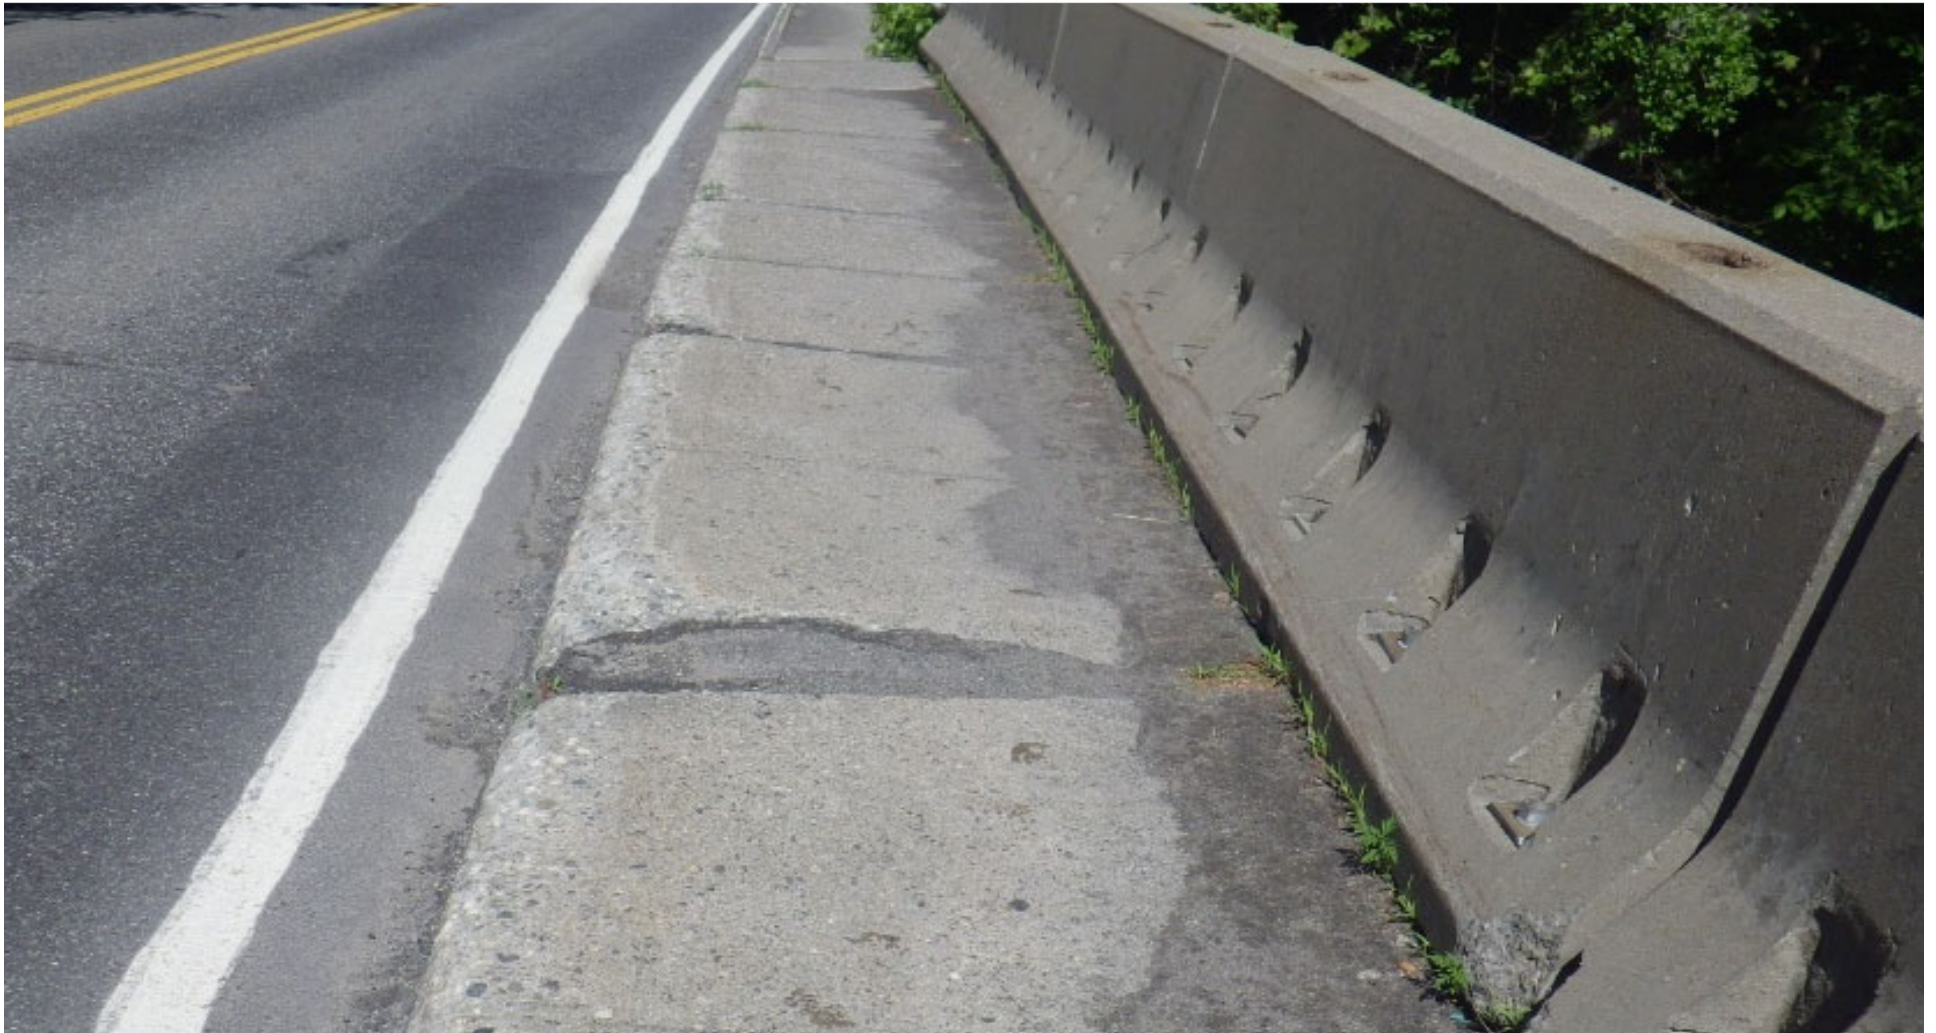
## Sidewalk

- Narrow and in poor condition
- Pavement patching and cracking

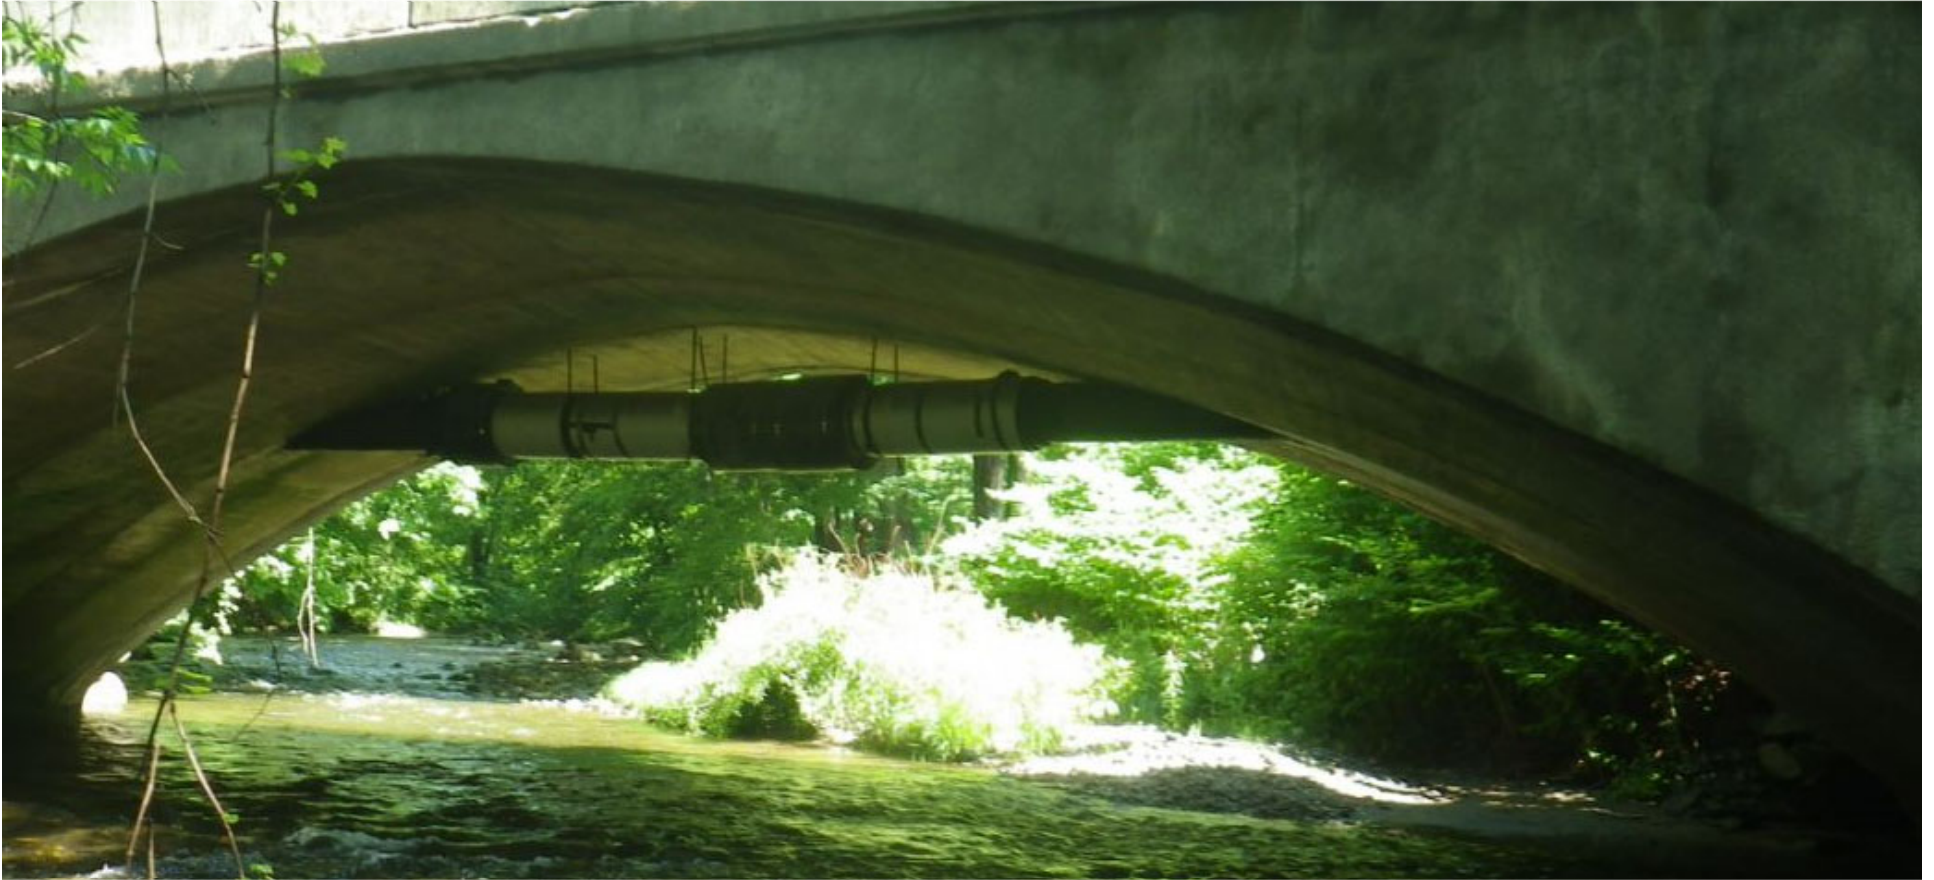
## Debris Blockage - Hydraulics

- Existing Conditions with Debris Blockage: There is no freeboard (measured from the bottom of the waterline) at the 2% and 1% AEP. Roadway overtopping occurs approximately 200 ft west of the bridge at the 1% AEP with an approximate maximum water depth of 0.62-feet.

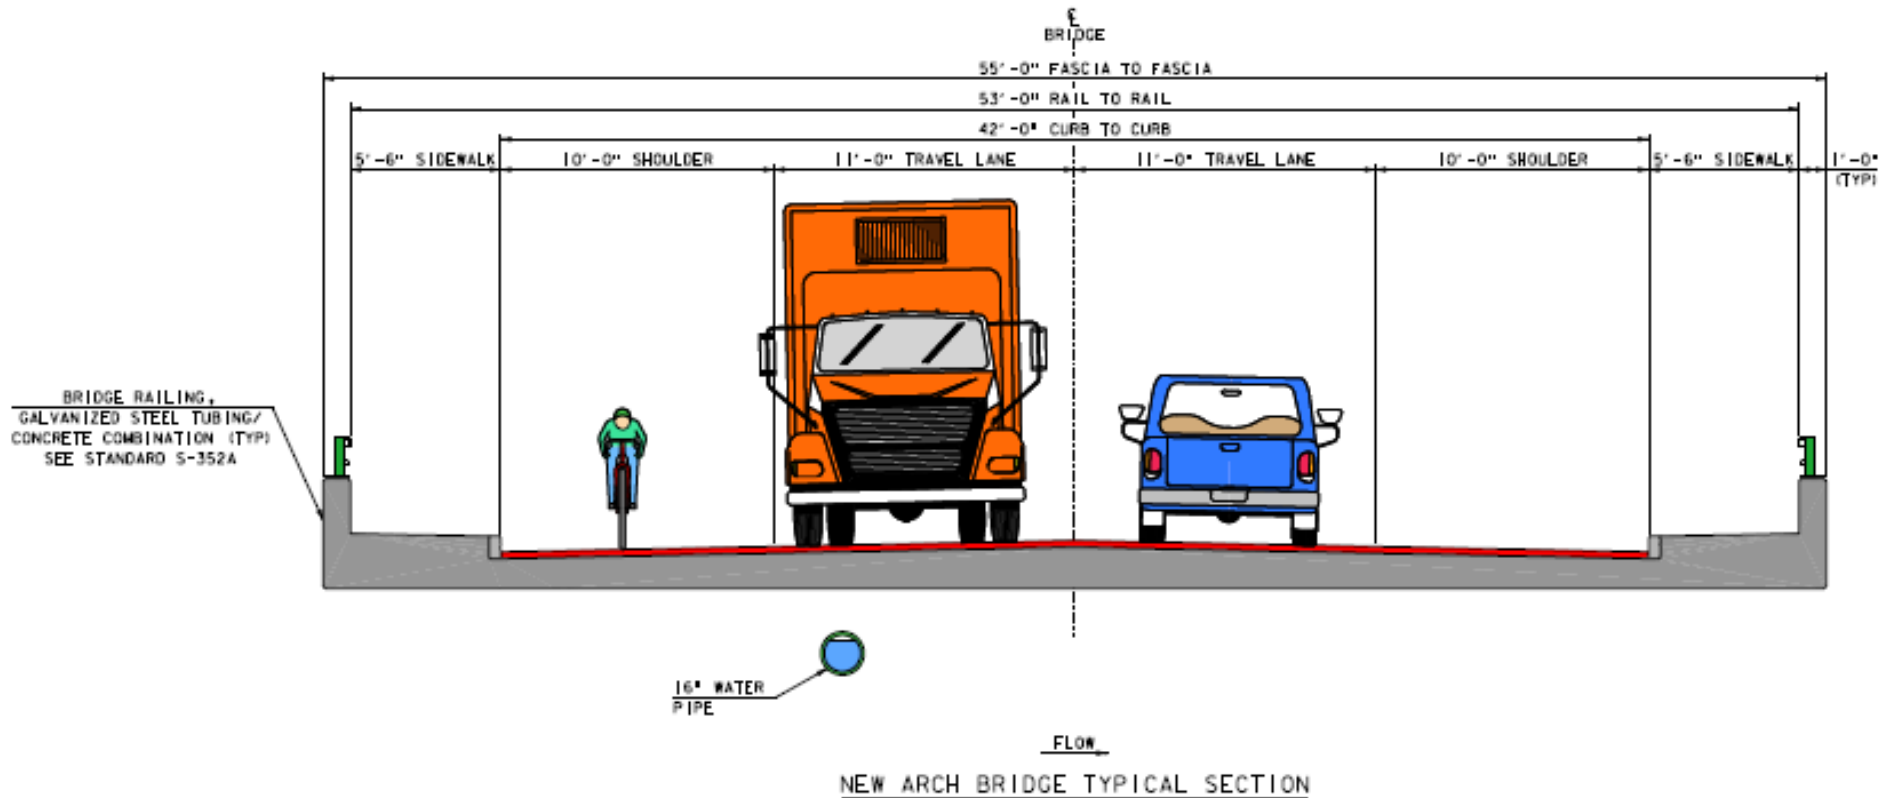
# Alternative 3: Full Bridge Replacement with New Arch Typical Section

- 10-11-11-10 with 5' sidewalk on north and south side
- Increased skew to channel for improved hydraulic condition
- 100-year design life

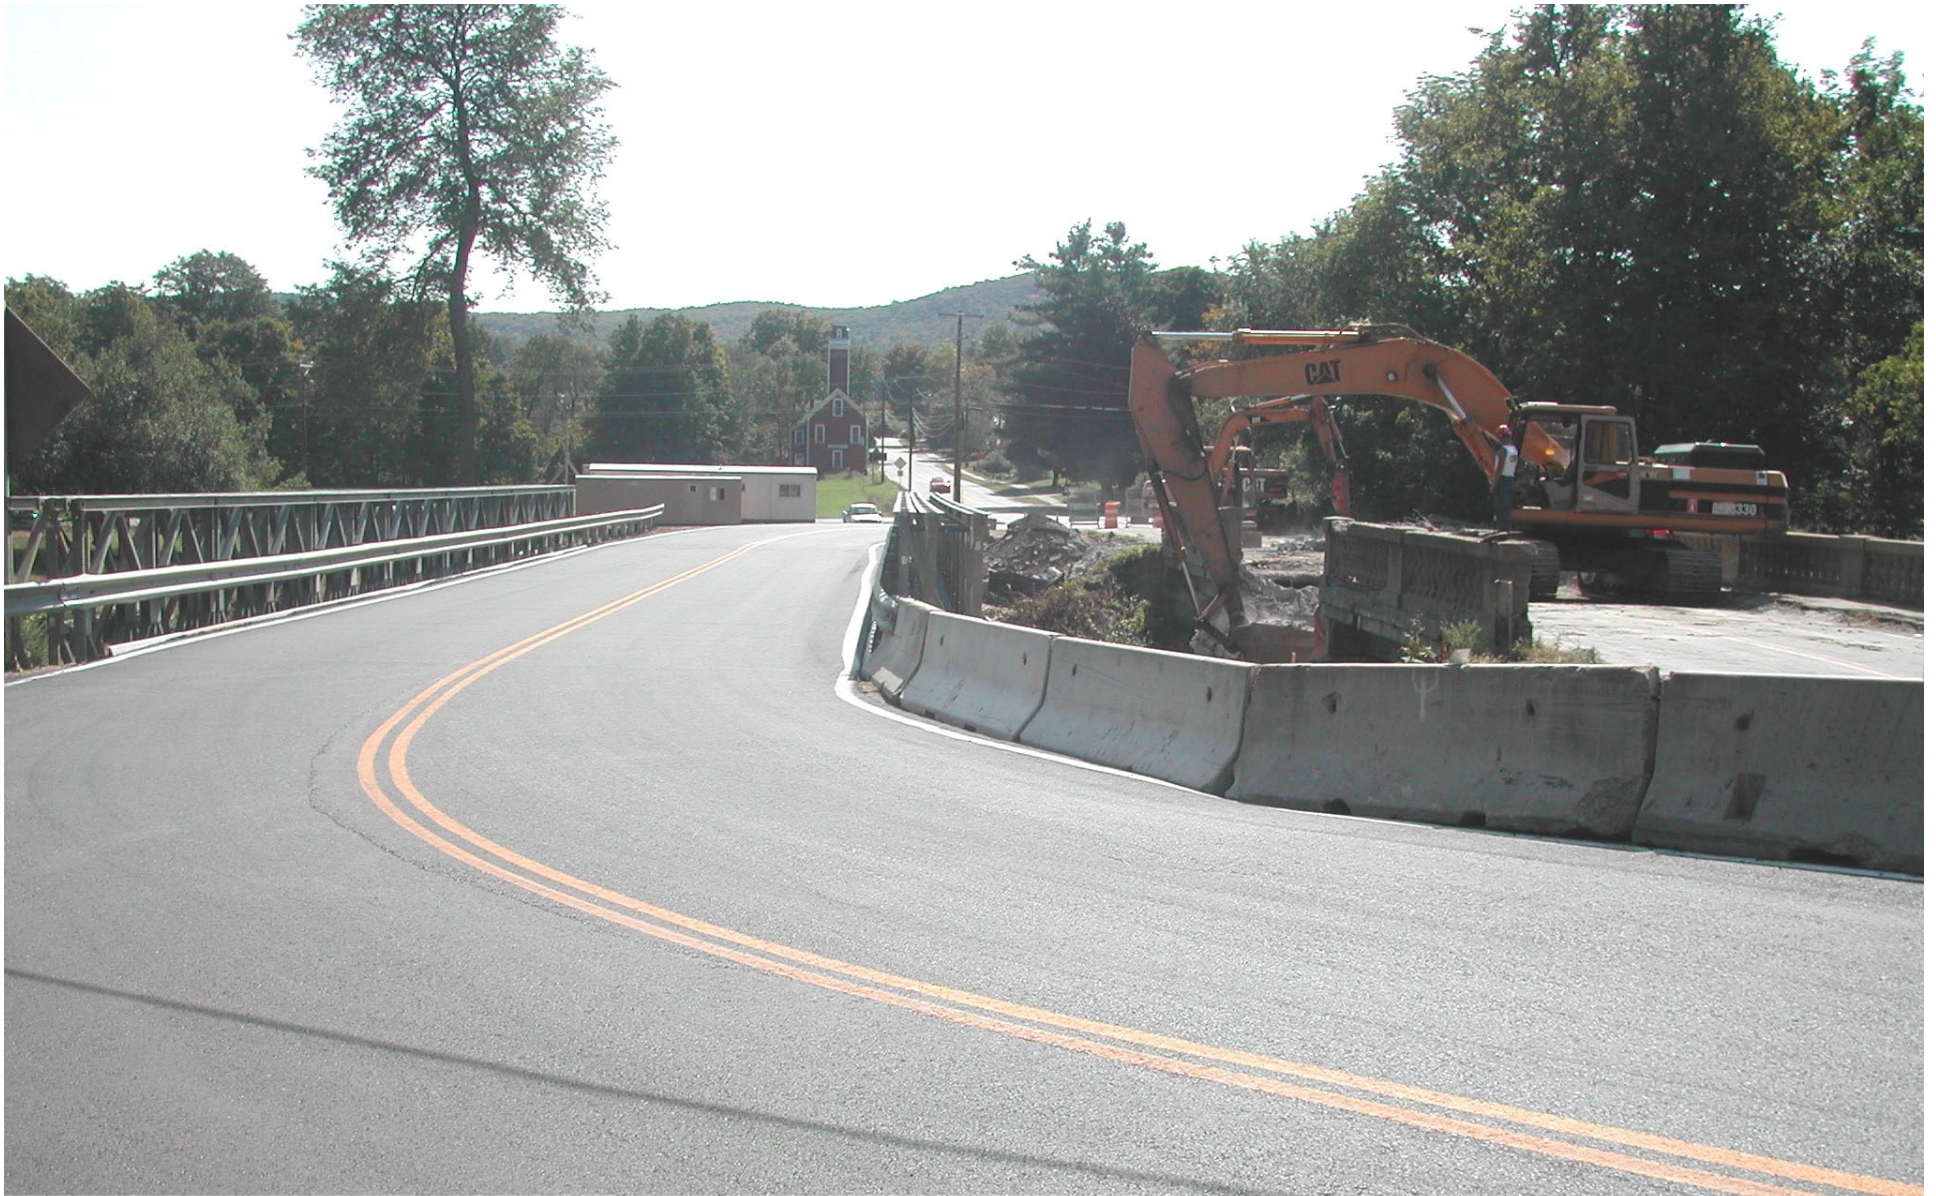
## Temporary Bridge

- Two Lane Temporary Bridge Downstream

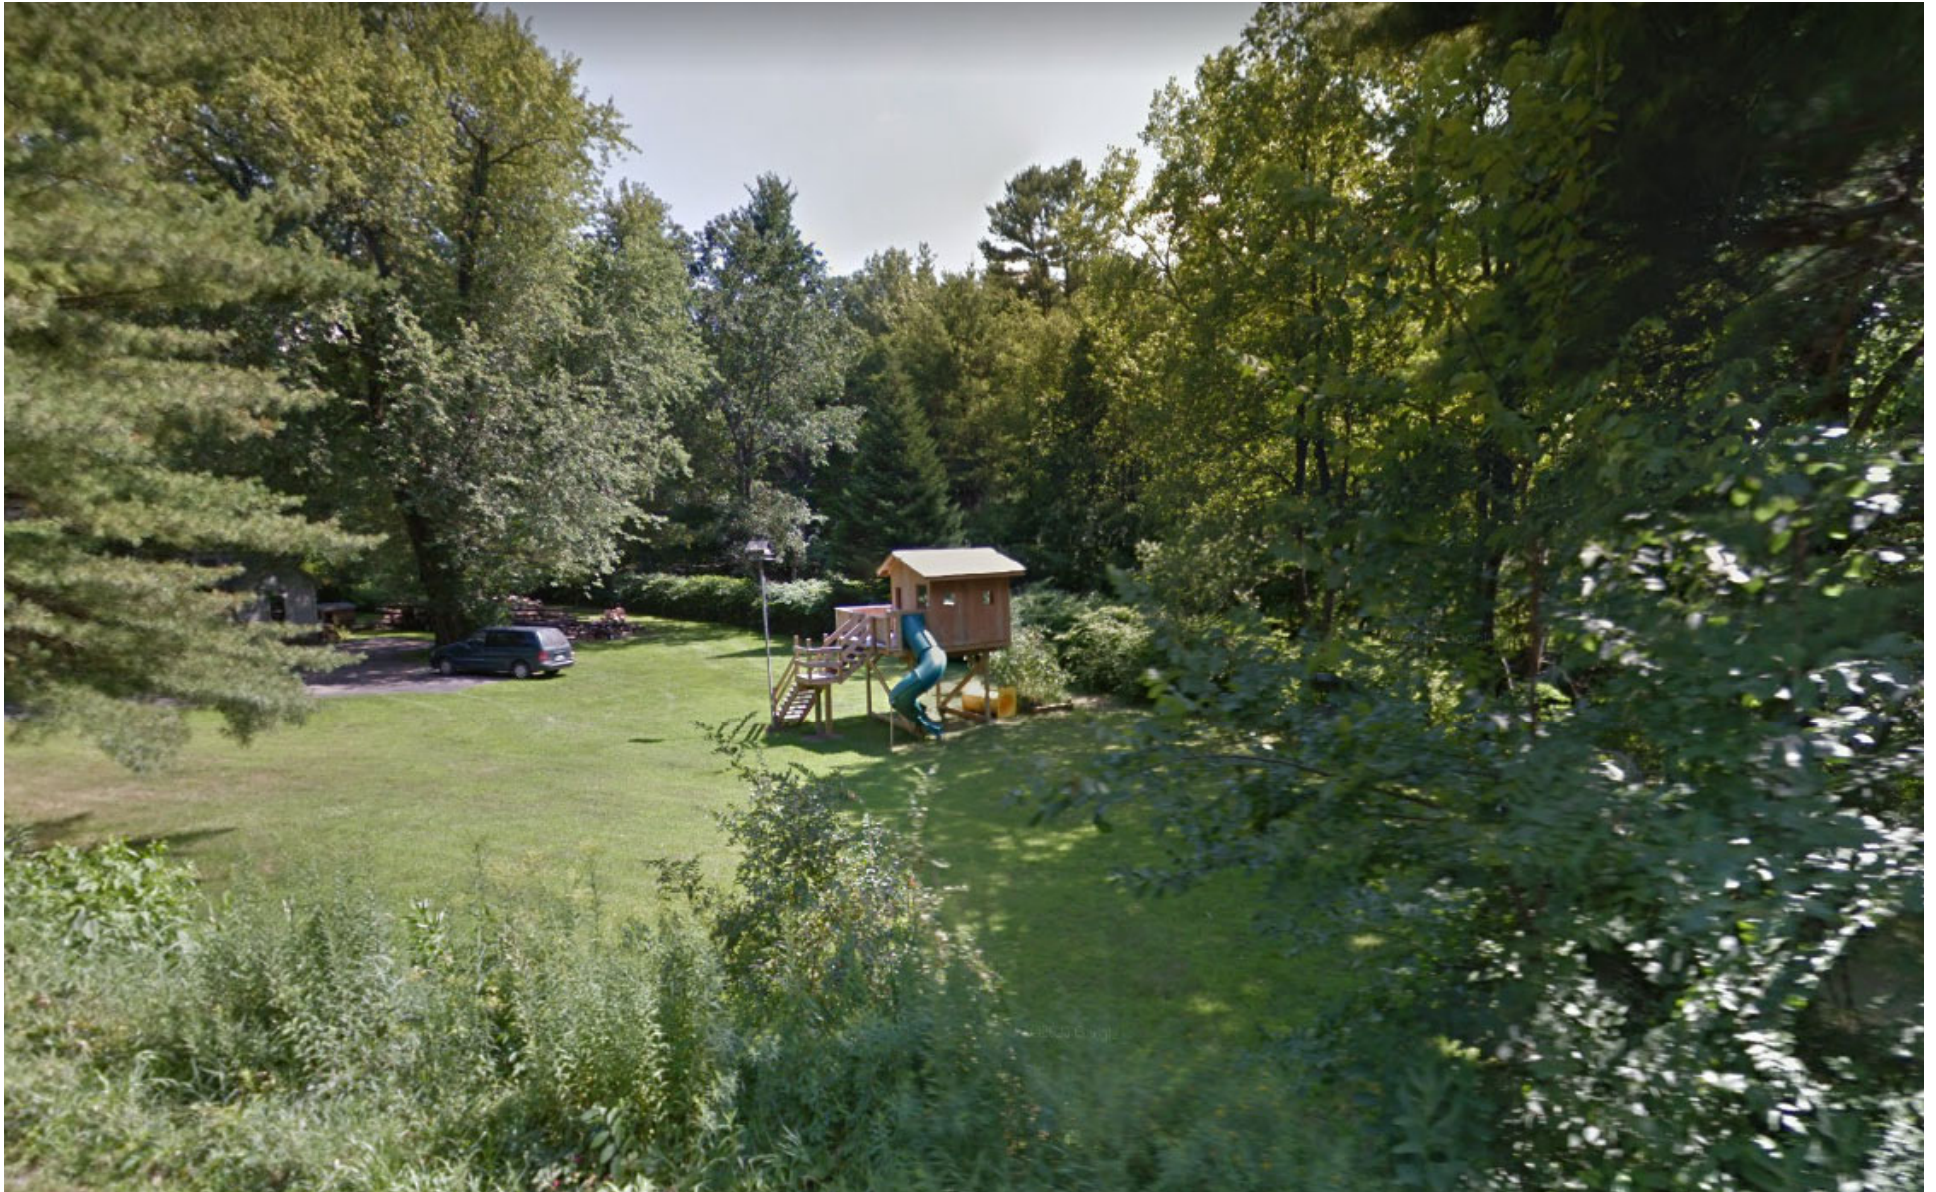
## Temporary Bridge

- Play structure relocation
