Brattleboro BF 2000(28) Alternatives Presentation Meeting

VT Route 9– Bridge #54 over Whetstone Brook

September 21st, 2021

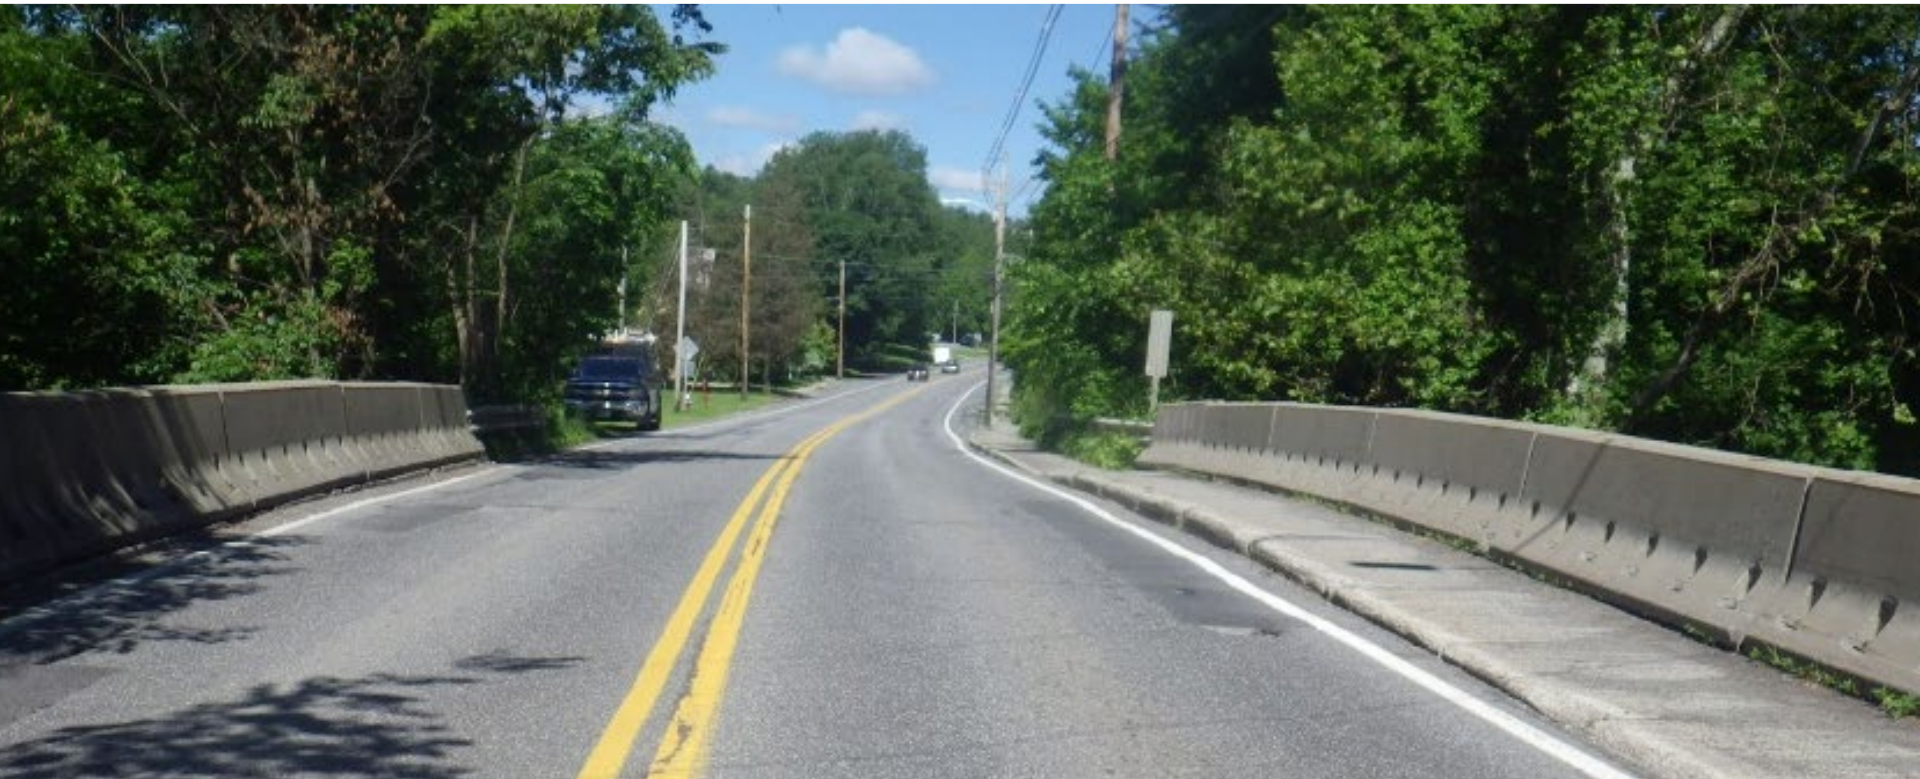
Looking West over Bridge

- Roadway Classification – Principal Arterial, National Highway System, Urban (Class 1 Town Highway)
- Bridge Type – 60' Span Single Span Cast-in-Place Concrete Arch
- Ownership – Town of Brattleboro
- Constructed in 1914

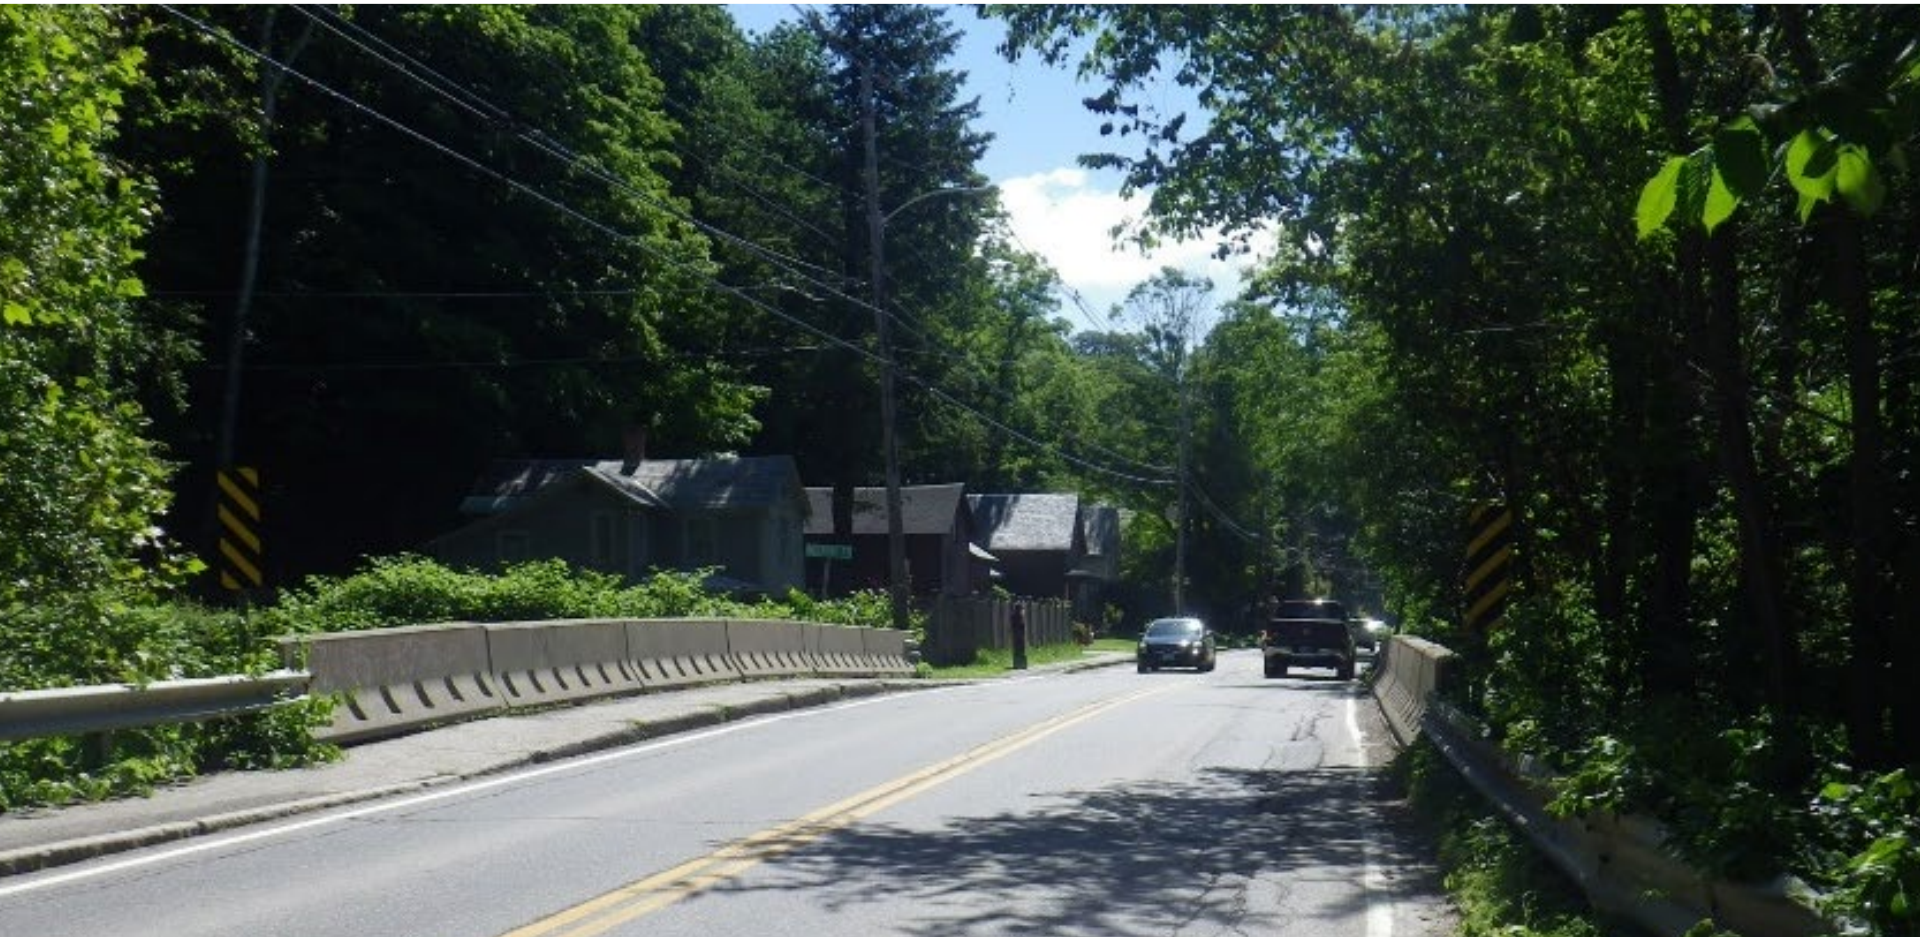
Looking East over Bridge

- Narrow sidewalk over north side of bridge
- Located in densely populated area
- Bridge is skewed 20 degrees

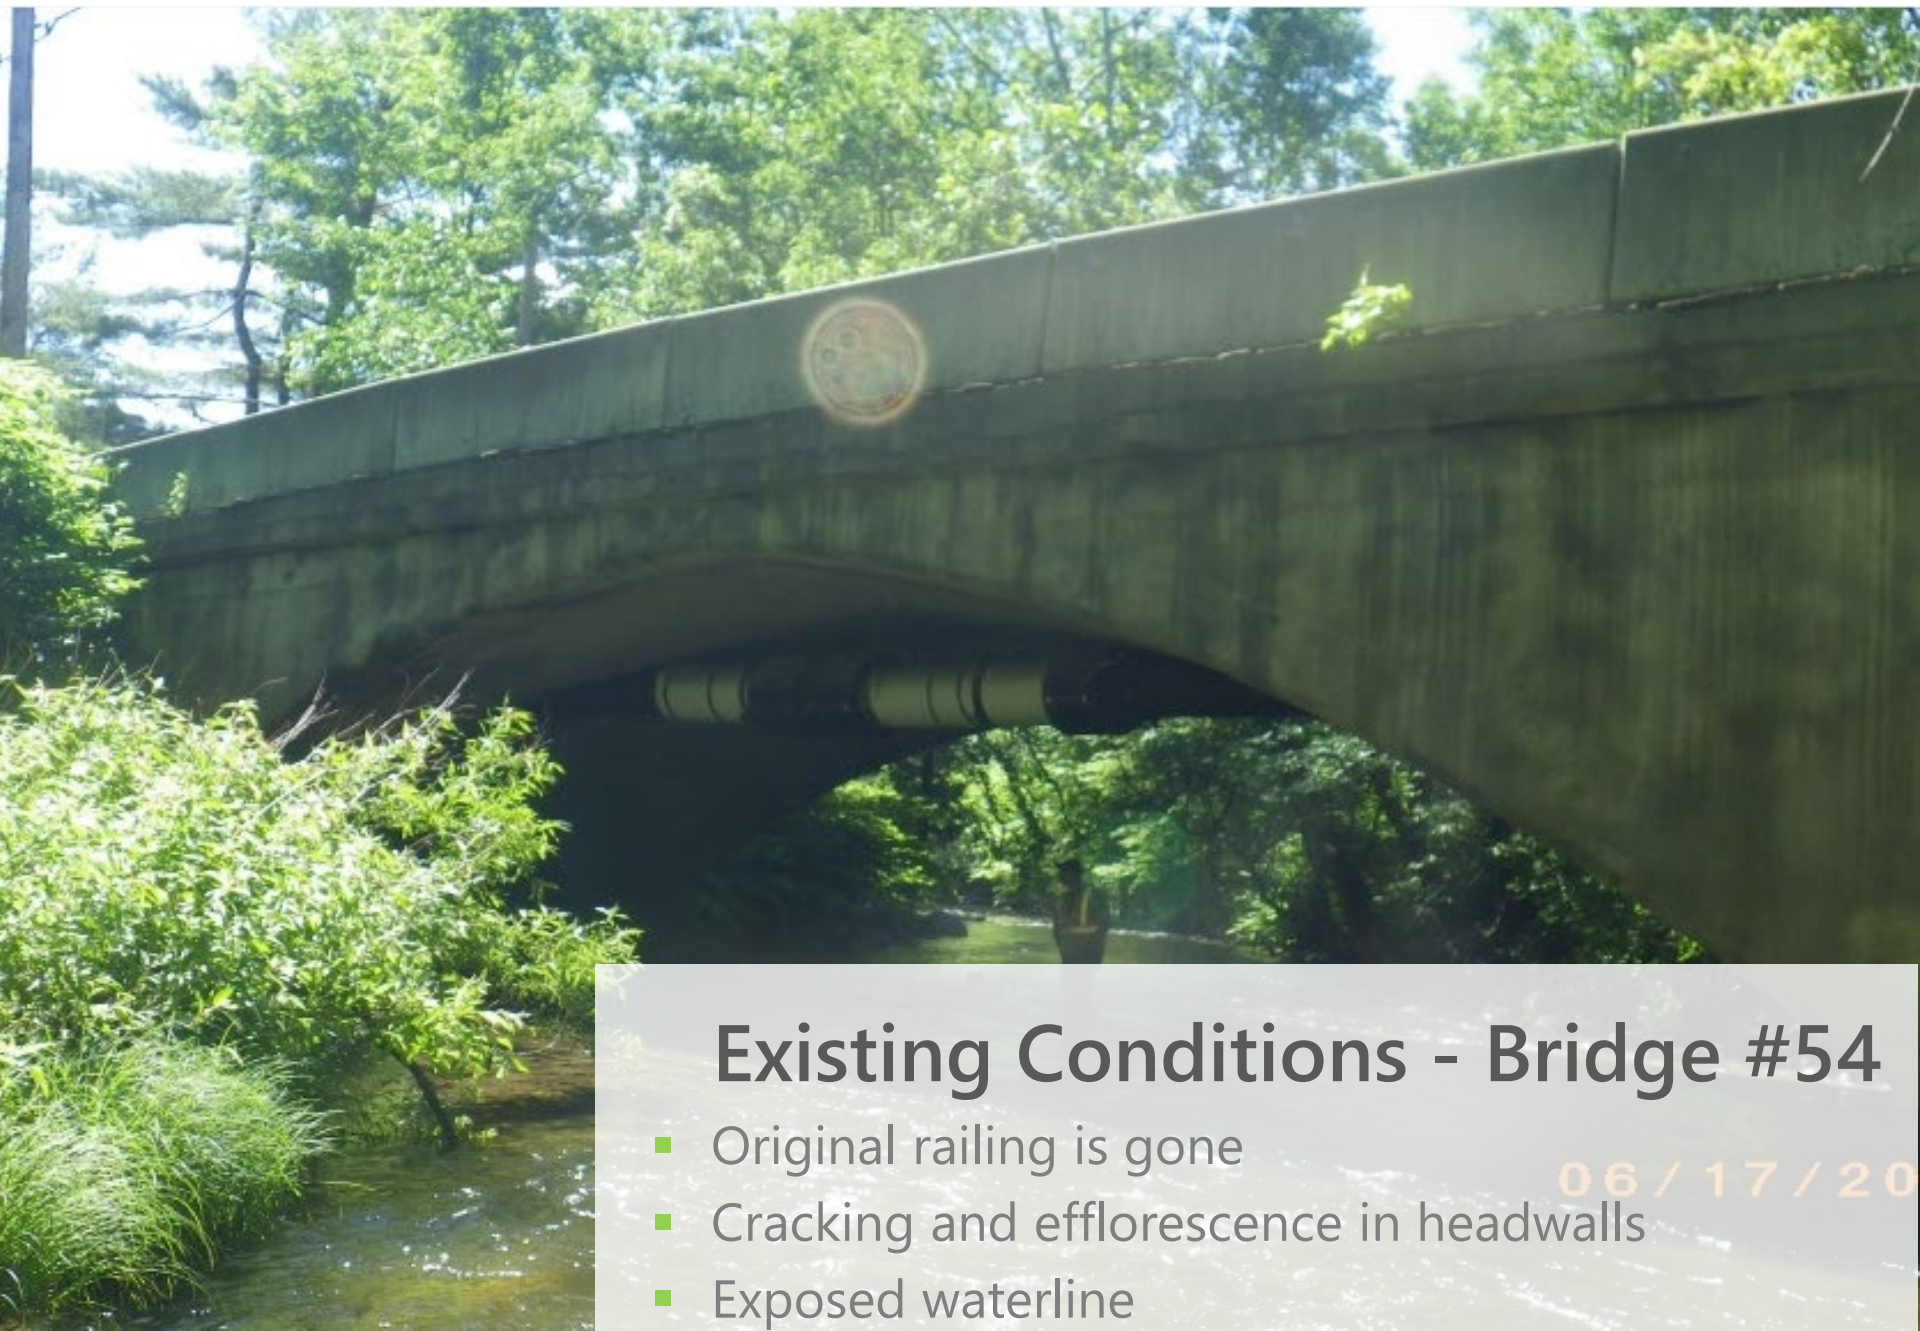
Bridge Fascia

- Original railing is gone
- Cracking and efflorescence in headwalls
- Exposed waterline

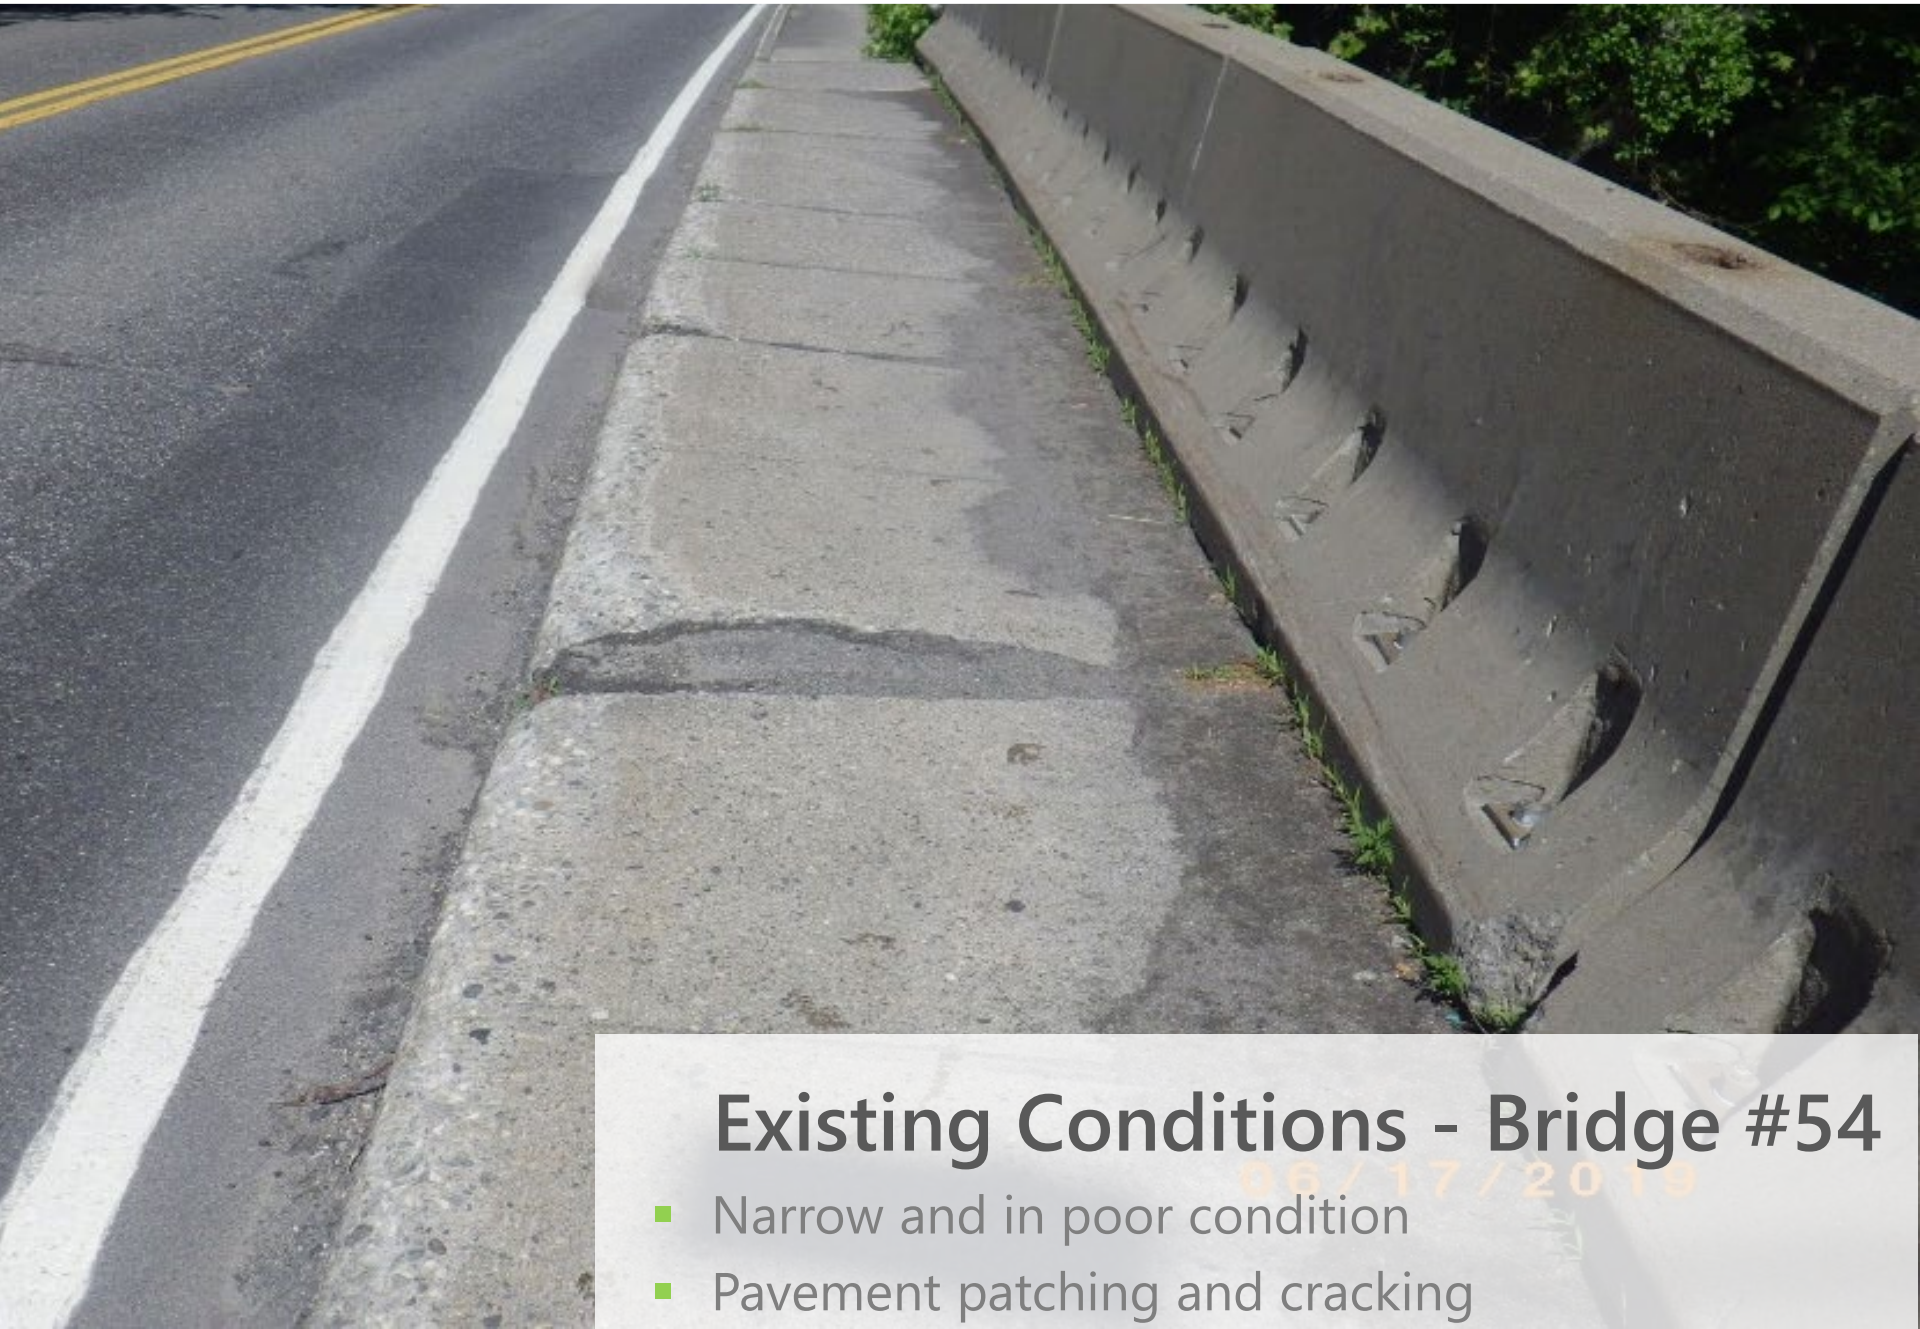
Sidewalk

- Narrow and in poor condition
- Pavement patching and cracking

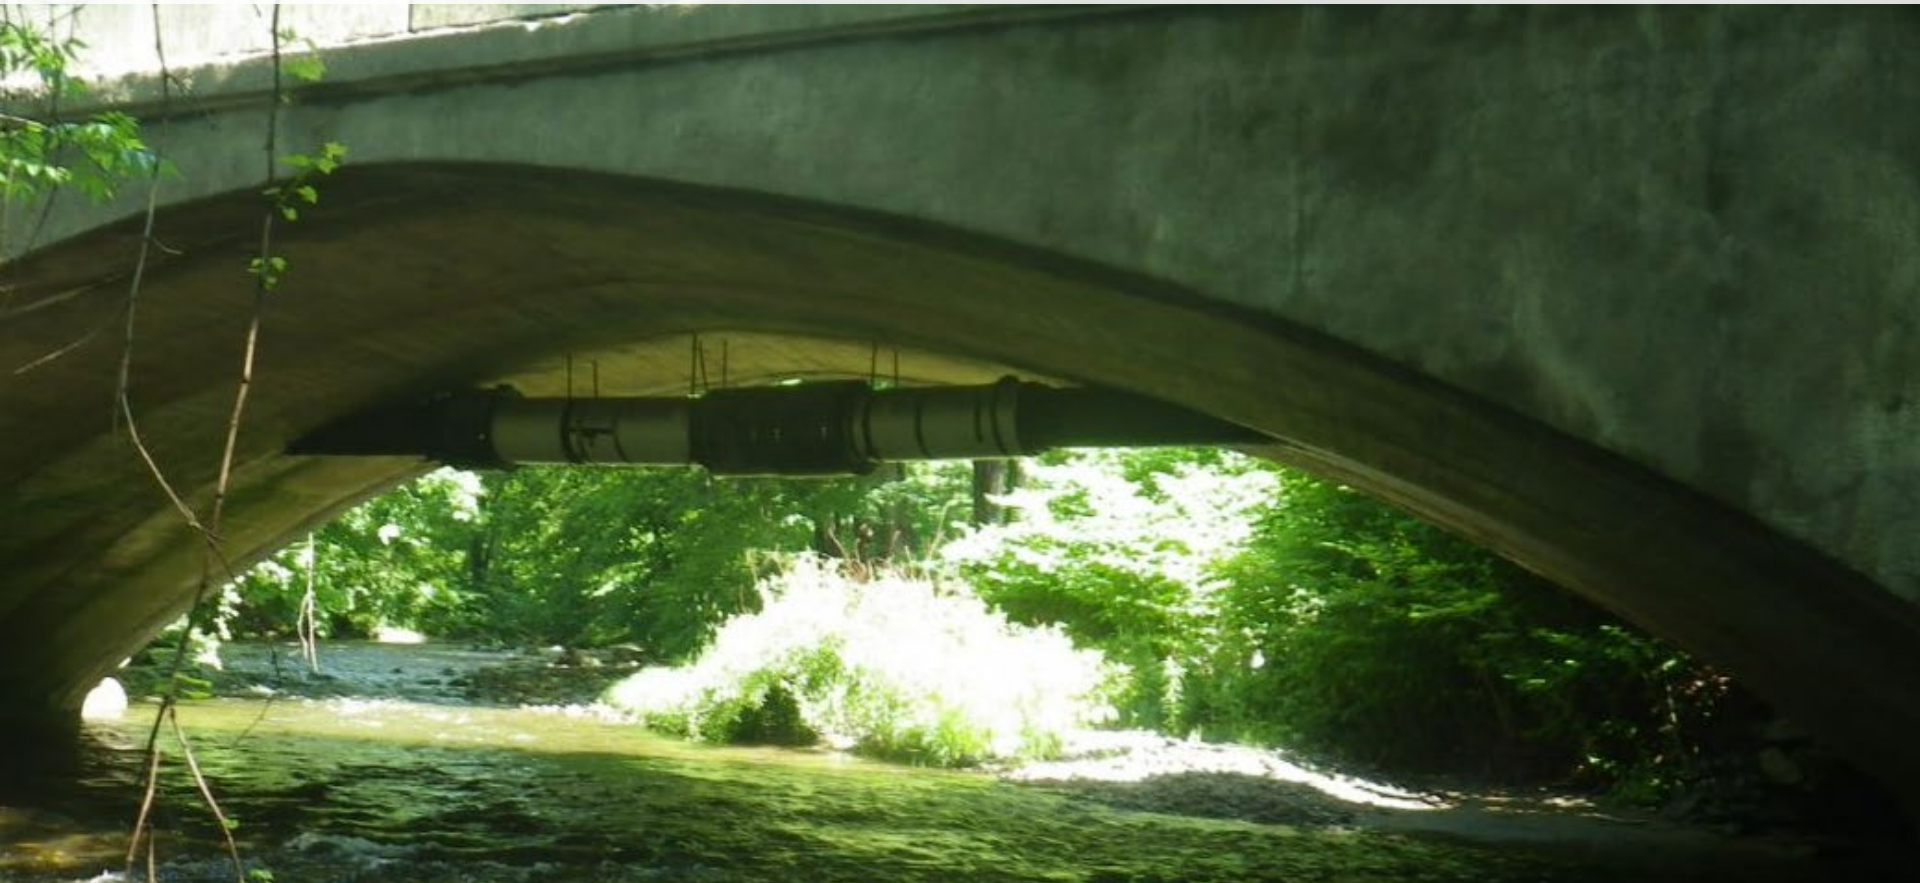
- Existing Conditions with Debris Blockage: There is no freeboard (measured from the bottom of the waterline) at the 2% and 1% AEP. Roadway overtopping occurs approximately 200 ft west of the bridge at the 1% AEP with an approximate maximum water depth of 0.62-feet.
