Western Ave. (VT Route 9) over Whetstone Brook Brattleboro, VT VT Route 9 Bridge 54 Project No. BF 2000 (28)

# **Project Overview (Preliminary Plans)**

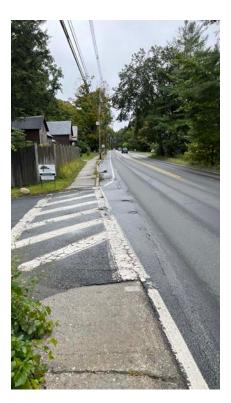
# **Existing Wearing Surface Condition**

- Wearing surface not rated in previous inspection report
- Appears to be bituminous
  - Cracks and minor wear are visible
  - Scattered potholes
- Sidewalk on north side of bridge
  - Fair to Poor condition
  - Cracking
  - Grass growing in sidewalk
- Crosswalk at northeast side of bridge across Melrose Street

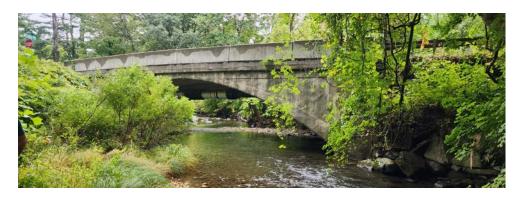
### **Existing Arch and Abutments Condition**

- Rated 6 (Satisfactory)
- Minor wearing along lower portions of both ends
- Minor cracking with saturation and efflorescence leakage along lower portions
- Small area of spalling with exposed reinforcing along lower portion near West Abutment (Abutment 1)

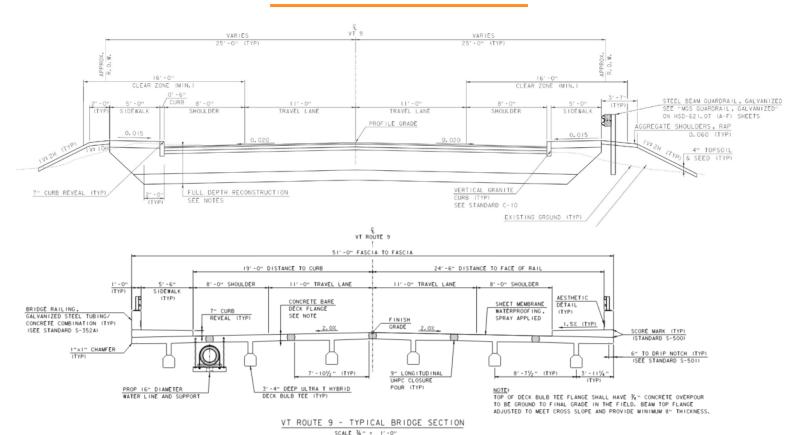
# **Typical Section**

- 5-6" (including curb width) Sidewalks on both sides
- New concrete integral abutments
- New guardrails at all four (4) corners
- New retaining walls at all four (4) corners
- Prestressed concrete deck tee beams with closure pours

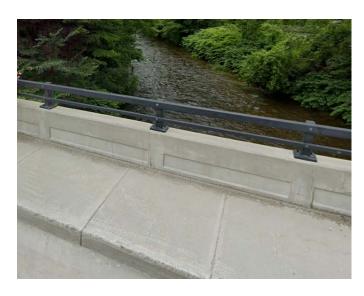
# Typical Sidewalk/ Bridge Railing

Example Bridge railing from Ludlow, VT
Main Street over Black River

- > 5'-6" Wide Sidewalk on north and south sides
- Galvanized Steel Tubing/Concrete Combination Railing

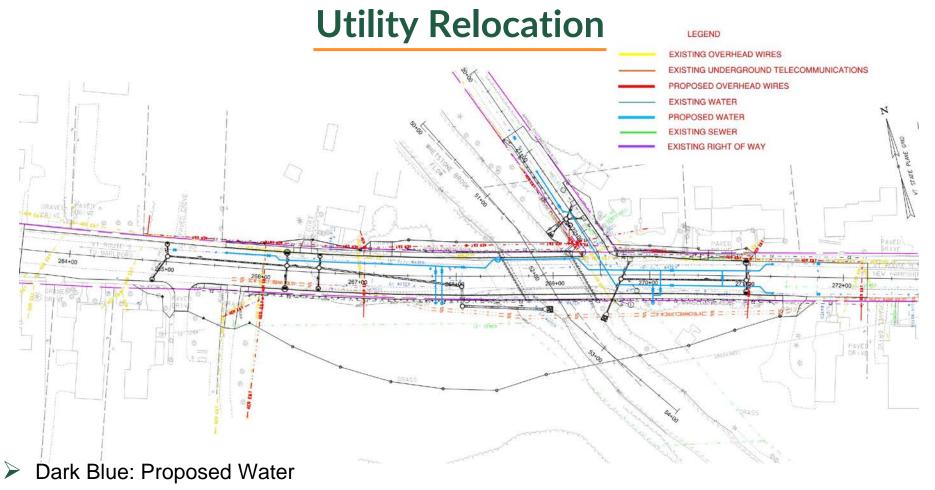
- Municipal Utilities:
  - The Town of Brattleboro has a 16" cast iron waterline attached underneath the bridge.
  - The Town of Brattleboro has two sewer lines buried on both sides of Whetstone Brook. On the west side, a 12" pipe runs parallel to Western Avenue, then turns South parallel with Whetstone Brook. On the east side, an 8" pipe runs down Melrose Street and continues South parallel with Whetstone Brook.
- Underground:
  - Consolidated Communications(Telephone)
- Aerial
  - Comcast
  - Green Mountain Power (Electric)
  - First Light Fiber

➤ Red: Proposed Overhead Wires/Utility Poles

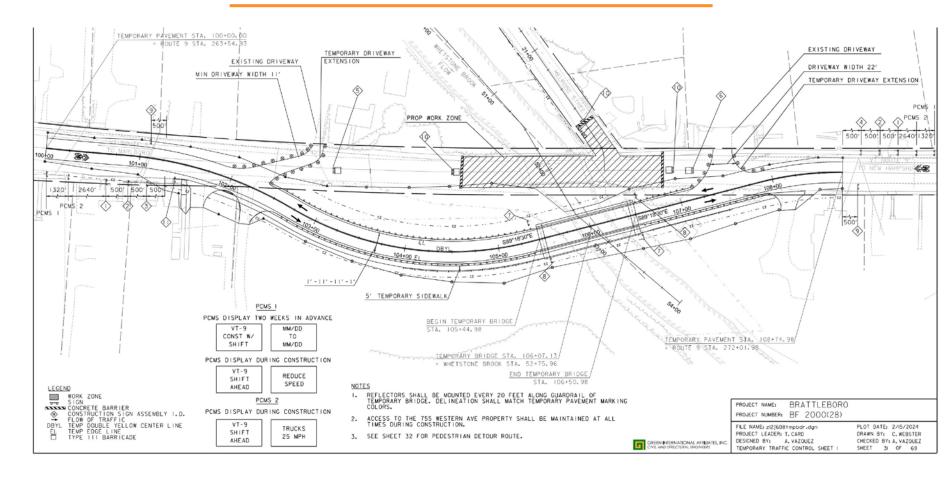
# **Proposed Temporary Layout**

- Temporary Bridge will be installed downstream of bridge
- Typical Section at Temporary Bridge:
  - 24' minimum roadway width between rails
  - 11' travel lanes
  - > 1' shoulders
  - > 5' temporary sidewalk
  - Guardrail Barrier between temporary road and temporary sidewalk
- Temporary access to surrounding driveways

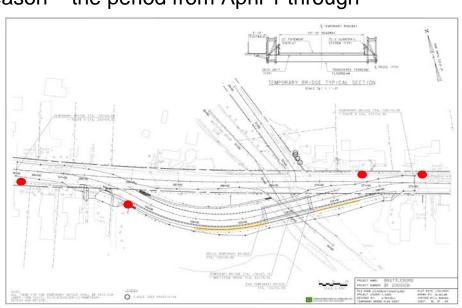
- Temporary Bridge will be installed downstream of the bridge
  - Two-way traffic will be maintained at all times
  - Temporary detour to access Melrose Street

Temporary Lighting (Red)

Fence for headlight mitigation (orange)
