**Burke BO 1447(31)**

## **Alternatives Presentation Meeting**

**Town Highway 31 – Bridge #35 over the West Branch of Passumpsic River**

April 2, 2018

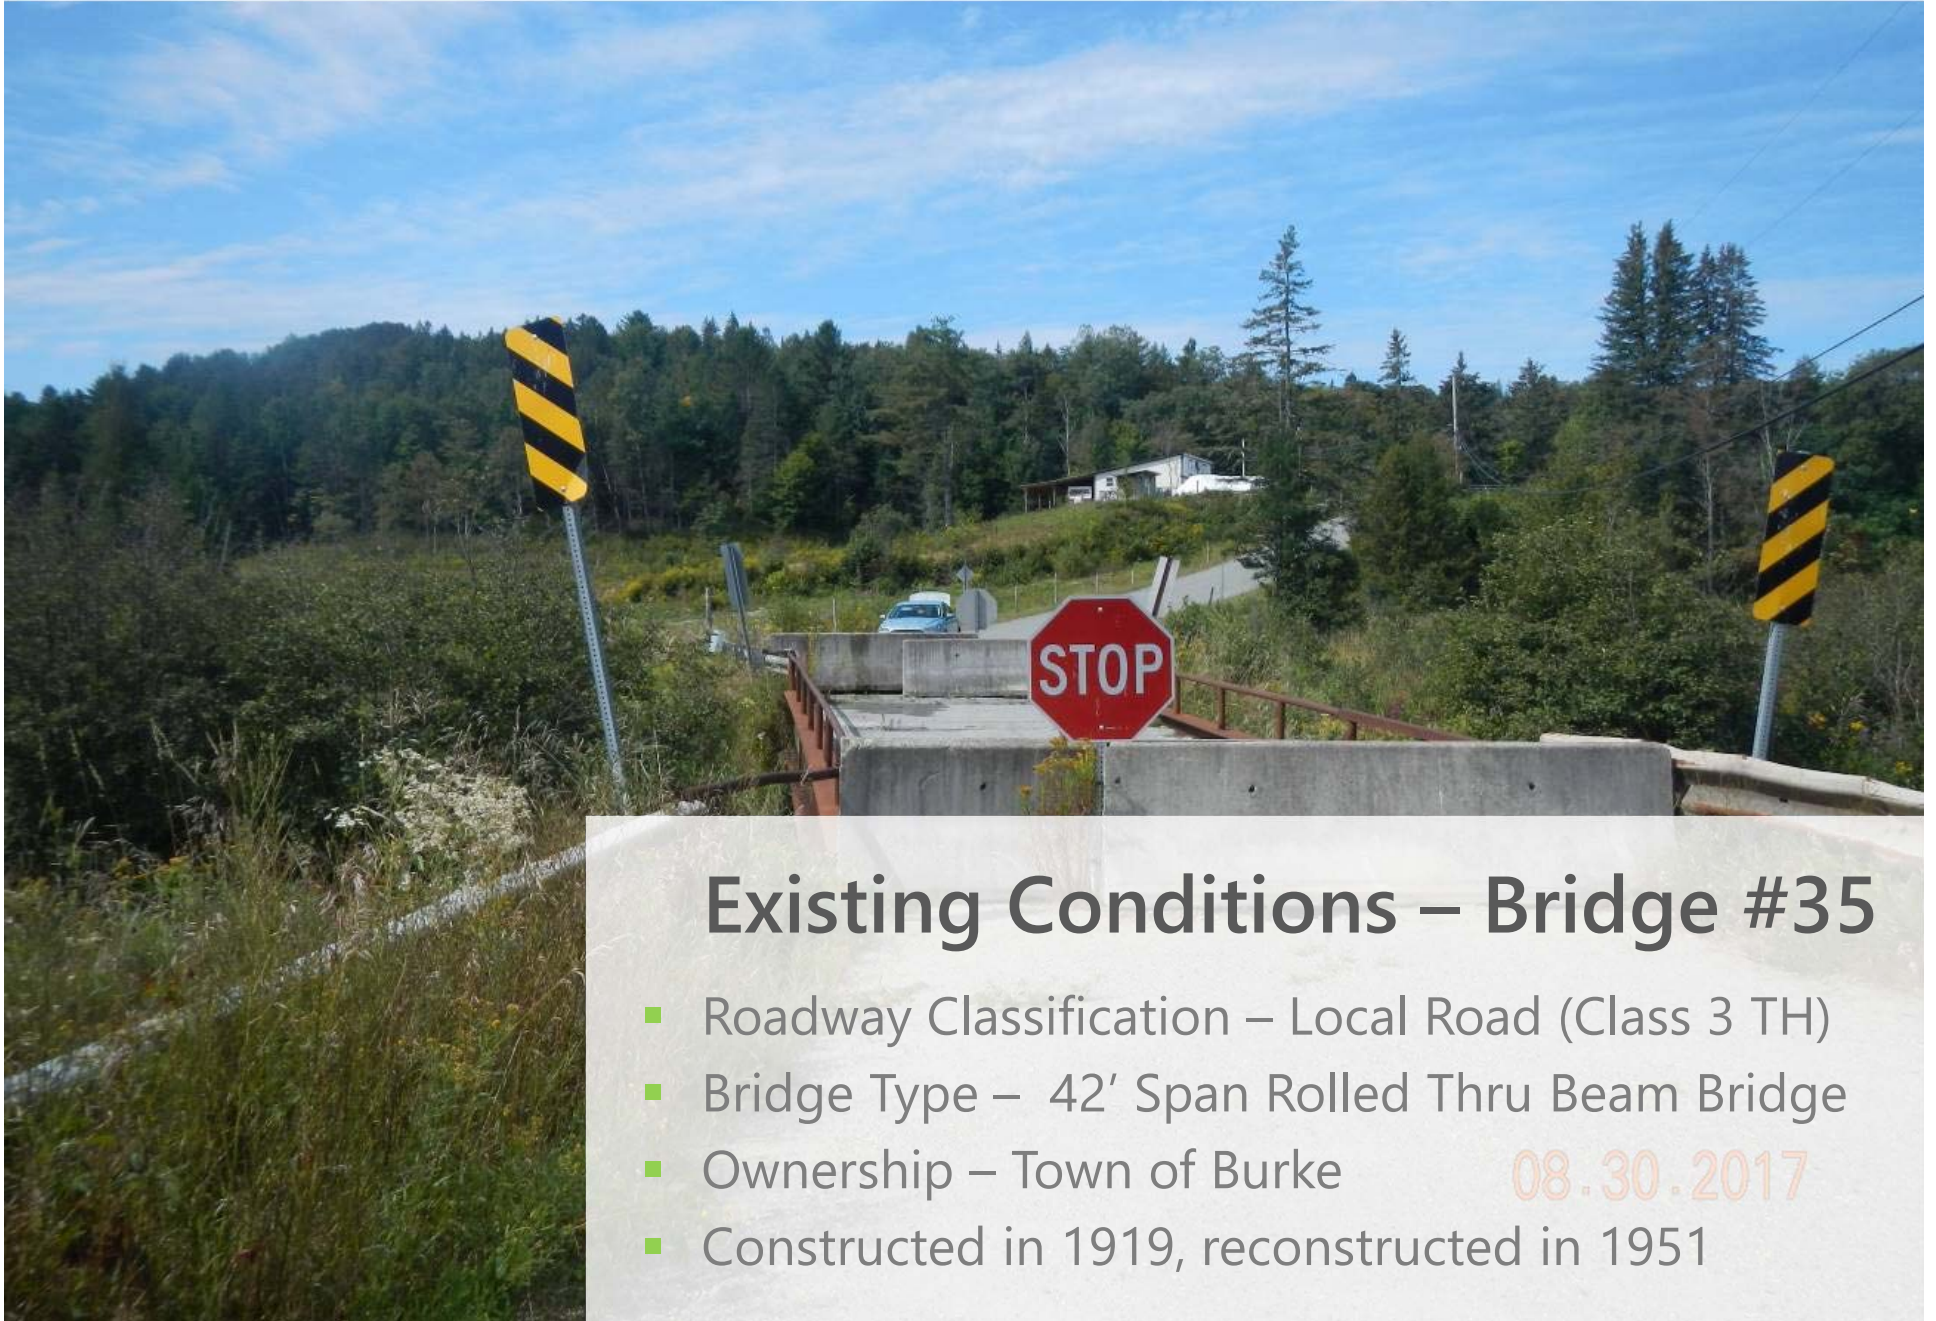
## Looking West over Bridge

### Existing Conditions – Bridge #35

- Roadway Classification – Local Road (Class 3 TH)
- Bridge Type – 42' Span Rolled Thru Beam Bridge
- Ownership – Town of Burke
- Constructed in 1919, reconstructed in 1951

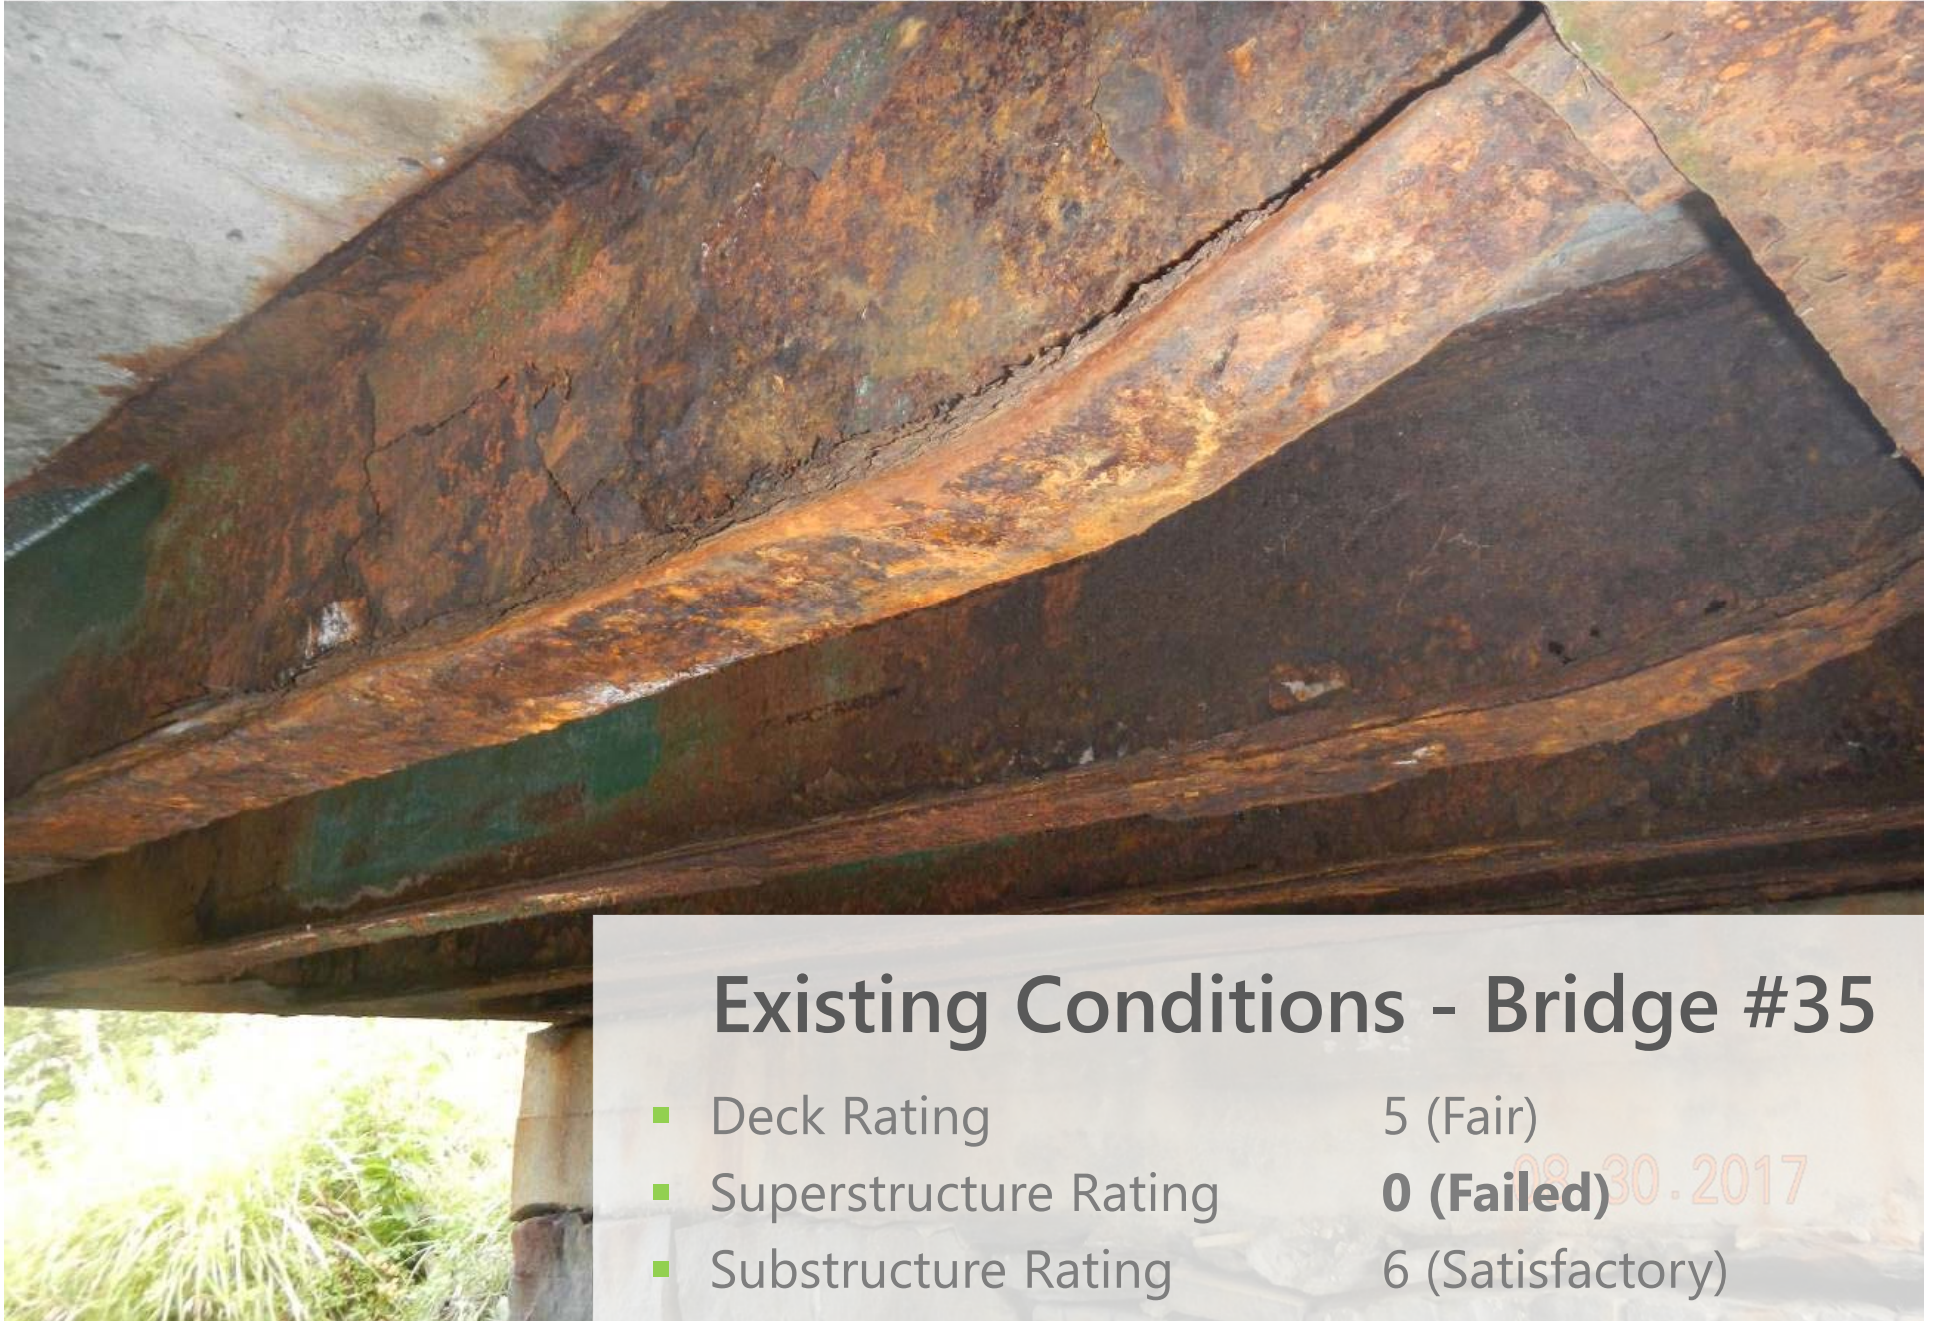
## Failed Superstructure

### Existing Conditions - Bridge #35

- Deck Rating 5 (Fair)
- Superstructure Rating **0 (Failed)**
- Substructure Rating 6 (Satisfactory)

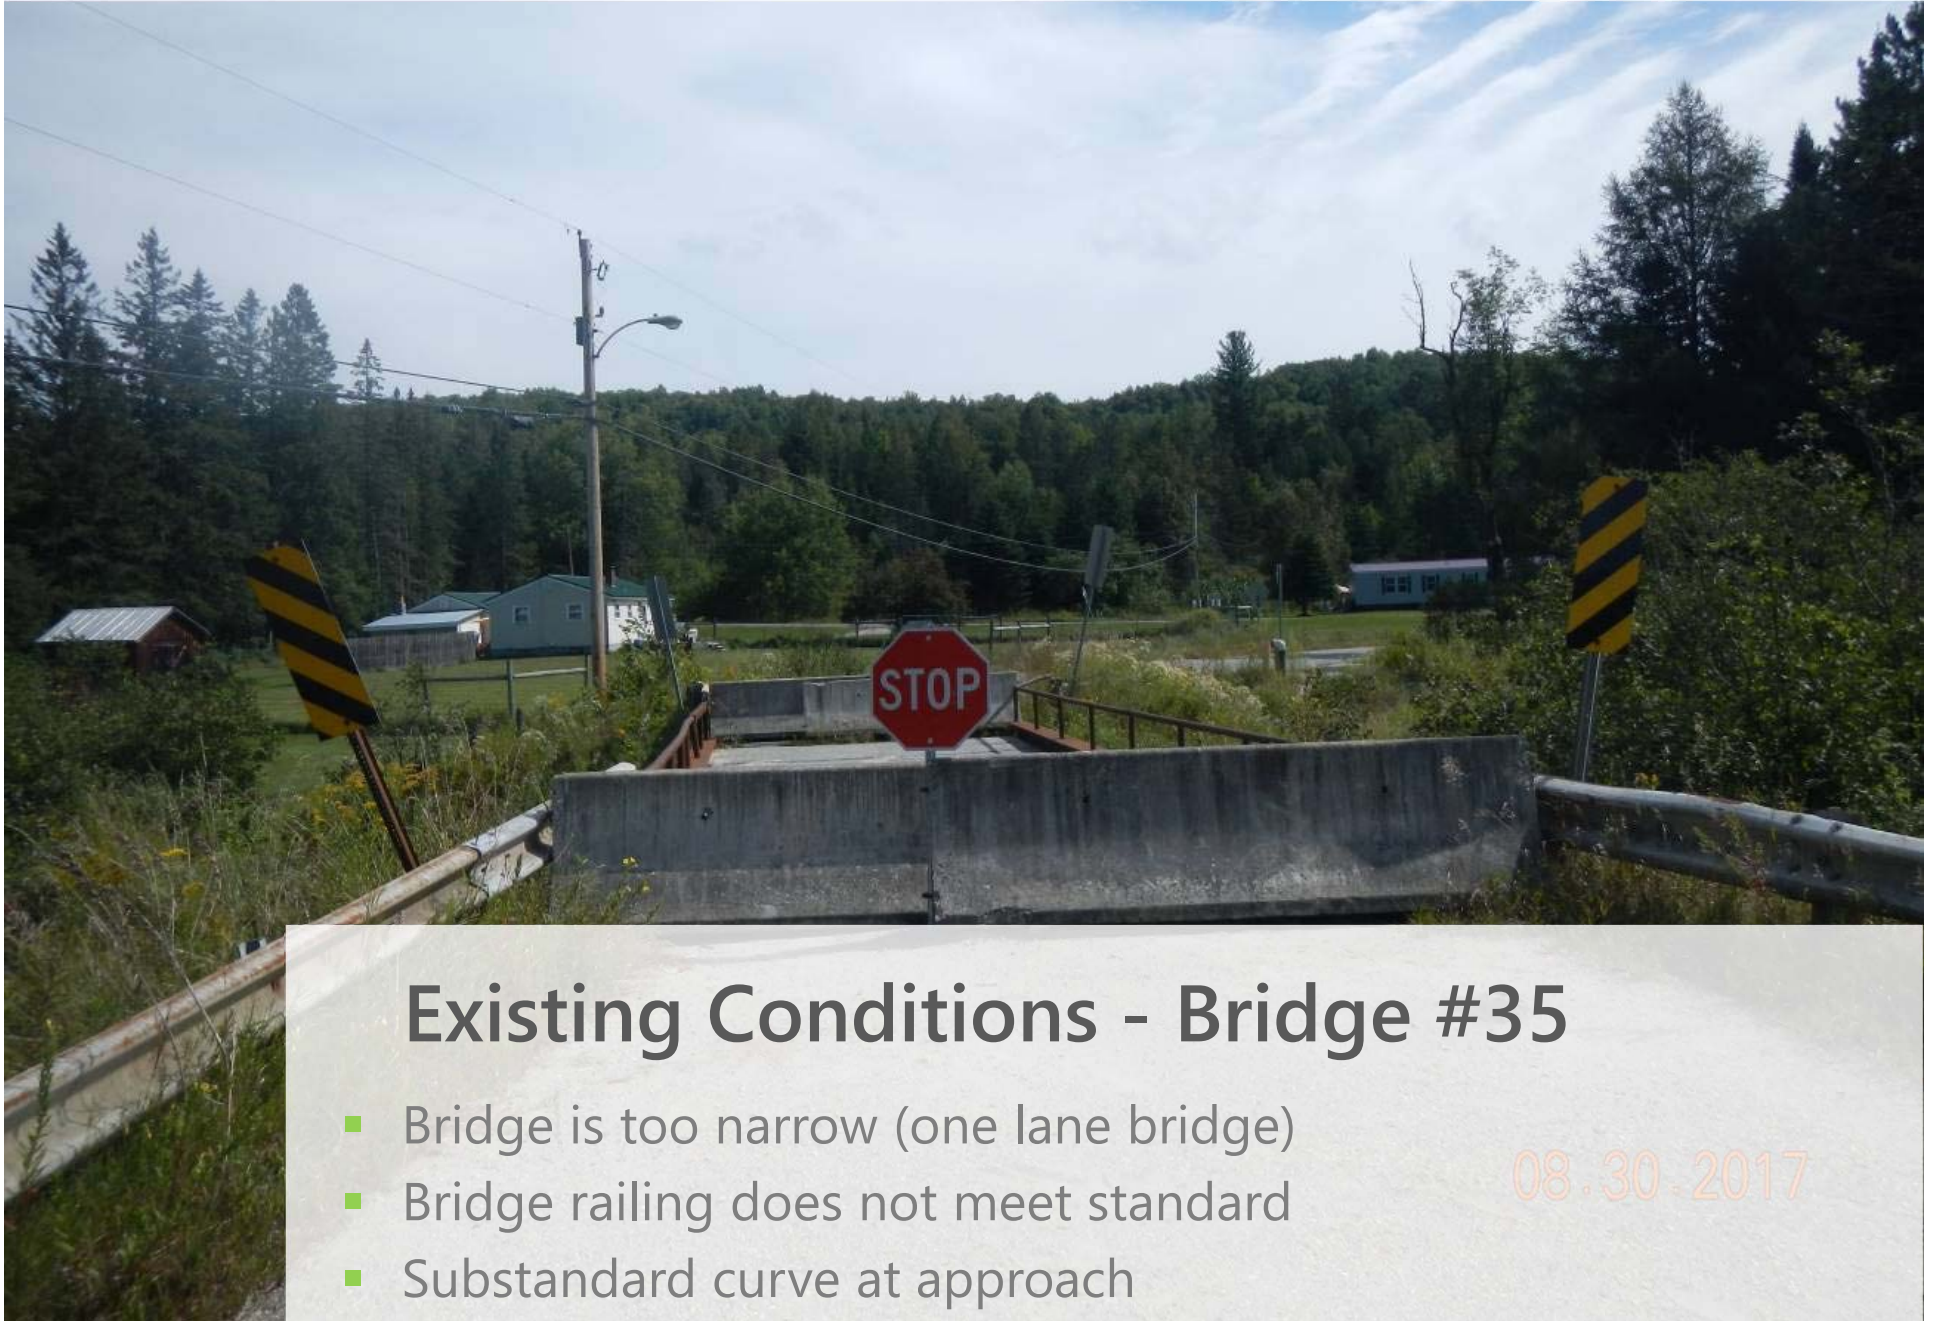
Looking East over Bridge

## Existing Conditions - Bridge #35

- Bridge is too narrow (one lane bridge)
- Bridge railing does not meet standard
- Substandard curve at approach

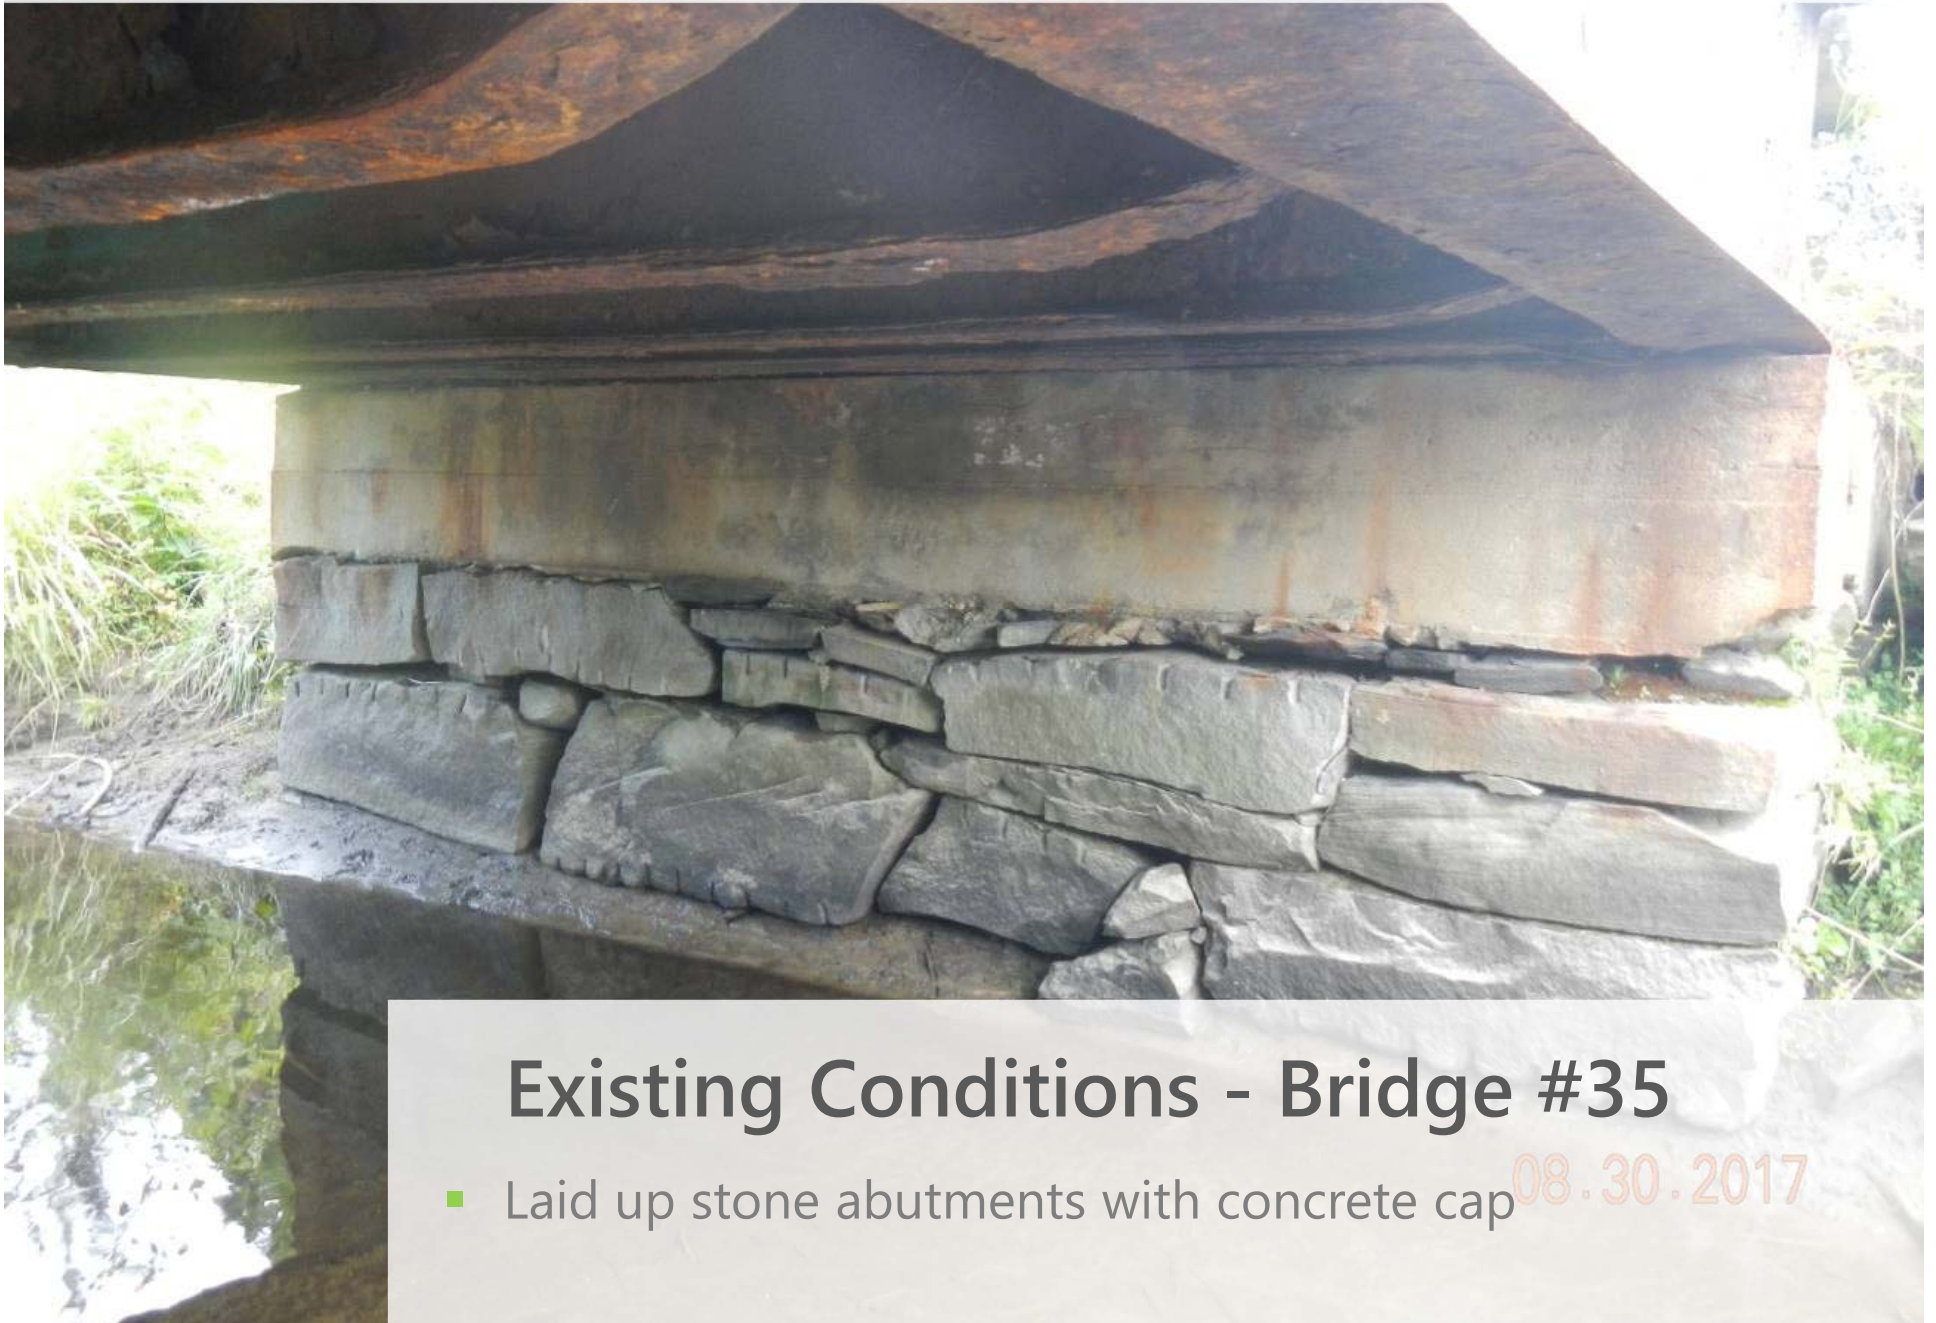
## Substructure – Eastern Abutment

## Existing Conditions - Bridge #35

- Laid up stone abutments with concrete cap

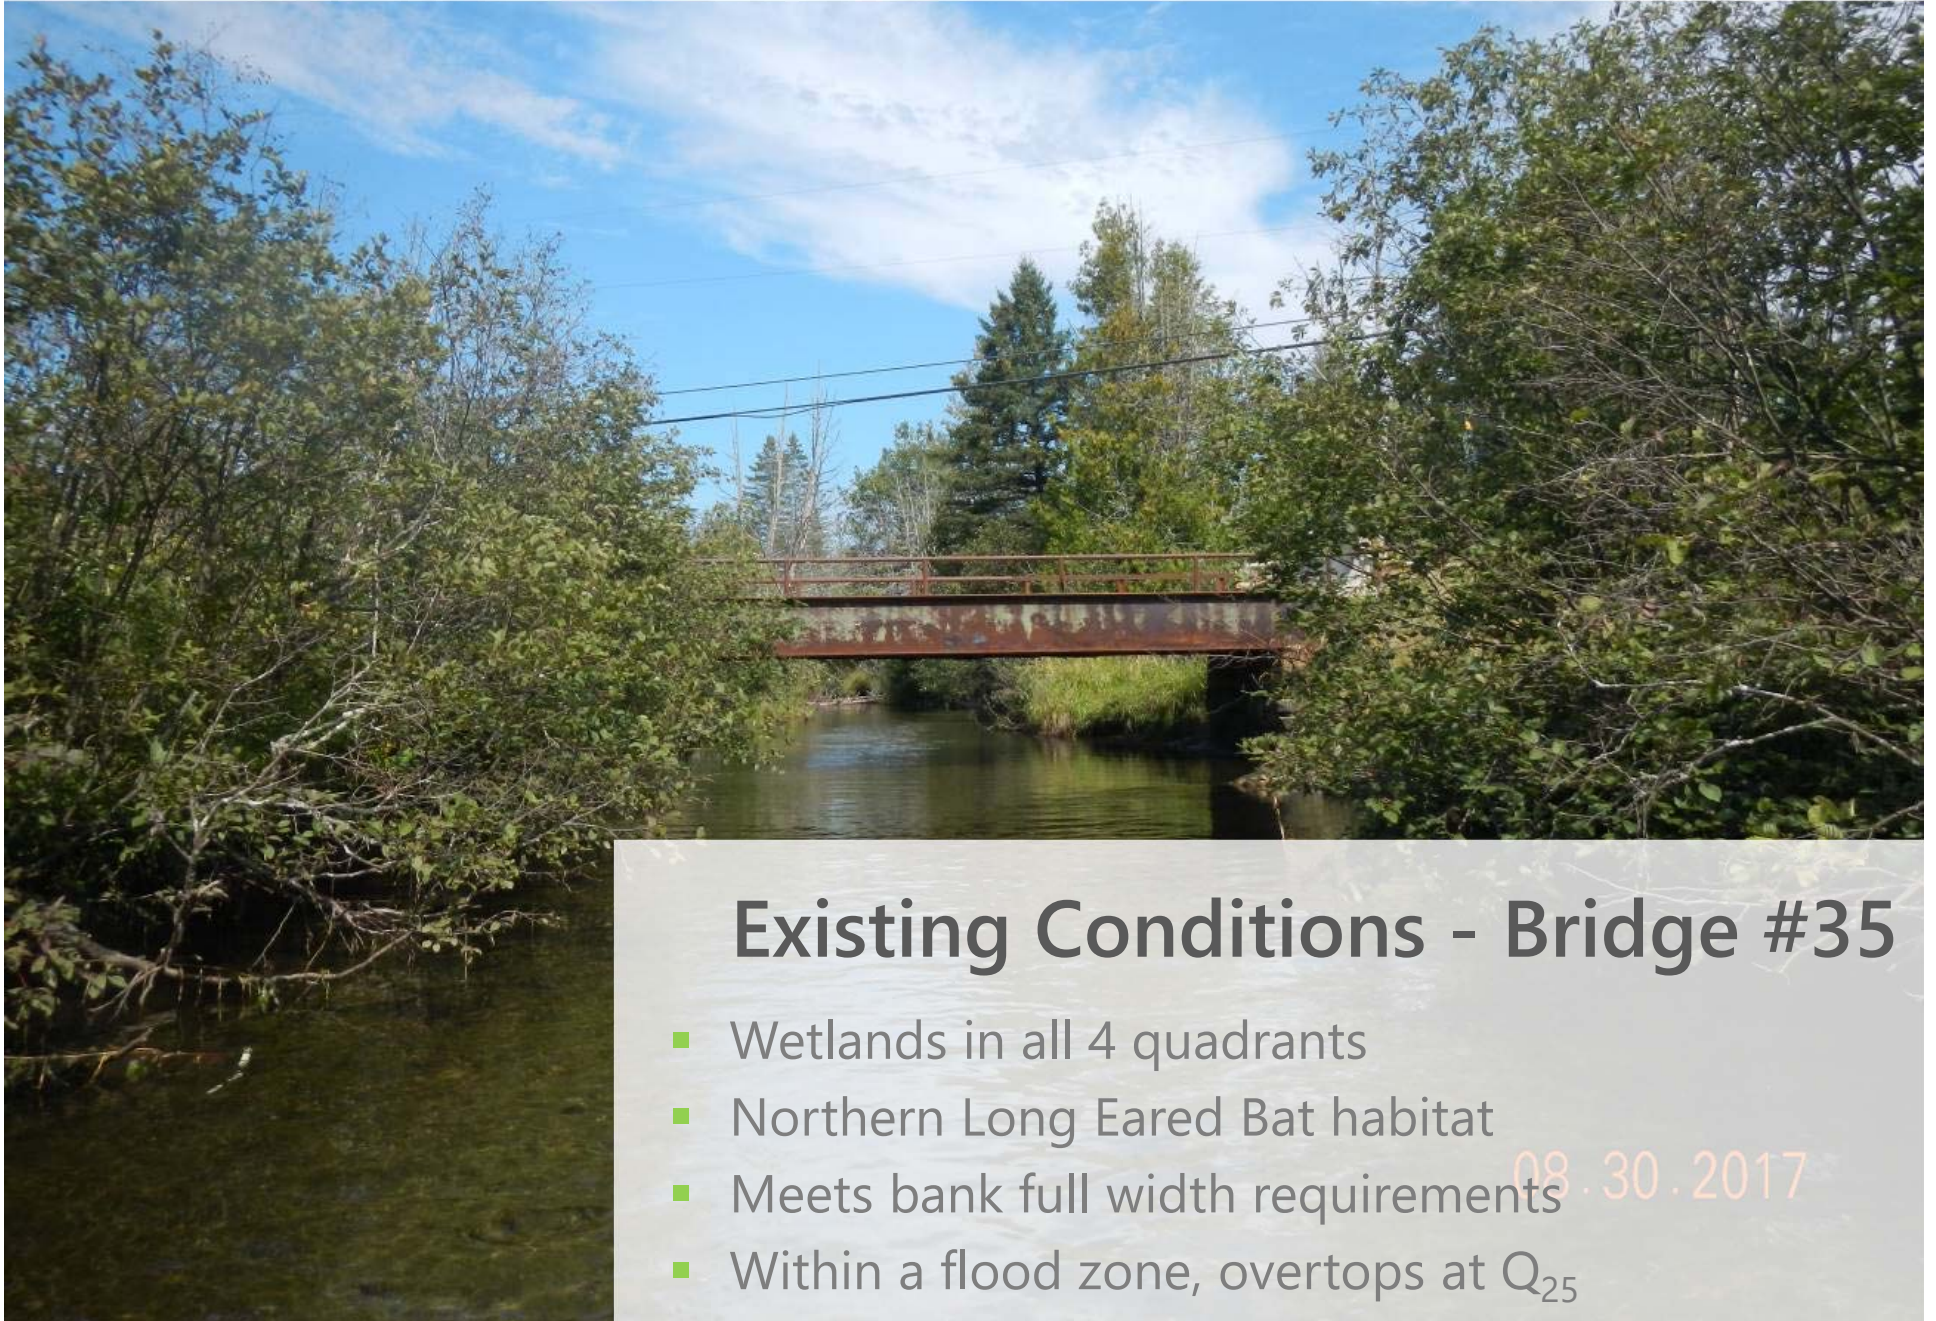
## Hydraulics and Environmental Resources

### Existing Conditions - Bridge #35

- Wetlands in all 4 quadrants
- Northern Long Eared Bat habitat
- Meets bank full width requirements
- Within a flood zone, overtops at  $Q_{25}$
