**STATE OF VERMONT
AGENCY OF TRANSPORTATION**

Scoping Report

Fairfield BO 1448(46)

Town Highway 29, Bridge 49 over Black Creek

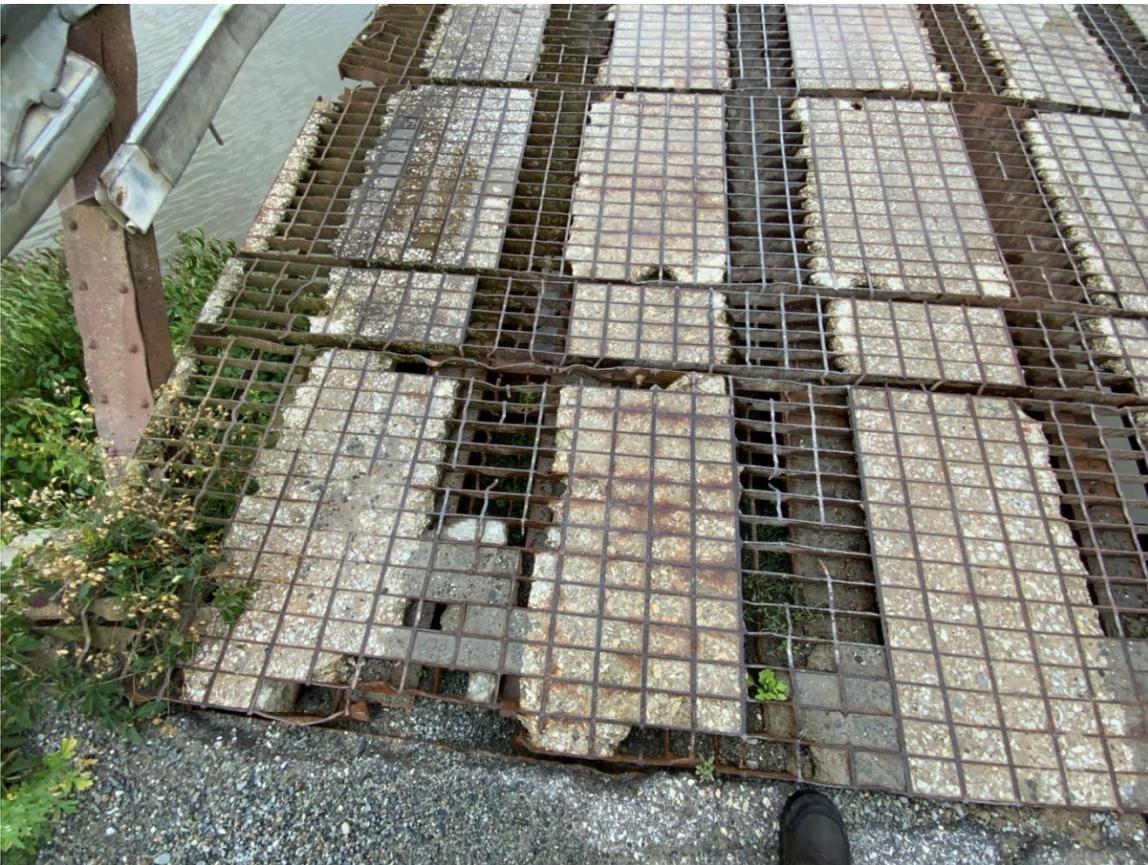
Wearing surface

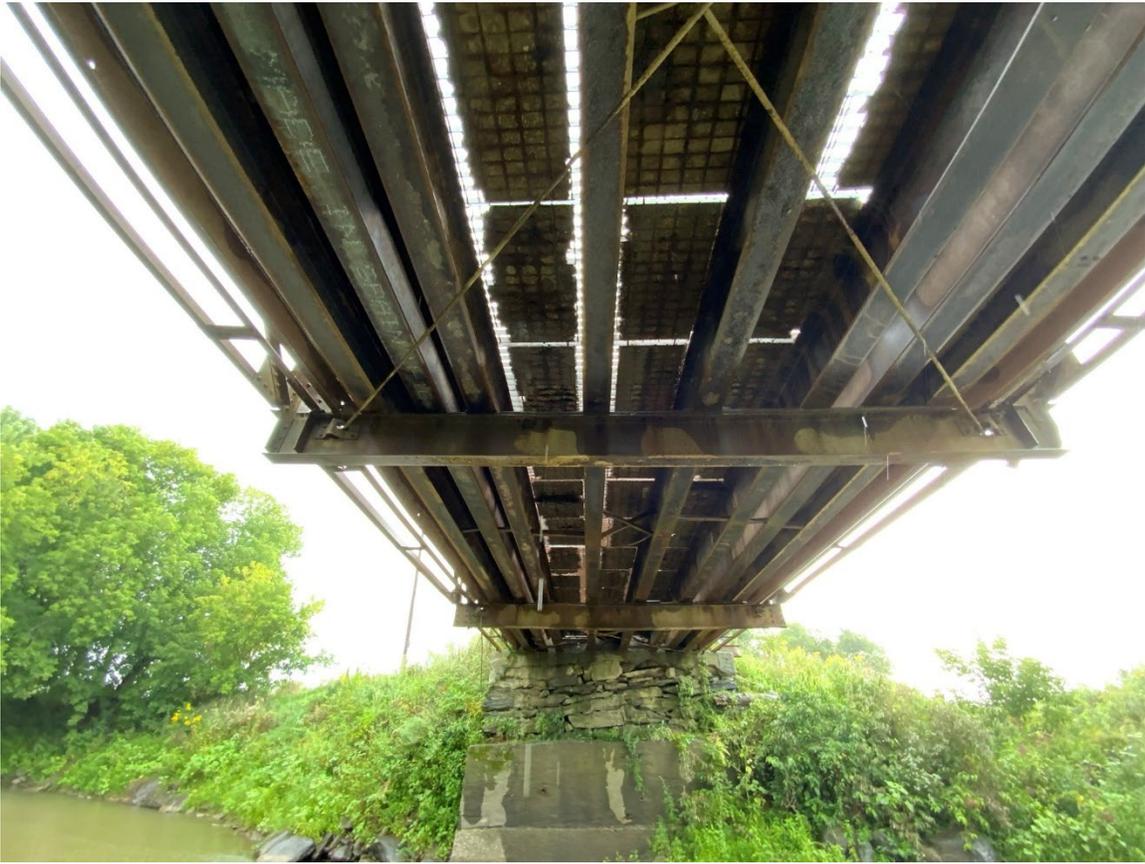
Soffit/Superstructure

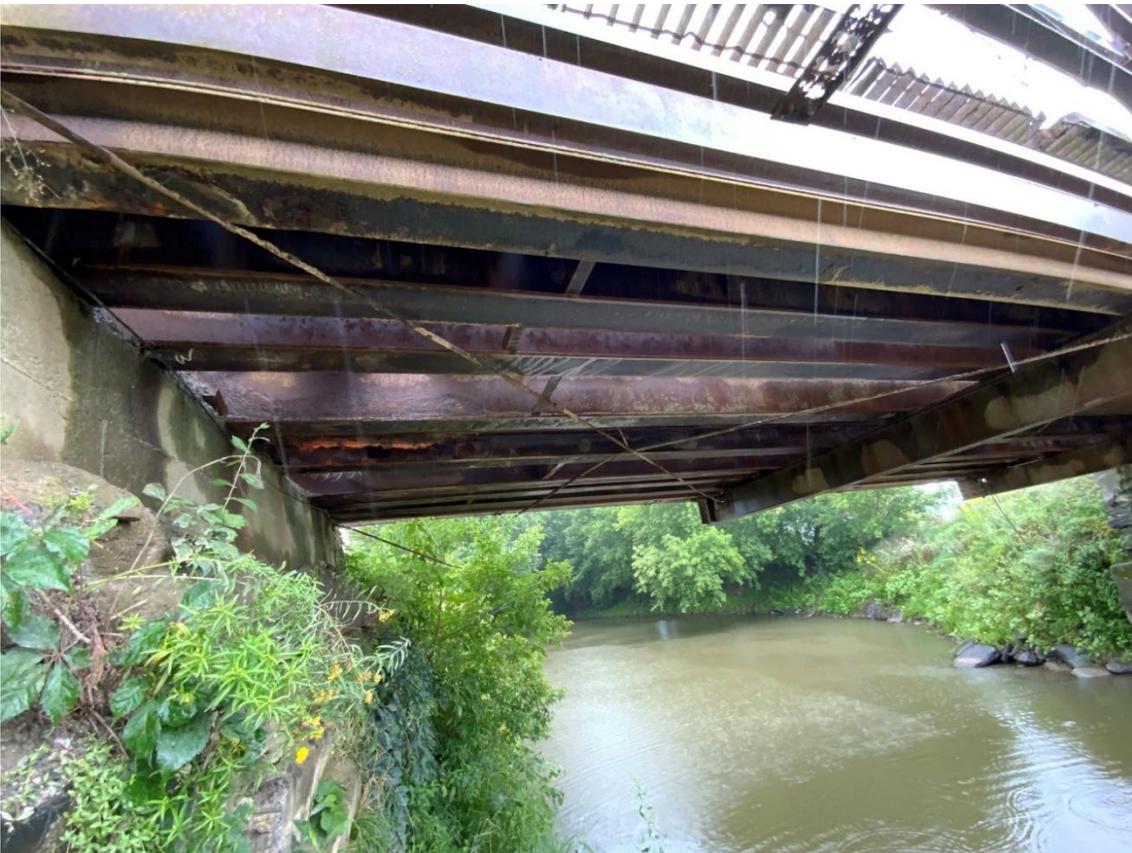
Stringer ends abutment 1

1. The bridge needed replacement since 2018 due to heavy deterioration along the beam ends from sediment buildup and open grid steel deck. In 2020 there were stringer beams added to compensate for the failed stringer ends at abutment 2. During the annual inspection, it was discovered that the lateral bracing has significant sections of loss throughout and some failed members, and the stringers still have section loss in the older stringer ends and large perforations remaining in the abutment 2 beam ends.
2. The shoulder width on Bridge 49 is substandard.
3. Bridge 49 does not span bank full width and has substandard freeboard.

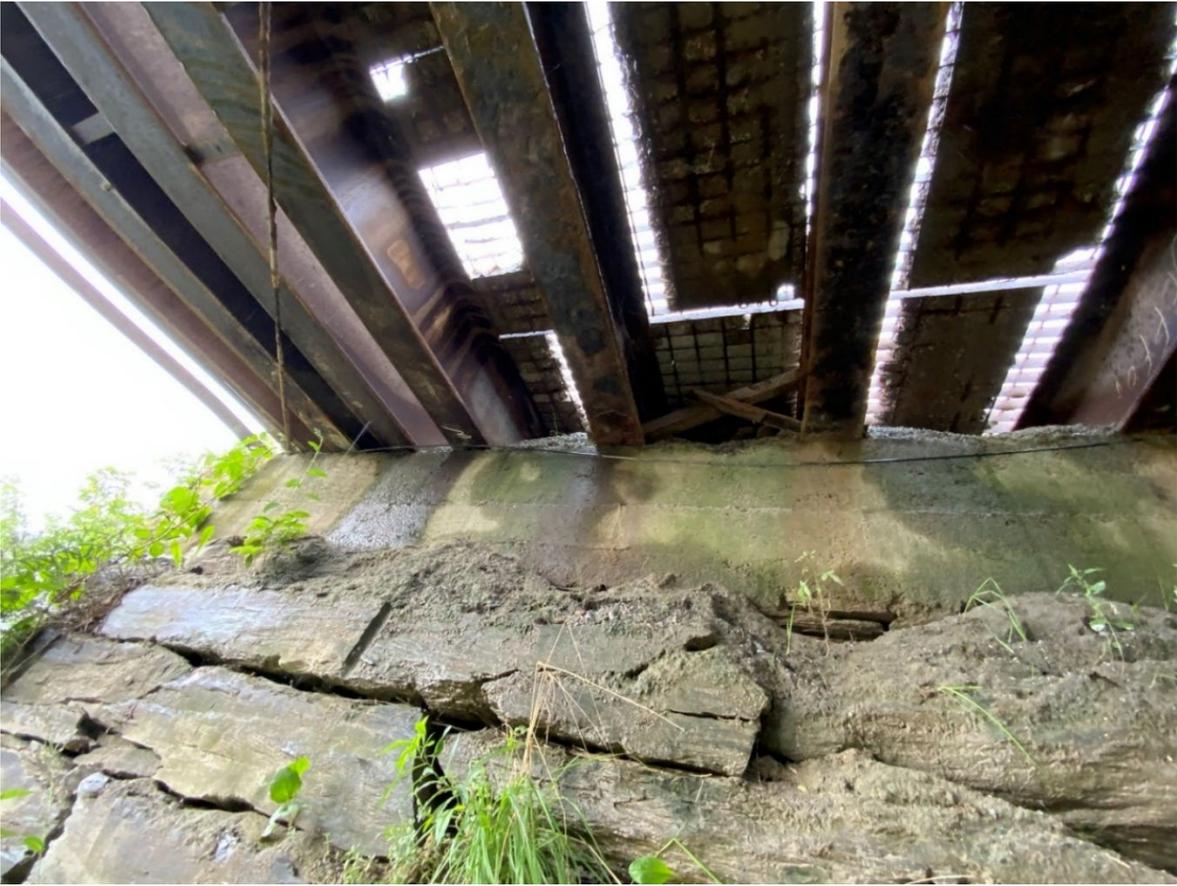
Abutment 1

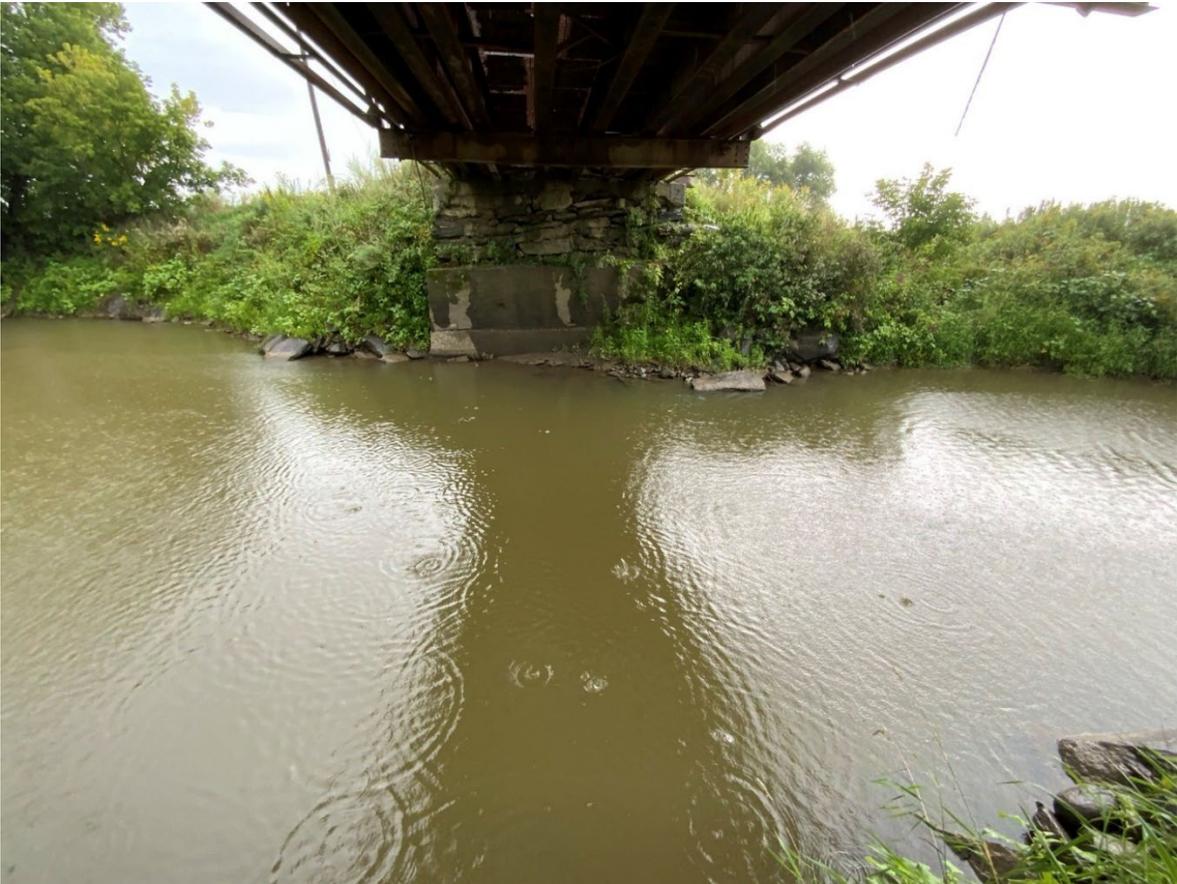
Abutment 2

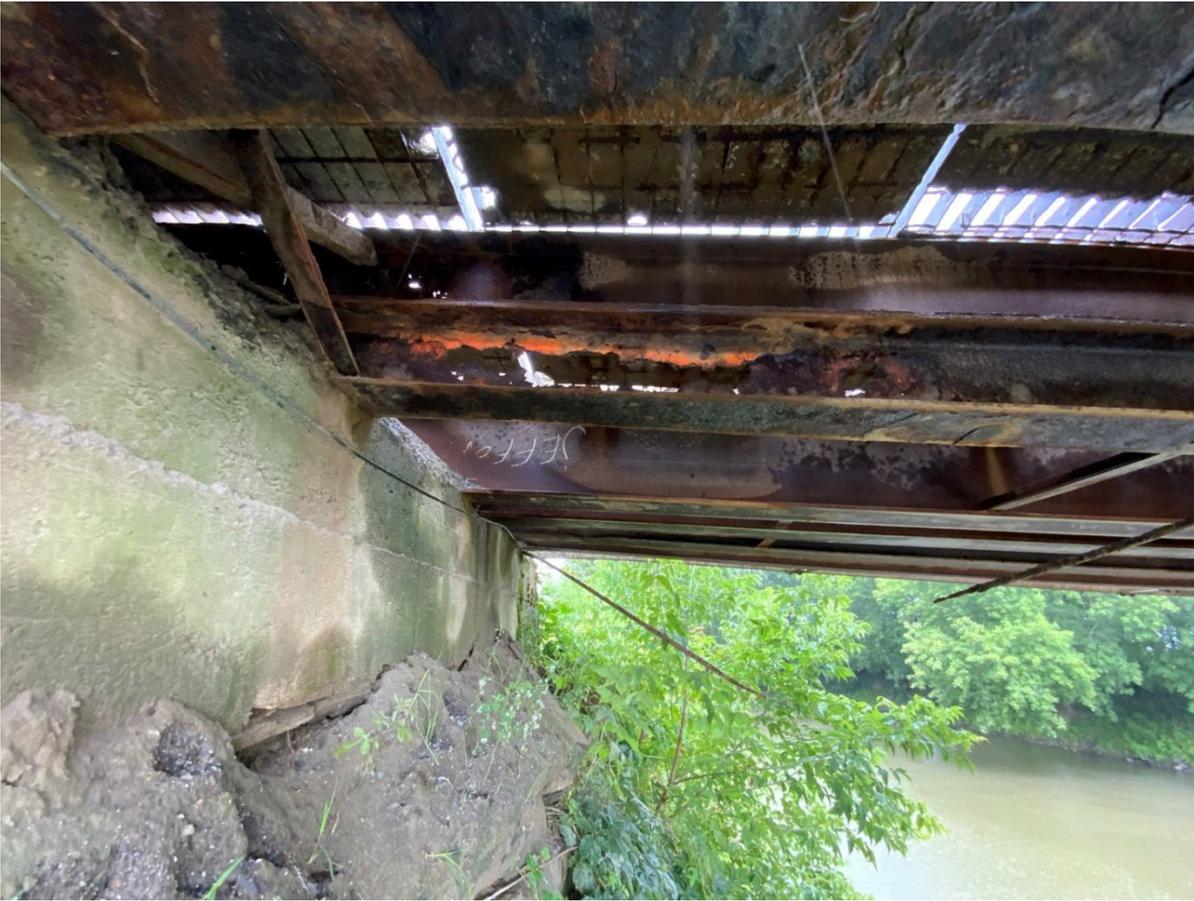
2021 Inspection Finding photo at stringer ends abutment 1.

11/4/2020 – Newly added stringer beams have been installed to compensate for the failed stringer ends at abutment 2, the structure is open, posted for 3 ton, and will be removed from the 12 month cycle. JW/MC
