Jericho BF 0209(10)
Alternatives Presentation Meeting
Town Highway 4/Browns Trace – Bridge 15 over Mill Brook

February 3, 2022

Town Highway 4/Browns Trace – Bridge 15 over Mill Brook

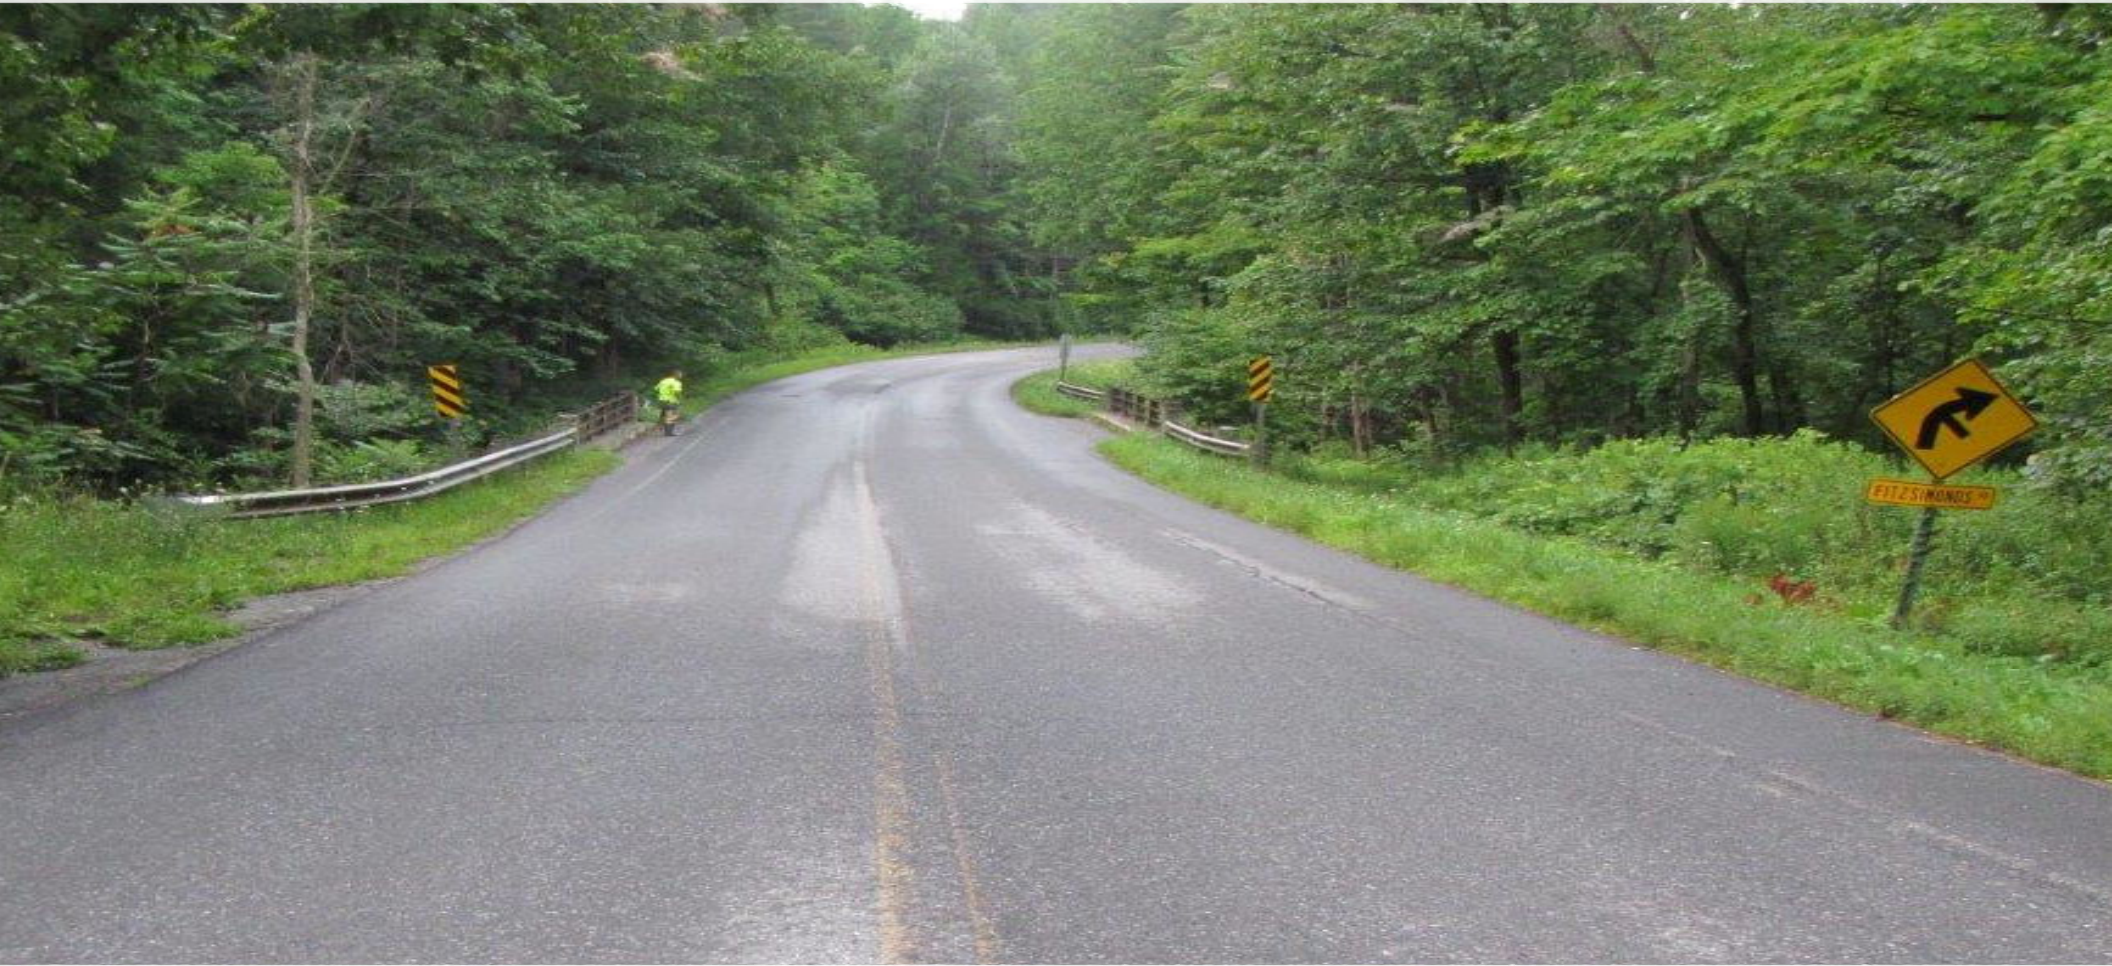
Looking South over Bridge 15

Existing Conditions – Bridge #15

- Roadway Classification – Minor Arterial
- Bridge Type – 38' Span Concrete T-Beam
- Ownership – Town of Jericho
- Constructed in 1927, reconstructed in 1962

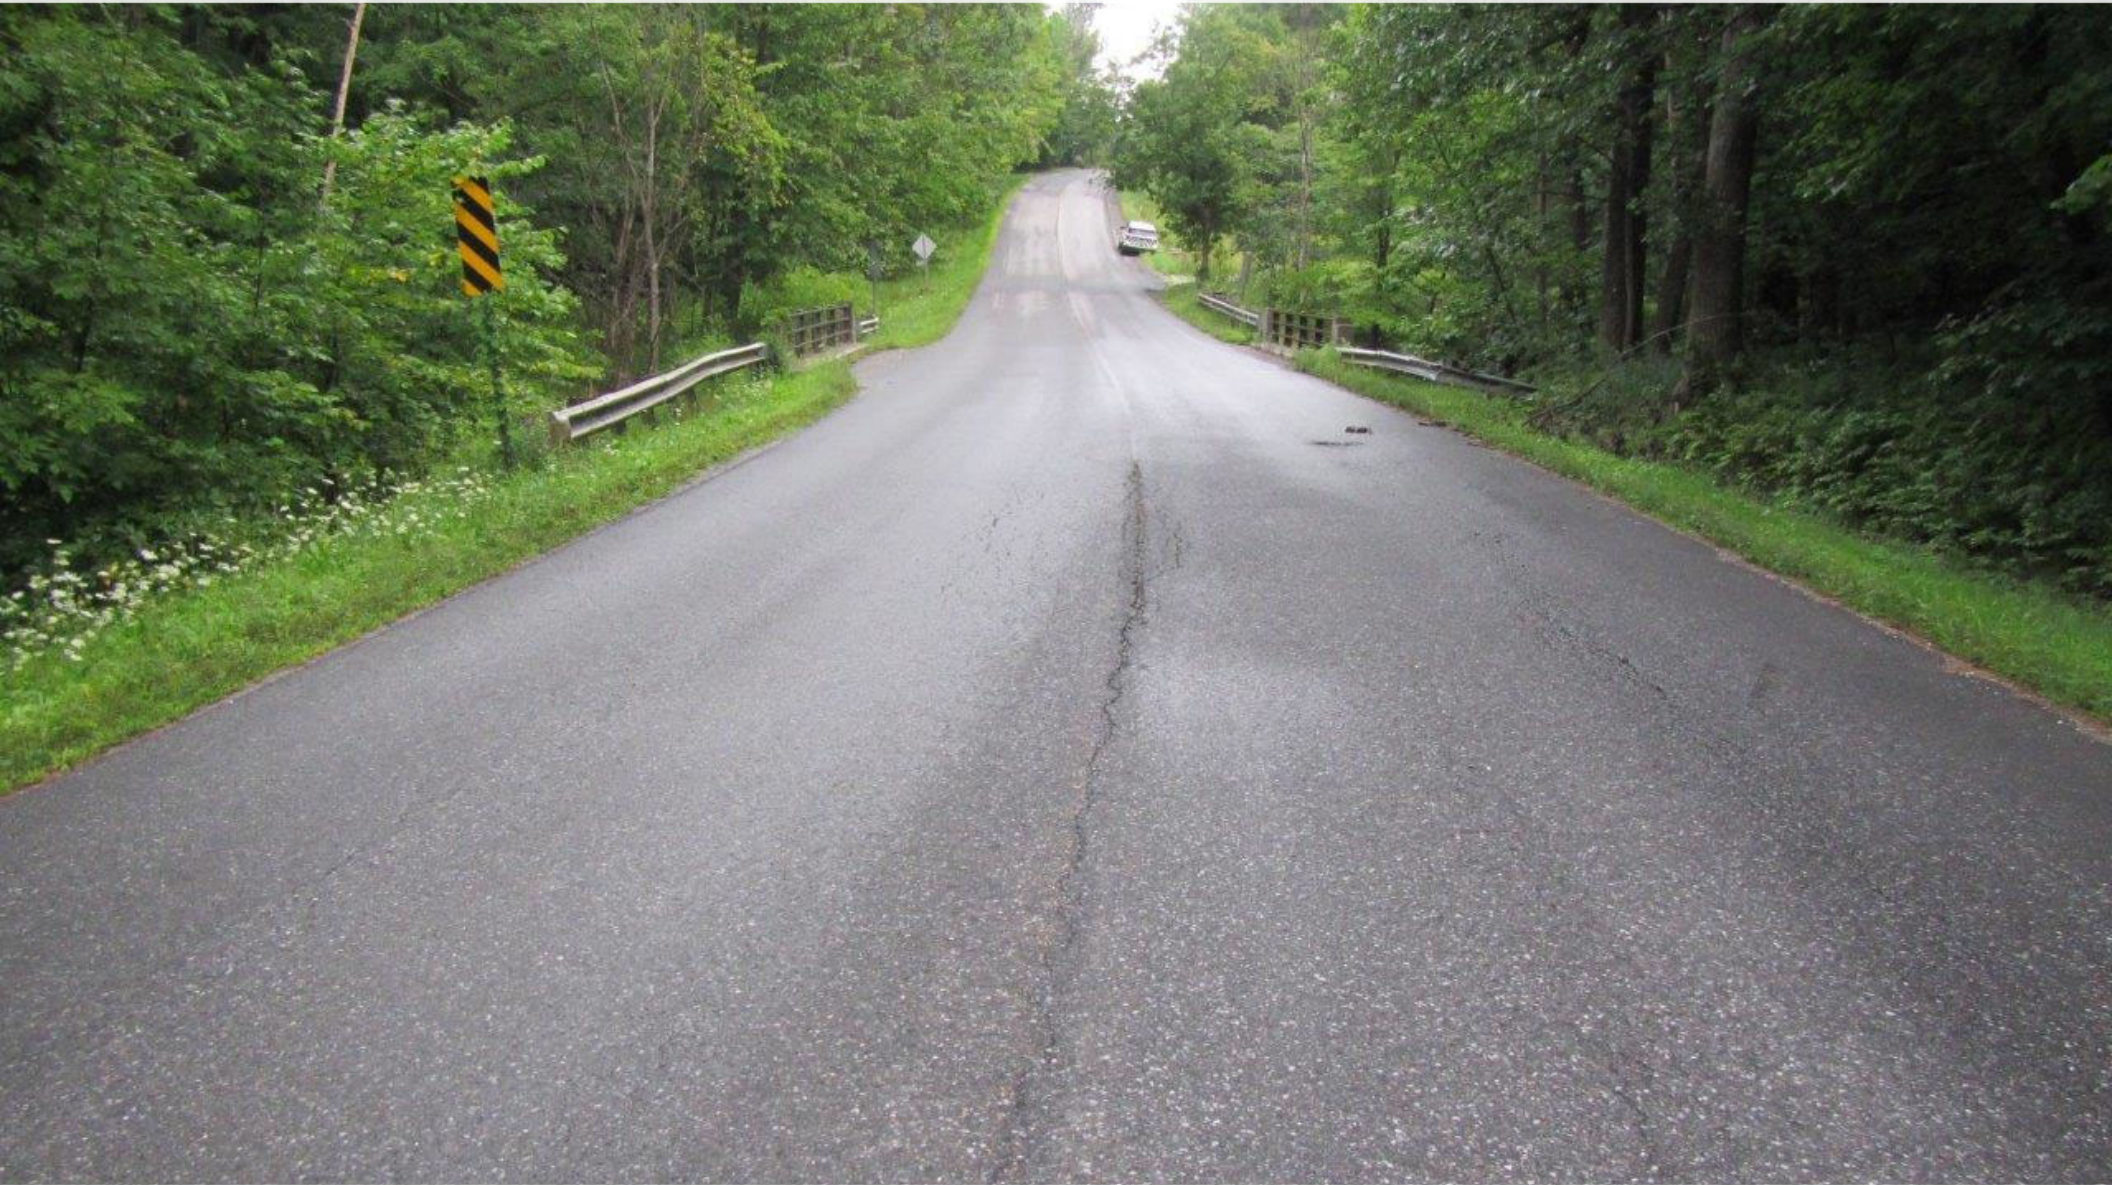
Looking North over Bridge 15

Existing Conditions – Bridge #15

- Utilities (aerial and underground)

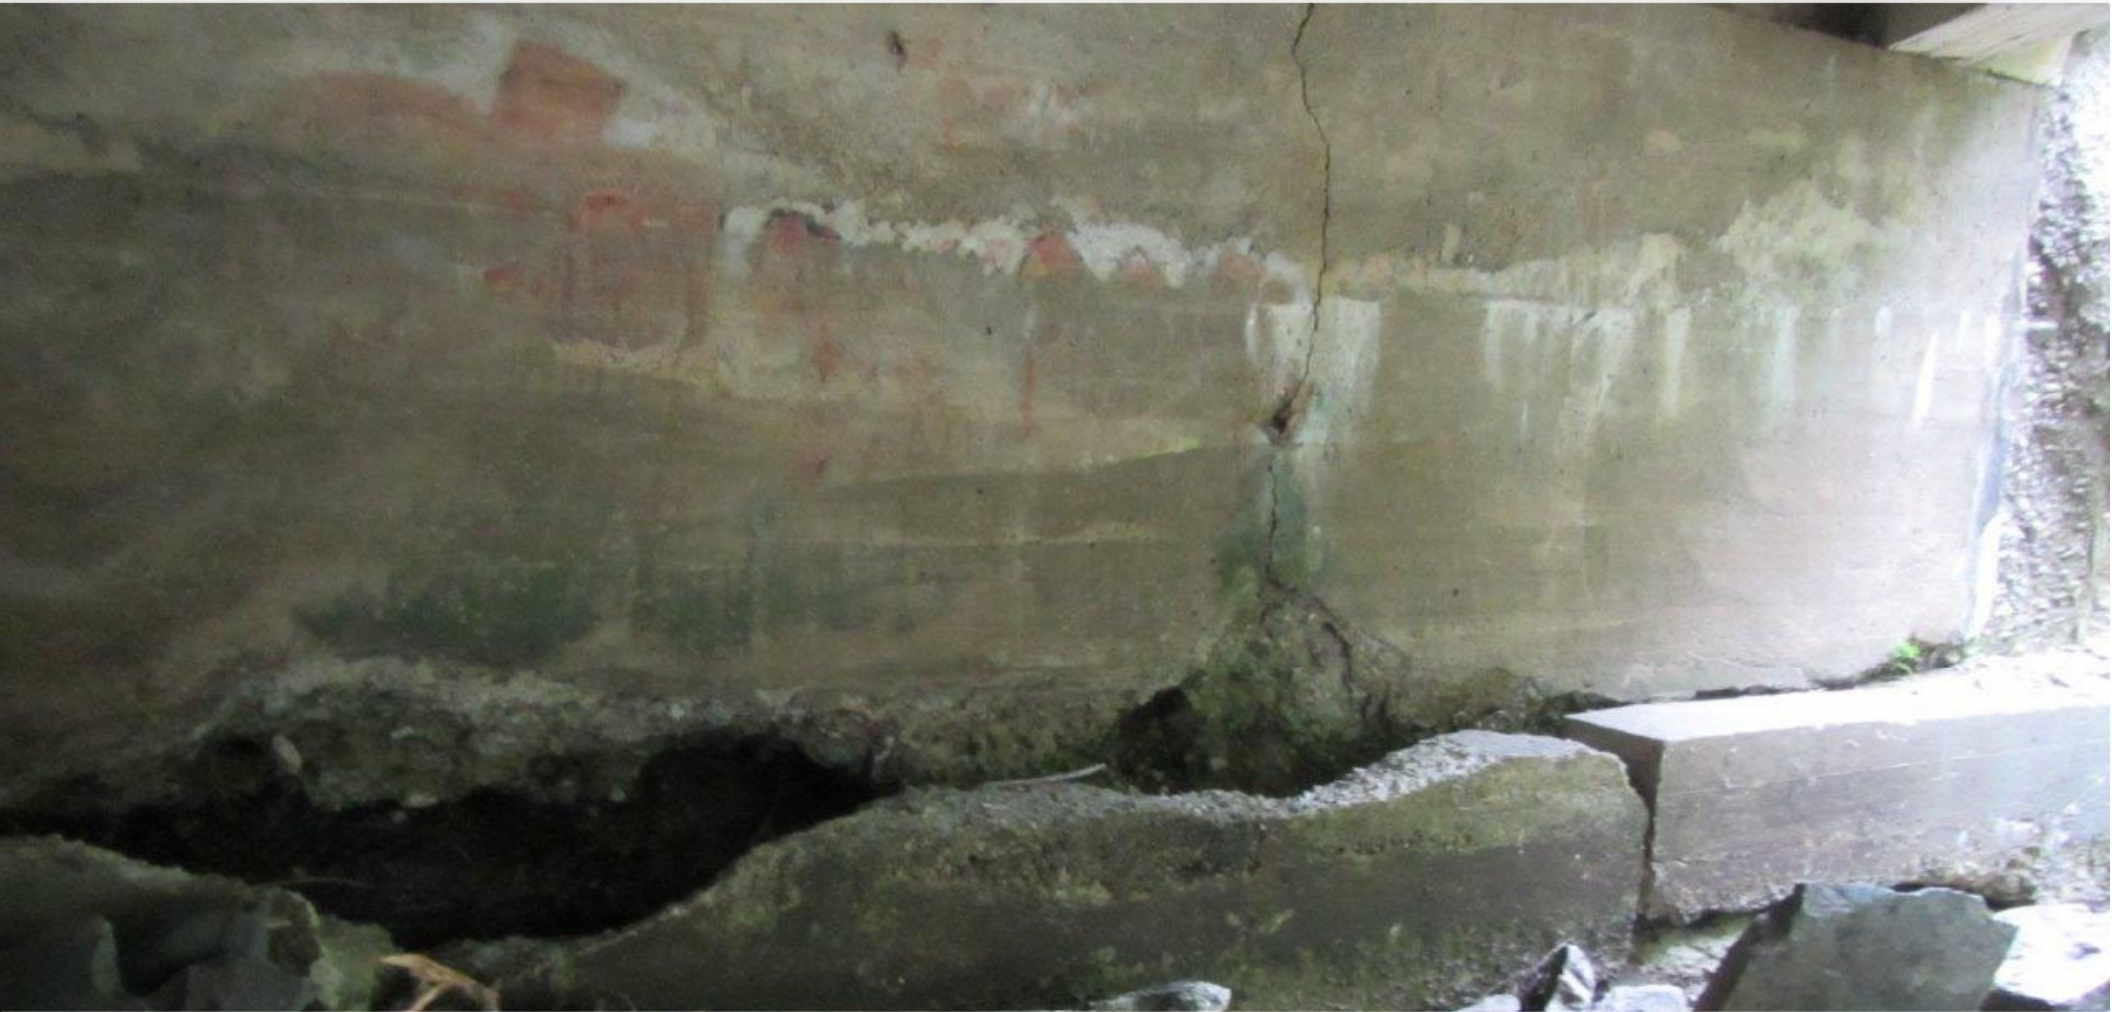
Bridge Inspection Report Ratings

Existing Conditions - Bridge #15

- Deck Rating 6 (Satisfactory)
- Superstructure Rating 5 (Fair)
- Substructure Rating 5 (Fair)

- The T-beams are in fair condition. The middle sistered-up beams have heavy spalling, and the stirrups are rusted through.
- The substructures have poorly rated wingwalls and footings. The southern abutment has severe spalling and scaling along the downstream portion of the abutment stem wall. The footing has deep voids forming in the lower portions of the abutment.
- The sag vertical curve and stopping site distance through the project area are substandard.
- The bridge does not meet the minimum bank full width requirements.

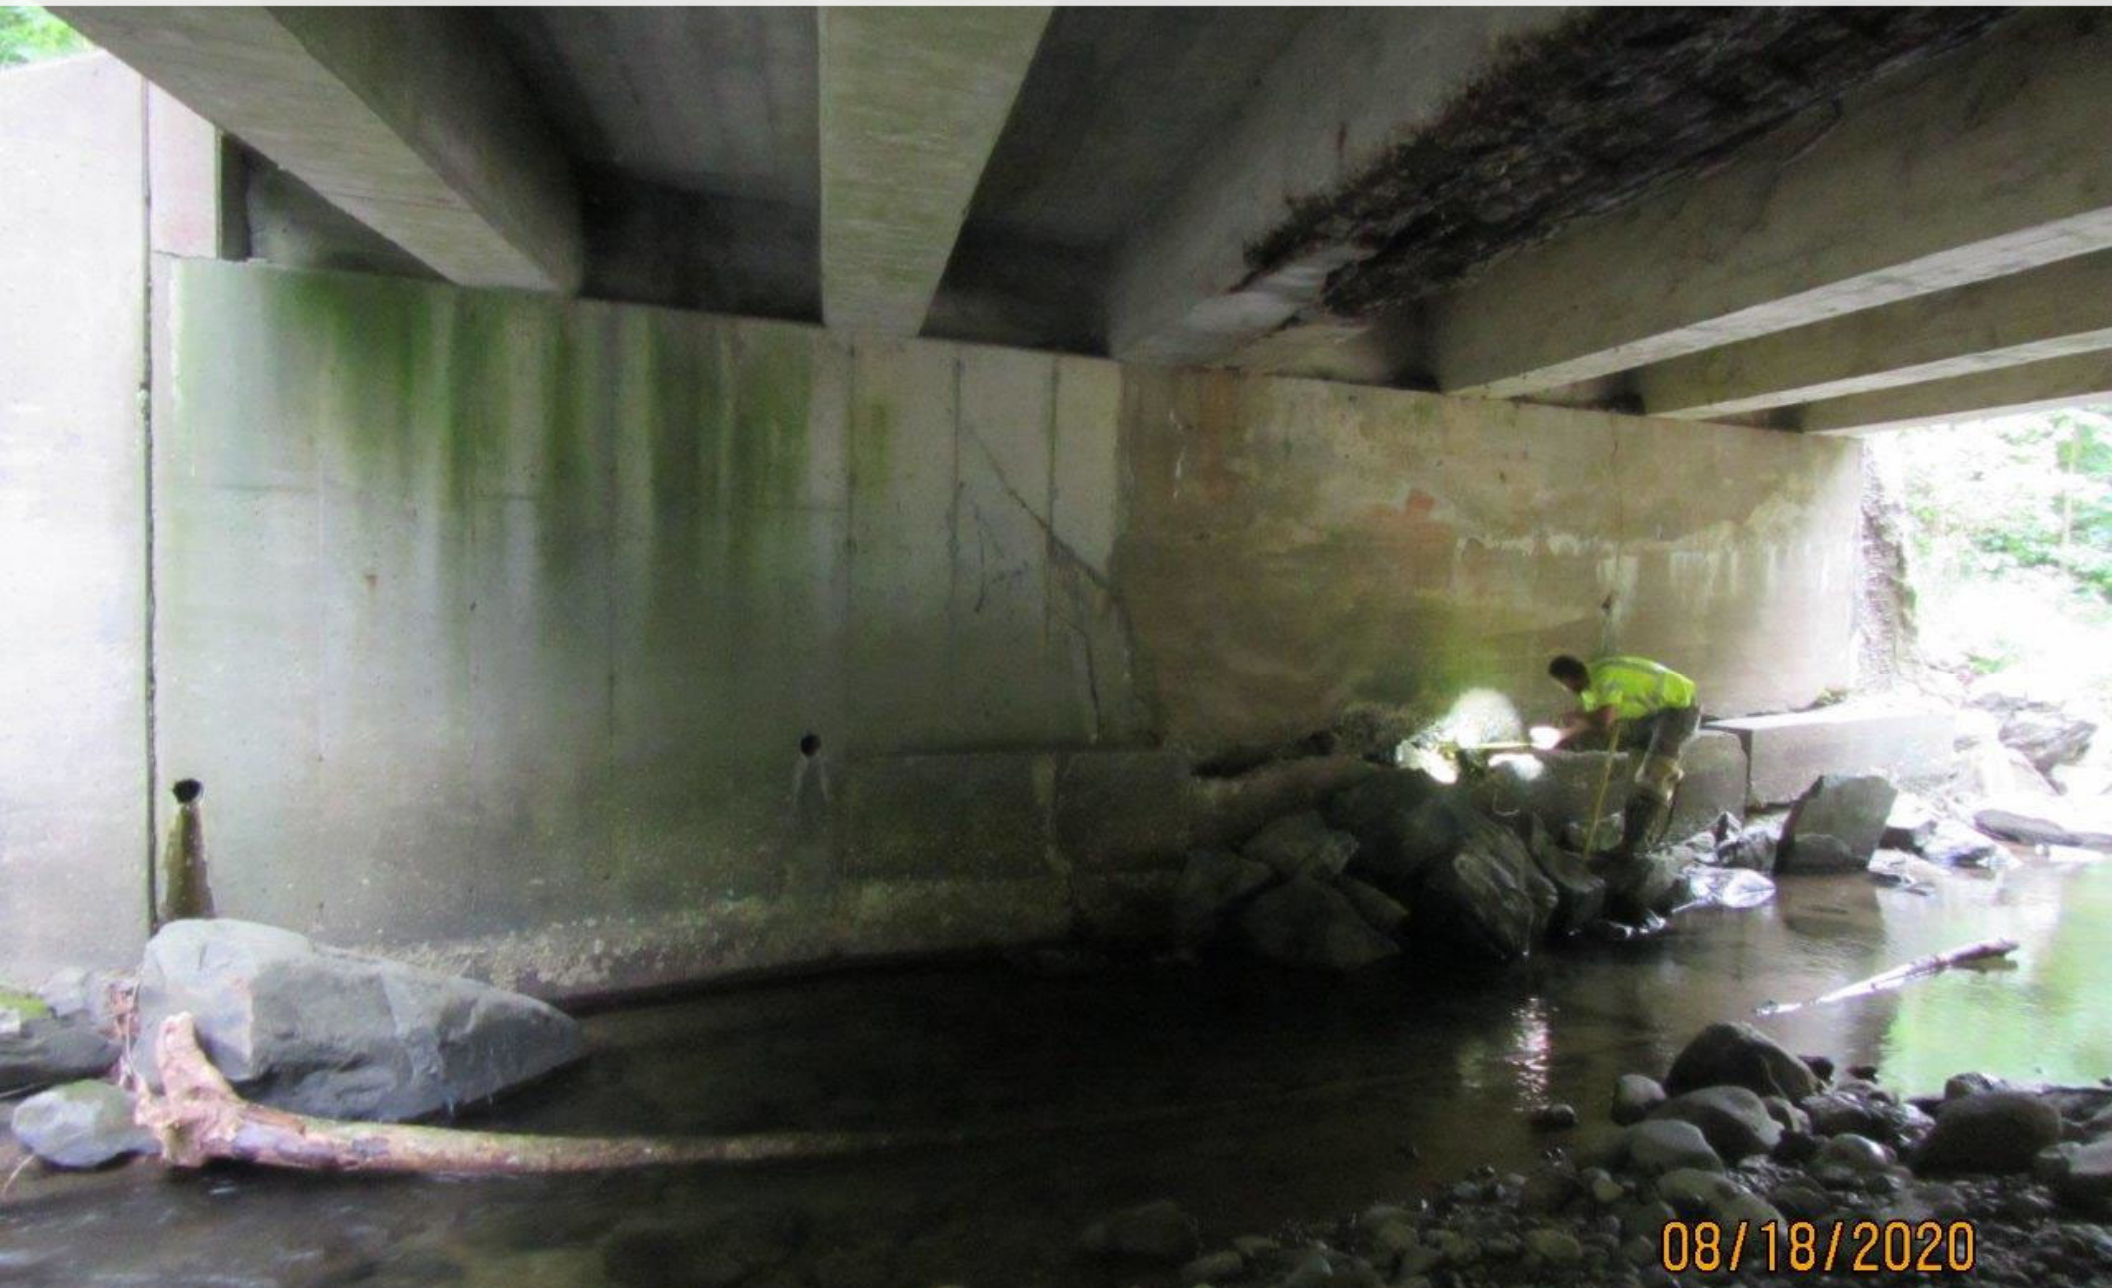
Southern Abutment

Existing Conditions - Bridge #15

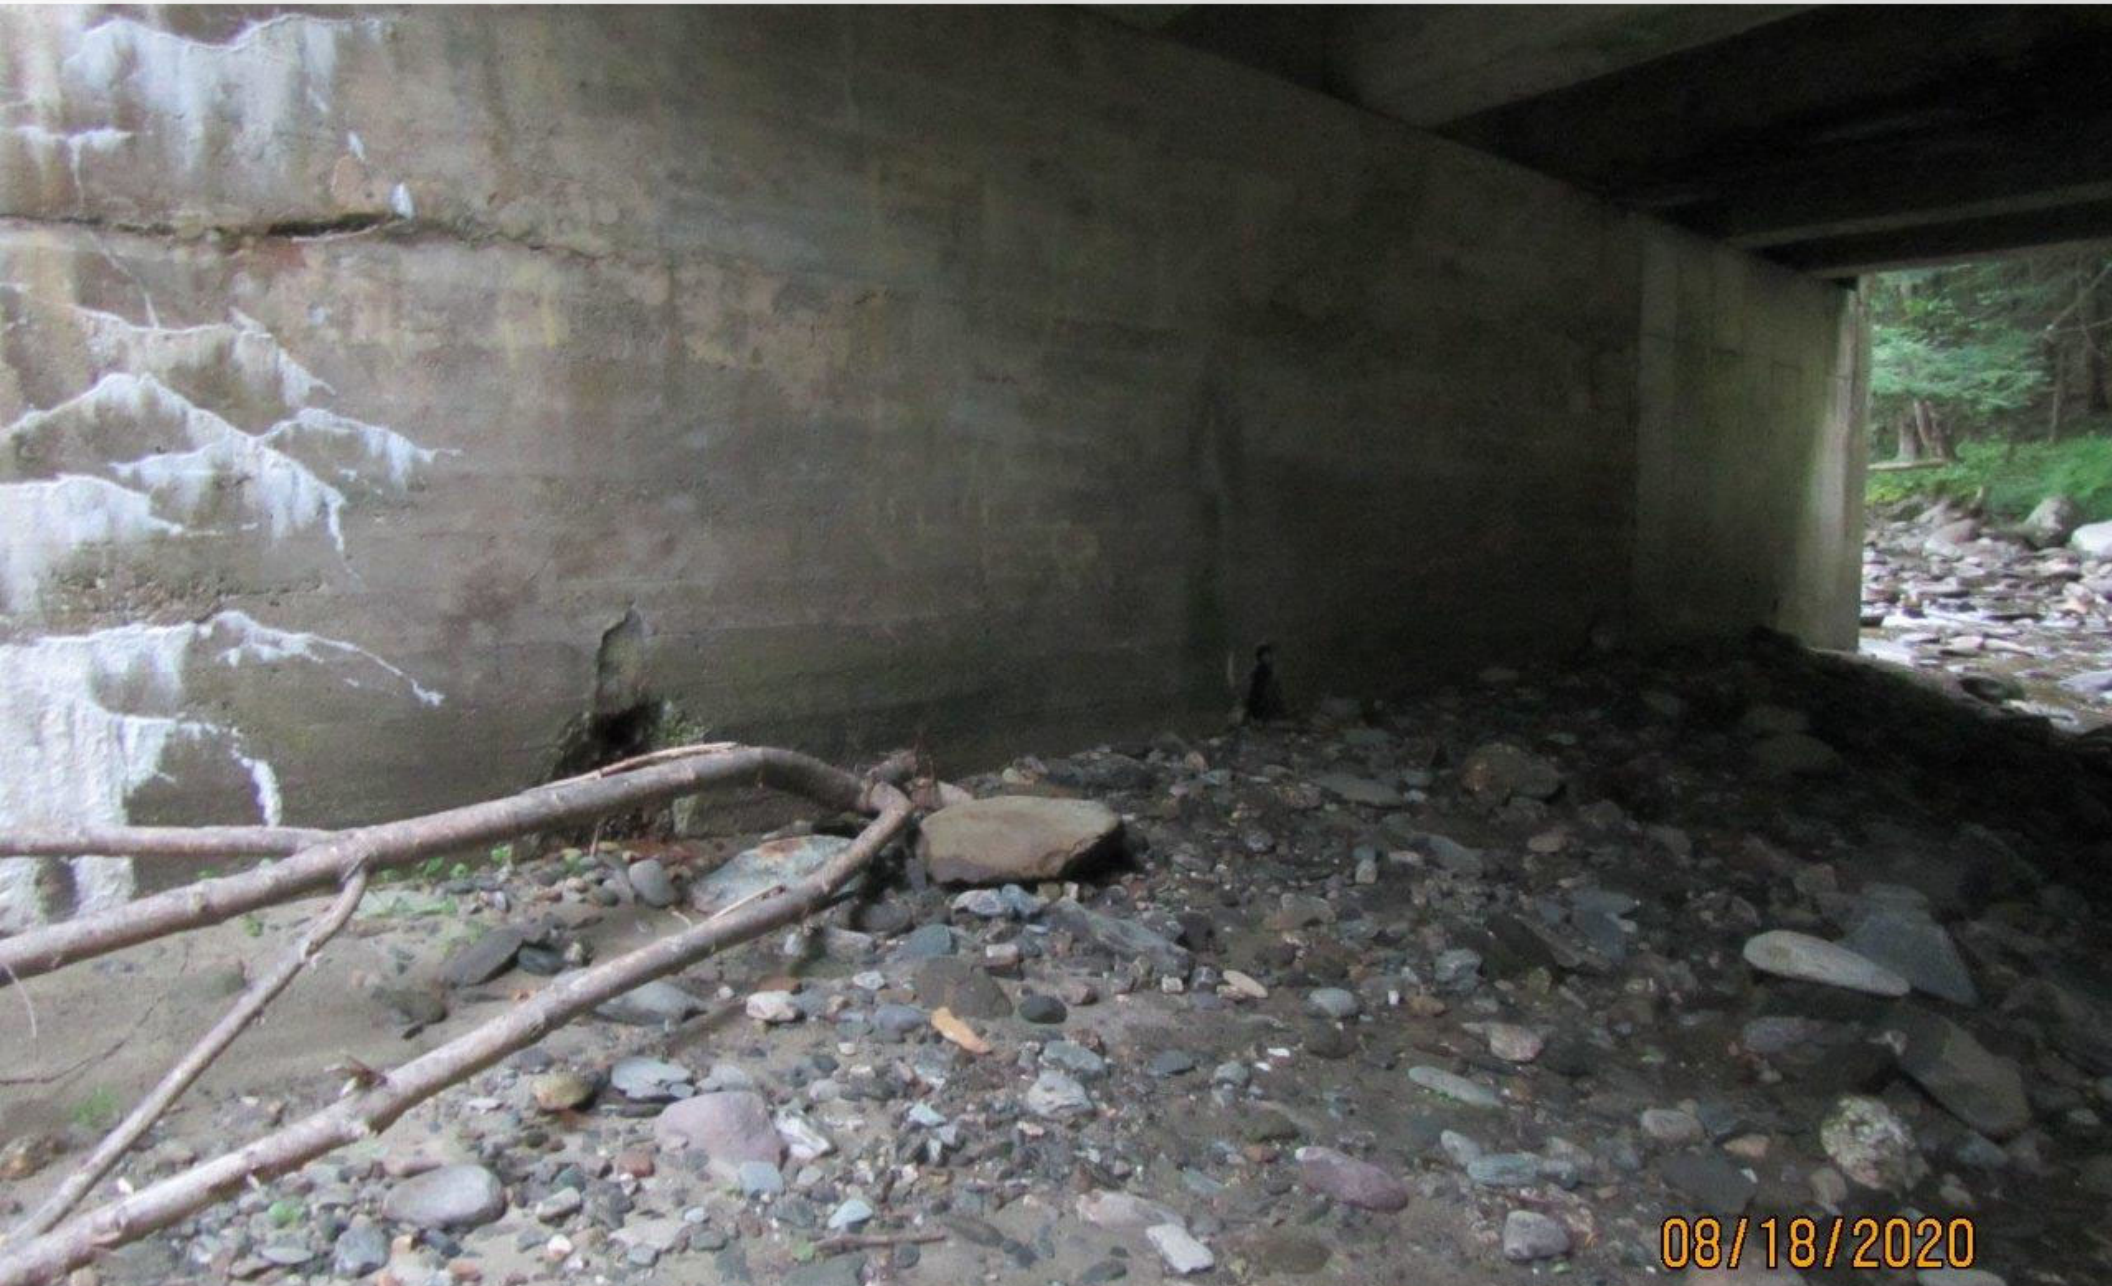
Northern Abutment

Existing Conditions - Bridge #15

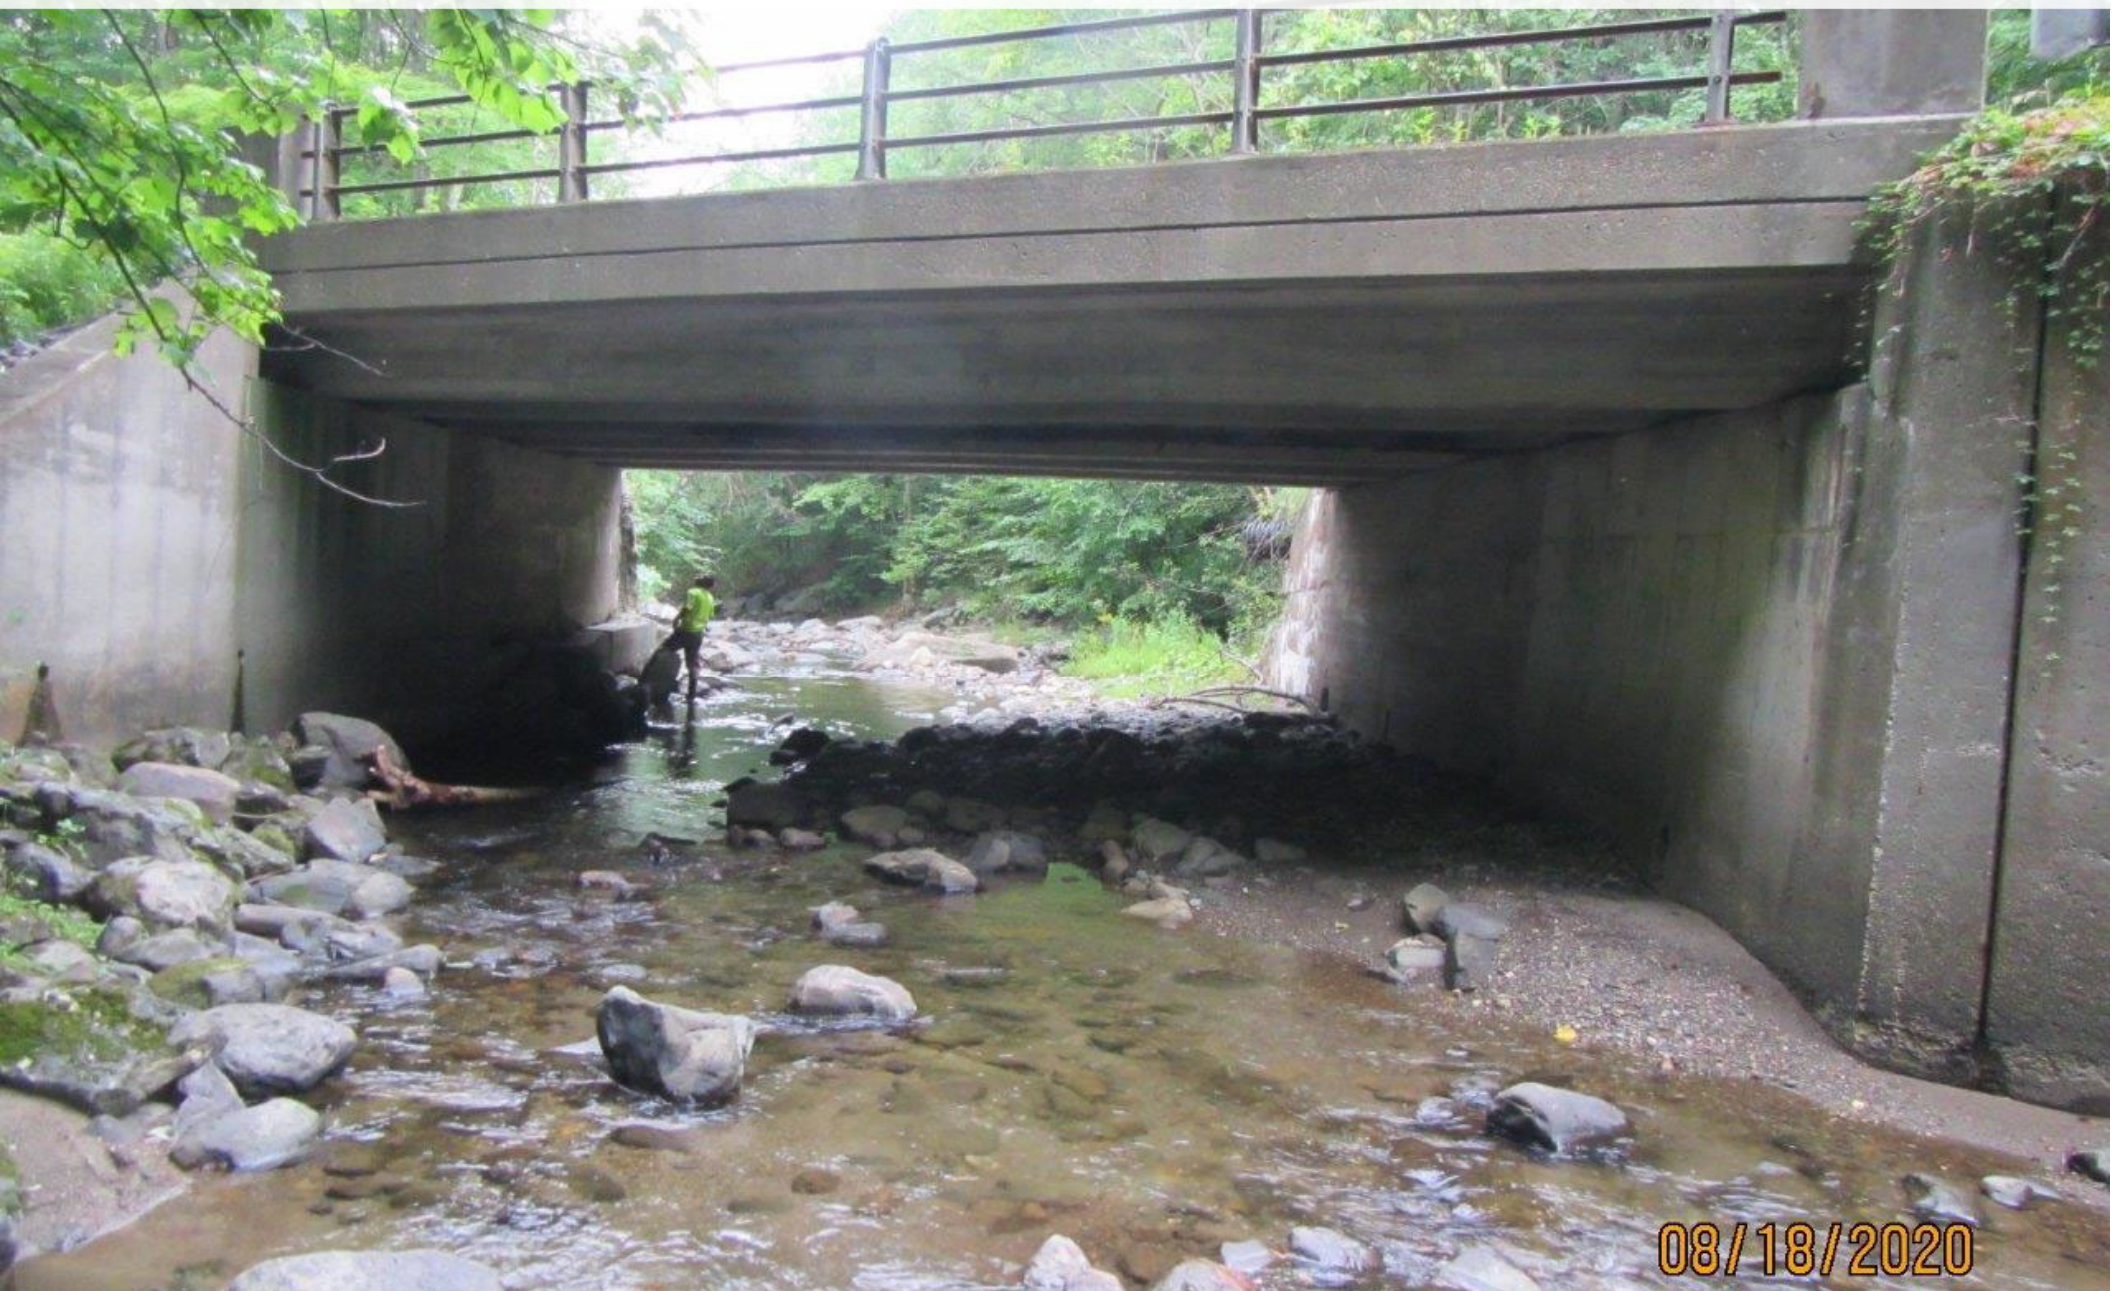
Upstream Fascia

Existing Conditions - Bridge #15

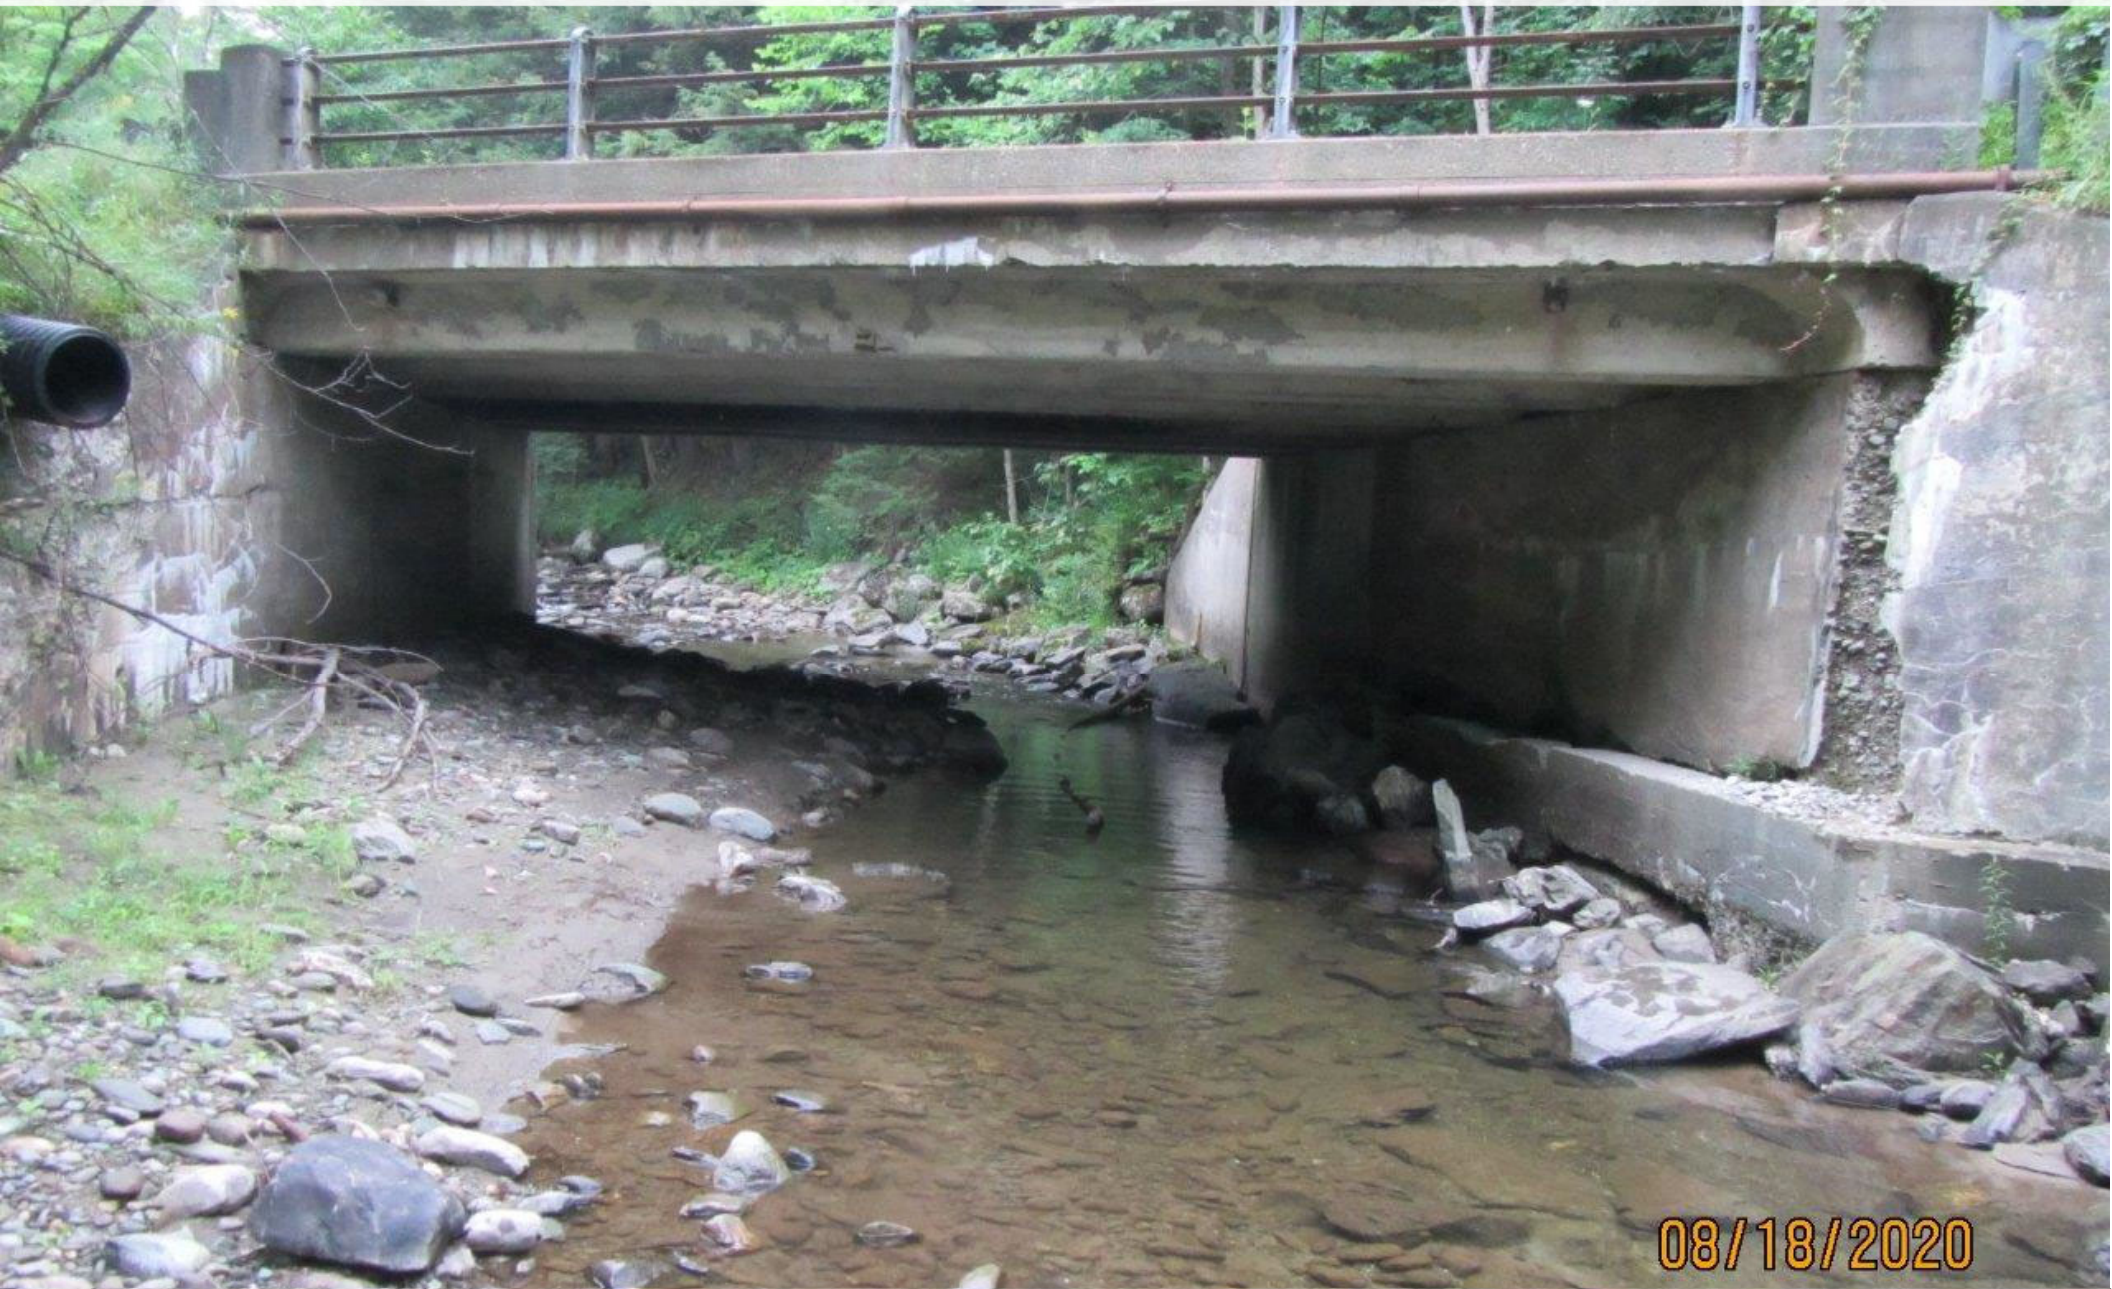
Downstream Fascia

Existing Conditions - Bridge #15

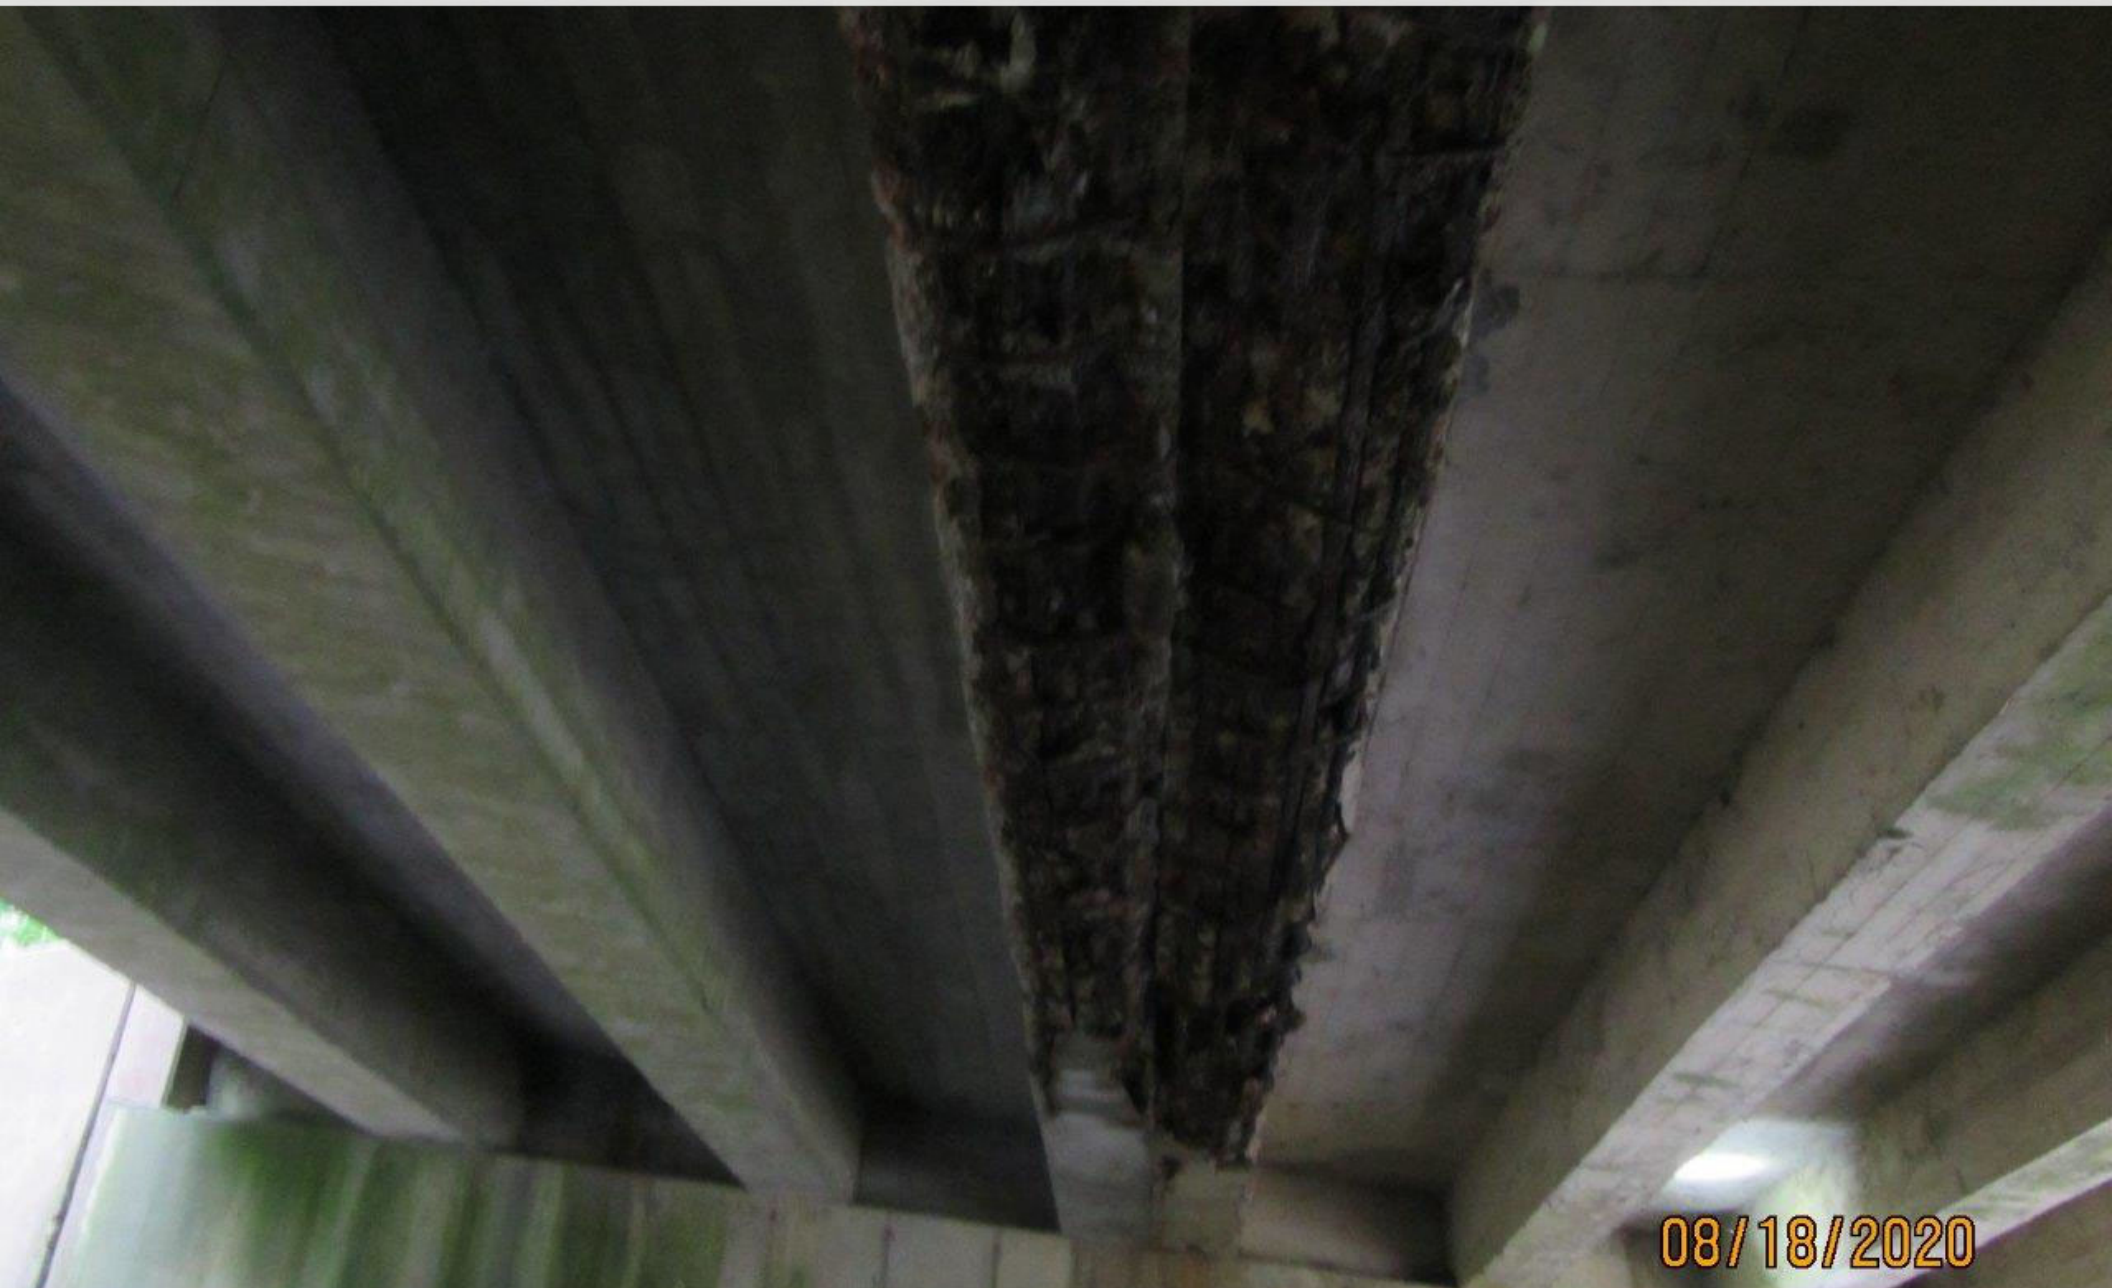
Sistered Up Concrete T-Beam

Existing Conditions - Bridge #15
