Jericho BF 0209(10)
Alternatives Presentation Meeting
Town Highway 4/Browns Trace – Bridge 15 over Mill Brook

February 3, 2022

Town Highway 4/Browns Trace – Bridge 15 over Mill Brook

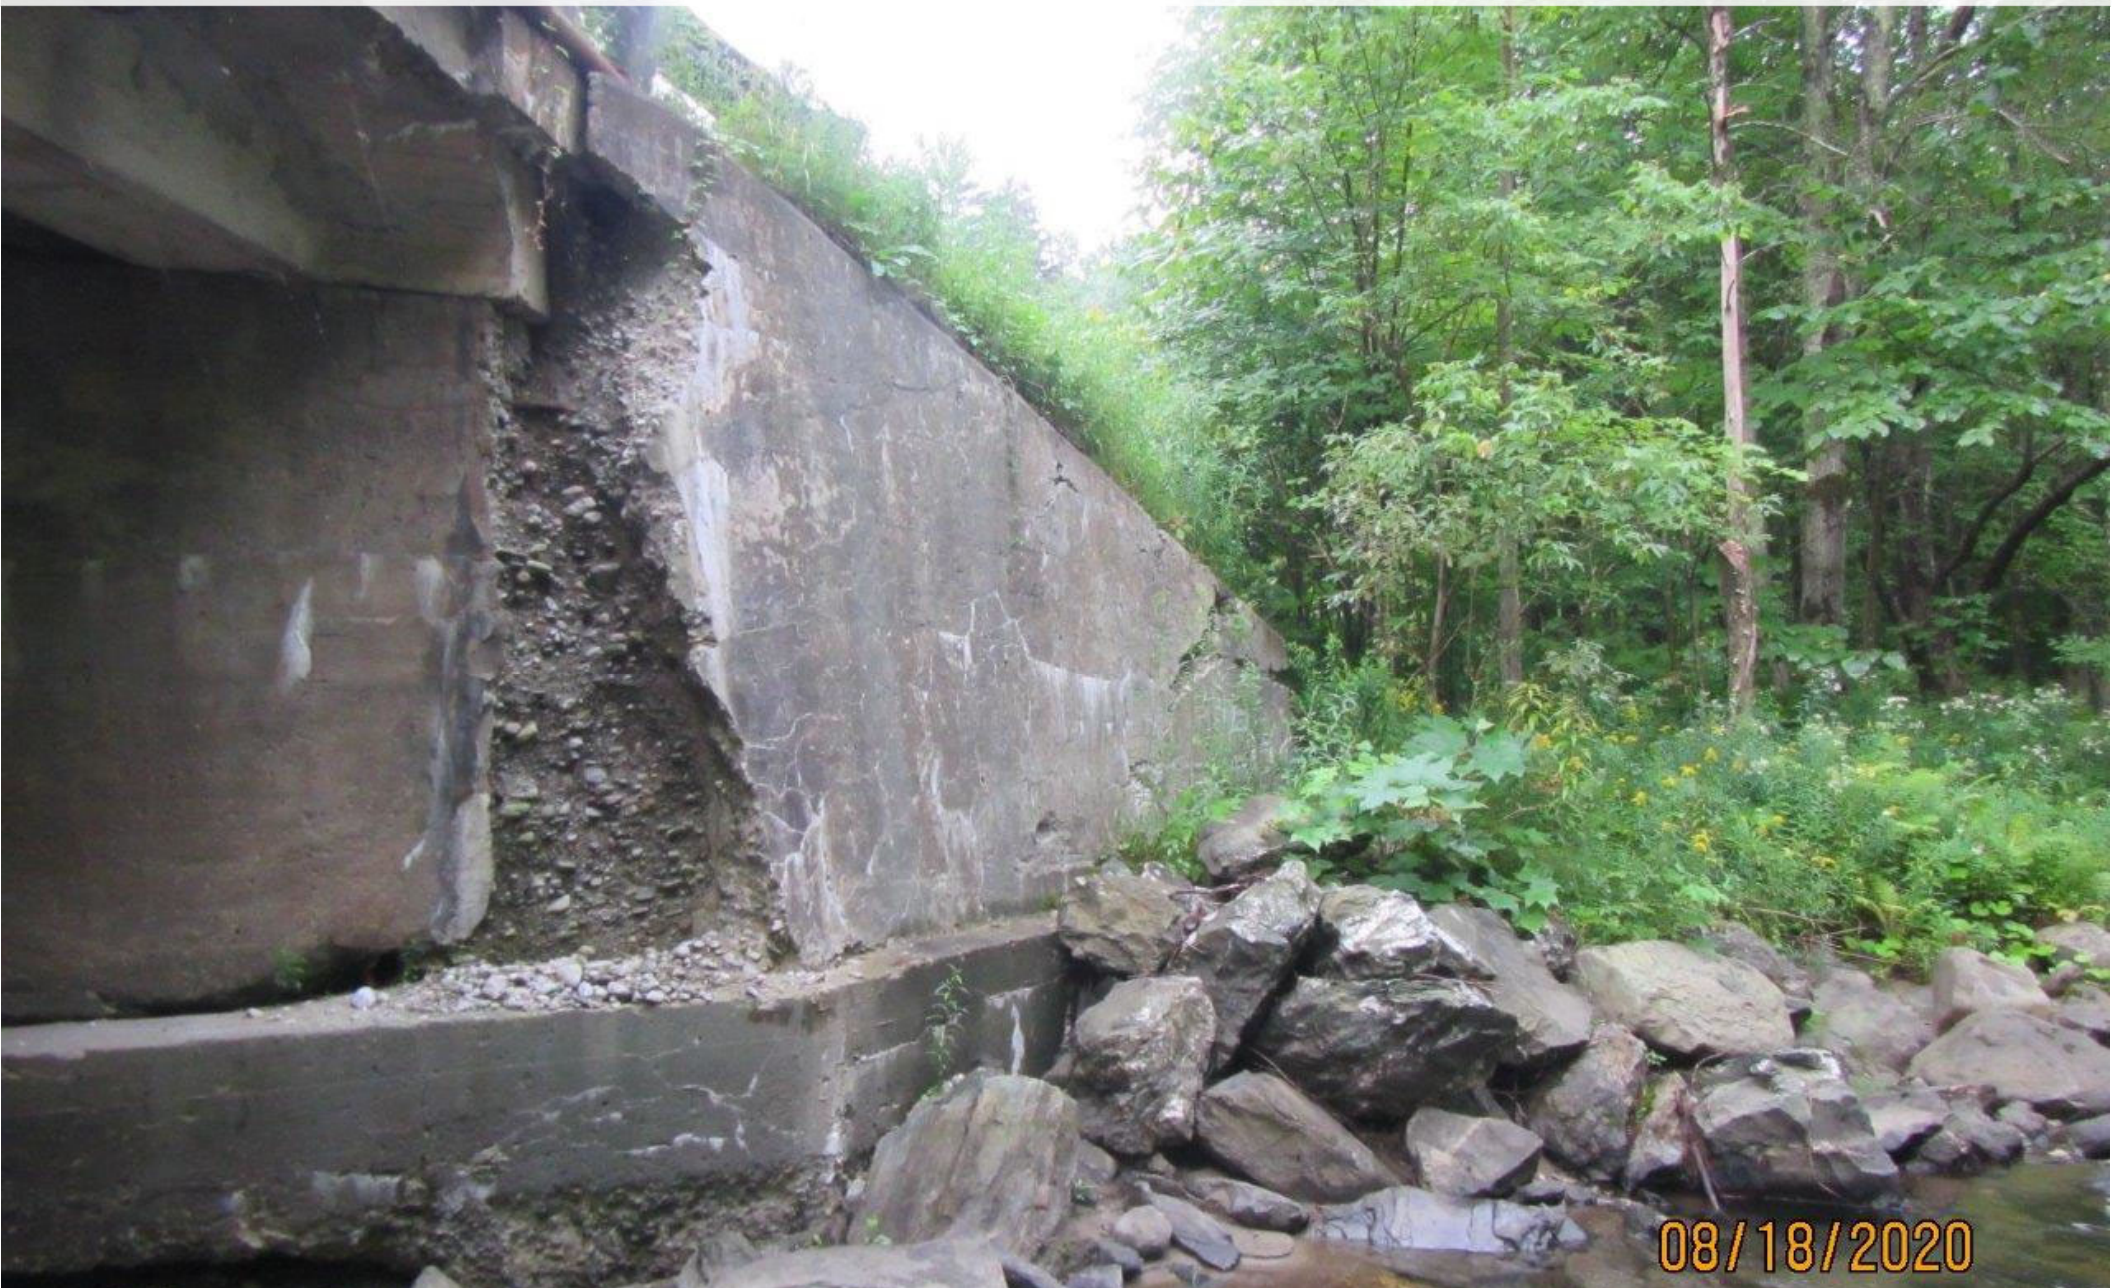
Spalling at Southwest Wingwall

Existing Conditions - Bridge #15

- The T-beams are in fair condition. The middle sistered-up beams have heavy spalling, and the stirrups are rusted through.
- The substructures have poorly rated wingwalls and footings. The southern abutment has severe spalling and scaling along the downstream portion of the abutment stem wall. The footing has deep voids forming in the lower portions of the abutment.
- The sag vertical curve and stopping site distance through the project area are substandard.
- The bridge does not meet the minimum bank full width requirements.

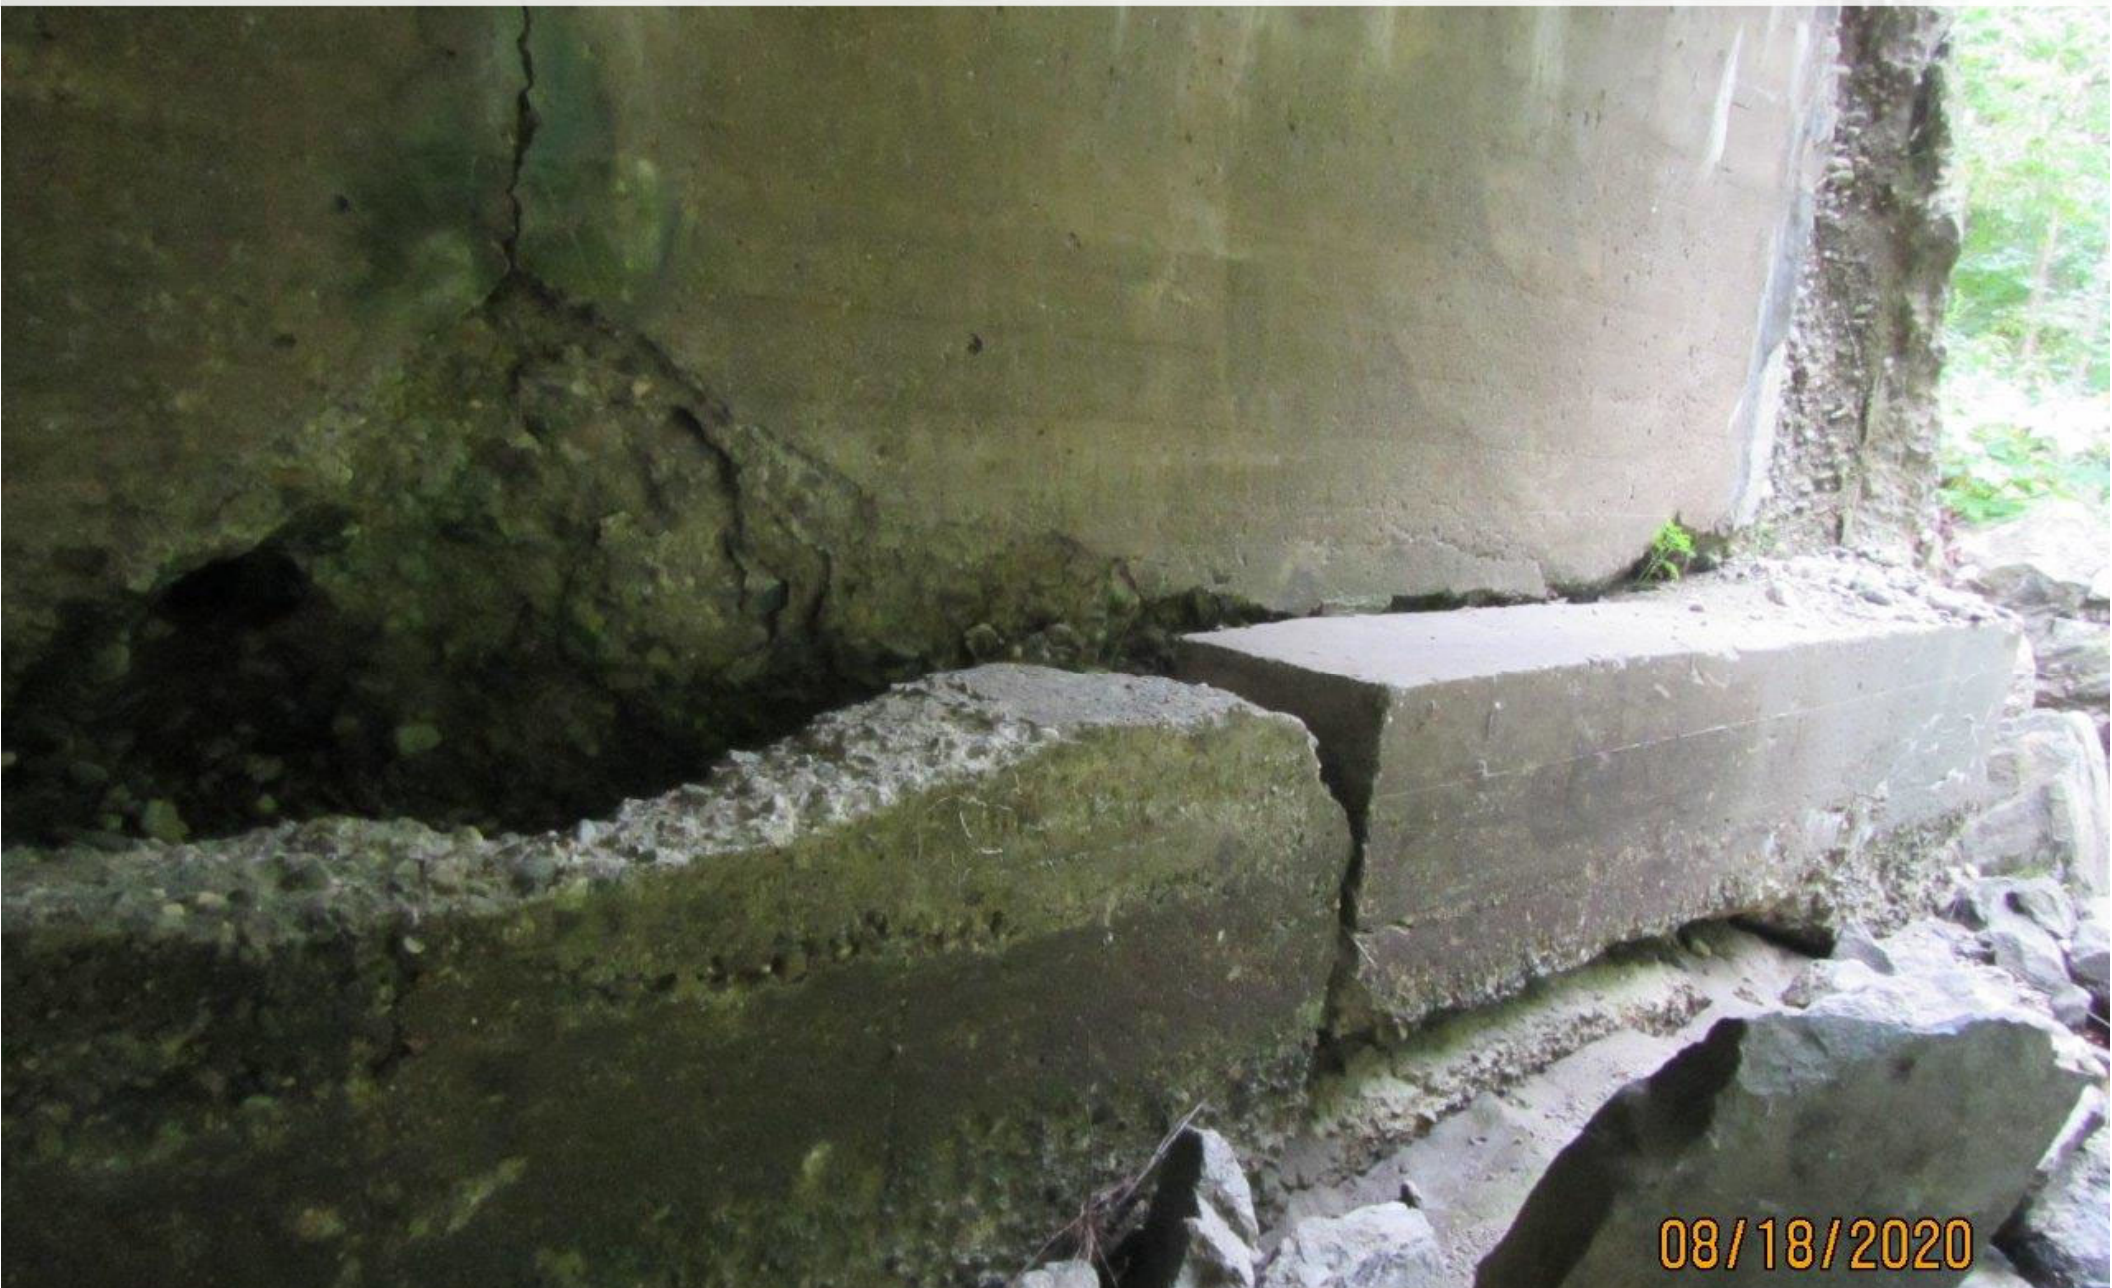
Voids at Southern Abutment Footing

Existing Conditions - Bridge #15

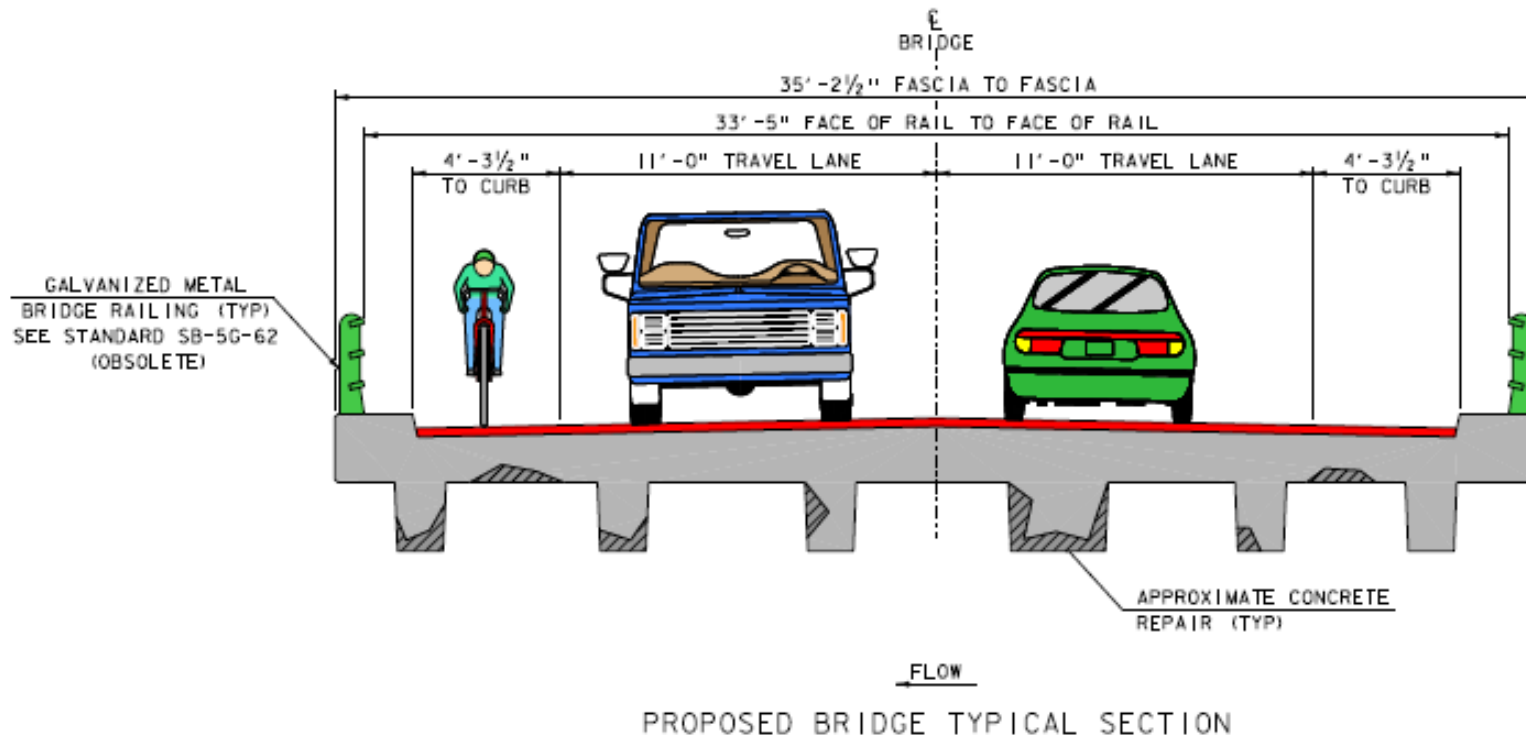
Alternative 1 Typical Section

Minor Rehabilitation - Bridge #15

- Deterioration issues addressed
- Substandard bridge railing not addressed

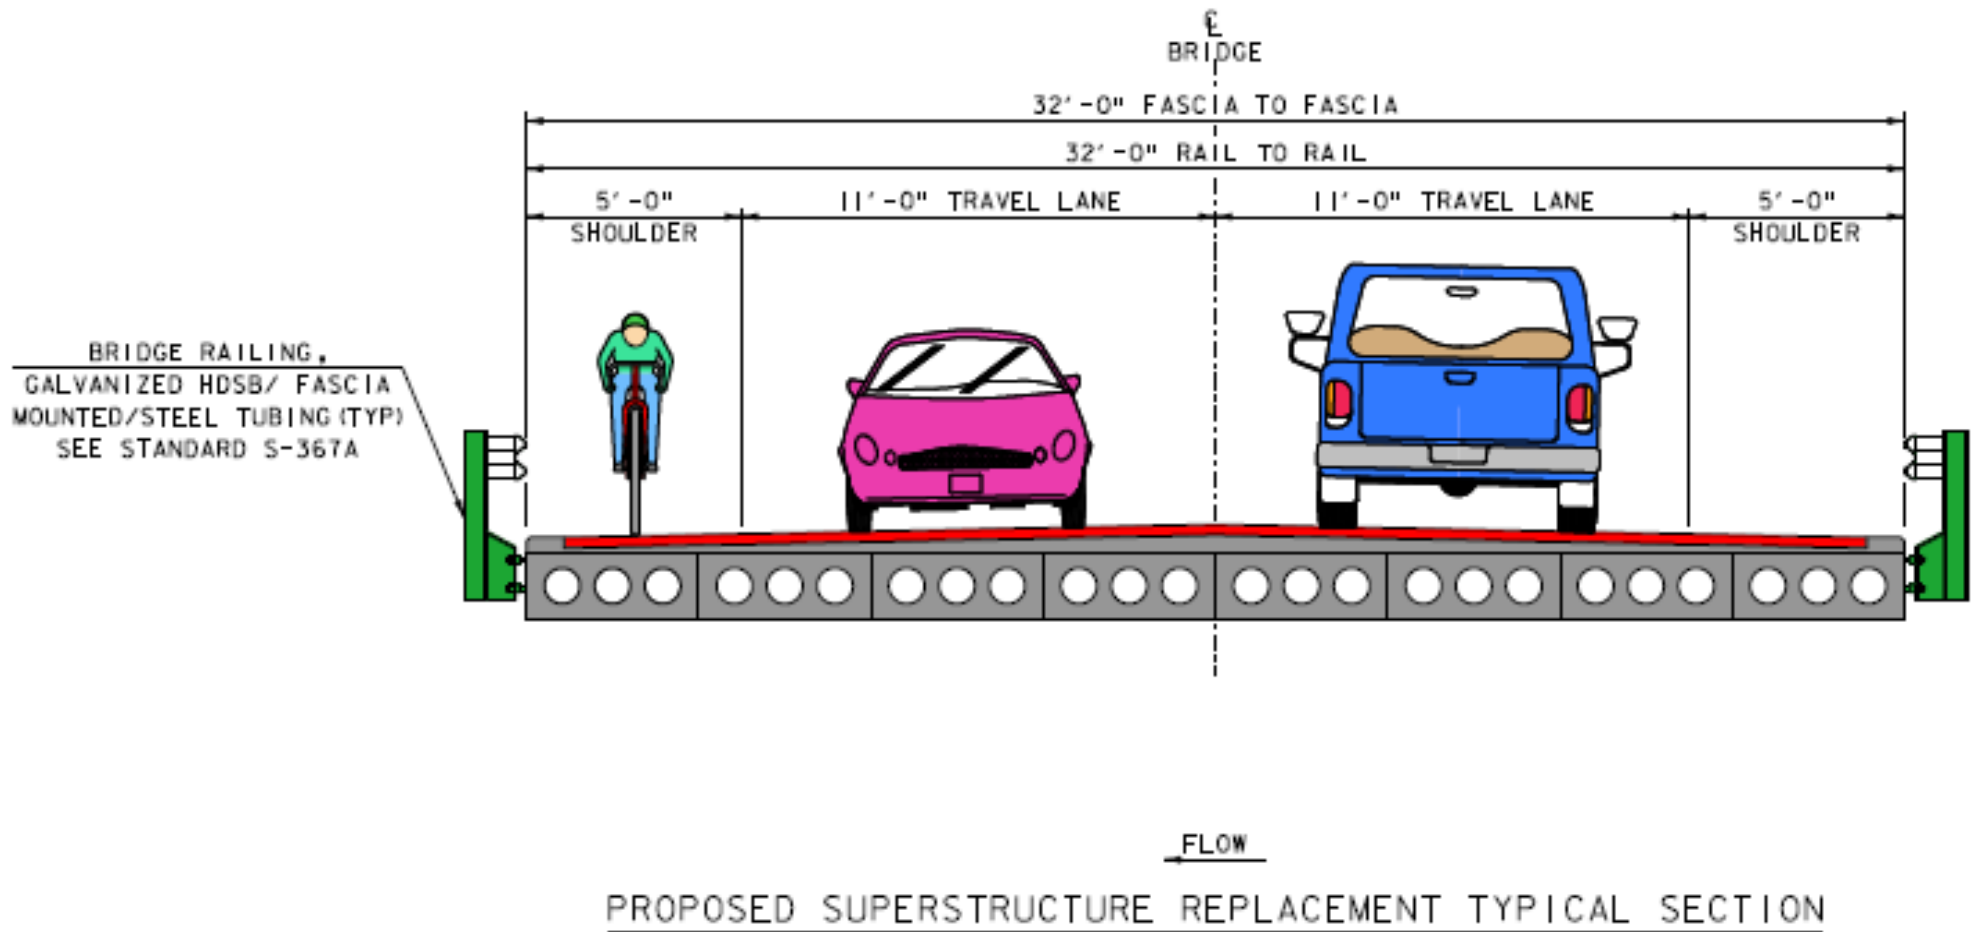
Alternative 2 Typical Section

Superstructure Replacement - Bridge #15

- New deck, railings, and superstructure
- Maintains minimum standard bridge width (5'-11'-11'-5')

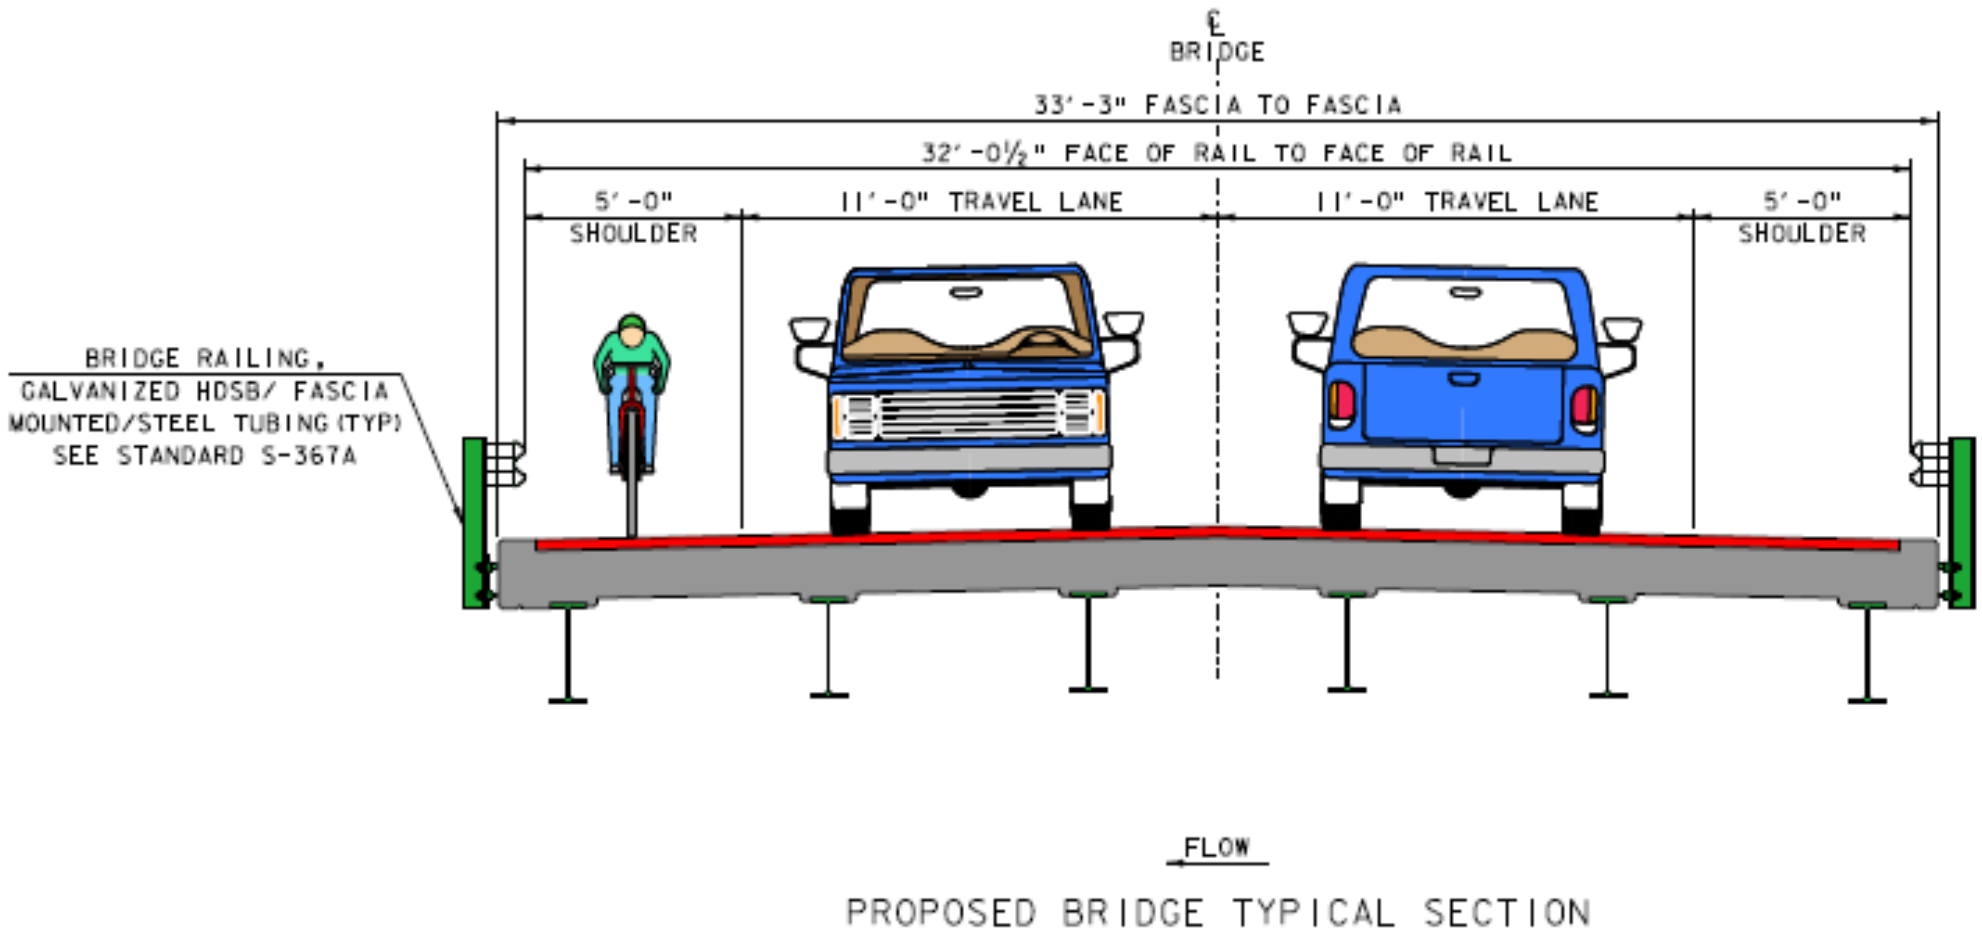
Alternative 3 Typical Section

Full Bridge Replacement - Bridge #15

- New deck, railings, superstructure, and substructures
- Maintains minimum standard bridge width (5'-11'-11'-5')

- Full bridge replacement
 - Existing bridge has exceeded its expected design life
 - Lengthen to 50-65-foot span, and decrease skew to 20-30 degrees to meet minimum hydraulic requirements, and stream equilibrium standards
 - Due to significant rehabilitation or replacement of the southern abutment, the full bridge replacement option is more cost effective
 - 75-year design life

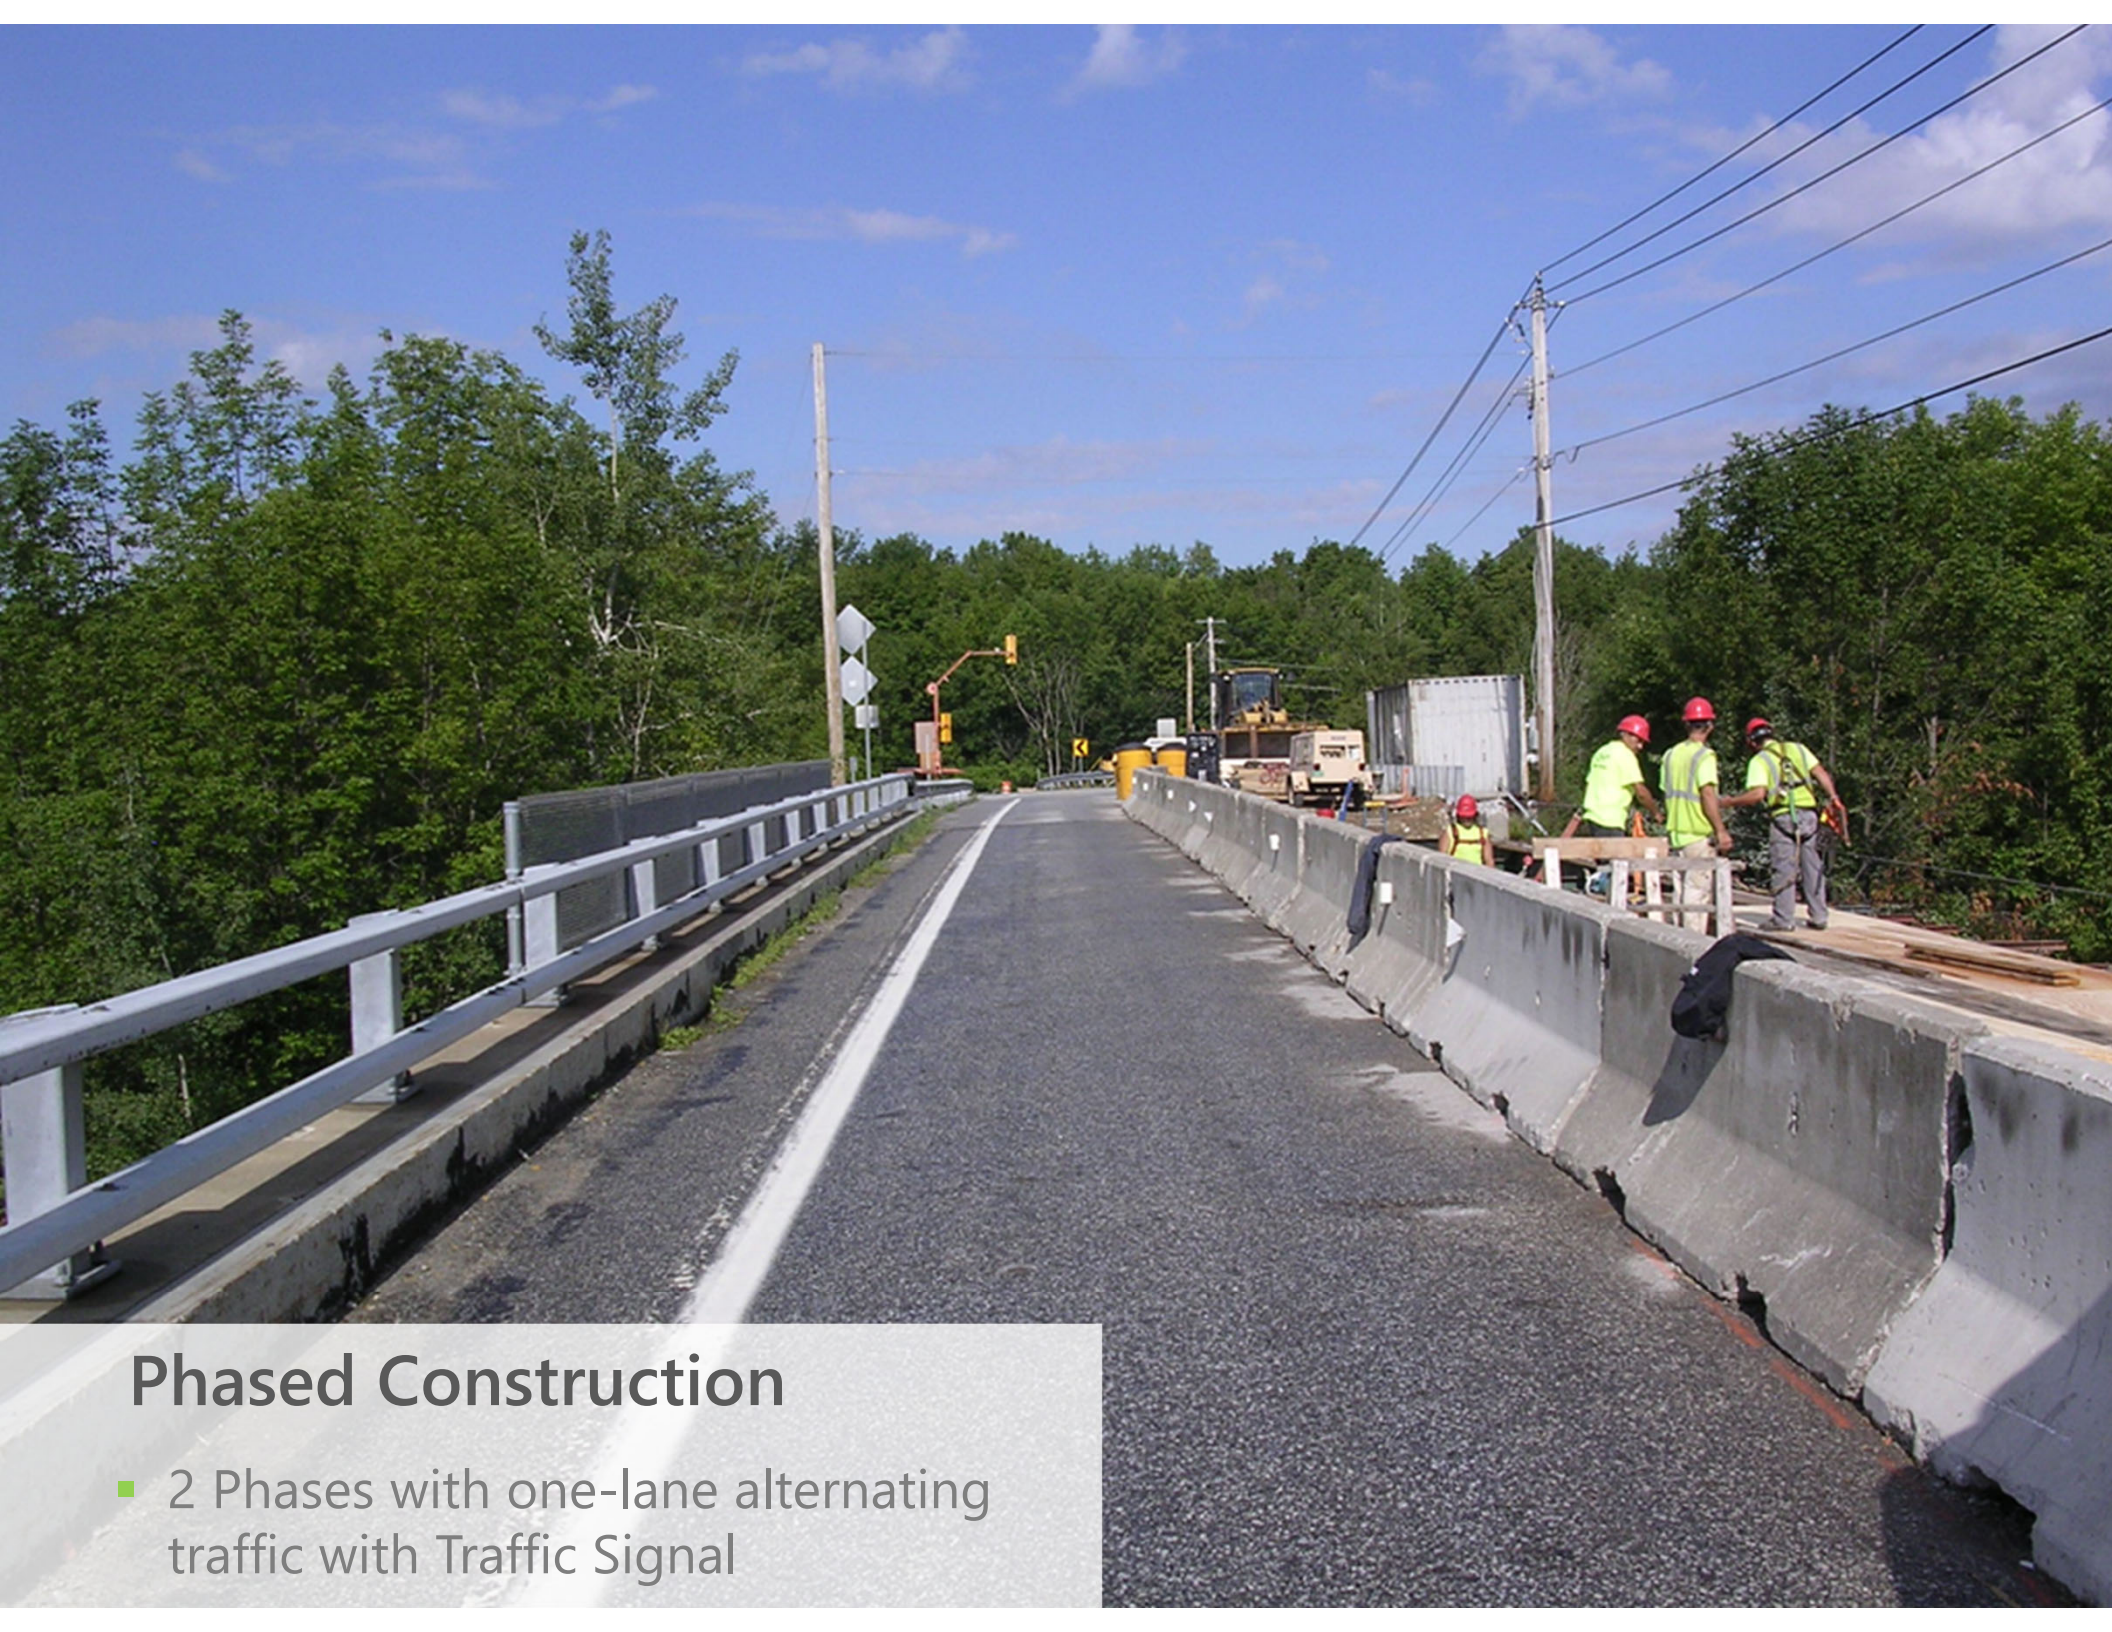
Traffic Control – Detour

- **Detour Route:** Browns Trace Road (FAS 209/TH 4), to Fitzsimonds Road and Barber Farm Road, back to Browns Trace Road
- Detour Distance: 2.0 miles
- Thru Route: 1.7 miles
- End-to-End Distance: 3.7 miles
- Added Distance: 0.3 miles

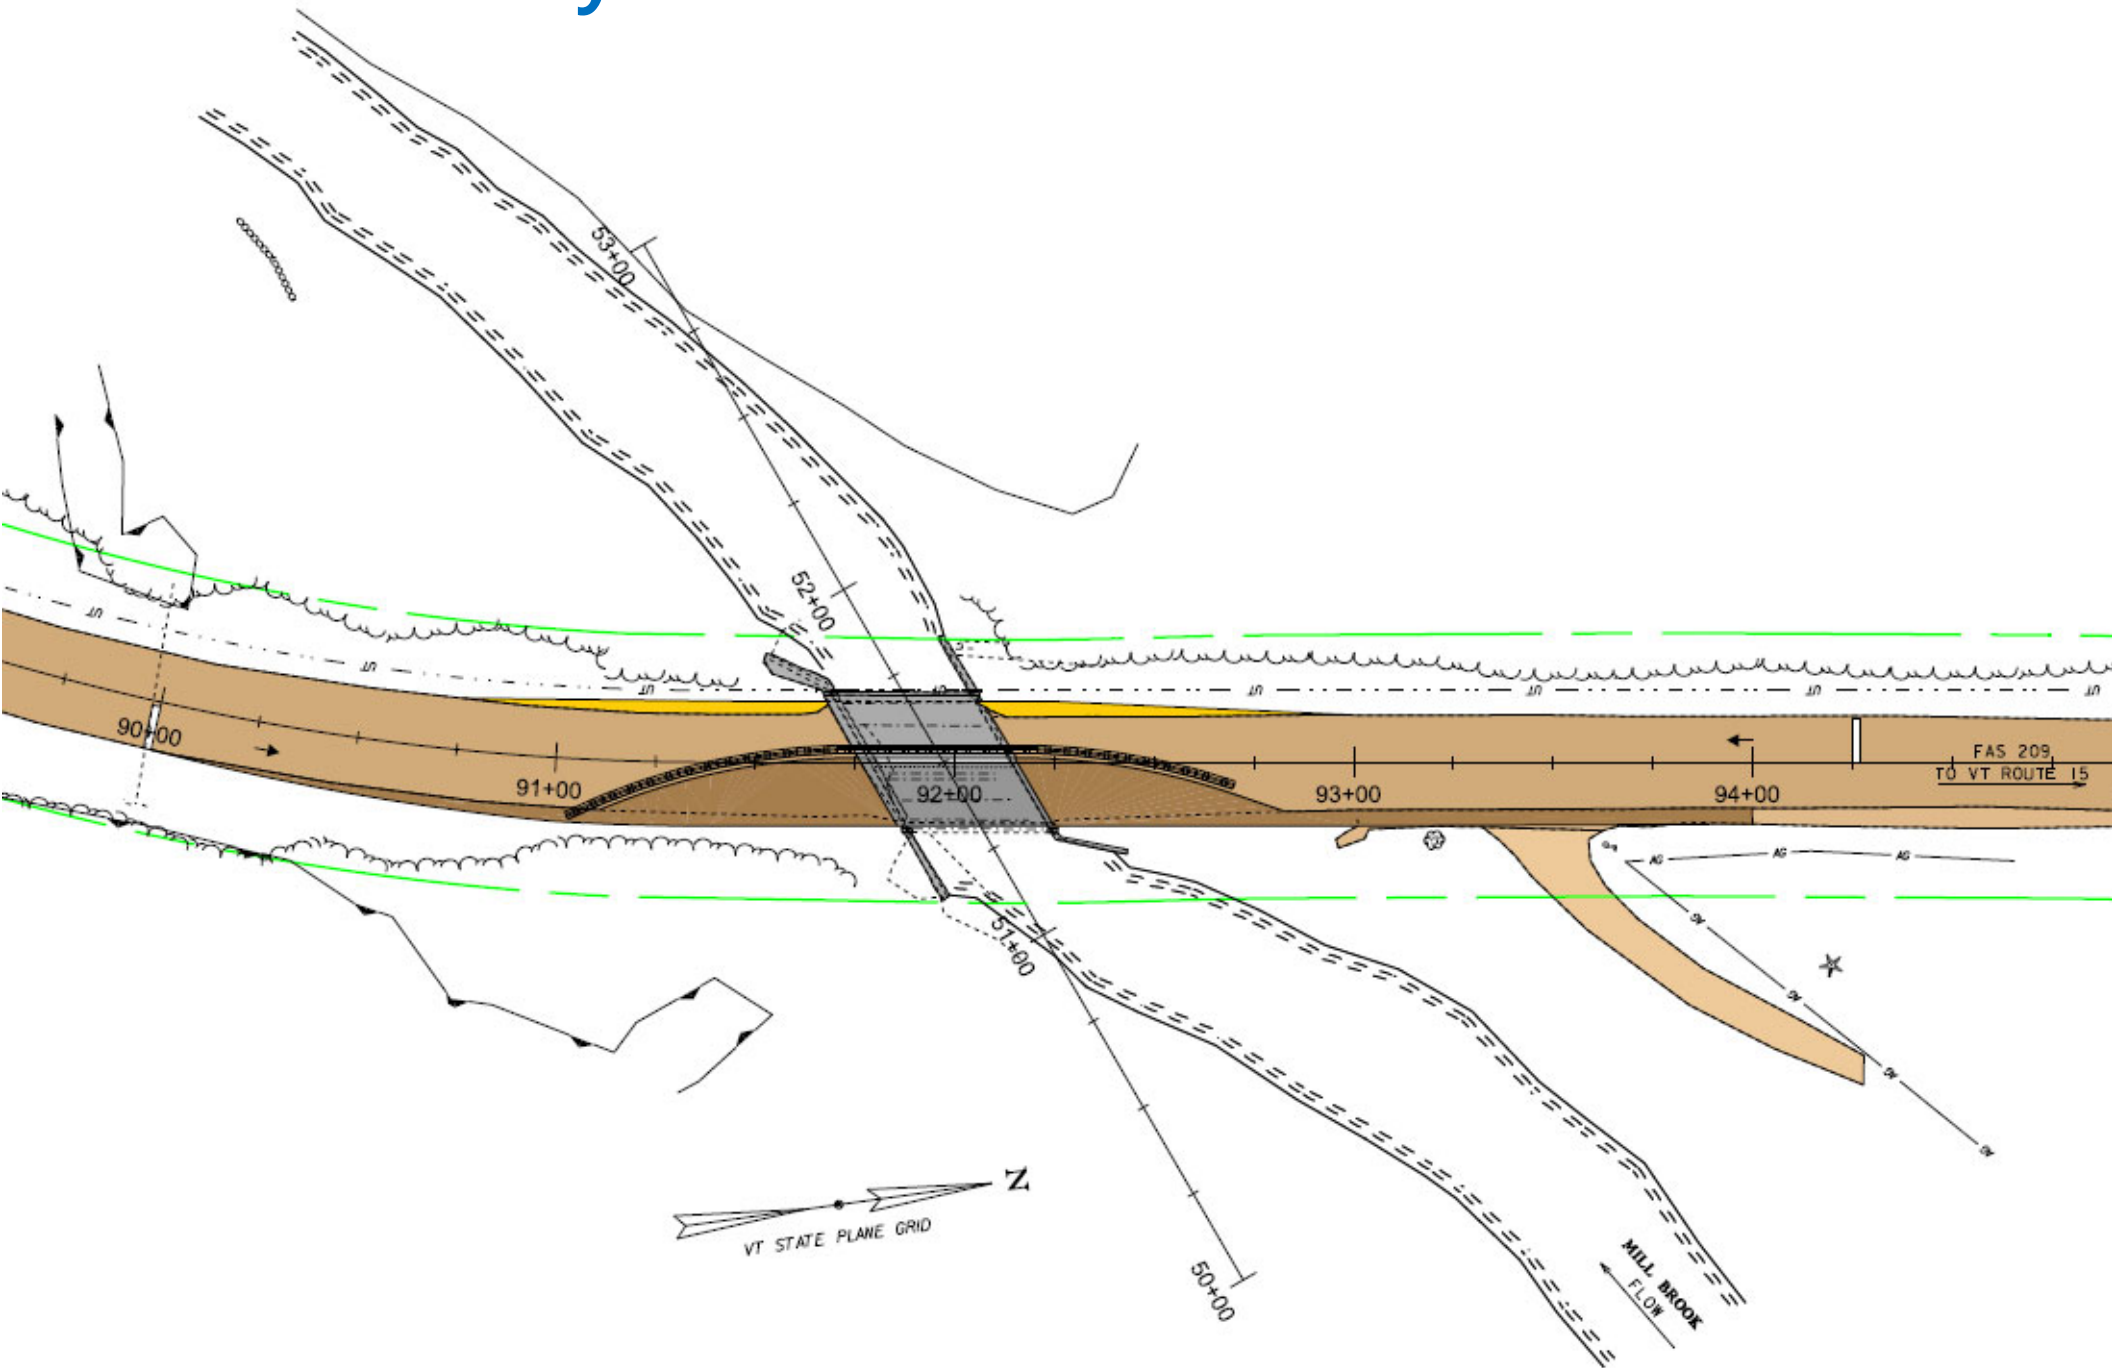
Phase 1 Layout

- 2 Phases with one-lane alternating traffic with Traffic Signal
