**Ludlow Village BO 1443(52)**  
**Alternatives Presentation Meeting**  
**Town Highway 324 – Bridge #57 over Black River**

February 3, 2020

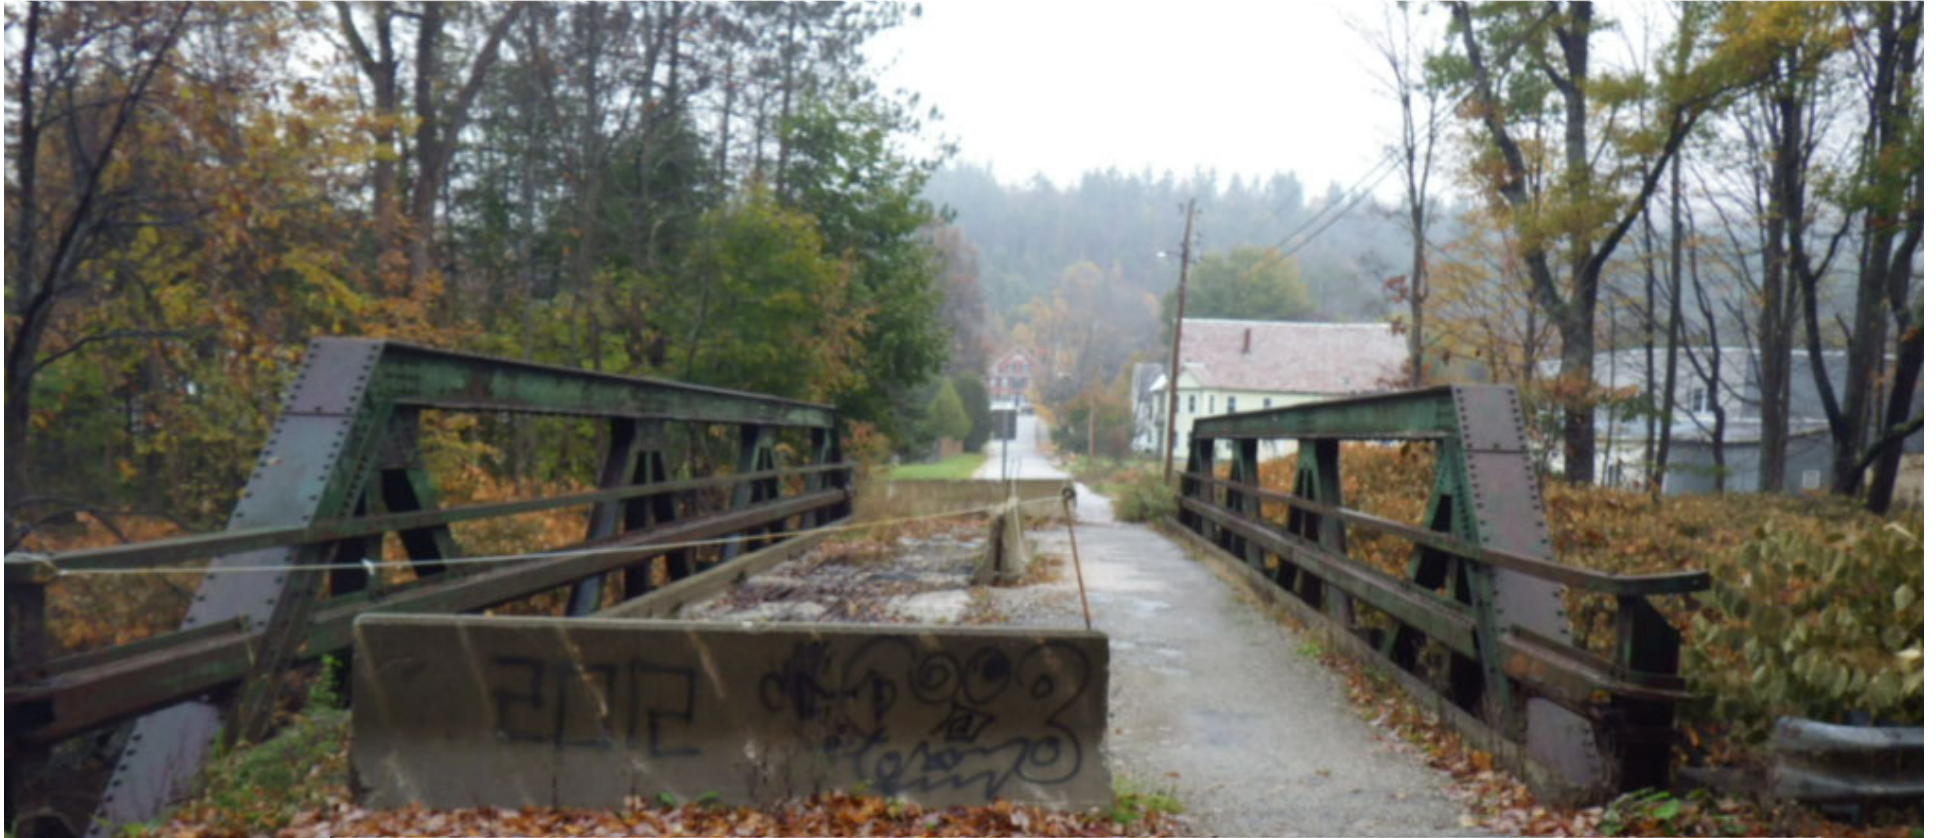
## Looking North over Bridge 57

- Roadway Classification – Local Road, Class 3 TH
- Bridge Type – 82' Long, Riveted Steel Warren Pony Truss
- Ownership – Town of Ludlow
- Constructed in 1929

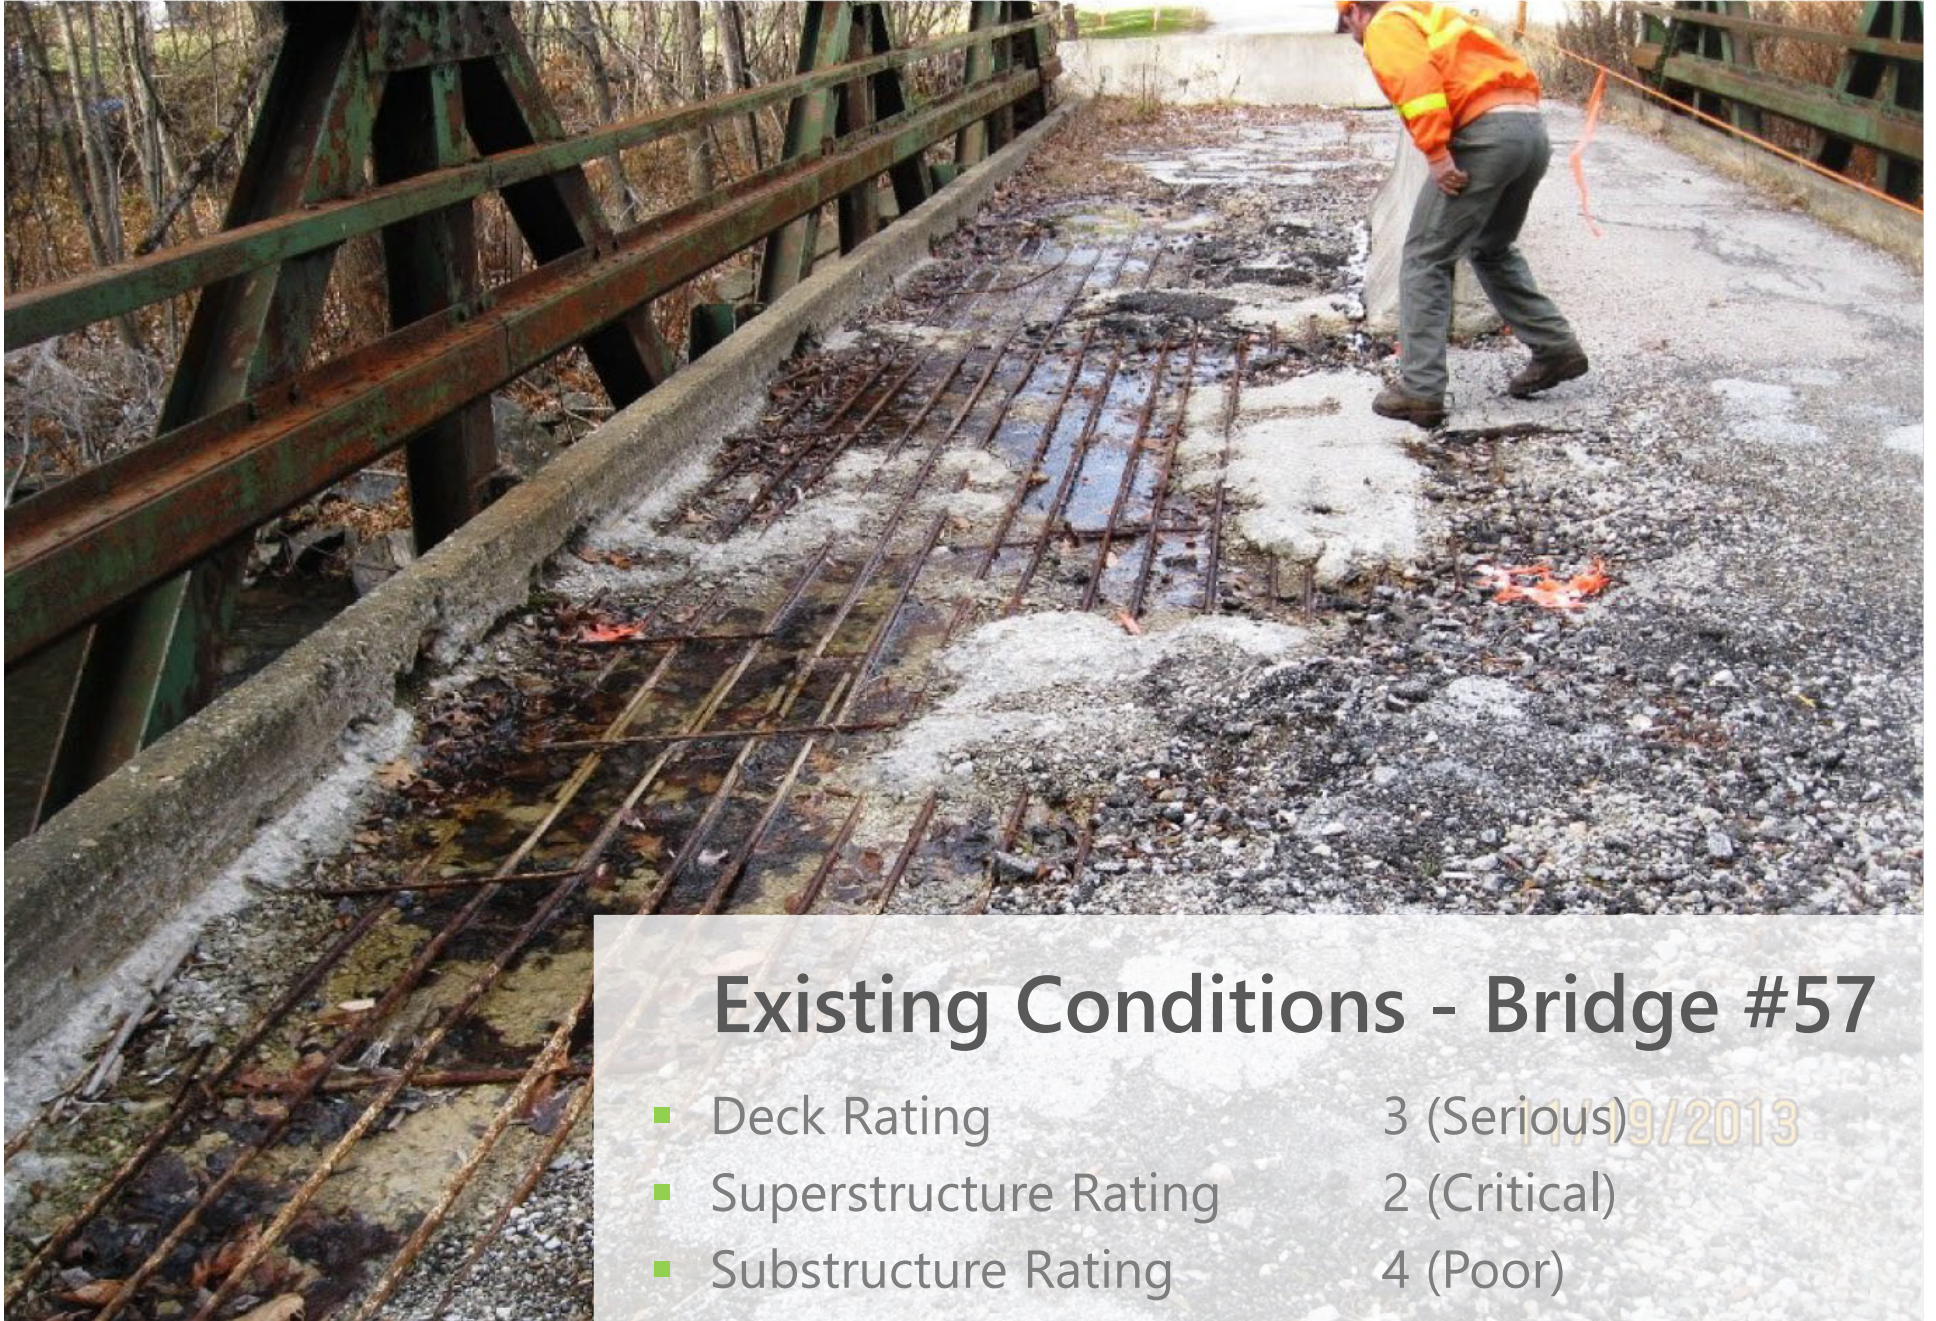
## Condition Ratings

- Bridge 57 is Structurally Deficient
  - Closed to vehicular traffic on October 10<sup>th</sup>, 2007 due to the amount of section loss in the gusset plate connections and floorbeams.
- The deck is in serious condition with large sections of spalling with exposed reinforcing steel on both the top and underside of the deck.
- The substructures are in poor condition. The abutment stems have cracks with leakage throughout as well as some areas of deep spalling.
- The existing bridge does not meet the minimum standard for width.
- The existing bridge railing is substandard.
- The bridge does not meet the minimum hydraulic standards.

- Deck Rating 3 (Serious) 9/2013
- Superstructure Rating 2 (Critical)
- Substructure Rating 4 (Poor)

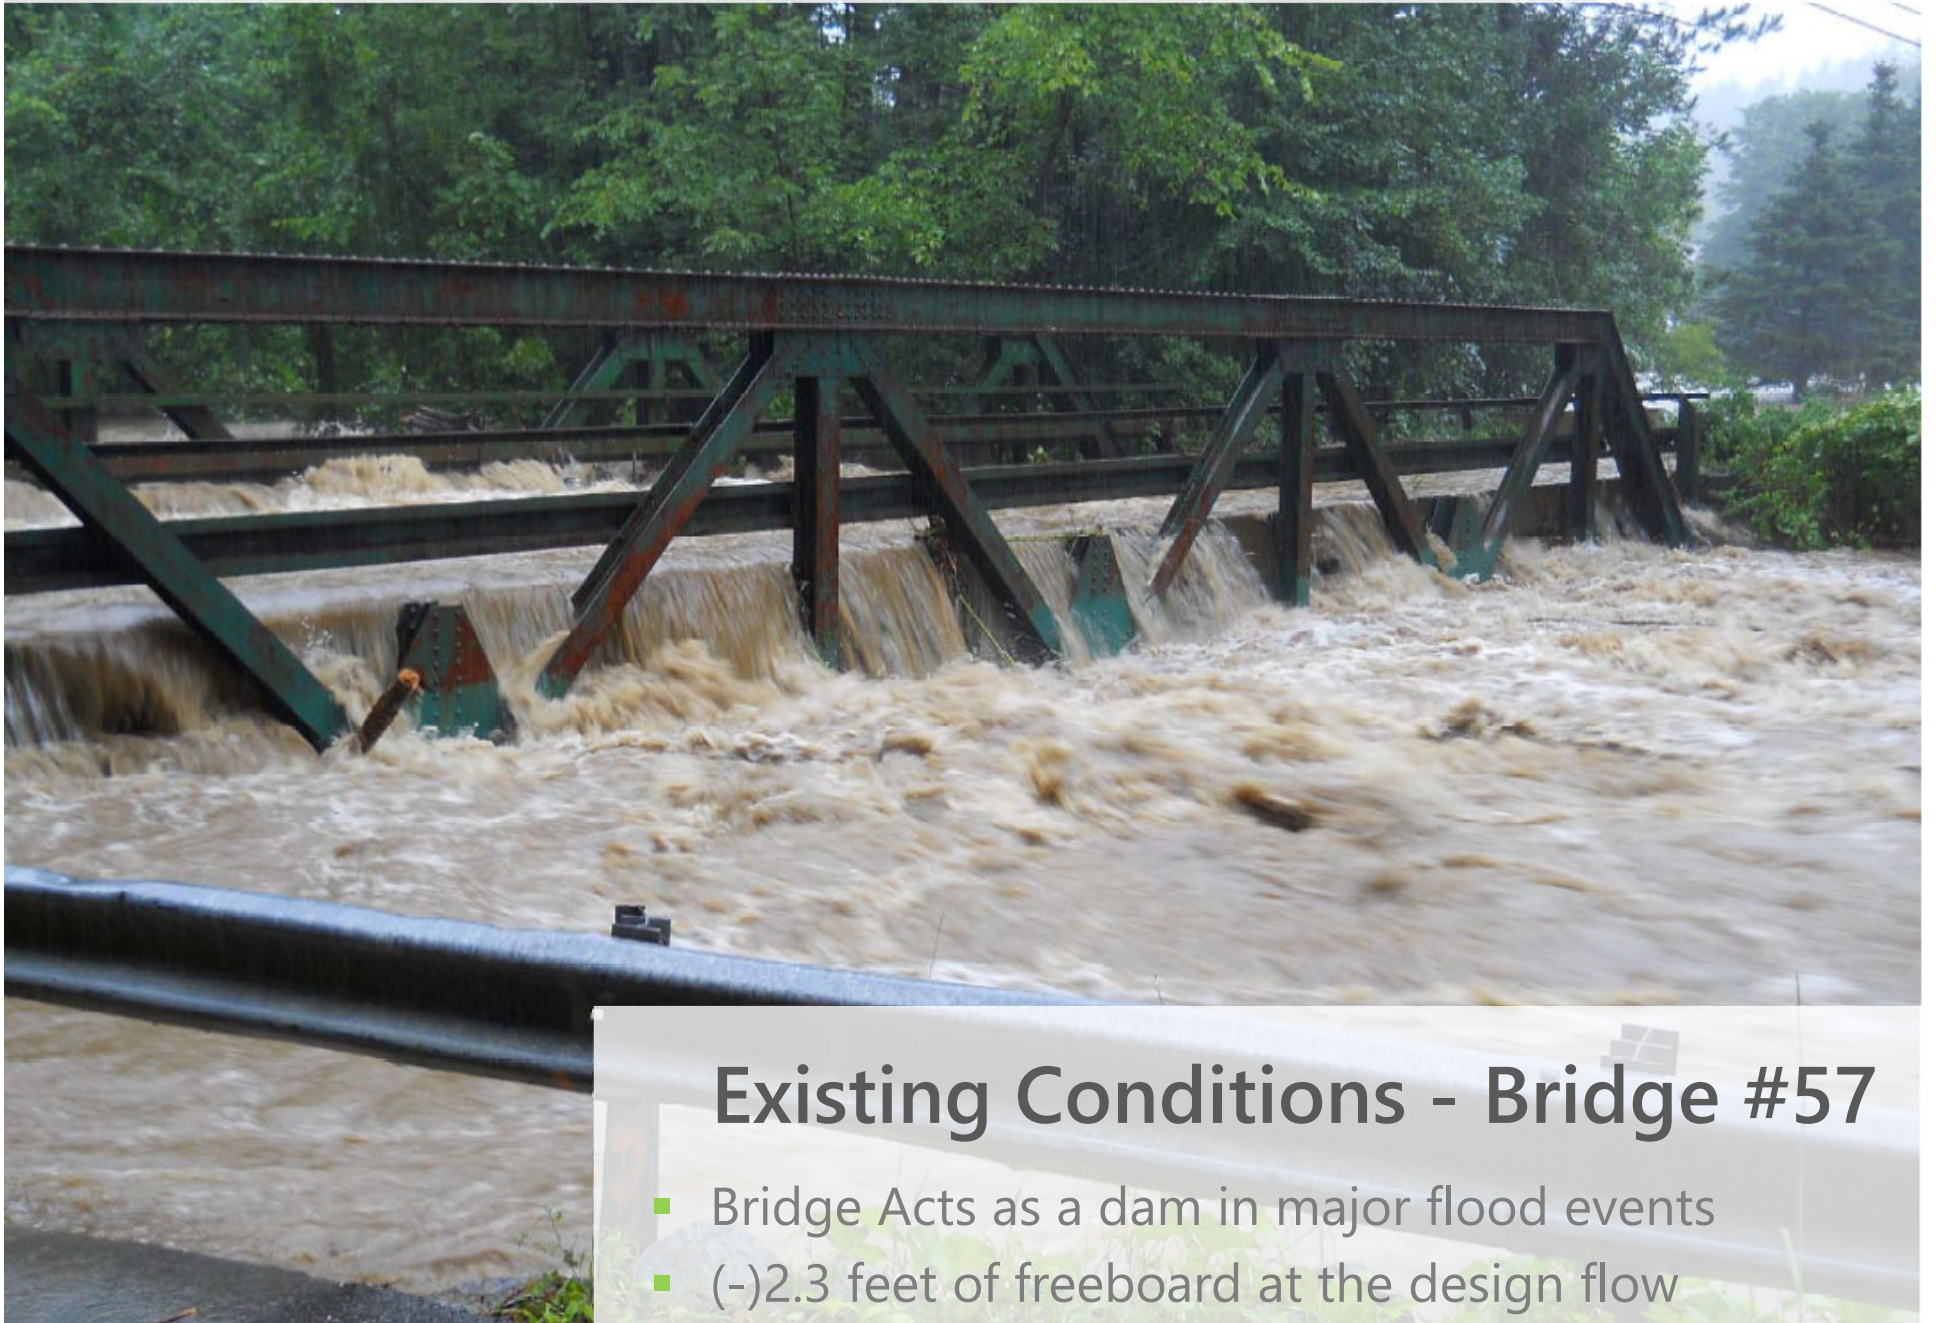
## Substandard Hydraulically (Tropical Storm Irene)

- Bridge Acts as a dam in major flood events
- (-)2.3 feet of freeboard at the design flow

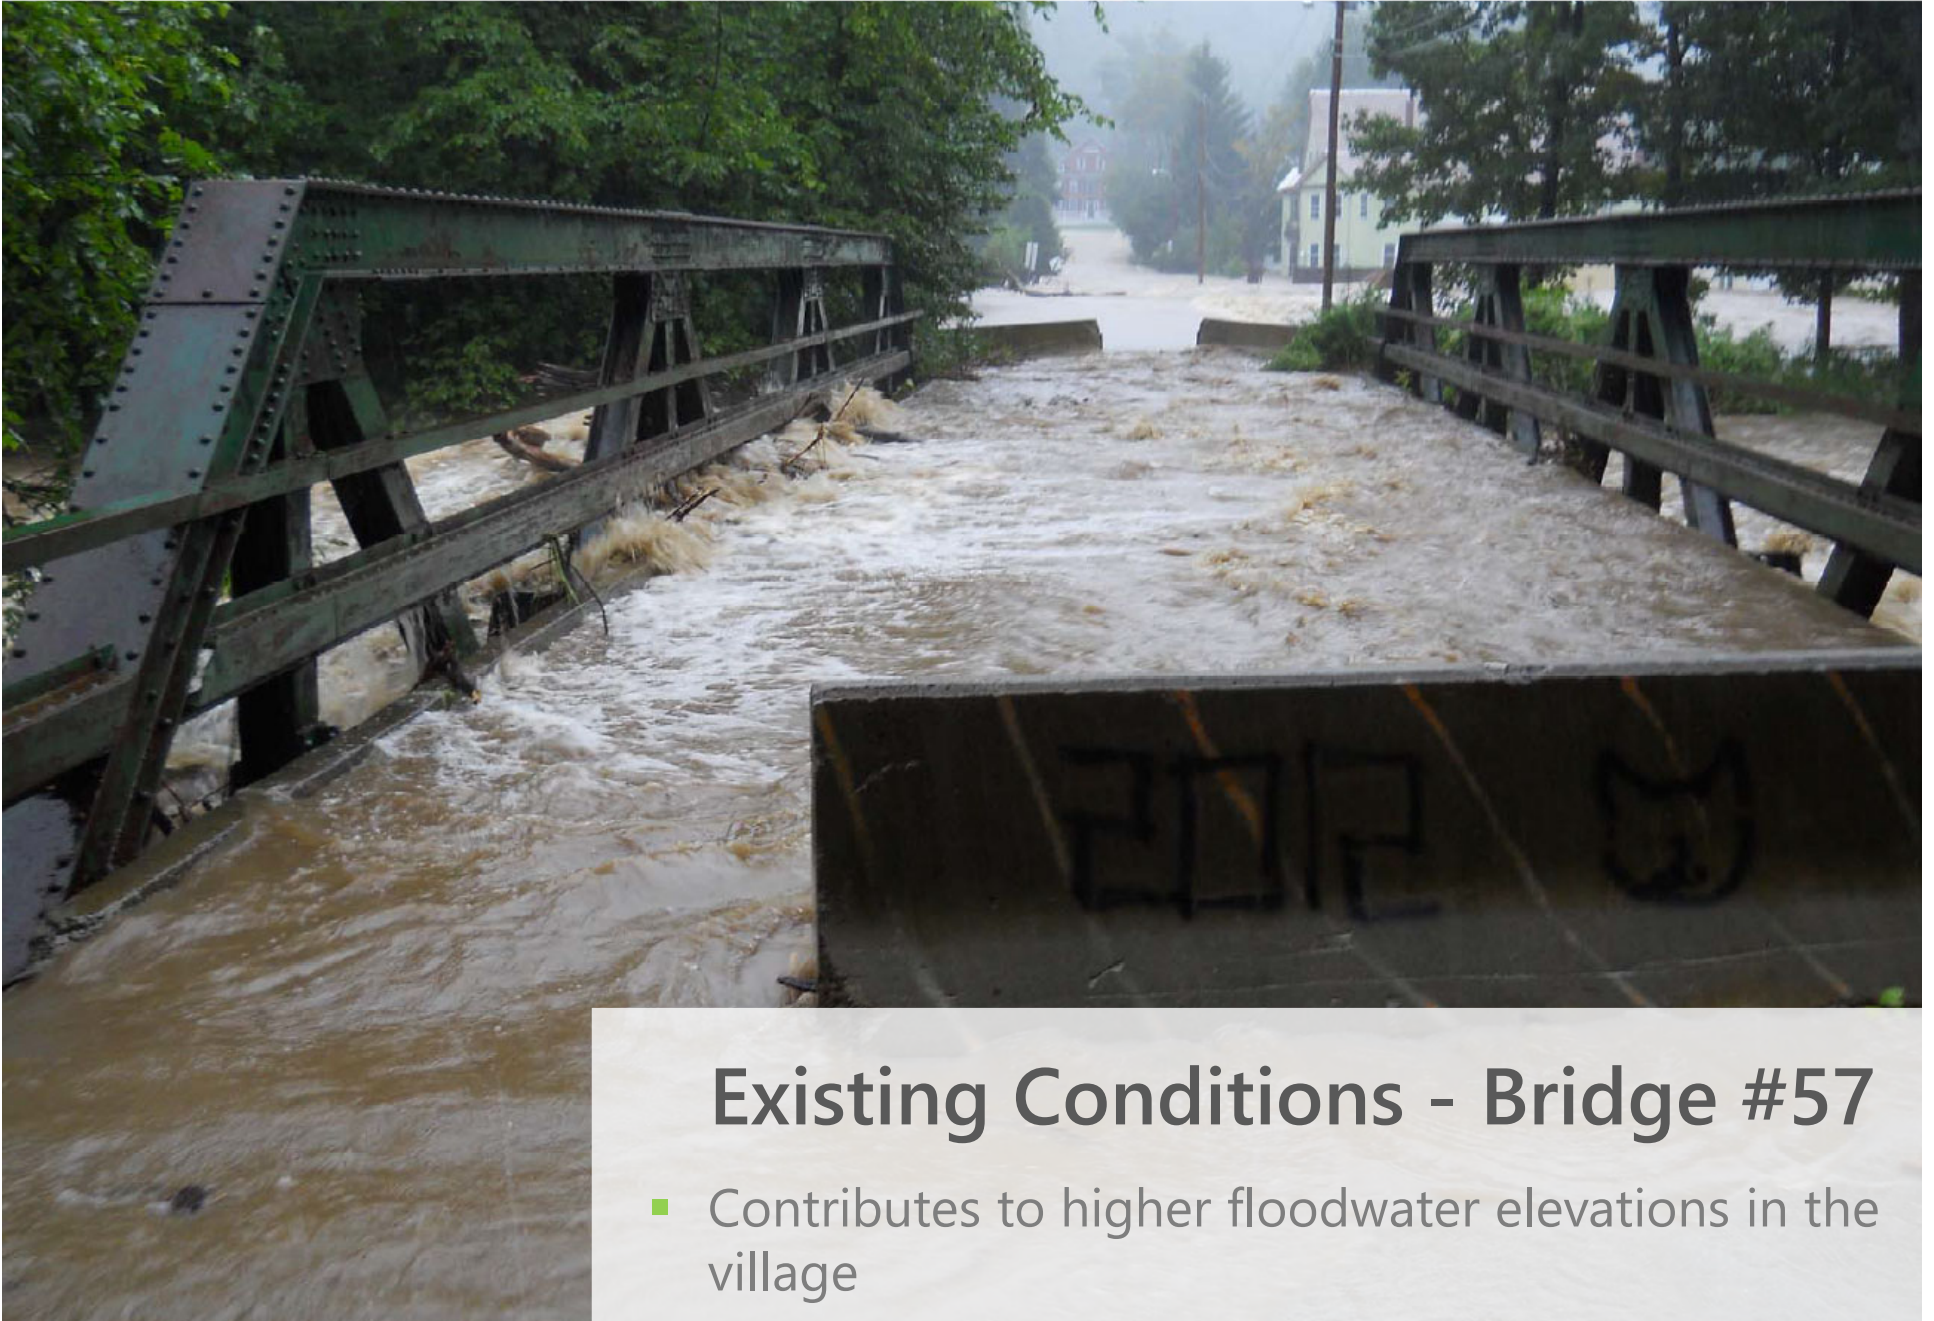
## Substandard Hydraulically (Tropical Storm Irene)

- Contributes to higher floodwater elevations in the village

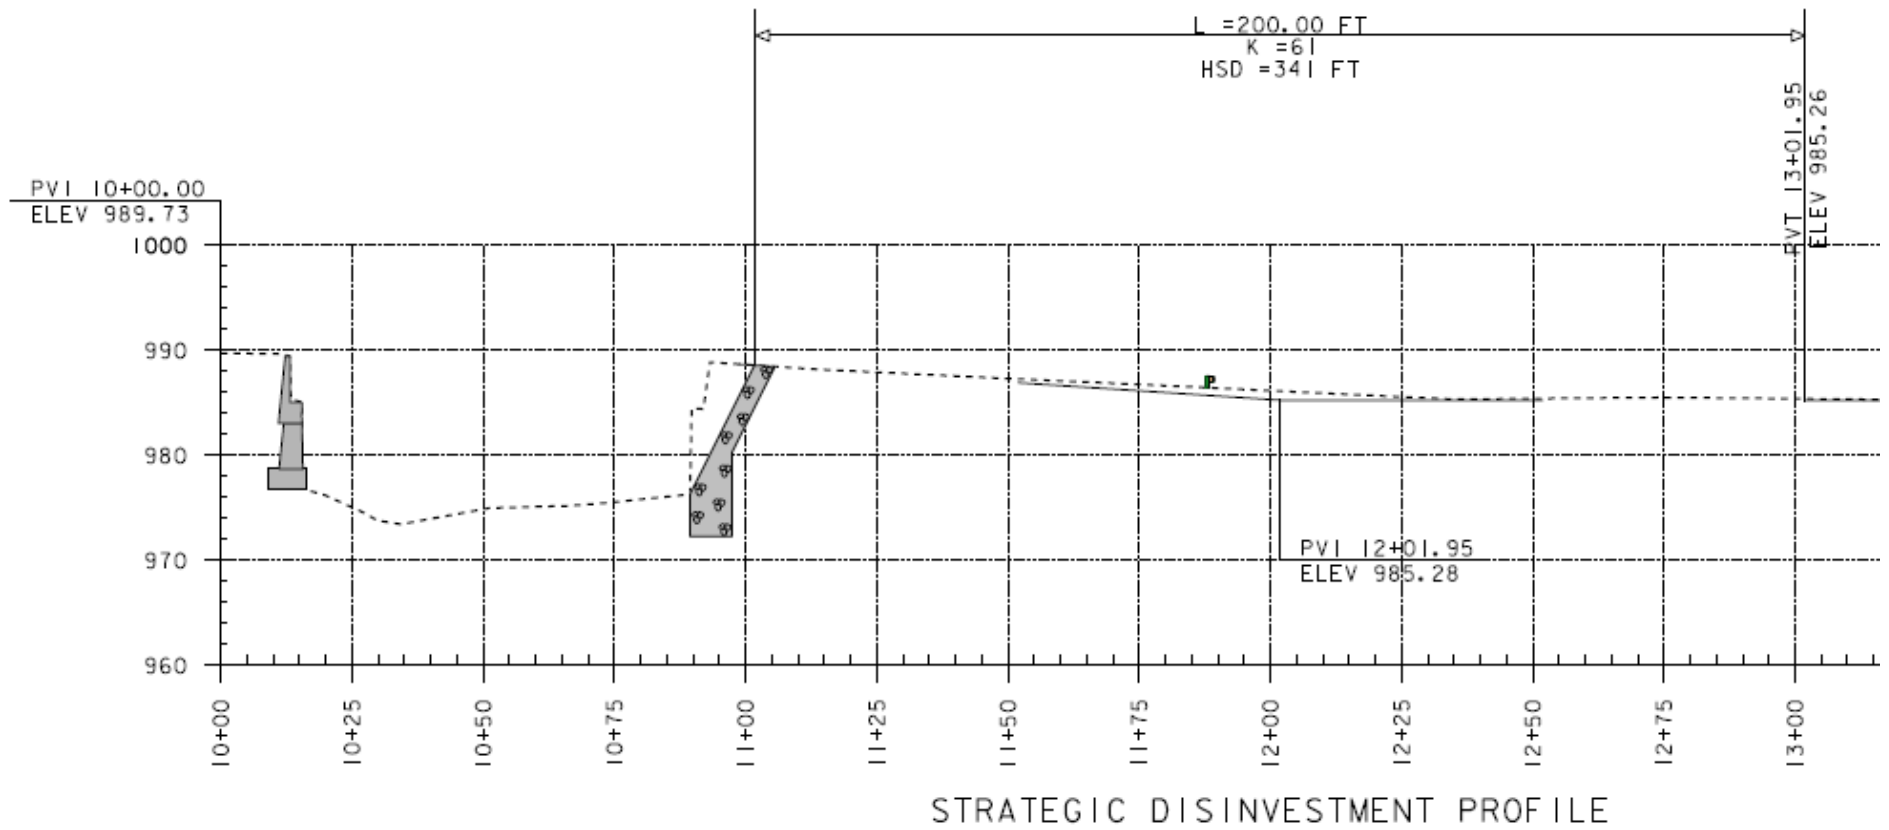
# Alternative 1: Strategic Disinvestment Profile

- Bridge removed
- Improved Hydraulic Condition

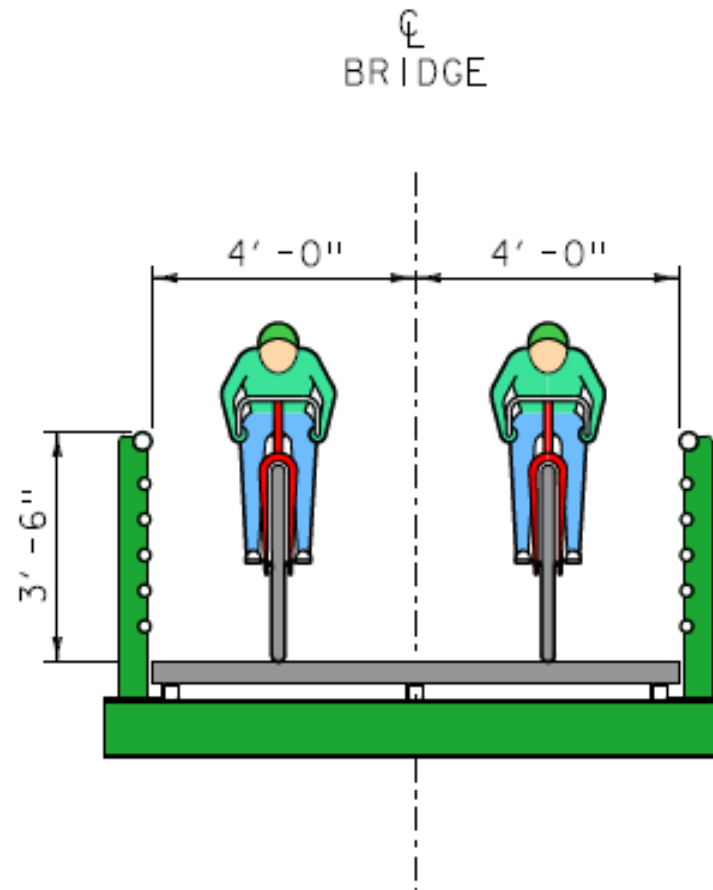
# Alternative 1b: Strategic Disinvestment with Pedestrian Bridge Typical Section (Recommended Alternative)

- Bridge removed
- Improved Hydraulic Condition

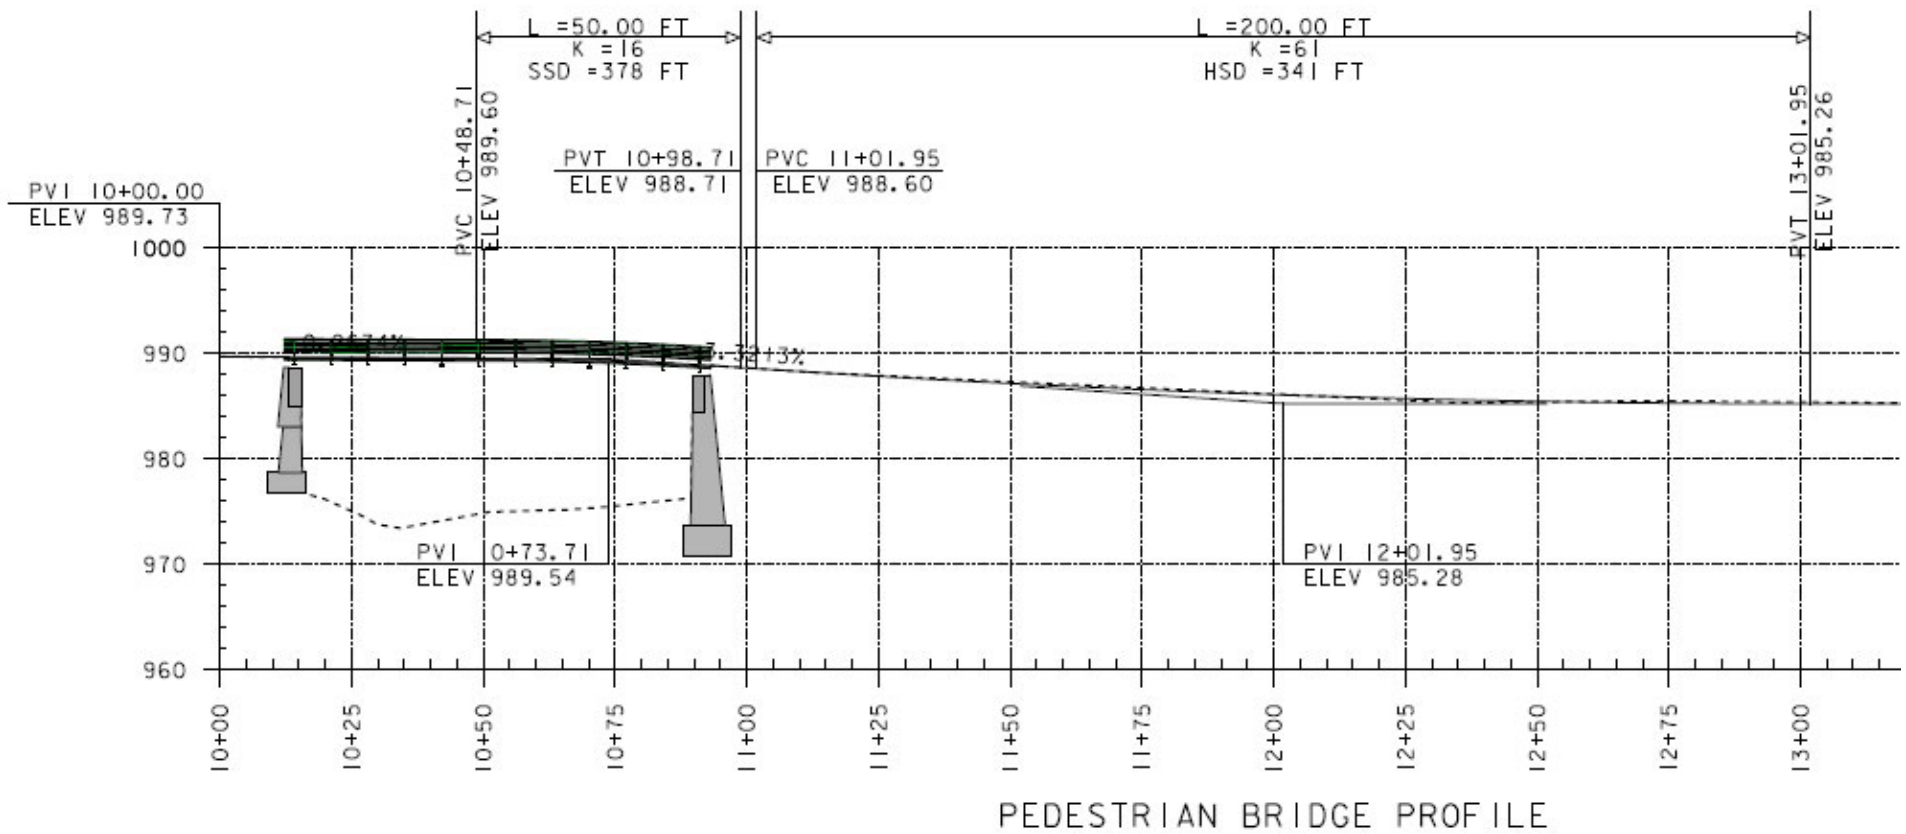
# Alternative 1b: Strategic Disinvestment with Pedestrian Bridge Profile (Recommended Alternative)

- Shallow Superstructure for Improved Hydraulic Condition
- Cambered for Improved Hydraulic Condition

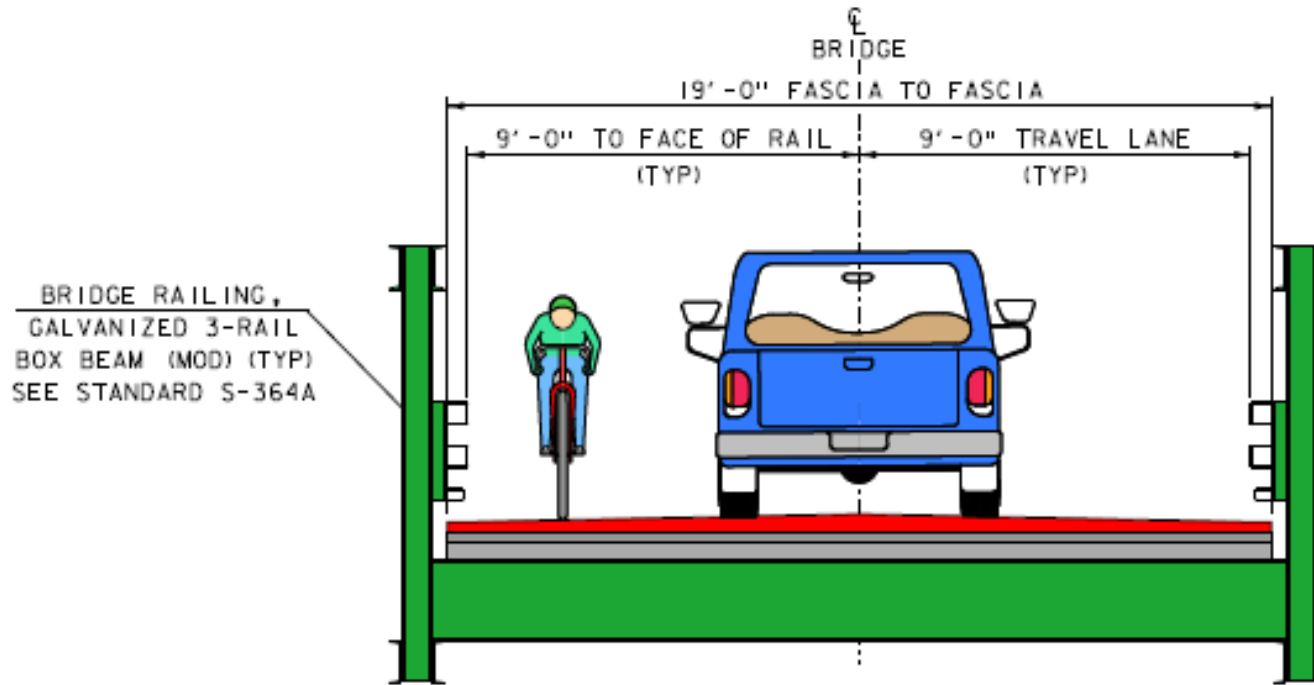
# Alternative 2: Truss Rehabilitation Typical Section

- 0'-9'-9'-0' Typical
- Rehabilitated for pedestrian loads only or for a reduced vehicular loading
- Hydraulic Condition not Improved – superstructure depth remains unchanged

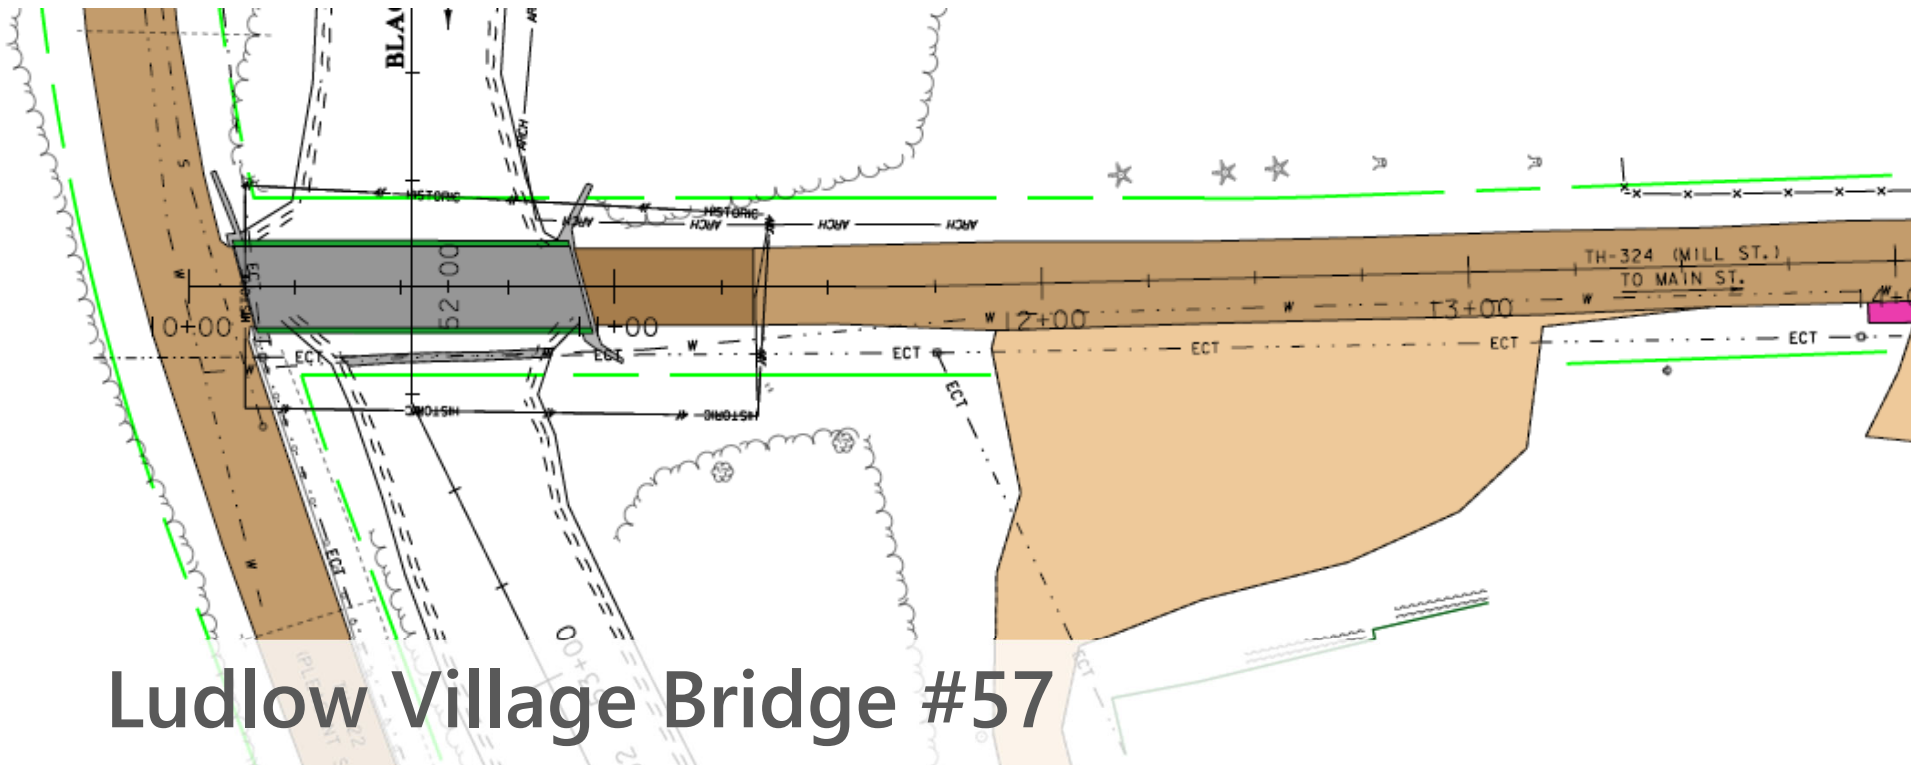
# Alternative 2: Truss Rehabilitation Layout

- Truss member replacement as necessary and a new cast-in-place deck
- Existing abutments to remain in place if rehabilitated for pedestrian loads
- New abutments poured if rehabilitated for vehicular loads
- 18' rail-to-rail bridge width
- 30-year design life
- 2.5% Local Share

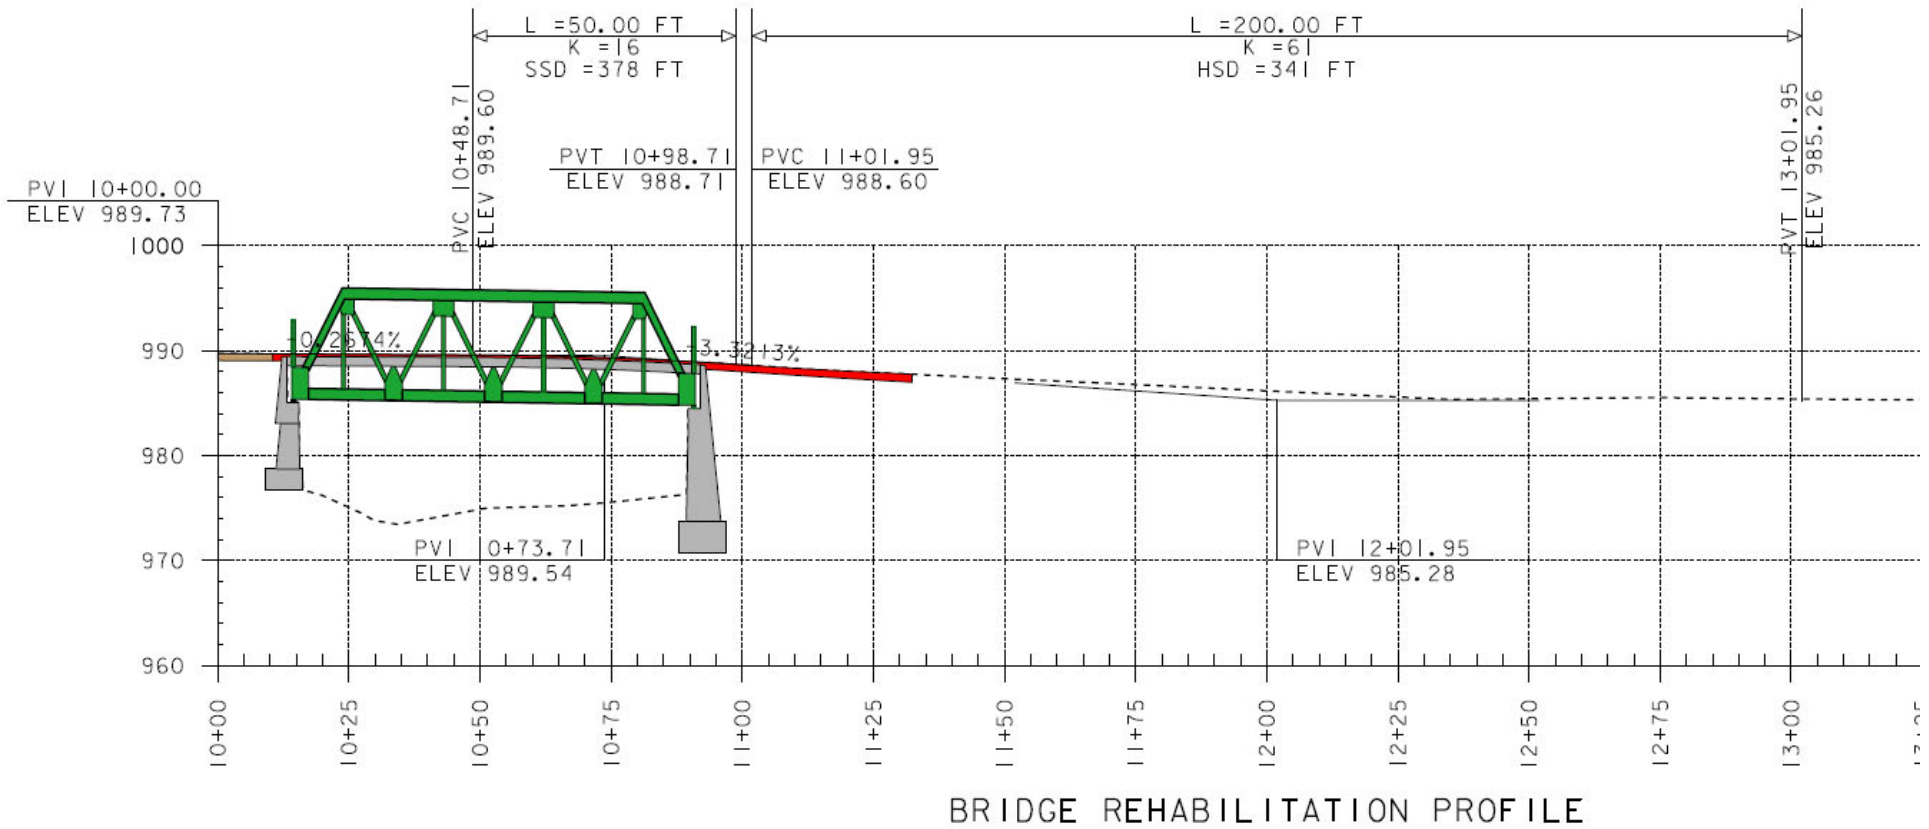
# Alternative 2: Truss Rehabilitation Profile

- Matches Existing
- Hydraulic Condition not Improved

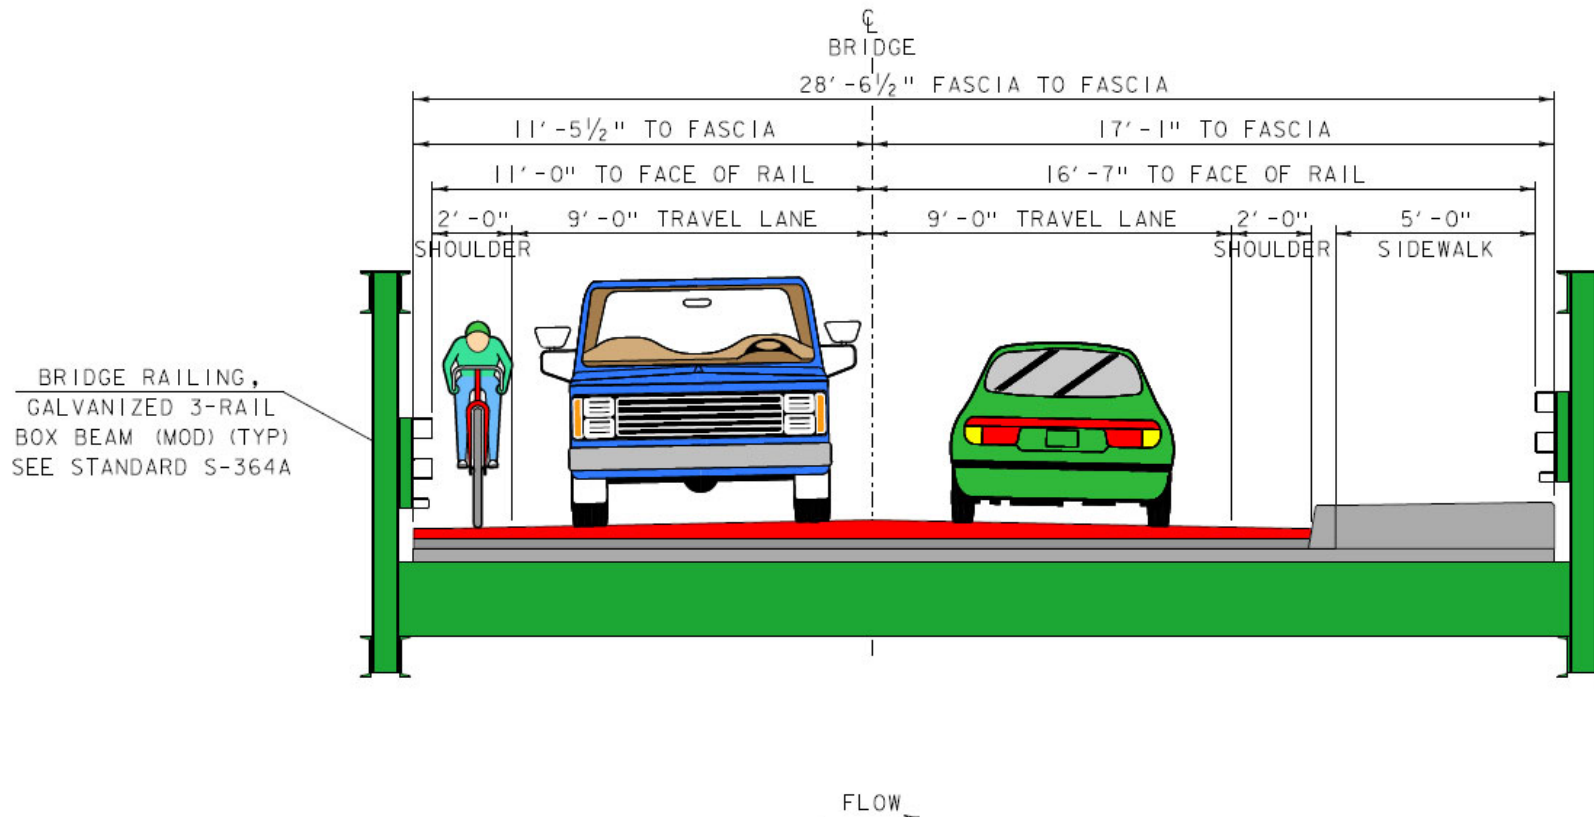
# Alternative 3: New Pony Truss Typical Section

- 2'-9'-9'-2' with a 5' Sidewalk
- Modern HL-93 loading
- Hydraulic Condition not Improved – superstructure depth remains unchanged

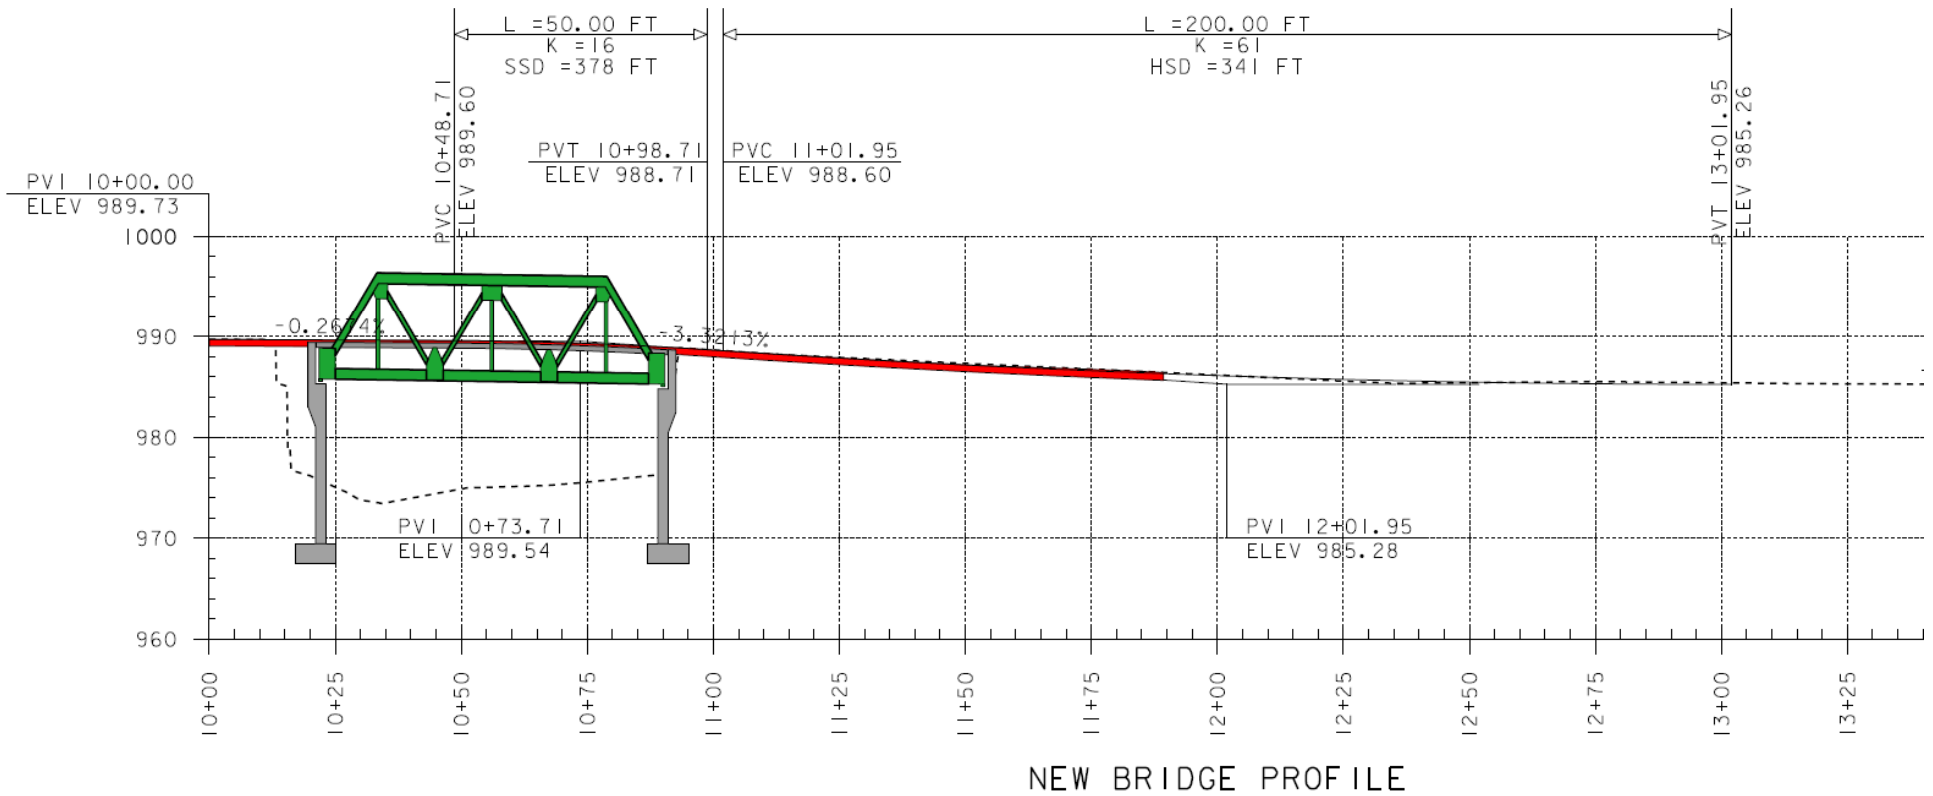
# Alternative 3: New Pony Truss Profile

- Matches Existing
- Hydraulic Condition not Improved

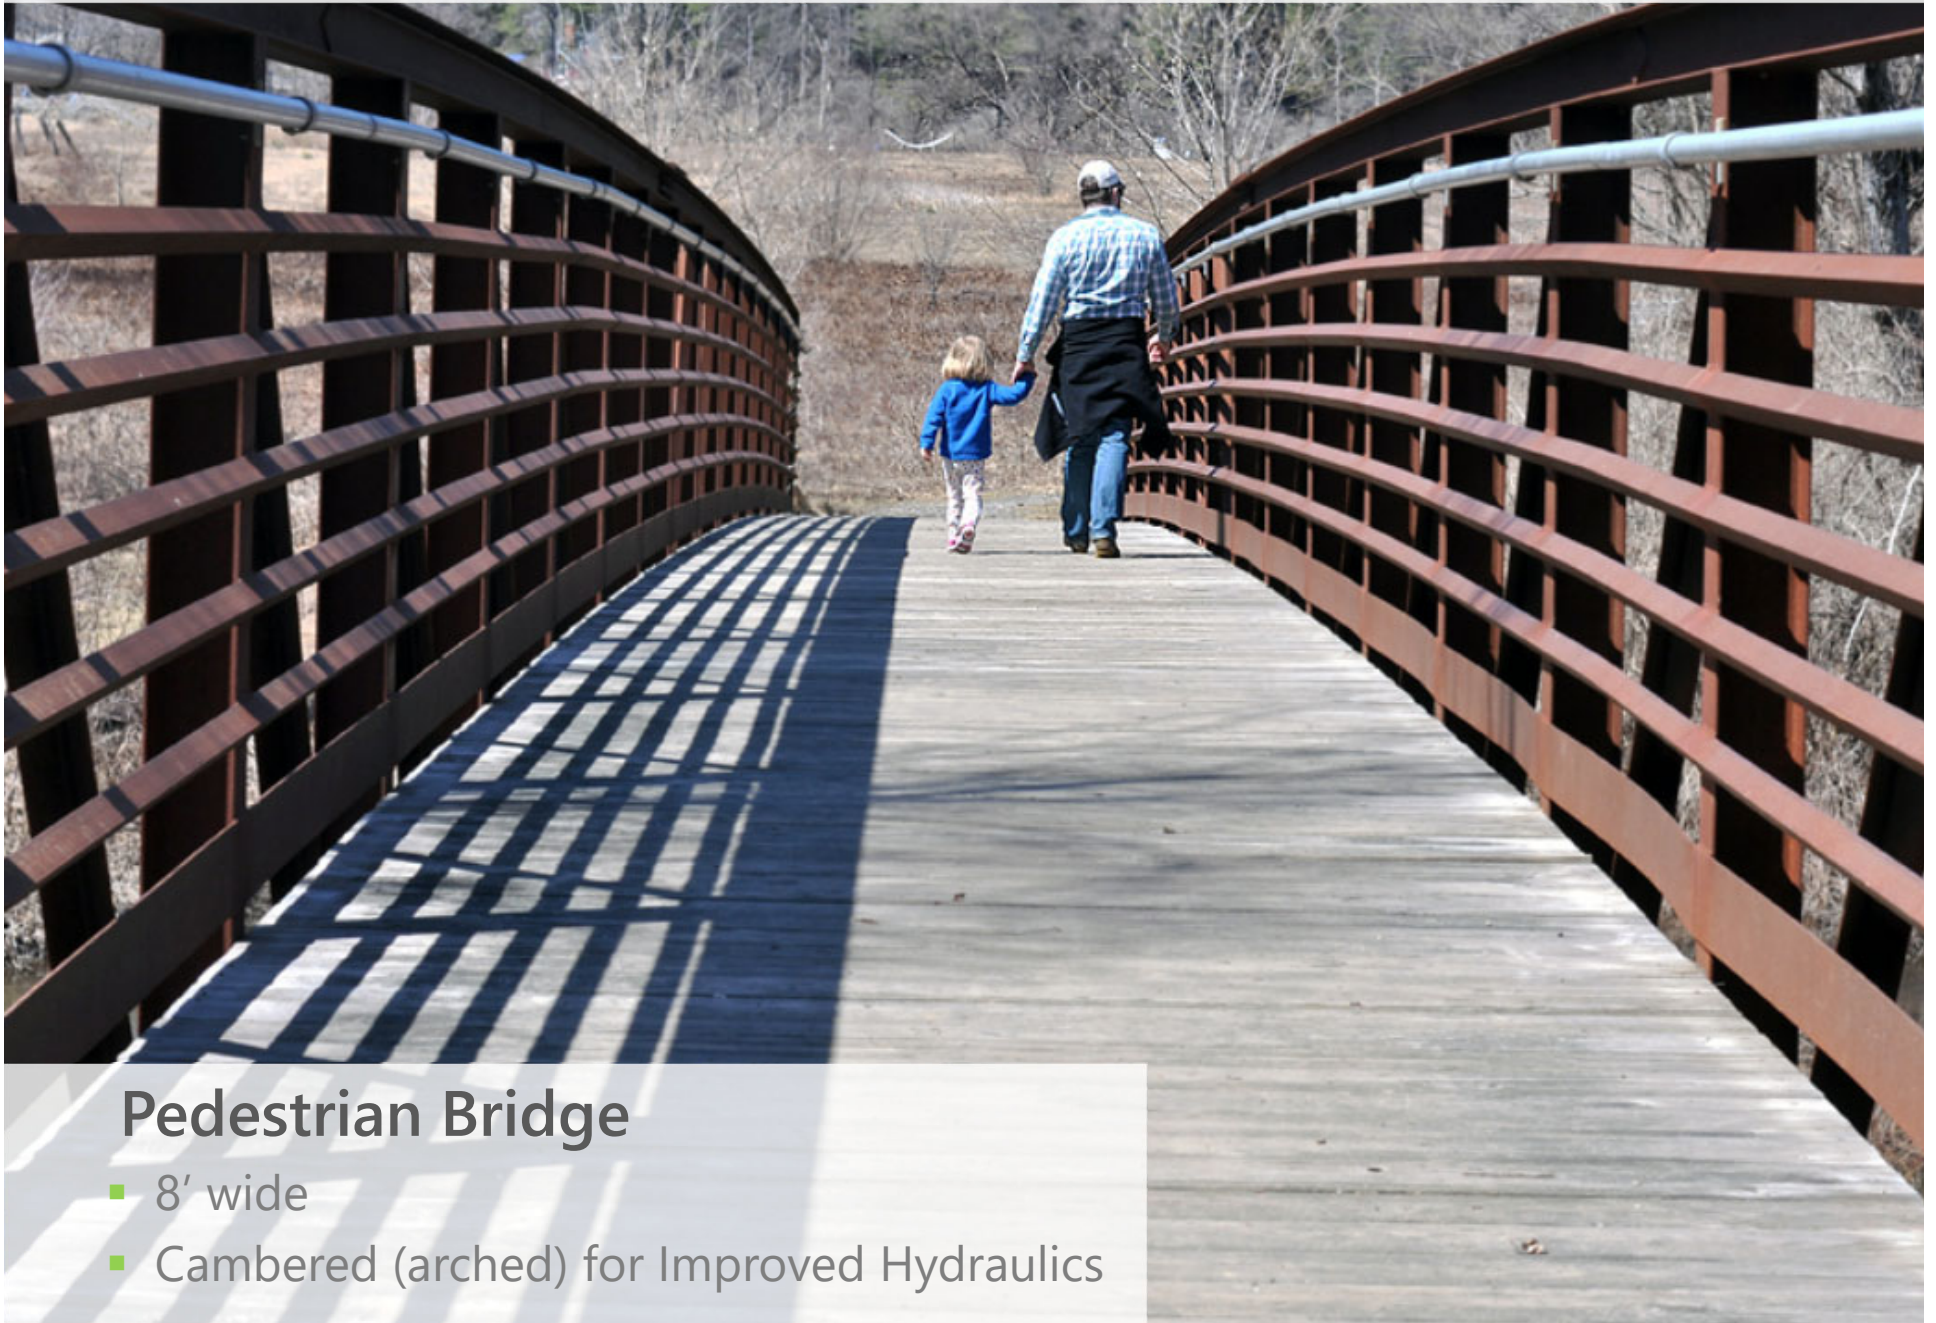
## What Will the New Bridge Look Like?

- 8' wide
- Cambered (arched) for Improved Hydraulics
