# Mt. Holly BO 1443(56) Project Update

**Town Highway 17 – Bridge 64 over Mill River Branch**

June 10, 2025

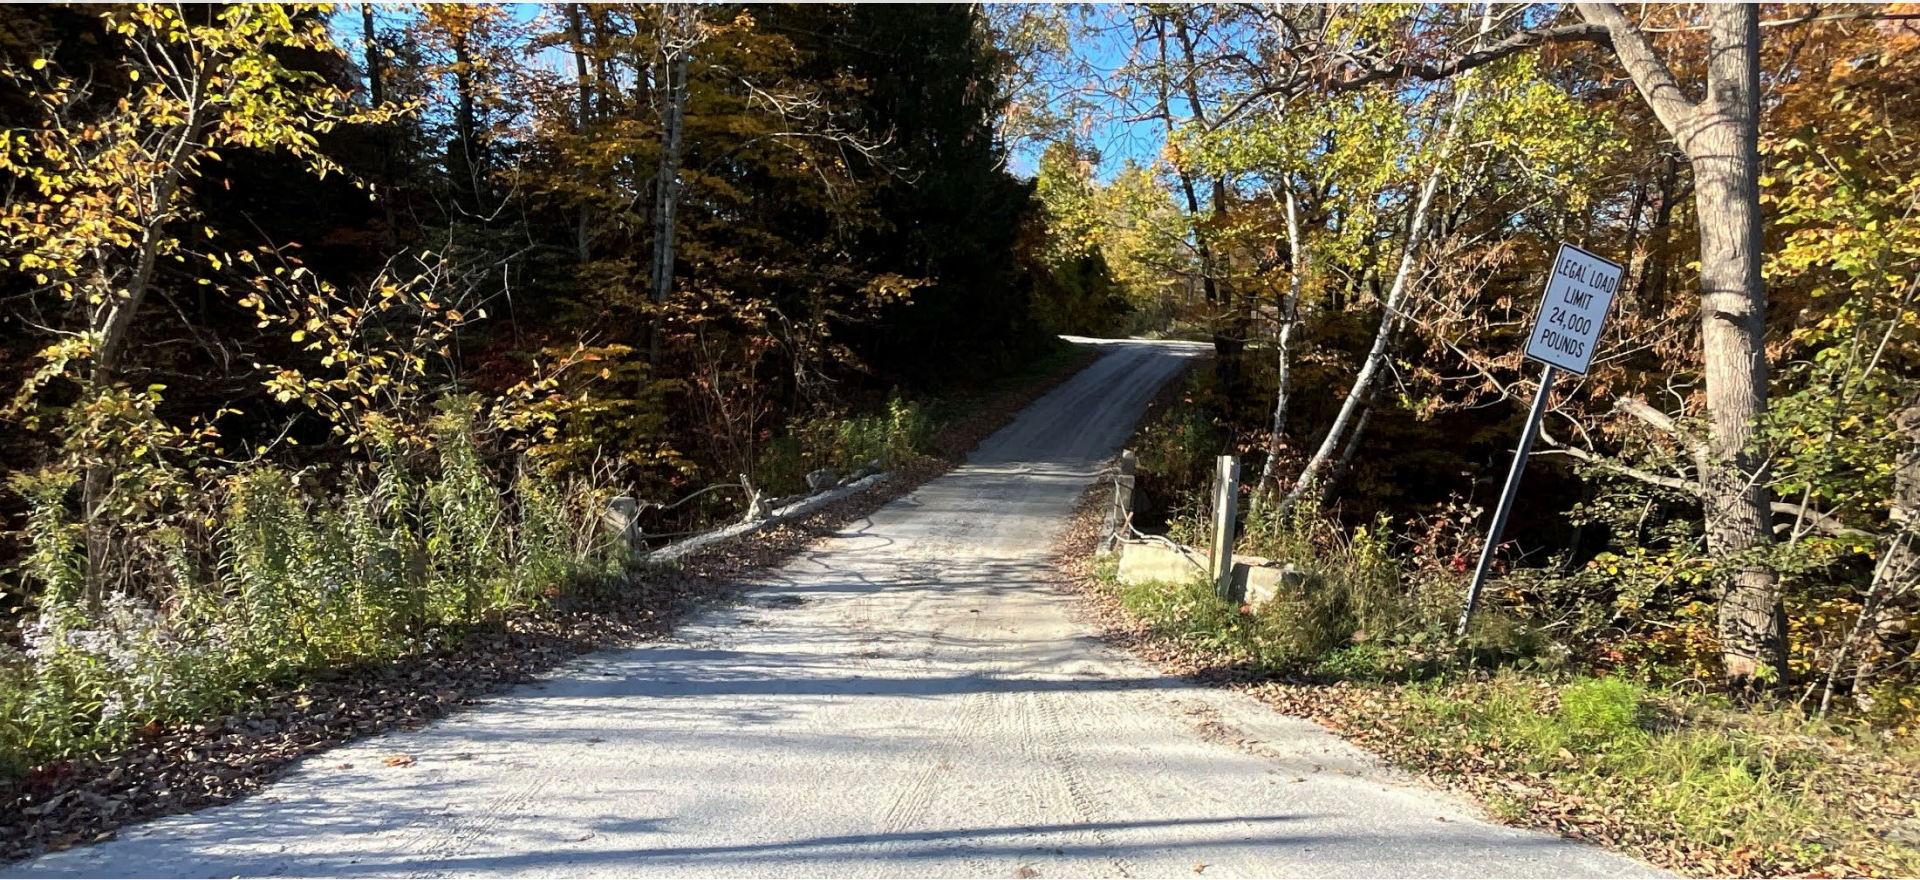
## Existing Conditions – Bridge #64

- Roadway Classification – Rural Local Road (Class 3)
- Bridge Type – 31-foot span Rolled Beam Bridge
- Ownership – Town of Mt. Holly
- Constructed in 1934

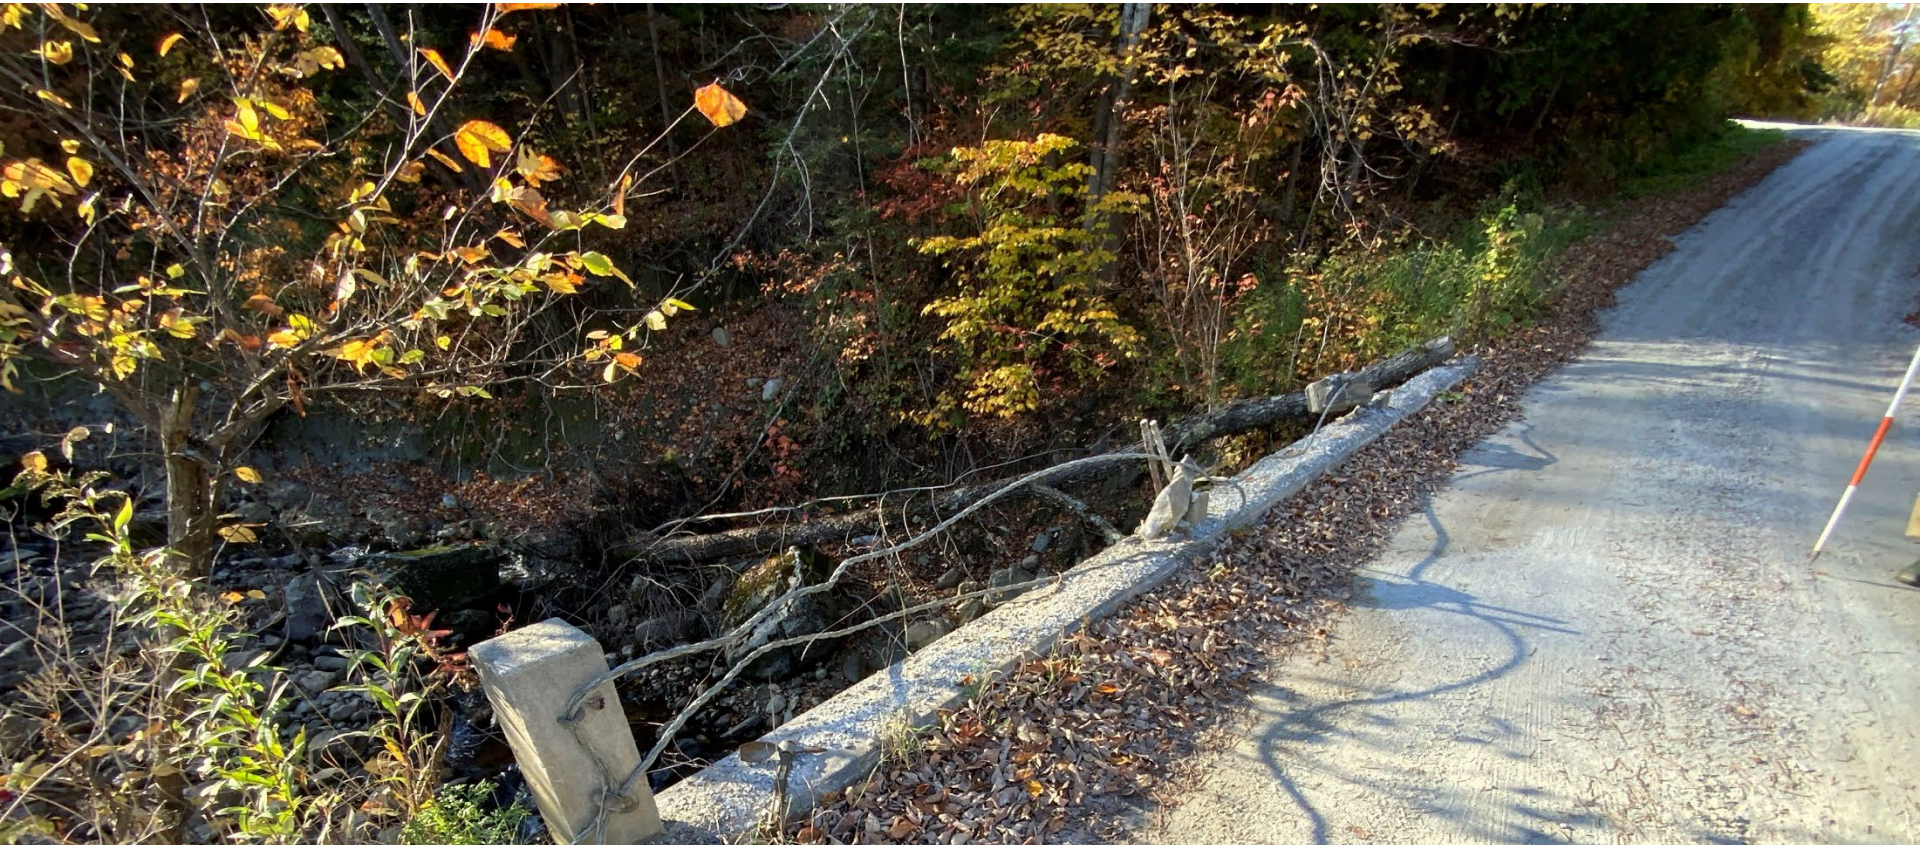
## Looking Northeast

- Aerial Utilities – Green Mountain Power (3 phase electric); Comcast (internet); Vermont Telephone Company (communications)
  - These lines run parallel to VT Route 103 along the eastbound lane which runs perpendicular to North Bowlsville Road. These powerlines are close to the bridge location and may have to be relocated for construction.

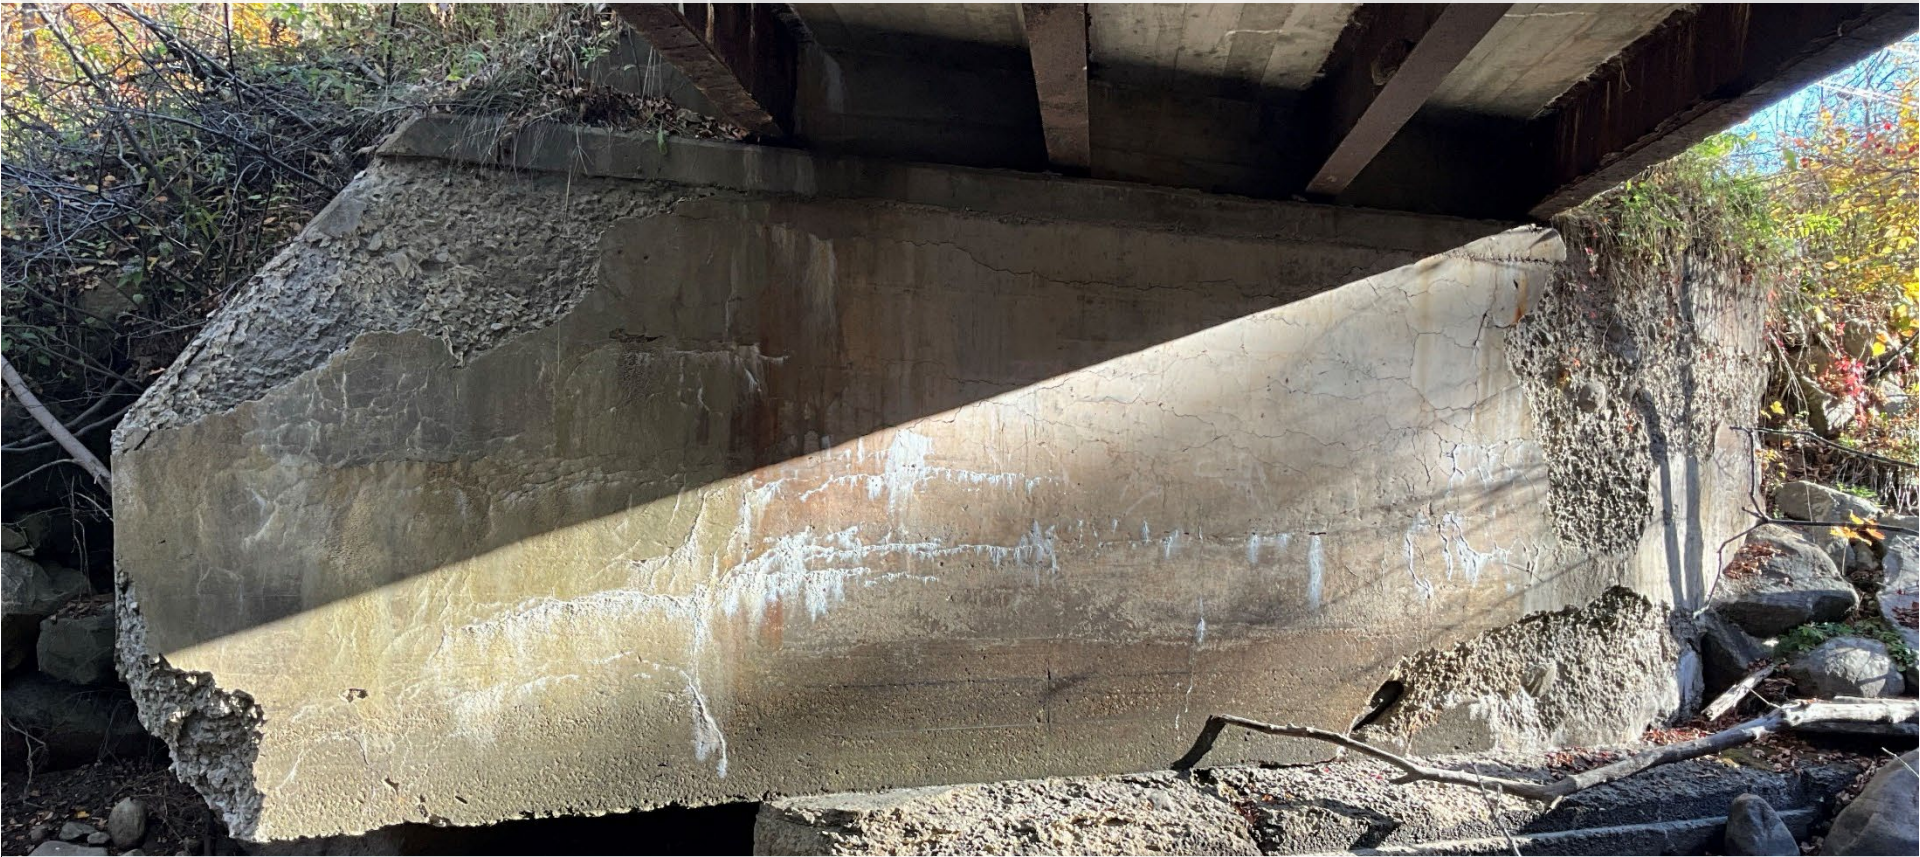
# Bridge Inspection Report Ratings

- Deck Rating 6 (Satisfactory)
- Superstructure Rating 4 (Poor)
- Substructure Rating 5 (Fair)
- Channel Rating 5 (Fair)

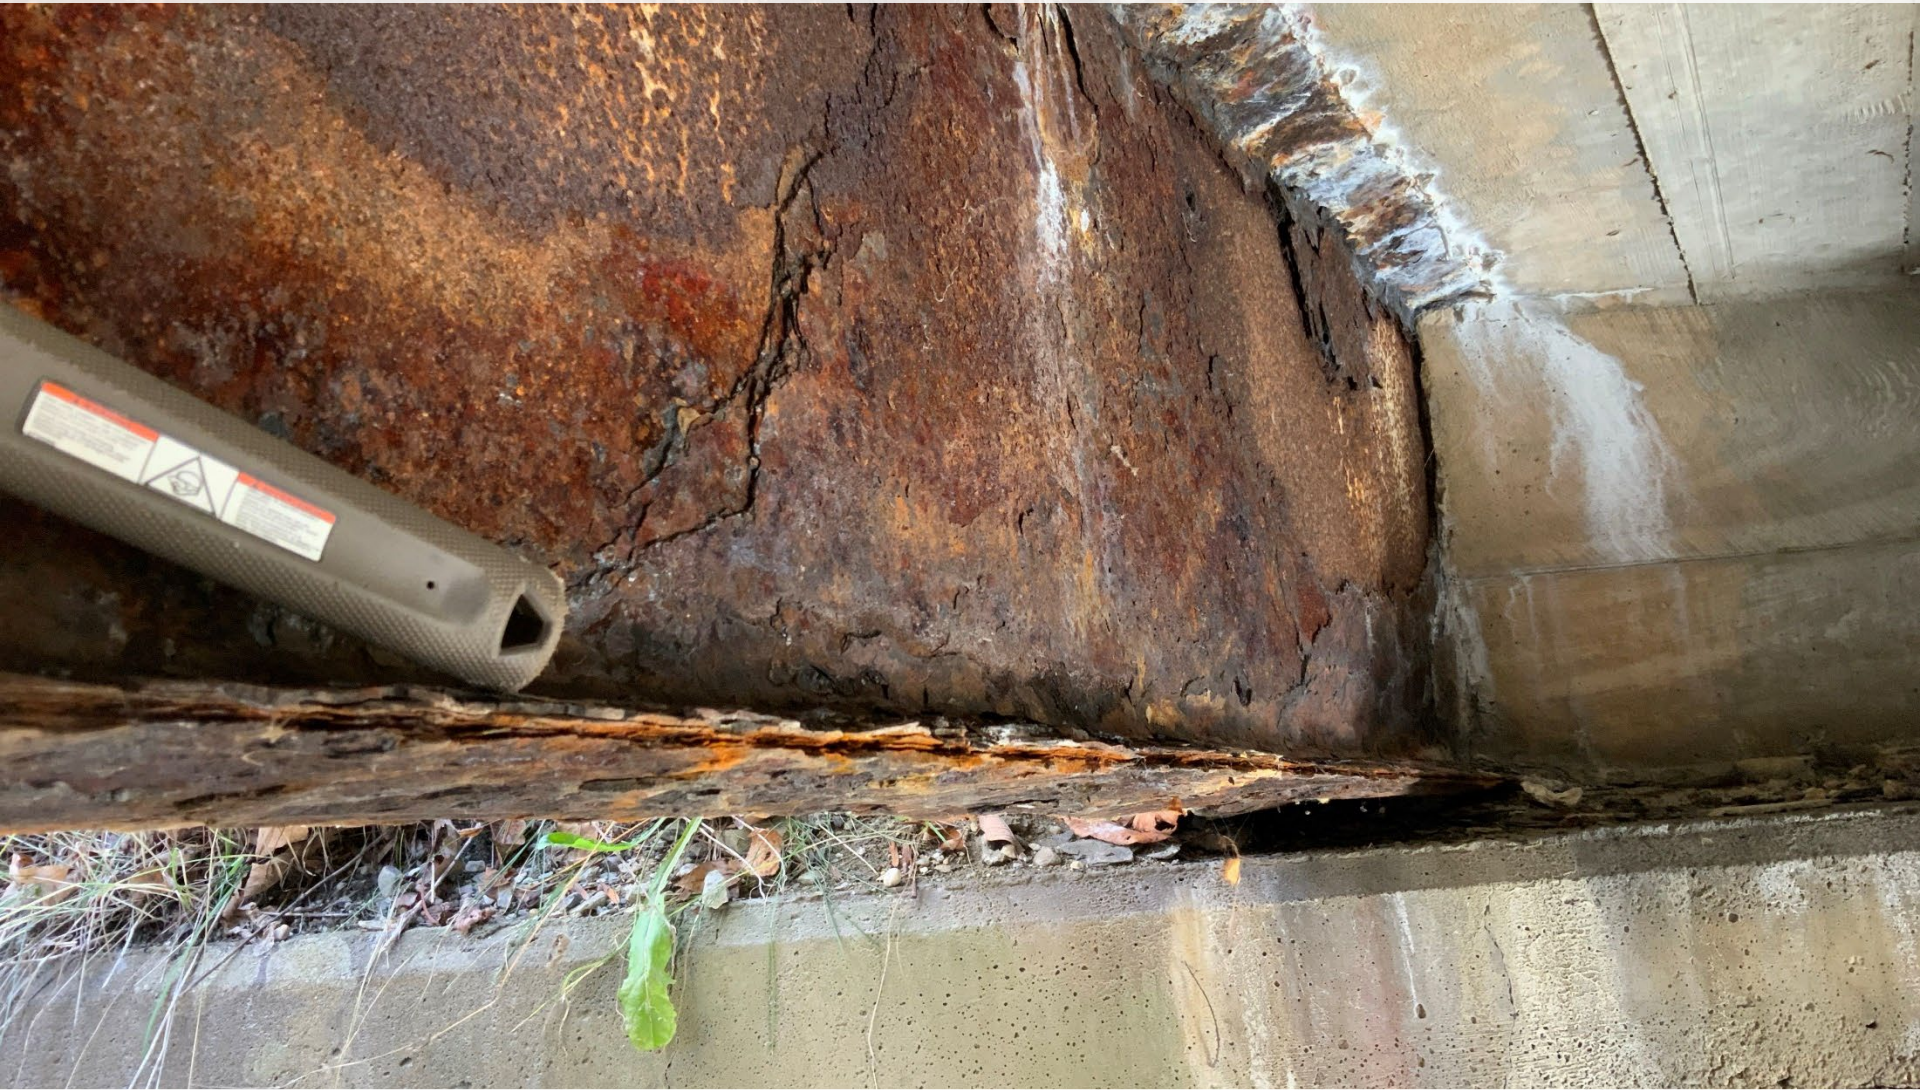
## Fascia Beam Rust

- The bridge has heavy deterioration and map cracking along the abutments, backwalls, and wingwalls.. There are many areas of section loss along the fascia beams and bottom flanges along the bridge. Scour hole occurring under one wingwall.
- The bridge does not meet the minimum standards for width.
- The bridge railing is substandard.
- Does not meet hydraulic standard for bank full width, and has a scour critical rating
