Woodstock BF 0166(12)

Alternatives Presentation Meeting

FAS Route 166 (TH 1), Bridge 1 over Gulf Stream

September 20, 2022

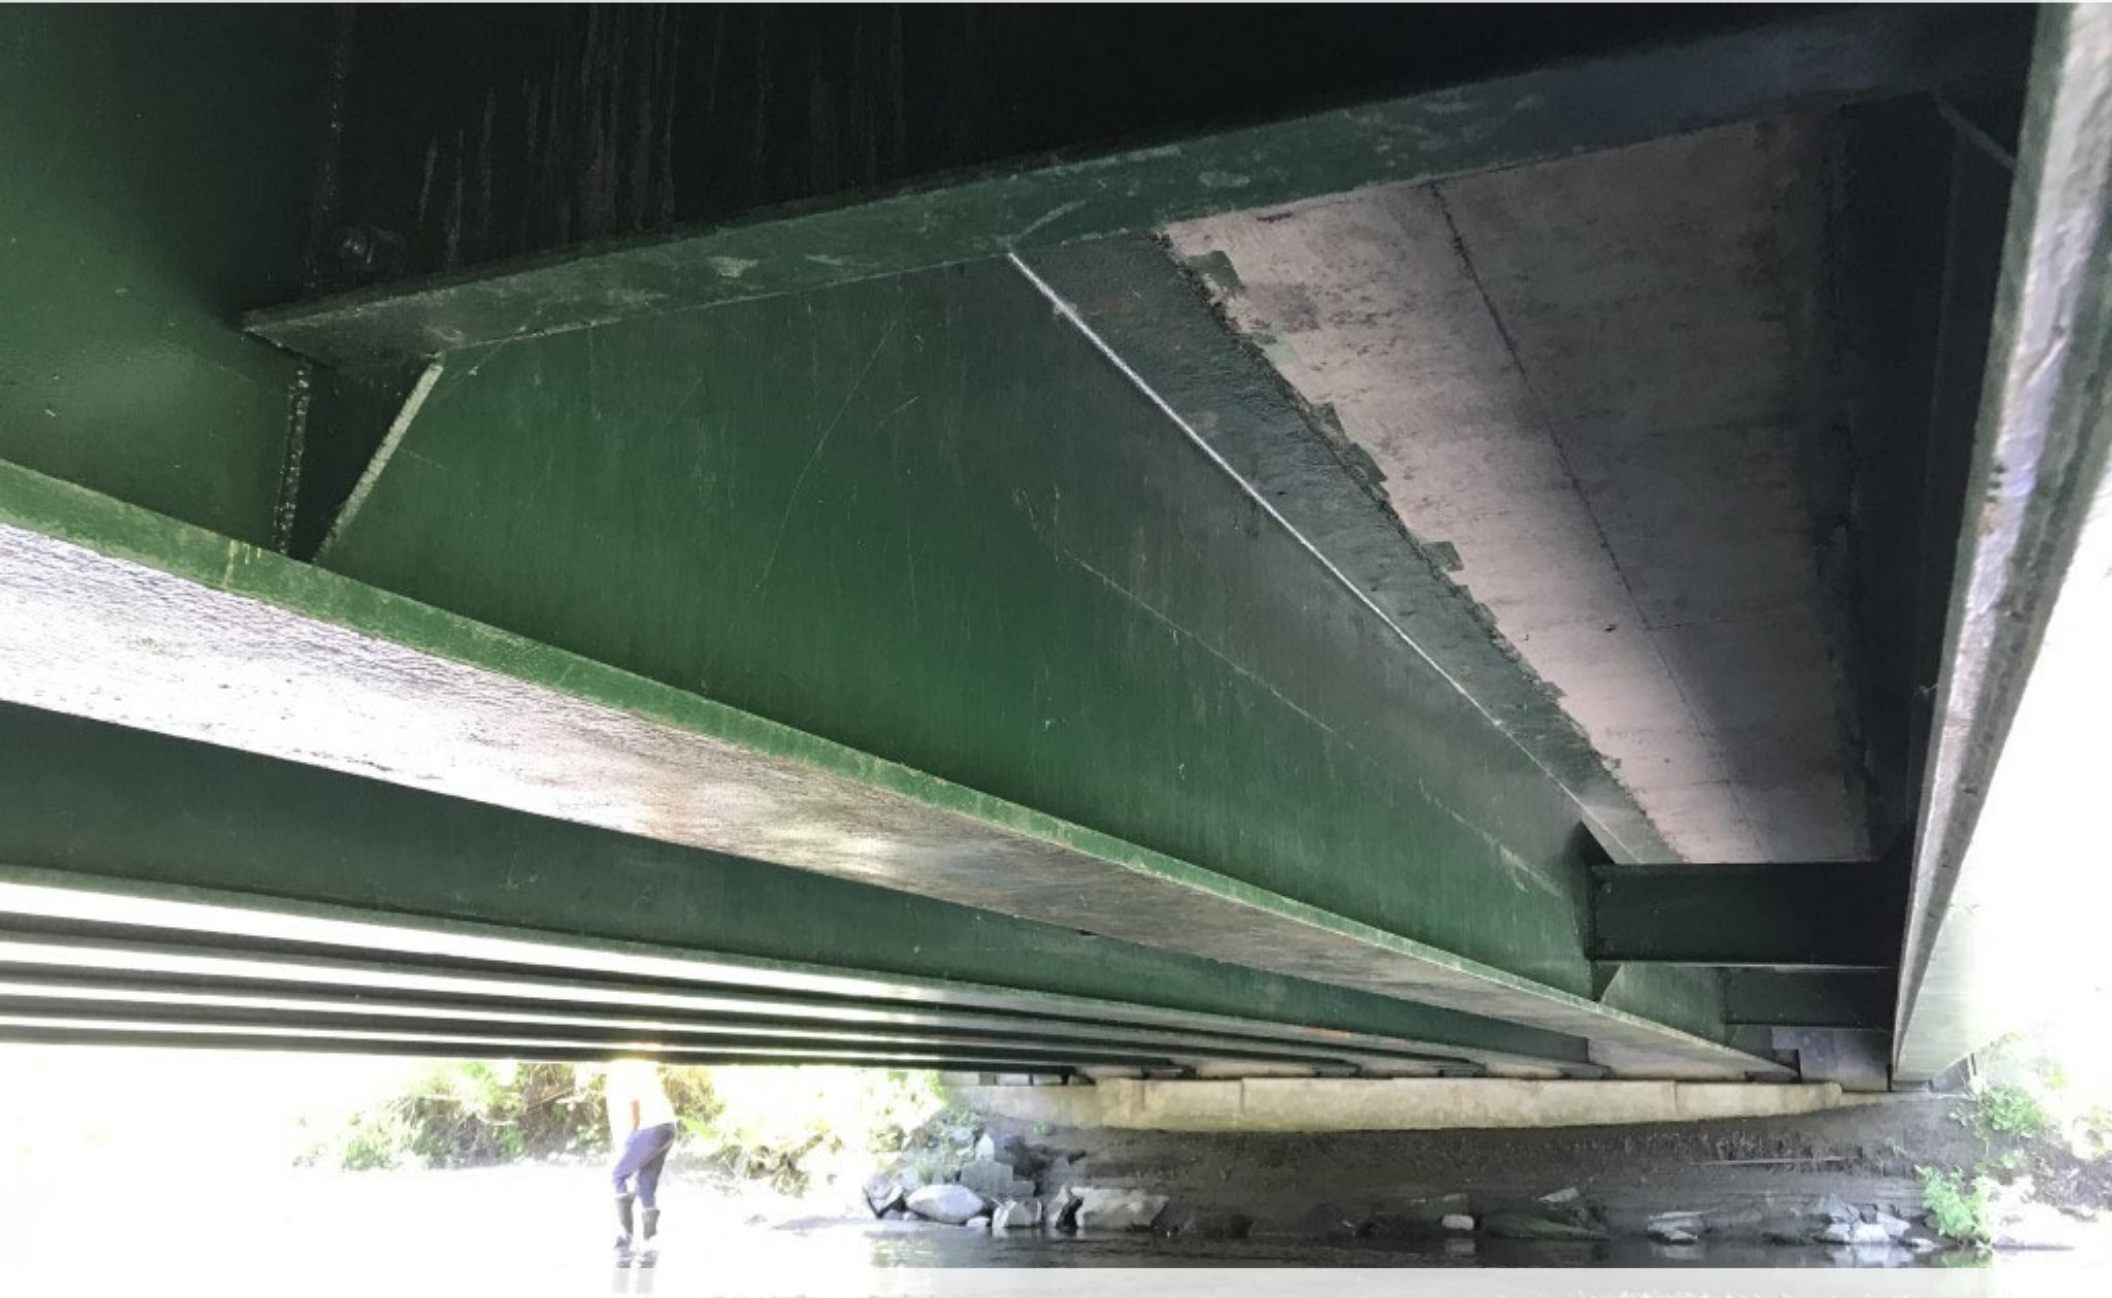
Typical Abutment Condition

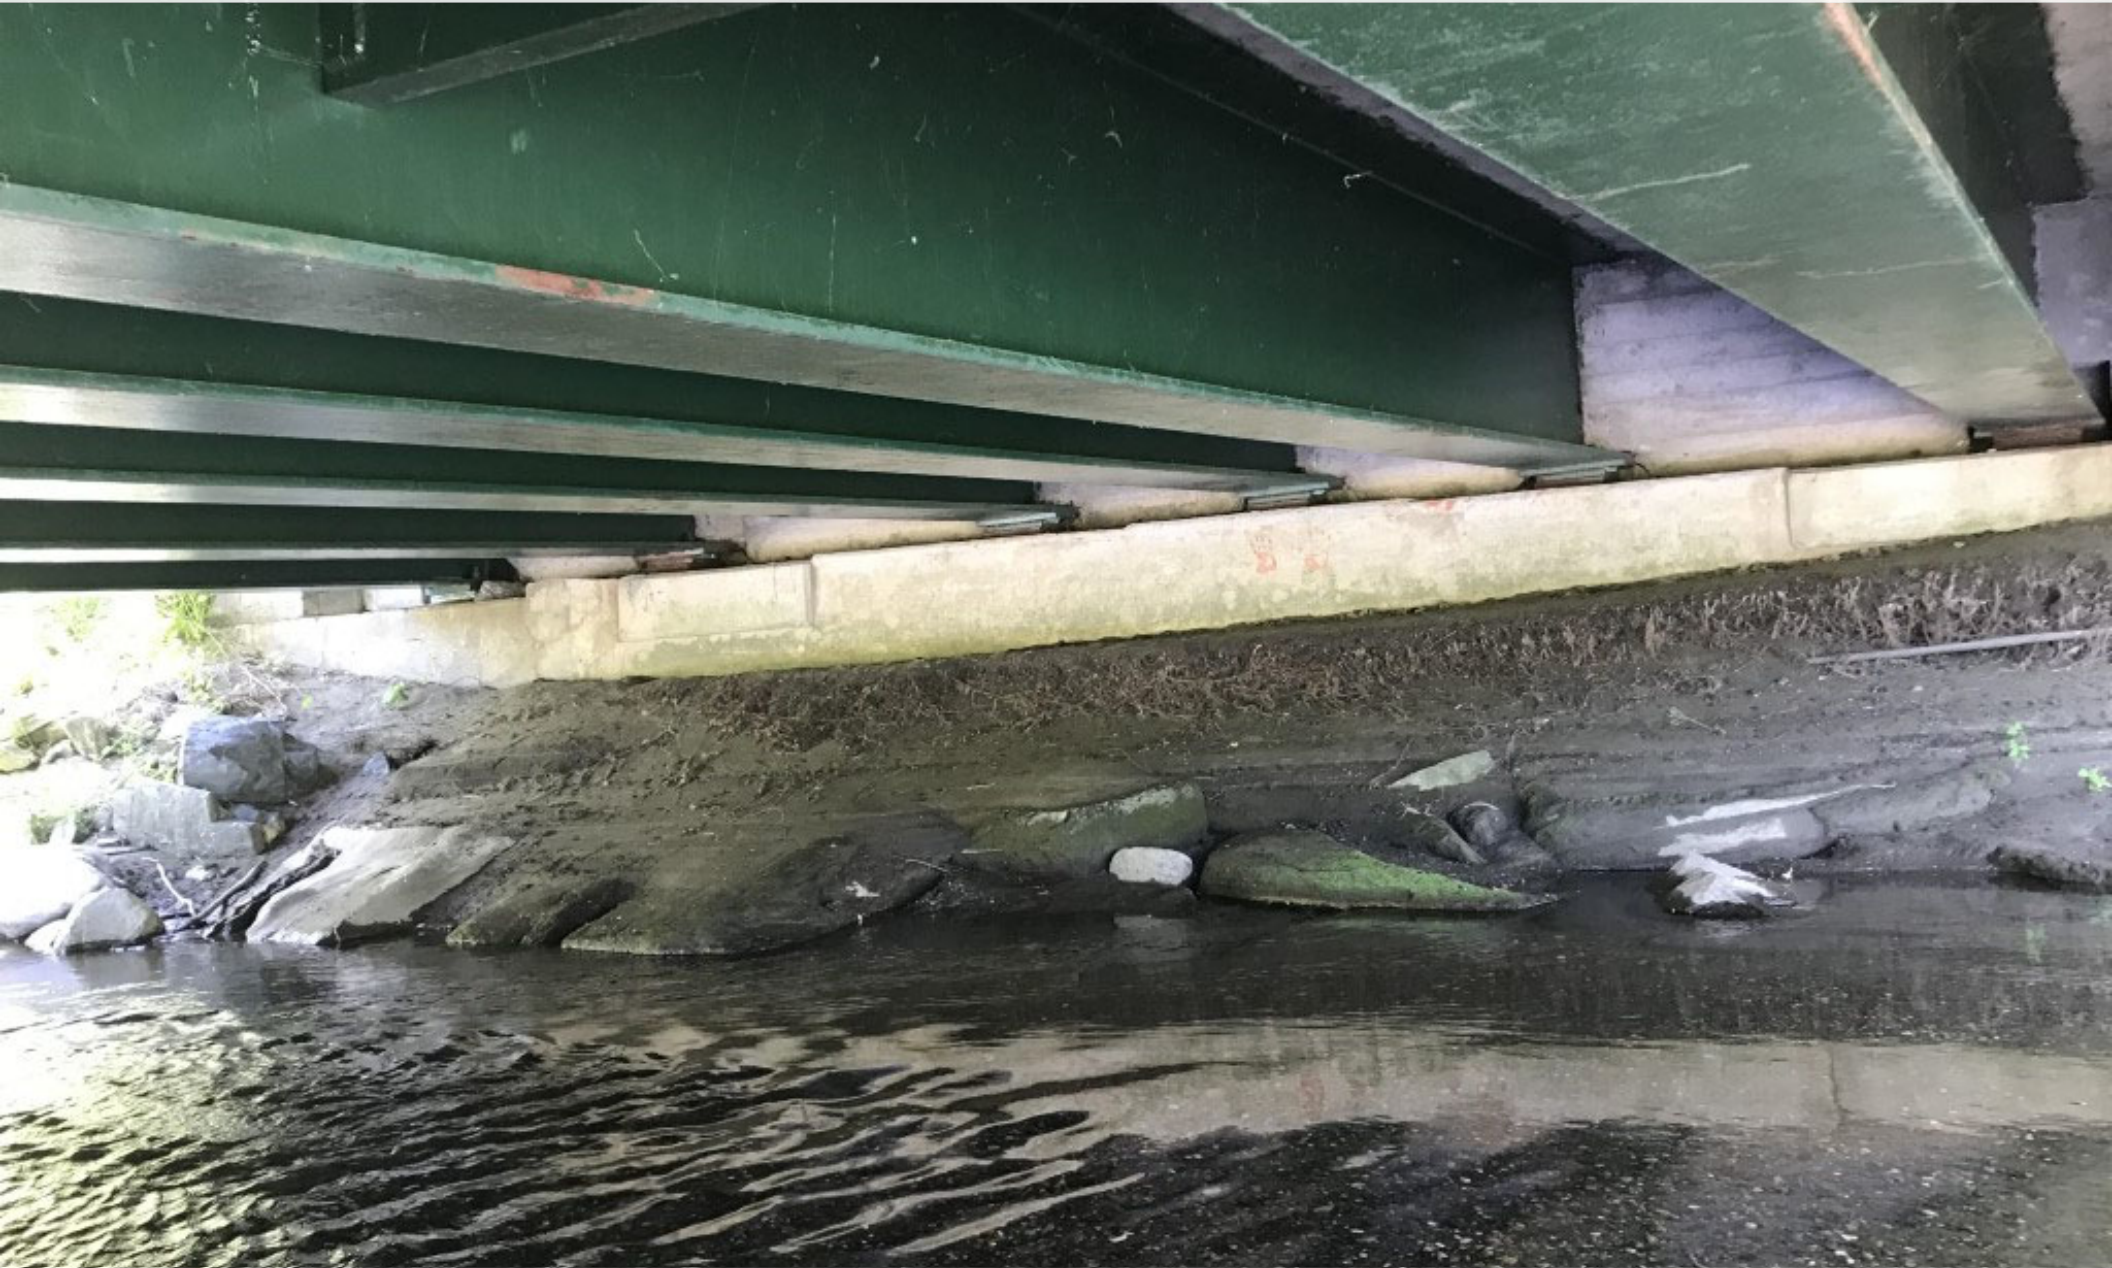
Typical Backwall Condition

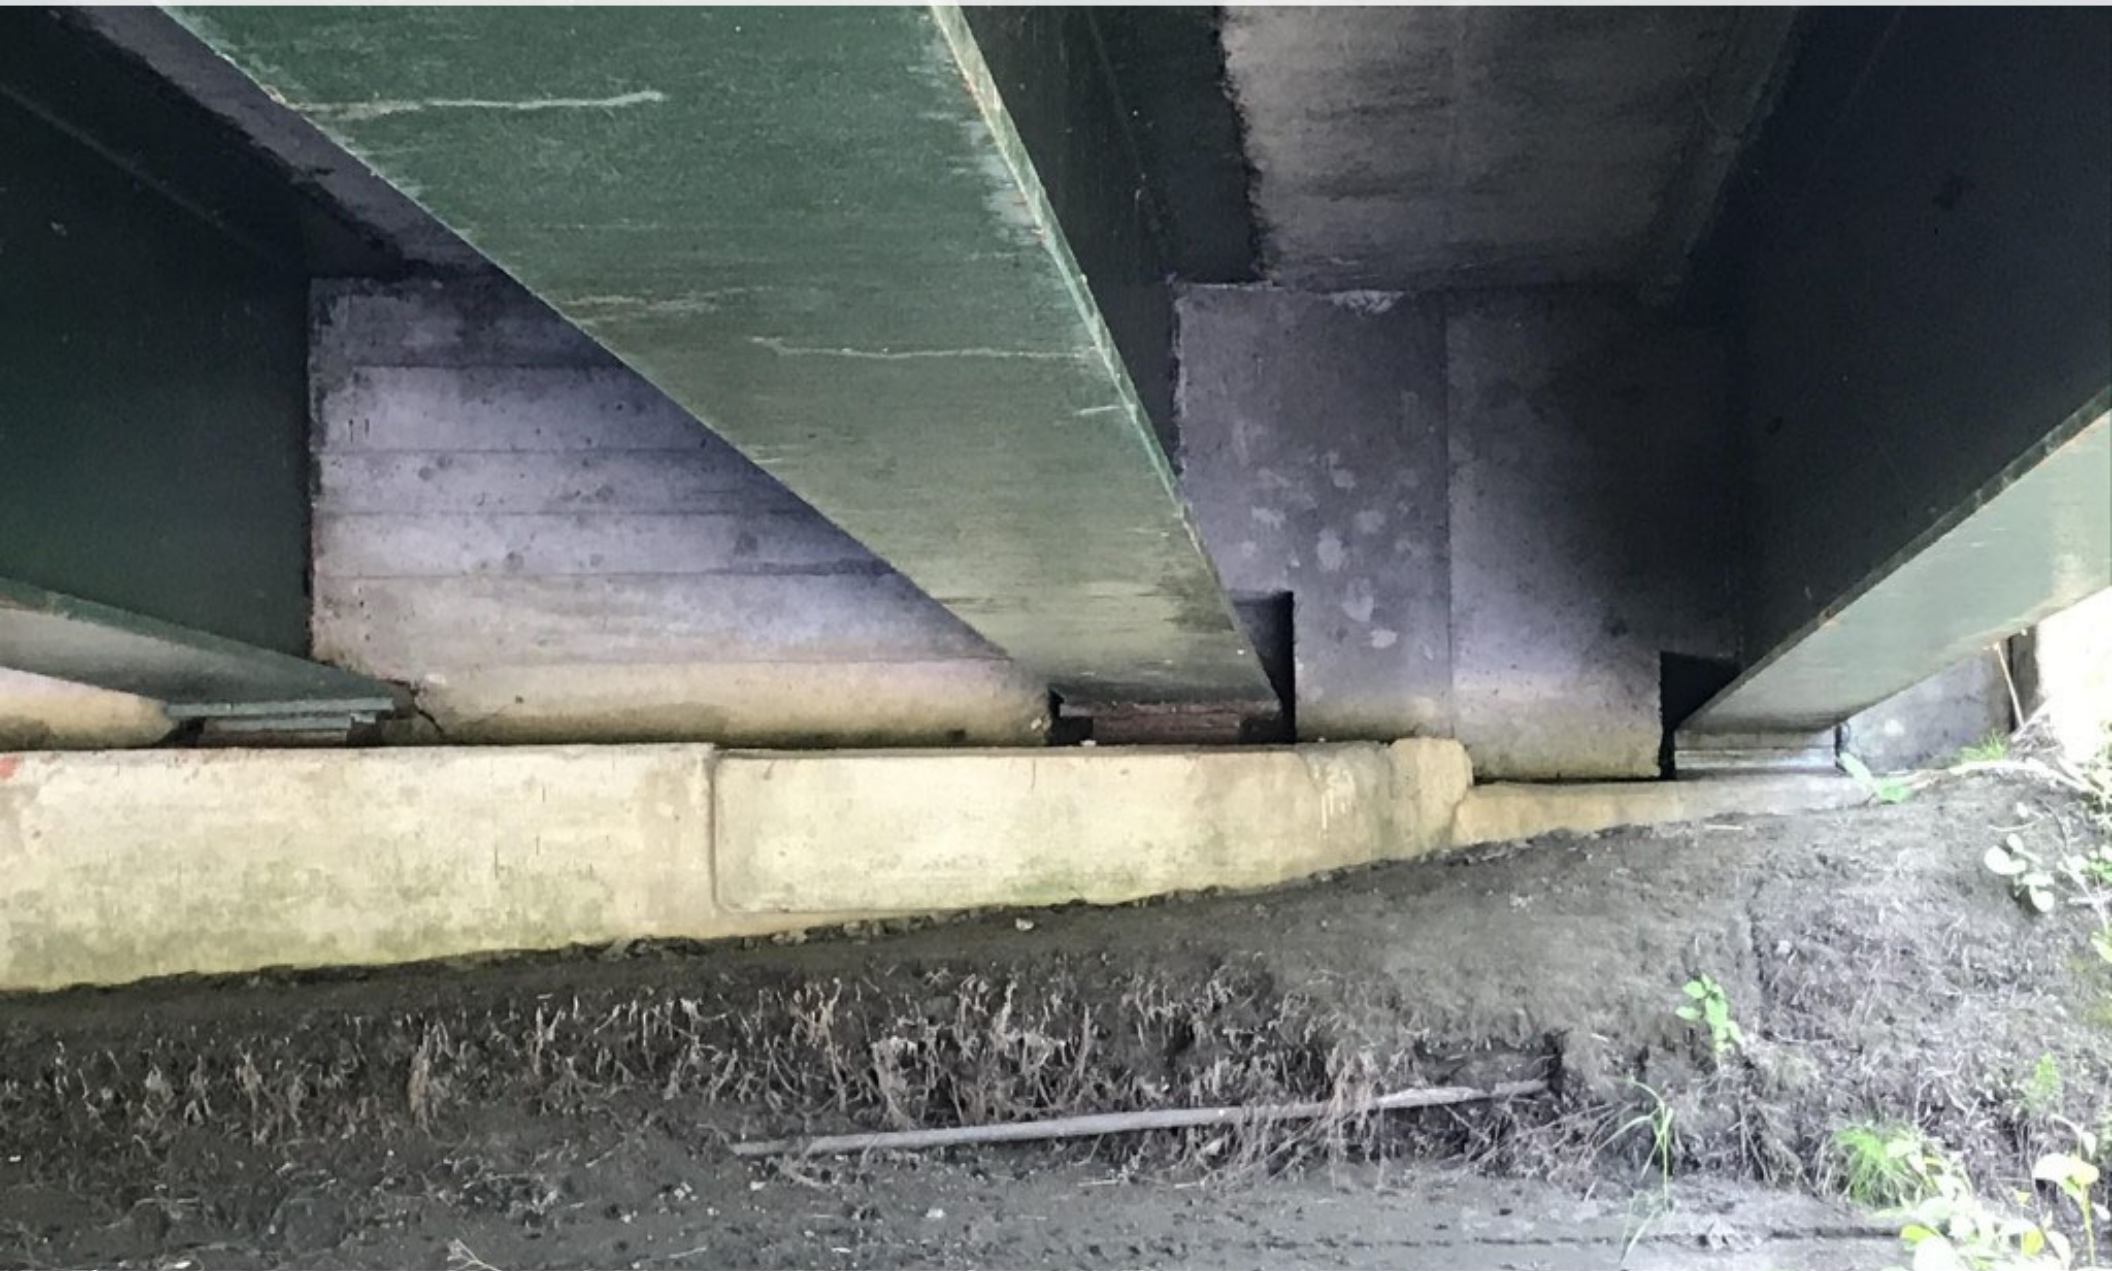
Debris Build-up Following Large Flow Event

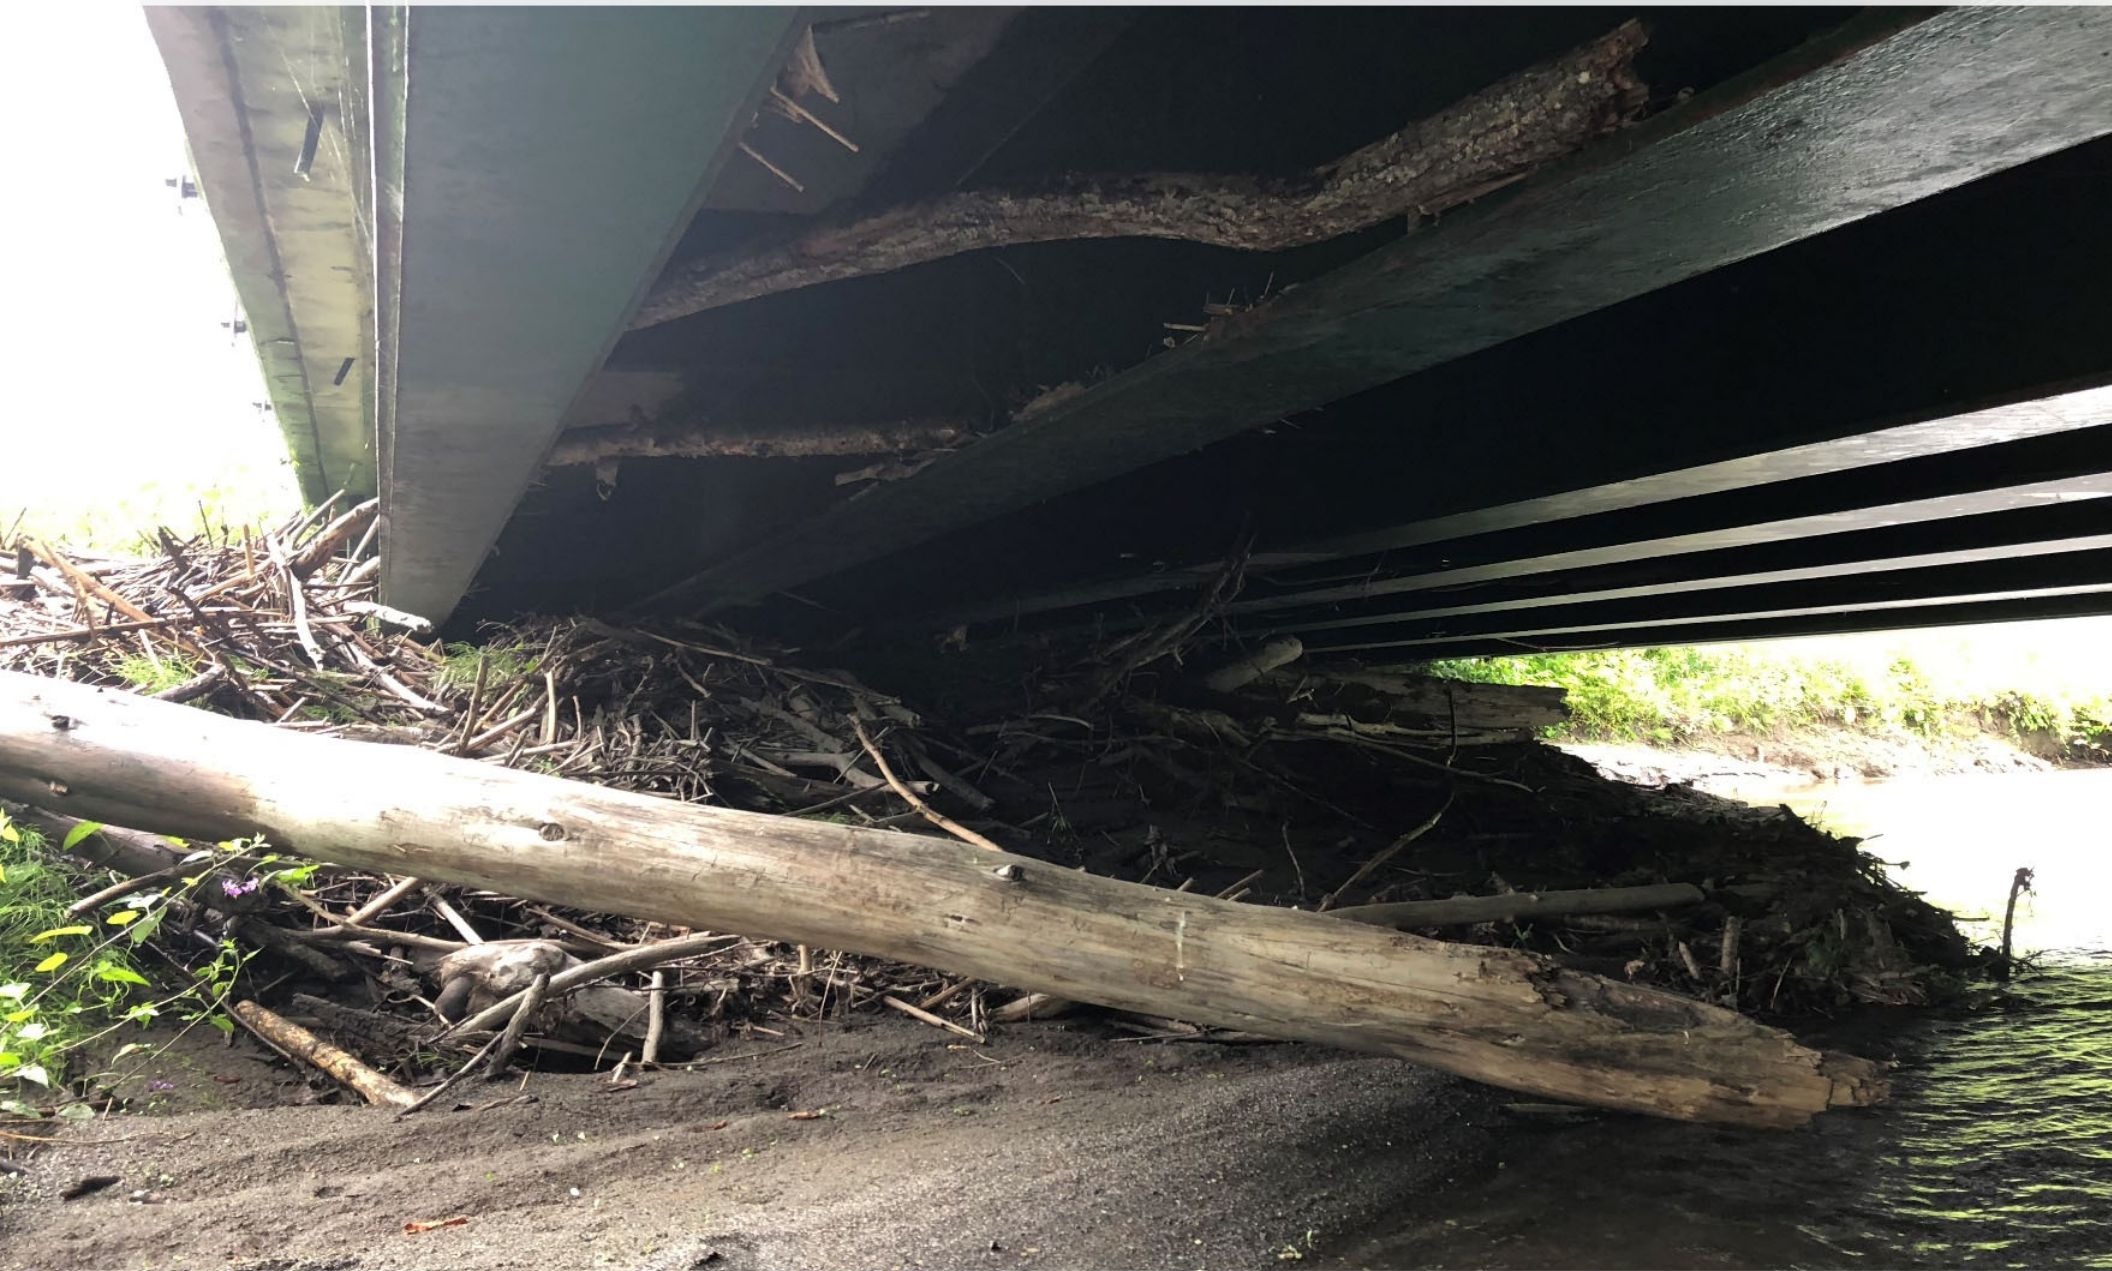
Corroded Box Drain
