STATE OF VERMONT
AGENCY OF TRANSPORTATION

Scoping Report

Weybridge-New Haven BF 032-1(19)
VT ROUTE 17, BRIDGE 8 OVER OTTER CREEK

April 6, 2016

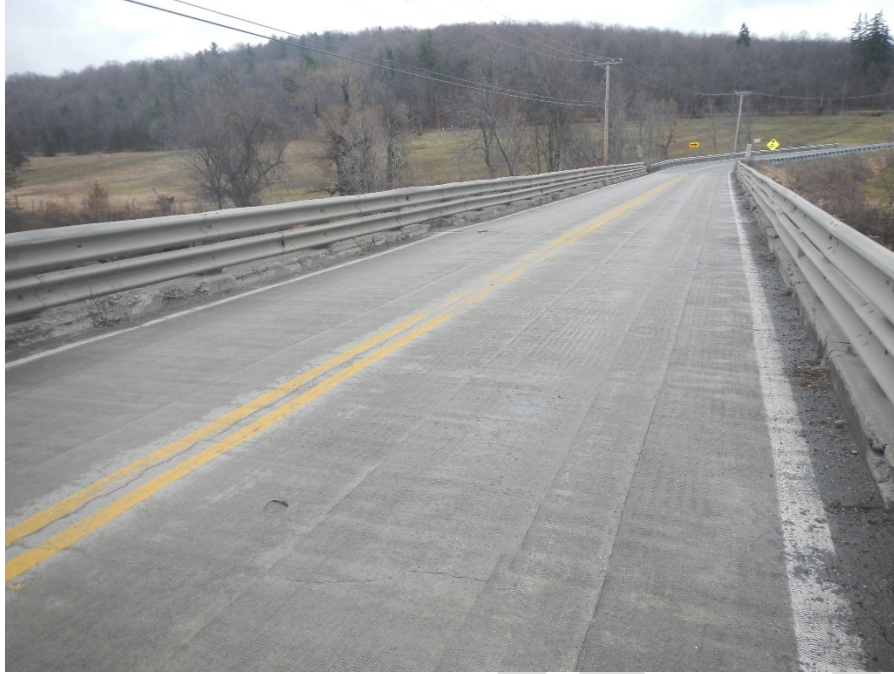
Photo 1: Bridge 8 – Looking West, Typical Top of Deck

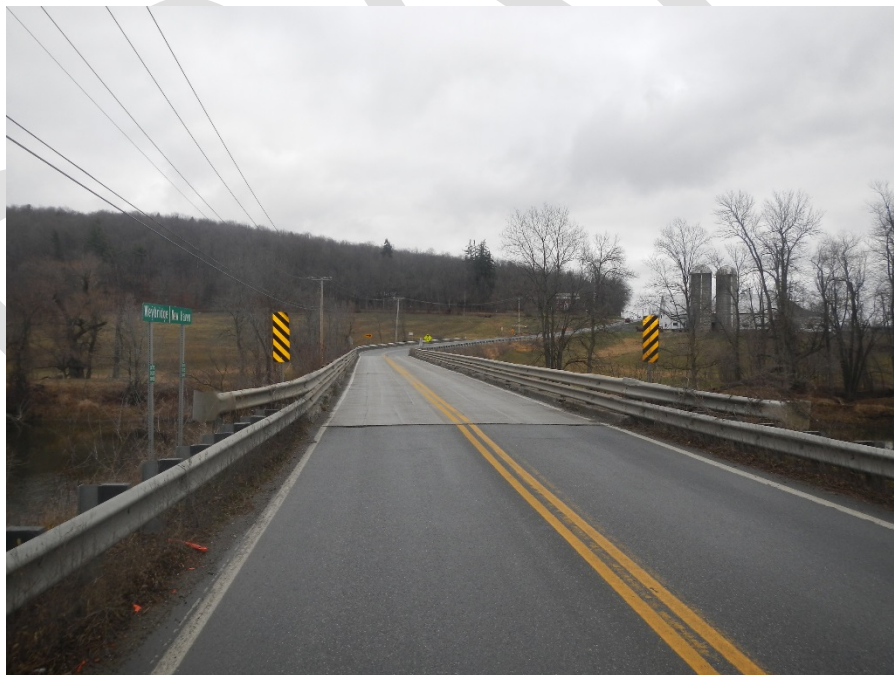
Photo 2: Bridge 8 – West Approach looking East

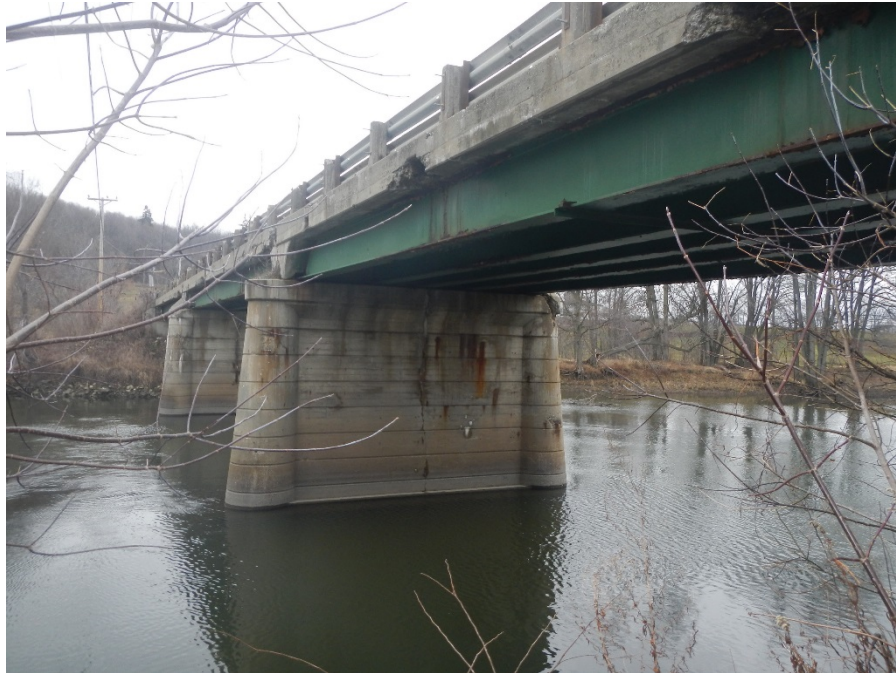
Photo 5: Bridge 8 – Looking at North Fascia, Typical Pier and Typical Superstructure

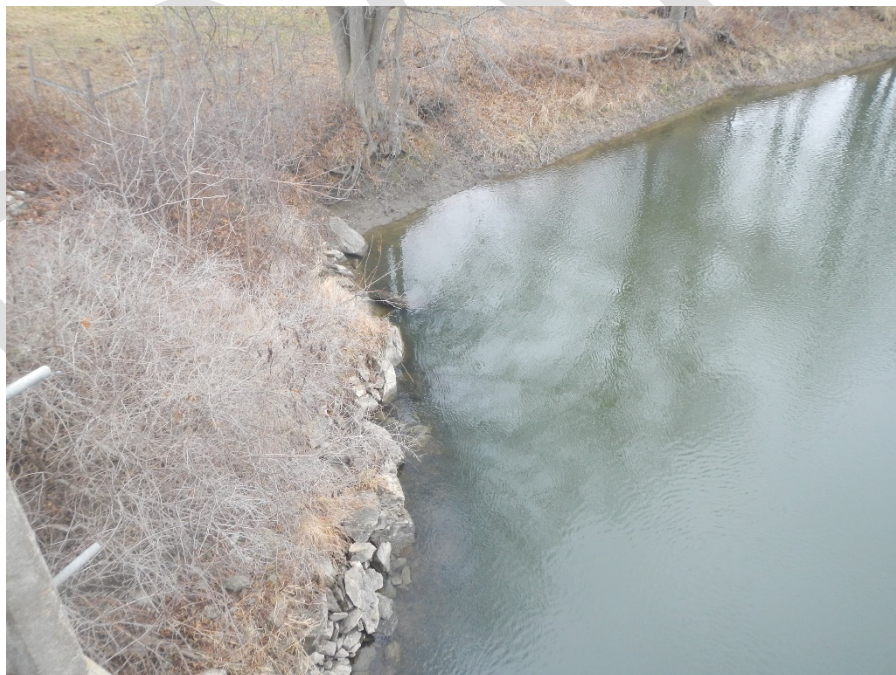
Photo 6: Bridge 8 – Northeast embankment, North Abutment No. 1

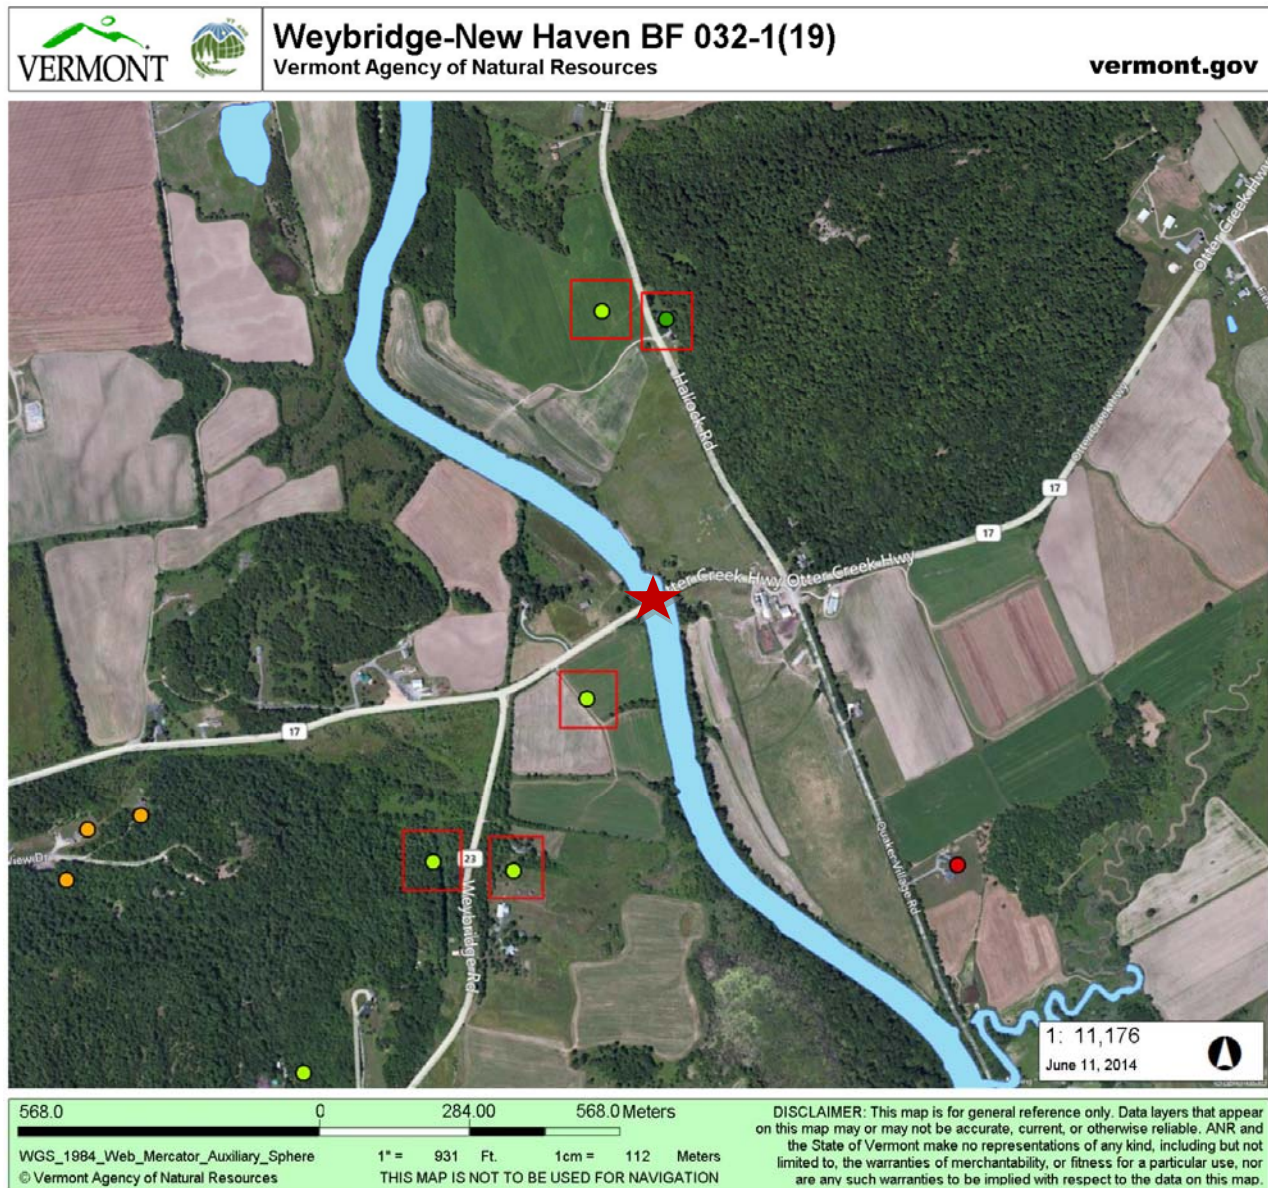
Figure 1 shows the project and the locations of surrounding wells. The wells used for information on the subsurface conditions are highlighted by red boxes.

Figure 1. Highlighted well locations near subject project

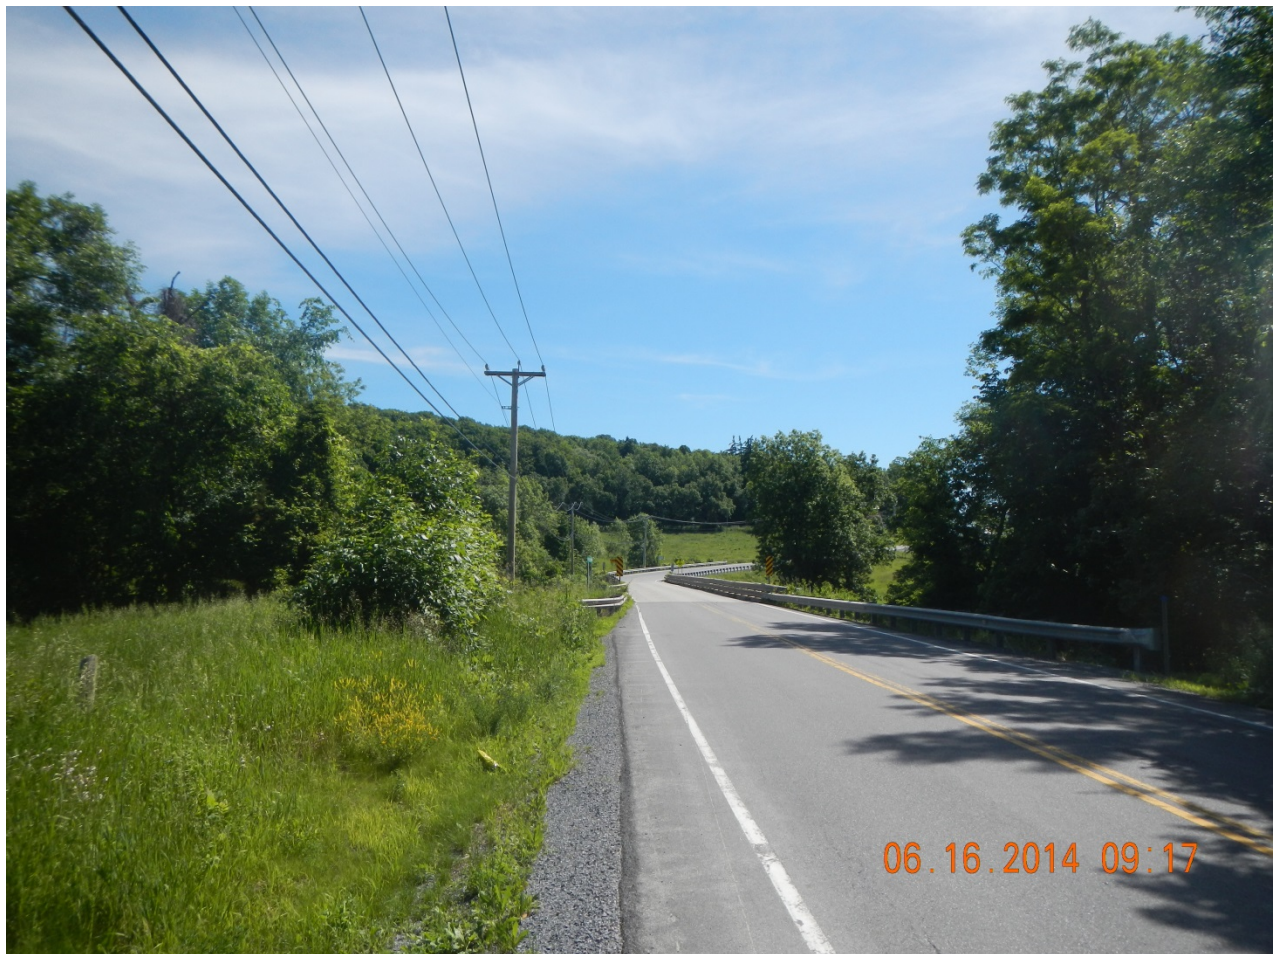
Figure 2. View of Bridge, Looking Northeast

Overhead utilities run along the North side of the bridge, Figure 2, but should not conflict with boring operations.

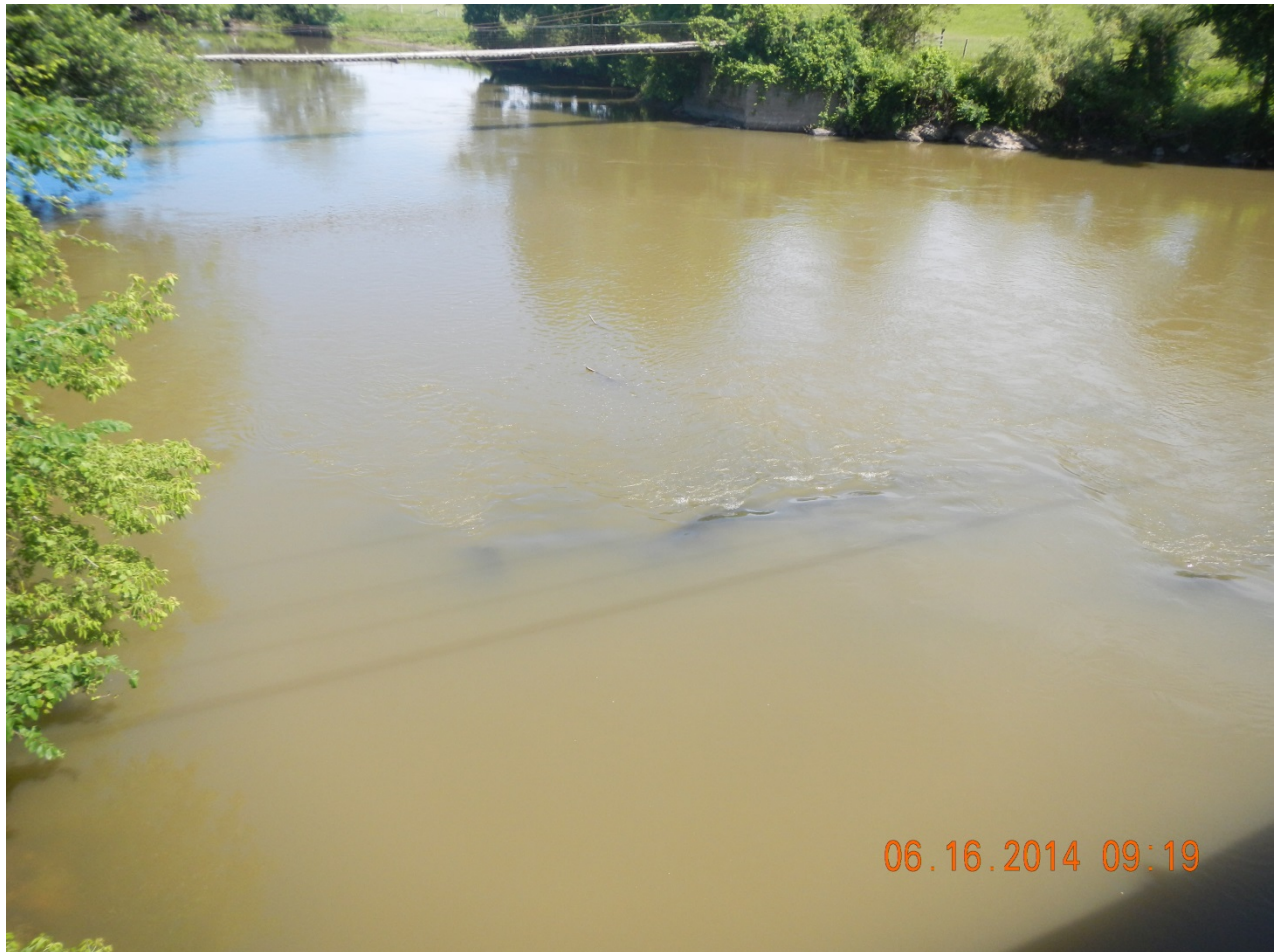
The surrounding surficial soils are within the floodplain. The sides of the rivers were heavily vegetated and the water had high turbidity which made it difficult to see the streambed or any evidence of erosion of the banks. From what we could observe there was minimal scour and erosion at the bridge piers and river banks. There were a couple large boulders on the North side of the bridge as shown in Figure 3.

Figure 3. Submerged boulders on the North side of the bridge

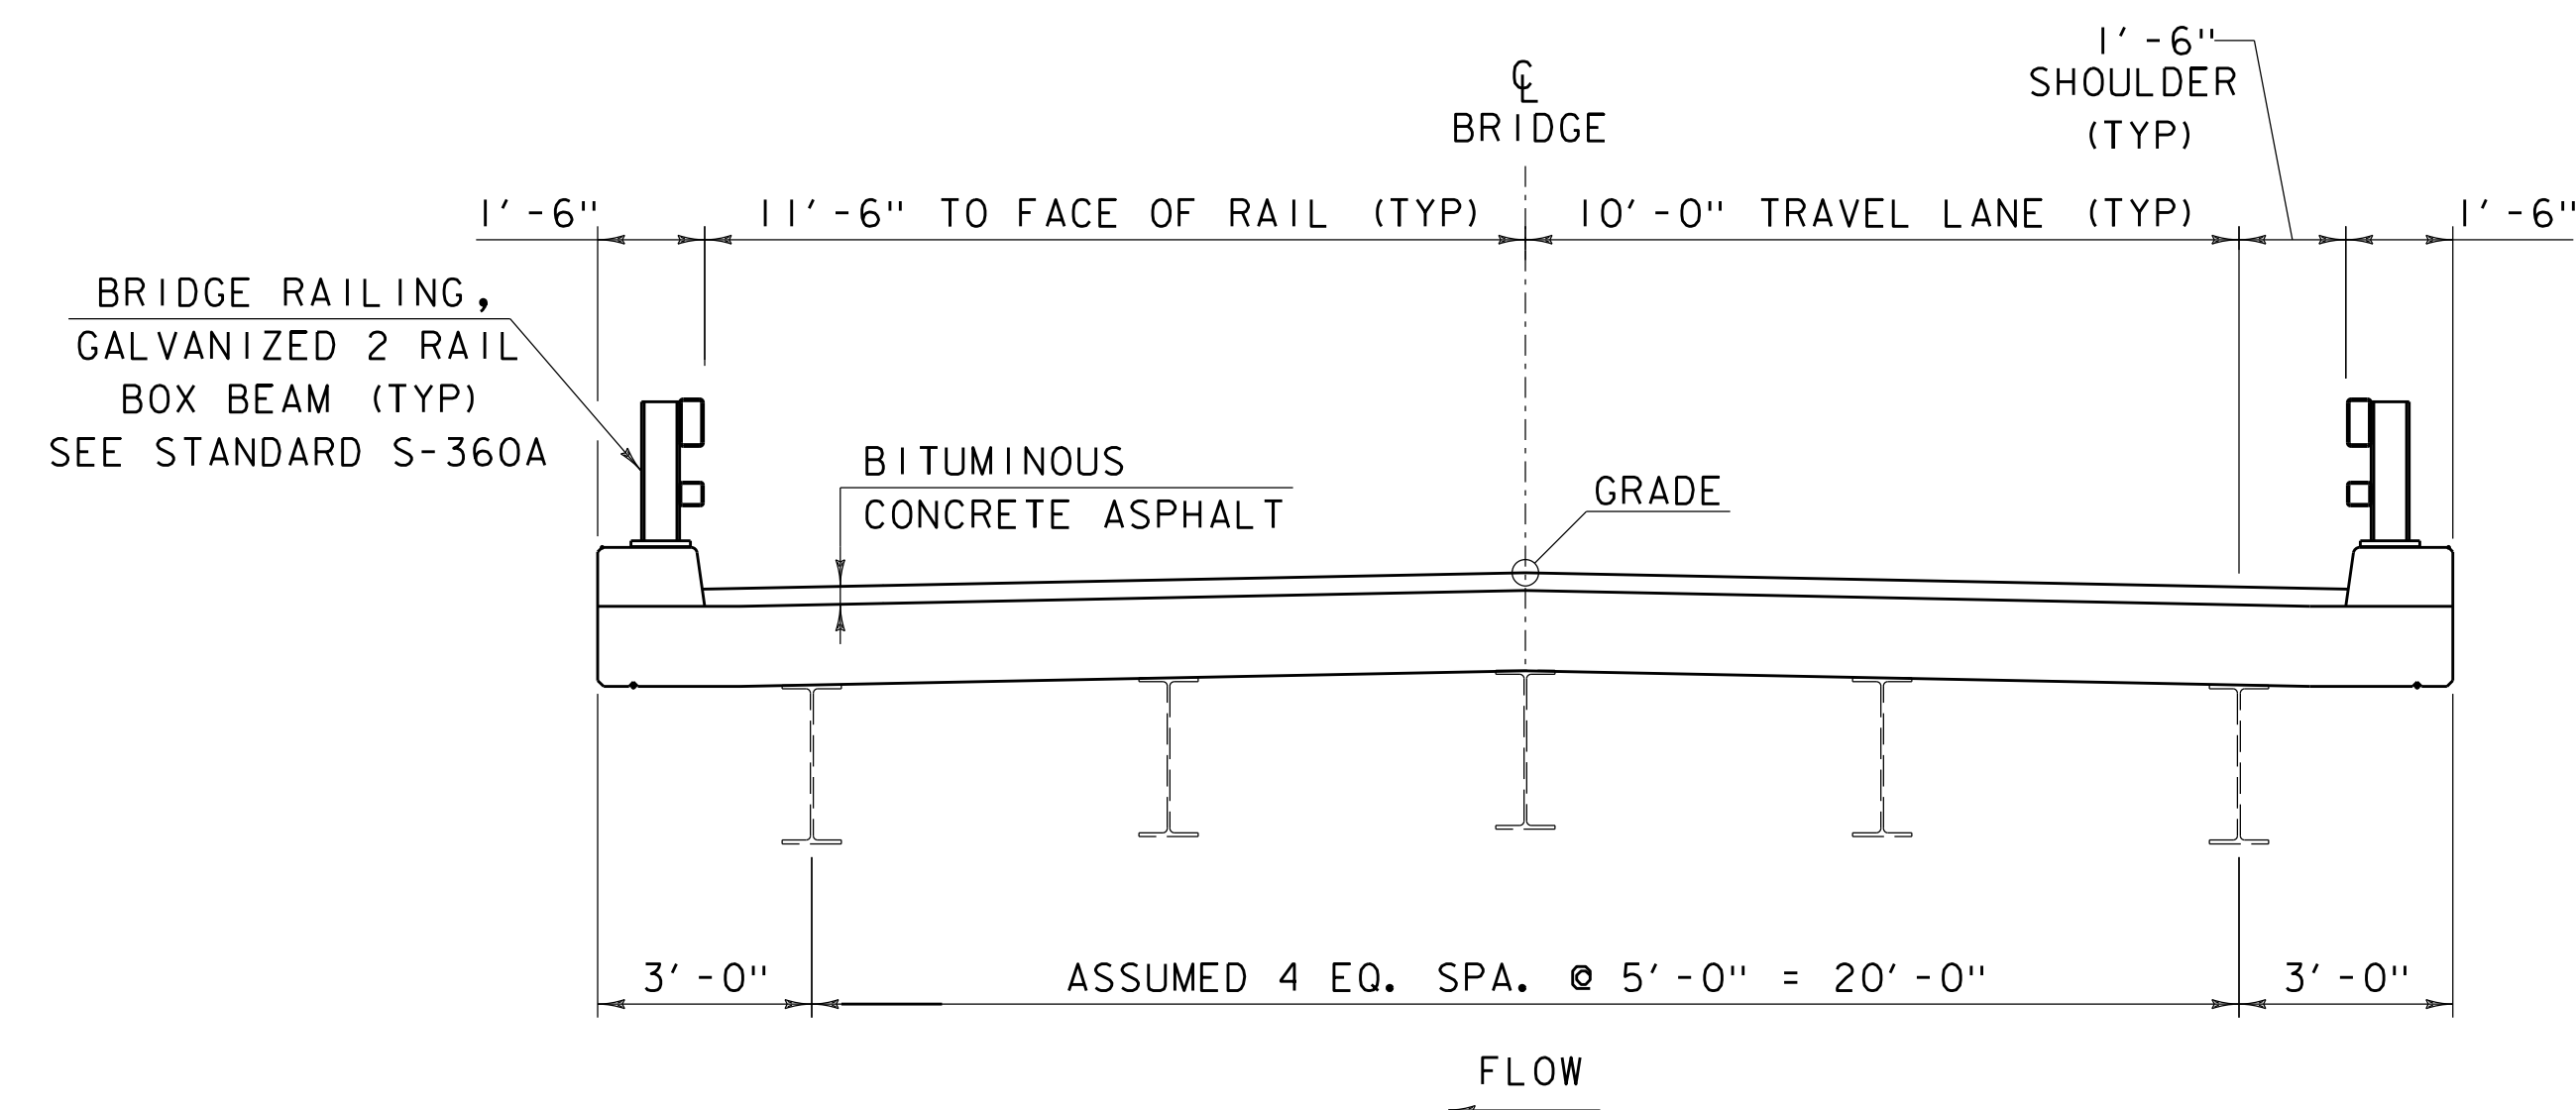
ALTERNATIVE 1 & 2 PROPOSED VT ROUTE 17 BRIDGE TYPICAL SECTION

It is assumed that this alternative would have the same typical section as the deck replacement, 1.5'-10'-10'-1.5', since the substructure and alignment are being maintained. A slightly wider typical section may be possible, however, it can only be determined after more detailed structural analysis. Traffic could be maintained by detour route or a temporary bridge. Phasing is not an option for this alternative due to the limited bridge width.

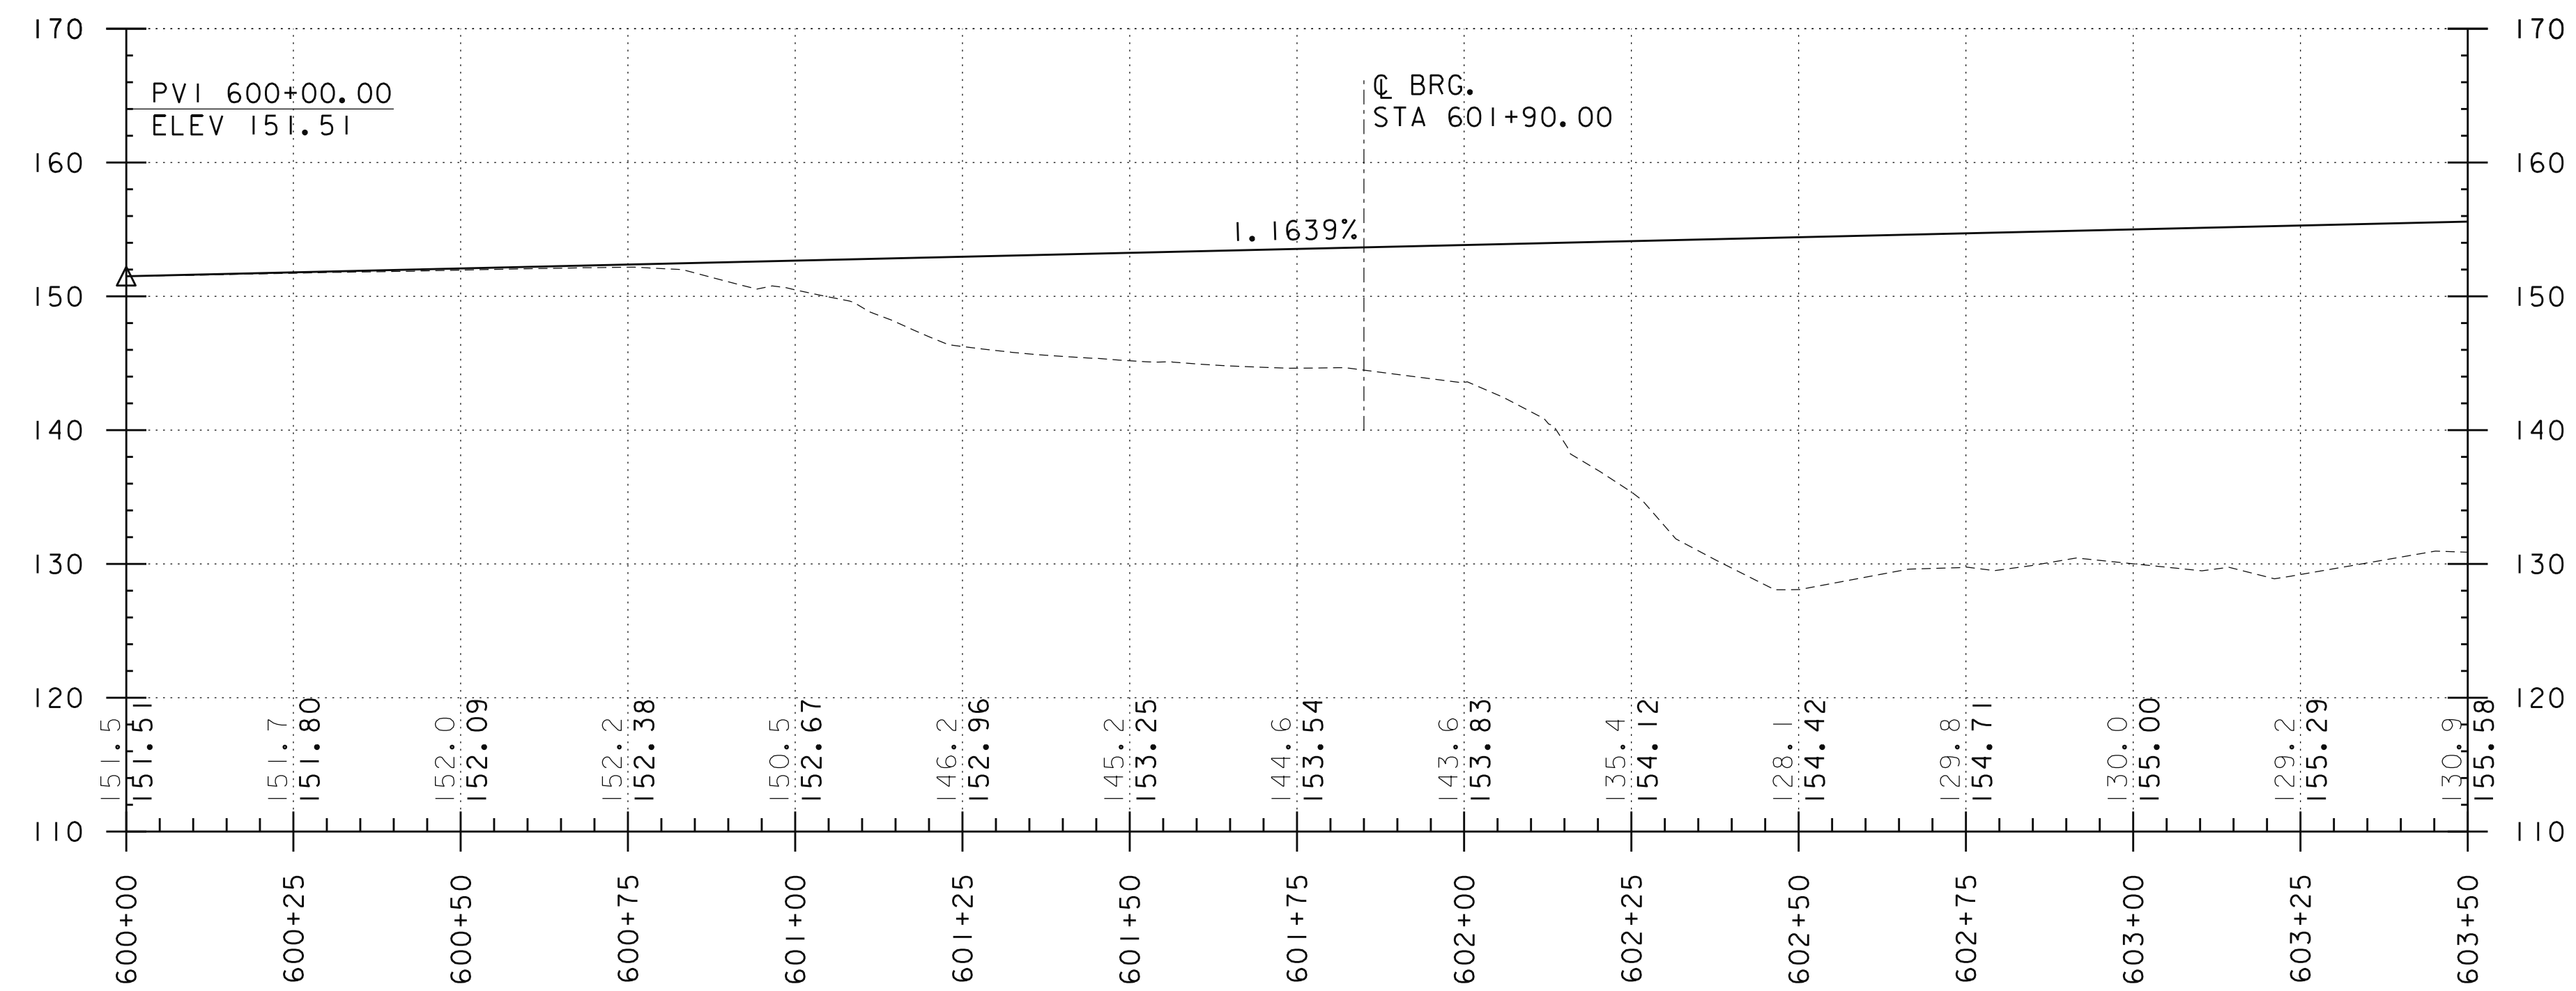
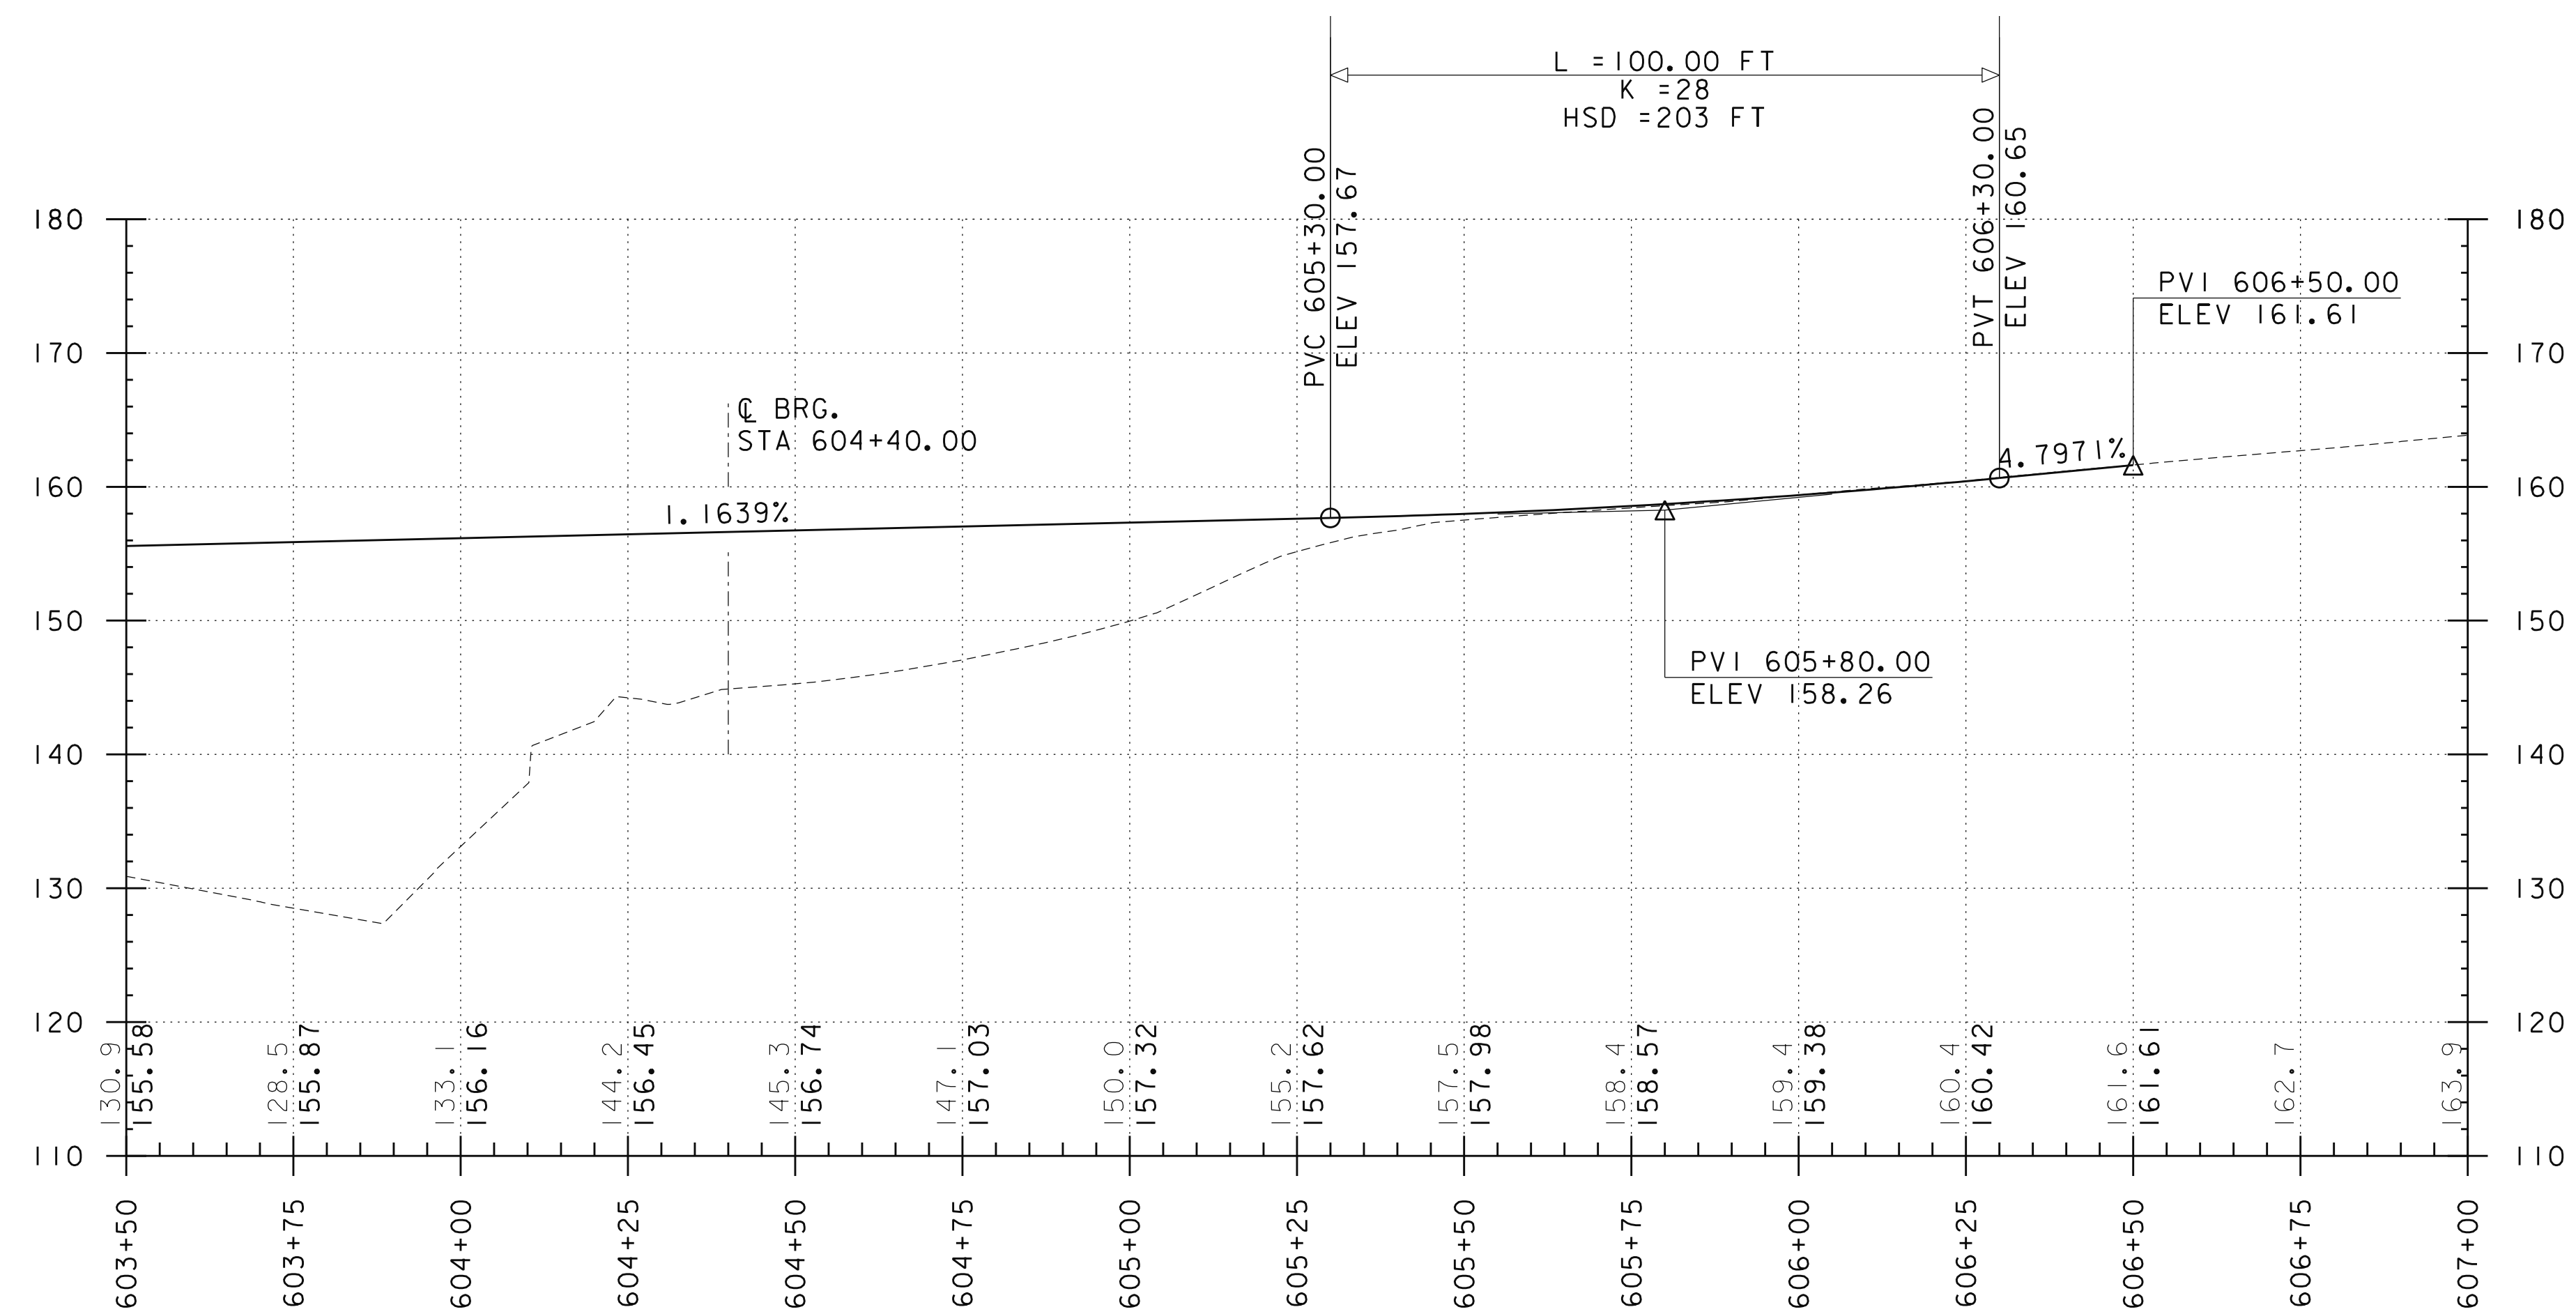
TEMPORARY BRIDGE PROFILE
 SCALE: HORIZONTAL 1"=20'
 VERTICAL 1"=10'

Based on the daily traffic volumes, a one-lane temporary bridge with two-way alternating traffic, controlled by a temporary signal, would be appropriate. There would be some delays and disruption to traffic with the alternating signal and the speed limit would need to be reduced to 25 mph to limit impacts. This is reasonable given the proximity to Hallock Road intersection to the east which has an advisory speed limit of 25 mph under current conditions. Based on a preliminary capacity analysis of the temporary traffic signal, utilizing the Synchro 9 software, average vehicle delays are expected to be approximately 20 seconds, which corresponds with Level of Service (LOS) "C" operating conditions. The vehicle queues at either end of the bridge are expected to be approximately 2-3 vehicles in length. See Appendix K for the Level of Service analysis. Additional costs would be incurred to use a temporary bridge, including the cost of the bridge itself, installation and removal, and restoration of the disturbed area. Additional studies would be triggered by the impacts to the archeologically sensitive areas, wetlands, and habitat of threatened and endangered species in the area. A single span temporary bridge is feasible but costly due to the 230' plus span length required.

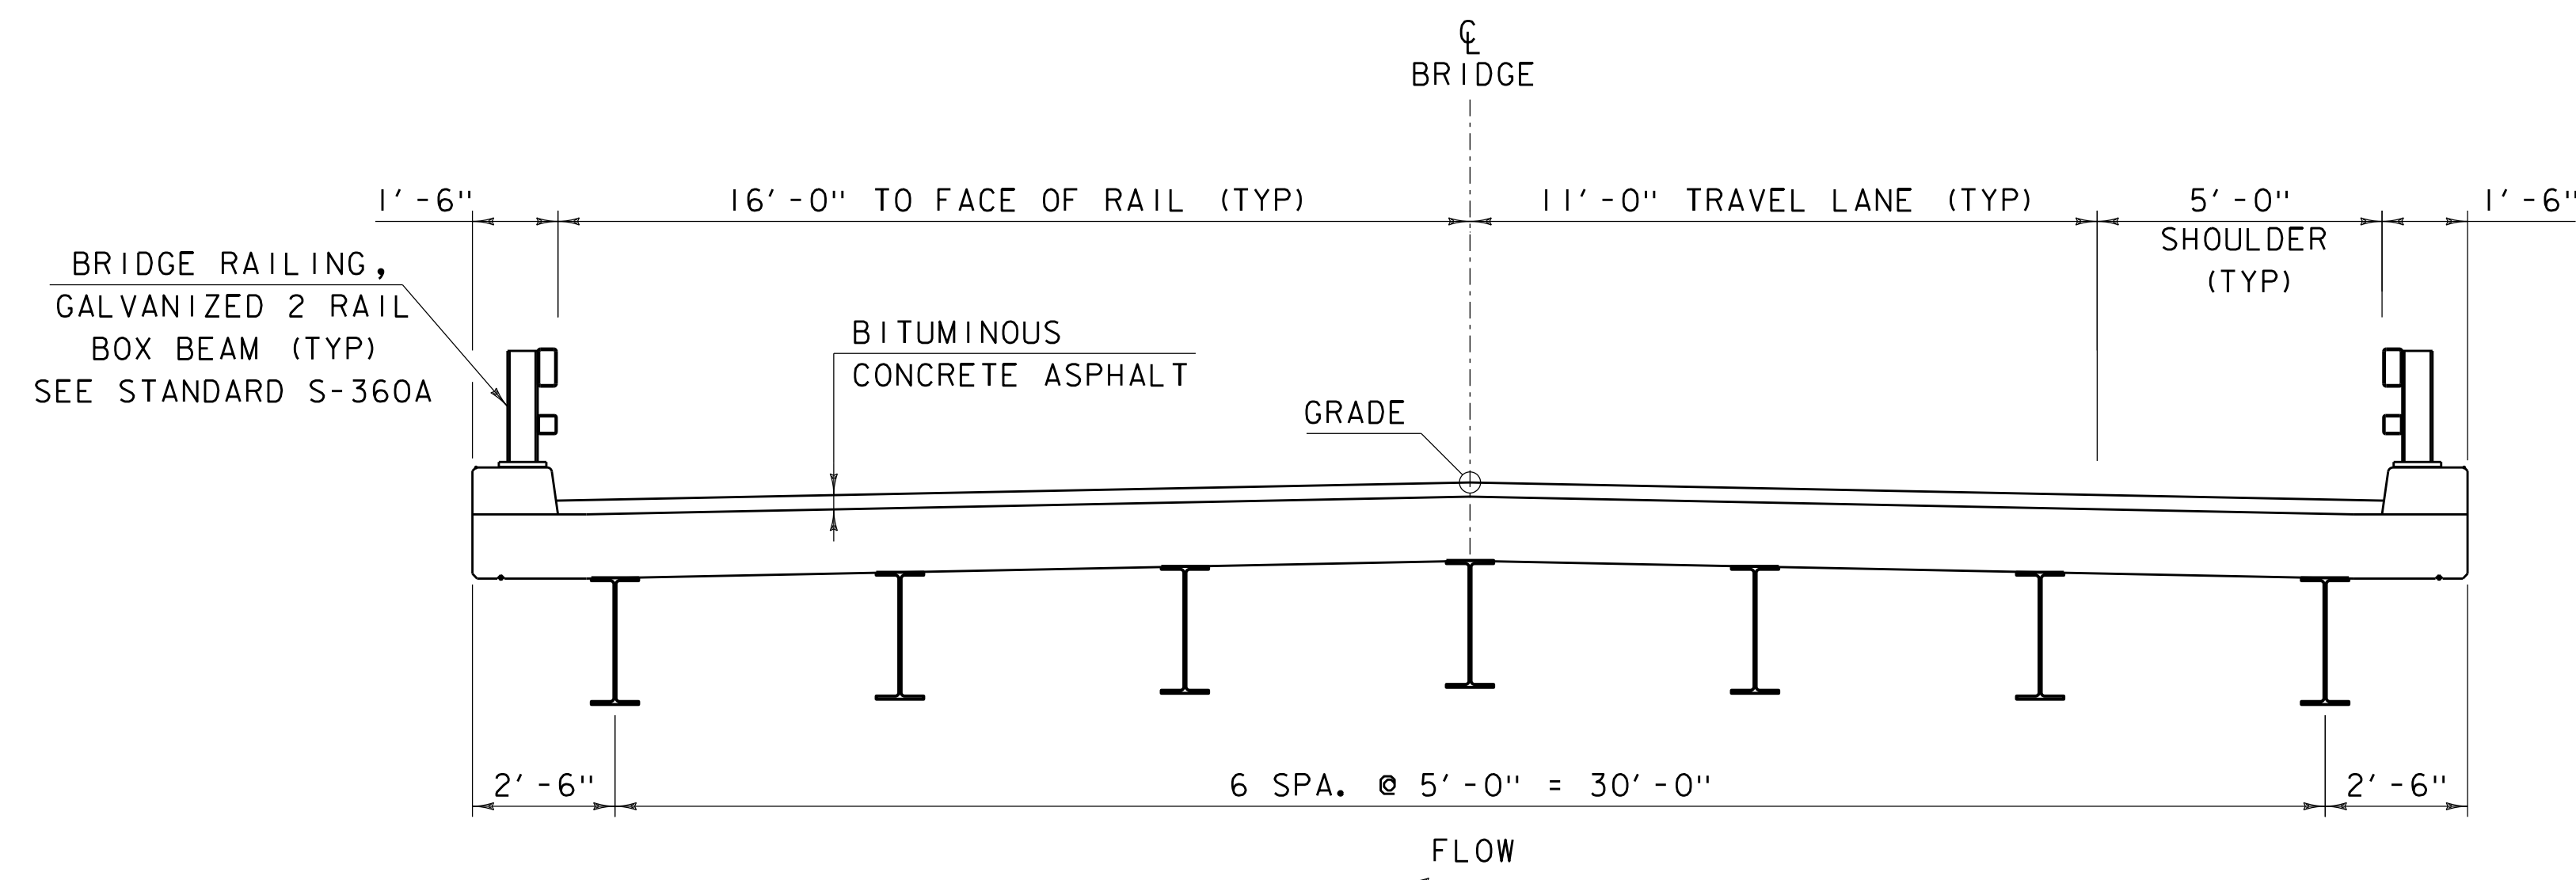
ALTERNATIVE 3 PROPOSED VT ROUTE 17 BRIDGE TYPICAL SECTION

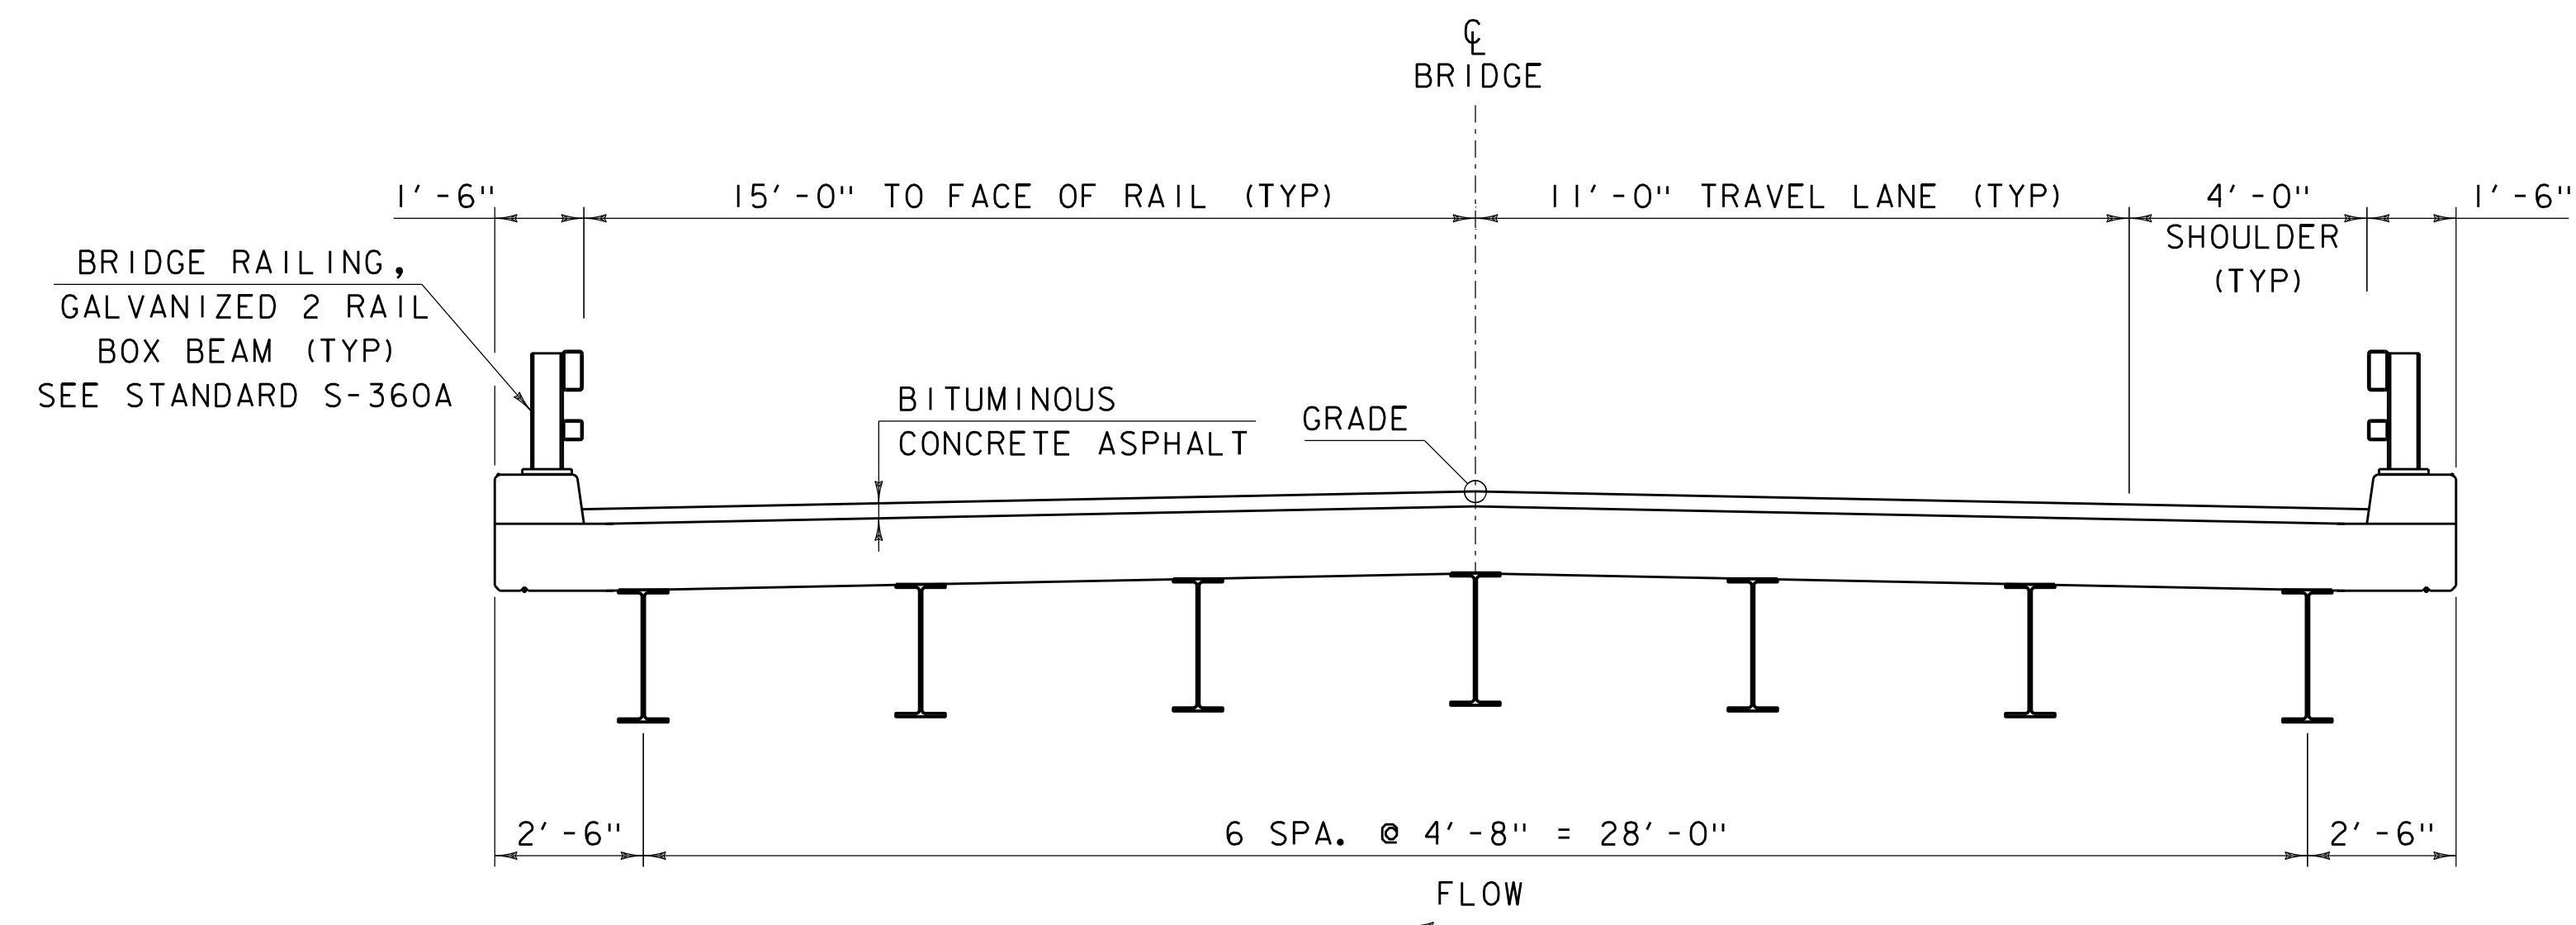
ALTERNATIVE 4 PROPOSED VT ROUTE 17 BRIDGE TYPICAL SECTION
