**STATE OF VERMONT
AGENCY OF TRANSPORTATION**

**Scoping Report
FOR
Dover BF 013-1(20)**

**VT ROUTE 100, BRIDGE 59 OVER THE NORTH BRANCH OF THE
DEERFIELD RIVER**

December 6, 2013

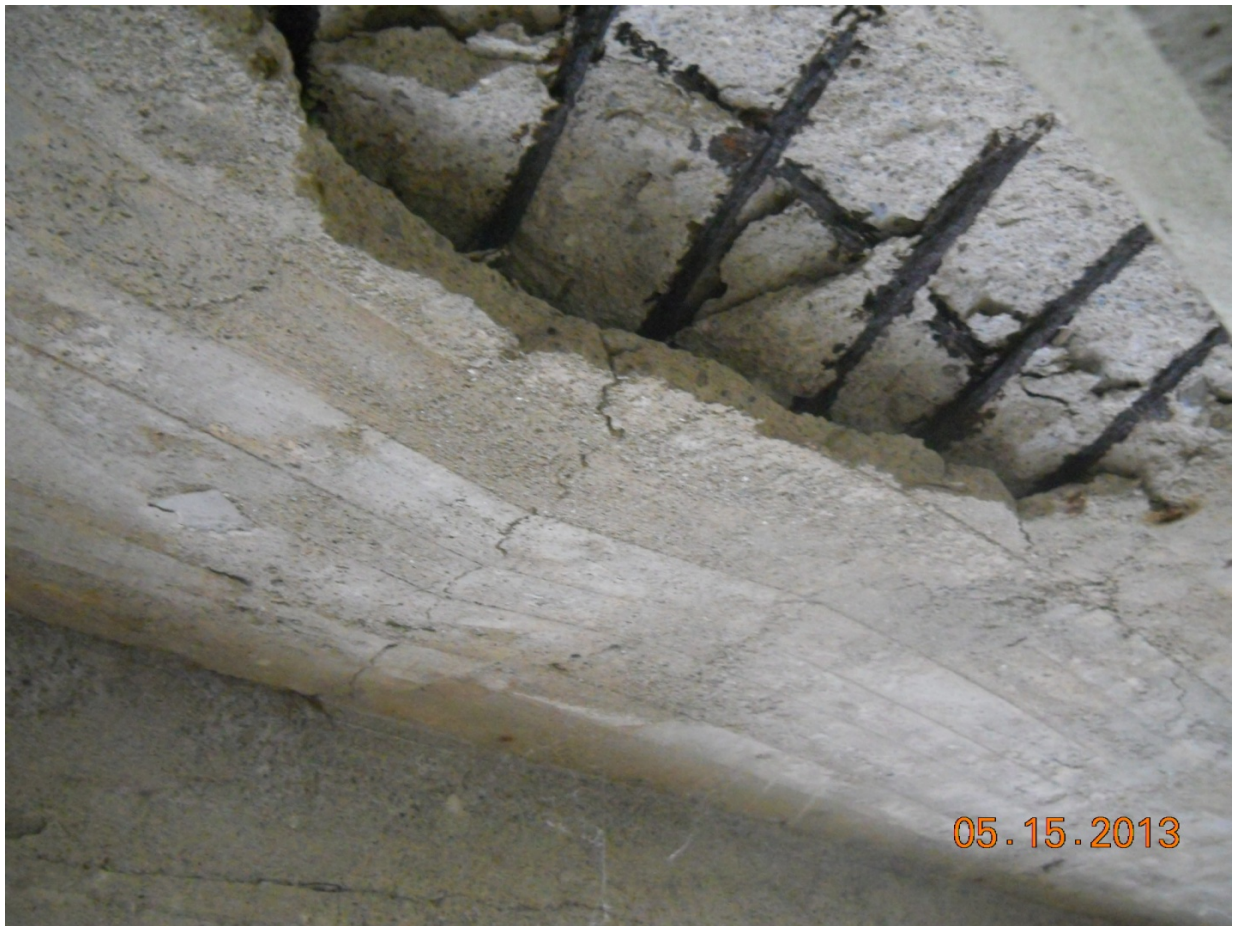
1. The deck is in poor condition. There are areas of heavy spalling on the original deck soffit, exposing the steel reinforcement. The bridge is considered structurally deficient.
2. The existing bridge does not meet the hydraulic standard. The channel is in fair condition, but is stable for scour.
3. The bridge railing does not meet crash standards.

6/19/2013 – This structure is going to need a deck rehab project of the older section in the near future due to the extensive deterioration. The spalling in the soffit between the tee beams penetrated up to the 4th layer of rebar in some areas. The downstream wingwall will have to be replaced as well as it is cracked through and separated from the stemwall, tipping towards the channel 3" @ 4'. ~JWW/JDM

04/11/2011 – The deck soffit area has several large spalls and delaminated areas predominantly in bays 1 and 2. Local failures are eminent (sic) in the near future and may occur at anytime and anywhere. ~PLB

Deck Soffit Deterioration

This alternative is not recommended. The deck is in poor condition and will continue to deteriorate. Additionally, full depth holes in the deck are increasingly likely with time. Something will have to be done to improve this bridge in the near future. Although the bridge does not appear to be in imminent danger of collapse, it will eventually be posted for lower traffic loads. In the interest of safety to the traveling public, the No Action alternative is not recommended. No cost estimate has been provided for this alternative since there are no immediate costs.

A superstructure replacement option for this bridge would include a new precast superstructure, and substructure repair as follows:

The existing substructure is in satisfactory condition, and it is reasonable to assume that the existing substructure can safely carry anticipated traffic loads for an additional 20 years. Since the existing T-beams are integral with the deck, replacement of the deck only is not feasible.

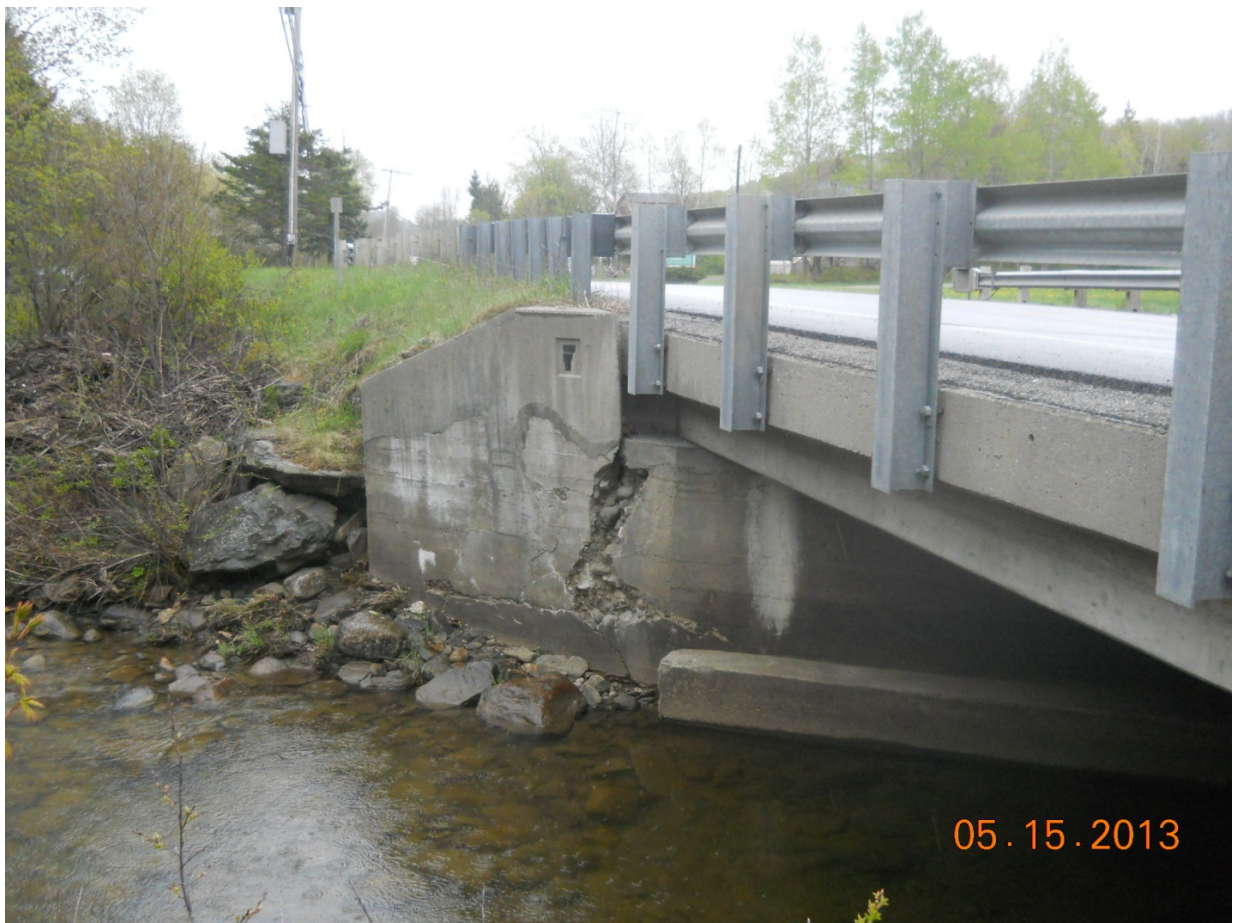
- Wingwall 2 is cracked through and separated from the stemwall. It is tipping in towards the channel 3" @ 4'. This wingwall should either be fully replaced, or soil nailed for stabilization and then concrete patched. Due to the amount of concrete patching and need for extra equipment to soil nail, it is recommended that wingwall 2 is replaced.

Downstream Wingwall

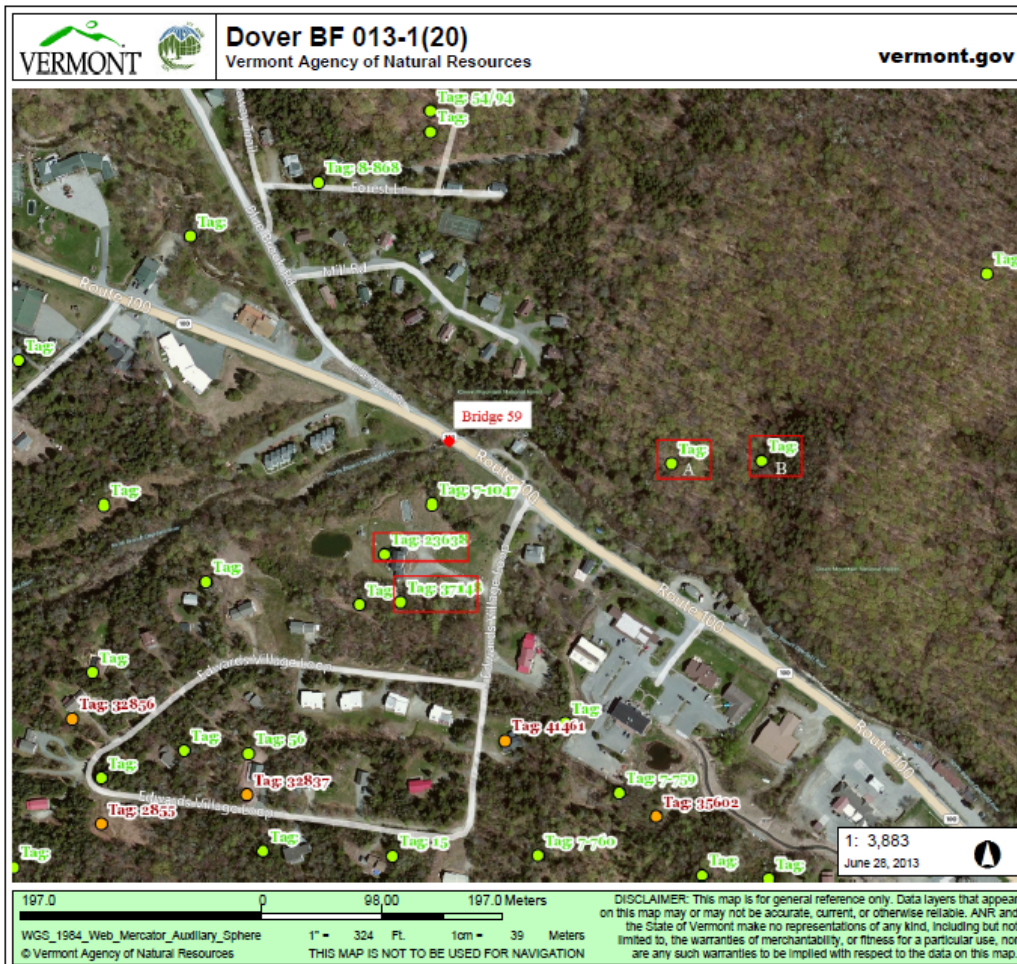
Figure 1 contains the project and surrounding well locations. The specific wells used to gain information on the subsurface conditions are highlighted by red boxes.

Figure 1. Highlighted well locations near subject project

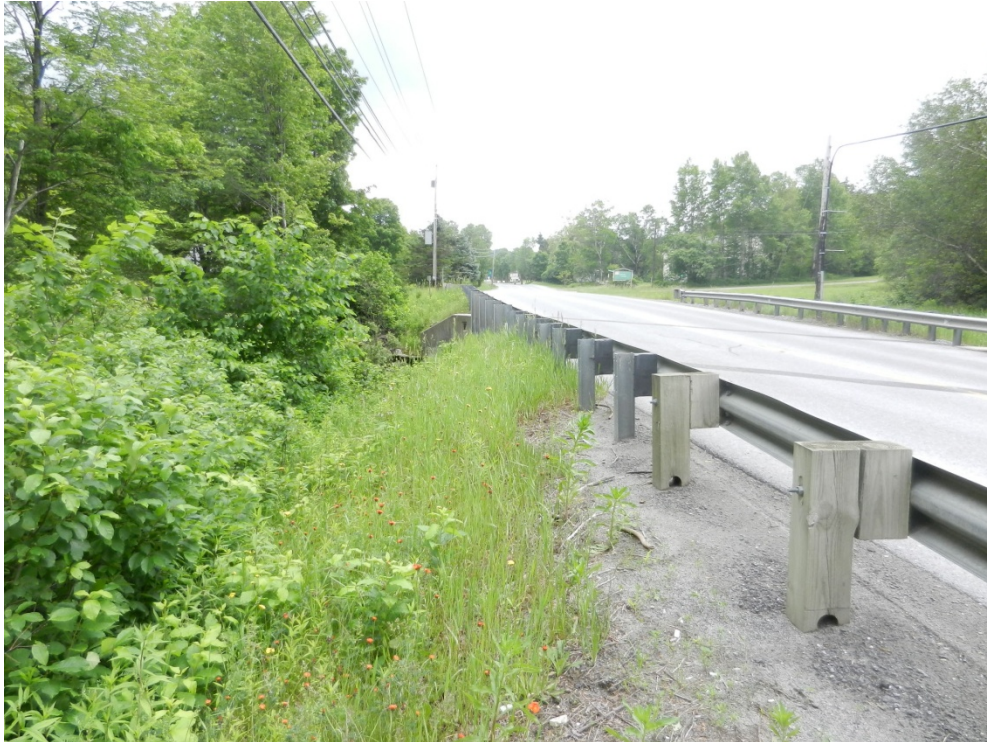
Figure 2. View of bridge, looking upstream (west)

Overhead power exists on both sides of the road, which may conflict with boring operations. With the available site distance, borings could easily be located in the roadway.

With a relatively short span, it is anticipated the structure may be replaced with a precast arch or stub abutment, which would both be founded on spread footings. If this is the case, two borings could be completed in the roadway, to relatively shallow depths, in a short timeframe. If integral abutments are the preferred alternative, borings should be advanced to bedrock, in which case we recommend two borings on opposite corners. Numerous cobbles were prevalent in the streambed and along the banks, which may impede boring and construction operations. The shallow depths to bedrock seen in private wells could make integral abutments unfeasible.

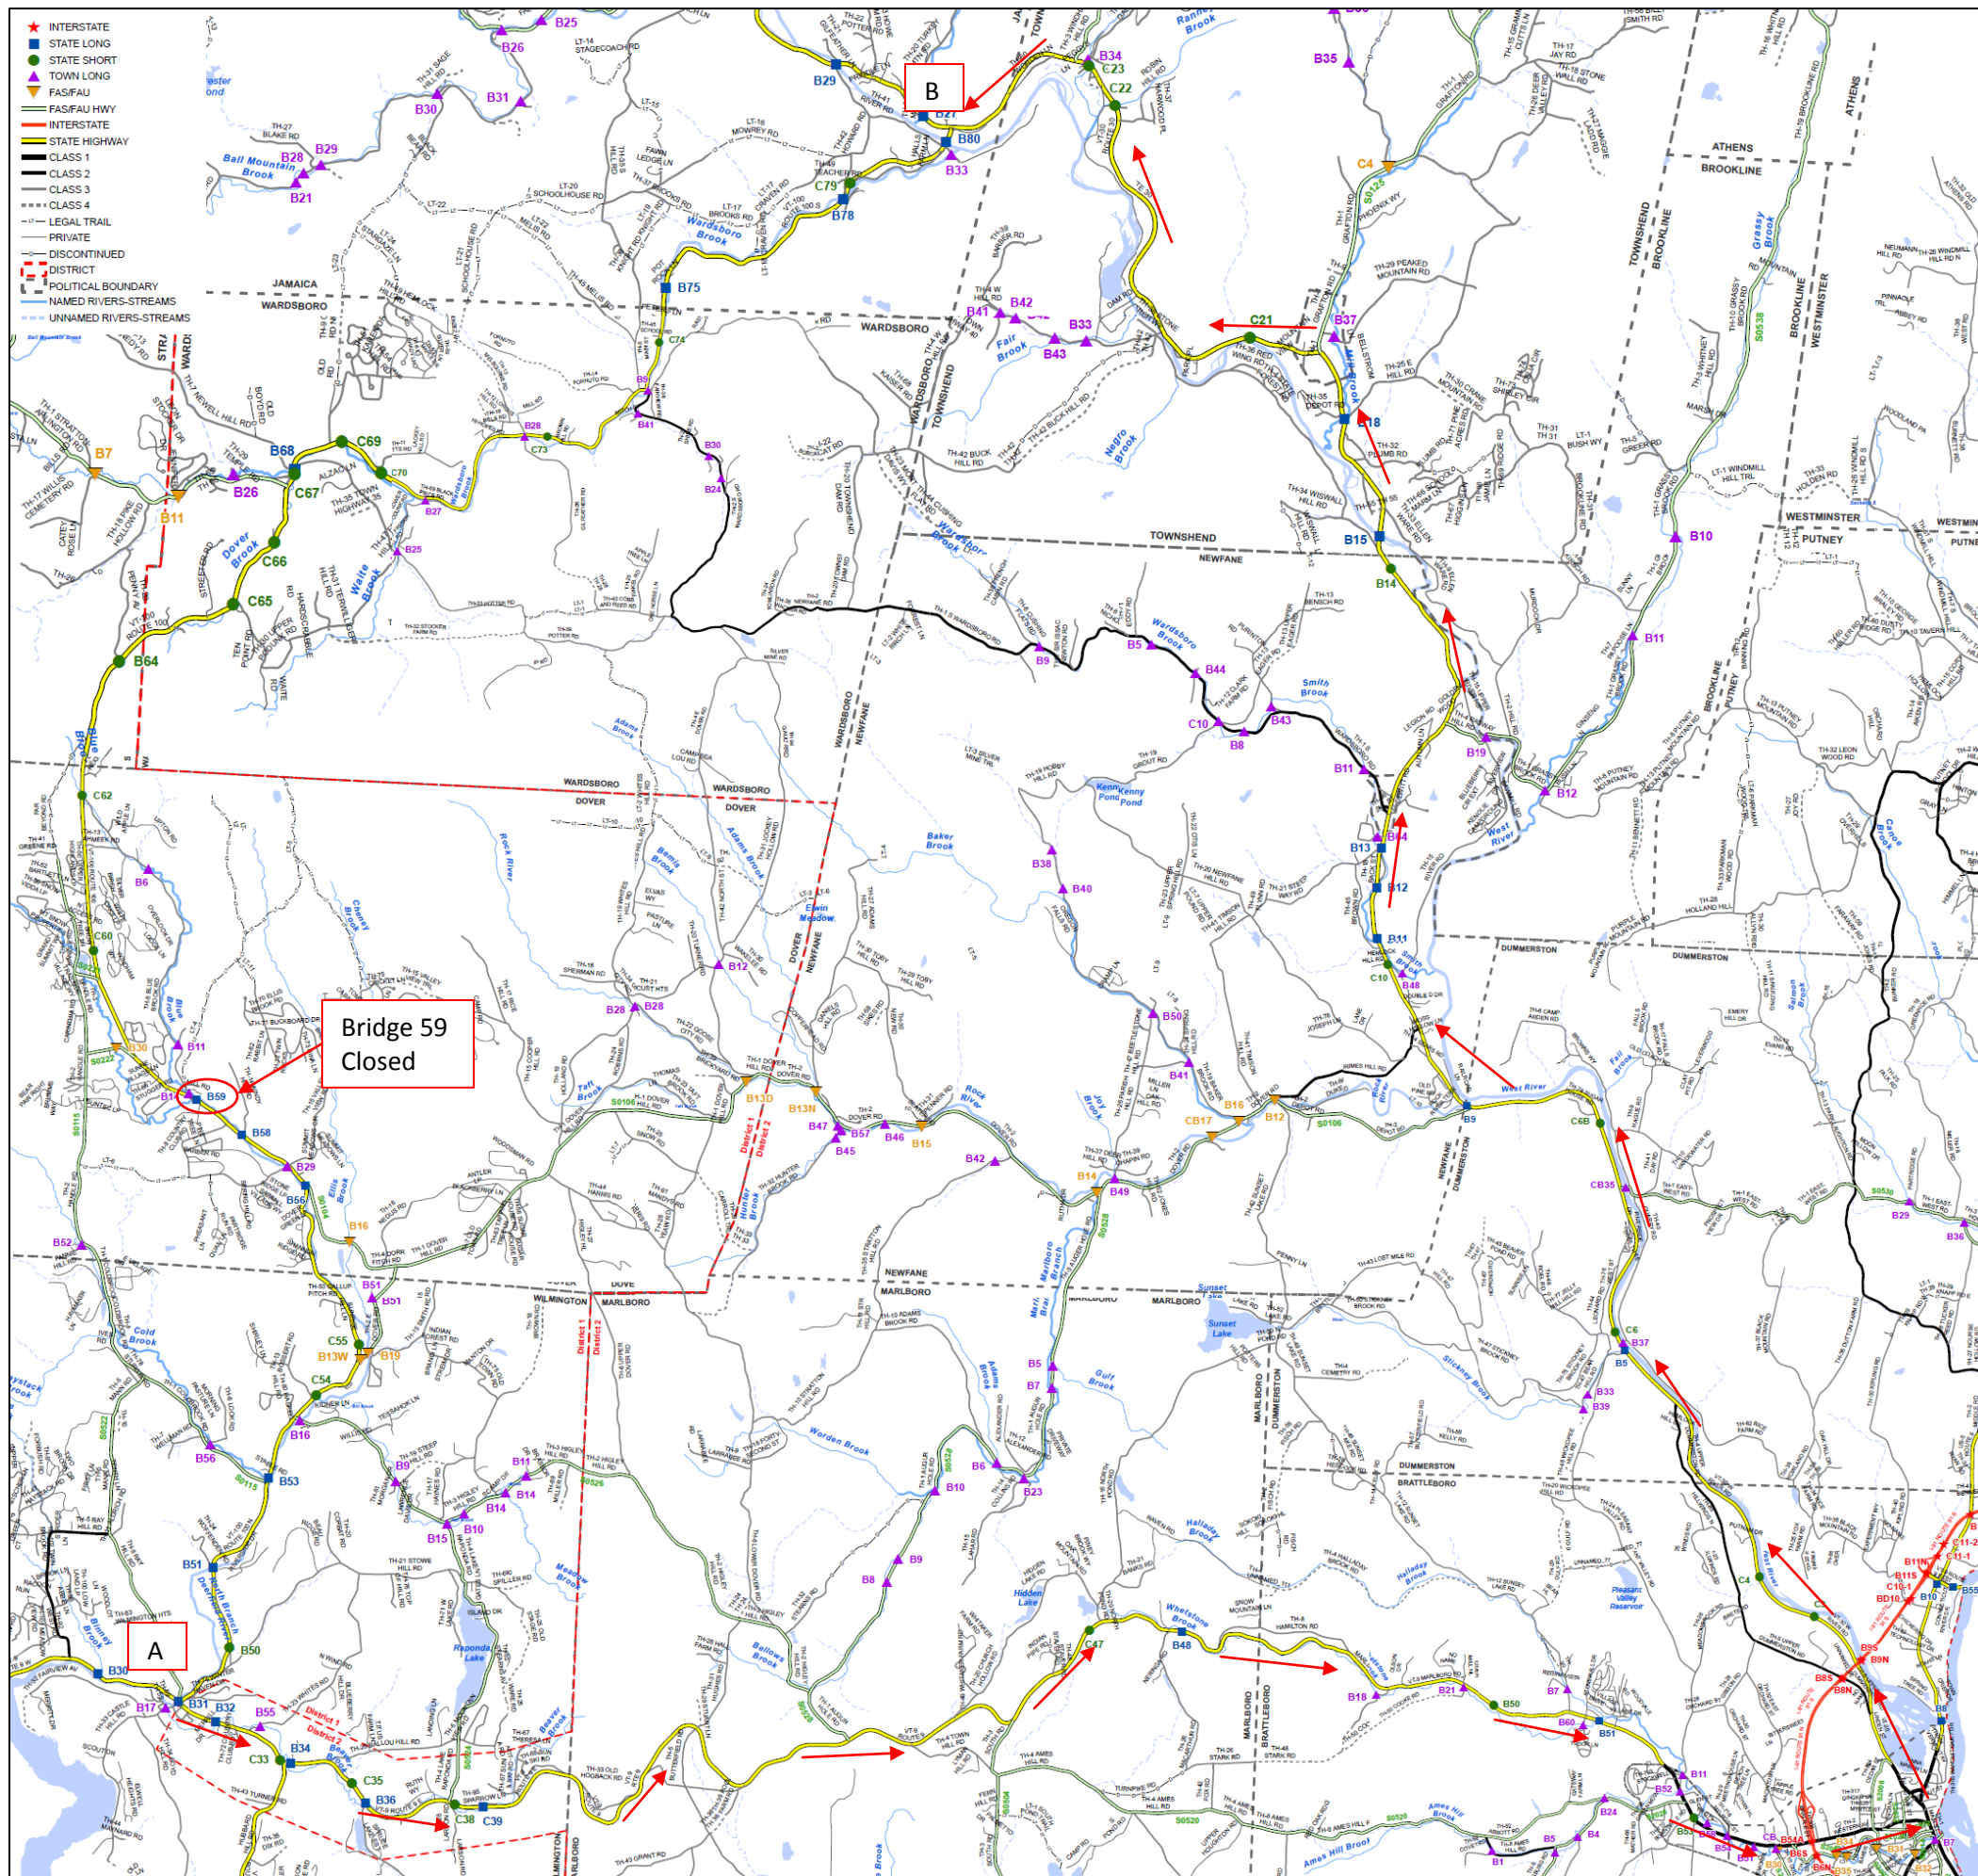
Detour Route

VT Route 100, to VT Route 9, VT Route 30, back to VT Route 100

Added Miles: 19.3 Miles

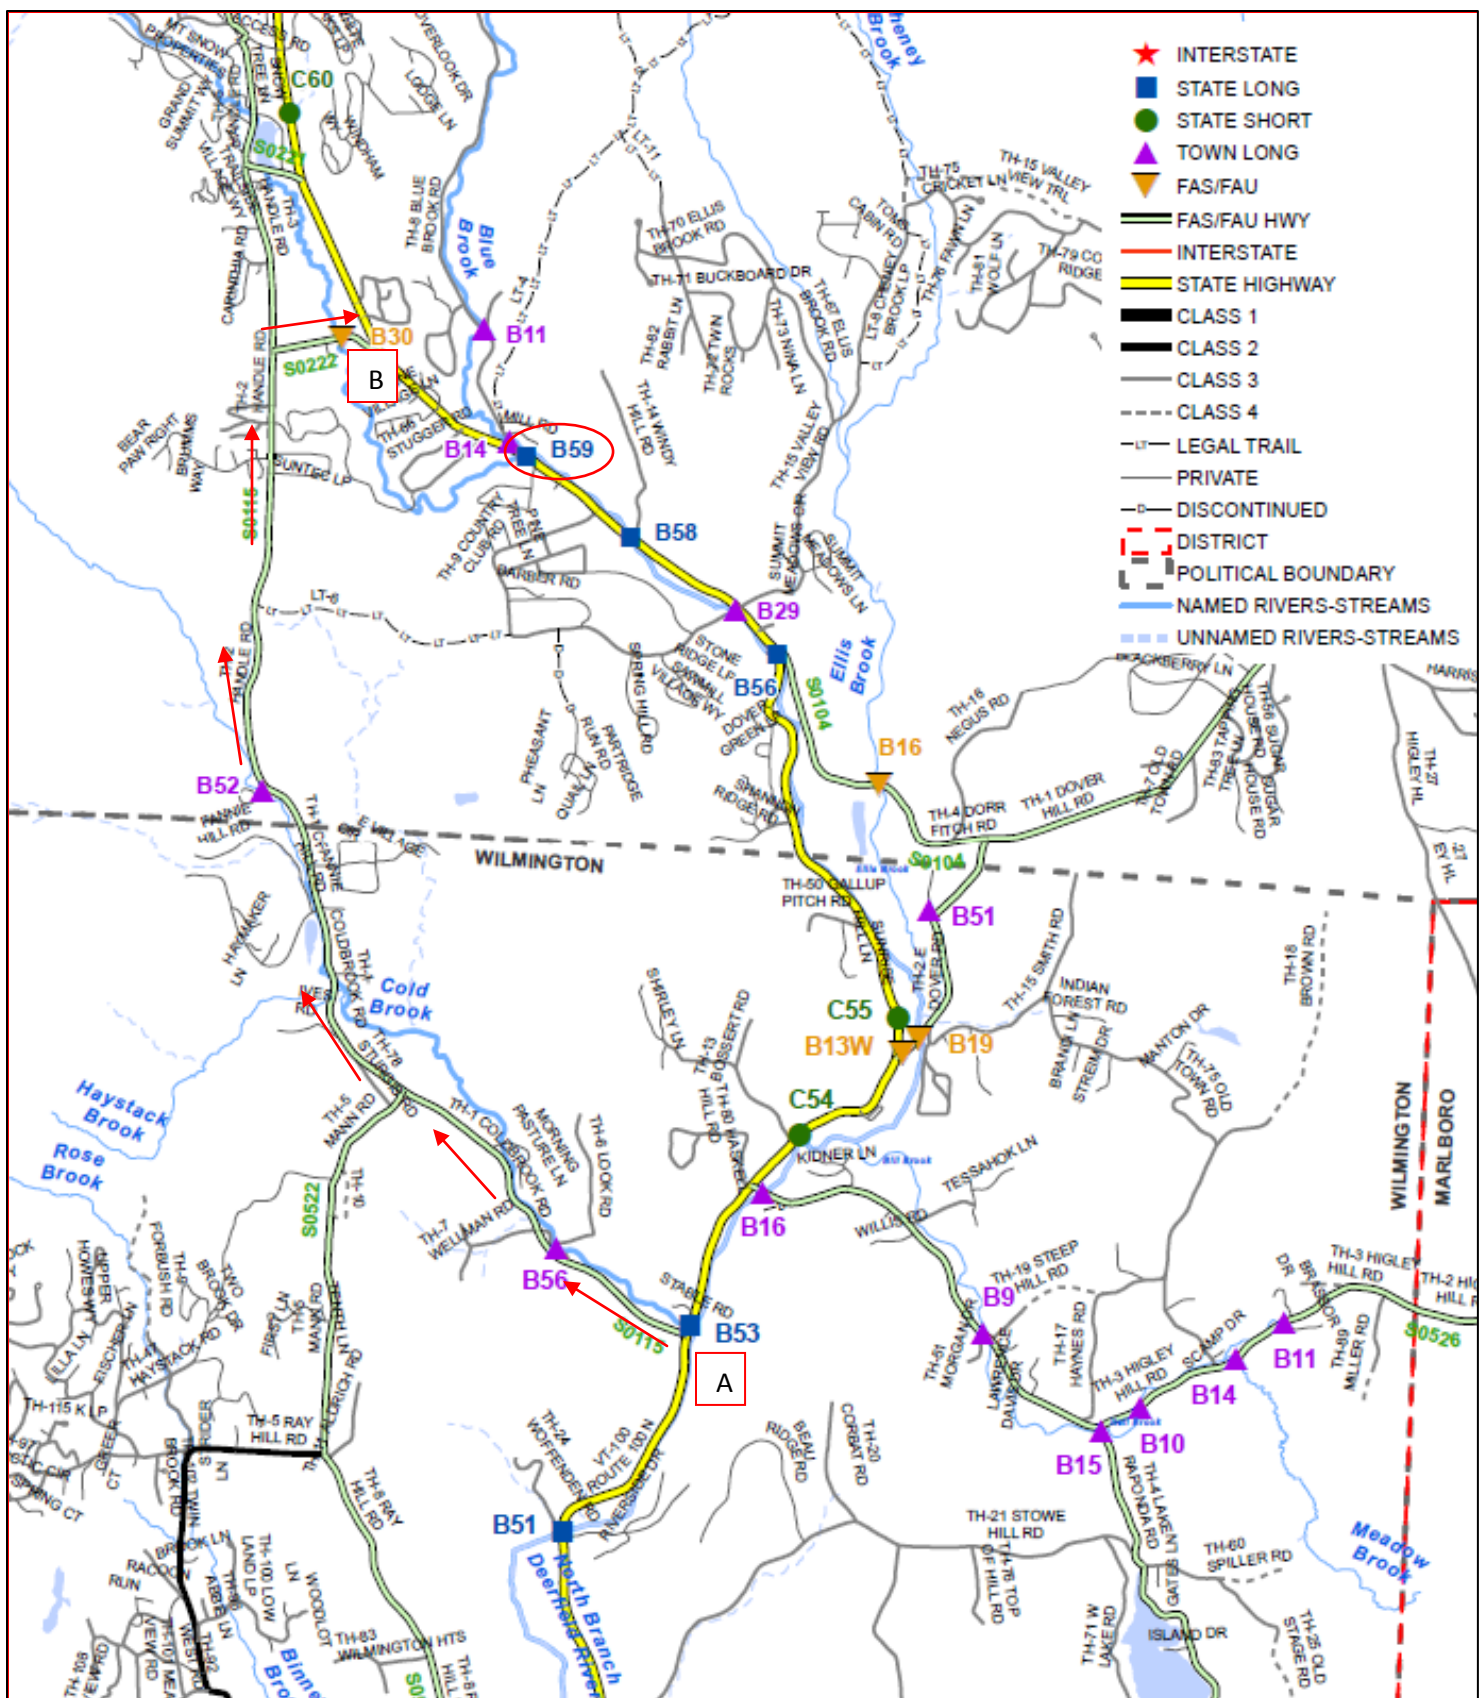
Local Bypass Route

VT Route 100, to Coldbrook Road, Handle Road, Tannery Road, back to VT Route 100

Added Miles: 0 Miles

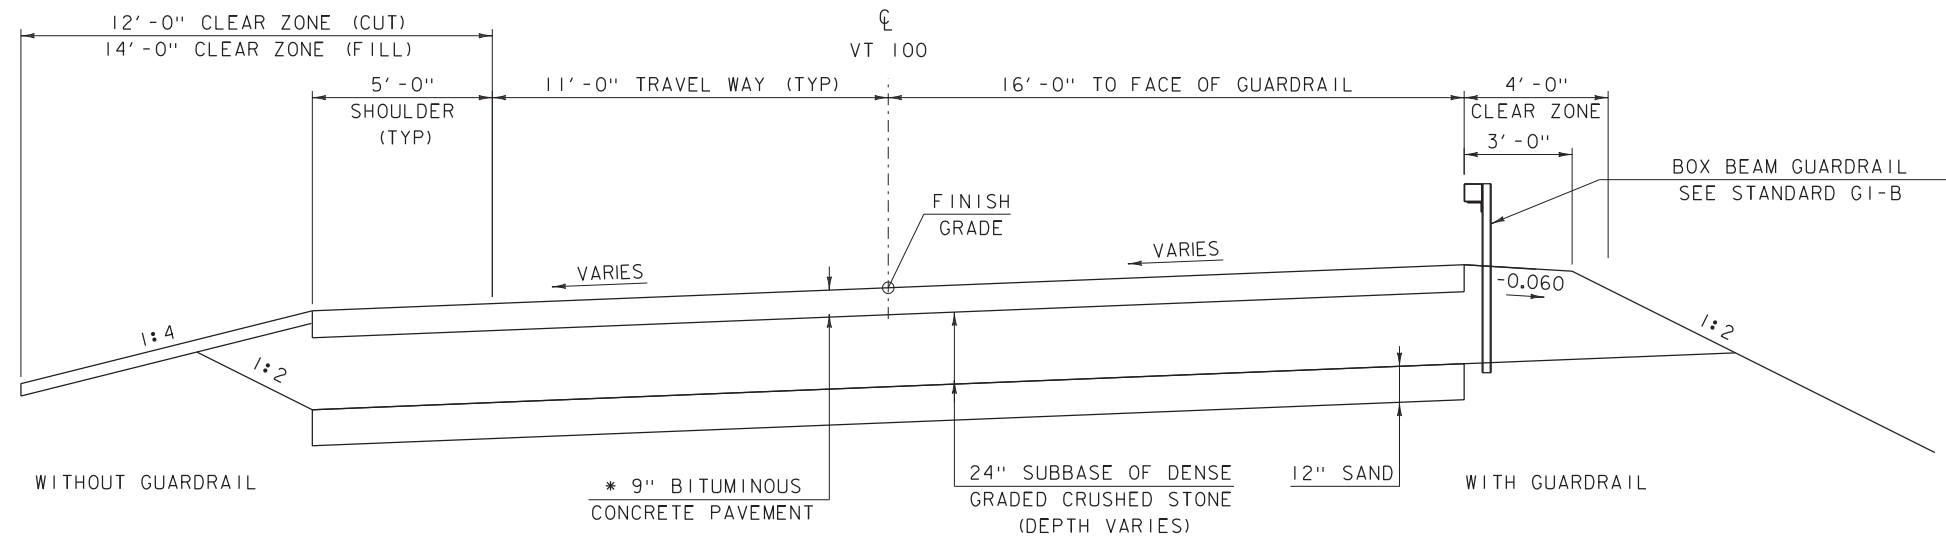
VT ROUTE 100 ROADWAY TYPICAL SECTION - ALTERNATIVE 1

* 1 1/2" TYPE IVS OVER
1 1/2" TYPE IVS OVER
3" TYPE IIS OVER
3" TYPE IIS

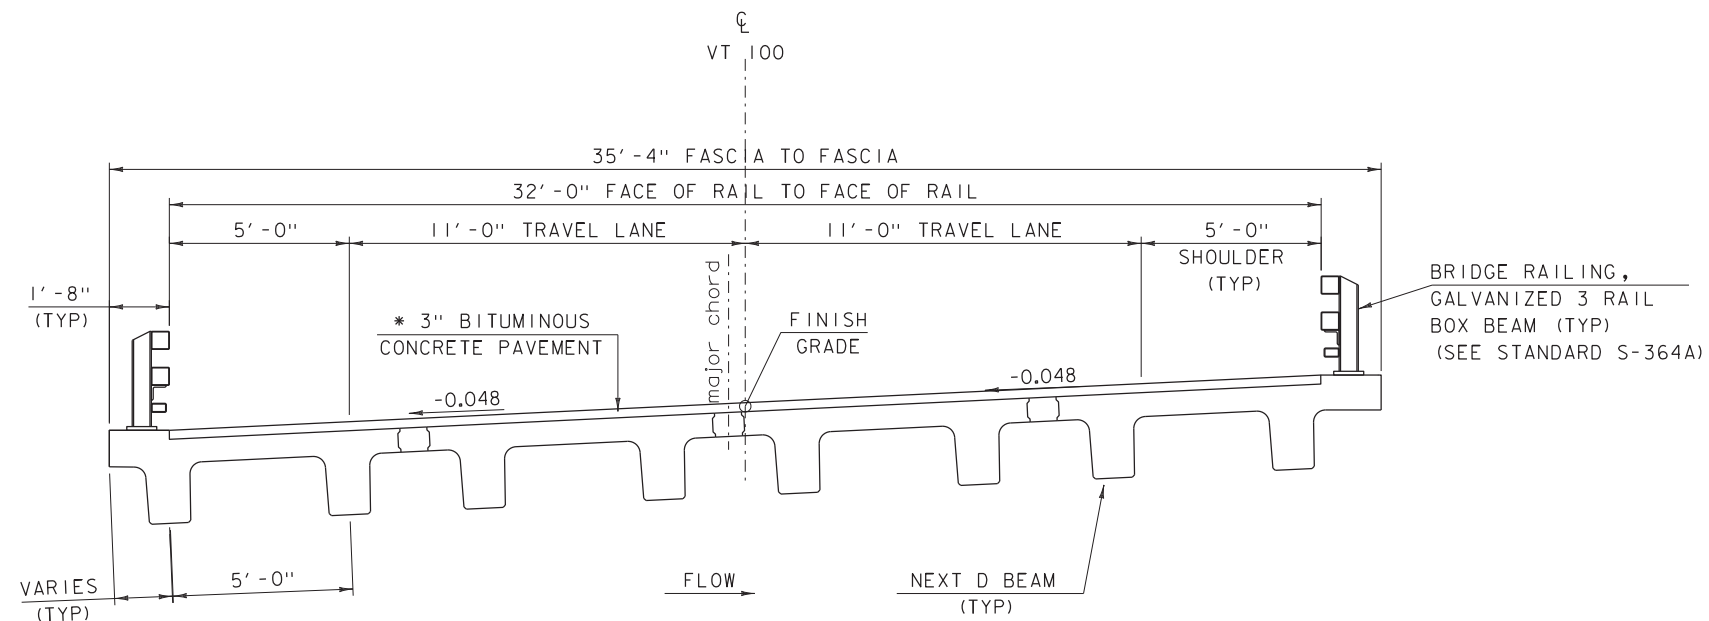
BRIDGE TYPICAL SECTION - ALTERNATIVE 1

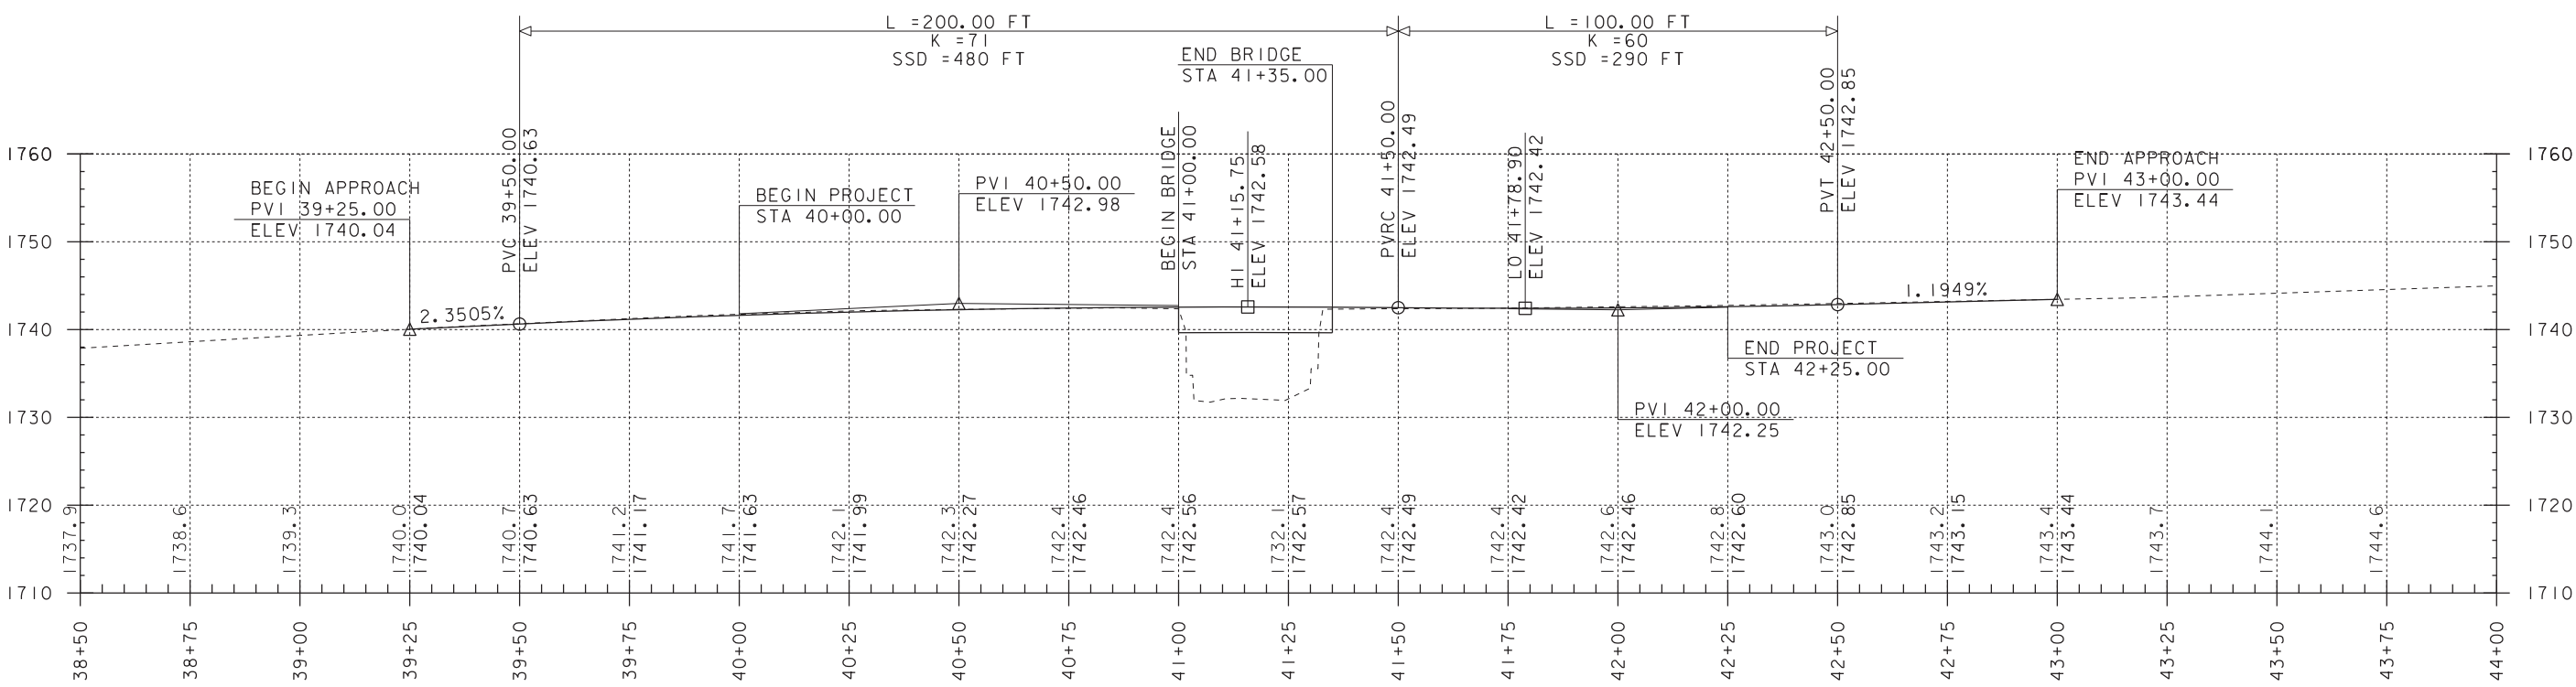
VT 100 PROFILE - ALTERNATIVE 1

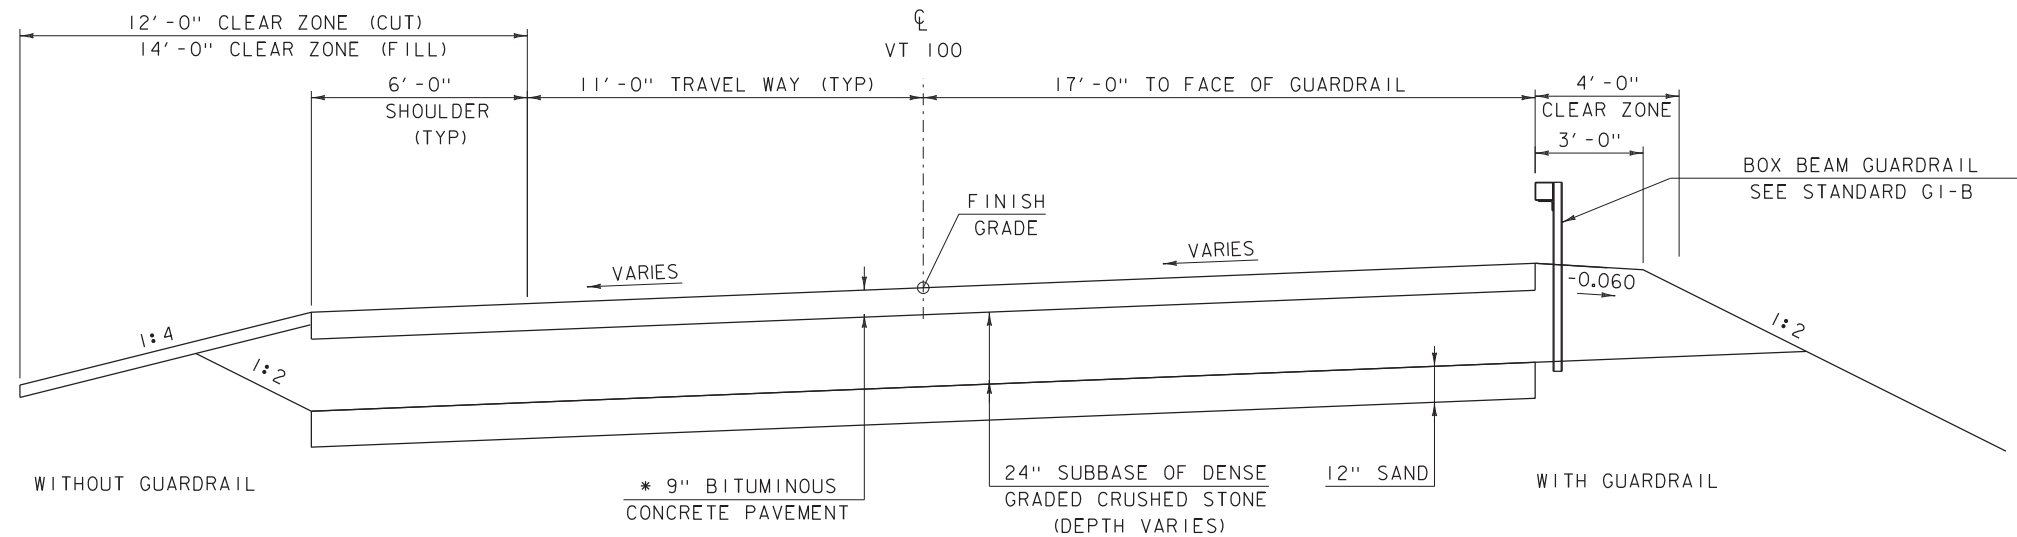
VT ROUTE 100 ROADWAY TYPICAL SECTION - ALTERNATIVE 2 & 3

* 1 1/2" TYPE IVS OVER
1 1/2" TYPE IVS OVER
3" TYPE IIS OVER
3" TYPE IIS

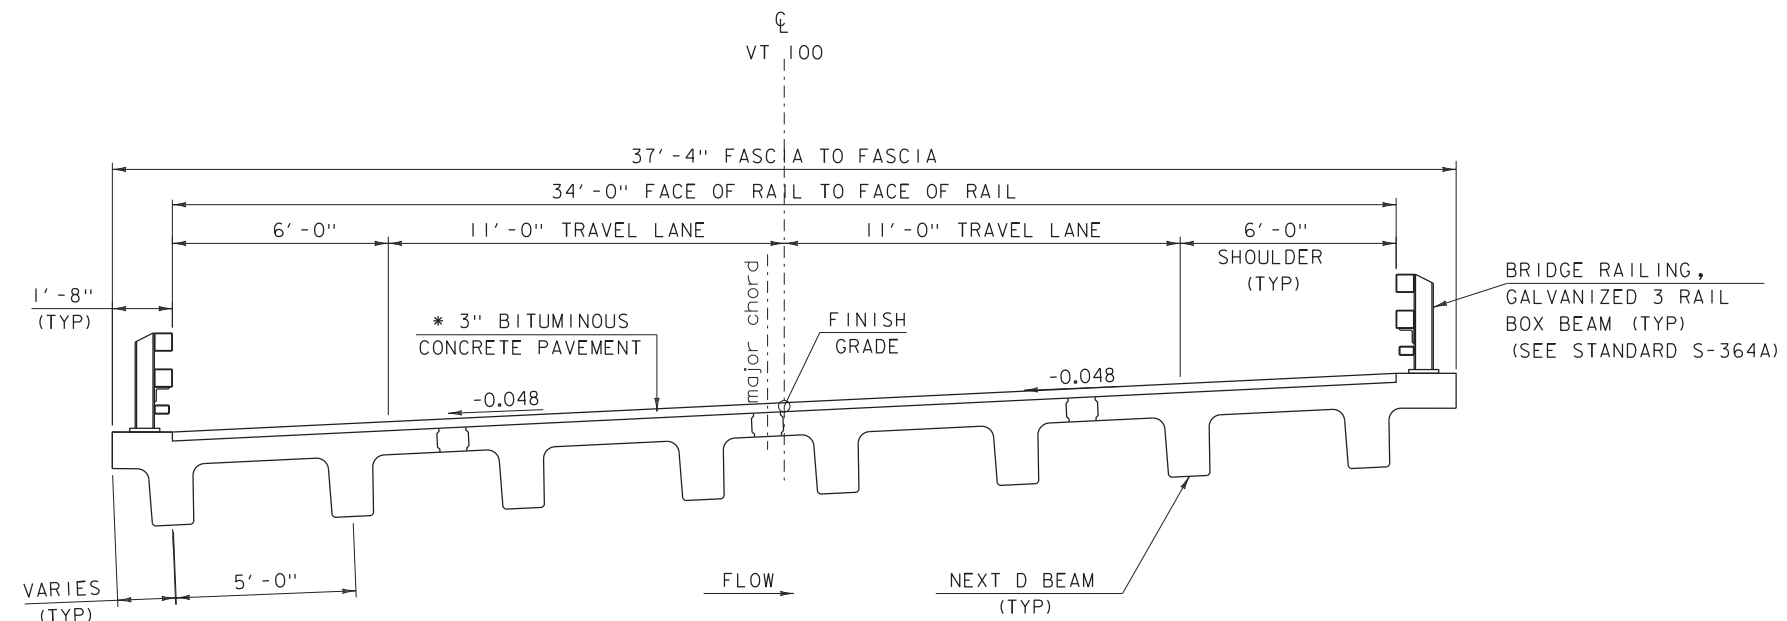
BRIDGE TYPICAL SECTION - ALTERNATIVE 2 & 3

The bridge will have a single span of 65 feet and a skew of 30 degrees to match the channel. The existing bridge has a width of 34 feet, which exceeds Vermont State Standards by two feet; this travel width will be maintained. Additionally, by choosing the 65 foot span bridge option, the vertical grade can remain the same, reducing permanent impacts. While the rehabilitation option has the lowest upfront costs, a bridge replacement has a lower per year cost based on an 80 year design life compared to a 20 year design life. Additionally, not only does a full bridge replacement address structural deficiencies of the existing bridge, but it also addresses the hydraulic deficiencies.

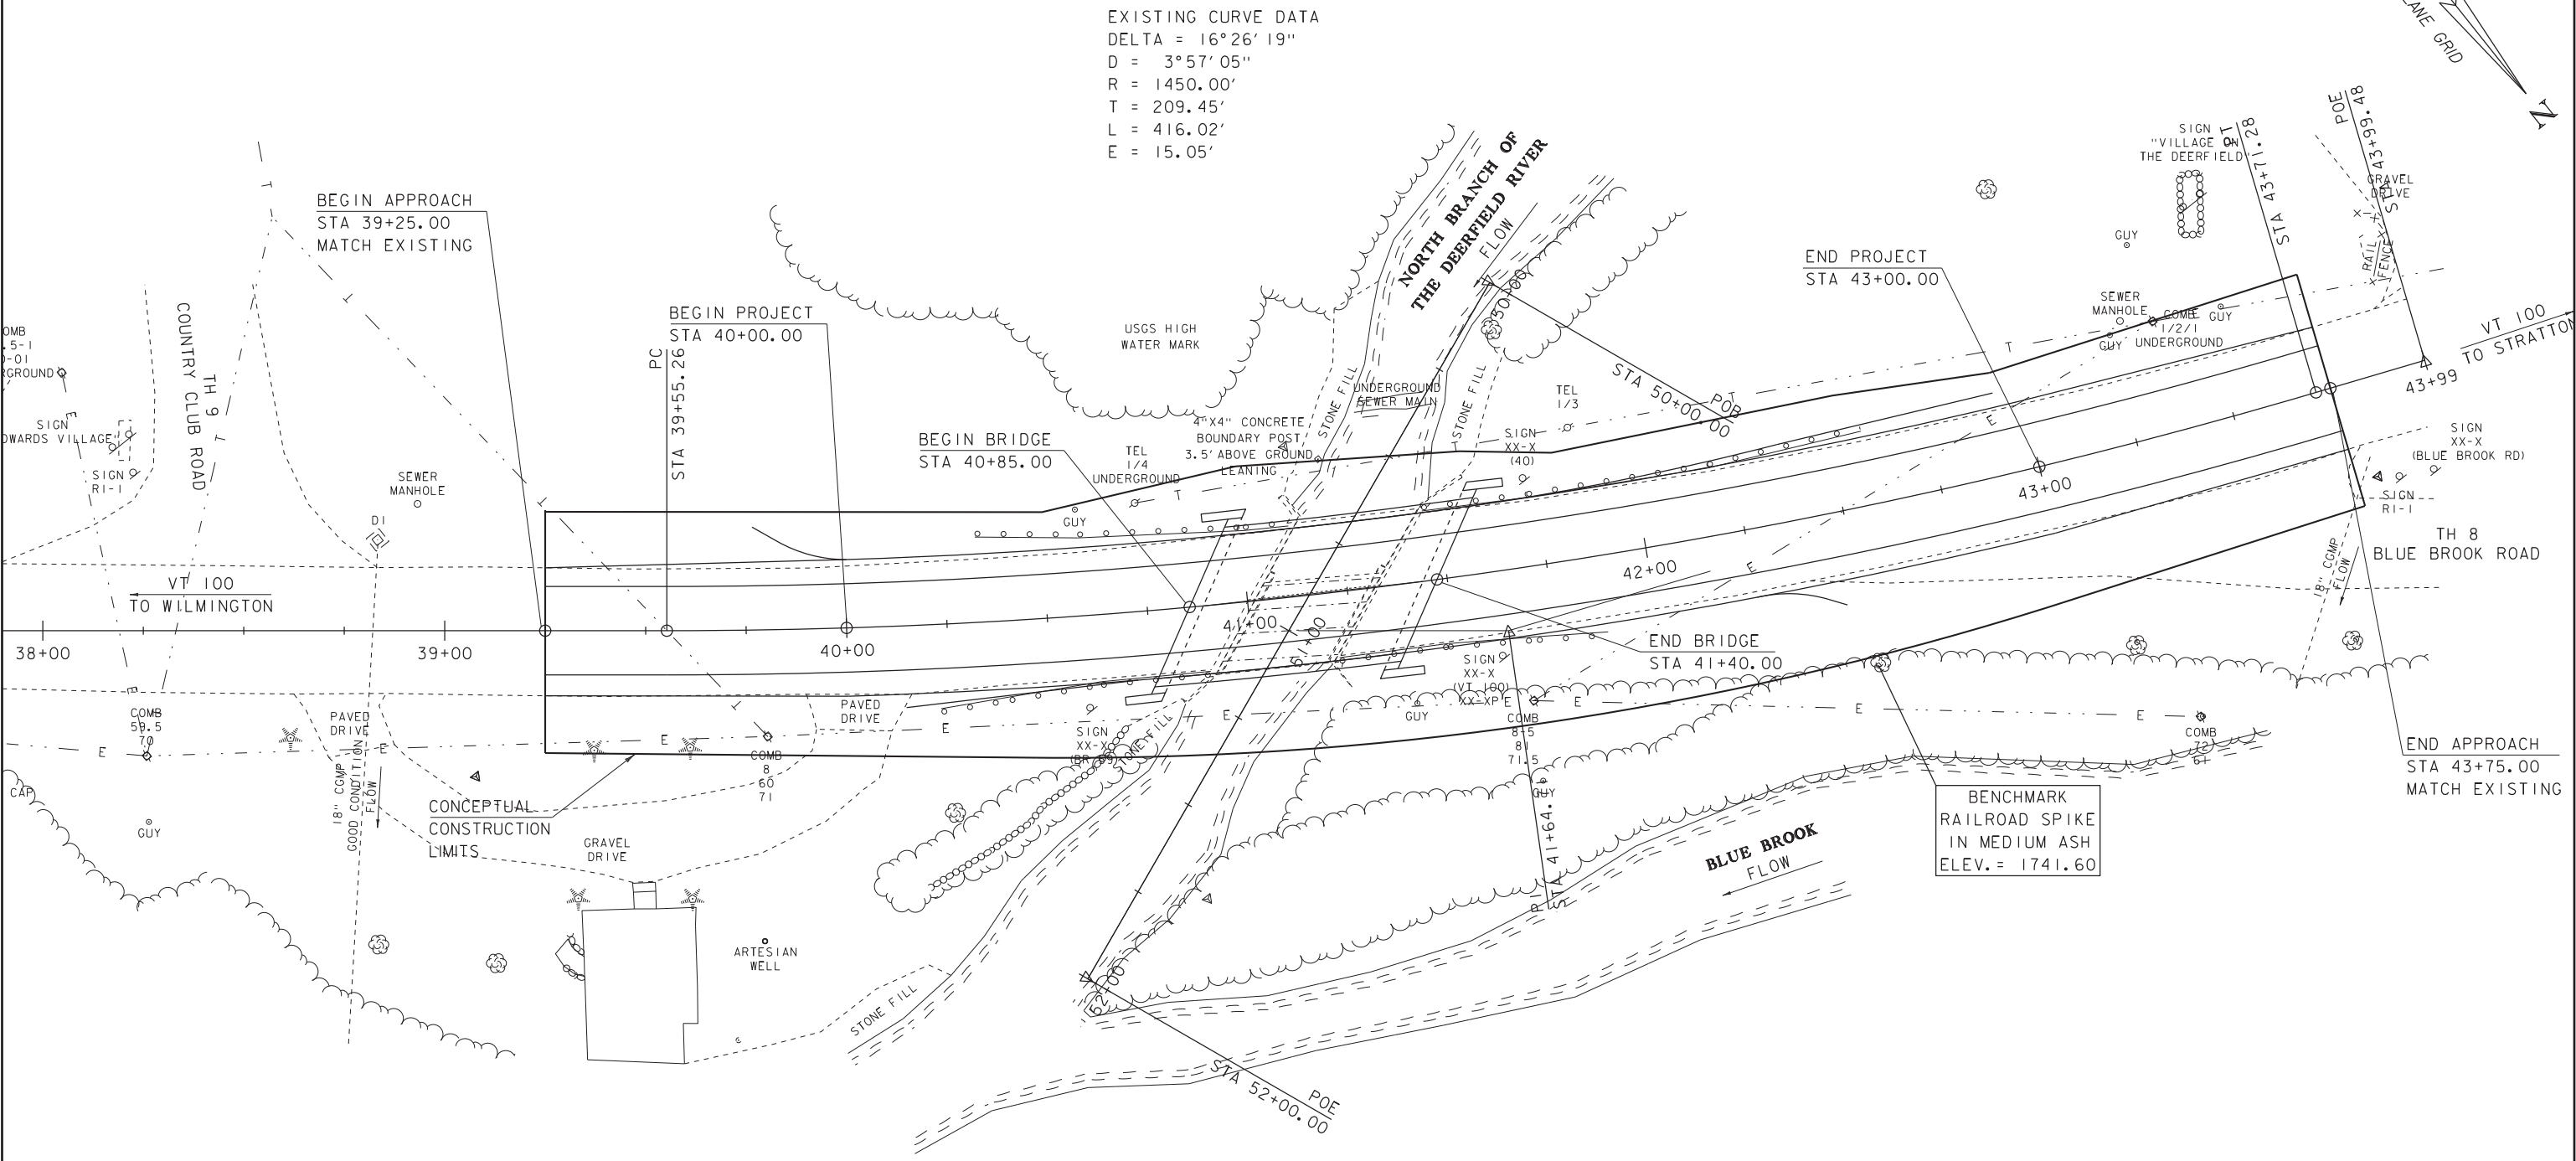
EXISTING CURVE DATA
DELTA = 16°26'19"
D = 3°57'05"
R = 1450.00'
T = 209.45'
L = 416.02'
E = 15.05'

ALTERNATIVE 2 LAYOUT

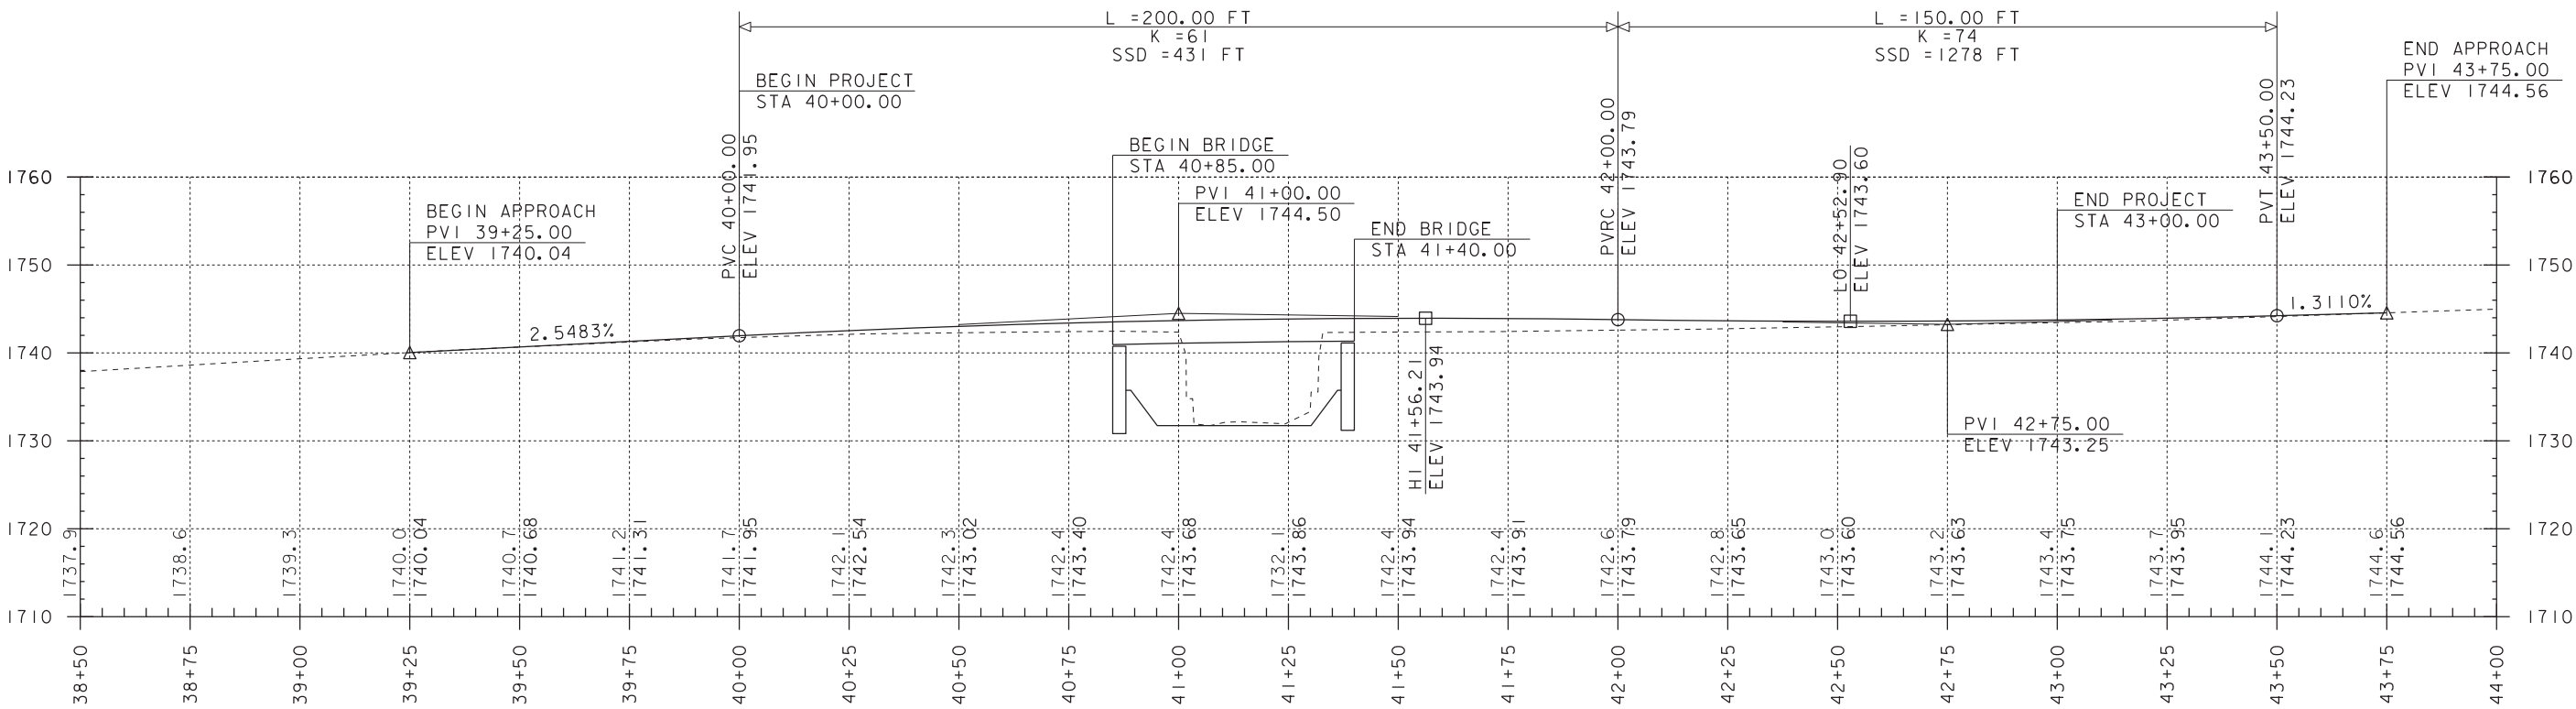
VT 100 PROFILE - ALTERNATIVE 2
