**STATE OF VERMONT
AGENCY OF TRANSPORTATION**

**Scoping Report
FOR
Dover BF 013-1(20)**

**VT ROUTE 100, BRIDGE 59 OVER THE NORTH BRANCH OF THE
DEERFIELD RIVER**

December 6, 2013

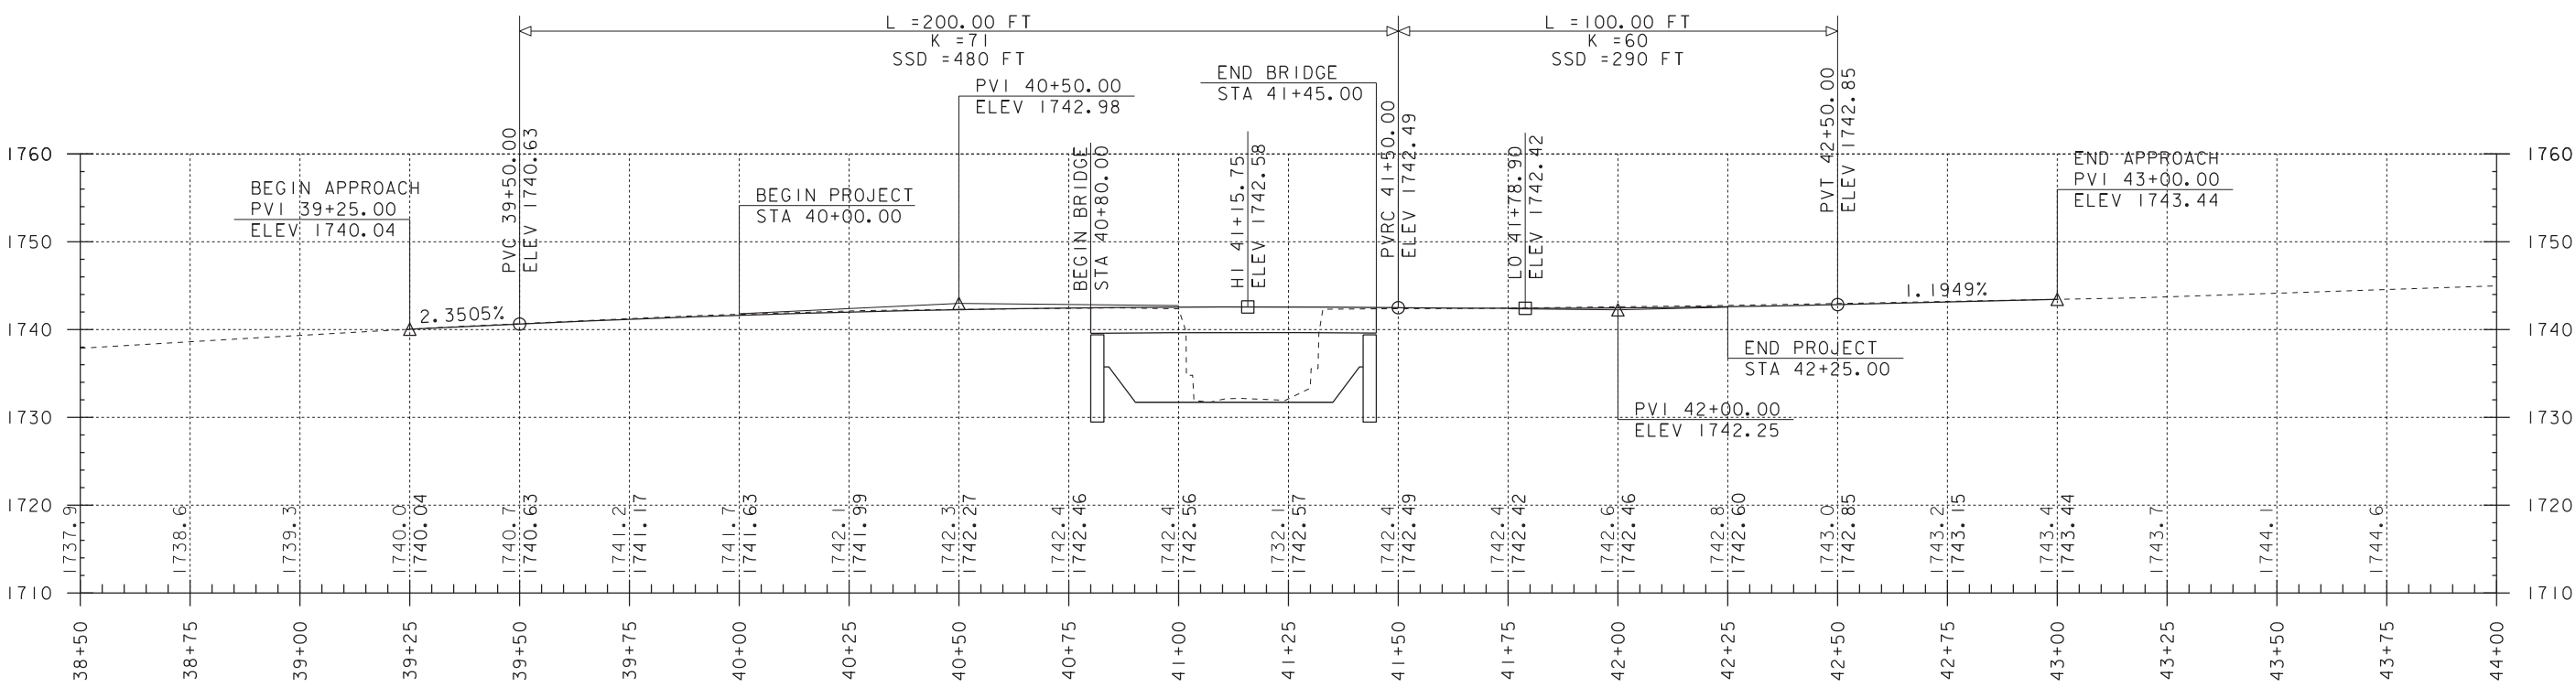
VT 100 PROFILE - ALTERNATIVE 3

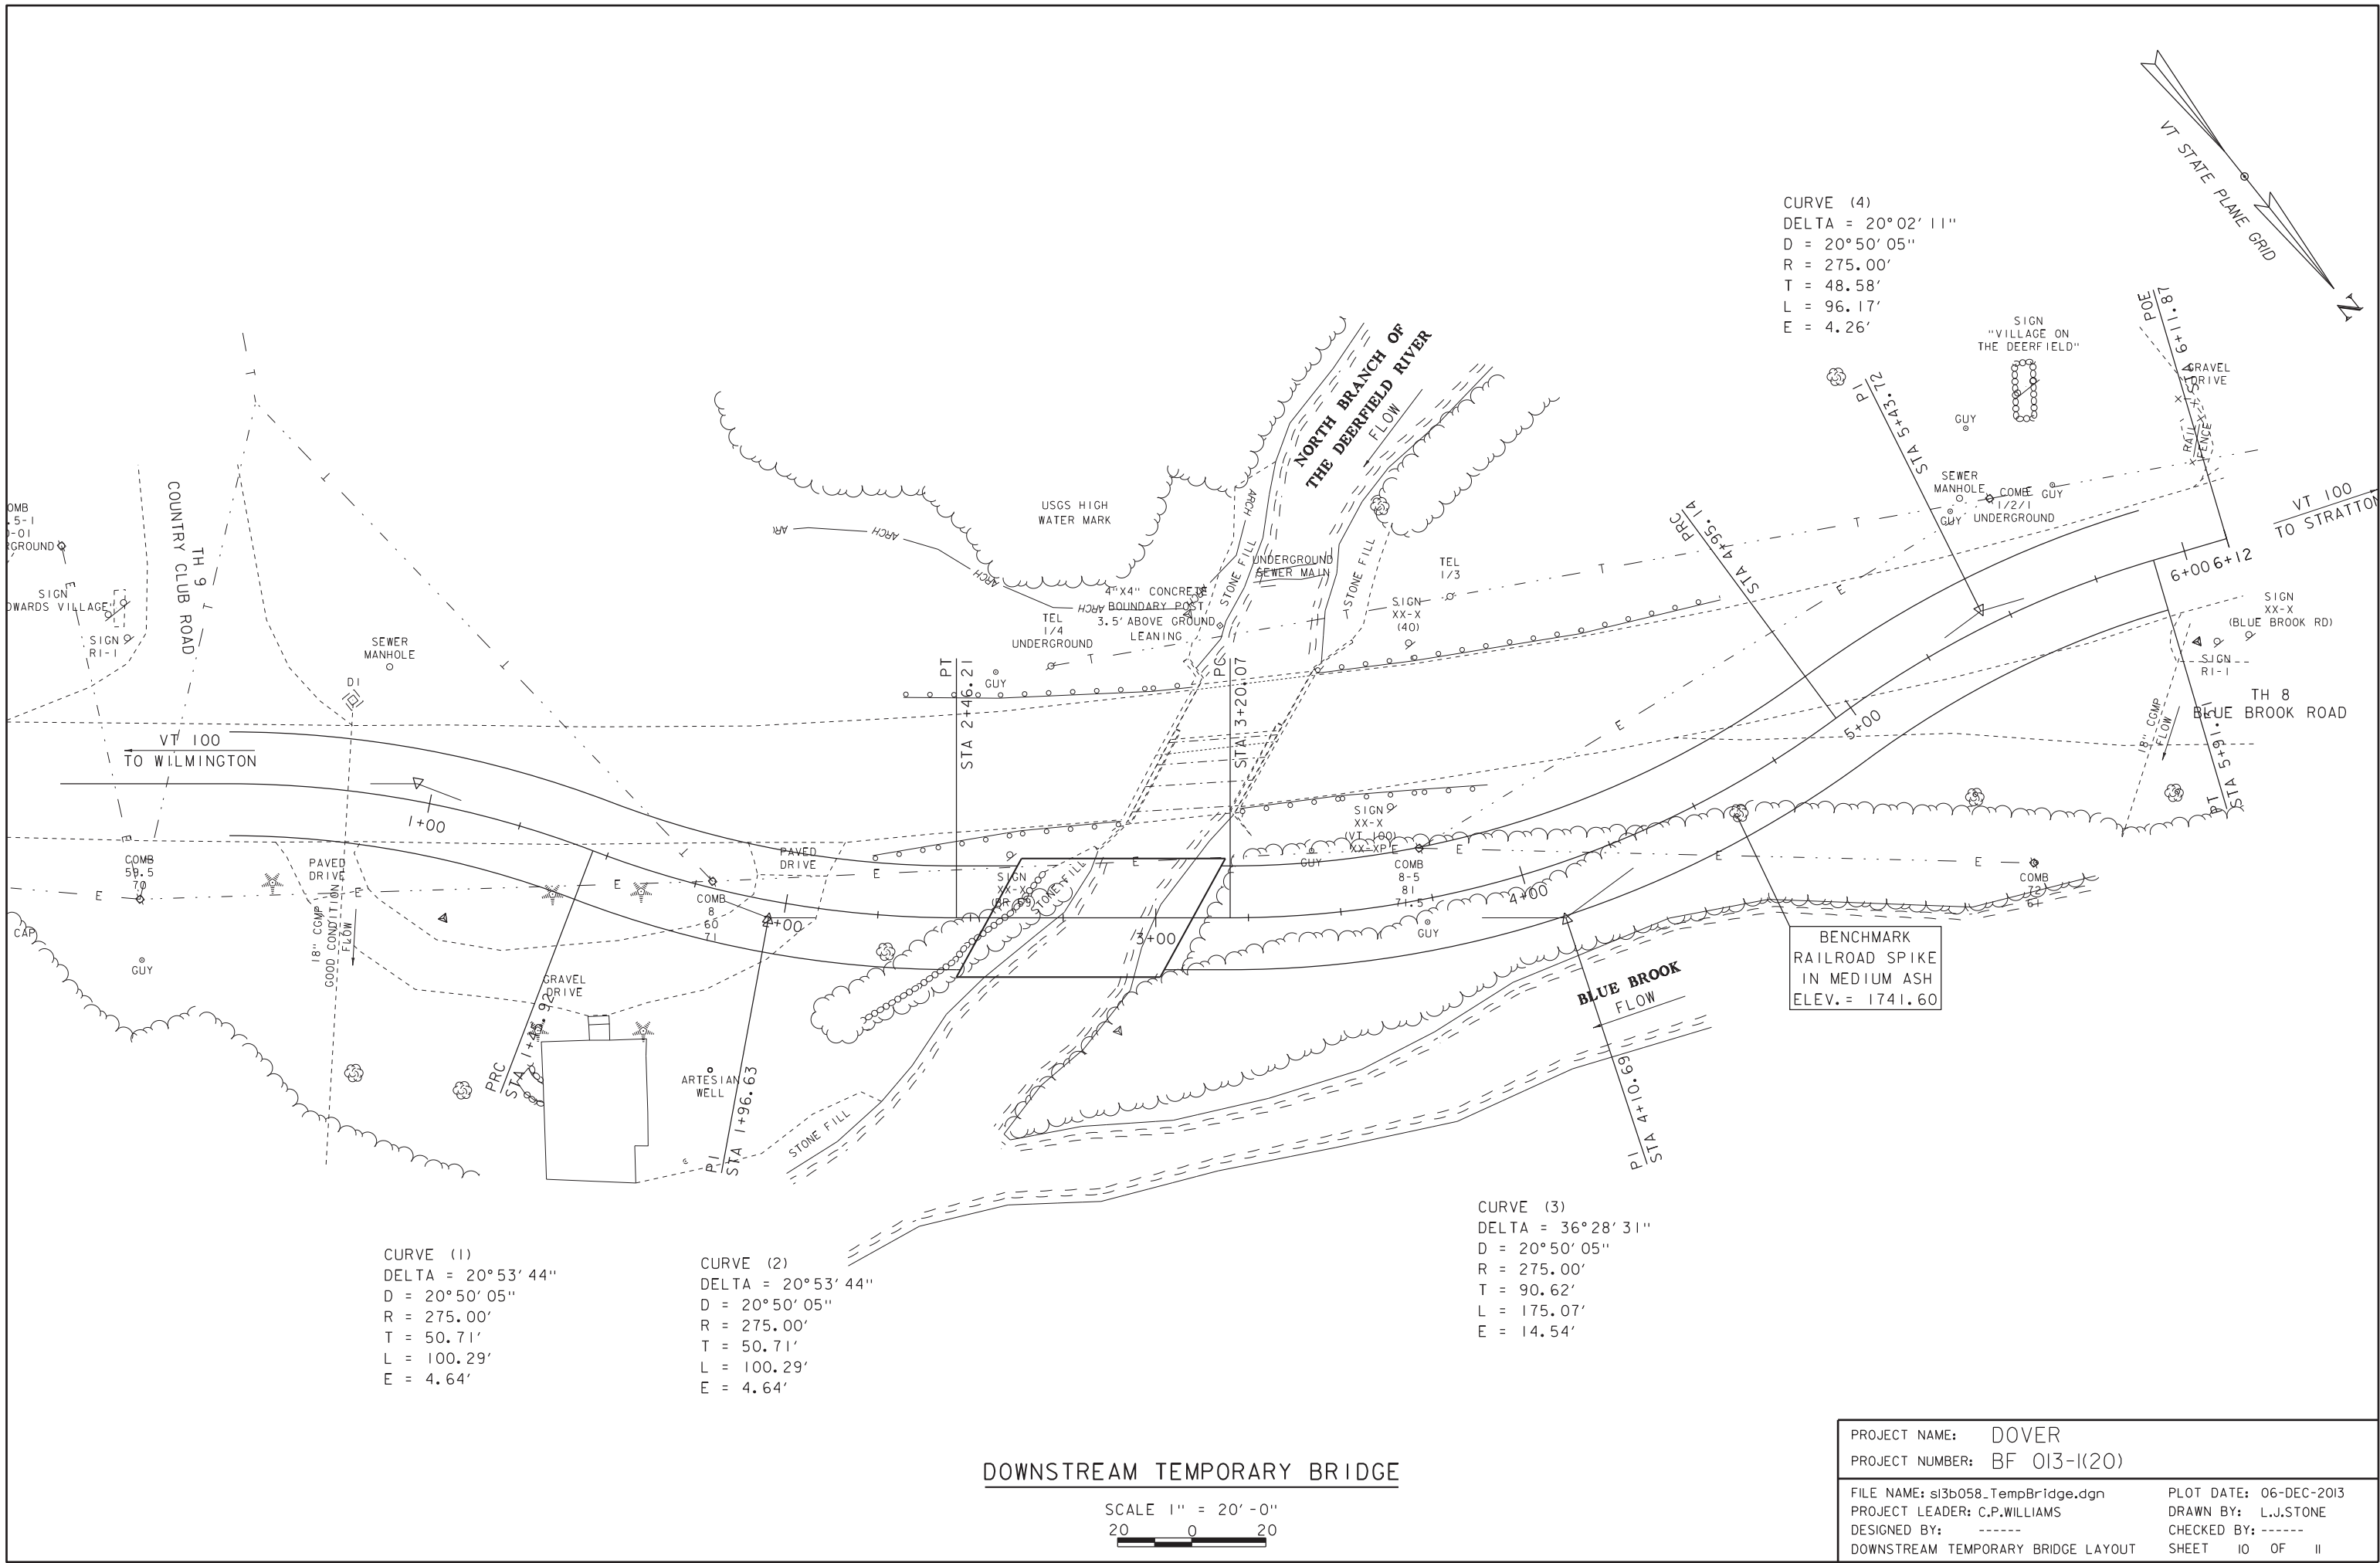
CURVE (4)
DELTA = 20°02'11"
D = 20°50'05"
R = 275.00'
T = 48.58'
L = 96.17'
E = 4.26'

CURVE (1)
DELTA = 20°53'44"
D = 20°50'05"
R = 275.00'
T = 50.71'
L = 100.29'
E = 4.64'

PROJECT NAME:	DOVER
PROJECT NUMBER:	BF 013-1(20)
FILE NAME:	s13b058_TempBridge.dgn
PROJECT LEADER:	C.P.WILLIAMS
DESIGNED BY:	-----
DOWNSTREAM TEMPORARY BRIDGE LAYOUT	
PLOT DATE:	06-DEC-2013
DRAWN BY:	L.J.STONE
CHECKED BY:	-----
SHEET	10 OF 11

If the Towns of Dover and Wilmington do not wish to have the Local Bypass Route signed, than a temporary bridge will be recommended. A two-way temporary bridge could be constructed on either the upstream or downstream side of the existing bridge.
