STATE OF VERMONT  
AGENCY OF TRANSPORTATION

Scoping Report

**Berlin BF 026-1(43)**  
**US 302 Bridge 3 over Stevens Branch**

January 11, 2018

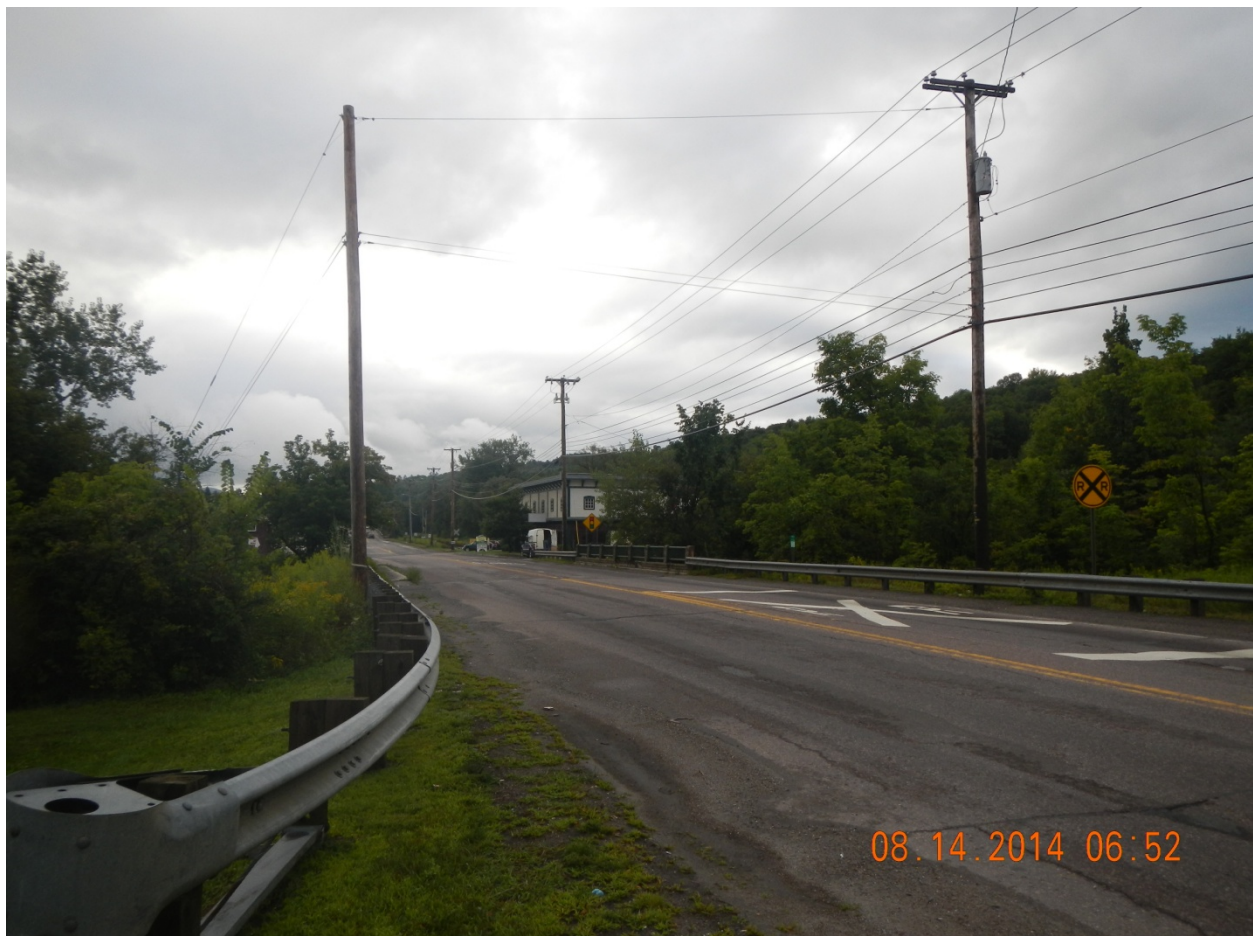
**Figure 2:** View of the Bridge Looking East

A preliminary site visit was conducted on August 14, 2014 to determine possible obstructions inhibiting boring operations and to make any other pertinent observations about the project. Overhead power lines run along the south side of the bridge and cross over the west end of the bridge. As shown in Figure 2.

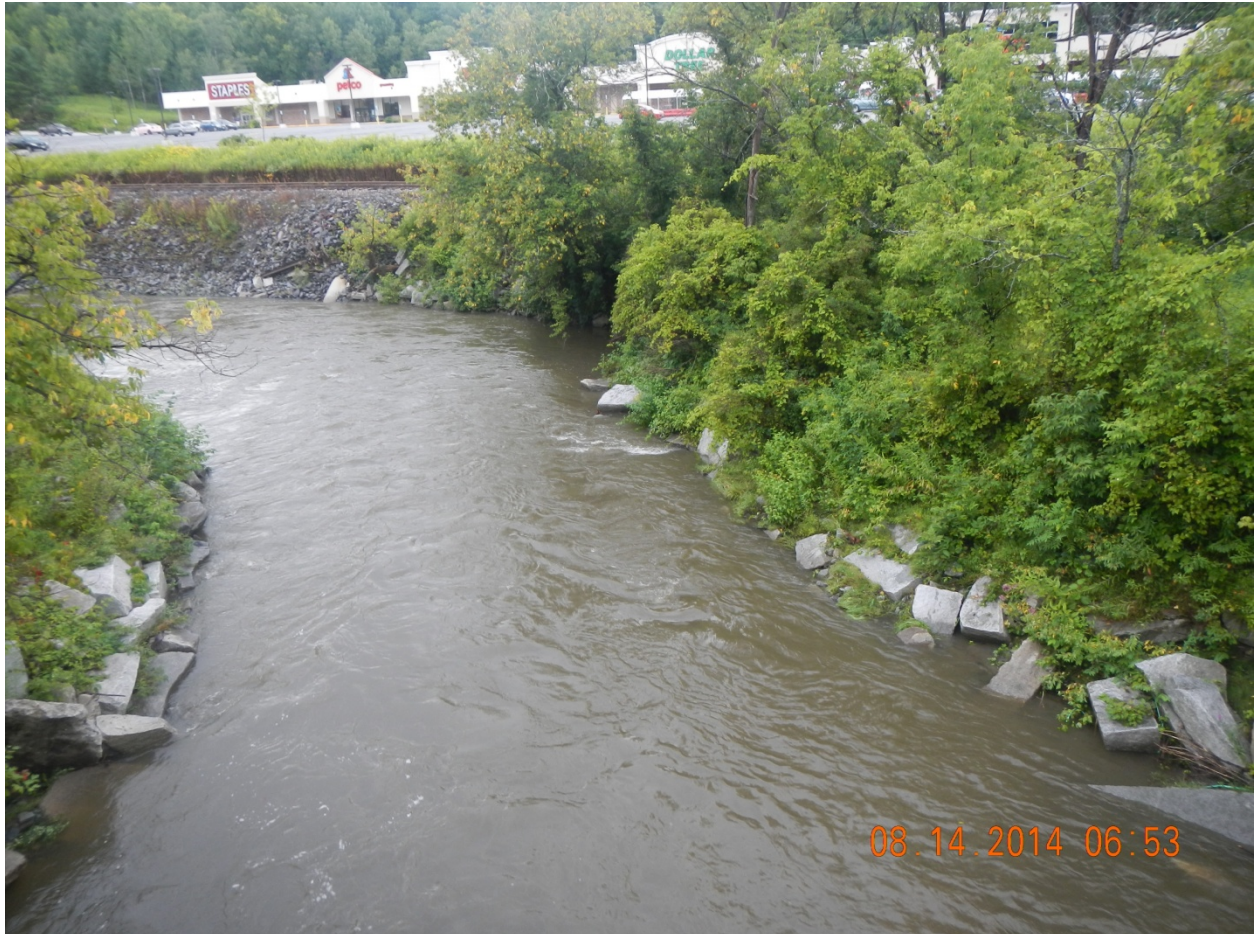
**Figure 3:** Stevens Branch, North side of the Bridge

According to record plans from previous construction, the existing abutments are founded on spread footings. No visible bedrock was seen during the site visit. The sides of the stream were armored with stone, shown in Figure 3. Because of the high turbidity of the river during the site visit it was difficult to see if there was bedrock or cobbles in the river.

Based on the site visit and a review of the bridge inspection report and photos, the existing foundations appear to be in satisfactory condition. For this reason, reuse of the existing foundations with minor repairs and replacement of the superstructure should be considered. If this is not the preferred option, possible foundation alternatives for a bridge replacement include the following:

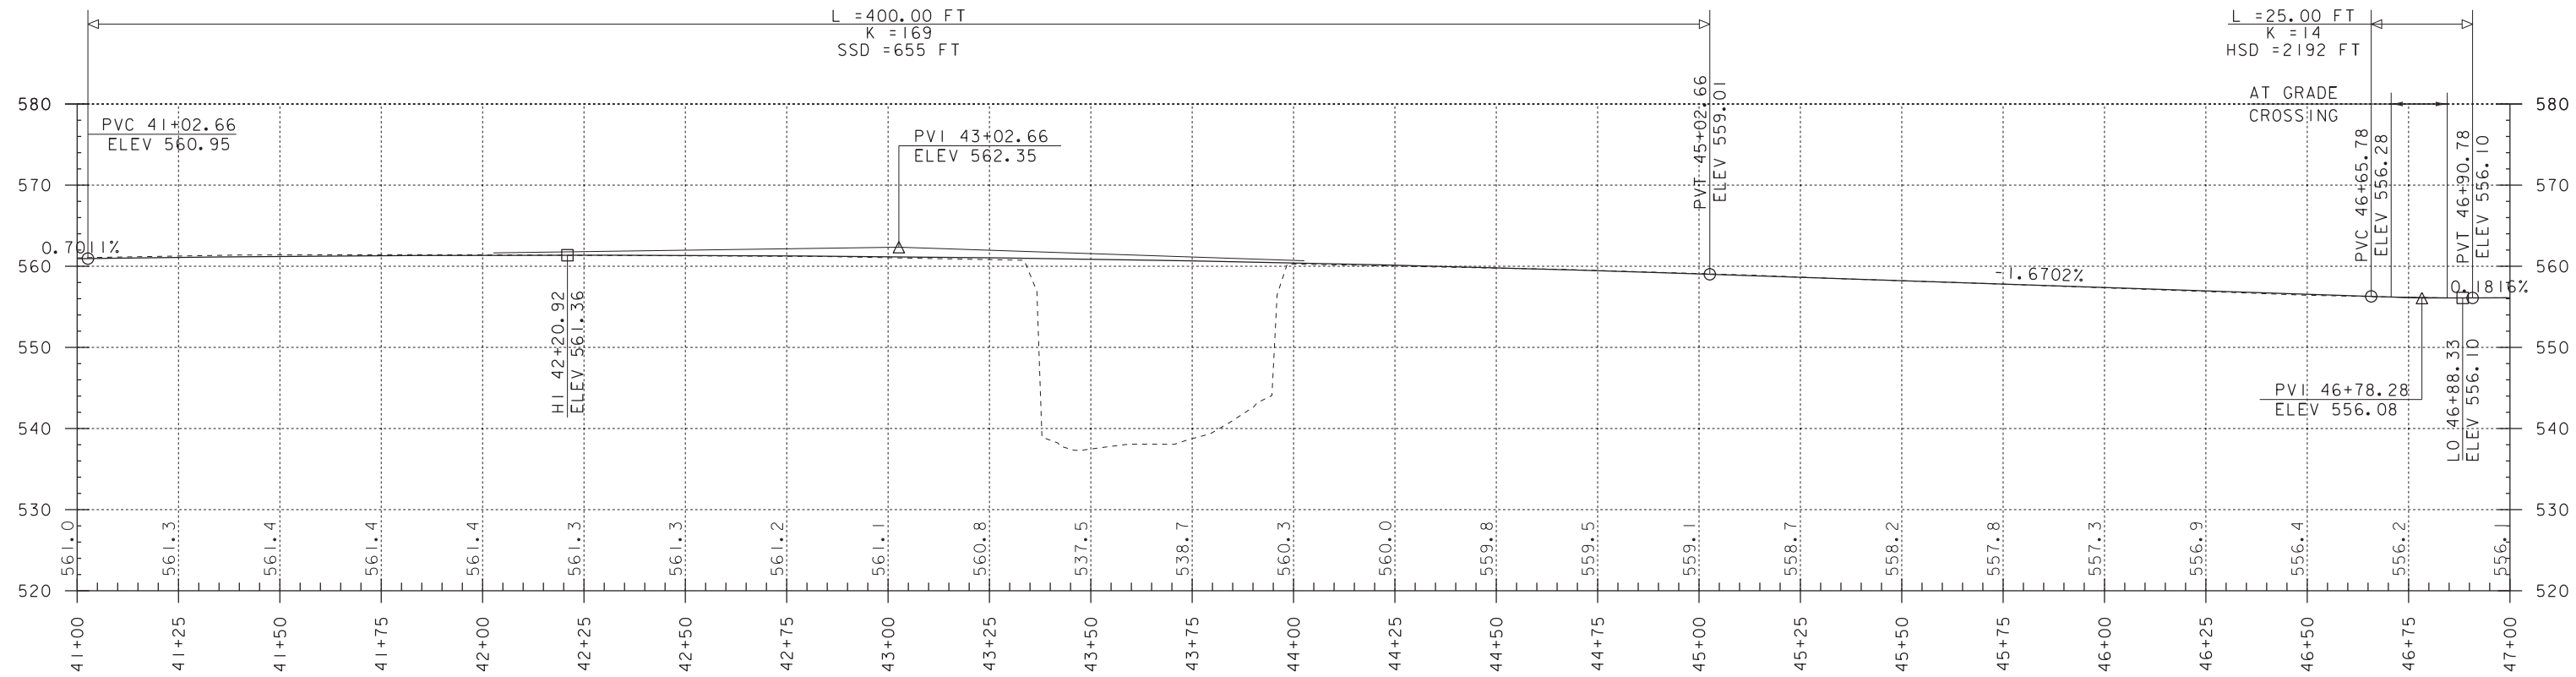
US RT 302 PROFILE

NOTE:  
 GRADES SHOWN TO THE NEAREST  
 TENTH ARE EXISTING GROUND ALONG  $\phi$   
 GRADES SHOWN TO THE NEAREST  
 HUNDREDTH ARE FINISH GRADE ALONG  $\phi$

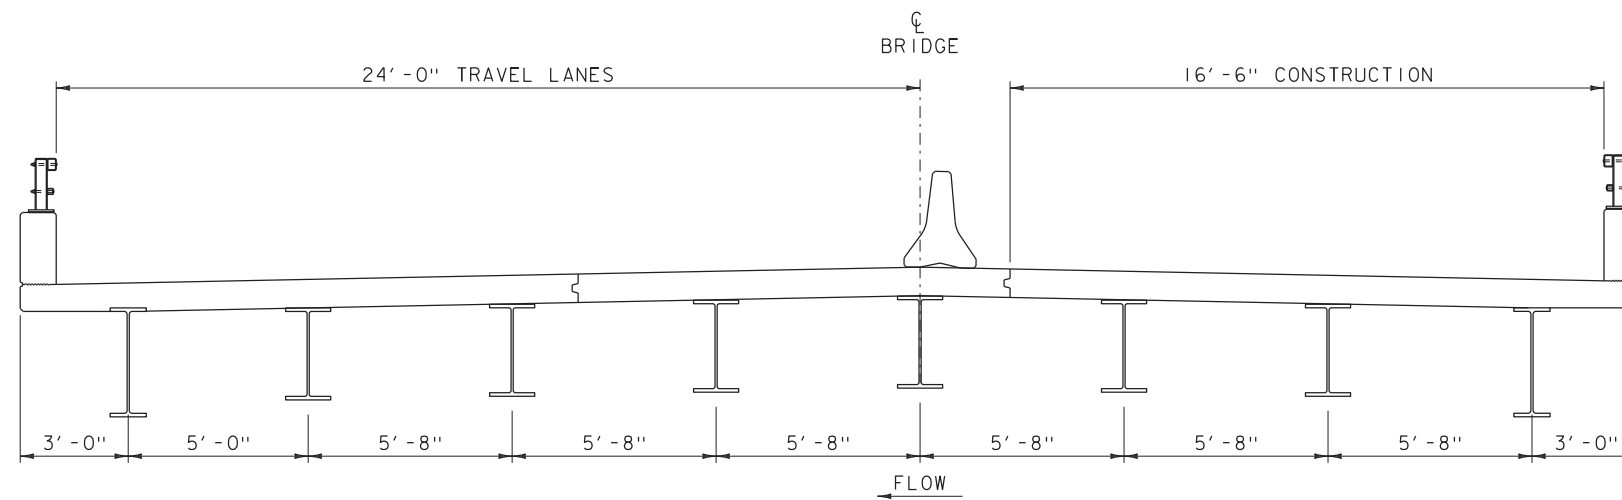
PHASE 3 TYPICAL SECTION

GIRDER SPACING TAKEN FROM AS BUILT PLANS
