**STATE OF VERMONT
AGENCY OF TRANSPORTATION**

Scoping Report

**Killington BF 020-2(42)
US ROUTE 4, BRIDGE 33 over Ottauquechee River**

March 9, 2015

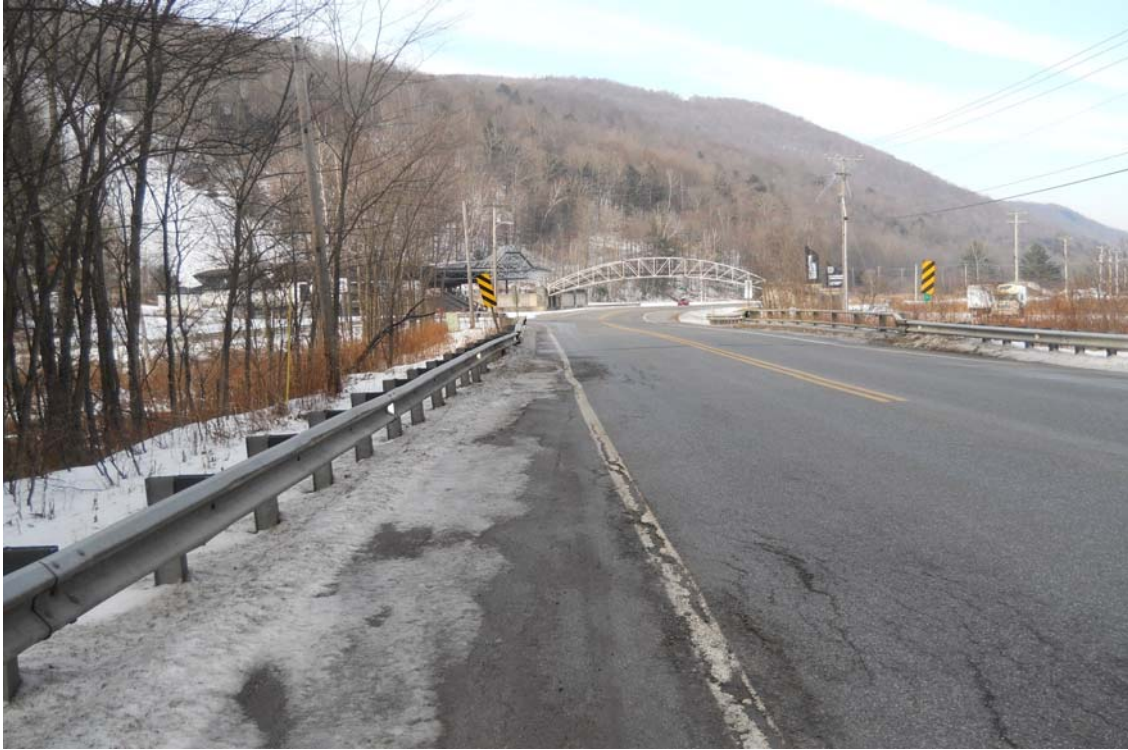
Bridge 33 Looking West

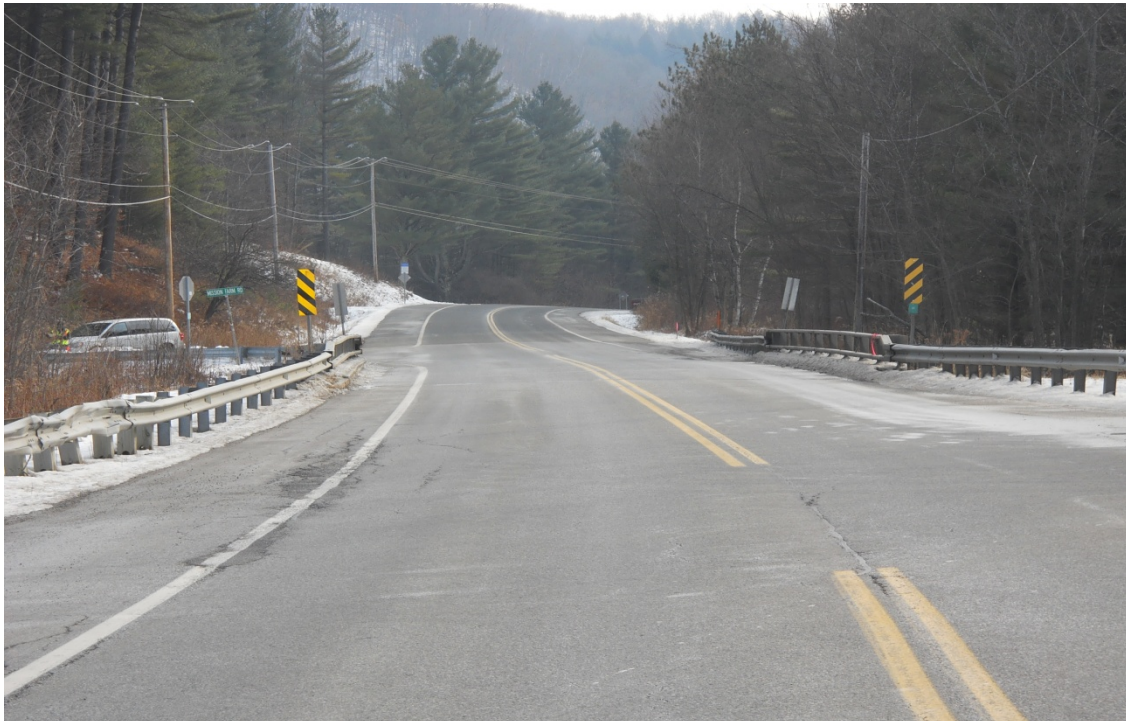
Bridge 33 Looking East

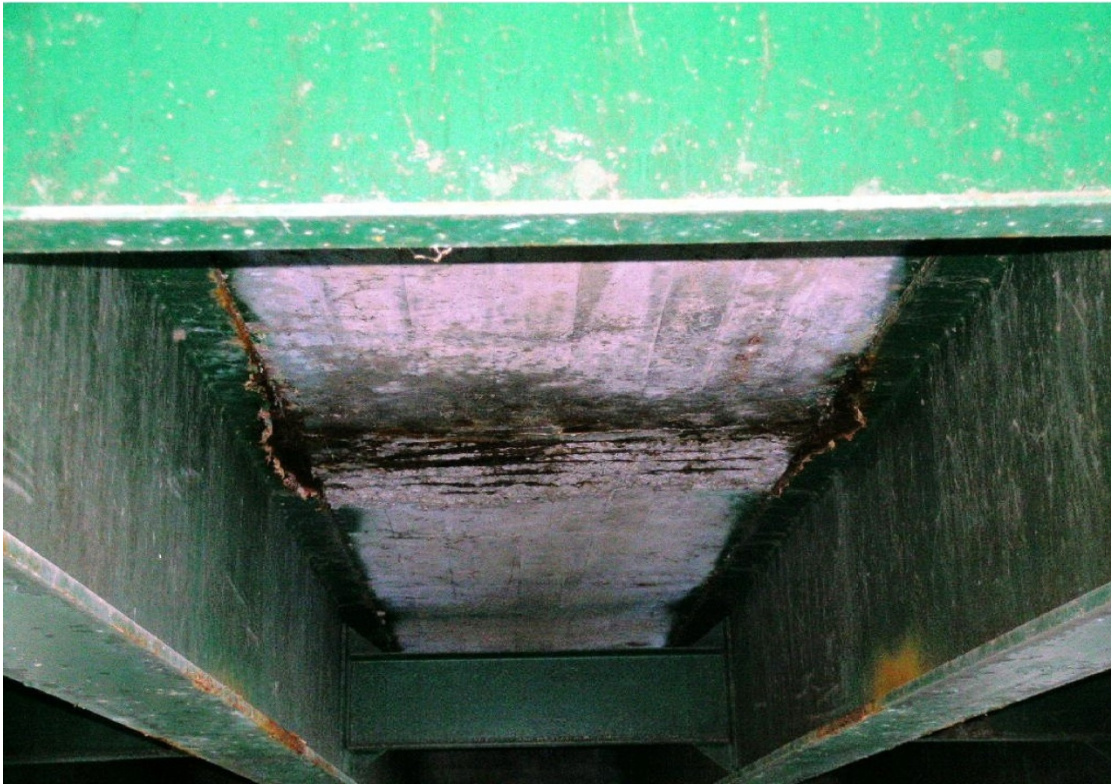
Deck Deterioration

“05/16/13 Deck is in poor condition & full depth hole is highly likely at mid span. Deck needs replacement soon. MJK SH

08/19/11 Deck soffit continues to deteriorate mainly at mid span with moderate to heavier spalling and delams in each bay. Structure is a good candidate for full deck replacement as full depth failures are possible. MK & NV

04/22/09 Structure's in satisfactory condition overall. However the concrete deck continues to deteriorate and soffit has areas of exposed rebar. Areas of large delams in localized spots. Full depth failures are possible. Structure would be a good candidate for deck replacement. MJK”

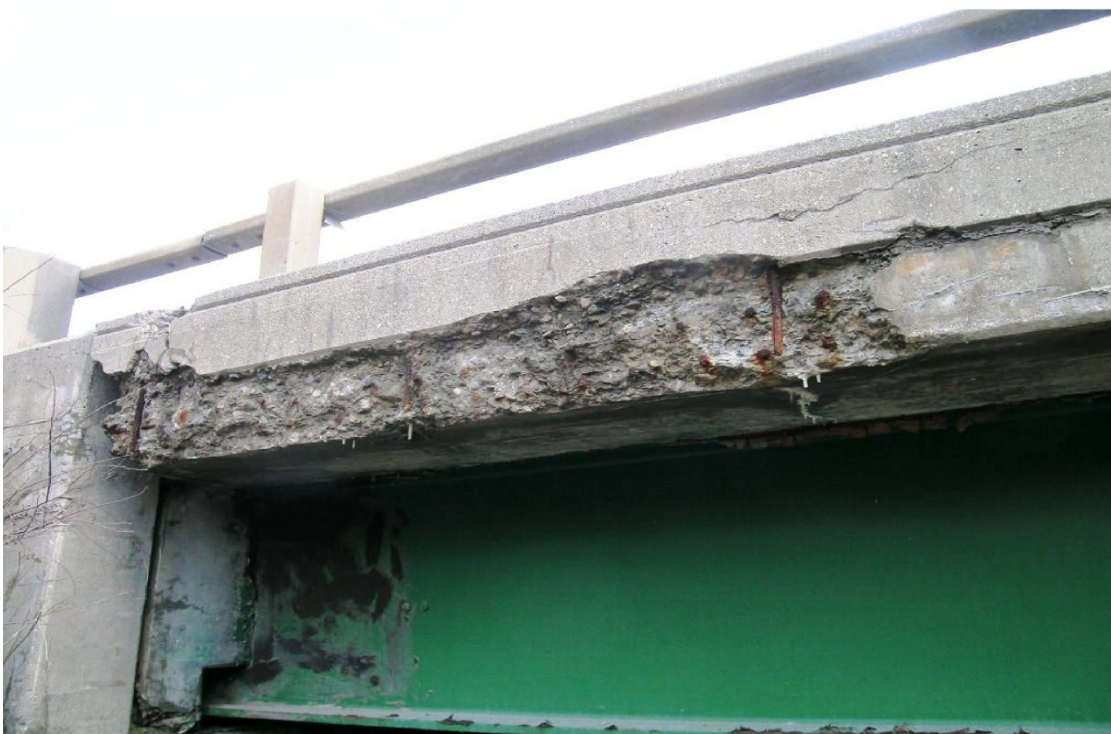
Fascia Deterioration

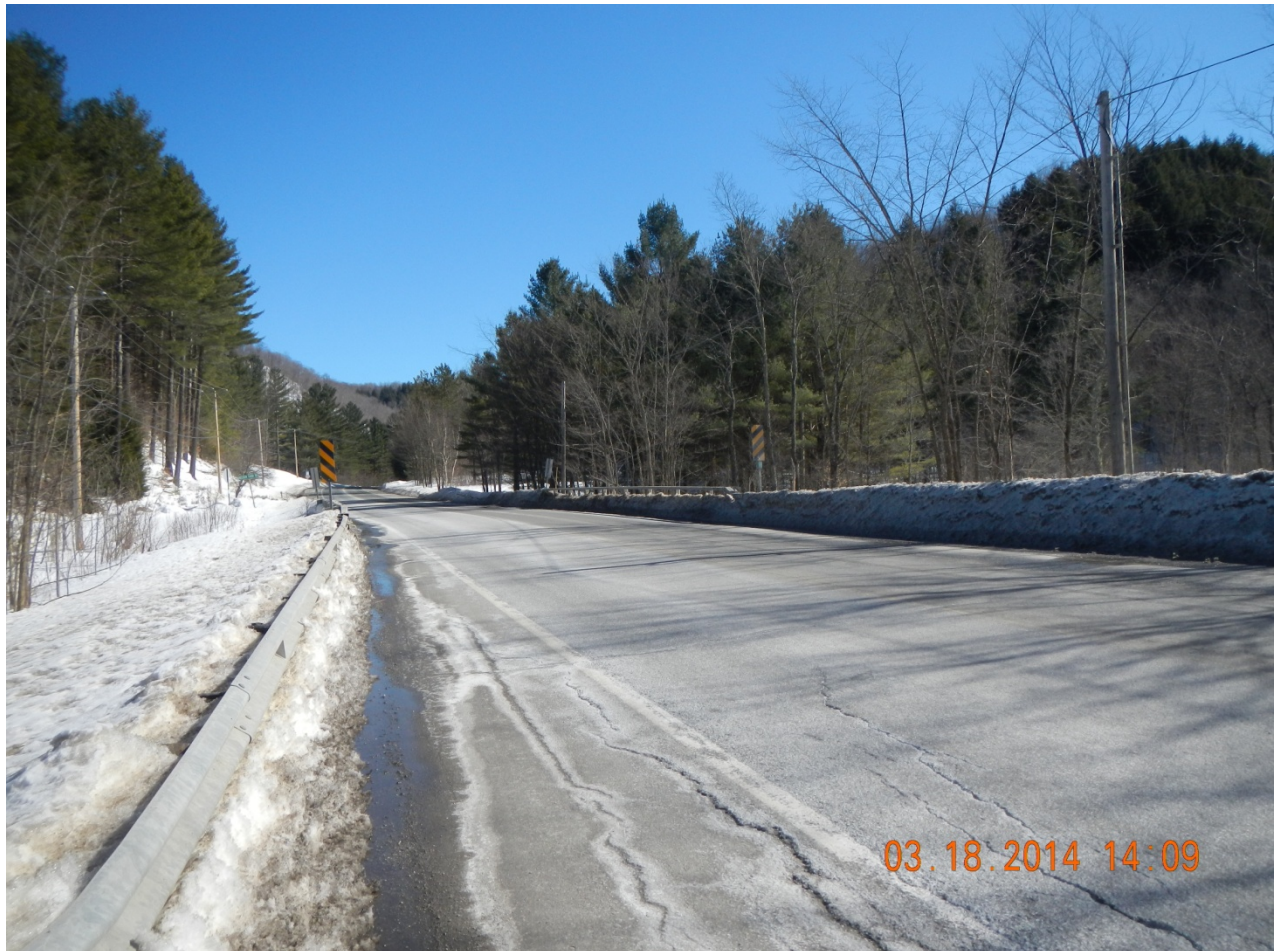
Figure 2. View of Bridge, Looking Southeast

Overhead utilities run along either side of the bridge, Figure 2, but should not conflict with boring operations. A utility conduit also crosses under the bridge on the northwest side as shown in Figure 3.

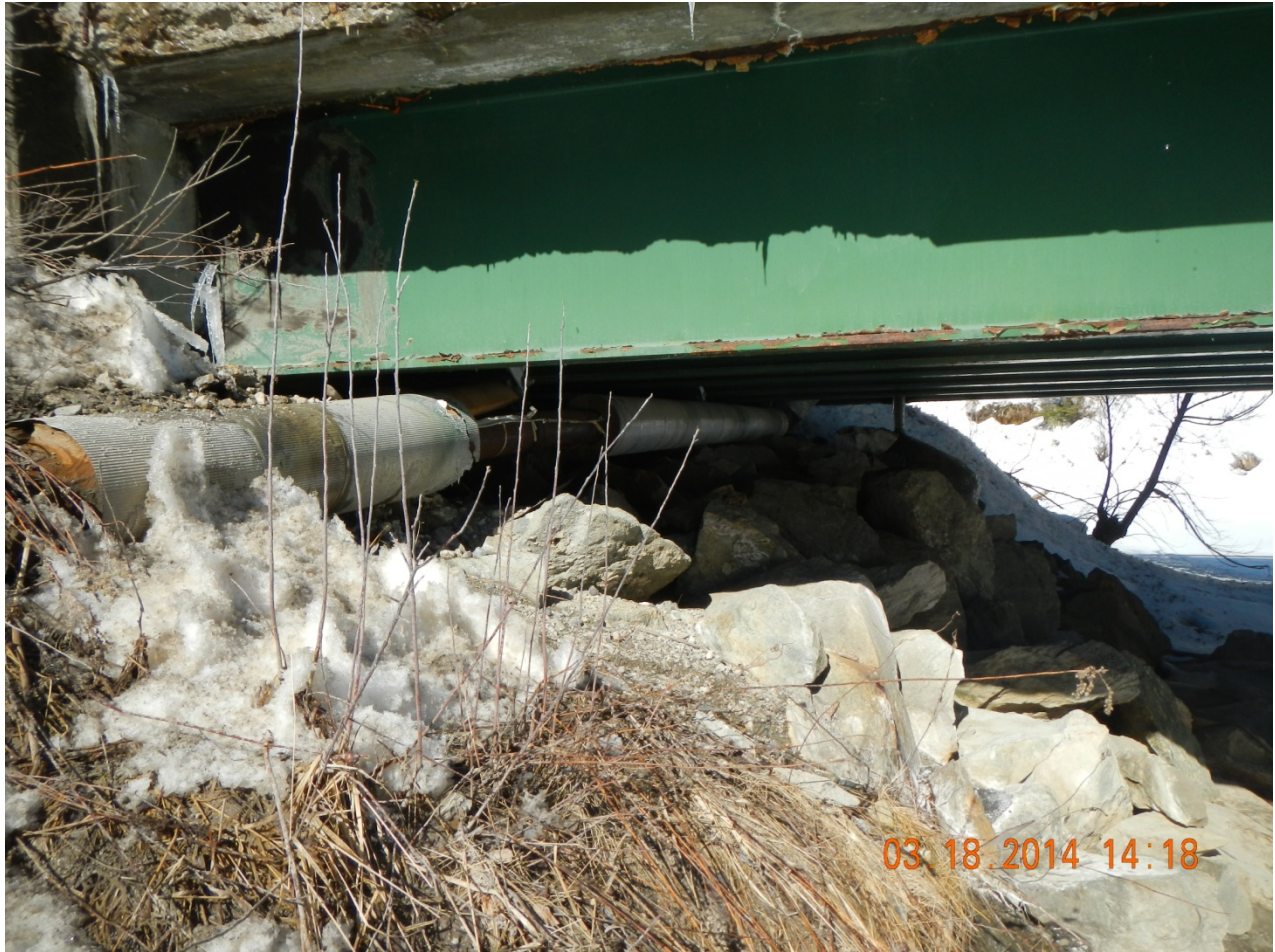
Figure 3. Utility Conduit below Northwest end of Bridge

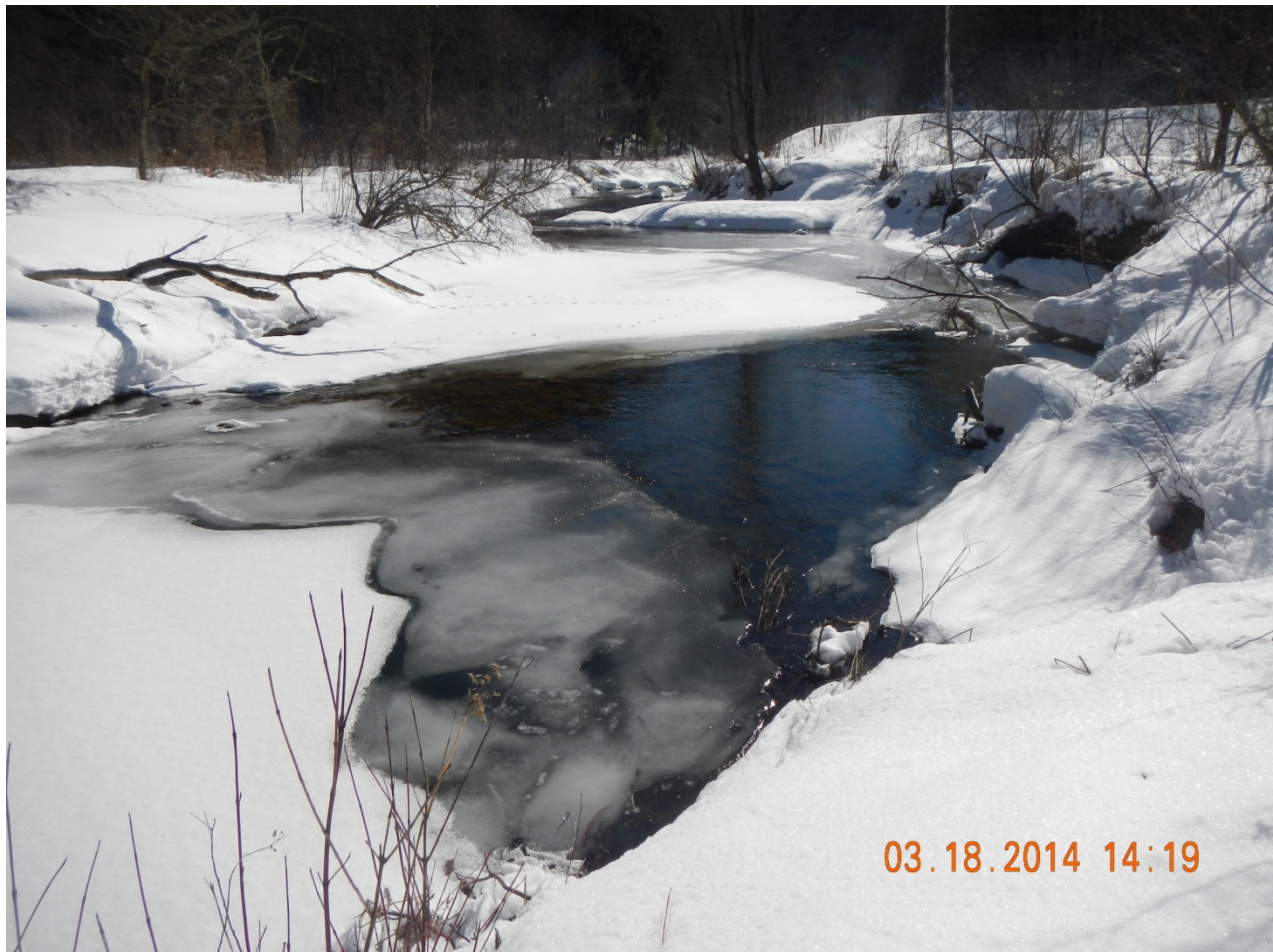
The surrounding surficial soils are within the floodplain. Large amounts of snow and ice present during a visit to the project site made it difficult to see the streambed or any erosion of the banks of the river. From what was observed, the minimal presence of cobbles and boulders in the river suggests borings and piles could be advanced with limited difficulty. Figure 4 shows an exposed part of the streambed south of the bridge.

Figure 4. Streambed Downstream of the Bridge
