# Killington BF 020-2(42) Public Meeting

**US Route 4 – Bridge #33 over Ottauquechee River**

March 6, 2015

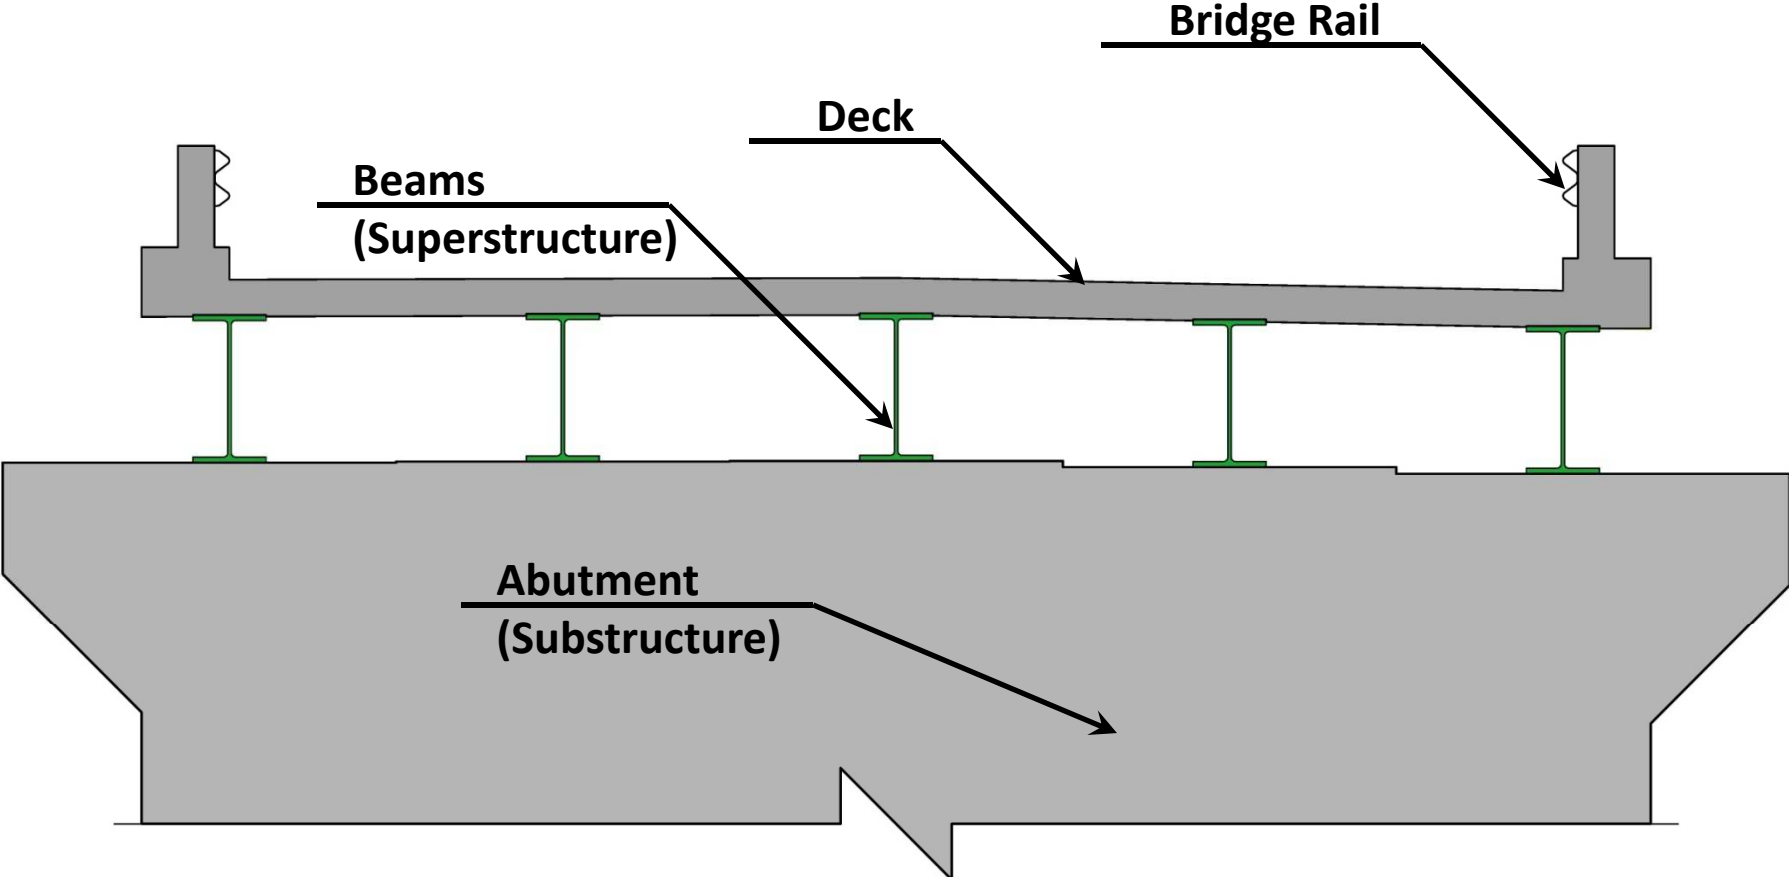
**Cross Section of Bridge**

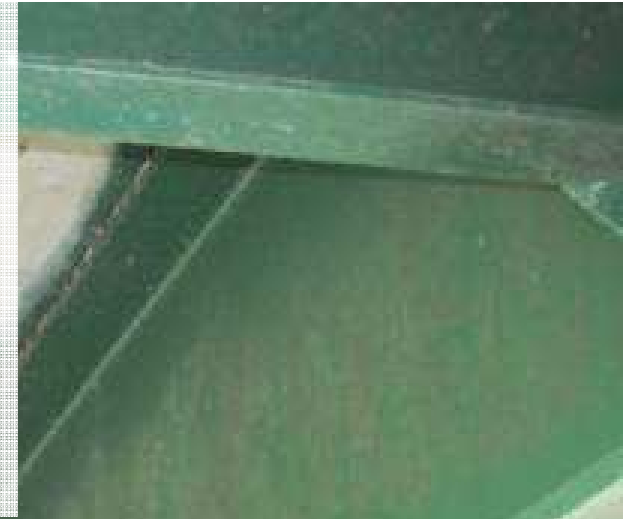
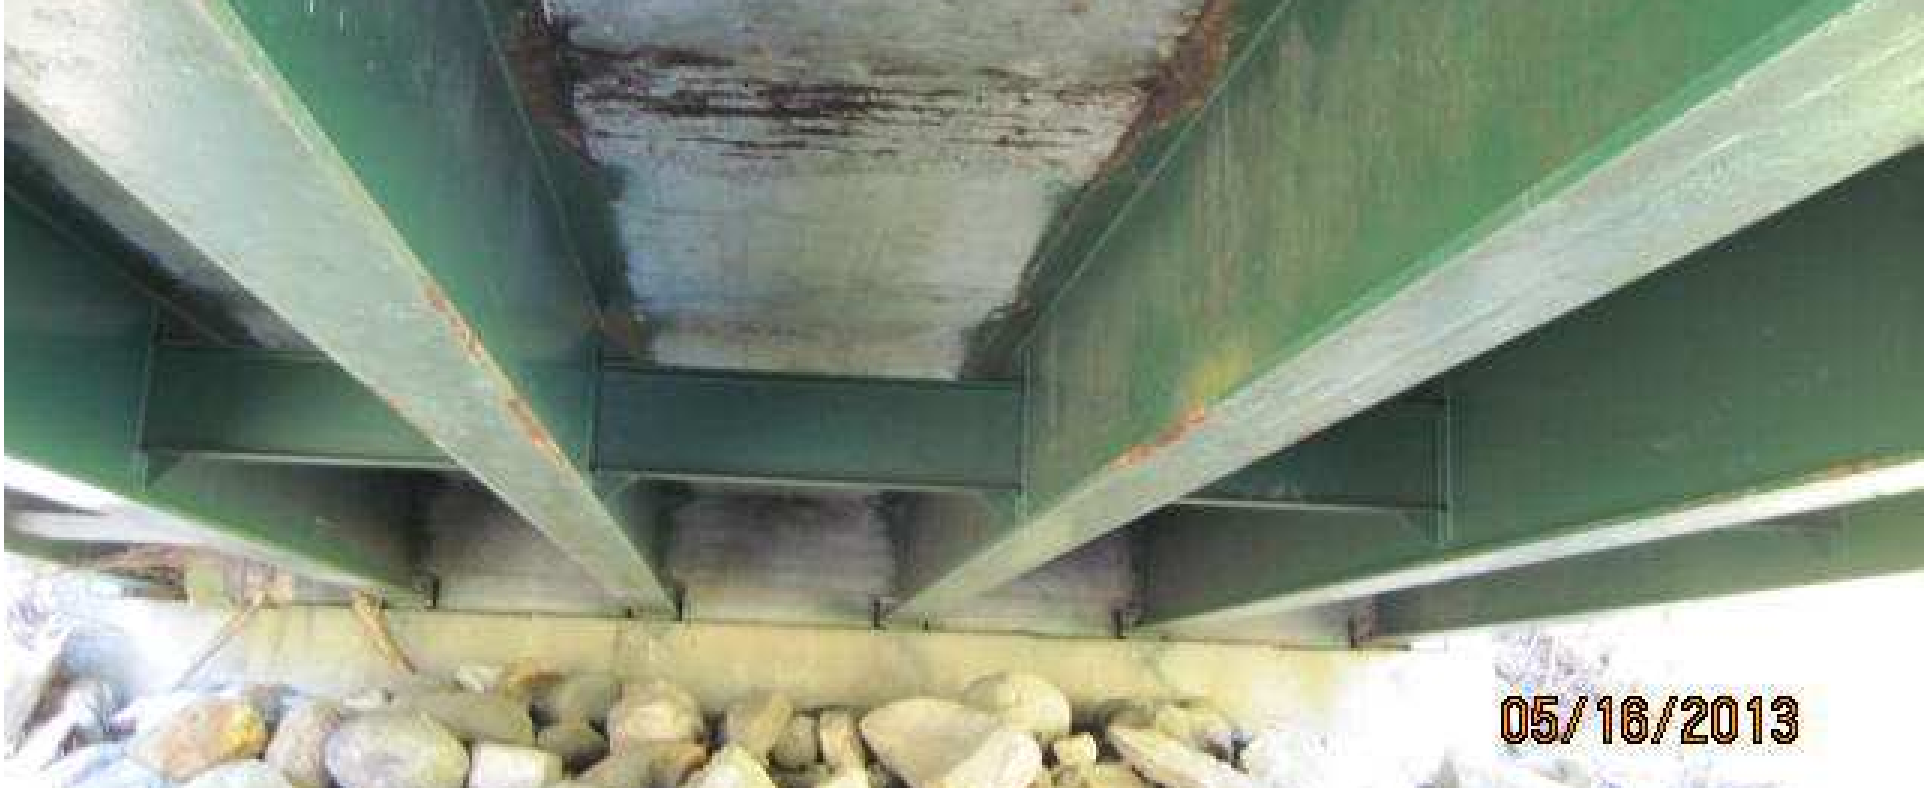
05/16/2013

- Deck Rating 4 (Poor)
- Superstructure Rating 7 (Good)
- Substructure Rating 7 (Good)
- Channel Rating 6 (Satisfactory)

Typical deck deterioration with exposed rebar

- The existing concrete deck is in poor condition
- The bridge is considered structurally deficient
- Approach and bridge lane and shoulder widths are substandard
- The approaches have substandard banking
- The clear zones are substandard
- High crash location
- VTrans Geotechnical Section recommends replacement of substructures

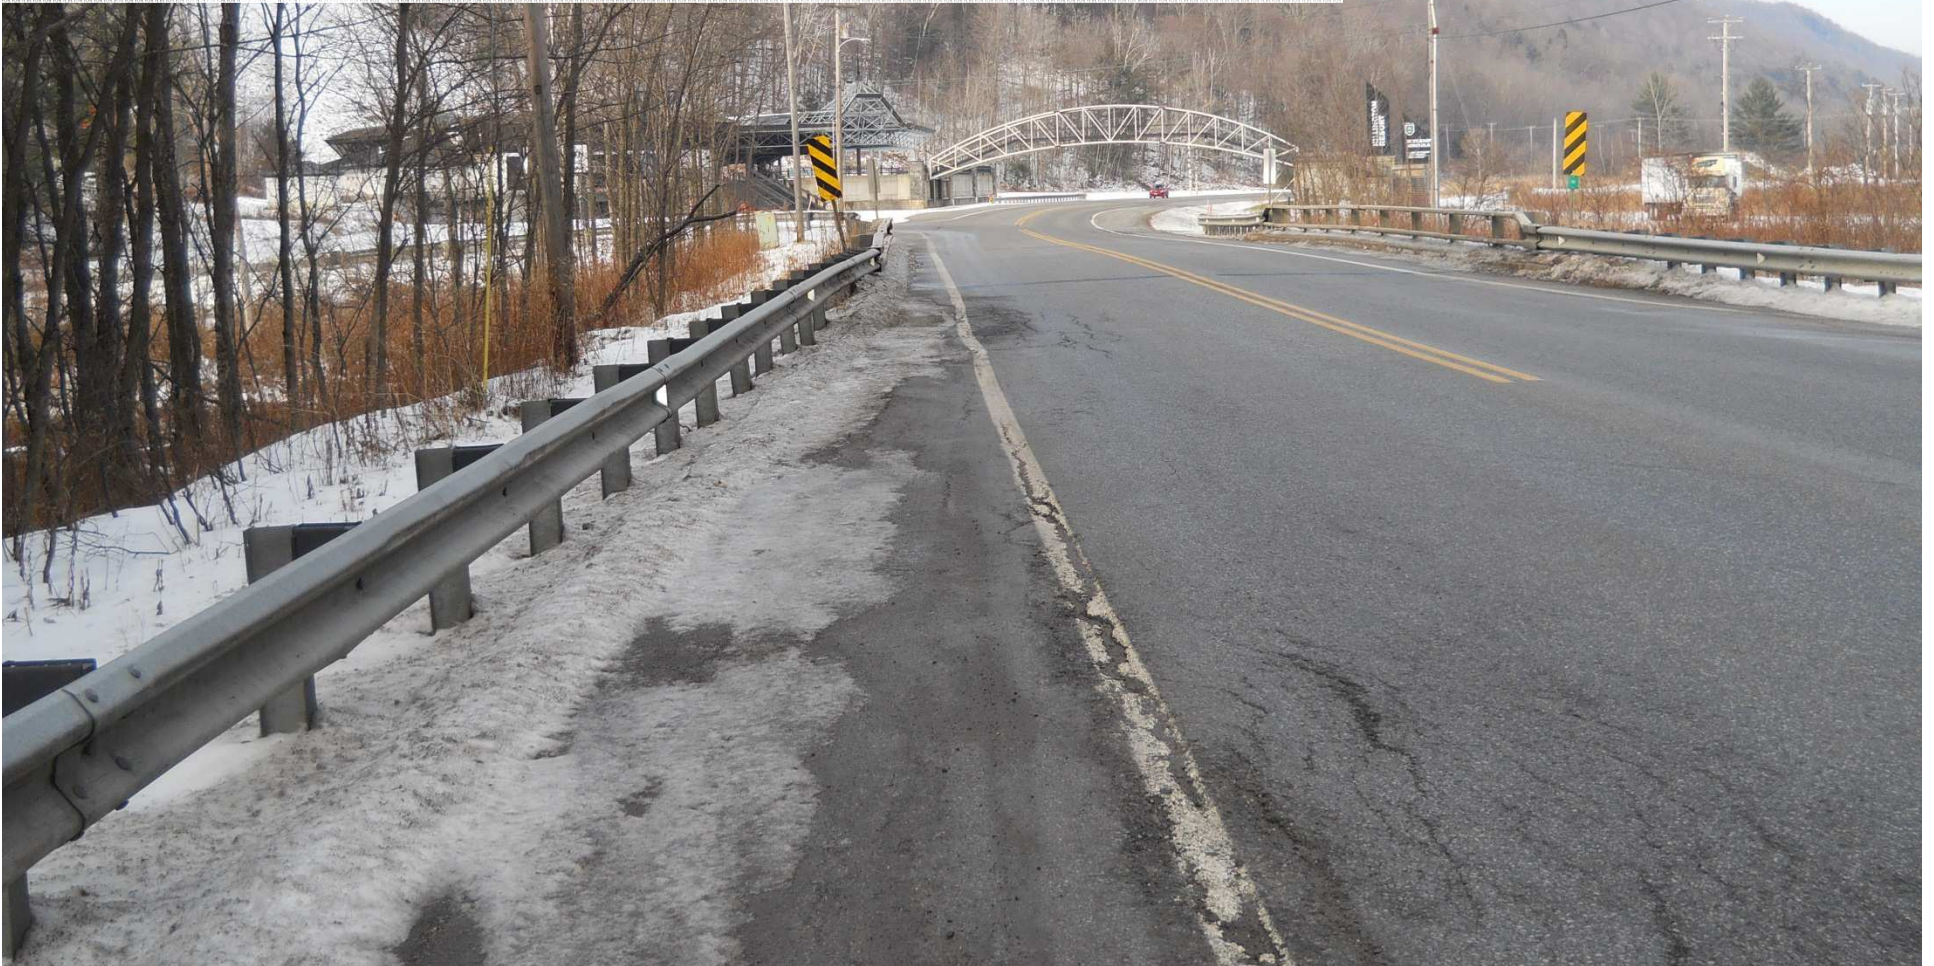
Bridge 33 Looking West

- Substandard approach and bridge shoulder width
- Substandard banking beyond bridge

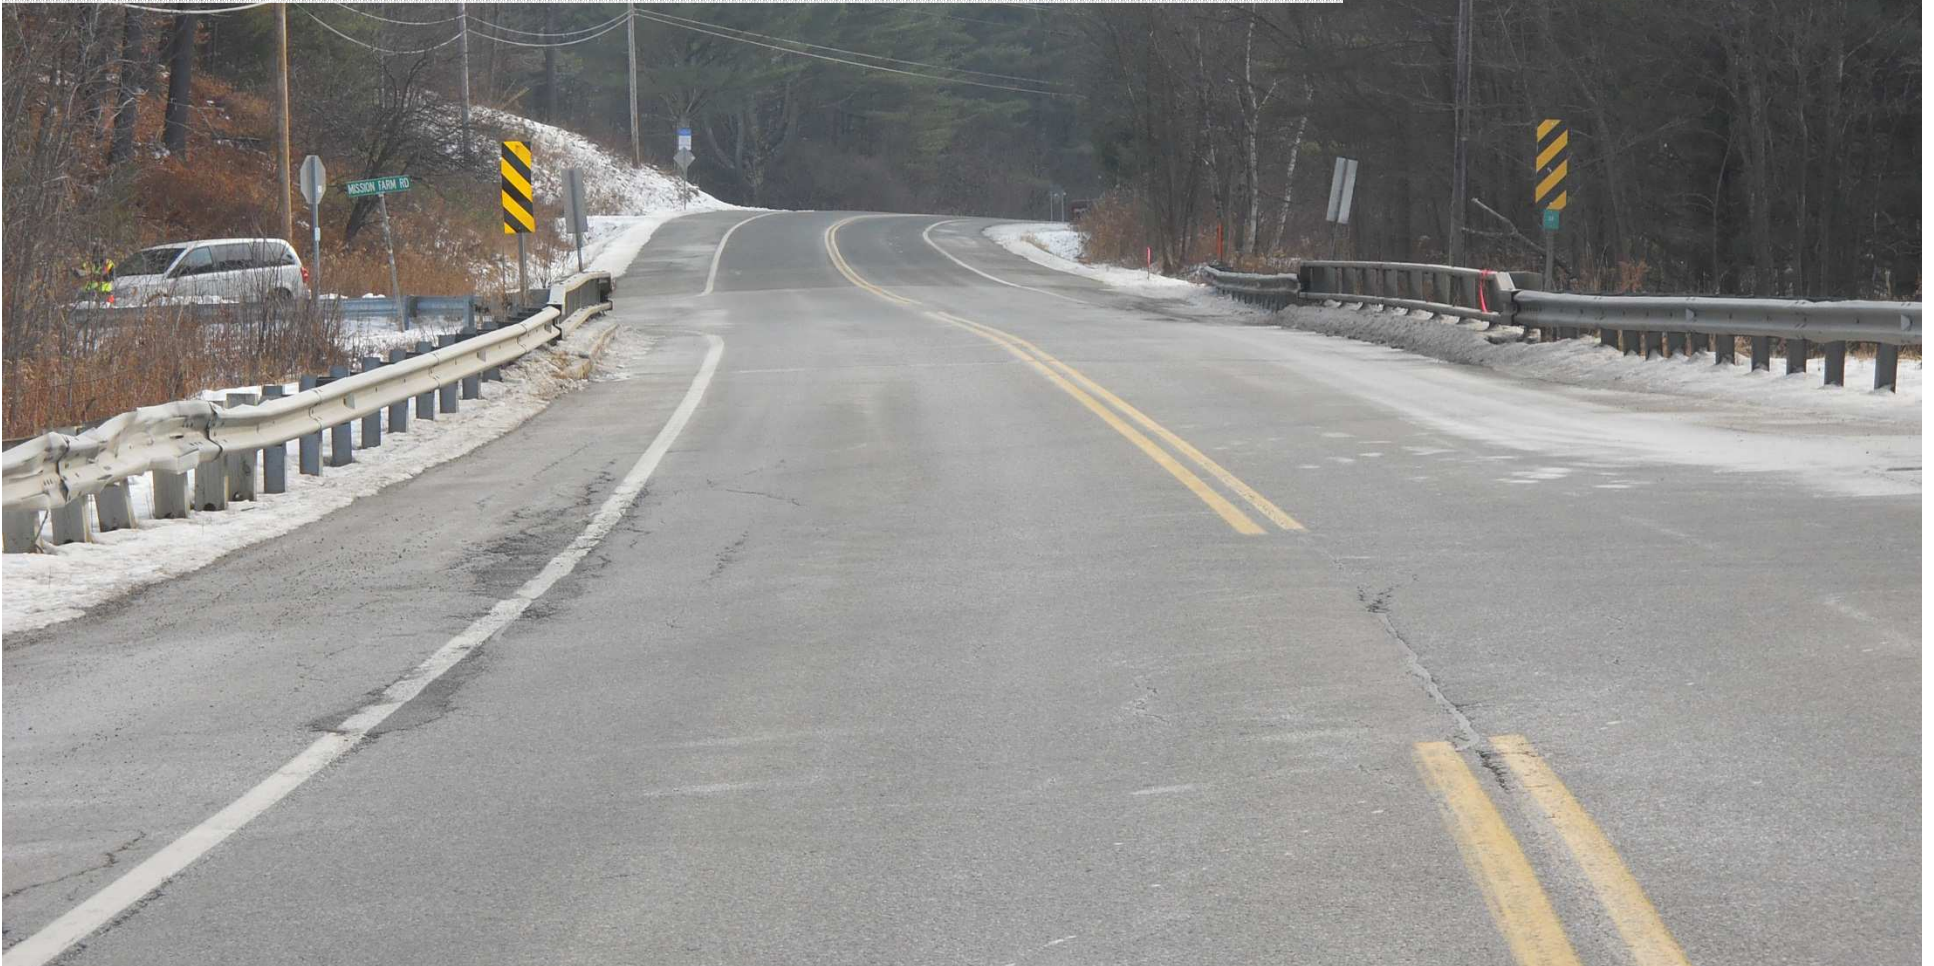
Bridge 33 Looking East

- Substandard approach and bridge shoulder width
- Substandard banking beyond bridge

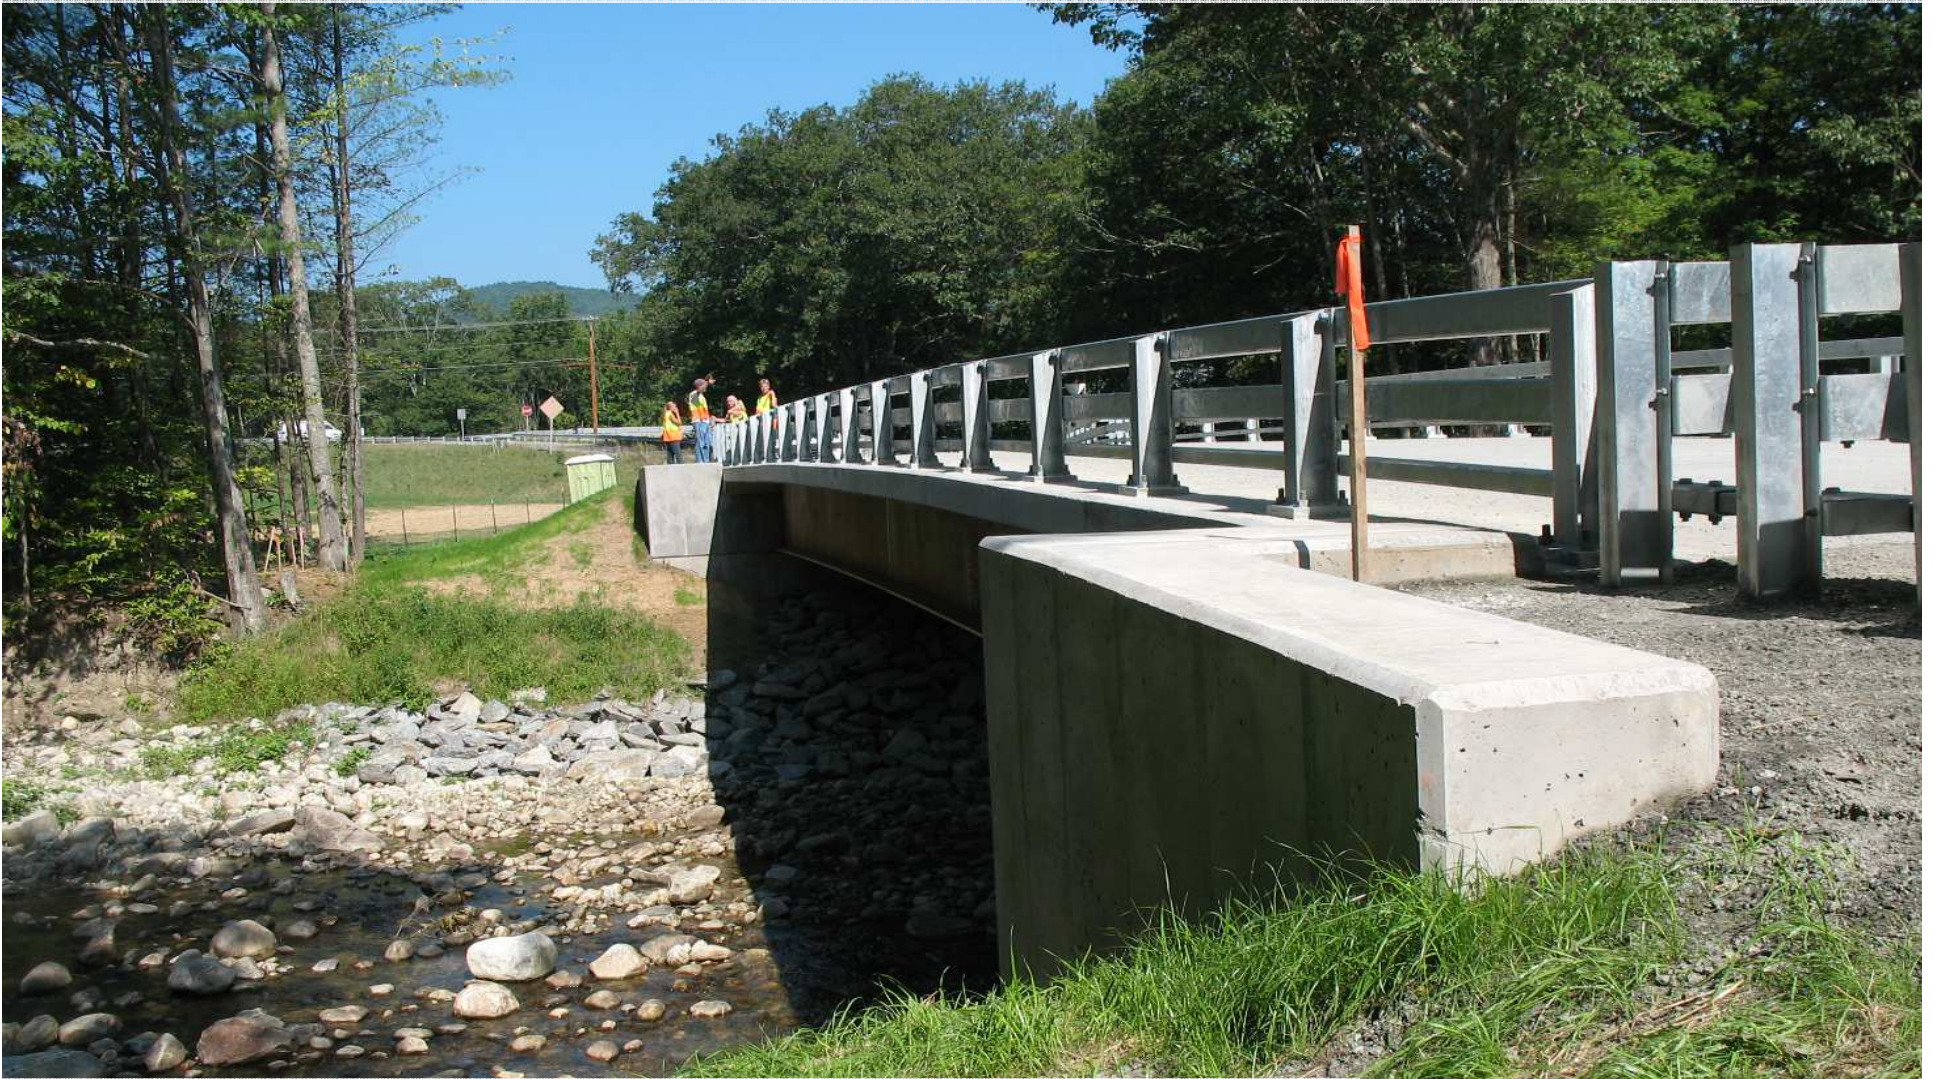
## Proposed Example – Bridge #33

- Steel Beam Bridge
- 3 Rail Box Beam Bridge Rail

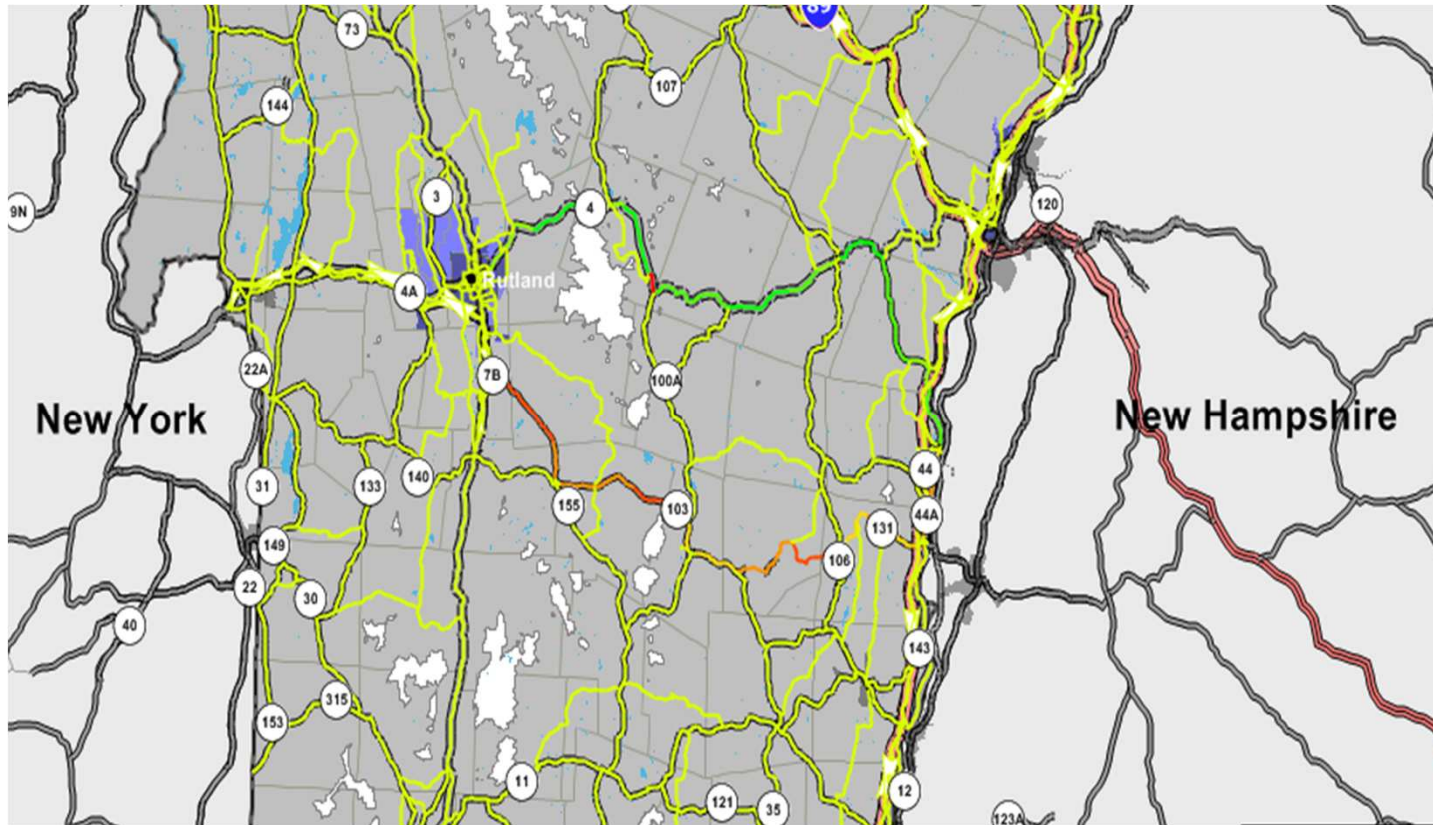
Phasing Scenario – increase in travel times shown in red and orange, decreases shown in green

- In the Phasing Scenario, the impacts of the construction will outweigh the benefits by 1.4 vehicle-hours of travel
- **Therefore, the Bridge Construction-Closure Scenario is preferable**

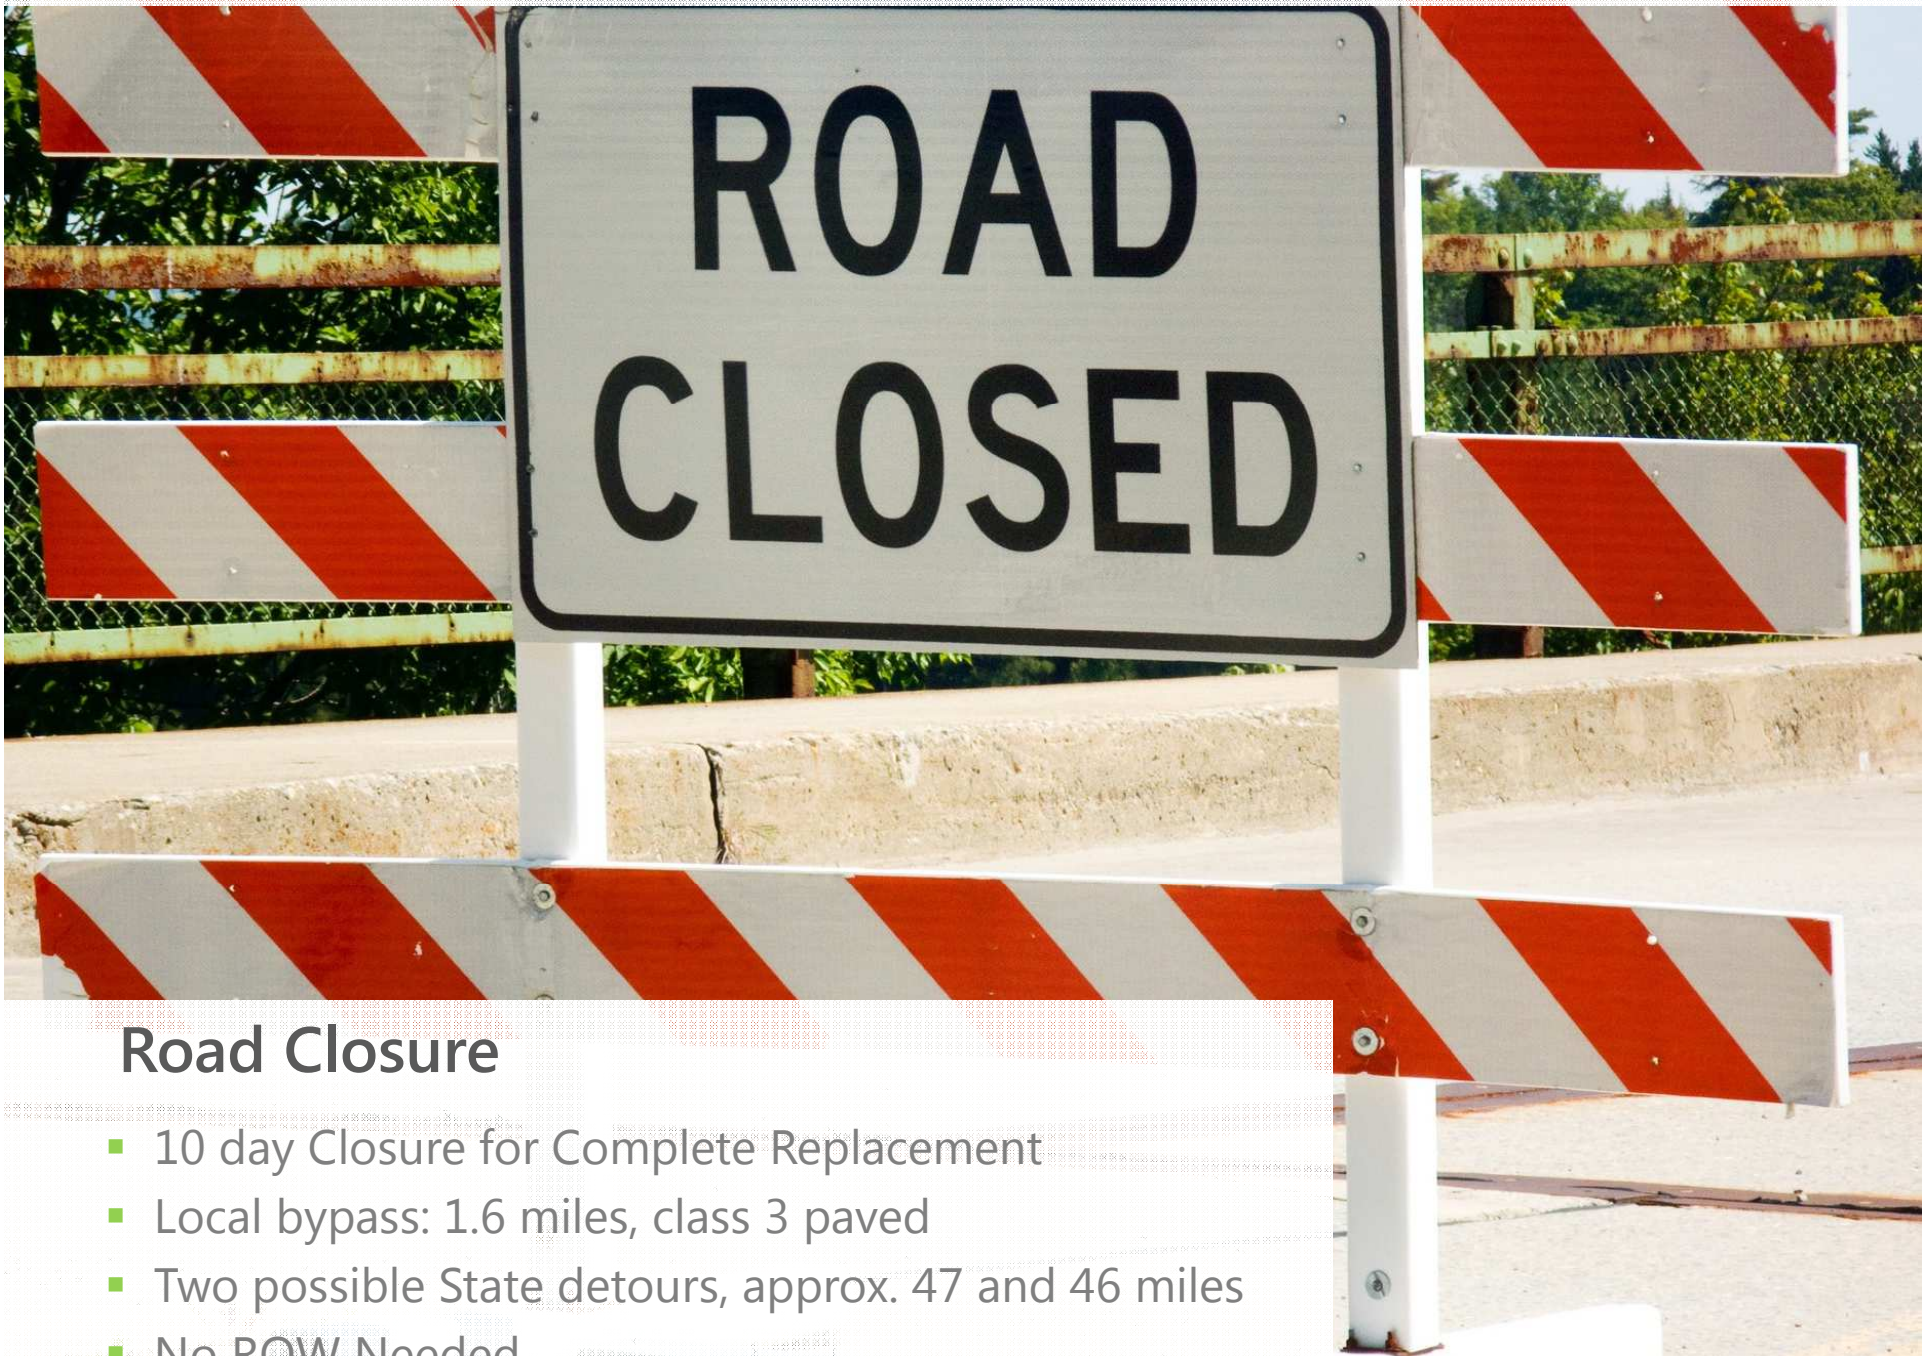
## Selected Method of Traffic Maintenance

### Road Closure

- 10 day Closure for Complete Replacement
- Local bypass: 1.6 miles, class 3 paved
- Two possible State detours, approx. 47 and 46 miles
- No ROW Needed

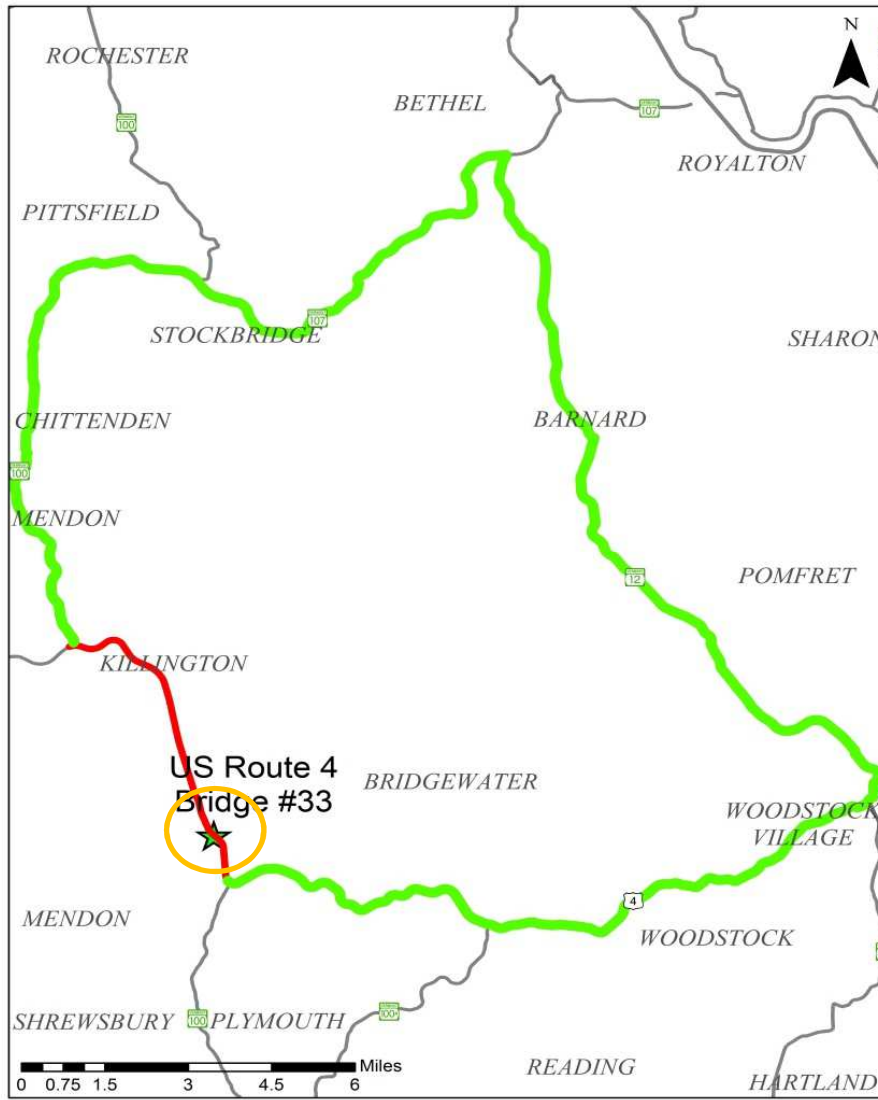
# Traffic Control – Offsite Detour - B

- 10 Day Road Closure w/  
Offsite Detour
  - Signed by State
  - 1 hr, 18 minutes to drive end-to-end
- US 4 to VT 12, VT 107, VT 100, US 4,
  - Through Route: 6.2 Miles
  - Detour Route: 46.7 Miles
  - Added Distance: 40.5 Miles
  - End-to-End Distance: 52.9 Miles

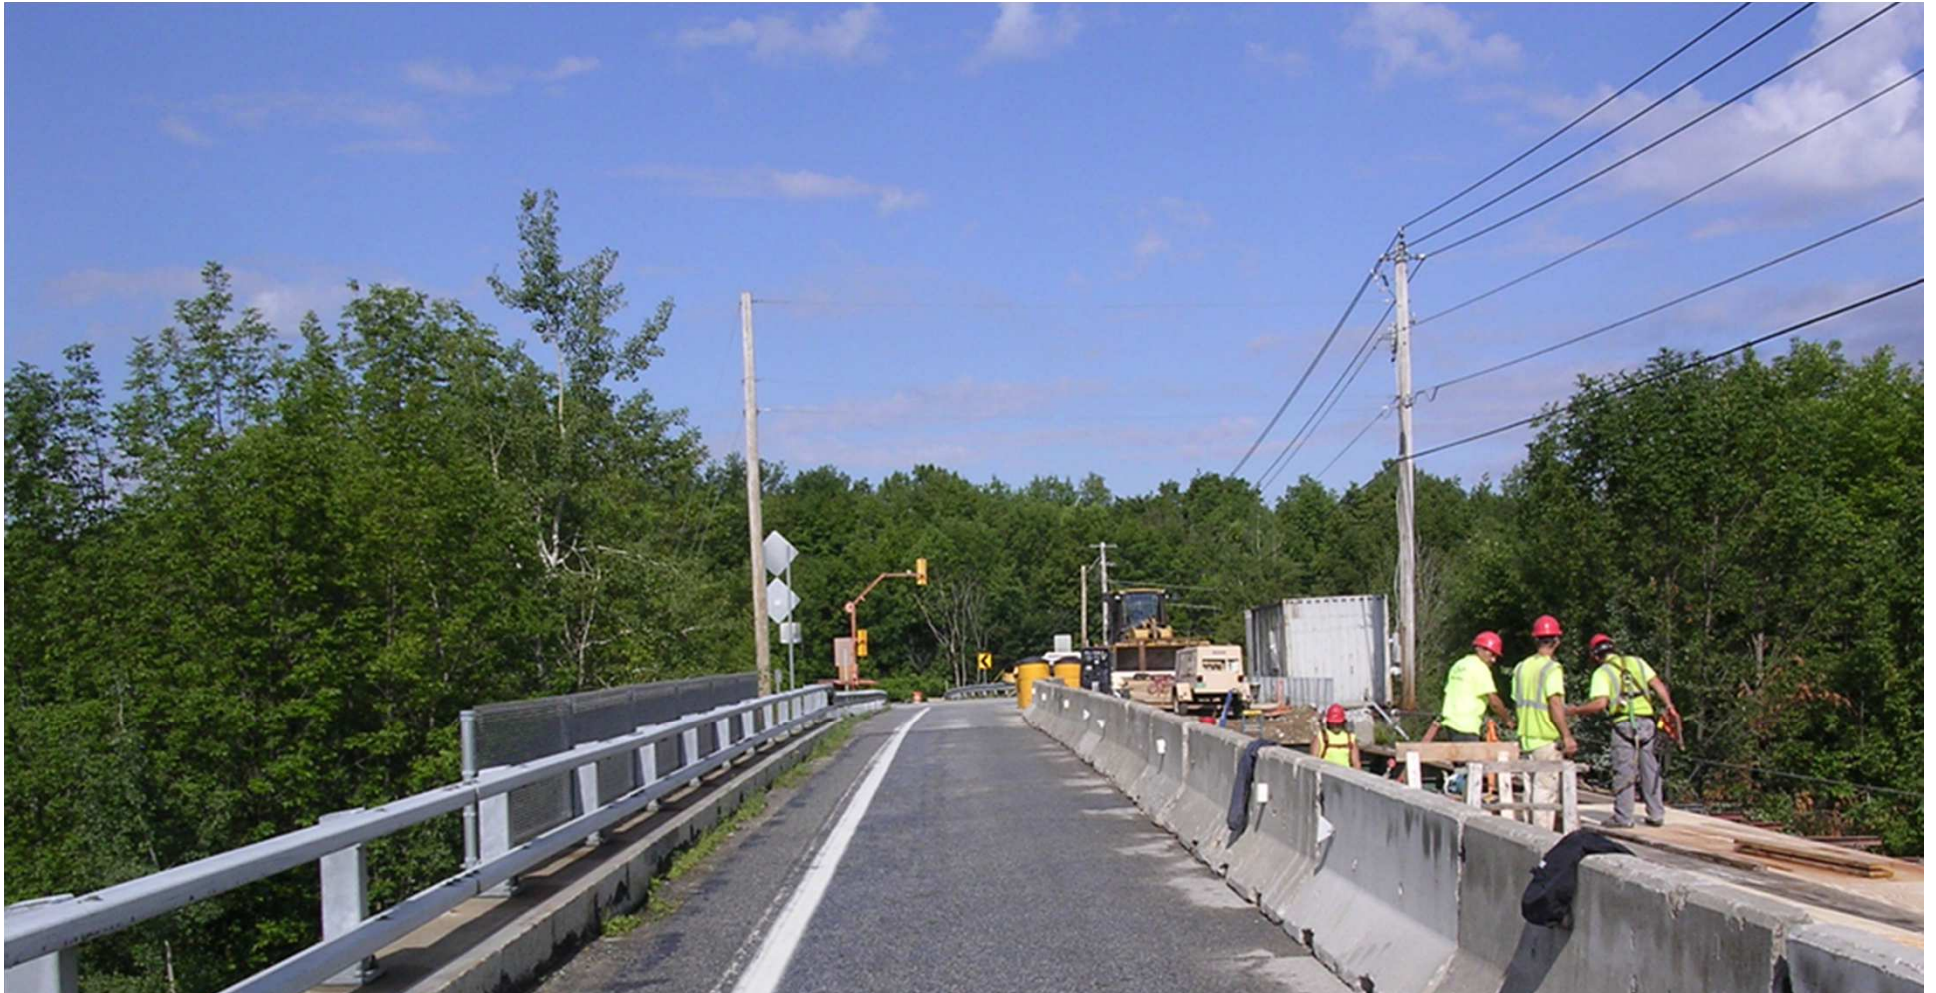
## Phased Construction

- One lane, alternating, with a traffic signal
- Existing is wide enough to complete deck replacement with 2 phases
- No ROW needed

(Picture from US Route 7 Bridge 184 in Highgate)

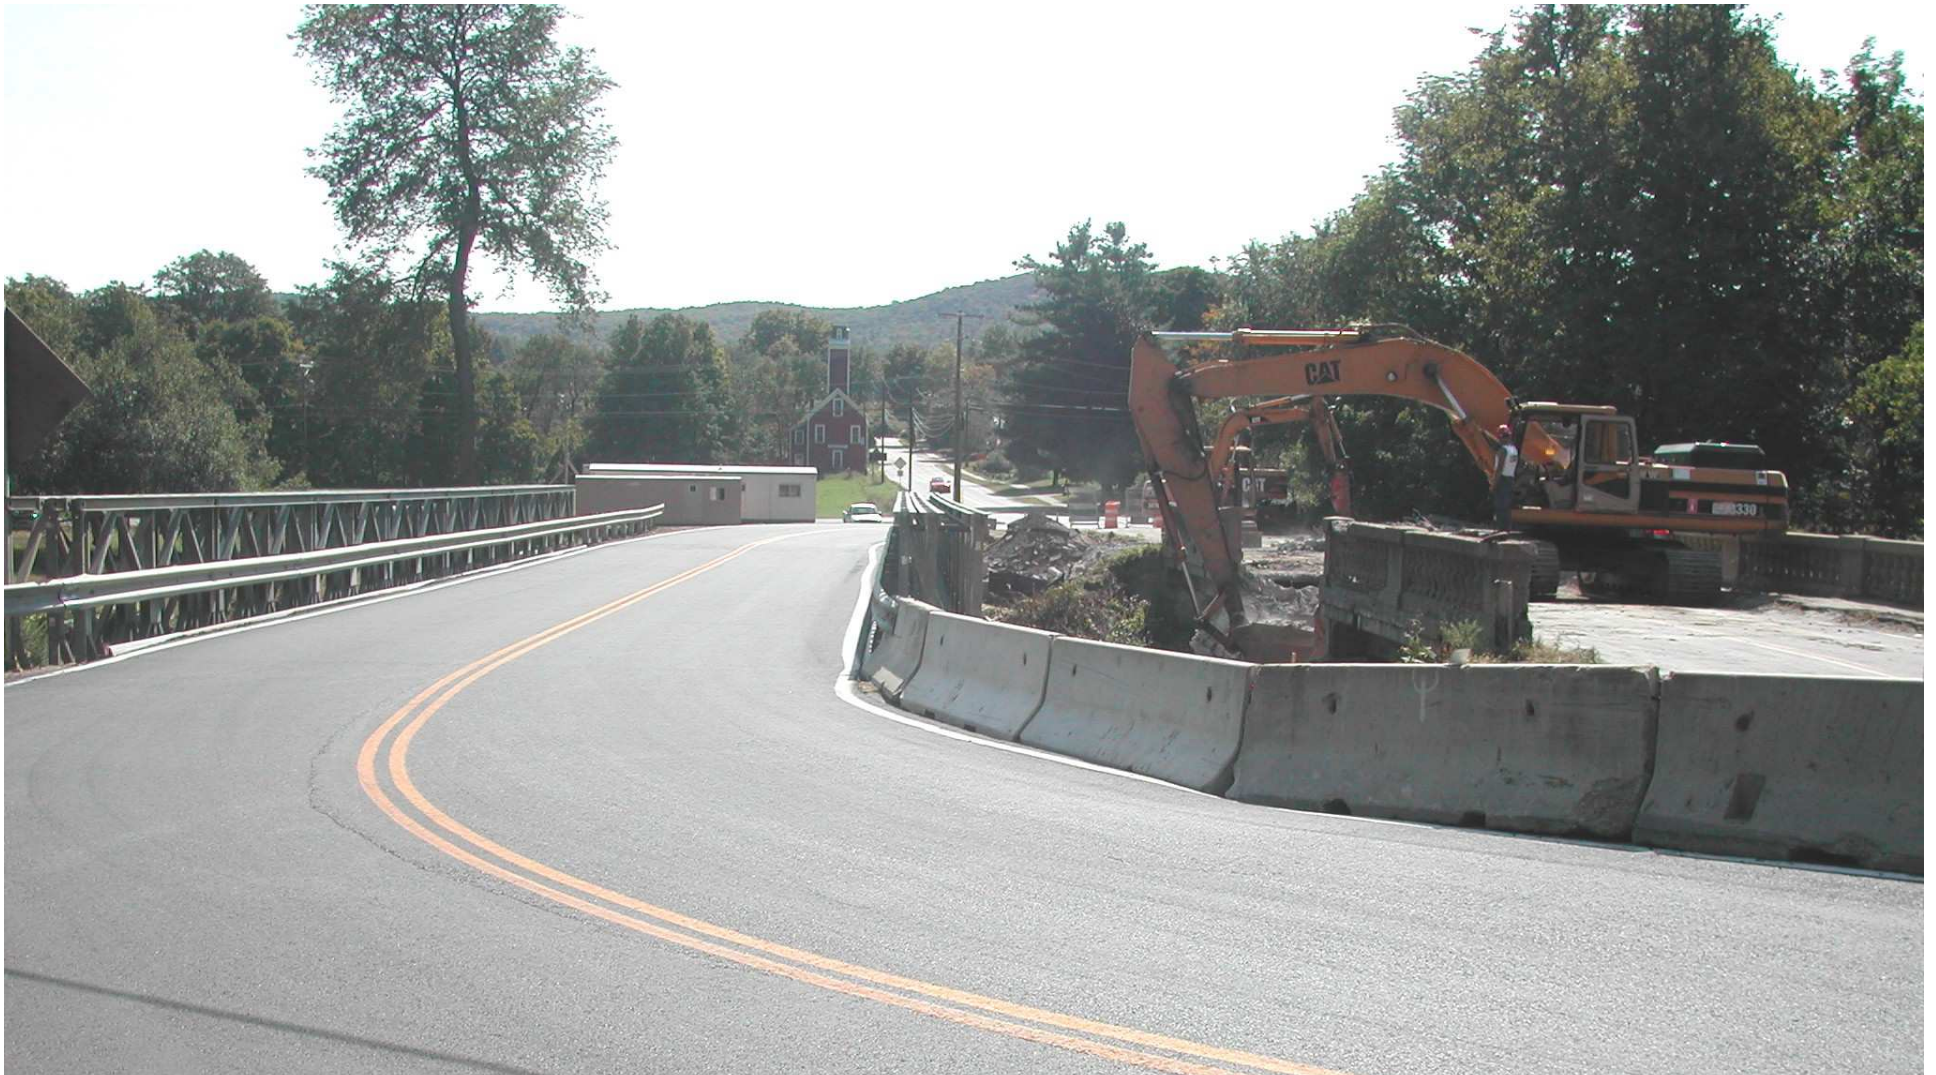
## Temporary Bridge

- Two Lane Temporary Bridge
- ROW needed if south side used
- Impacts to archaeologically sensitive areas and wetlands
