**STATE OF VERMONT
AGENCY OF TRANSPORTATION**

Scoping Report

**Brunswick BF 0271(23)
VT ROUTE 102, Bridge 6 OVER PAUL STREAM**

December 9, 2013

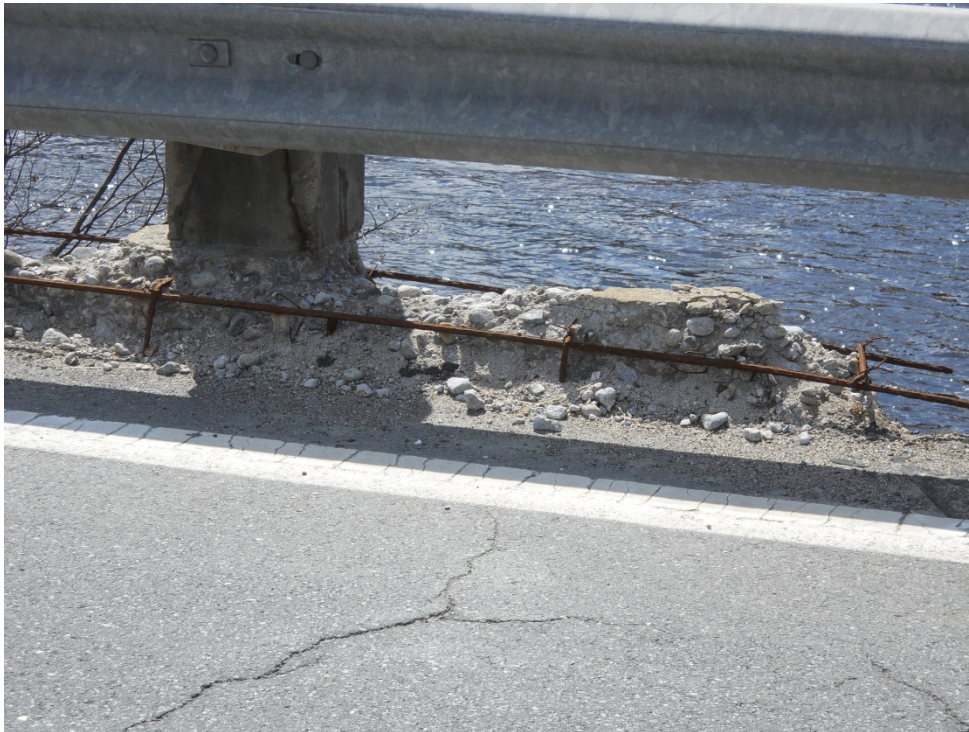
Advanced Deterioration of Curb and Fascia

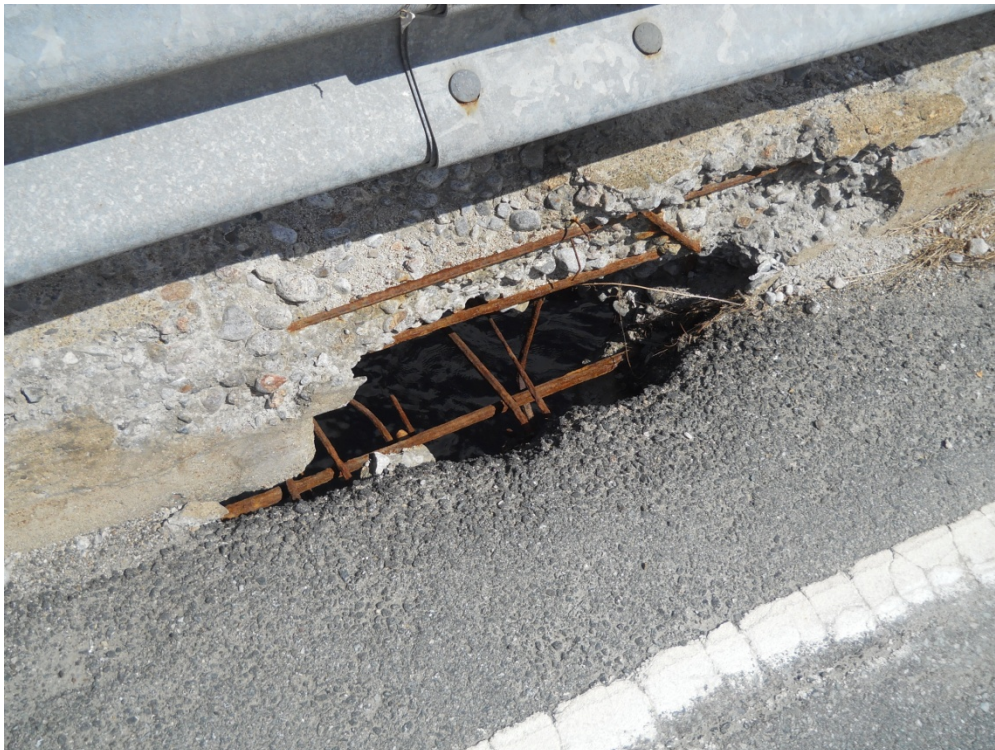
Advanced Deterioration of Curb and Deck

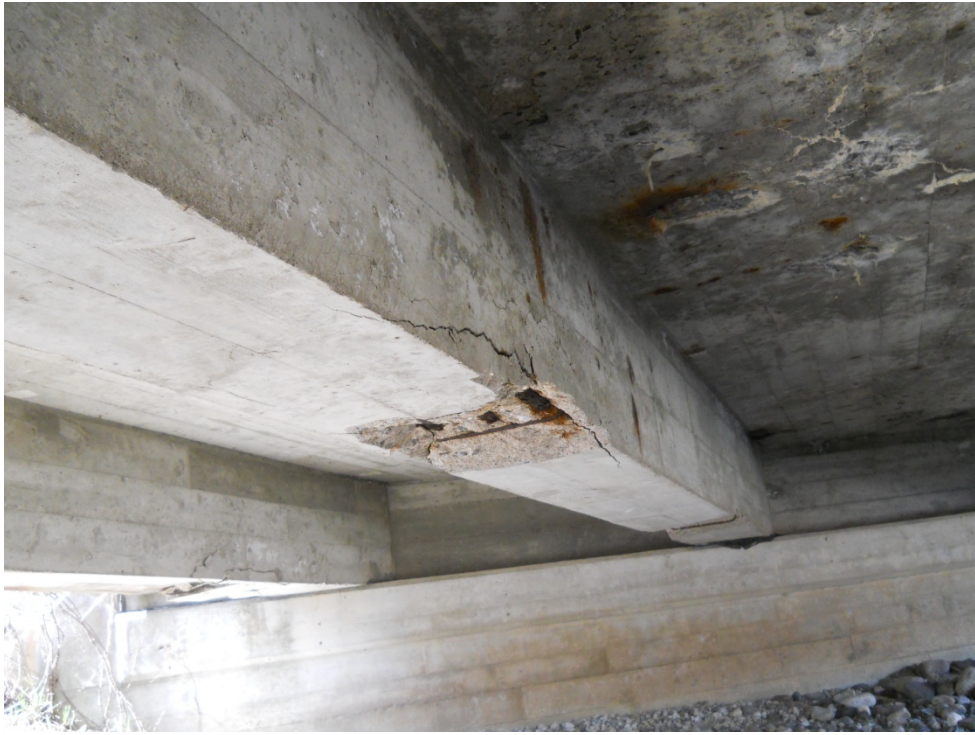
Deterioration of Tee-Beam Superstructure

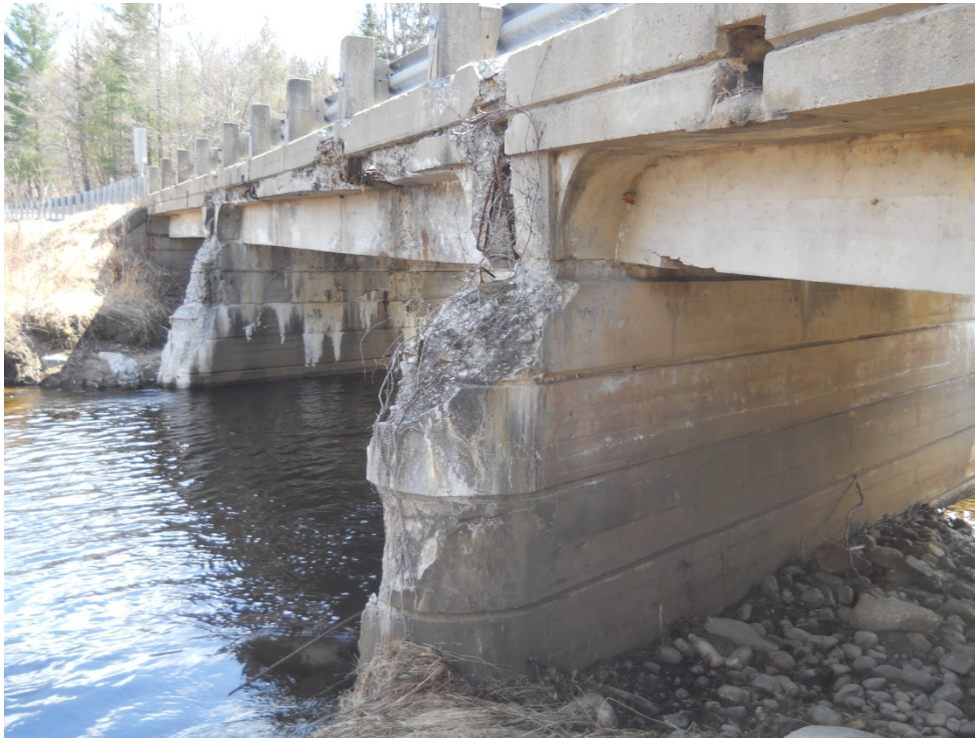
Deterioration of Fascia and Substructure

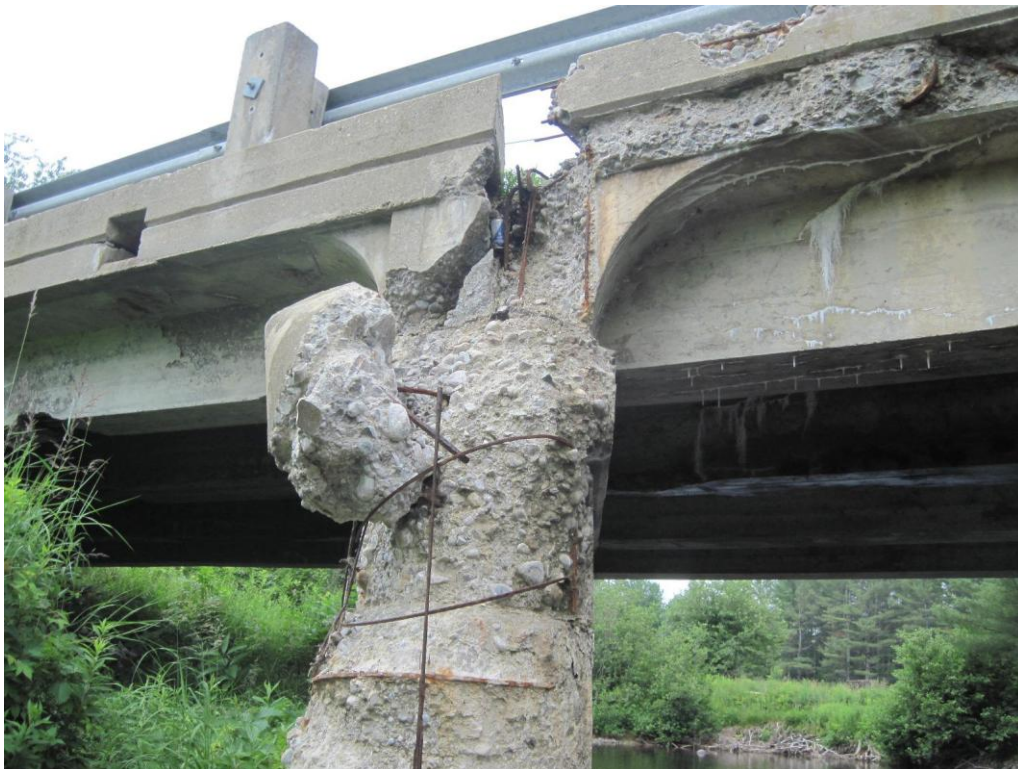
Based on the latest bridge inspection photos from July 2011, large portions of the piers and deck have deteriorated, as seen in Figures 2 and 3.

Figure 2. Severe Pier Deterioration

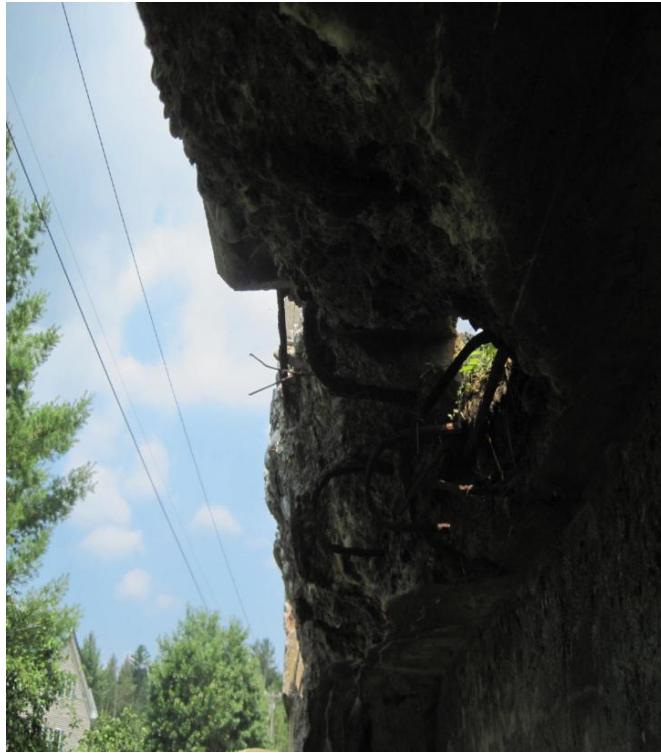
Figure 3. Severe Deck Deterioration

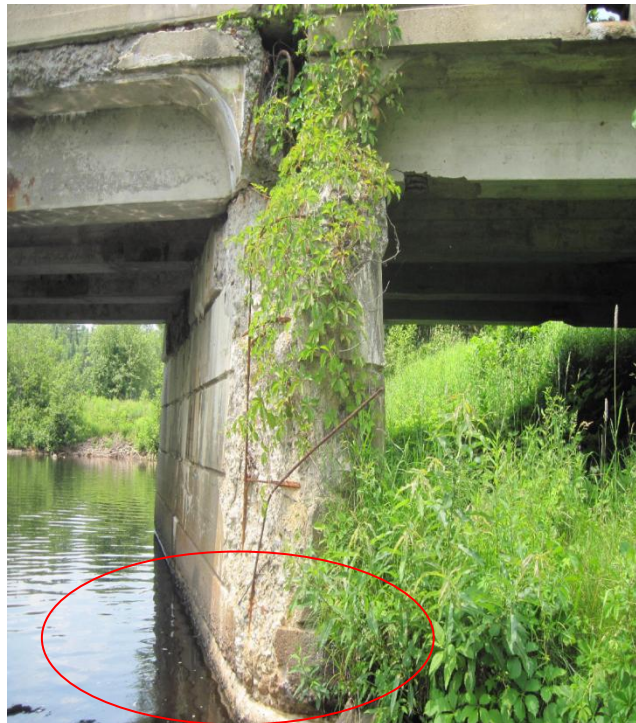
Despite the major spalling of concrete on the piers and abutments, no visible erosion or undermining was evident on either abutment. There does appear to be some undermining developing along one of the piers as shown in Figure 4. This undermining was confirmed during the site visit and rebar is currently exposed along the base.

Figure 4. Undermining Developing along Pier

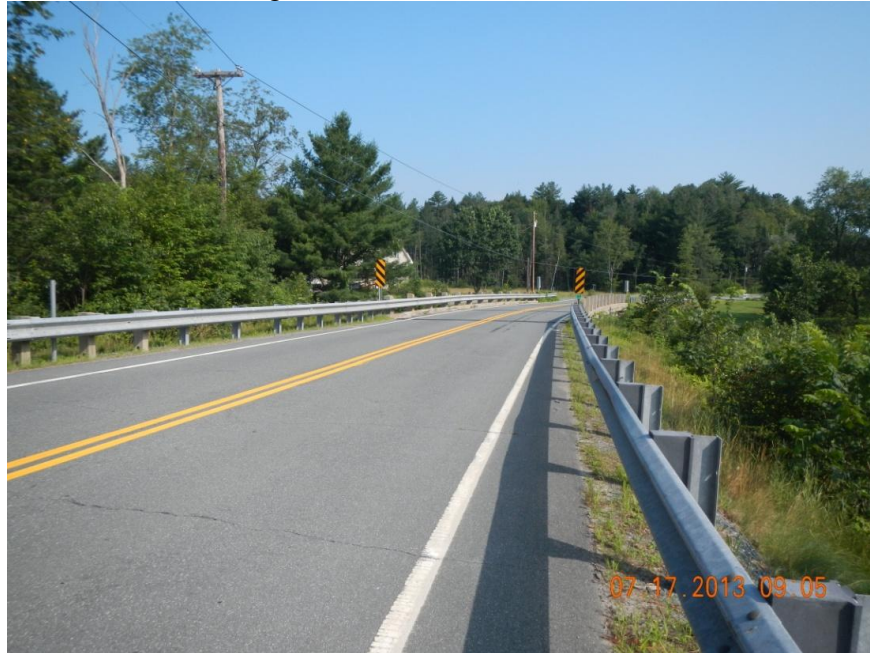
A preliminary site visit was conducted on July 17th, 2013 to determine possible obstructions inhibiting boring operations and other site characteristics. Information from this visit indicated no above ground utilities present directly above the bridge; however, power lines are located along the western side as seen in Figure 5.

Figure 5. Power Lines Located Along Western Side

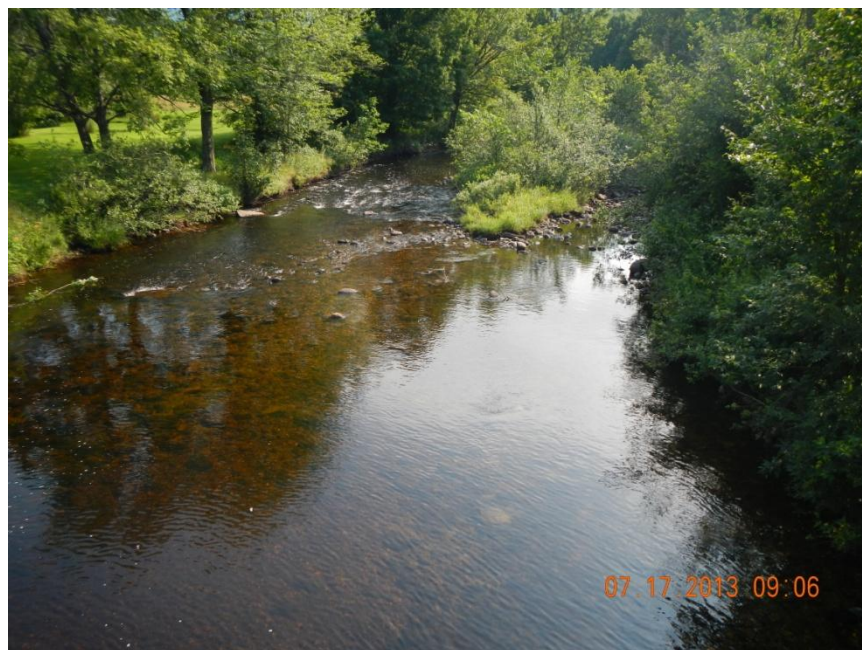
No visible bedrock outcrops were seen in the area. The stream bed did have some small cobbles as evident in Figure 6.

Figure 6. Cobbles Lining Stream Bed

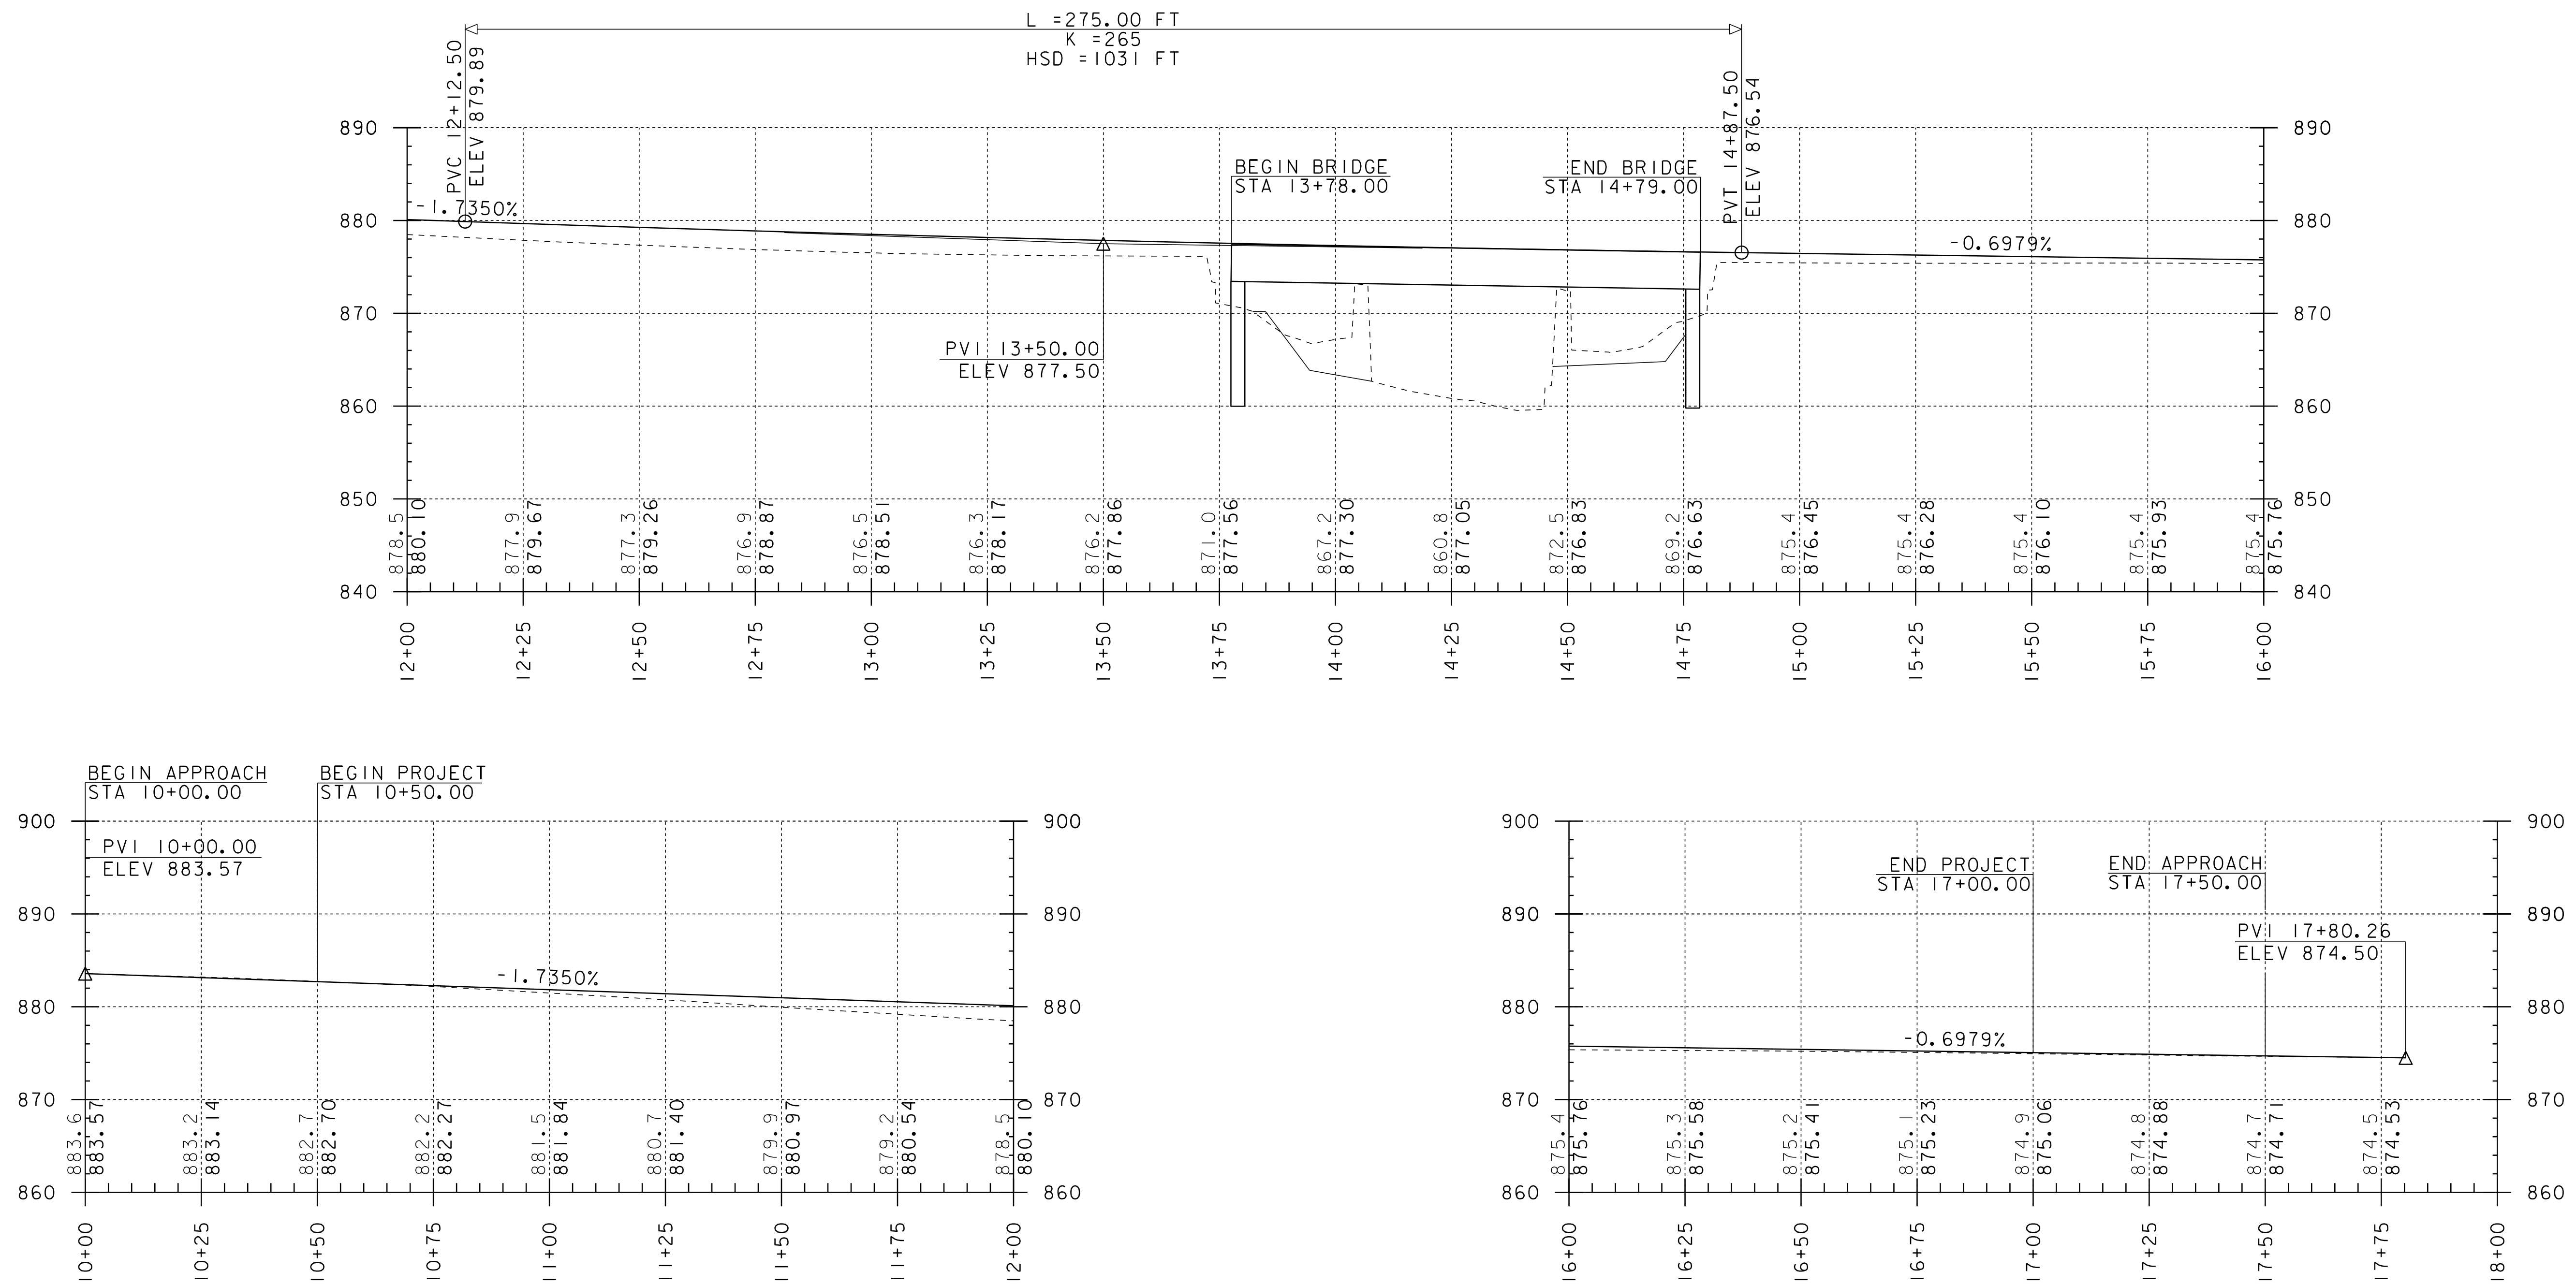
ALTERNATIVE 2a PROFILE

SCALE: HORIZONTAL 1"=20'-0"
 VERTICAL 1"=10'-0"
