**STATE OF VERMONT
AGENCY OF TRANSPORTATION**

Scoping Report

**FOR
Woodstock BF 0241(44)**

VT ROUTE 12, BRIDGE 19 OVER THE NORTH BRIDGEWATER BROOK

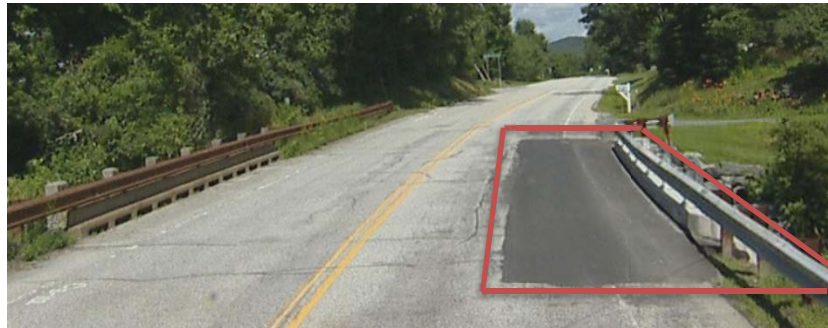
Above, the extent of the work completed in 2014. Replacement of the downstream fascia beam and guardrail.

- There is some cracking on the underside of the concrete beams that were not replaced in the minor rehabilitation work in 2014 completed by the District. This work included replacing the downstream fascia beam and replacing the curb mounted guardrail. The total cost of this work was approximately \$130,000. The remaining beams have longitudinal cracking with exposed reinforcing steel. This alternative proposes replacing these five beams to extend the life of the structure.

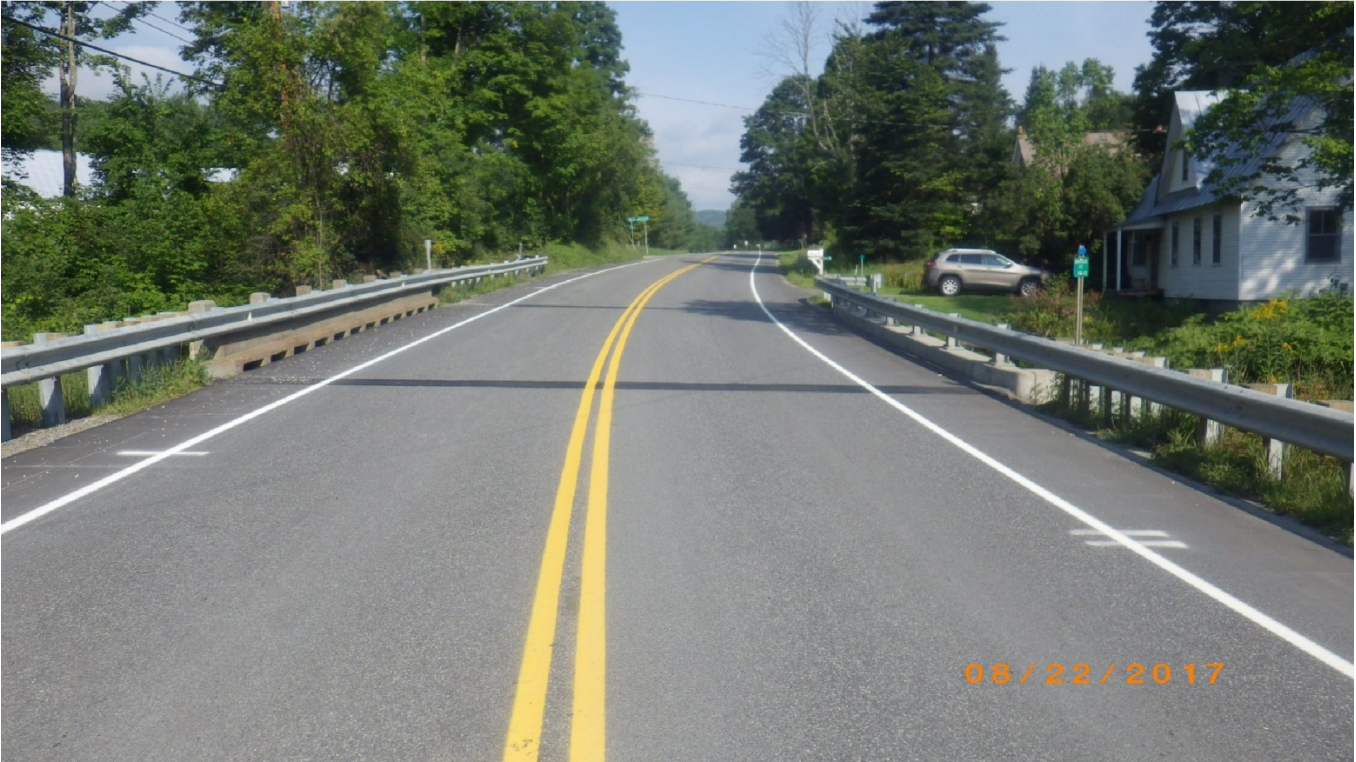
Looking north over the bridge.

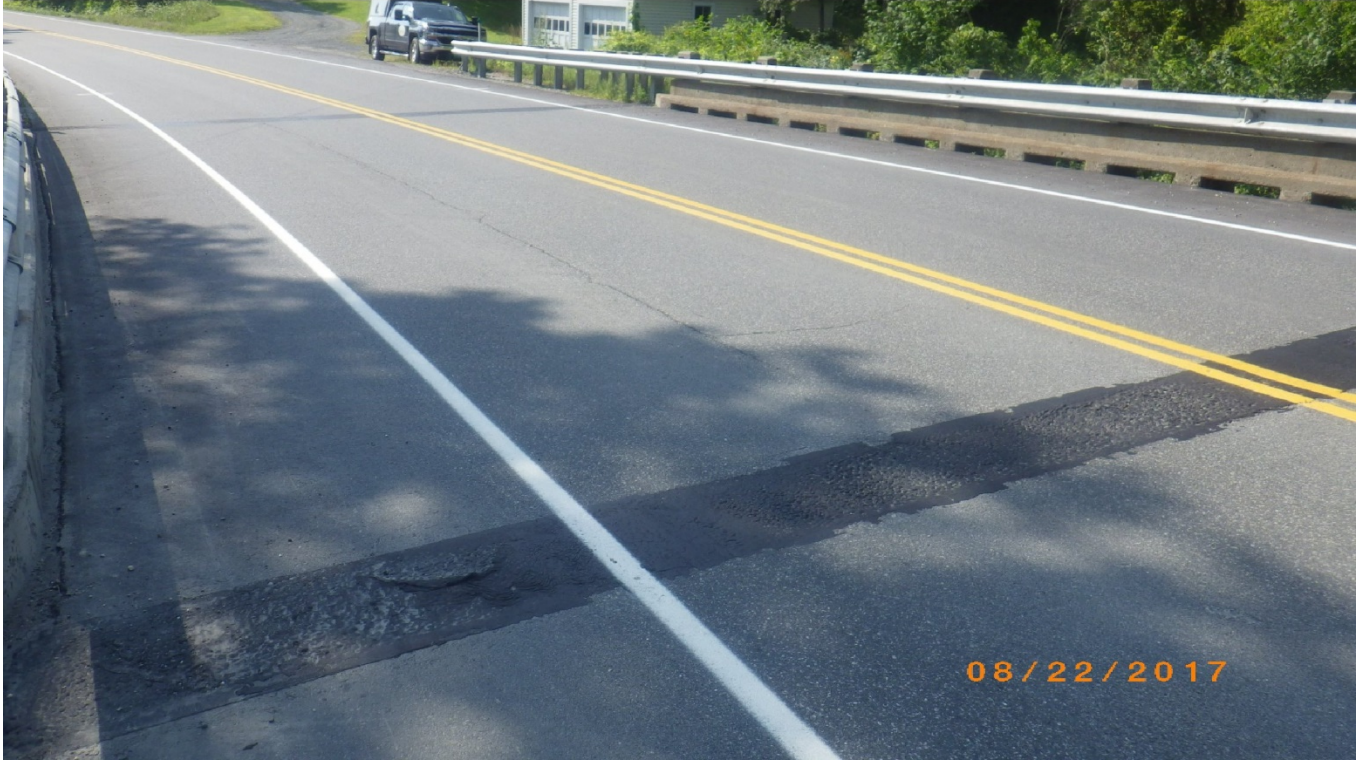
Looking south over the bridge.

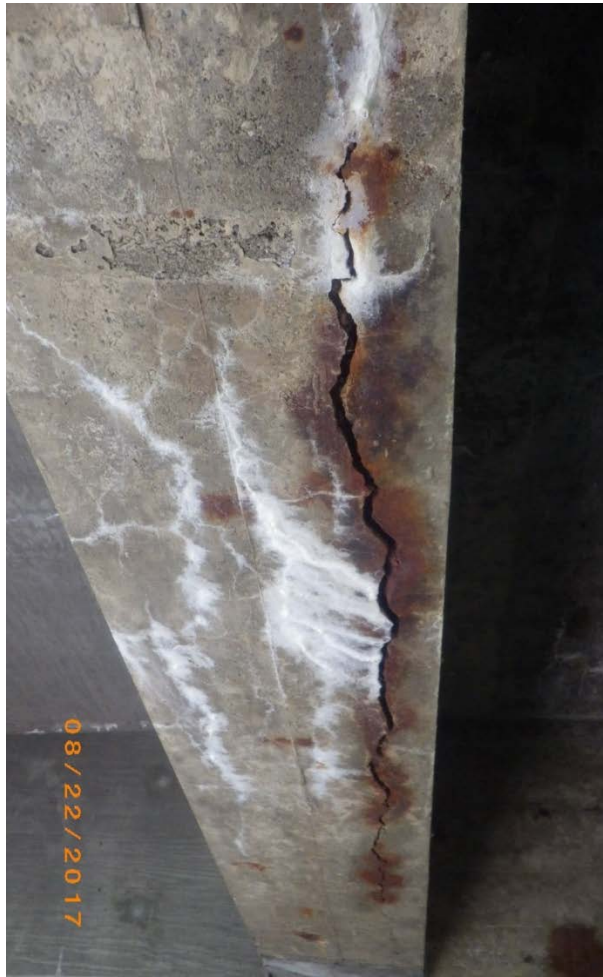
Beam cracking and efflorescence on soffit.

1. The existing T-beams are in satisfactory condition following rehabilitation work in 2014. There is some cracking occurring on the underside of the T-beams and on the diaphragms with exposed reinforcing steel.
2. The substructure is rated as good. The bridge is categorized as scour critical following its most recent inspection. Abutment foundations do not meet current recommended standards for burial beneath the stream bed.

The existing bridge is structurally sufficient, and the superstructure and deck are both rated as satisfactory (6). The beams beneath the deck have exposed reinforcing steel, and rust stains and efflorescence are present from water entering the bridge components and working its way through the concrete beams. In the 2015 inspection report for this bridge, a membrane installation and deck rehabilitation was recommended.

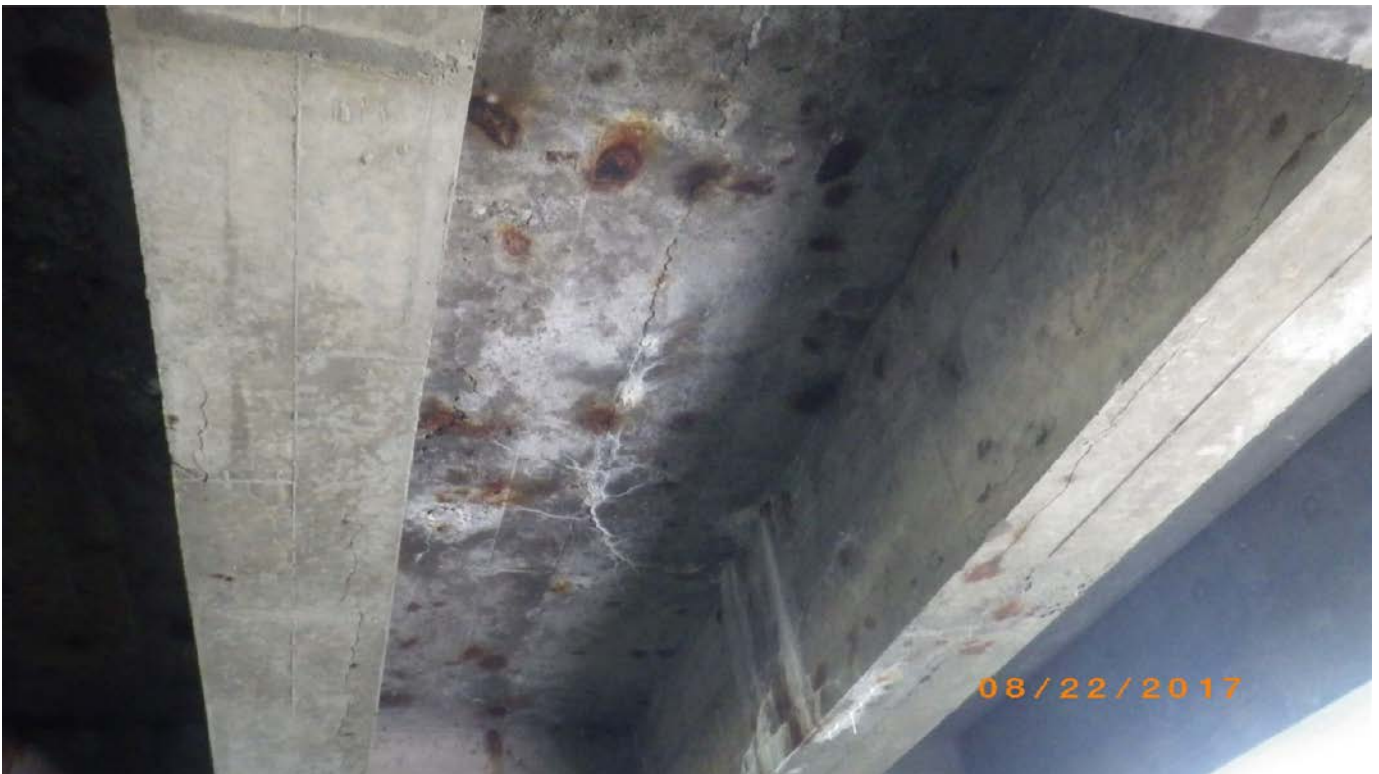
Recurring efflorescence on a beam that was patched in a rehabilitation project in 2014.

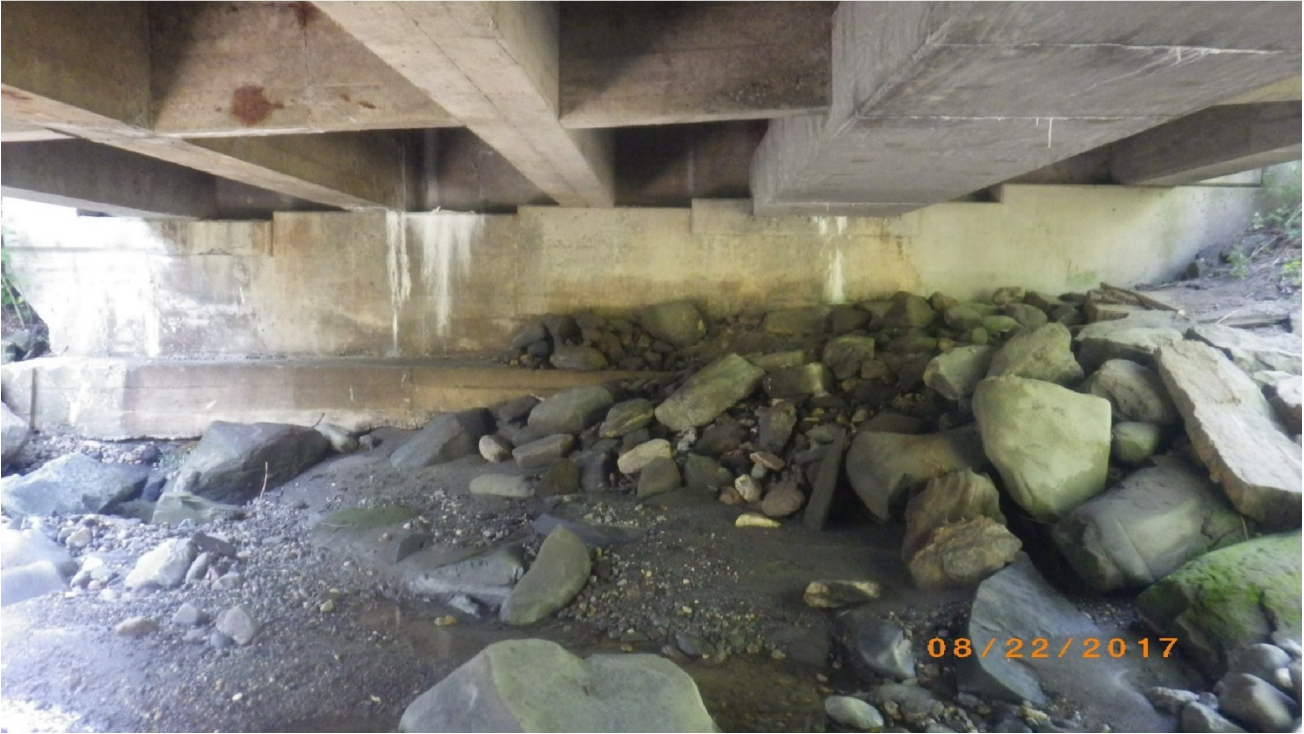
Southern abutment condition.

The clear span length is approximately 43' with a clear height of approximately 8', providing a waterway opening of 260 sq. ft. The bridge has concrete abutments and spread footings. The bridge is rated Scour Critical (3) in its most recent inspection report with observed undermining of the footings.

The inspection report states that the channel is stable for scour. However, we noted that in the pictures, the bottom of footings is showing. There may even be some undermining going on. The record plans show the bottom of the spread footings well above the channel bottom. This is not acceptable.

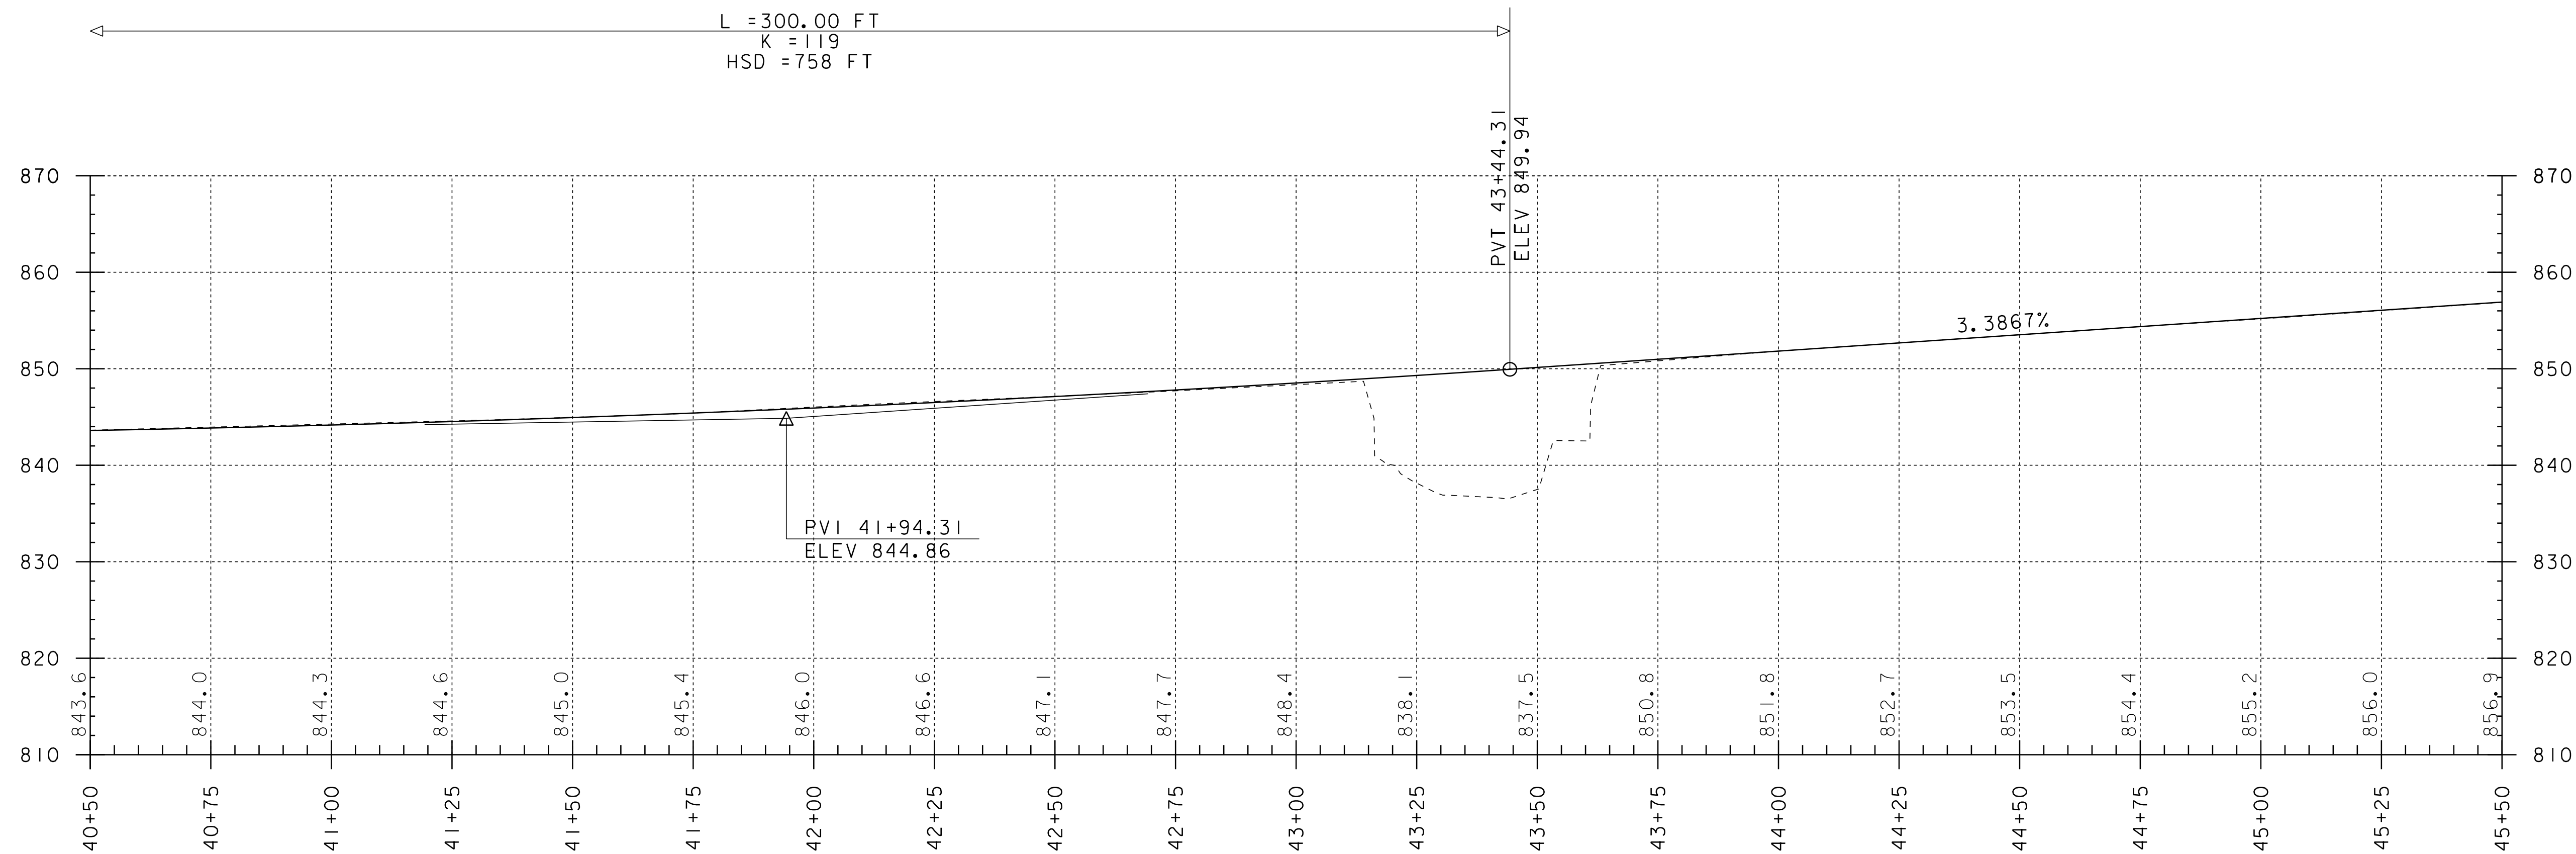
VT ROUTE 12 EXISTING PROFILE

SCALE: HORIZONTAL 1"=20'-0"
 VERTICAL 1"=10'-0"

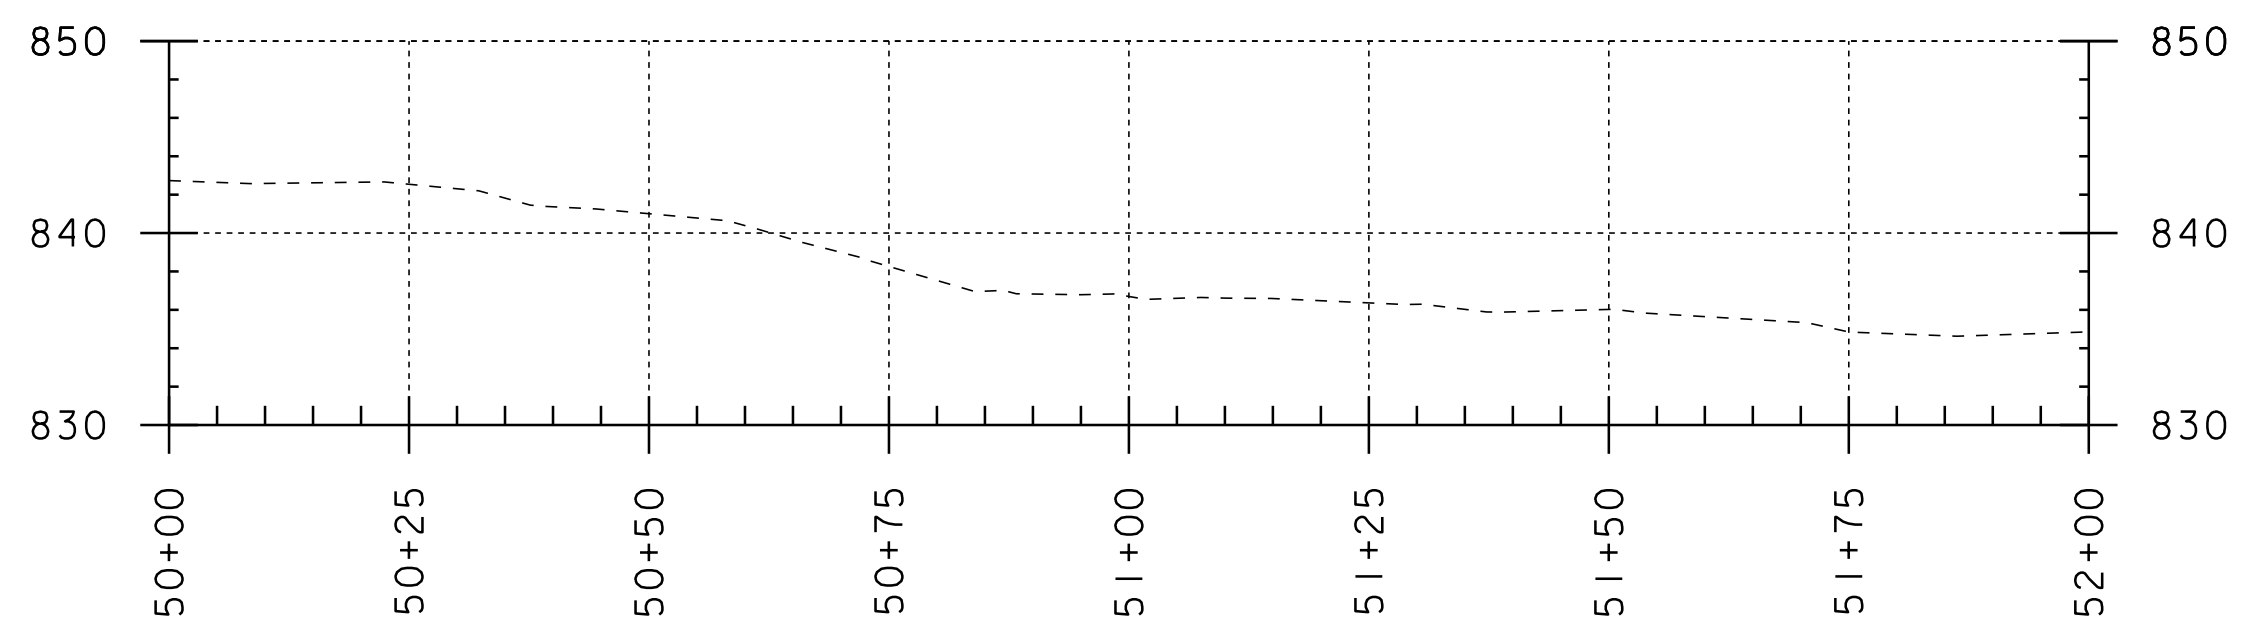
CHANNEL PROFILE

SCALE: HORIZONTAL 1"=20'-0"
 VERTICAL 1"=10'-0"
