# Montpelier BO 1446(36) Bridge 13 on Cummings Street over the North Branch of the Winooski River Alternatives Presentation

Presented by  
Christopher P. Williams, P.E.  
Senior Project Manager, Structures Section  
Vermont Agency of Transportation  
Chris.Williams@State.VT.US

November 6, 2013

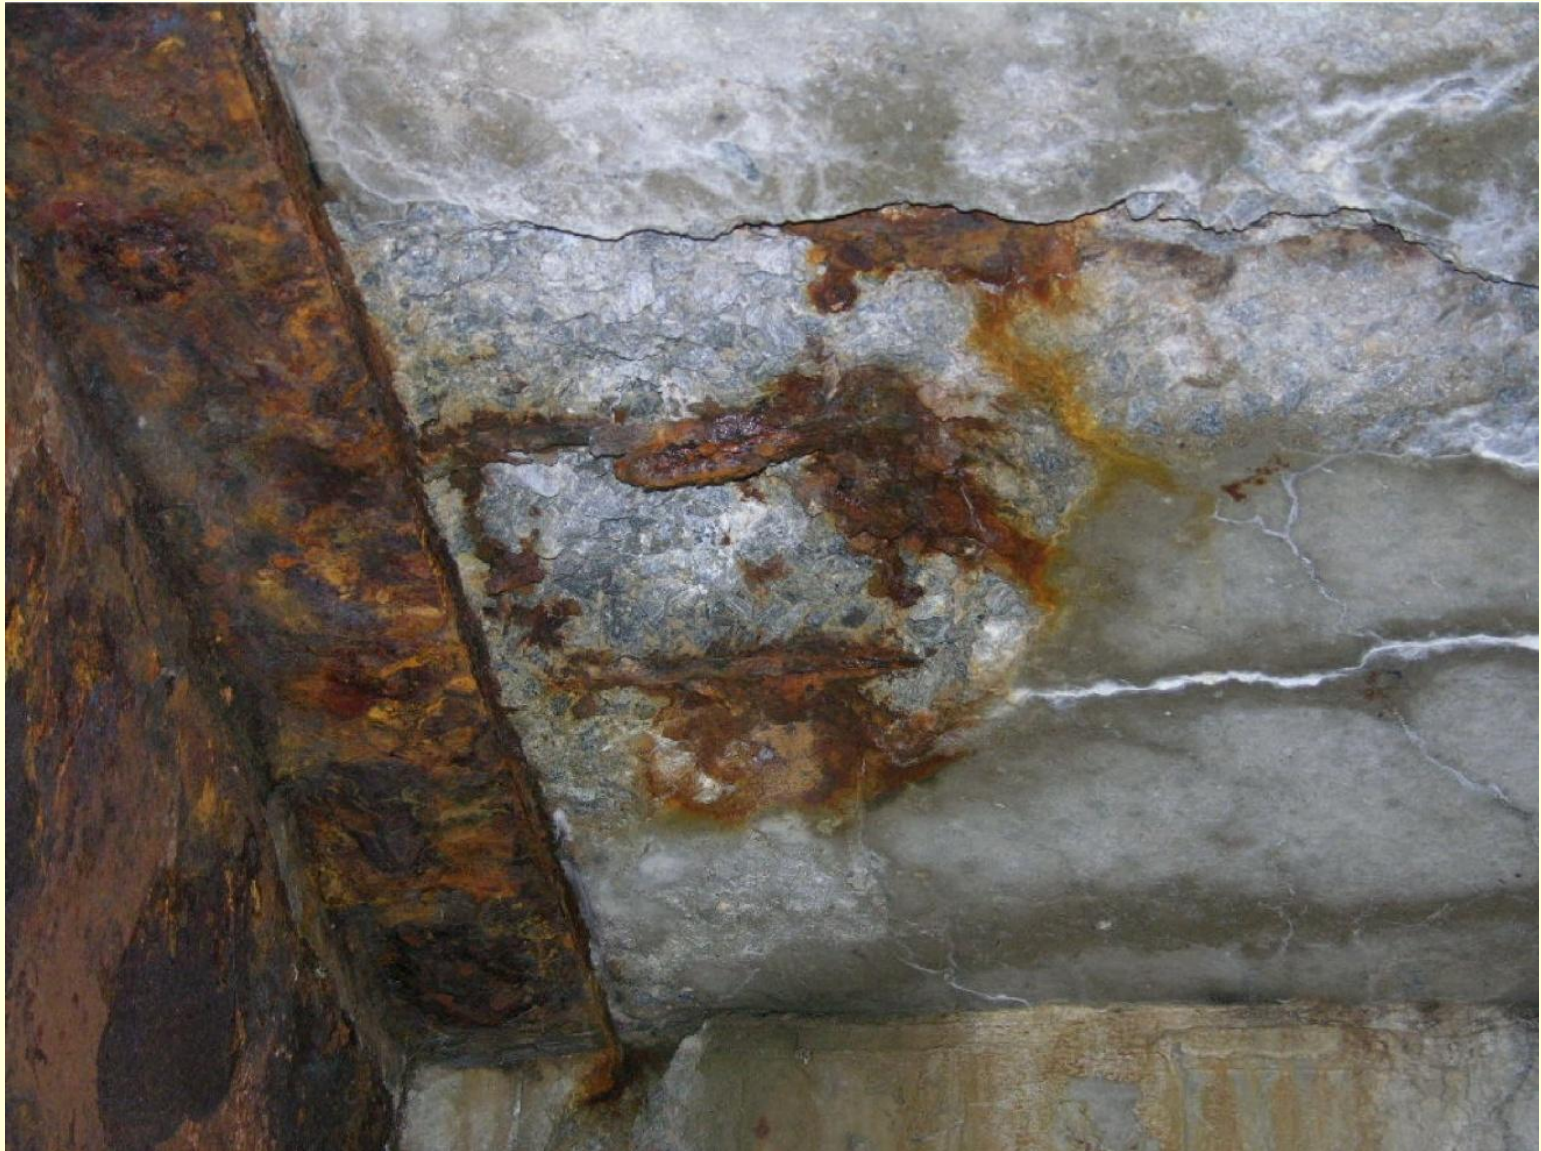
## Bottom of Deck showing Deterioration

- The bridge is structurally deficient with a poor deck rating
- The roadway and bridge are too narrow for the roadway classification, design speed and anticipated pedestrian use
- The approach railings are substandard
- The vertical alignment (crest vertical curve) is substandard

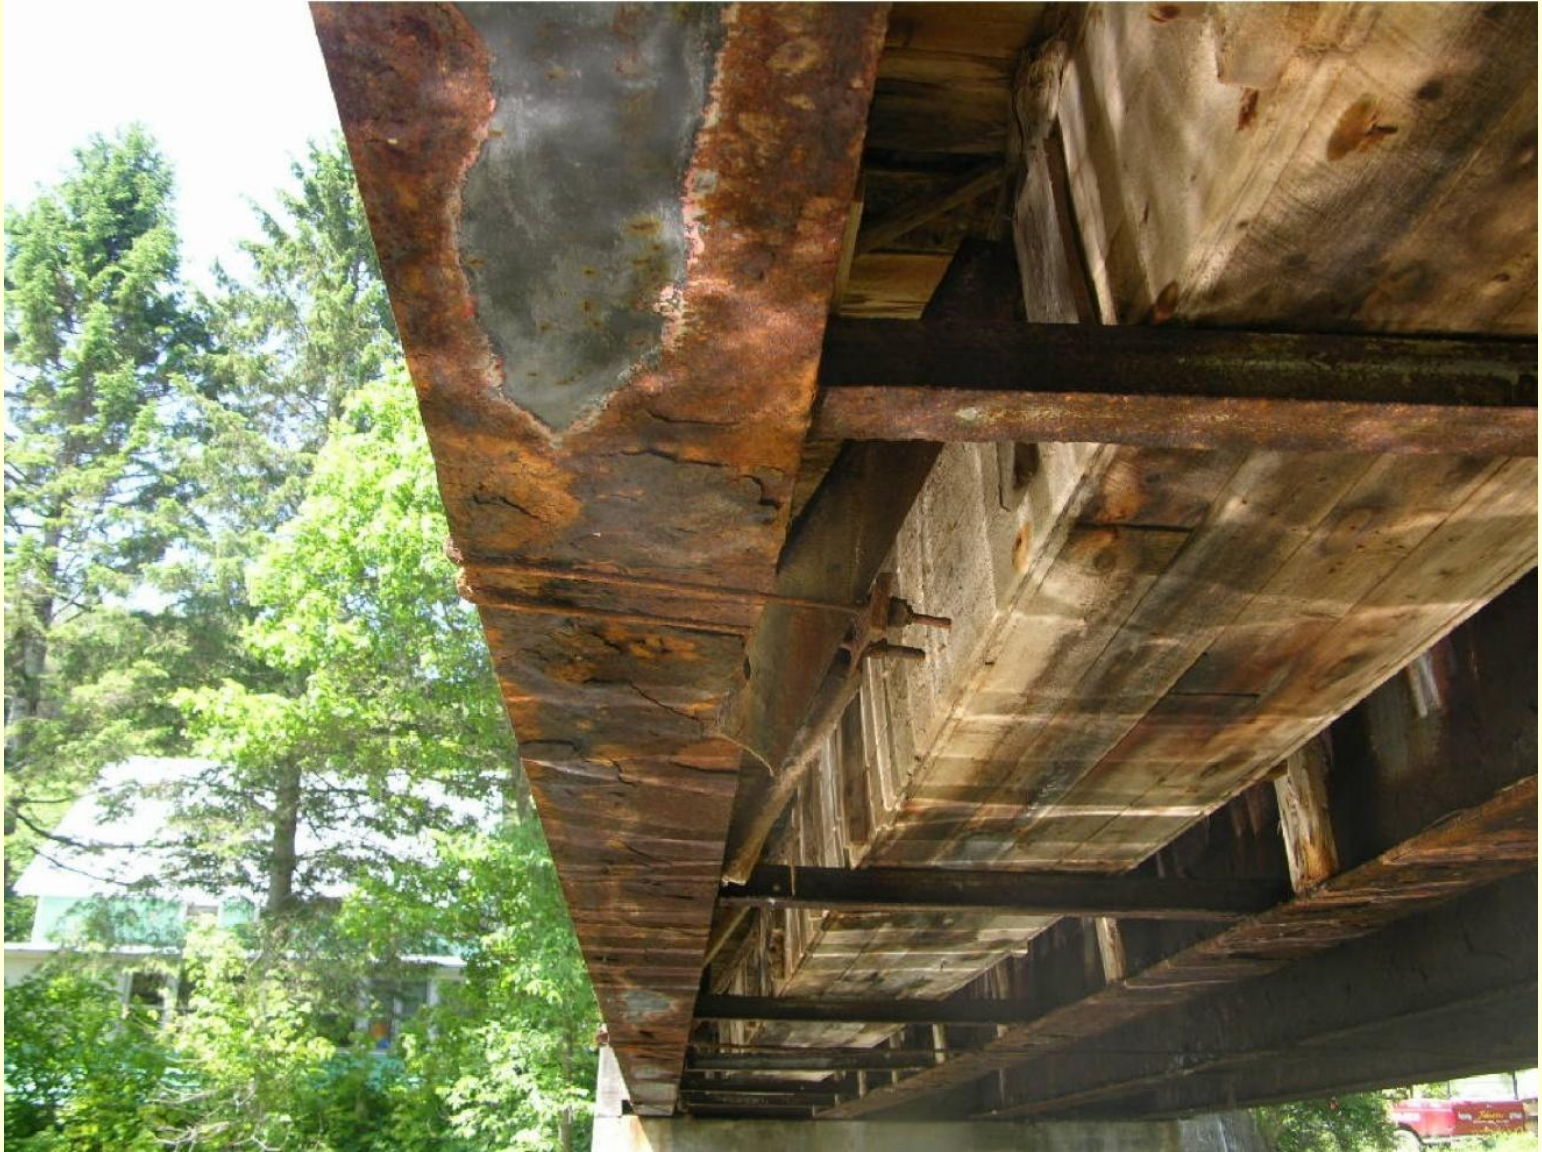
# Girder deterioration and water main

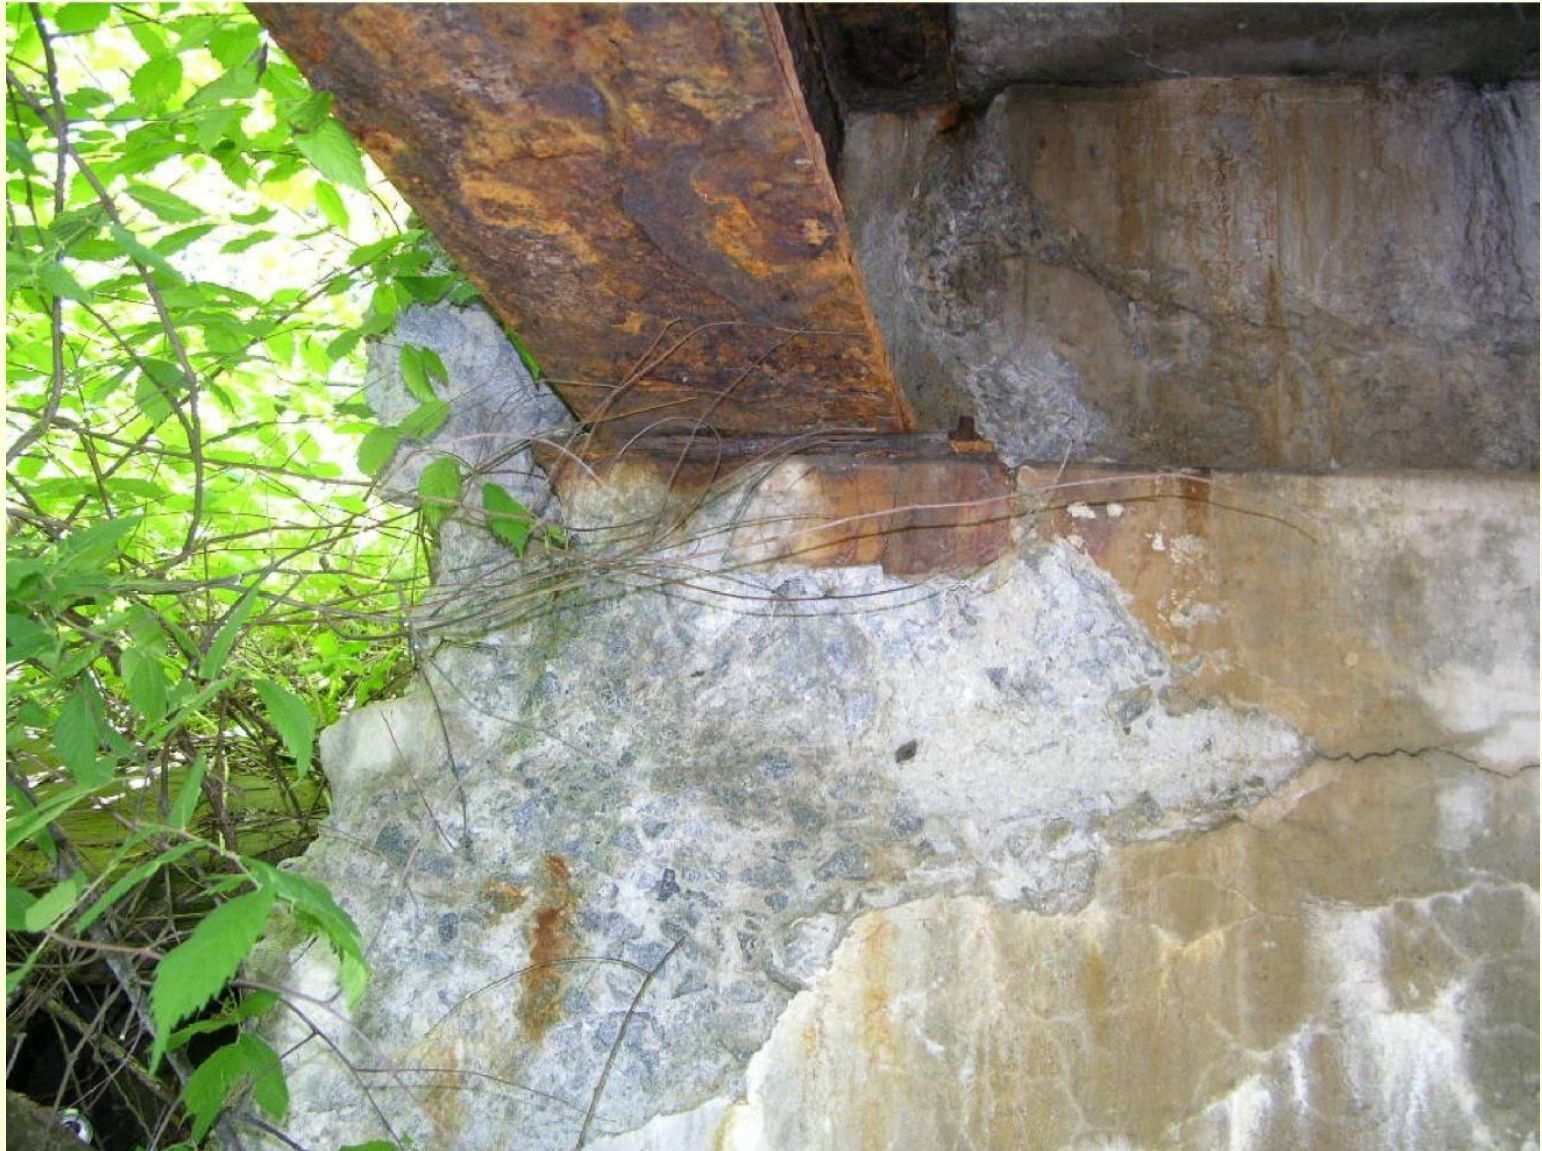
# Abutment deterioration at Beam Support

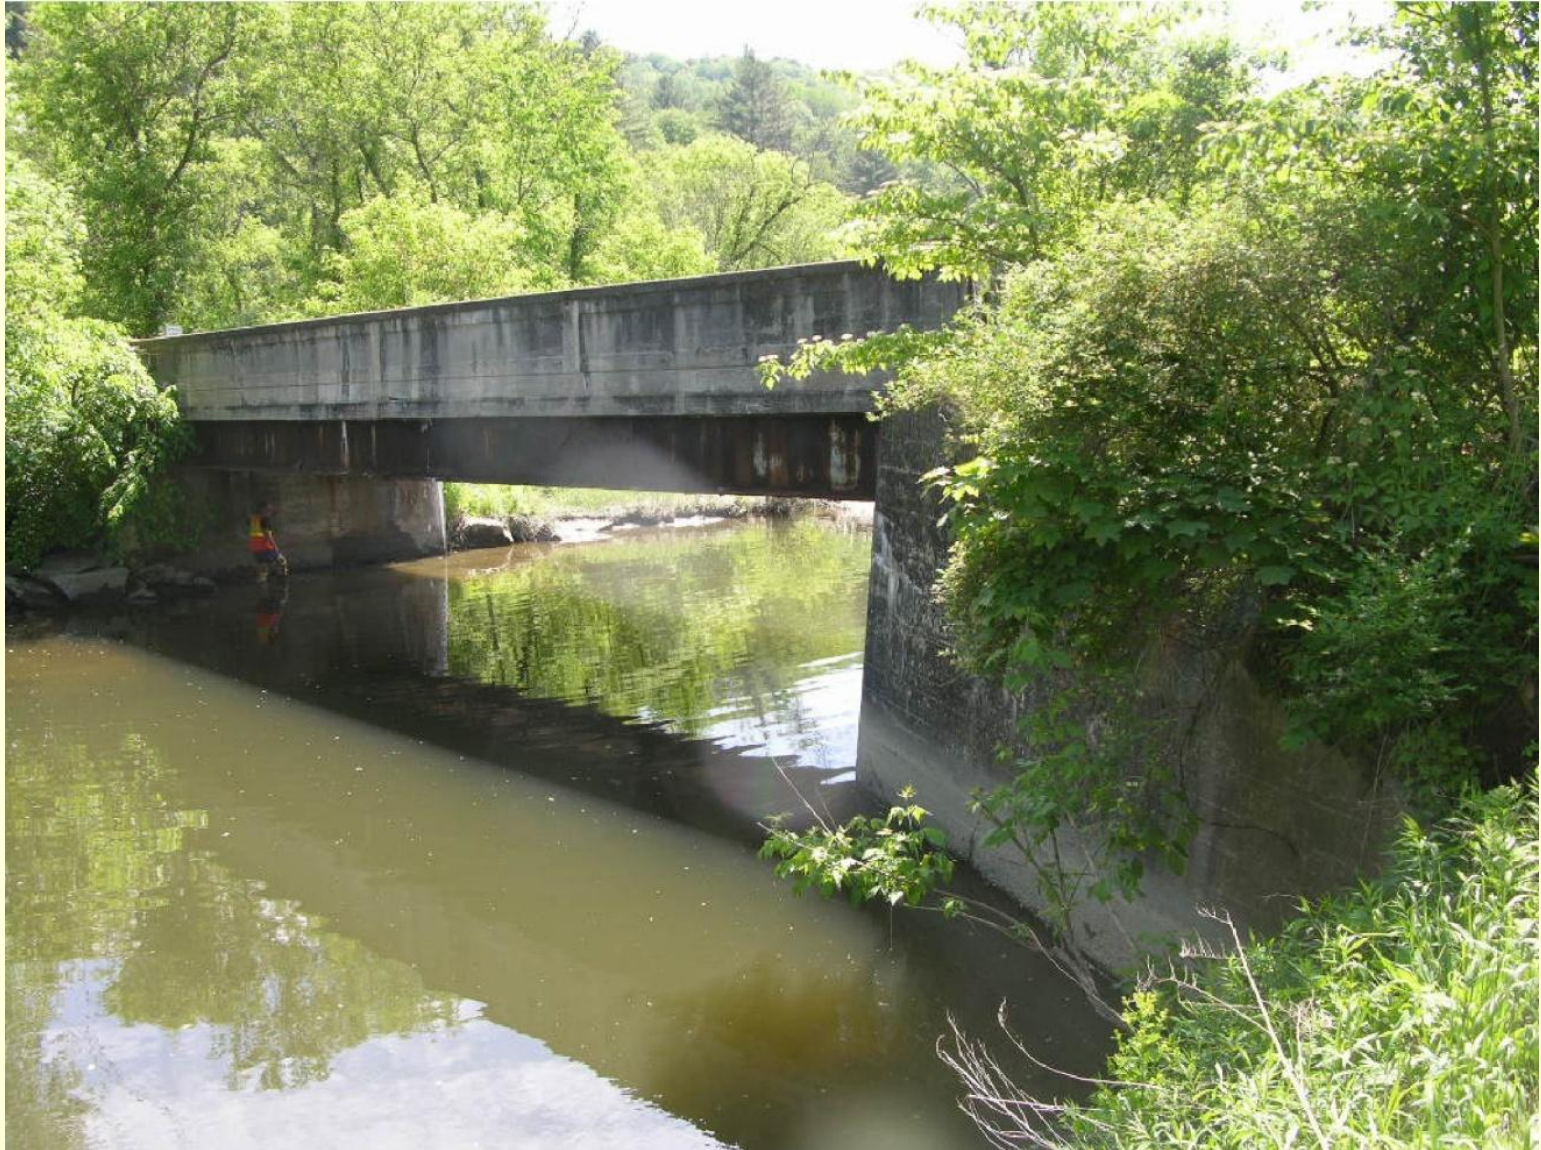
# Looking downstream @ waterway constriction

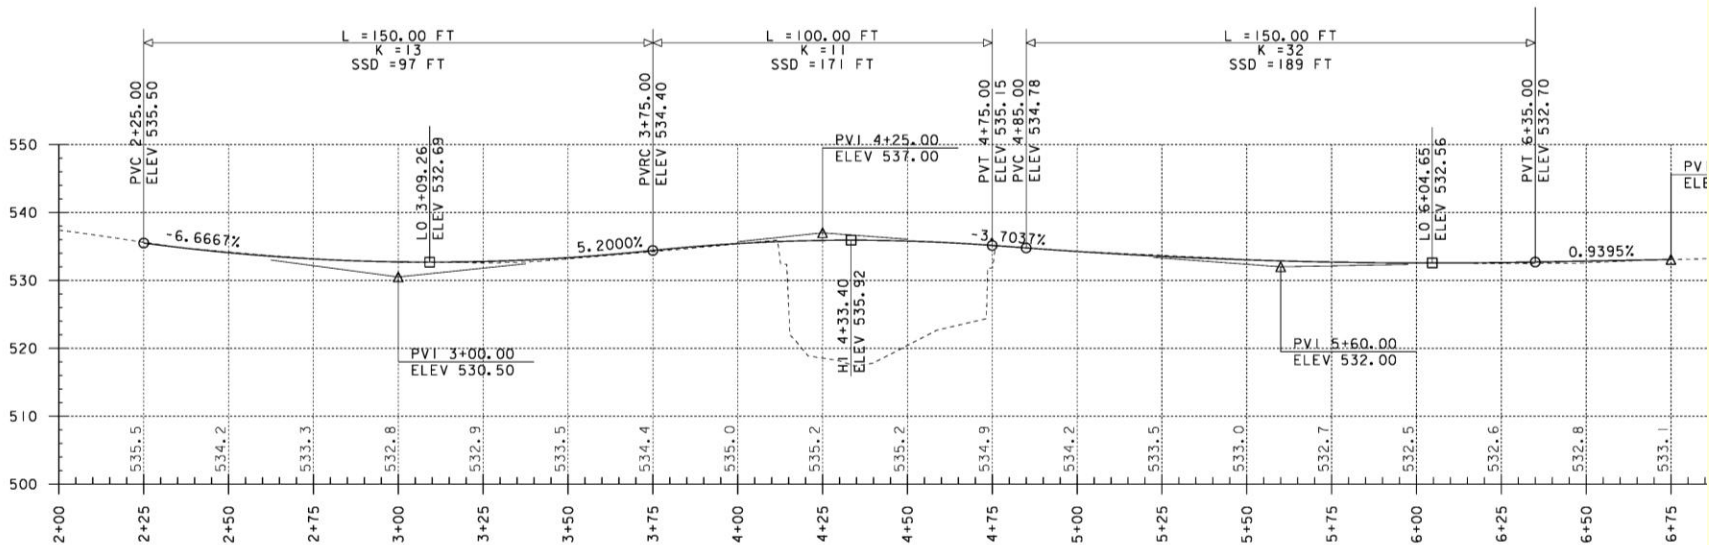
## TH 30 PROPOSED PROFILE

SCALE: HORIZONTAL 1"=20'-0"  
VERTICAL 1"=10'-0"

CONCEPTUAL ABUTMENTS SHOWN.  
BORINGS HAVE NOT BEEN TAKEN AND  
ABUTMENTS HAVE NOT BEEN DESIGNED.

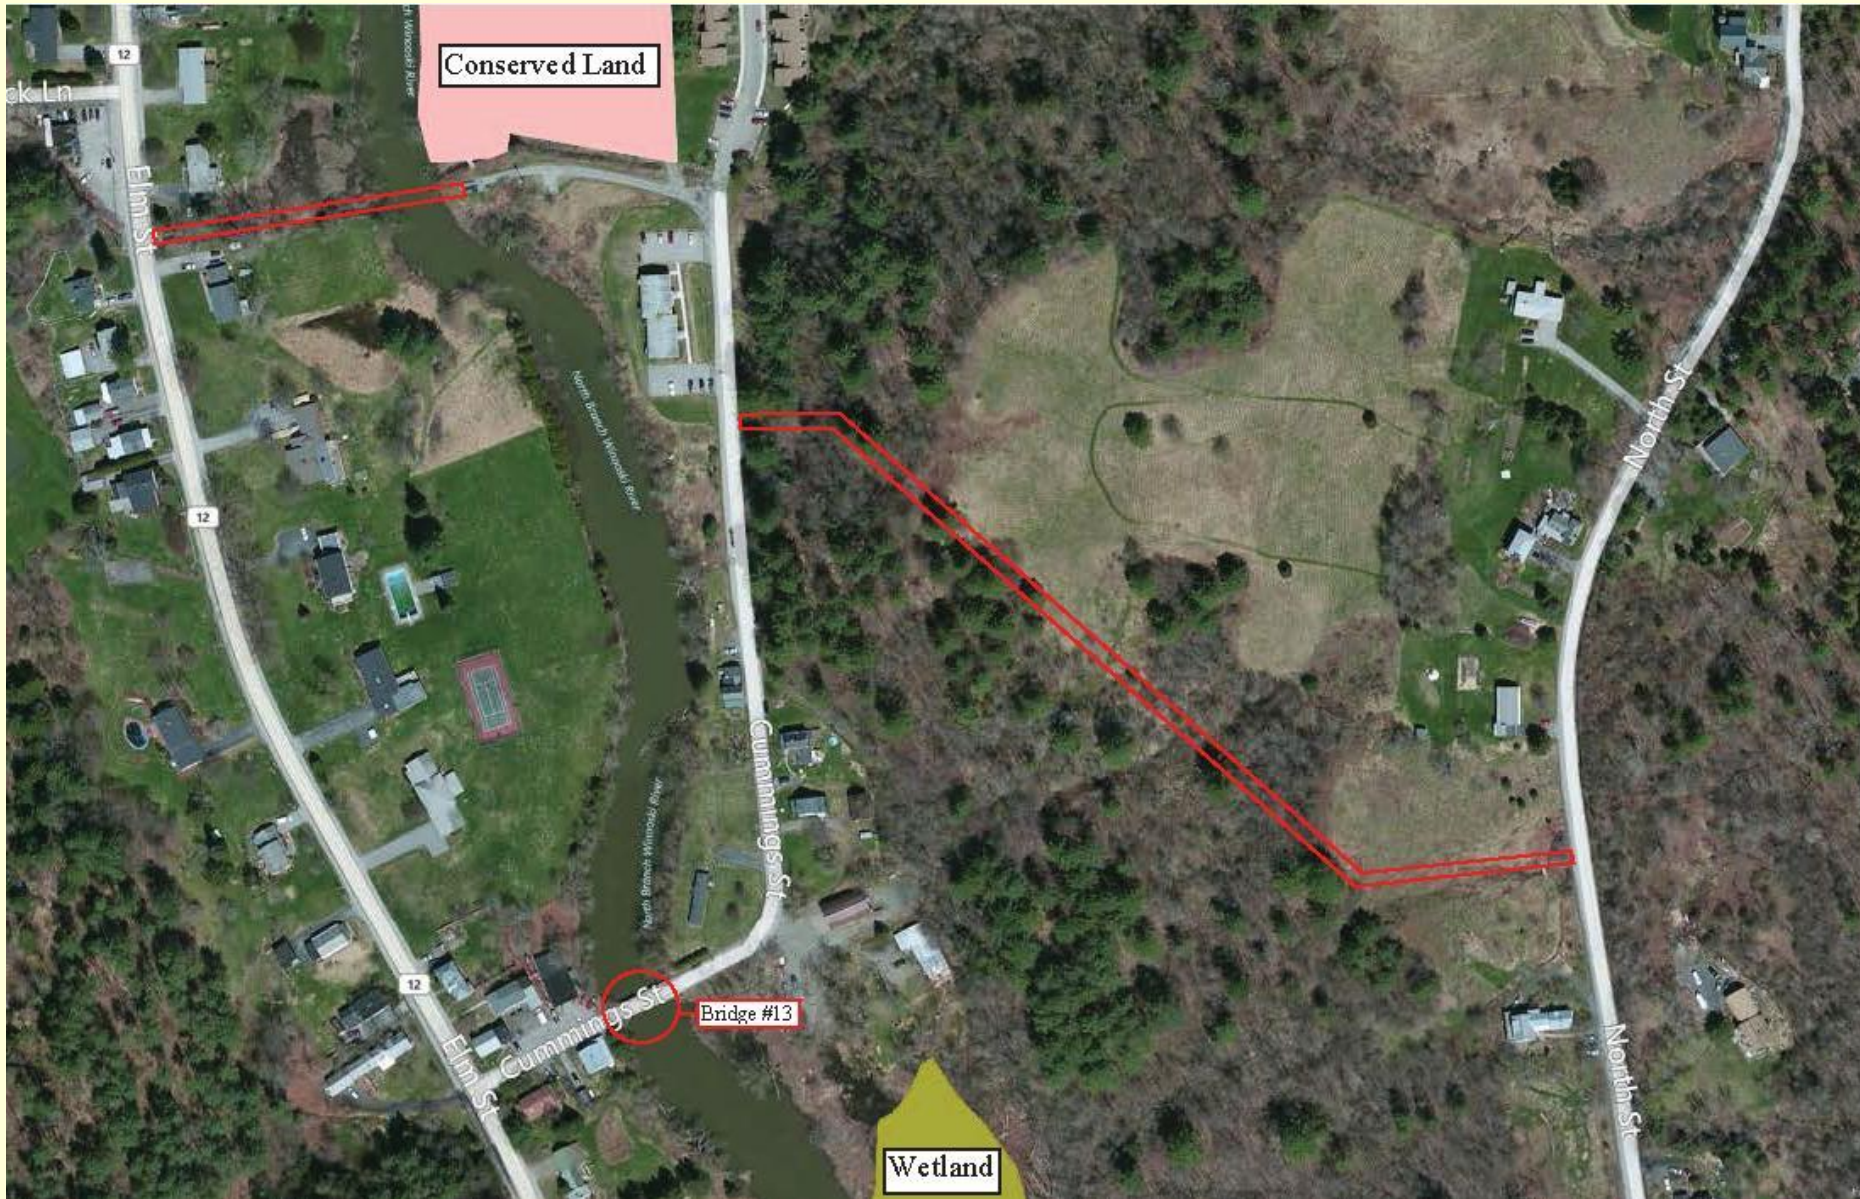
# Alternate Access Routes Considered

- Bridge 13 can not be closed without providing alternate access to the properties east of the bridge since Cummings Street is a dead end road
- Two alternate access routes were studied as shown in the following slide
- This method ruled out due to drastic changes in land use and transportation connections and not considered further
