**STATE OF VERMONT
AGENCY OF TRANSPORTATION**

Scoping Report

**Montpelier BO 1446(36)
Bridge 13 on Cummings Street
Over
the North Branch of the Winooski River**

September 10, 2013

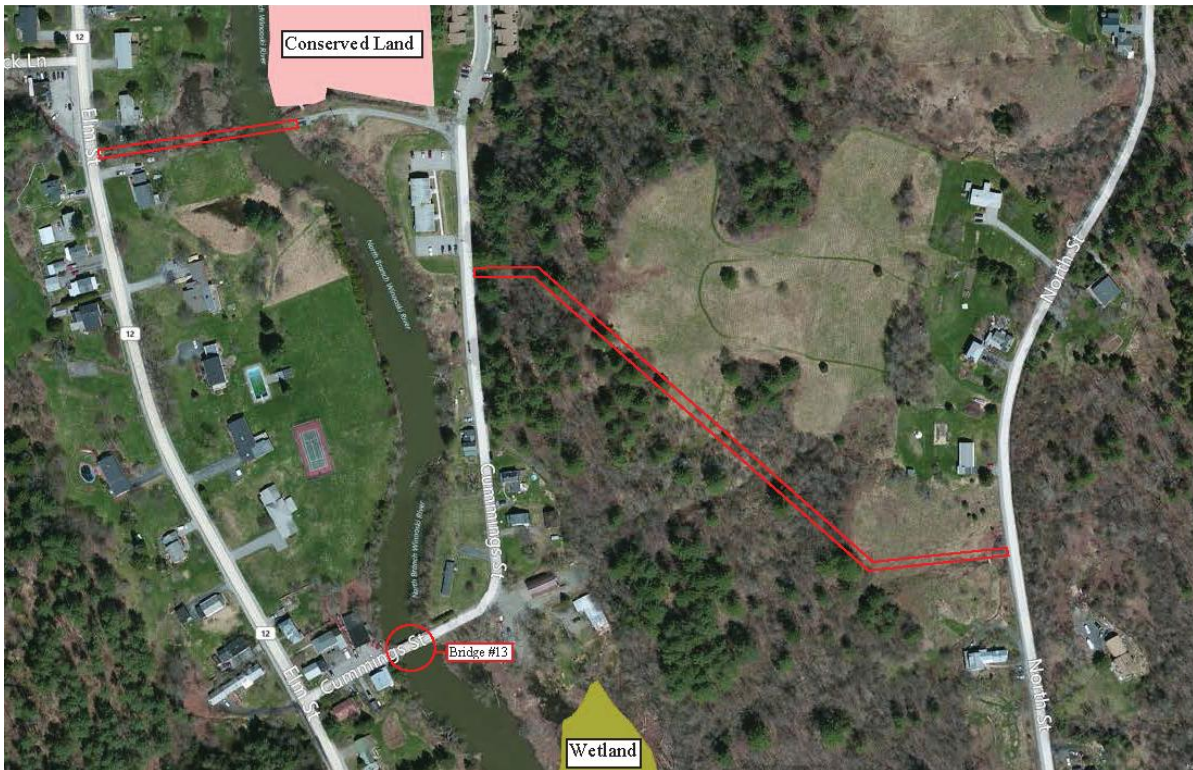
Potential Alternative Access to Cummings St

Cummings St is a dead end road with one access over Bridge 13. Thus, for an off-site detour one would need to provide alternative access to Cummings St. Two potential locations for connecting Cummings St to other roads were considered; both of these are shown in the image below.

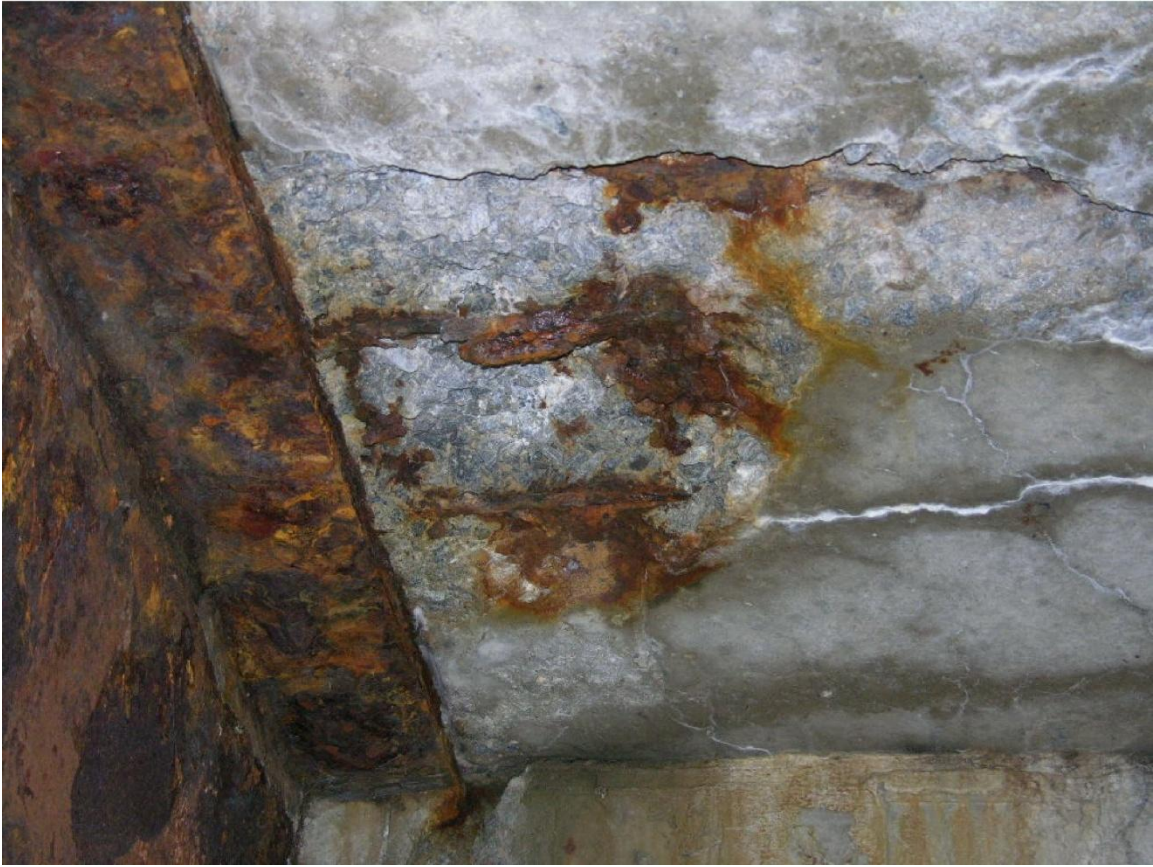
Deck and Girder Deterioration

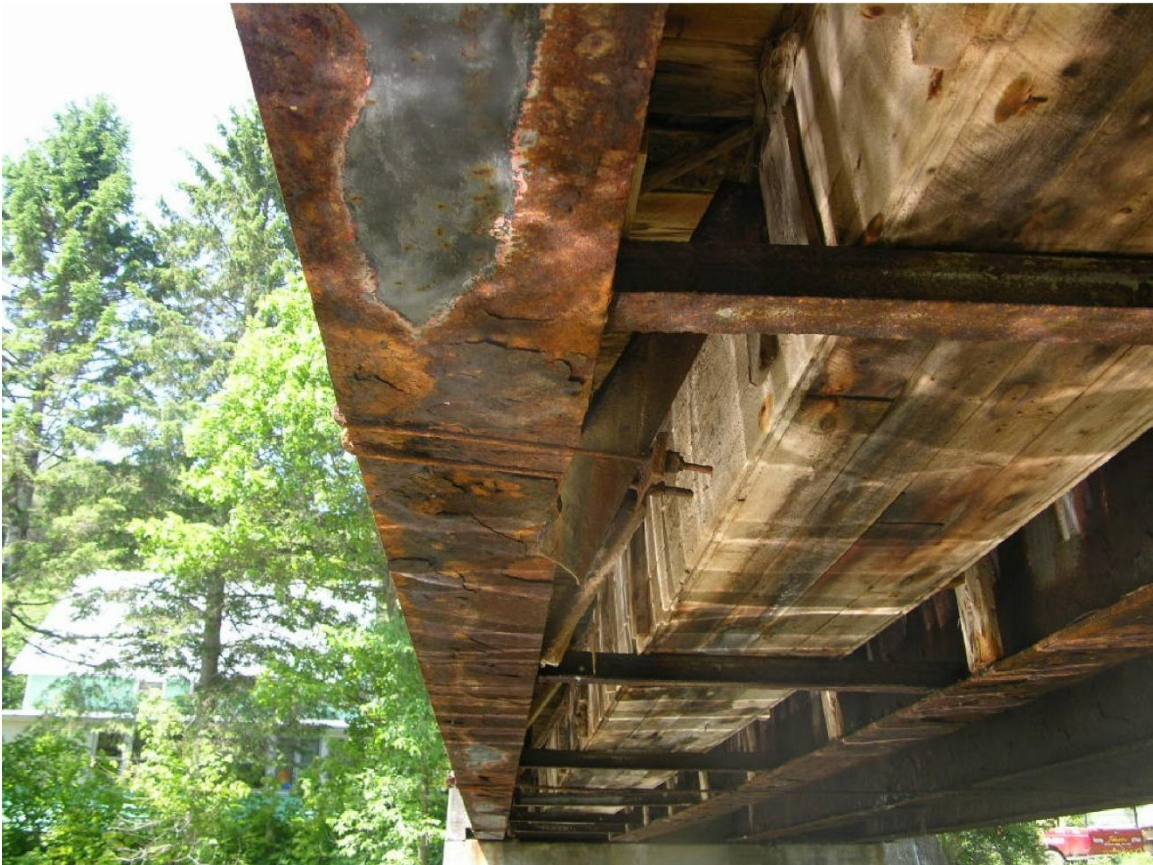
Girder Deterioration and Water Main Enclosure

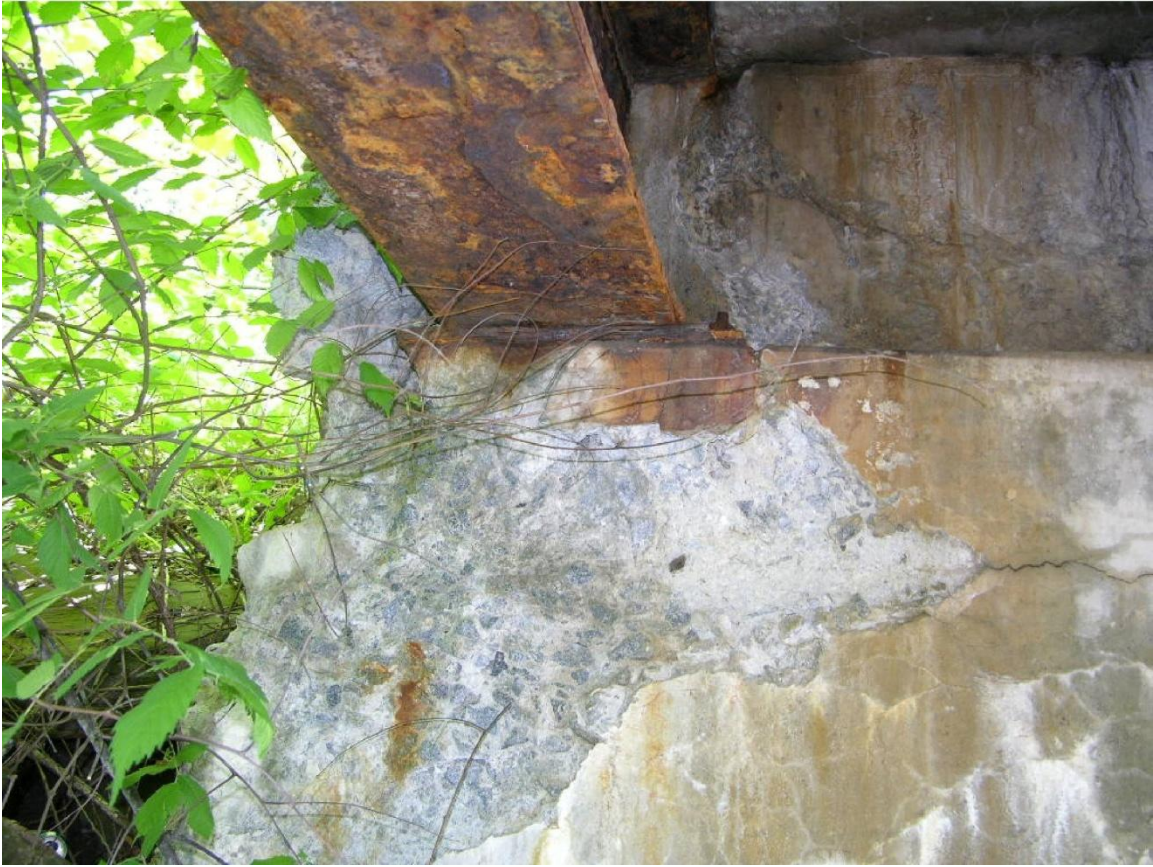
Abutment Deterioration

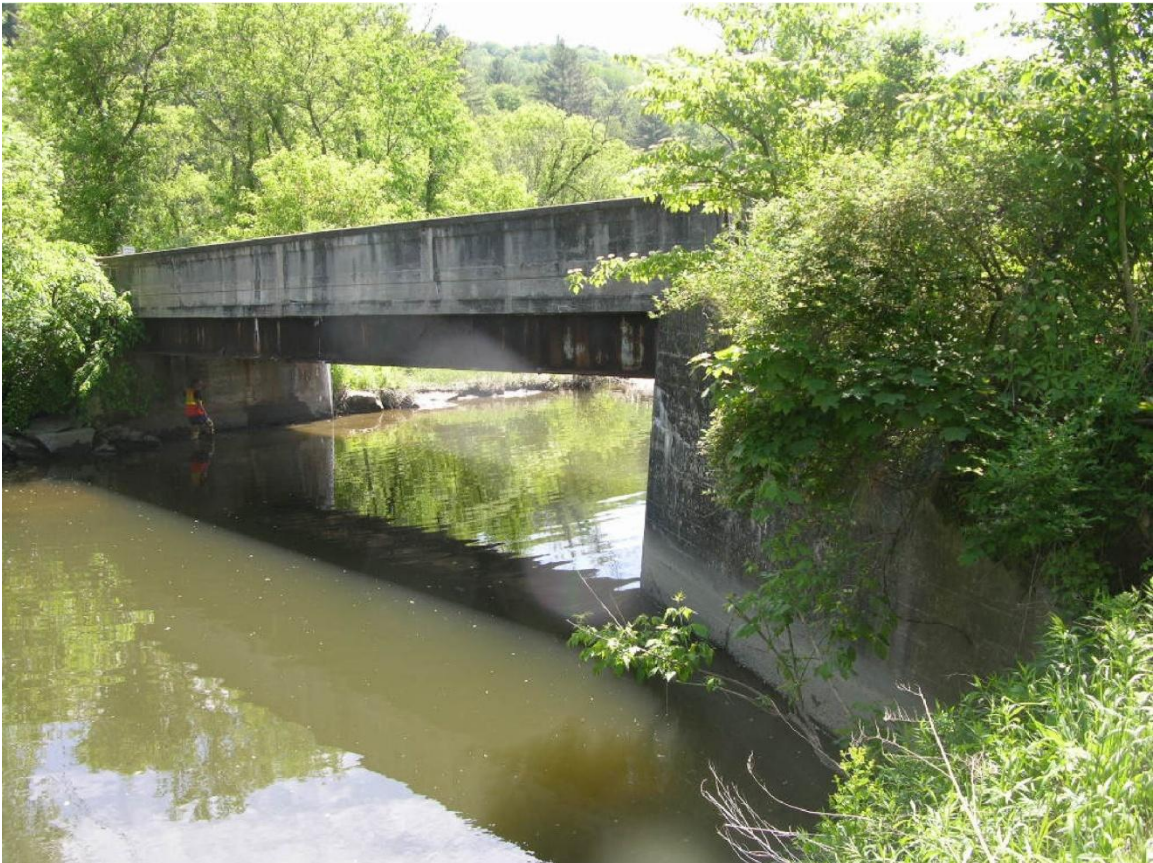
Looking downstream at waterway constriction

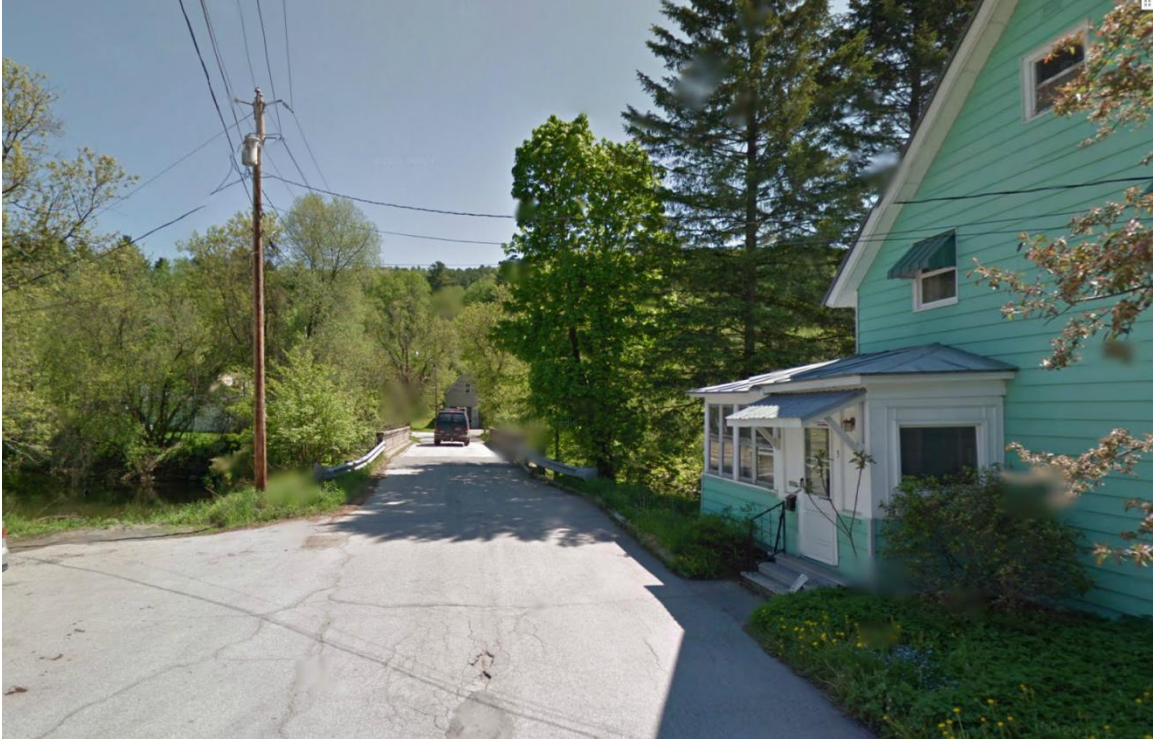
Looking east over the bridge at the narrow roadway

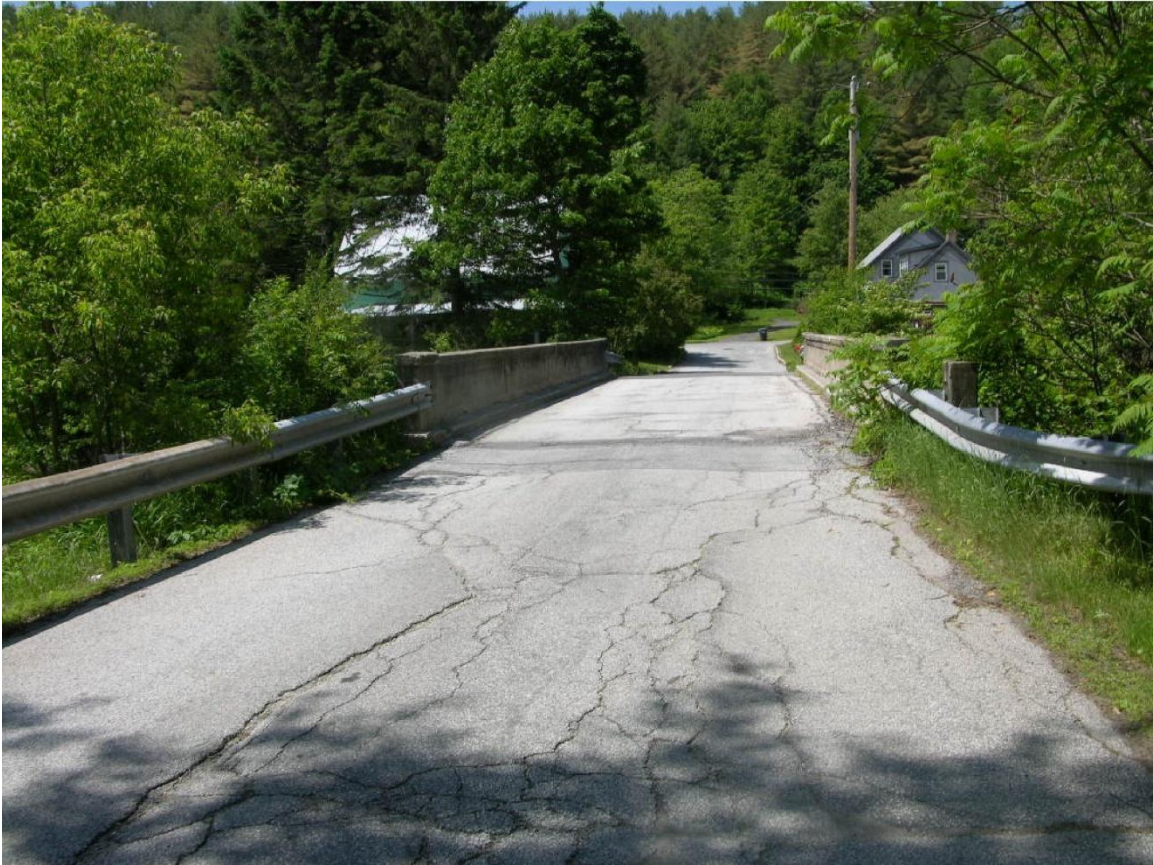
Looking west over the bridge at the patched joint

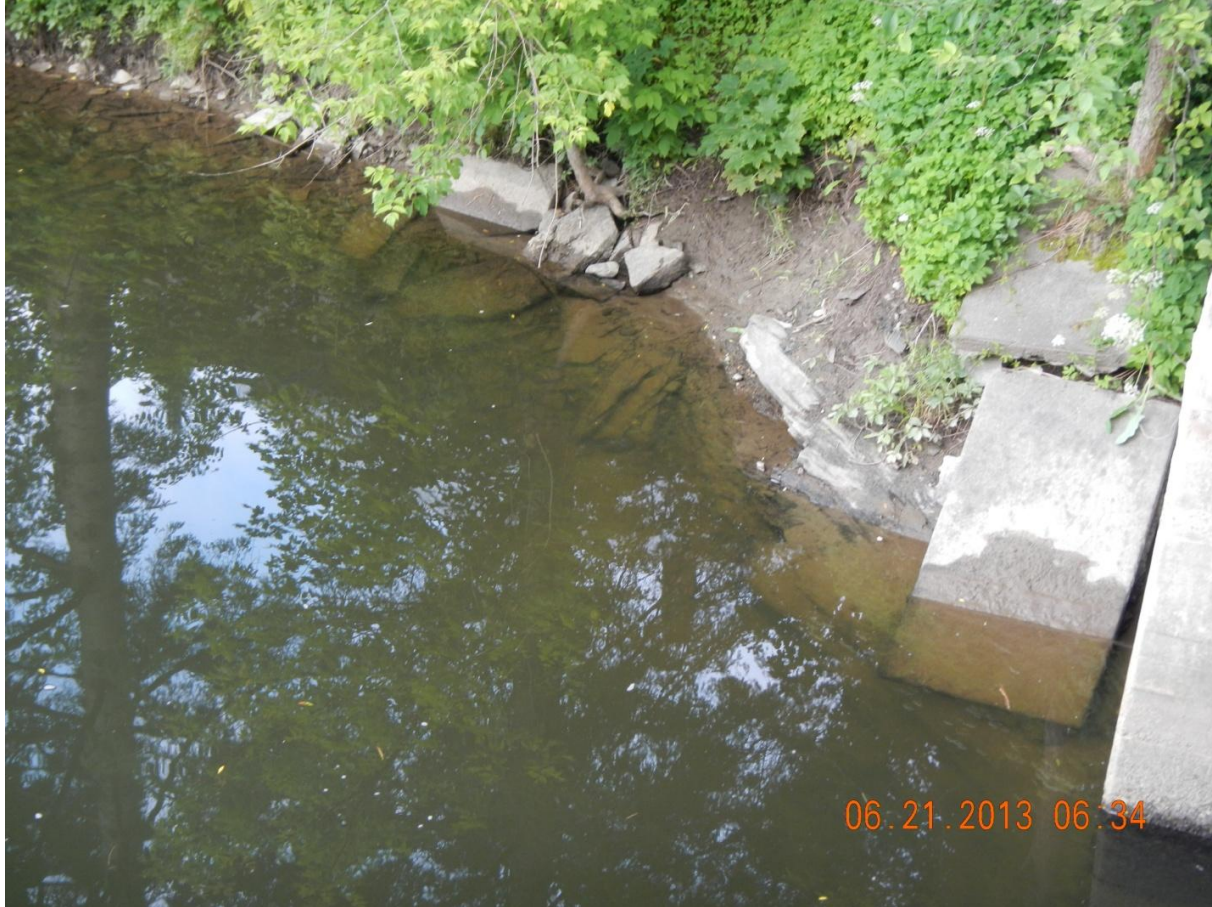
Some potential bedrock outcrops were identified on the eastern side of the bridge, however, stone rip rap lined the channel making it difficult to discern bedrock from buried rip rap. The bedrock information in the surrounding area indicates that the depth to ledge could vary greatly within the vicinity so additional information in this should be obtained.

Figure 3. Potential bedrock outcrop and rip rap stone lining the eastern side of the bridge.

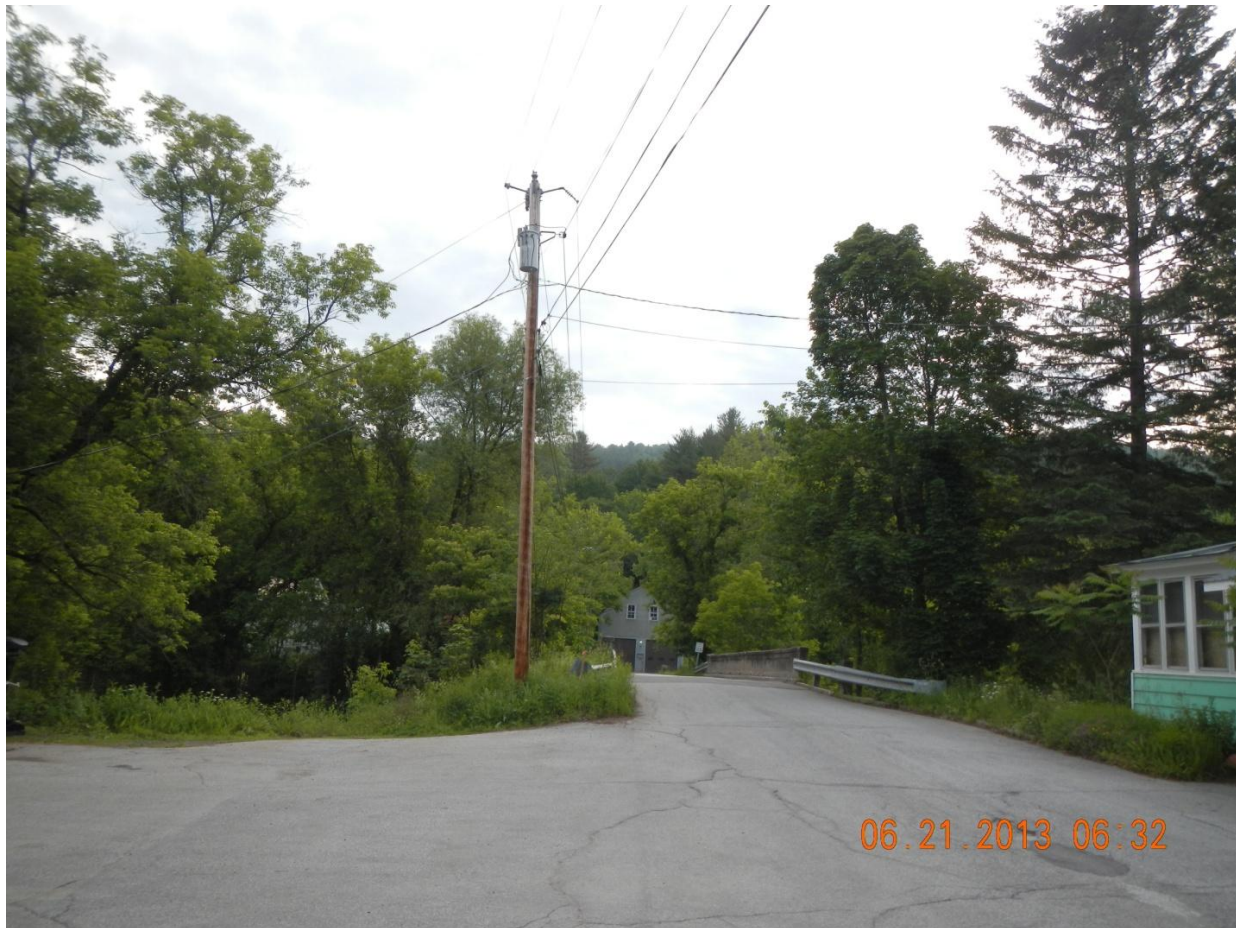
Figure 3. View of existing site. Photograph was taken facing east.

Overhead utilities were noted both on the northern and western sides of the road, as seen in Figure 3. Placement of the borings should take into consideration a minimum 10 foot clearance from these utilities.
