**STATE OF VERMONT
AGENCY OF TRANSPORTATION**

Scoping Report

**FOR
West Haven BO 1443(51)**

Town Highway 3, BRIDGE 10 OVER THE POULTNEY RIVER

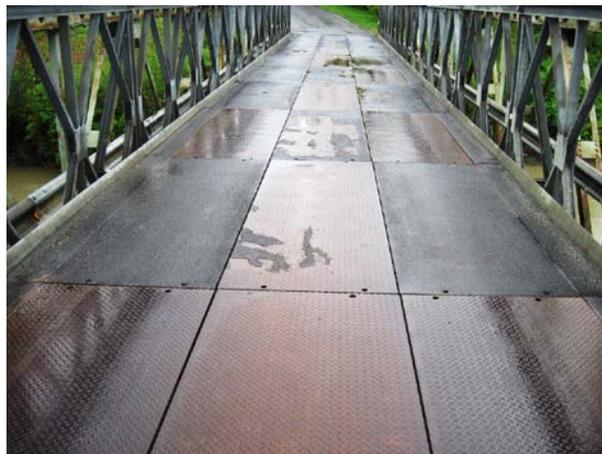
Bridge Deck.

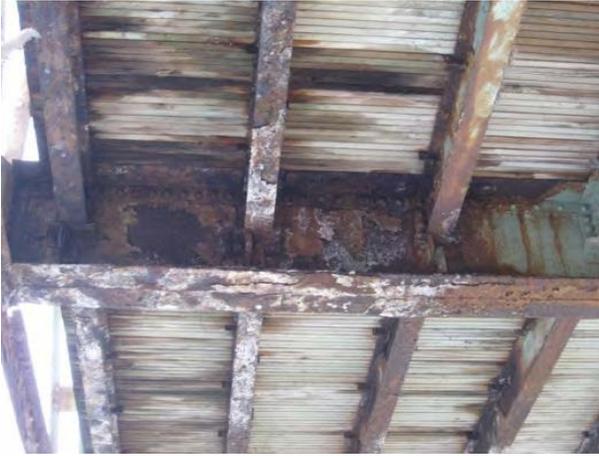
Floor beam deterioration.

1. The original pony truss is in poor condition and has been topped with a Maybe Bridge due to this condition. The original truss has seen severe section loss of the bottom chord, end posts, and floor beam to gusset connections, as well as stringers and lateral bracing. The Maybe Bridge is only for temporary use until the pony truss is rehabilitated or replaced.
2. The westbound approach is overtopped in the Q_{10} storm event.
3. The existing horizontal and vertical alignments through the project location do not meet the current standard.
4. The lane and shoulder widths of the bridge and approaches are too narrow for the traffic volume, design speed and roadway classification.
5. One or both of the abutments have moved or rotated toward the stream and, the condition of the abutment concrete is poor. Additionally, the current abutments do not span the bank full width.

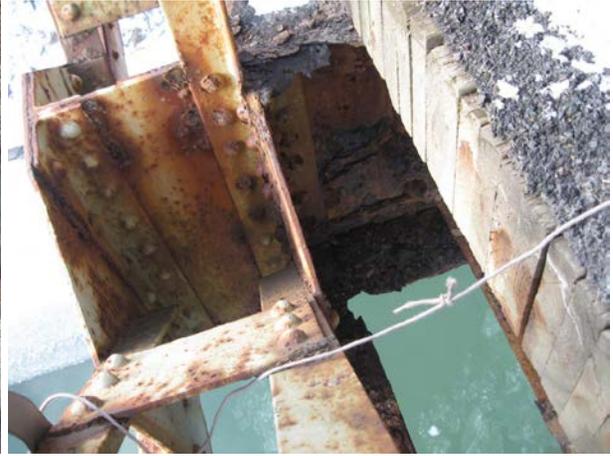
Gusset Plate distortion.

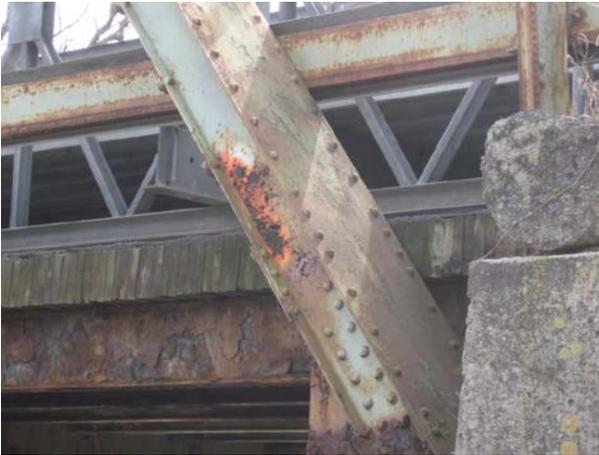
End post section loss (TYP).

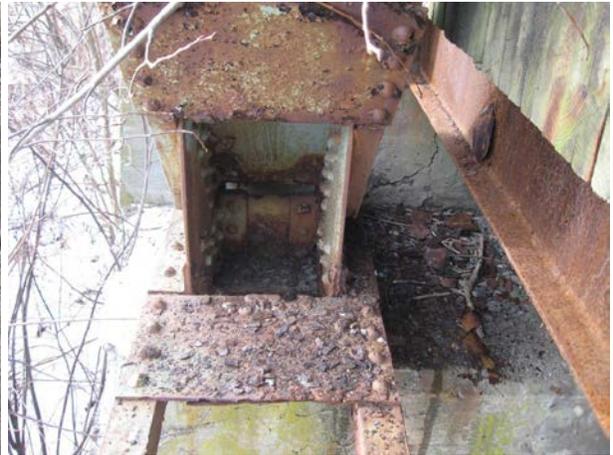
Bearing at southwest corner.

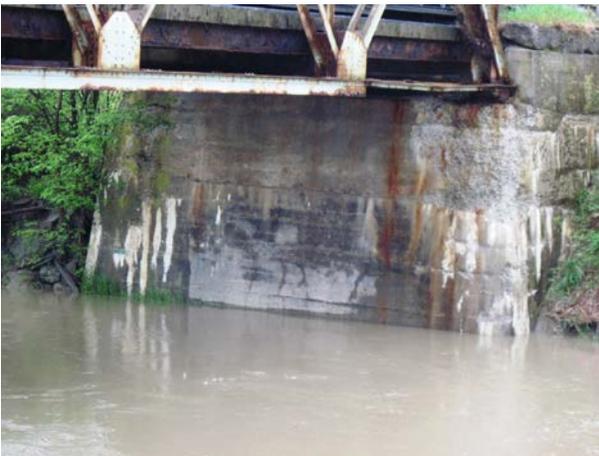
Southern abutment.

The existing substructure is in unsatisfactory condition, and it is reasonable to assume that the existing substructure cannot safely carry anticipated traffic loads for an extended period of time. The abutments have moved or rotated toward the stream. Additionally, the existing concrete is in poor condition. As such, a full replacement of the existing abutments is warranted.

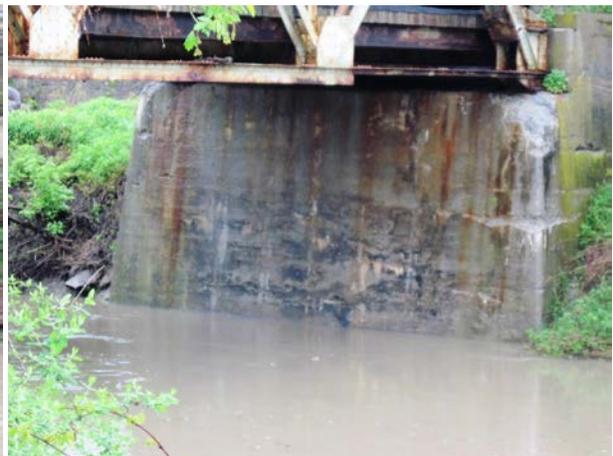
Northern abutment.

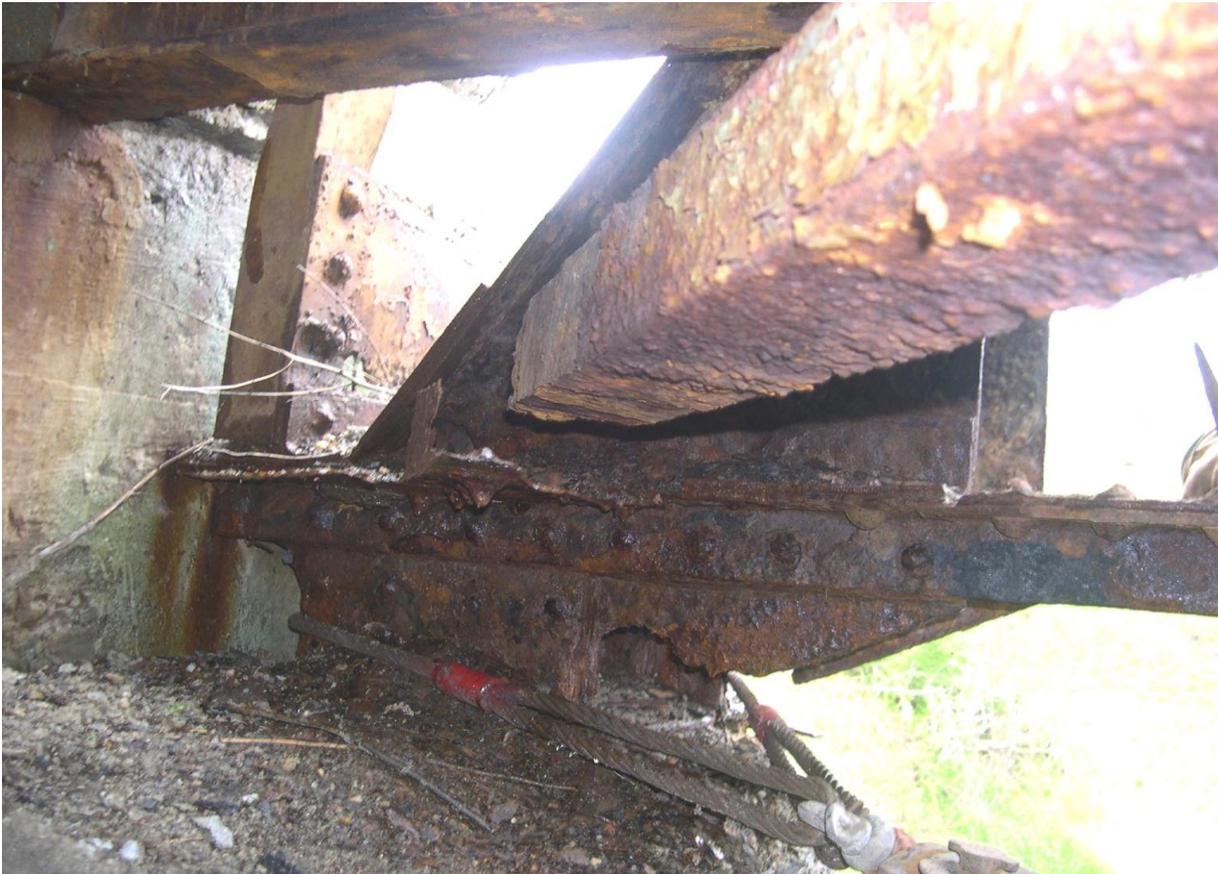
Based on the bridge inspection photos from May 2005, the original pony truss bridge has failed and severely deteriorated as can be seen in Figure 2 below.

Figure 2. Truss Failure and Severe Rust Deterioration

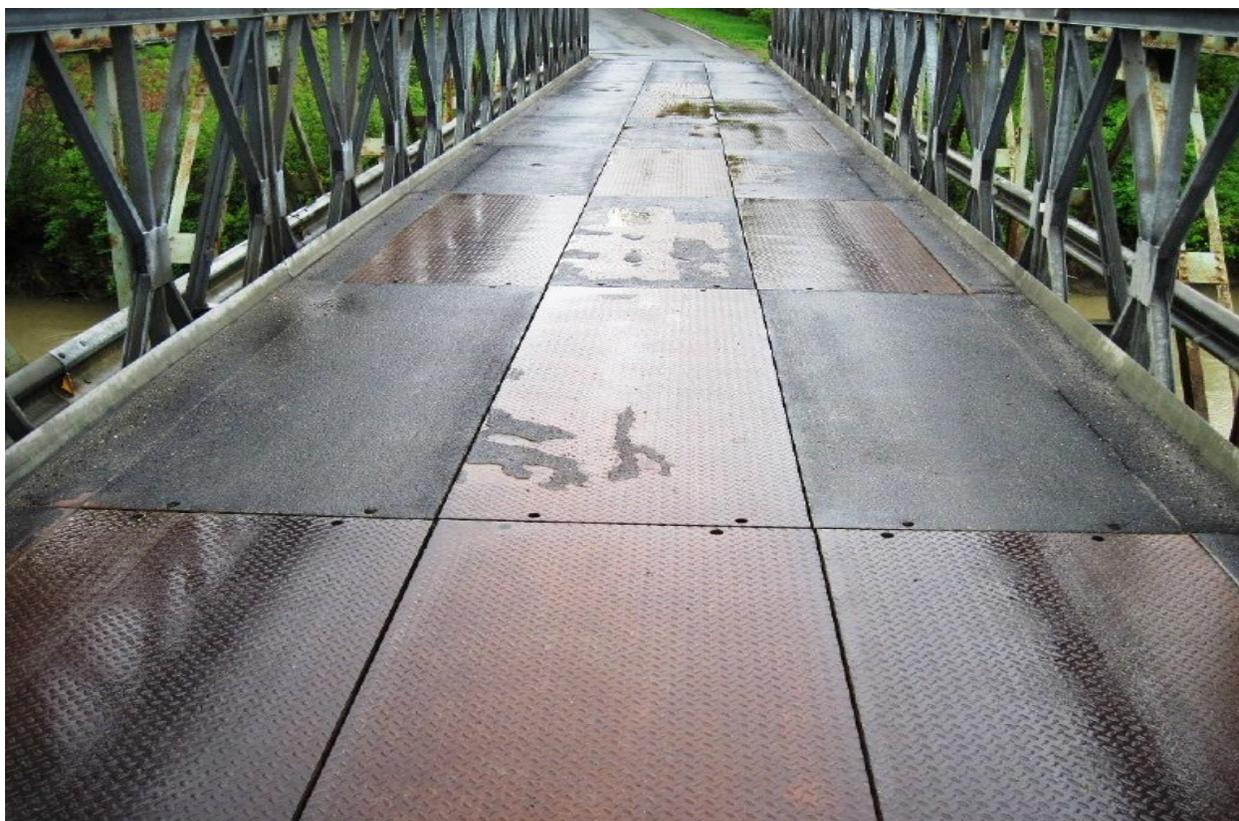
Due to the failed bridge, a temporary Mabey Bridge was set in place over the existing pony truss bridge. The temporary bridge is restricted to single lane traffic and limited visibility is evident on both approaches. Figure 3 below shows a picture of the temporary bridge deck taken during the latest bridge inspection in May 2011. Based on the latest bridge inspection report, some of the deficiencies include missing paddleboards that need to be replaced and the approach rail system at the northwestern end needs some improvement where the box beam has become loose and detached.

Figure 3. Temporary Bridge – Deck View

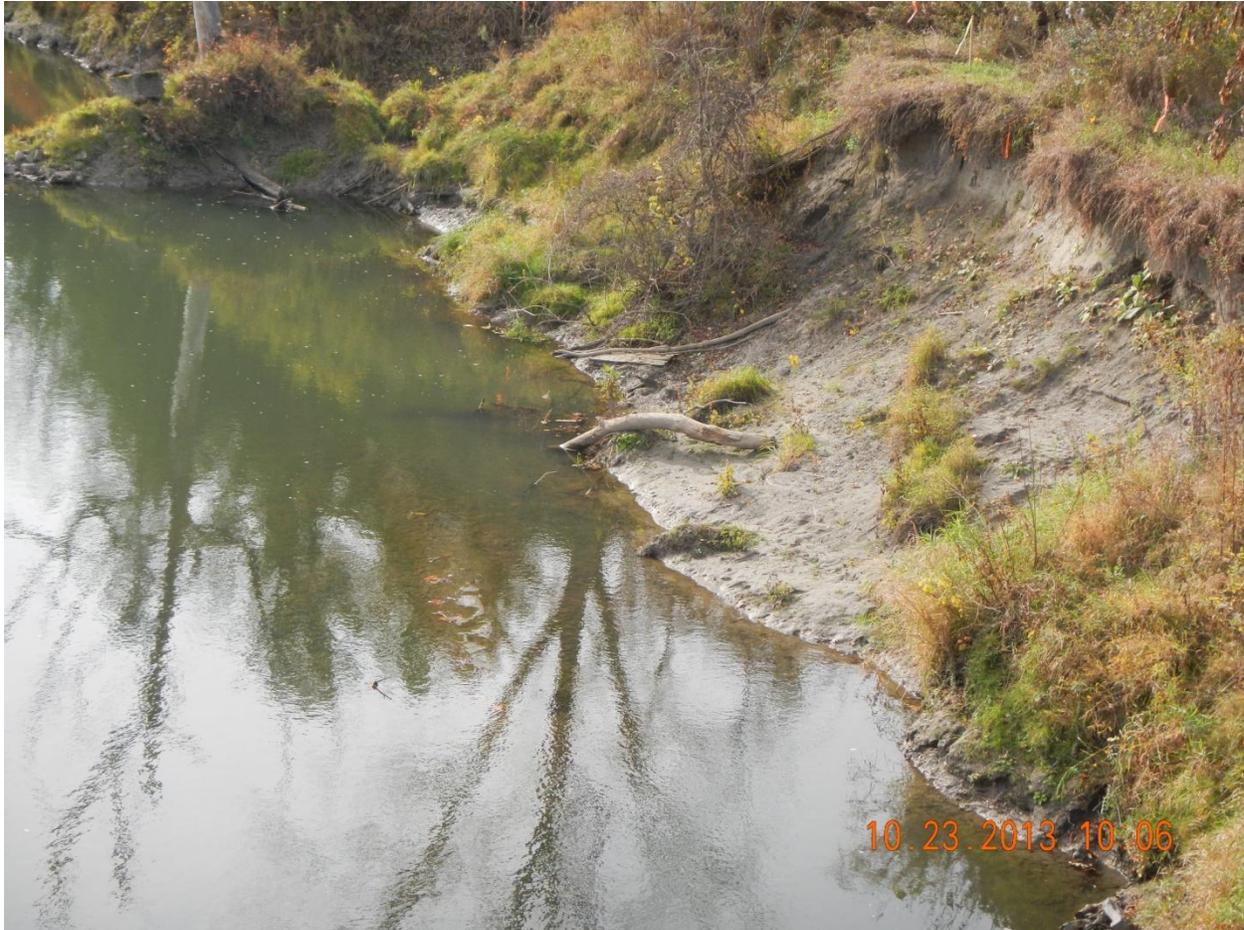
A preliminary site visit was conducted on October 23rd, 2013 to determine possible obstructions inhibiting boring operations and other site characteristics. Information from this visit indicated no above ground utilities located at the bridge. There are a few power lines along the southwest corner of the bridge but end around where the wingwall begins. The wingwalls on both abutments have bowed outward and the entire substructure should be replaced. There was stream bank erosion evident along the western bank just south of the bridge as seen in Figure 4. In addition, the water was very murky and no boulders or exposed bedrock were visible.

Figure 4. Stream Bank Erosion Just South of Bridge
