STATE OF VERMONT
AGENCY OF TRANSPORTATION

Scoping Report

FOR
Woodstock Village BF 020-2(43)

US ROUTE 4, BRIDGE 51 OVER THE KEDRON BROOK

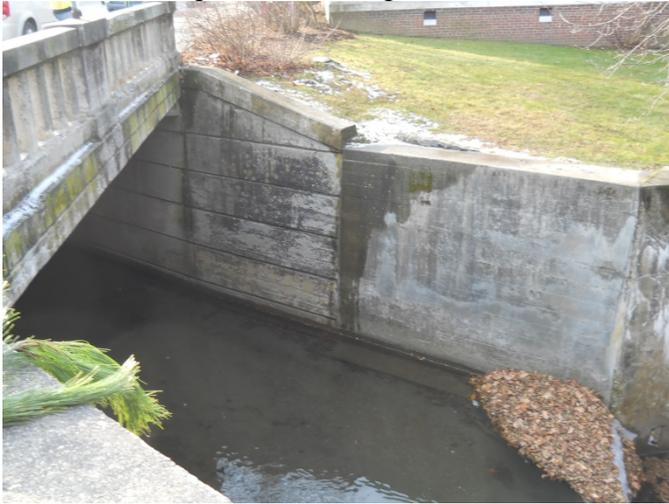
Figure 1: Northwest Wingwall

Northwest Wingwall

The northwest wingwall would be sawcut and removed down to the bridge seat elevation and recast after the new superstructure is placed.

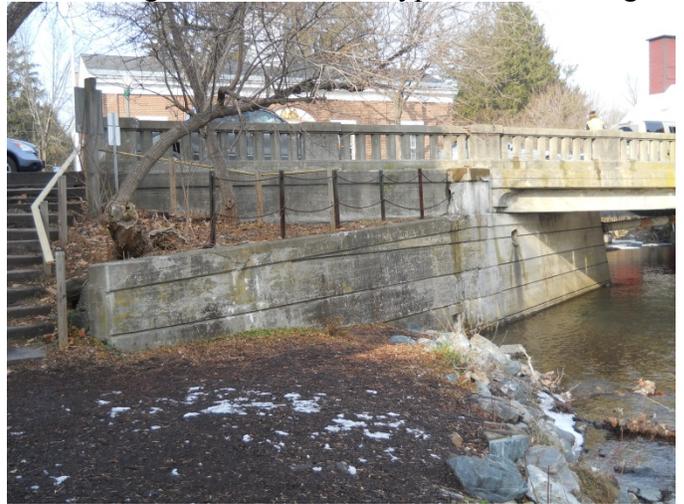
Figure 3: Southwest Wingwall

Southwest Wingwall

The wall portion that runs in line with the abutment is below the bridge seat and can be left unchanged. The wall that runs along the roadway which is mounted by historic railing, should be removed and recast along with new similar type historic railing.

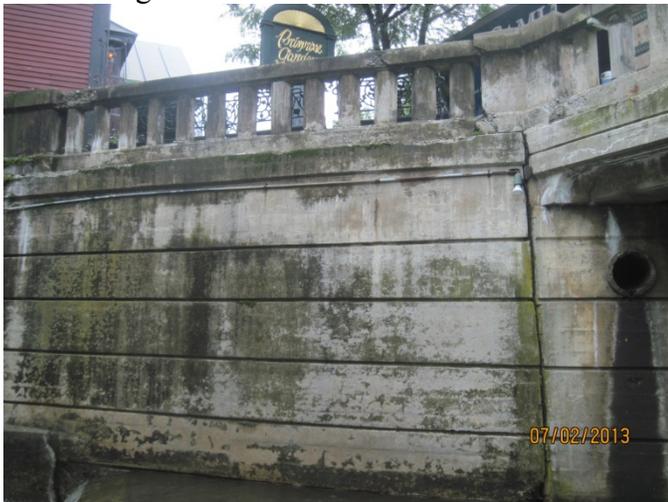
Figure 2: Northeast Wingwall

Northeast Wingwall

The northeast wingwall would be sawcut and removed (including the historic railing) down to the bridge seat elevation and recast after the new superstructure is placed. New similar type historic bridge railing would be cast on top of the new wall portion. This railing would run from the fascia of the bridge and abut up to the adjacent building as the existing does.

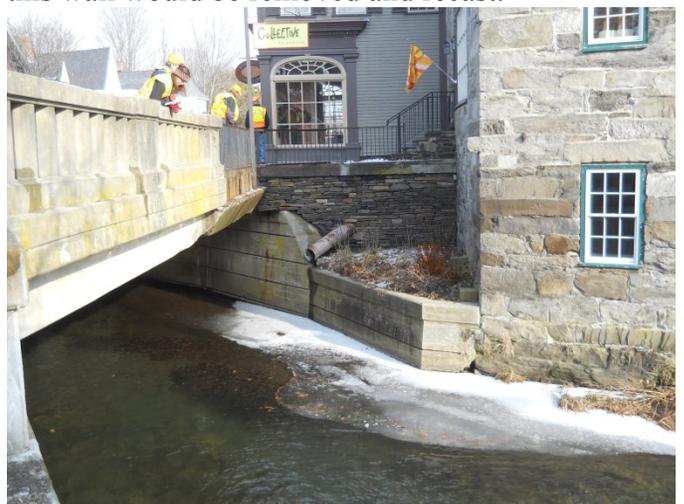
Figure 4: Southeast Wingwall

Southeast Wingwall

The laid up stone wall in the southeast quadrant will need to be partially removed and reset in order to place a new superstructure. The concrete topper for this wall would be removed and recast.

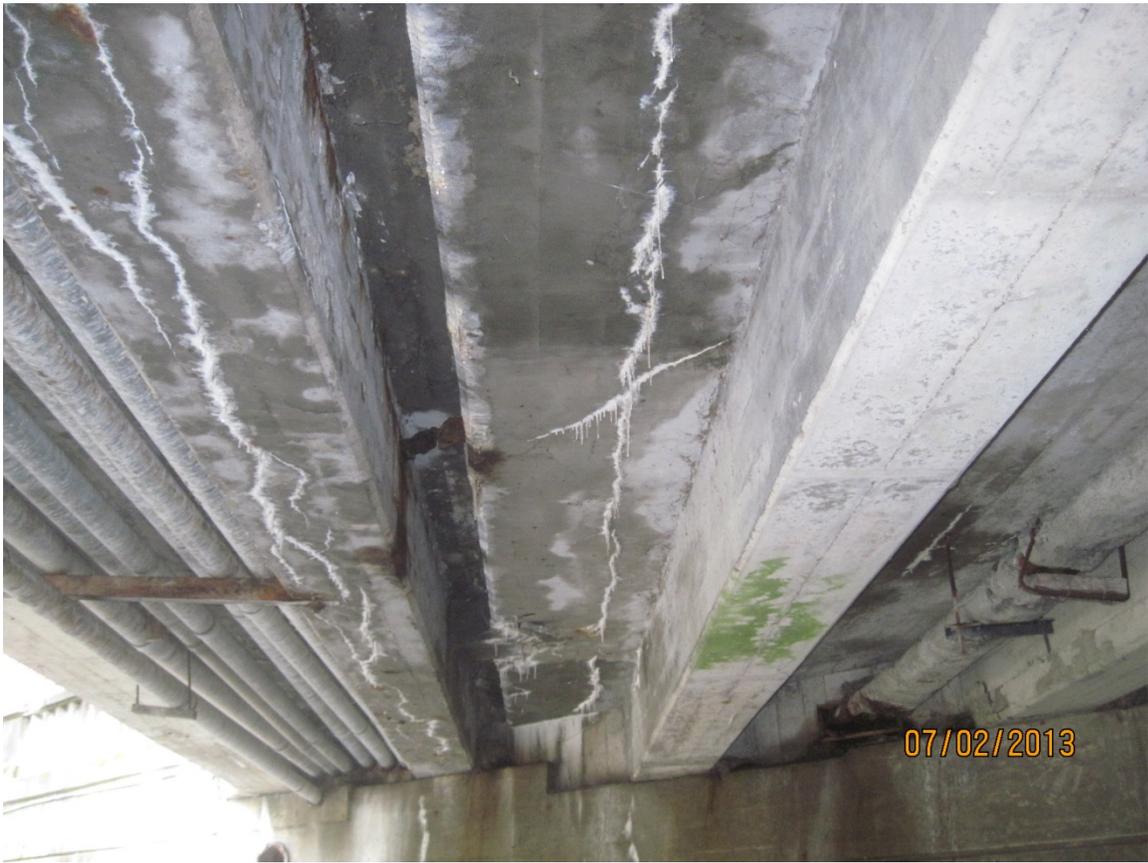
Cracking and saturation of existing T-beams.

7/2/2013 – Structure is in fair condition. The deck and superstructure continue to deteriorate and remain saturated in large areas with rust staining and efflorescence. There are large delaminated areas throughout and large spalled out areas in beams 8 and 9 with exposed rebar. ~JWW/JDM

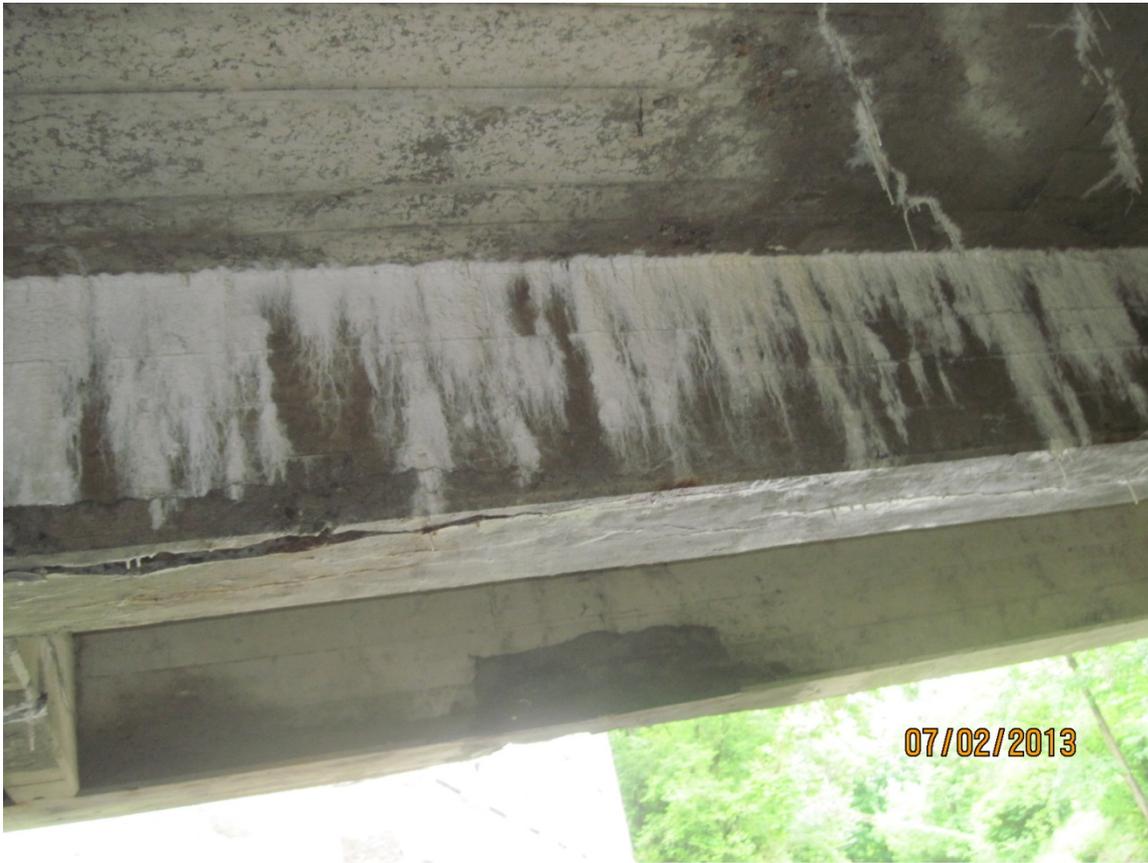
Efflorescence and crack saturation.

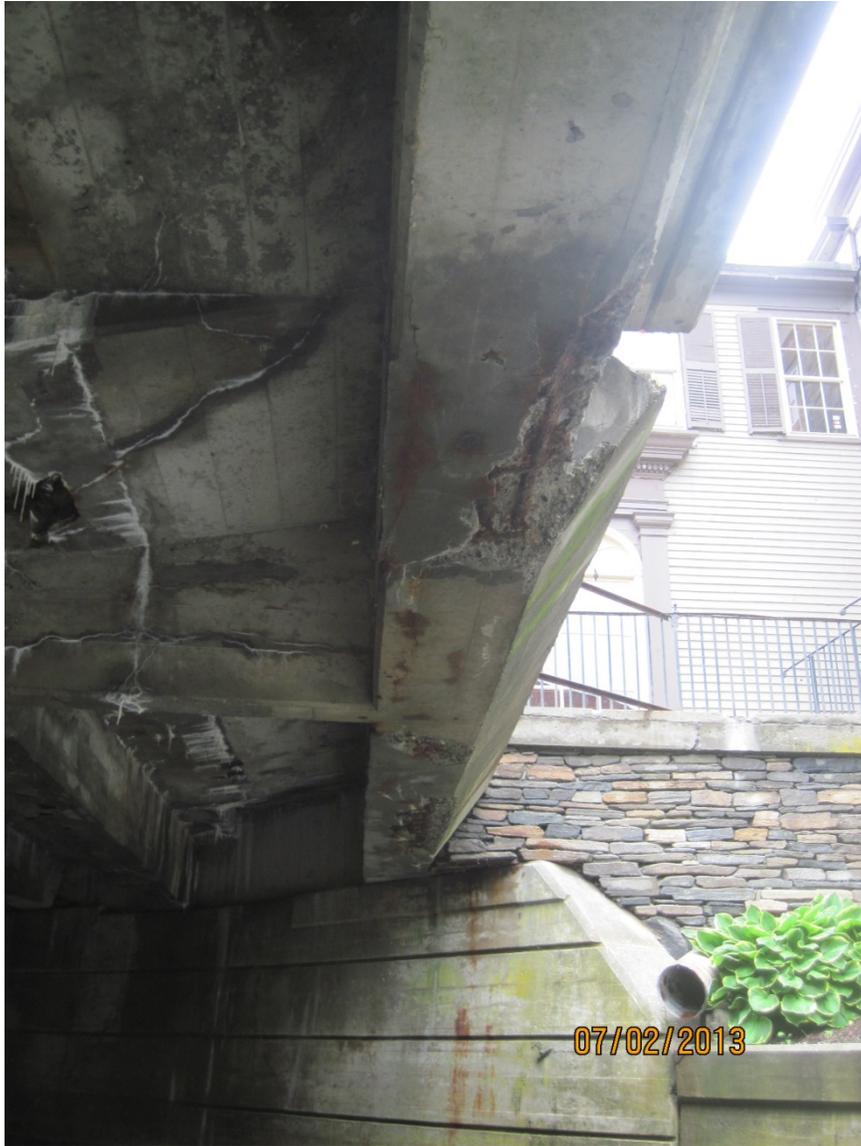
Fascia and T-beam deterioration.

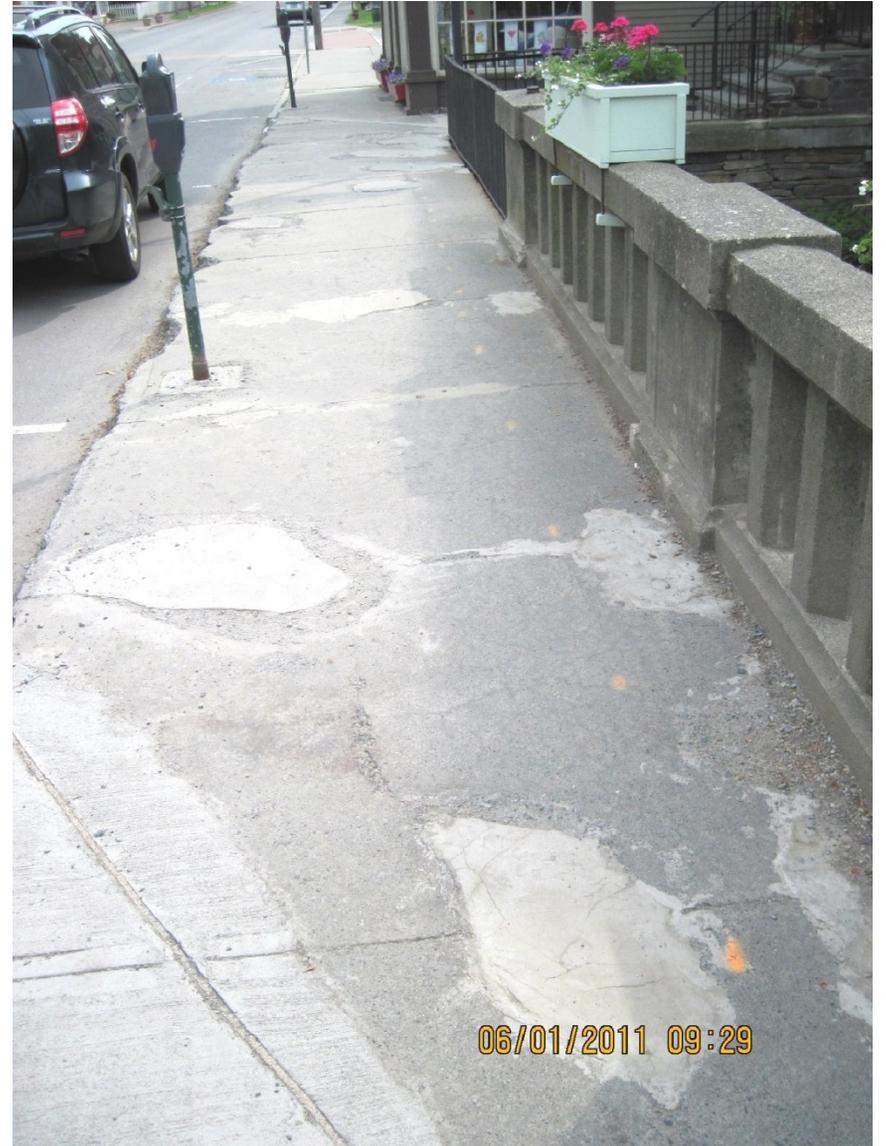
Sidewalk deterioration.

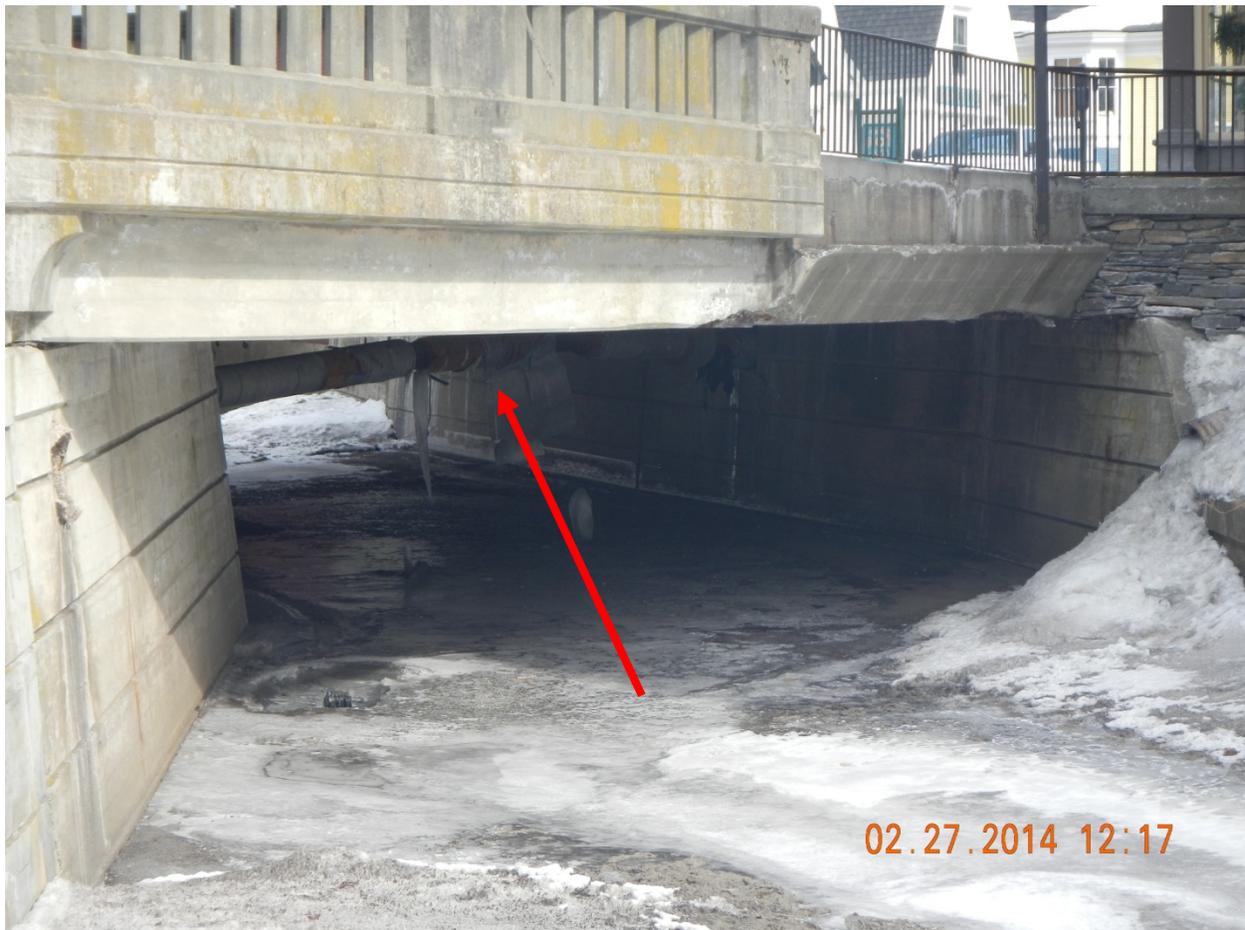
Figure 2: Electrical Conduit Running under Bridge 51

A preliminary site visit was conducted on February 27, 2014 to determine possible obstructions inhibiting boring operations and to make any other pertinent observations about the project. Utilities are buried in the Village of Woodstock and run beneath the bridge at the center along US Route 4.

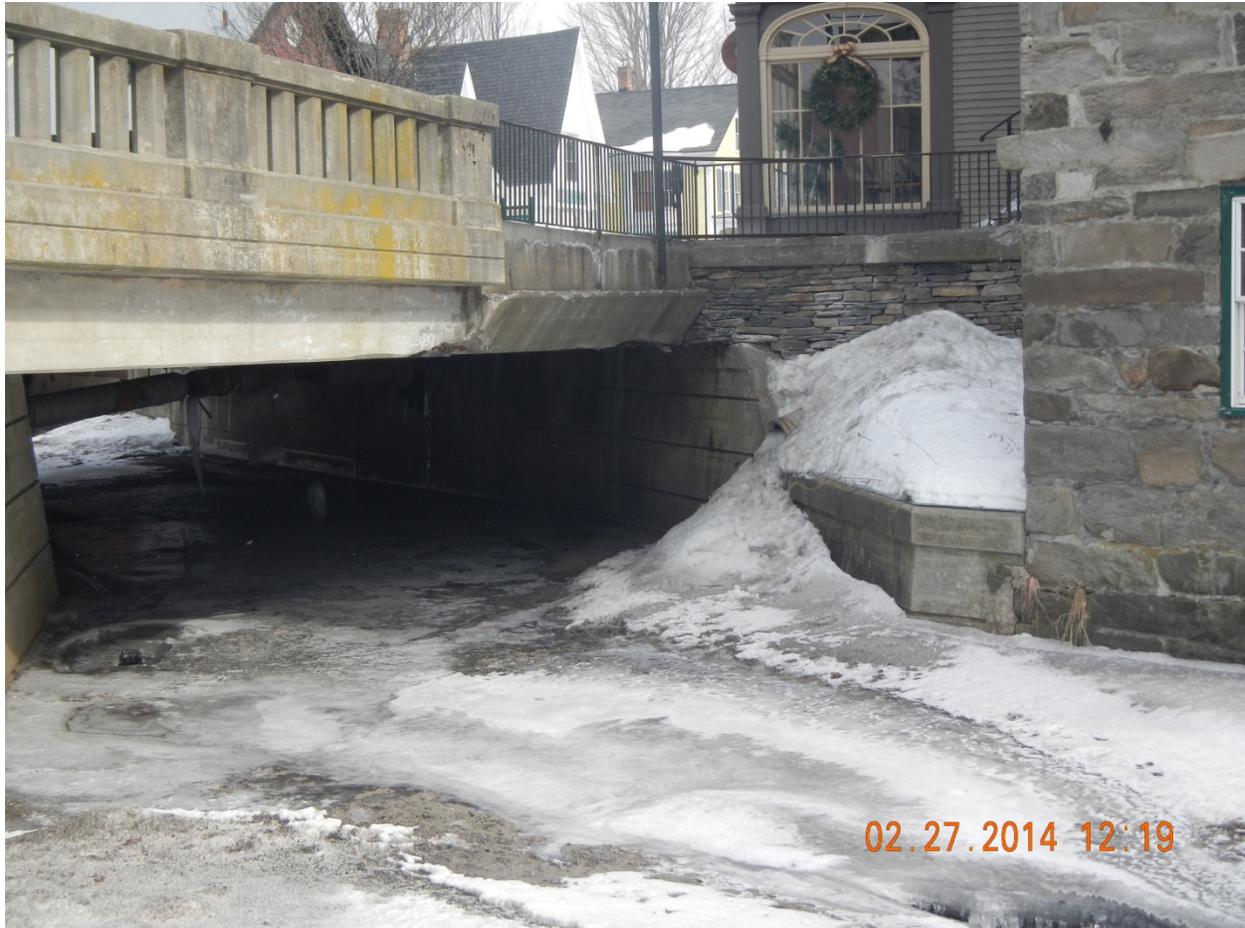
Figure 3: Building Next to Southeast Corner of the Bridge

In addition to the Utilities, there are also buildings in close proximity to the bridge. Several of the buildings are supported on the bridge abutments and wingwalls. Figure 3 and Figure 4 show two buildings that are located near the bridge location.

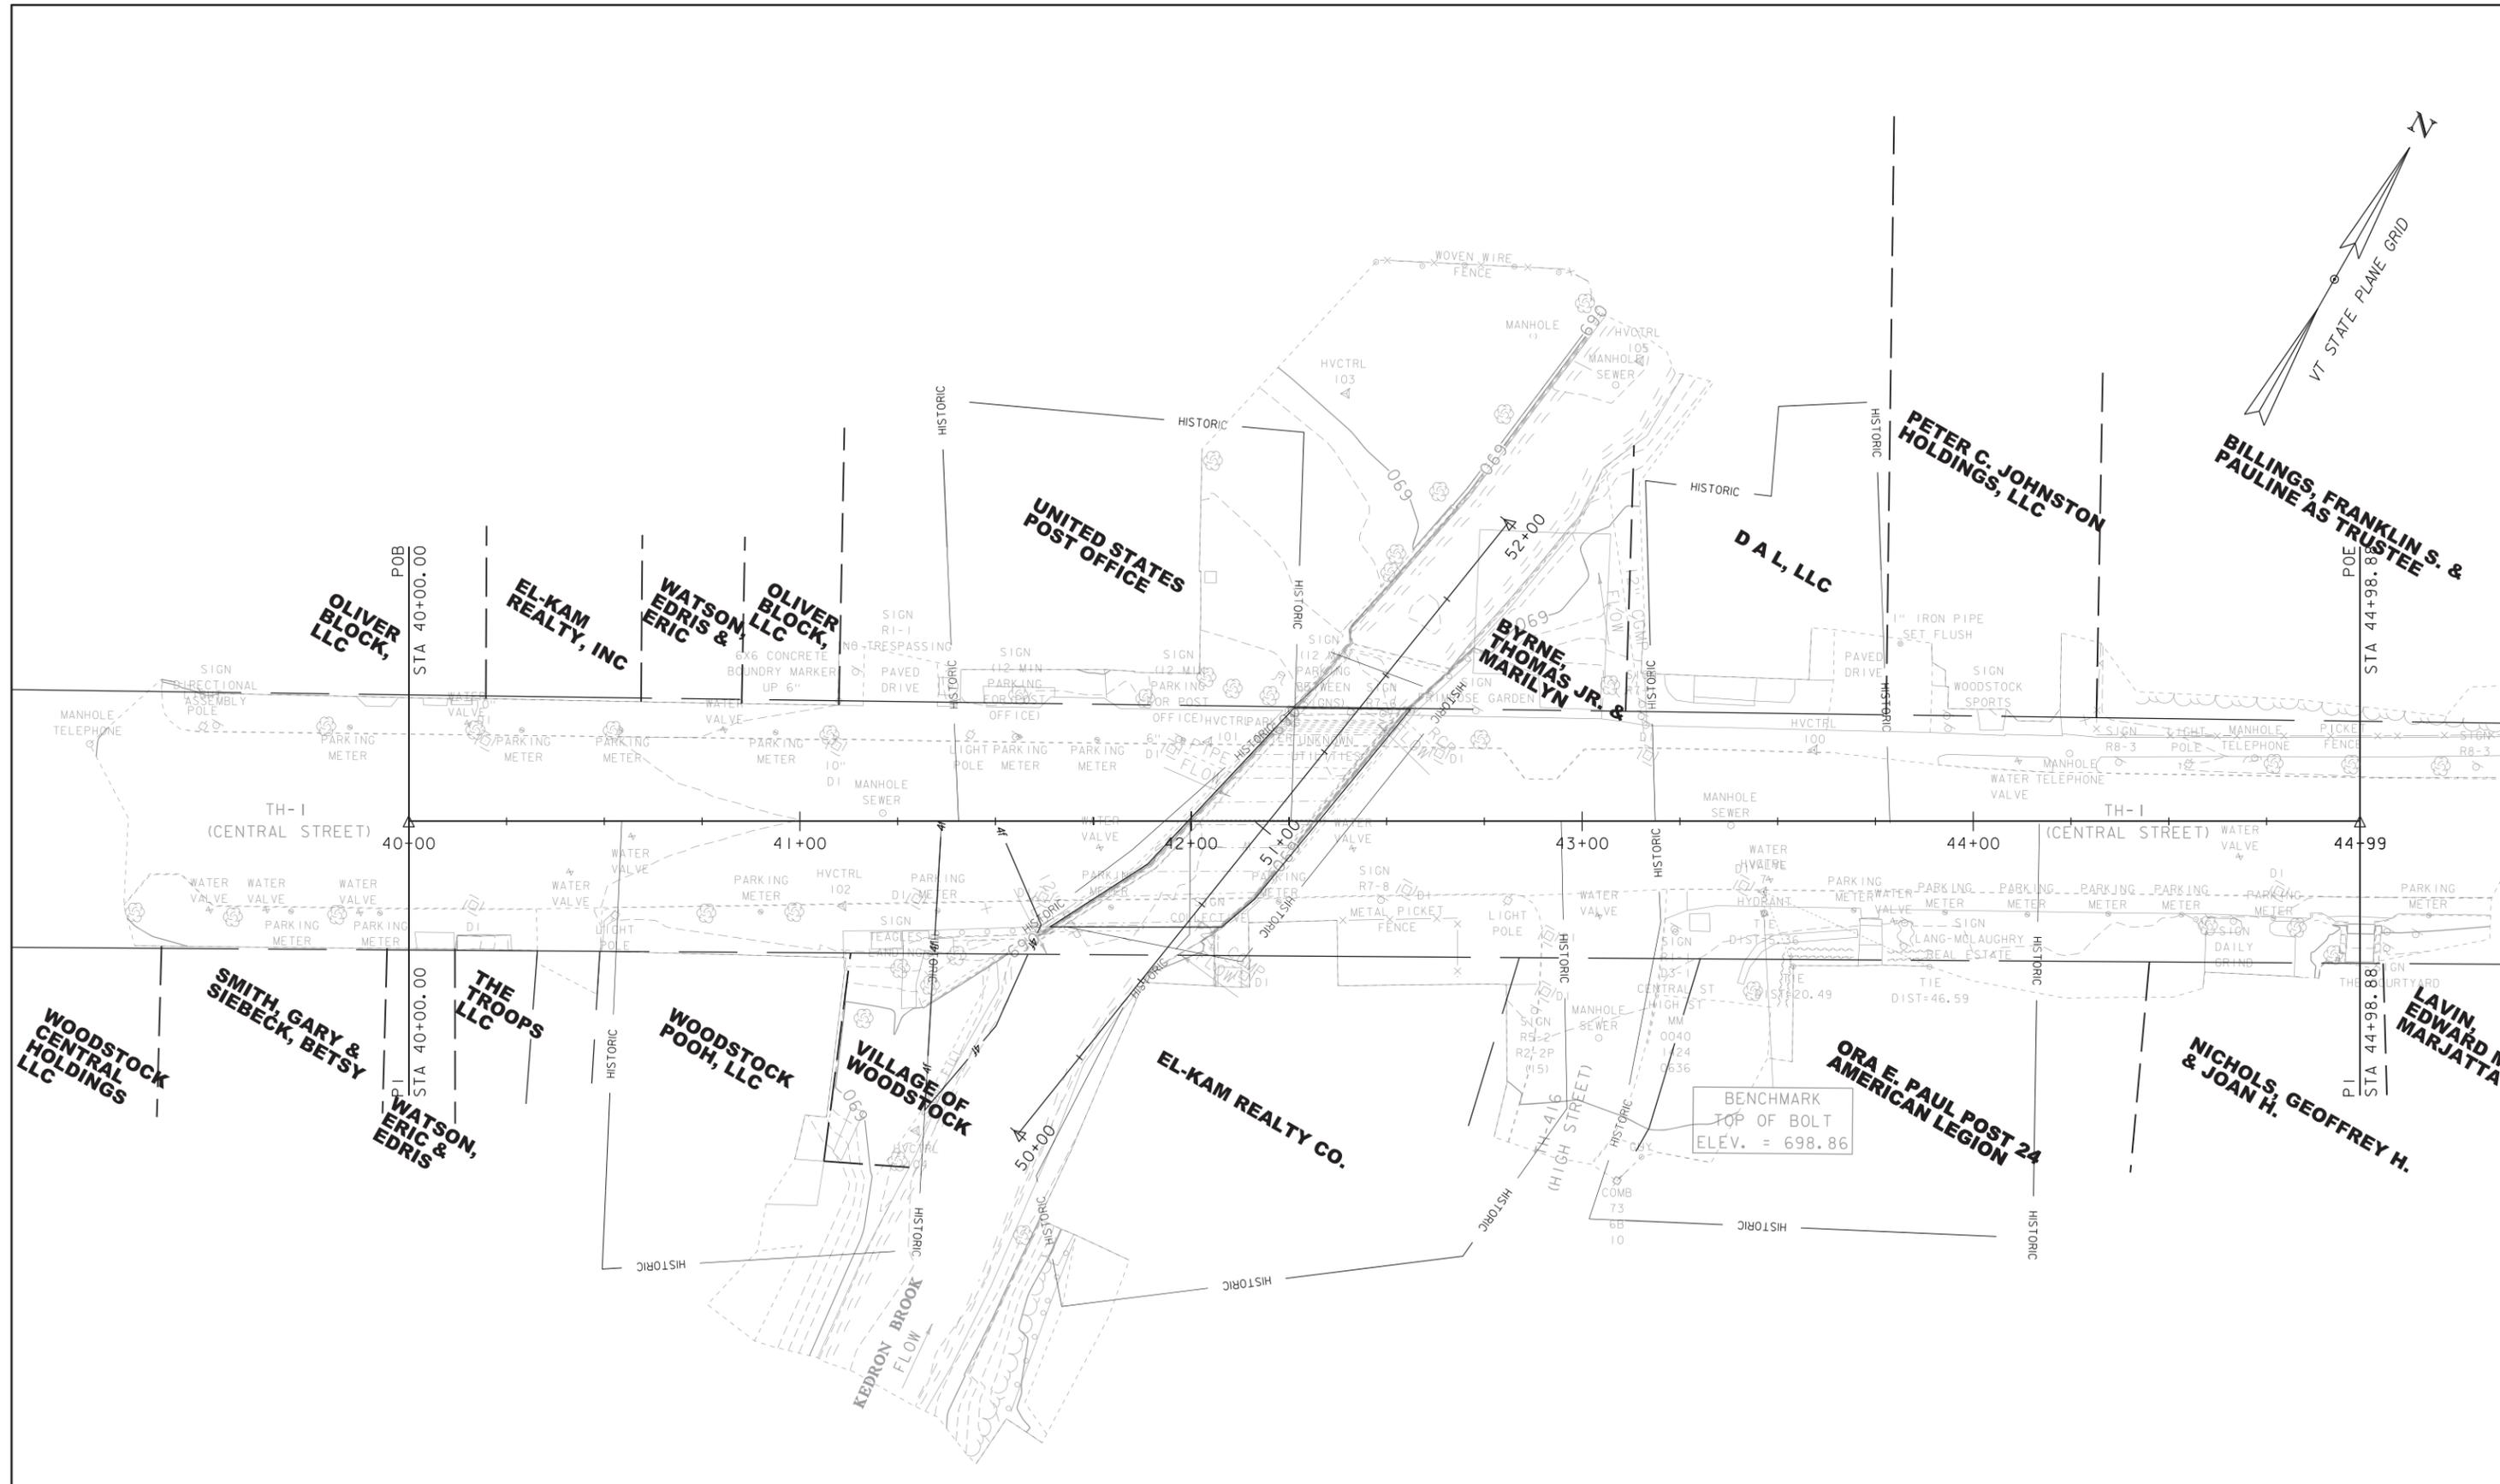
EXISTING CONDITIONS

CONCRETE T-BEAM BRIDGE
 BUILT 1935
 34' SPAN
 57' FASCIA TO FASCIA
