**STATE OF VERMONT
AGENCY OF TRANSPORTATION**

Scoping Report

**FOR
Newfane BF 0106(6)**

FAS ROUTE 106 (Town Highway 2), BRIDGE 12 OVER THE ROCK RIVER

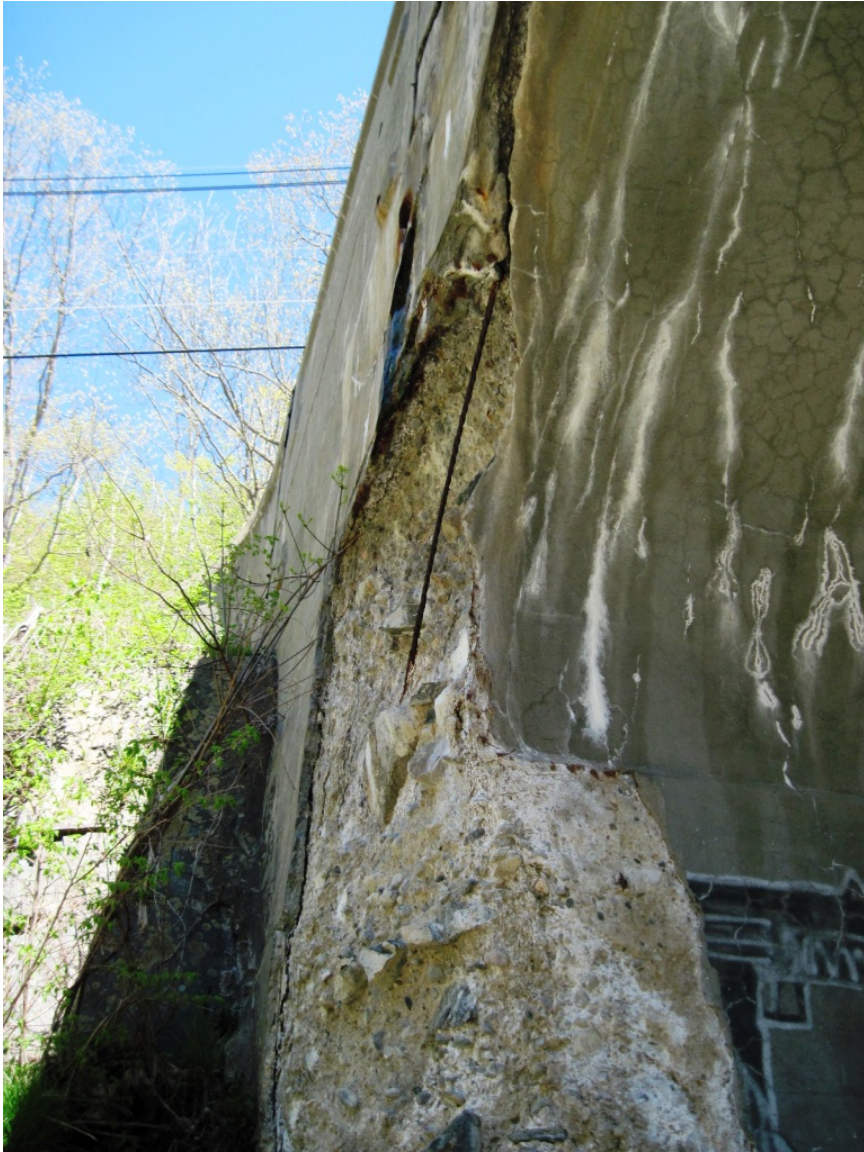
Delamination and Spalling of foundation.
Exposed rebar and efflorescence on arch ring.

- The foundation has map cracking and efflorescence throughout. Additionally it has areas with major delaminations and fully exposed rebar. The foundation concrete would need to be removed and patched with the appropriate level of concrete repair. When replacing concrete of this age with new concrete, it is required that the old concrete is removed down to “sound concrete”. It is possible that sound concrete will not be encountered, and if this is the case, then the entire foundation would need replacement.

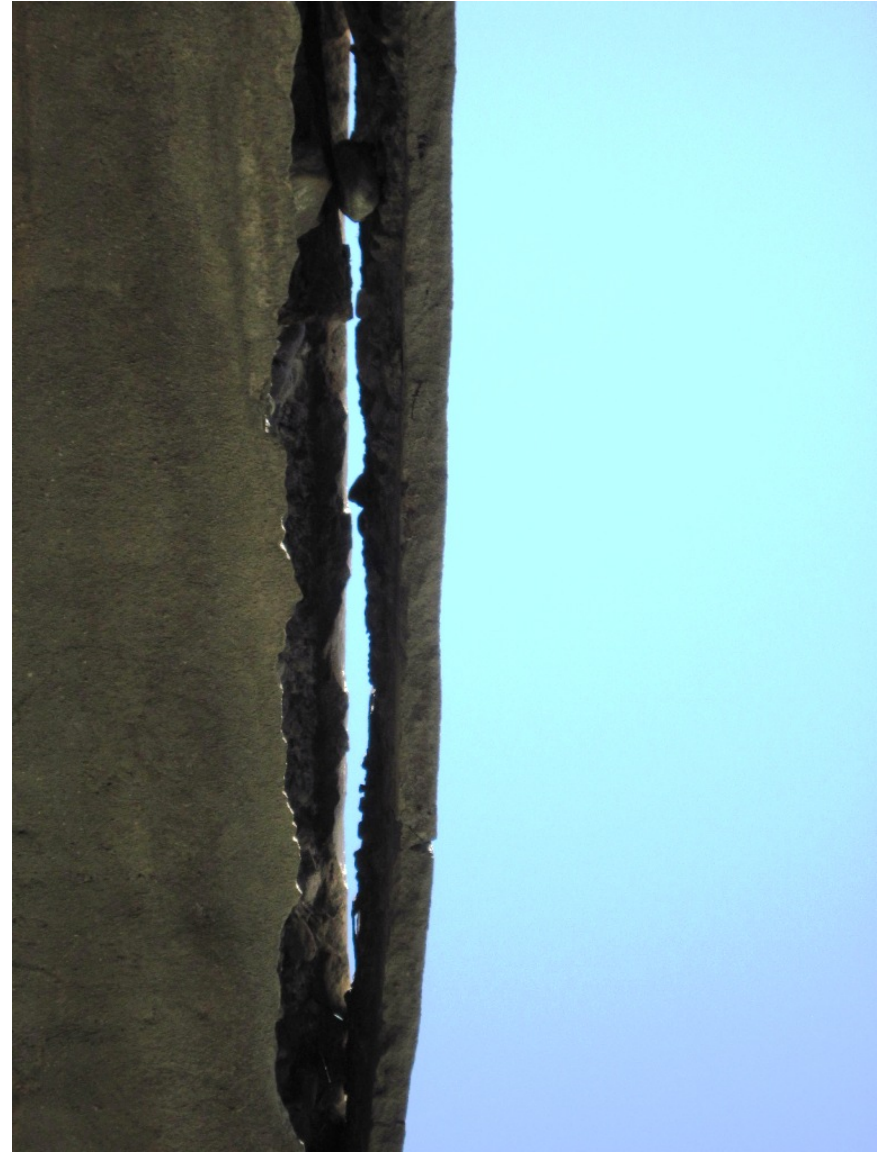
Delamination/separation of spandrel wall

- The existing spandrel walls have failed and would need to be entirely removed and replaced with new spandrel walls, as they are beyond rehabilitation. Any new spandrel walls will likely be thicker and heavier than existing since they will need to function as retaining walls

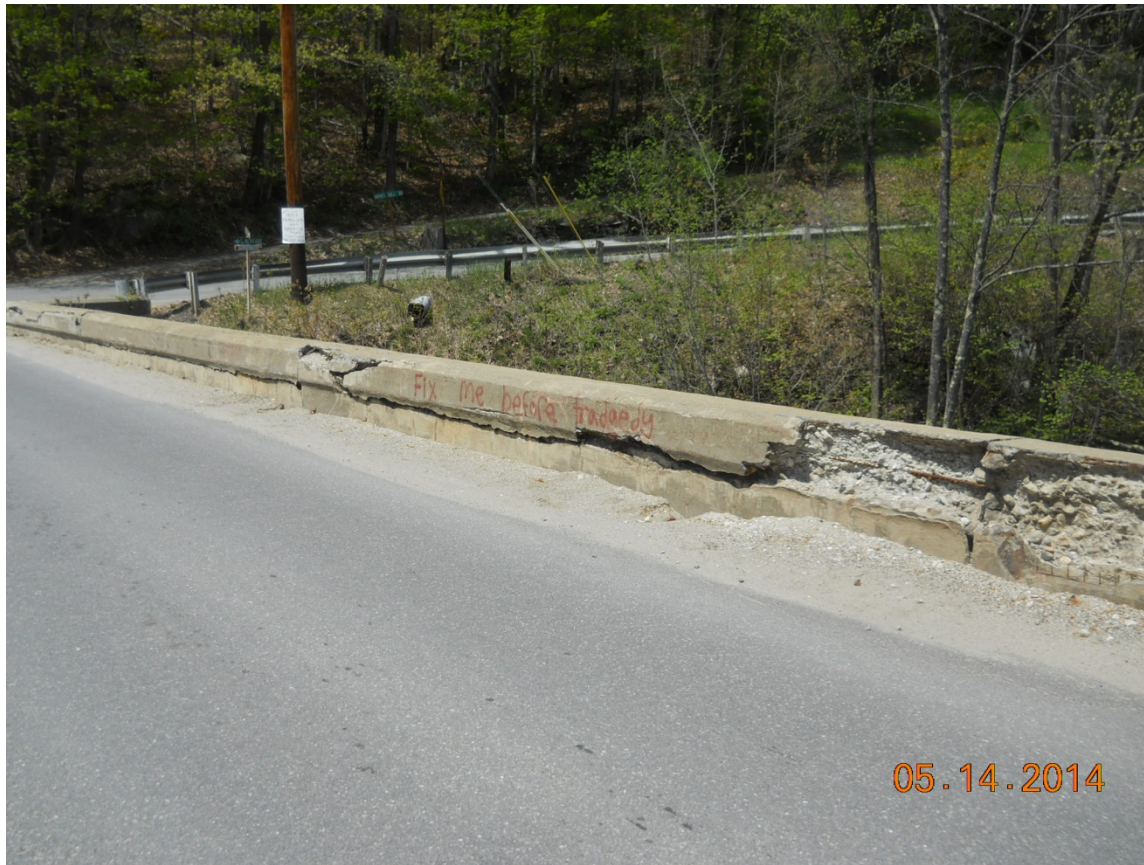
Failing Bridge Railing. Note exposed Rebar.

1. The original arch is in poor condition. The spandrel walls have failed and falling concrete from the delaminated walls poses a risk to swimmers below. There is map cracking throughout the arch ring, which is leaking. The foundation has map cracking and efflorescence throughout with major delaminations.
2. The existing vertical alignment through the project location does not meet the current standard.
3. The lane and shoulder widths of the bridge and approaches are too narrow for the traffic volume, design speed and roadway classification.
4. The existing bridge railing has failed.

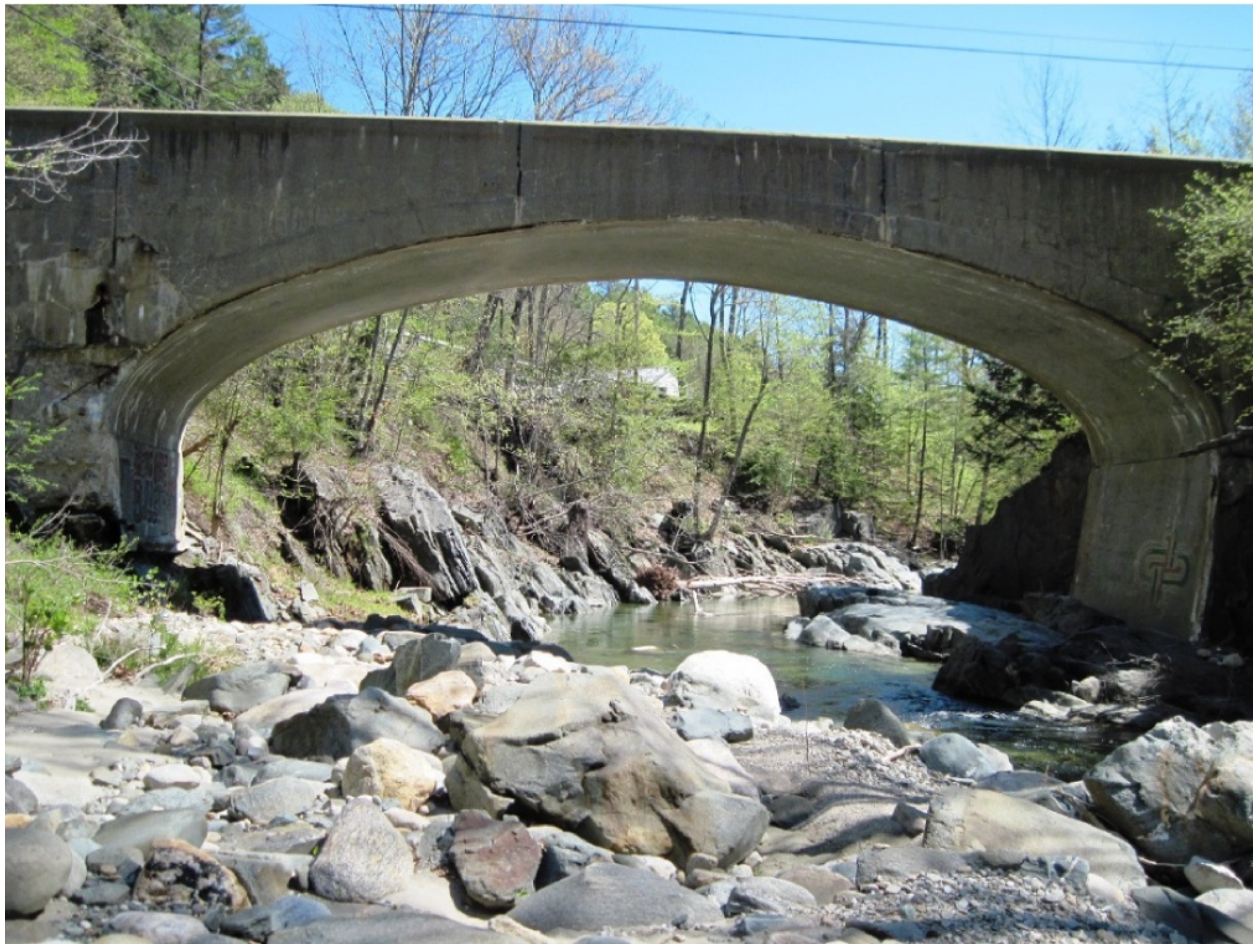
Figure 1 Photograph of Bridge 12. Photograph was taken during 2013 bridge inspection.

The bridge is a concrete arch type whose abutments rest directly on bedrock. The river channel at this location is floored by bedrock with recent alluvium deposits ranging from sand to boulder in size.

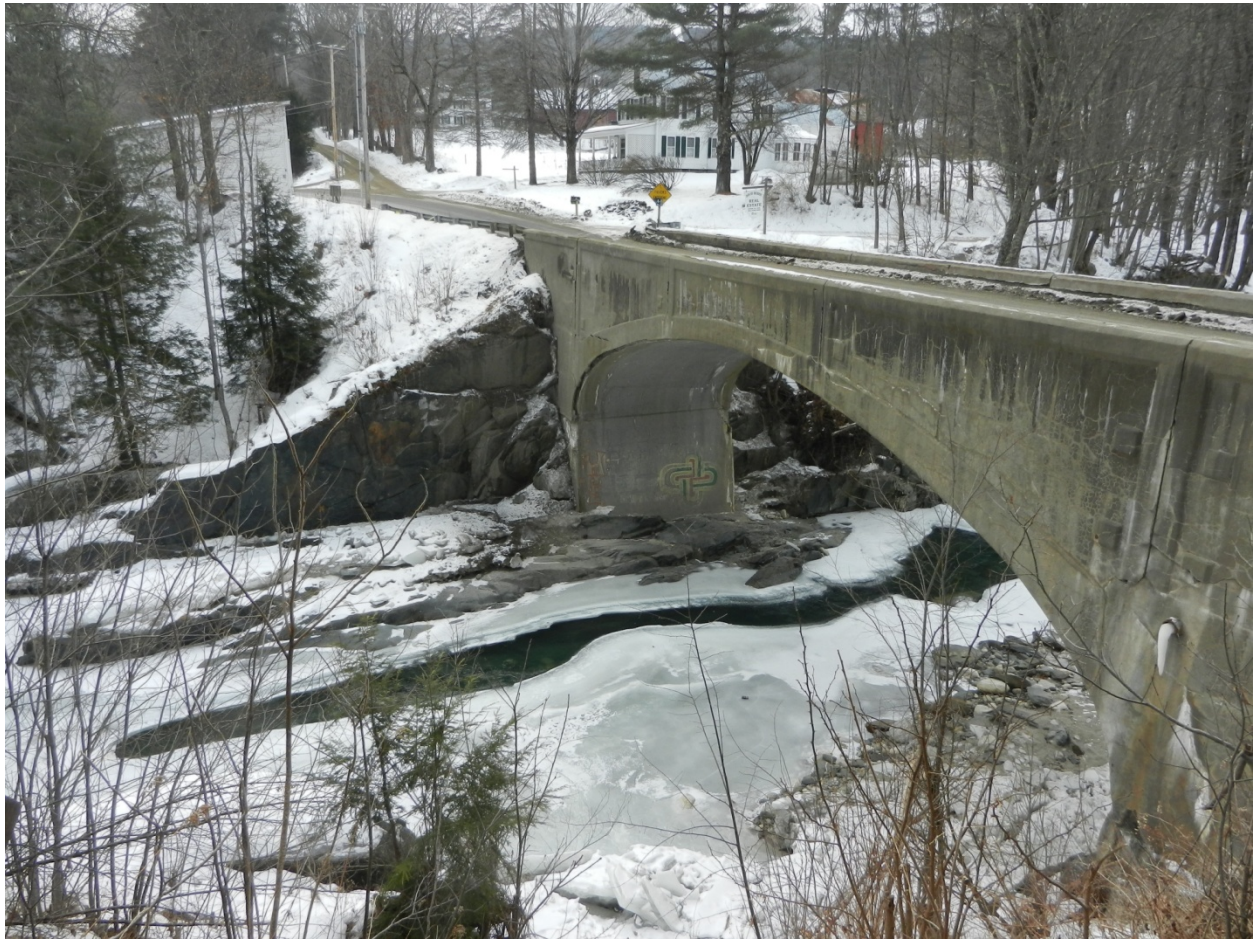
Figure 3 Bedrock exposed at southeastern abutment. Photograph was taken during site visit on January 31, 2013.

During our site visit performed on January 31, 2014, we observed that bedrock is exposed along in the river channel and both sides of riverbanks and it appears that both abutments are founded on bedrock (see Figure 3). Toppling failures of slabs of rock were noted adjacent to the southeastern abutment although these loose slabs do not appear to be adversely affecting the stability of the existing abutment.
