# North Hero BF 028-1(30)

## Public Meeting

US Route 2– Bridge #5 over Alburgh Passage

May 3<sup>rd</sup>, 2017

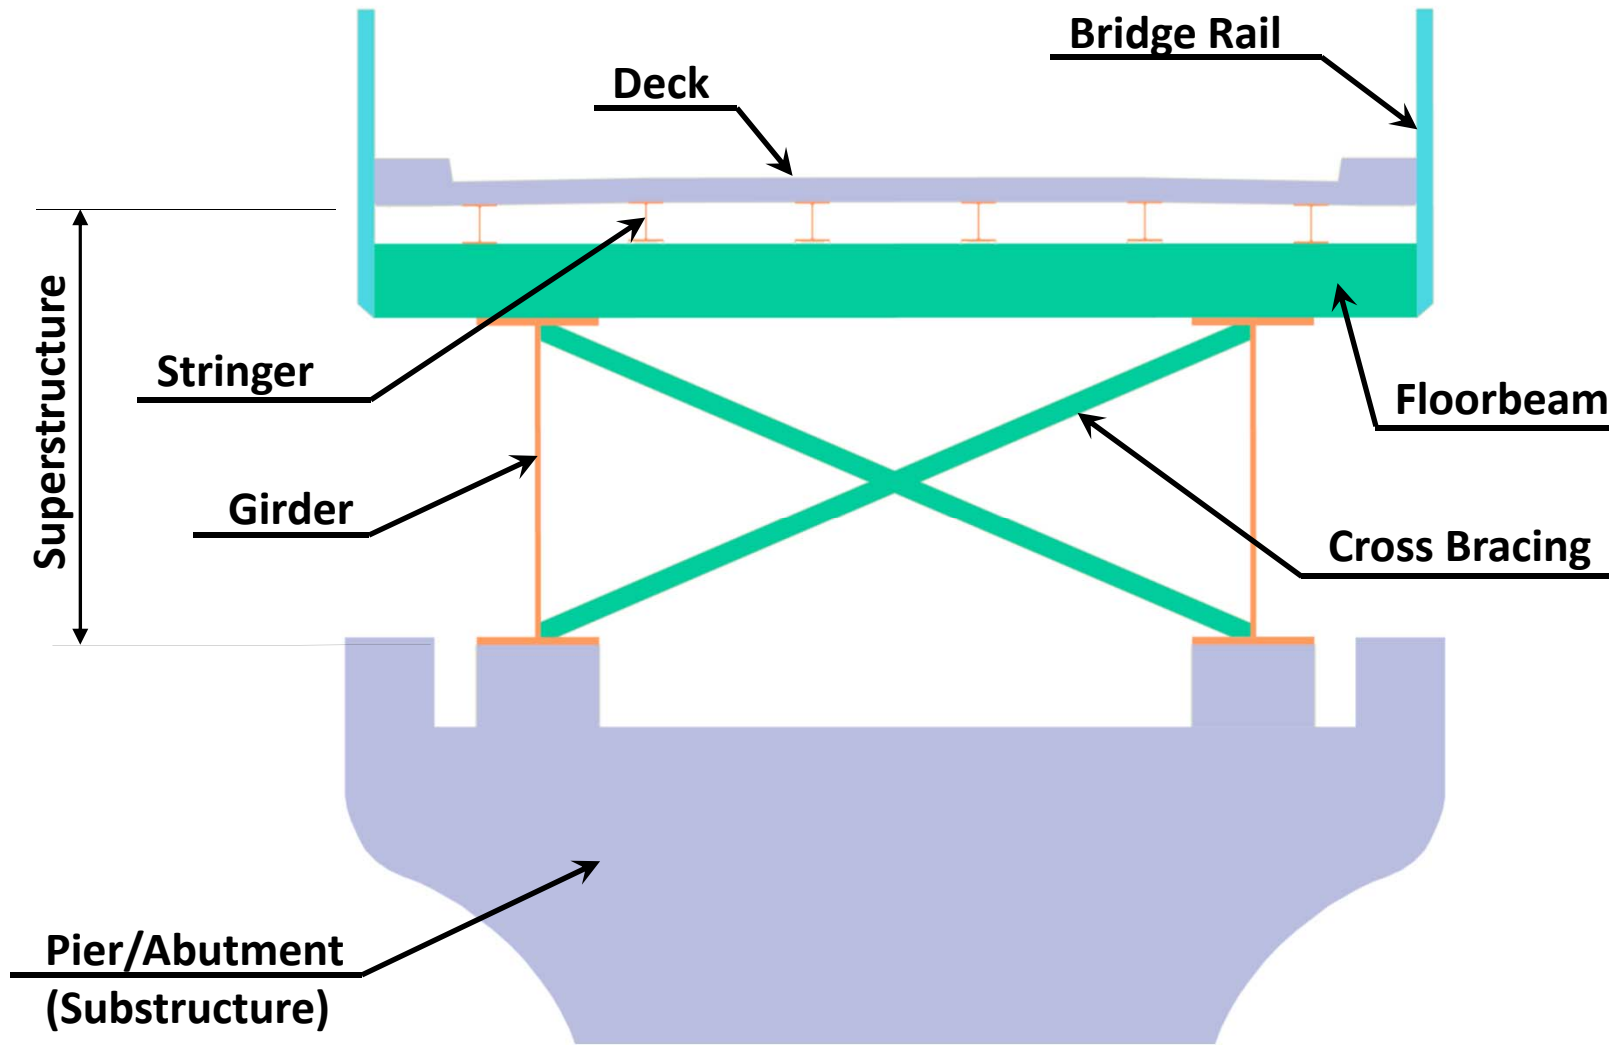
# Description of Terms Used

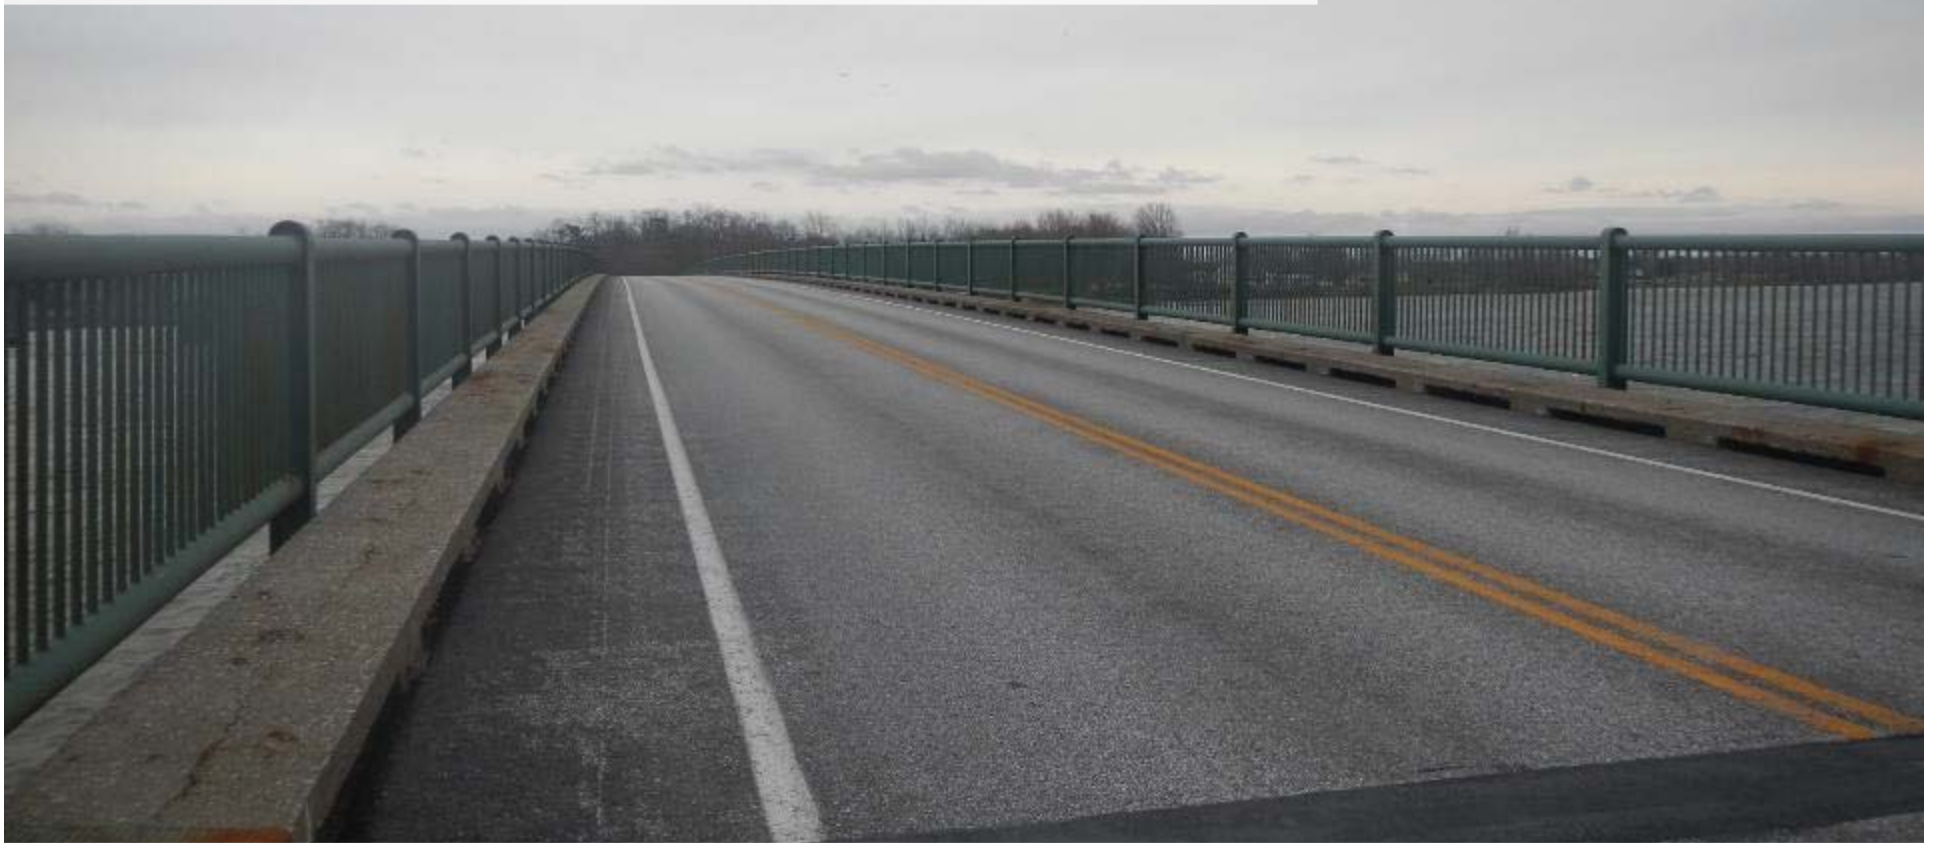
- Deck Rating 4 (Poor)
- Superstructure Rating 5 (Fair)
- Substructure Rating 6 (Satisfactory)
- Channel Rating 8 (Very Good)

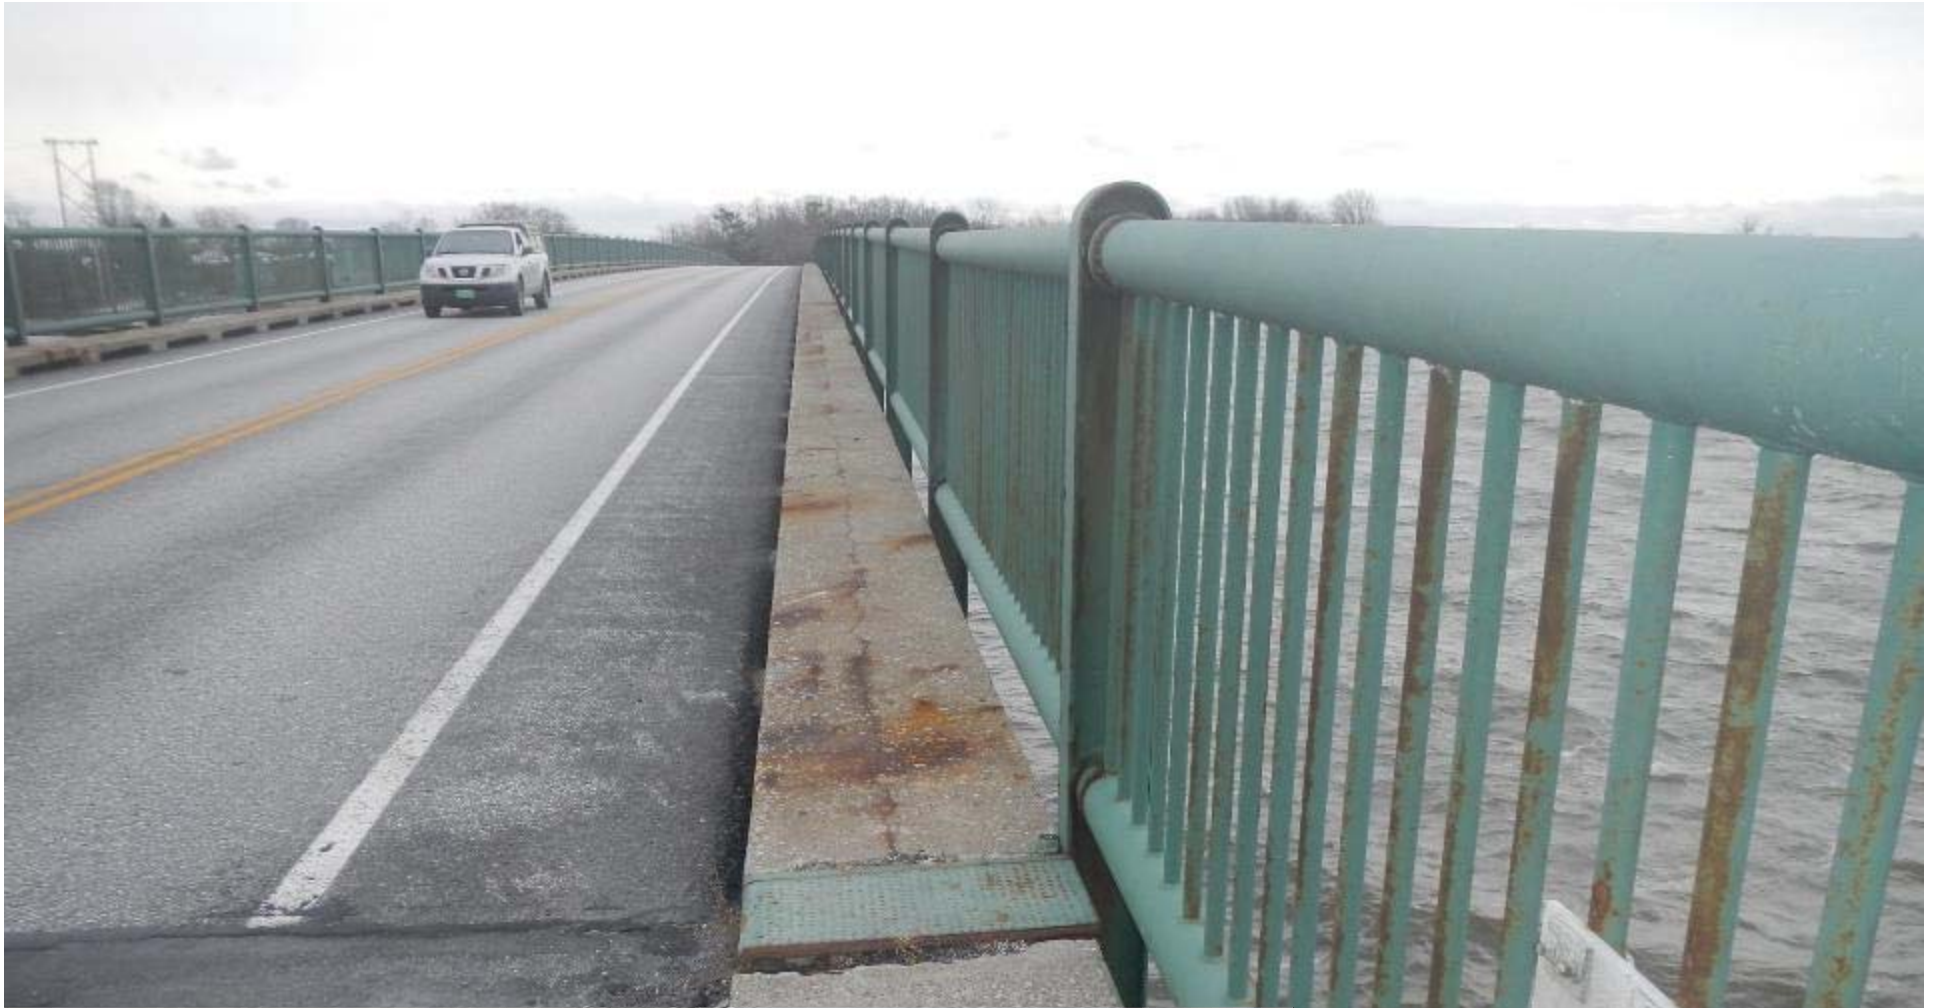
Typical Top of Deck Condition

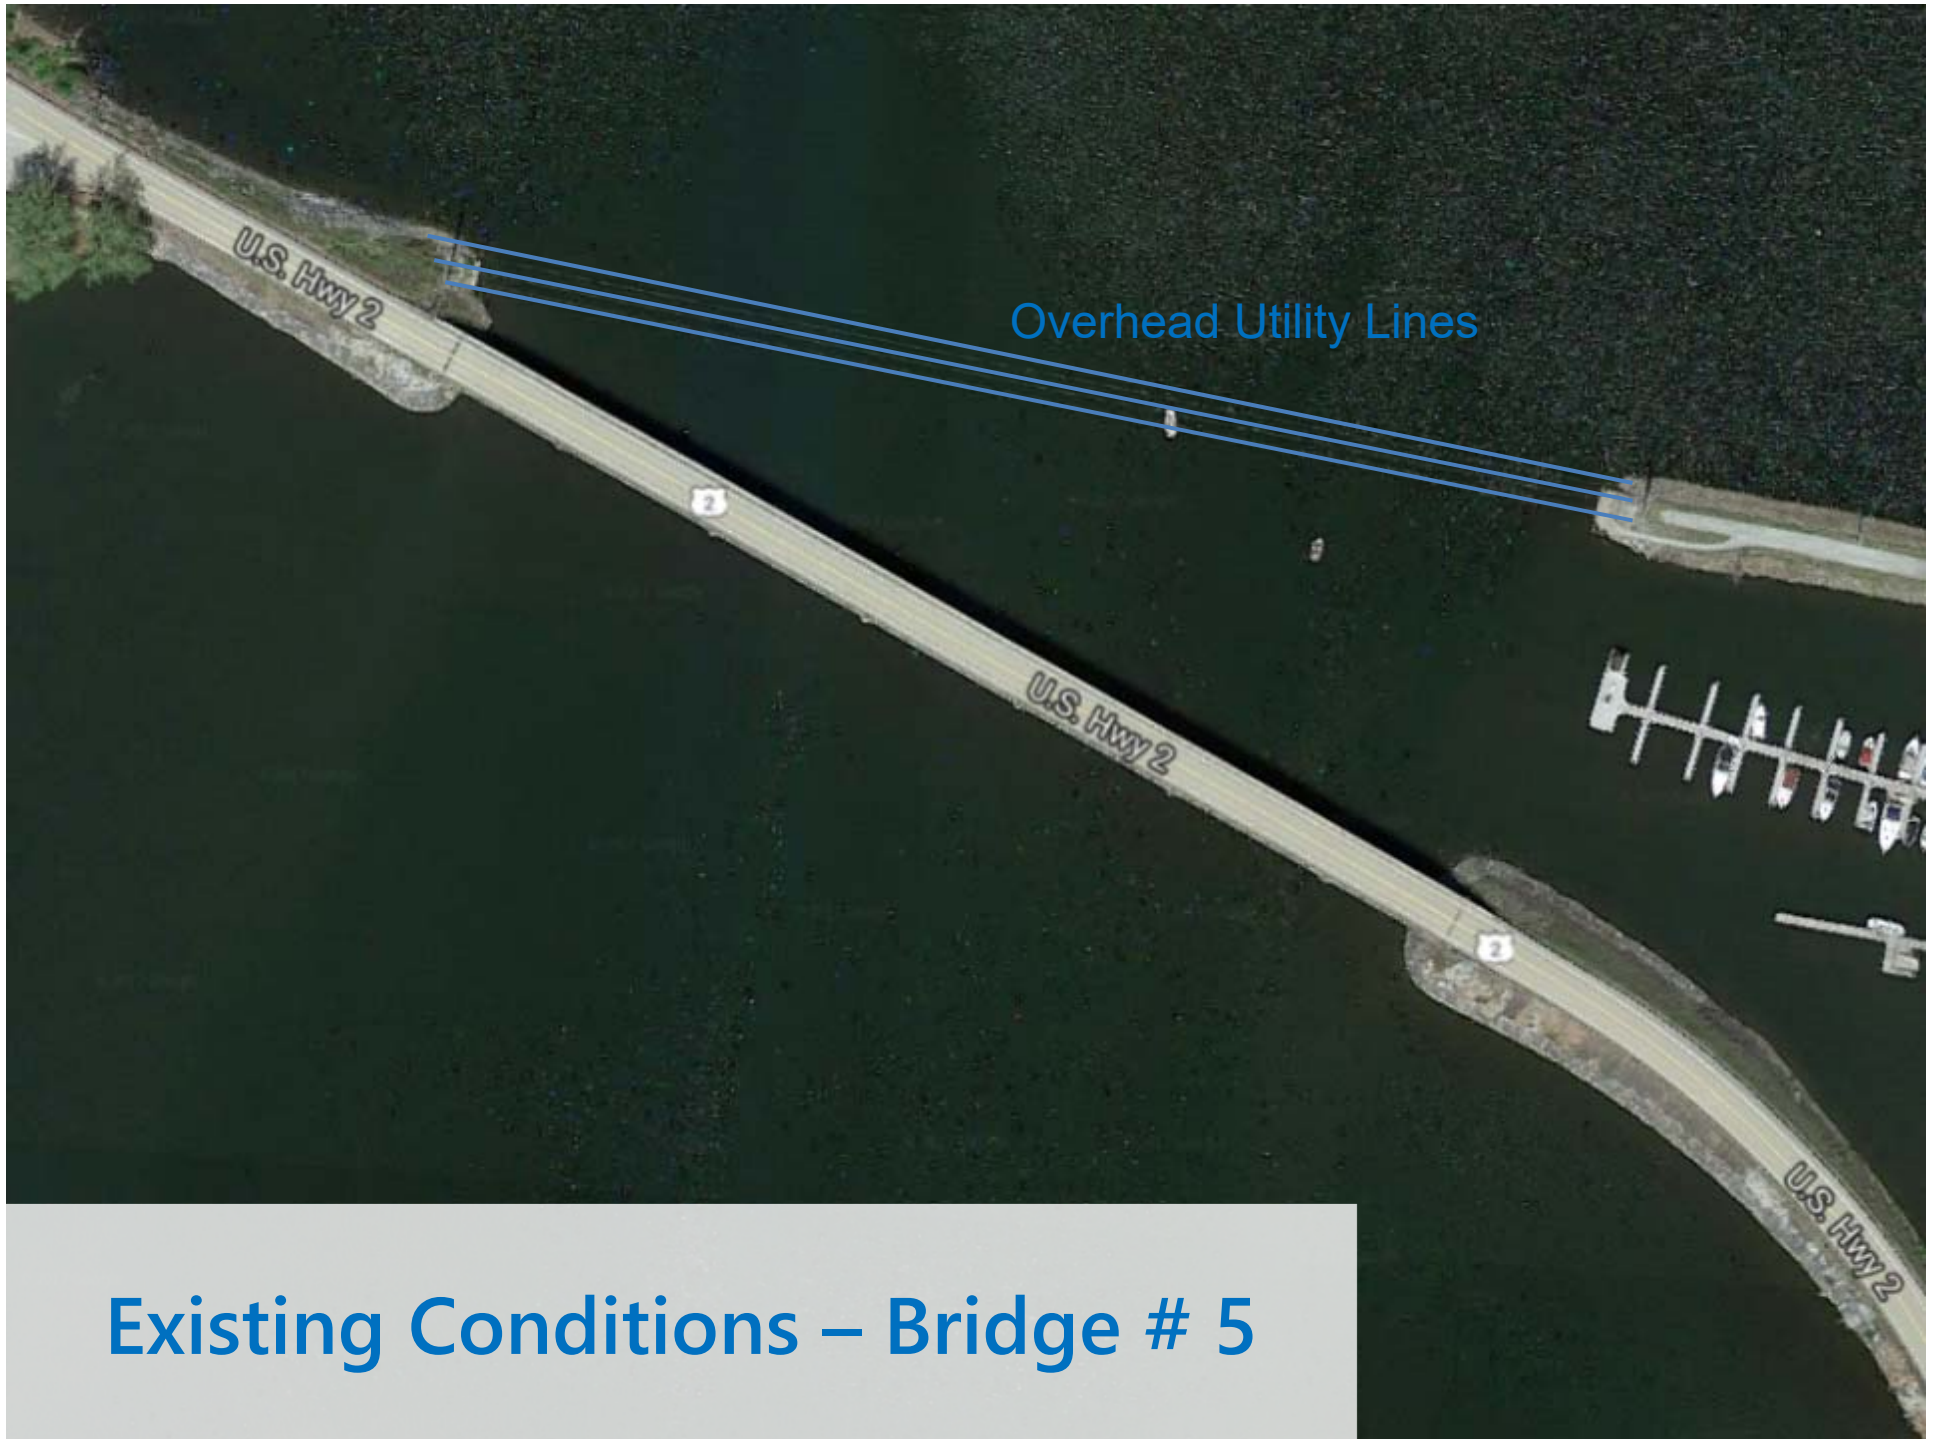
- Bridge Railing
  - Historic
  - Not crash tested

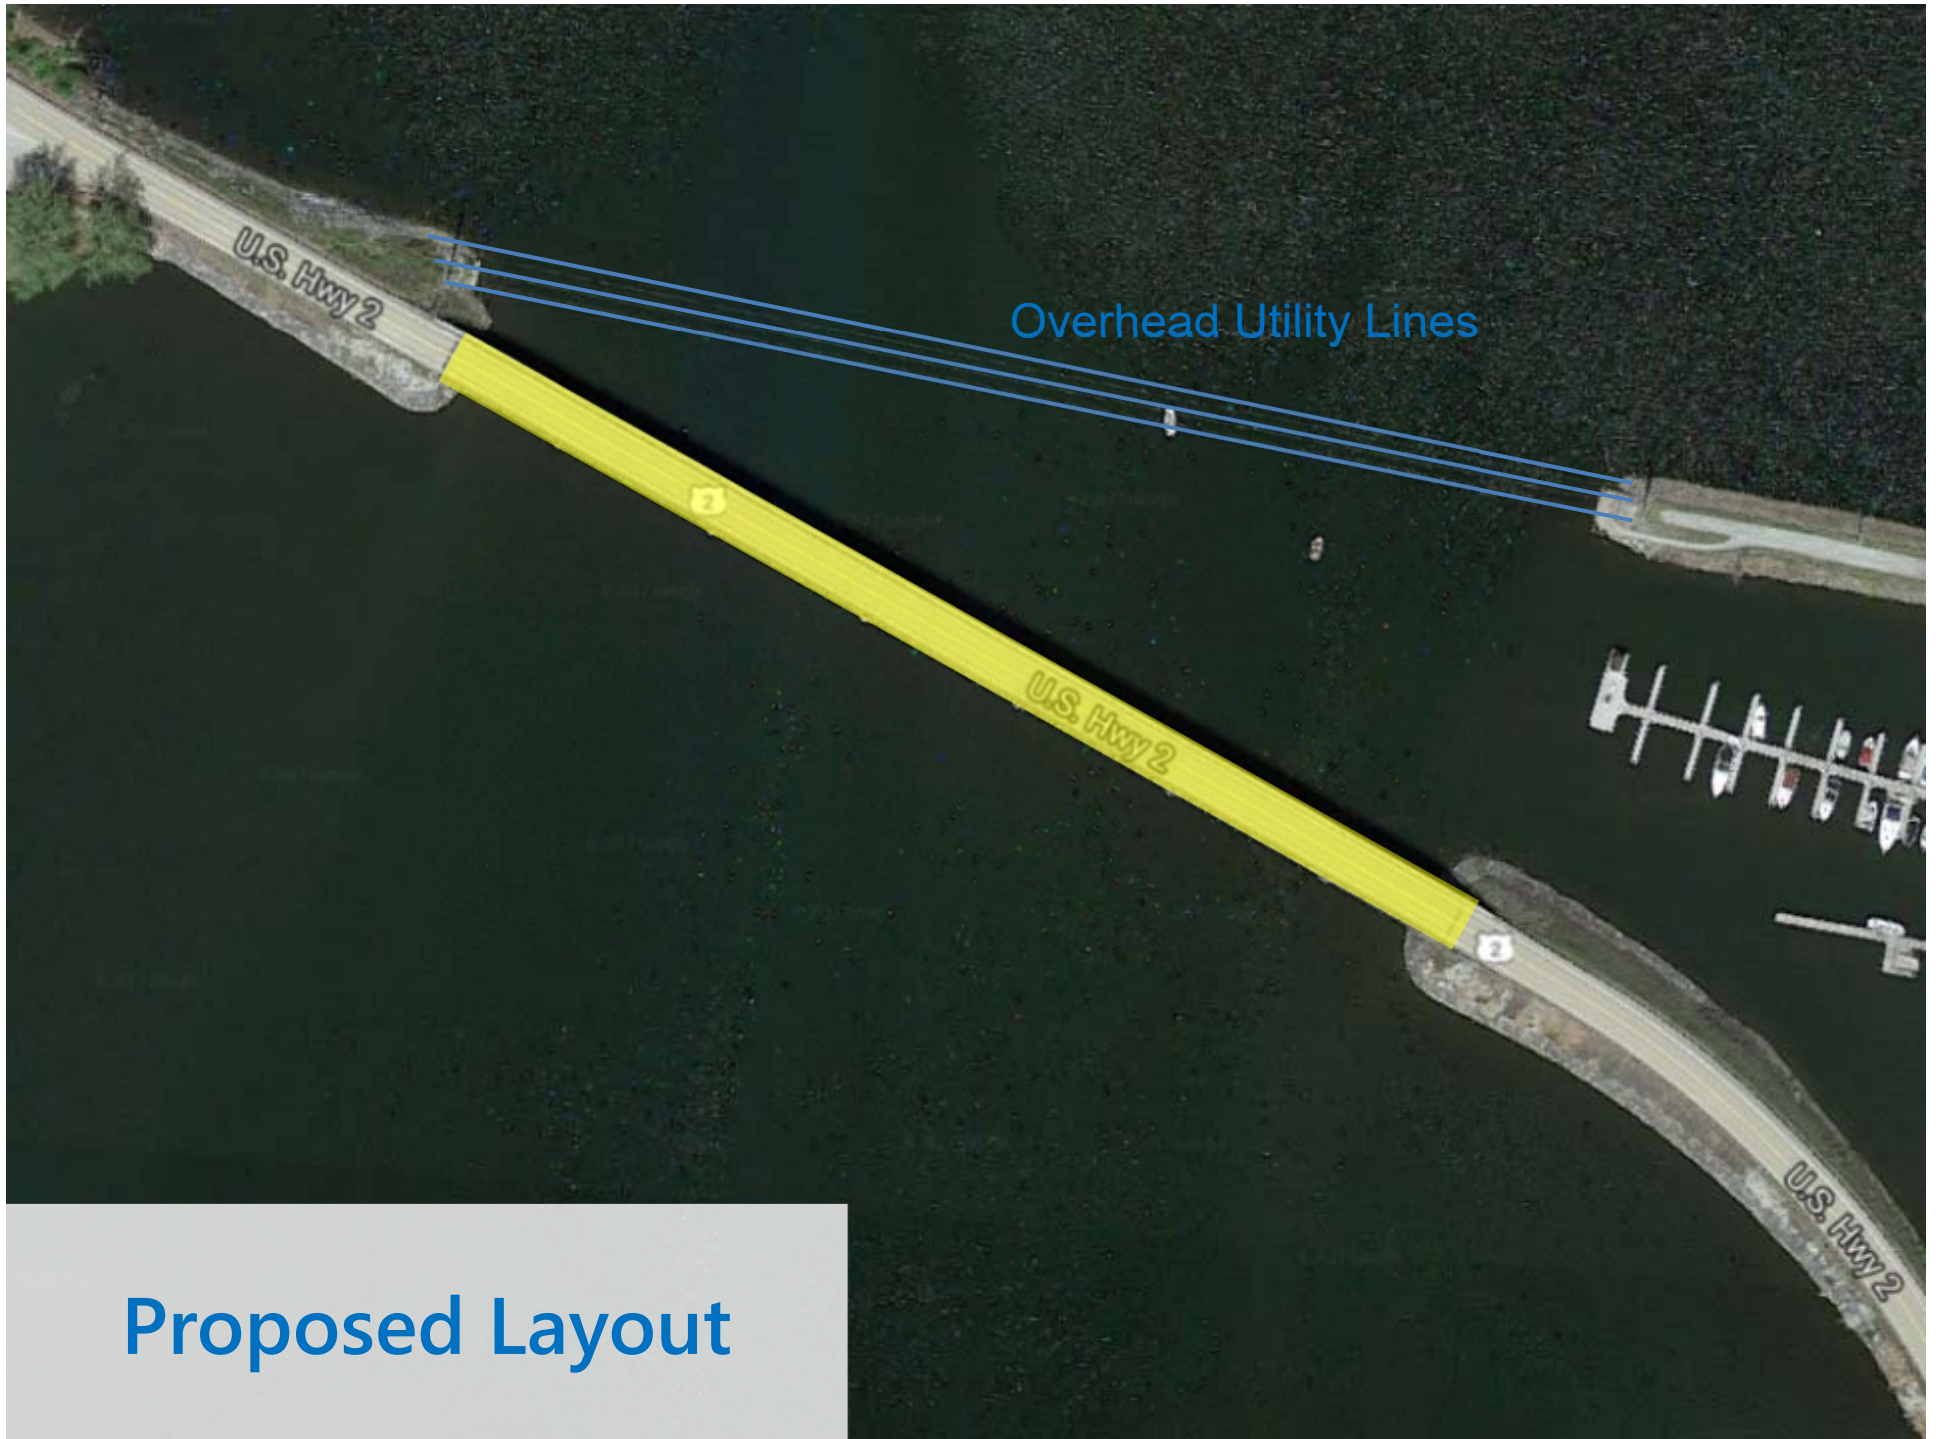
Proposed Layout

- Superstructure Replacement
  - Eliminate Fair fracture critical superstructure
  - Widen roadway to provide safe bicycle and pedestrian use
  - Provide crash tested railing
  - No Utility relocation expected
  - Minimizes ROW, environmental and archeological impacts
  - Minimizes work below the waterline

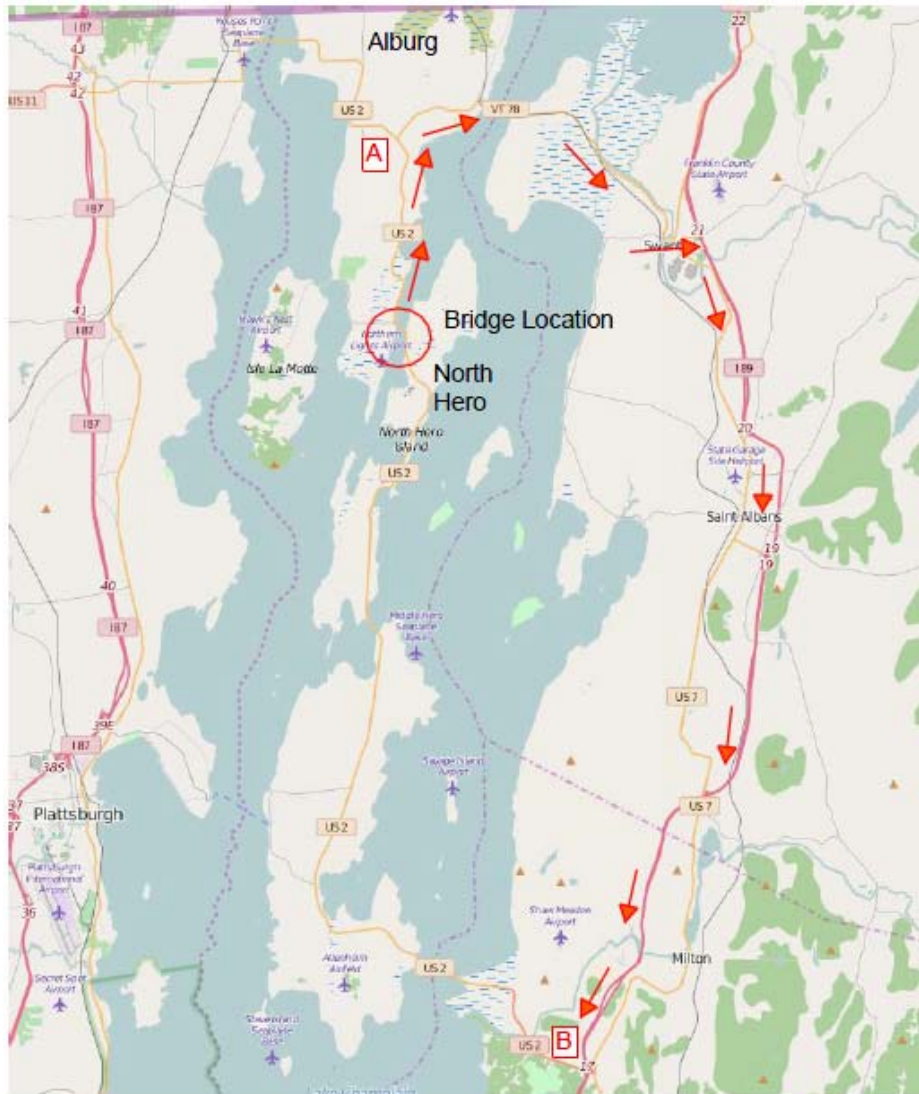
## Detour Route

US Route 2, to VT Route 78, to I-89,  
back to US Route 2

A-B Through Route: 32.6 miles

A-B Detour Route: 36.5 miles

Added Distance: 3.9 miles

End to End Distance: 69.1 miles

- Off-Site Detour with Bridge Closure
  - Detour route: 69.1 miles end to end
  - Significant impacts on local traffic

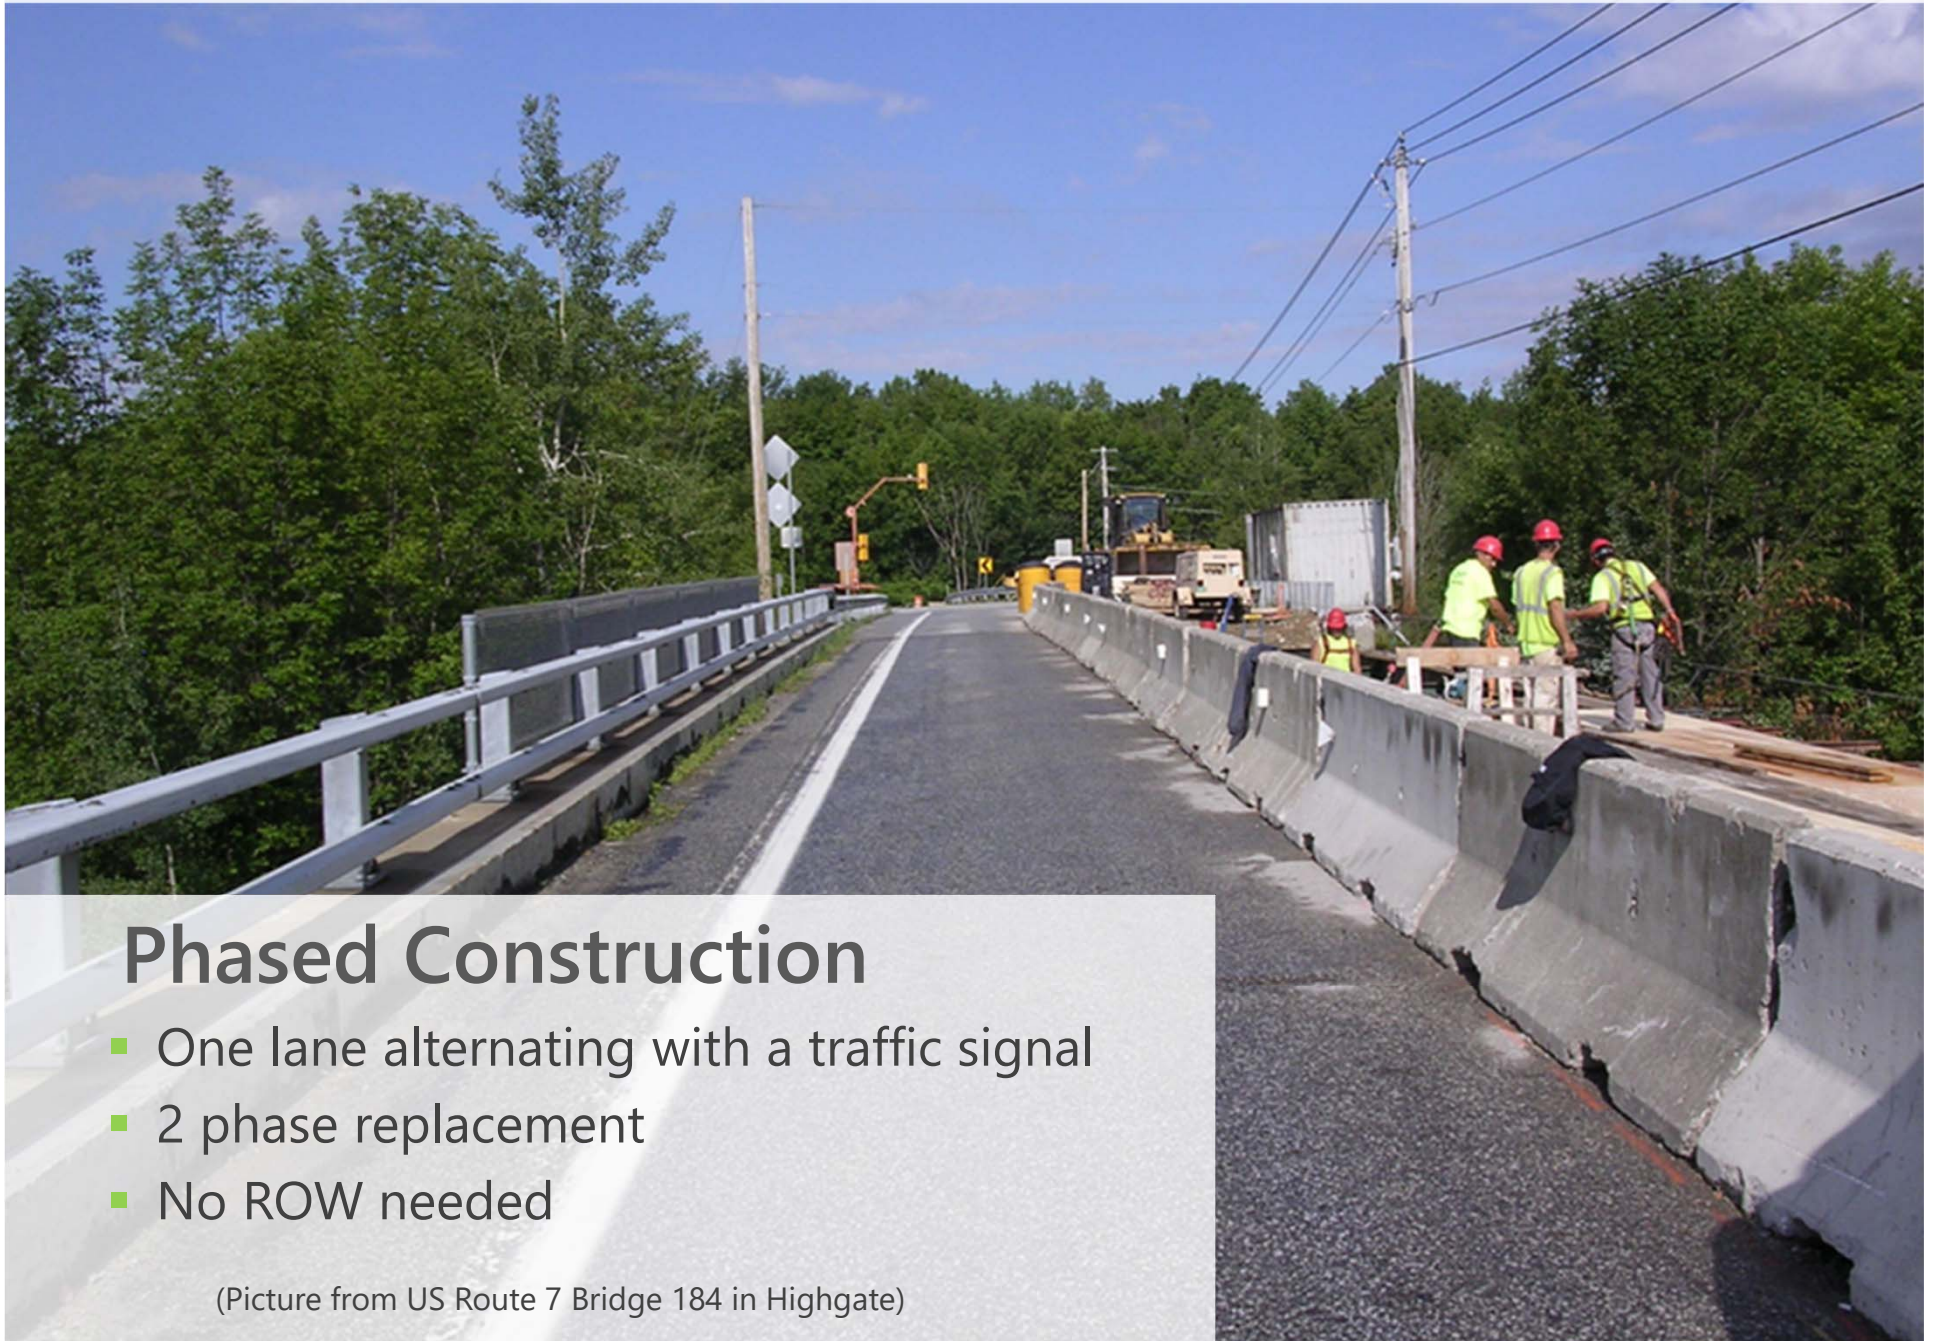
## Phased Construction

- One lane alternating with a traffic signal
- 2 phase replacement
- No ROW needed

(Picture from US Route 7 Bridge 184 in Highgate)
