**STATE OF VERMONT
AGENCY OF TRANSPORTATION**

Scoping Report

**Putney STP DECK(38)
US Route 5, BRIDGE 15 OVER SACKETTS BROOK**

February 1, 2016

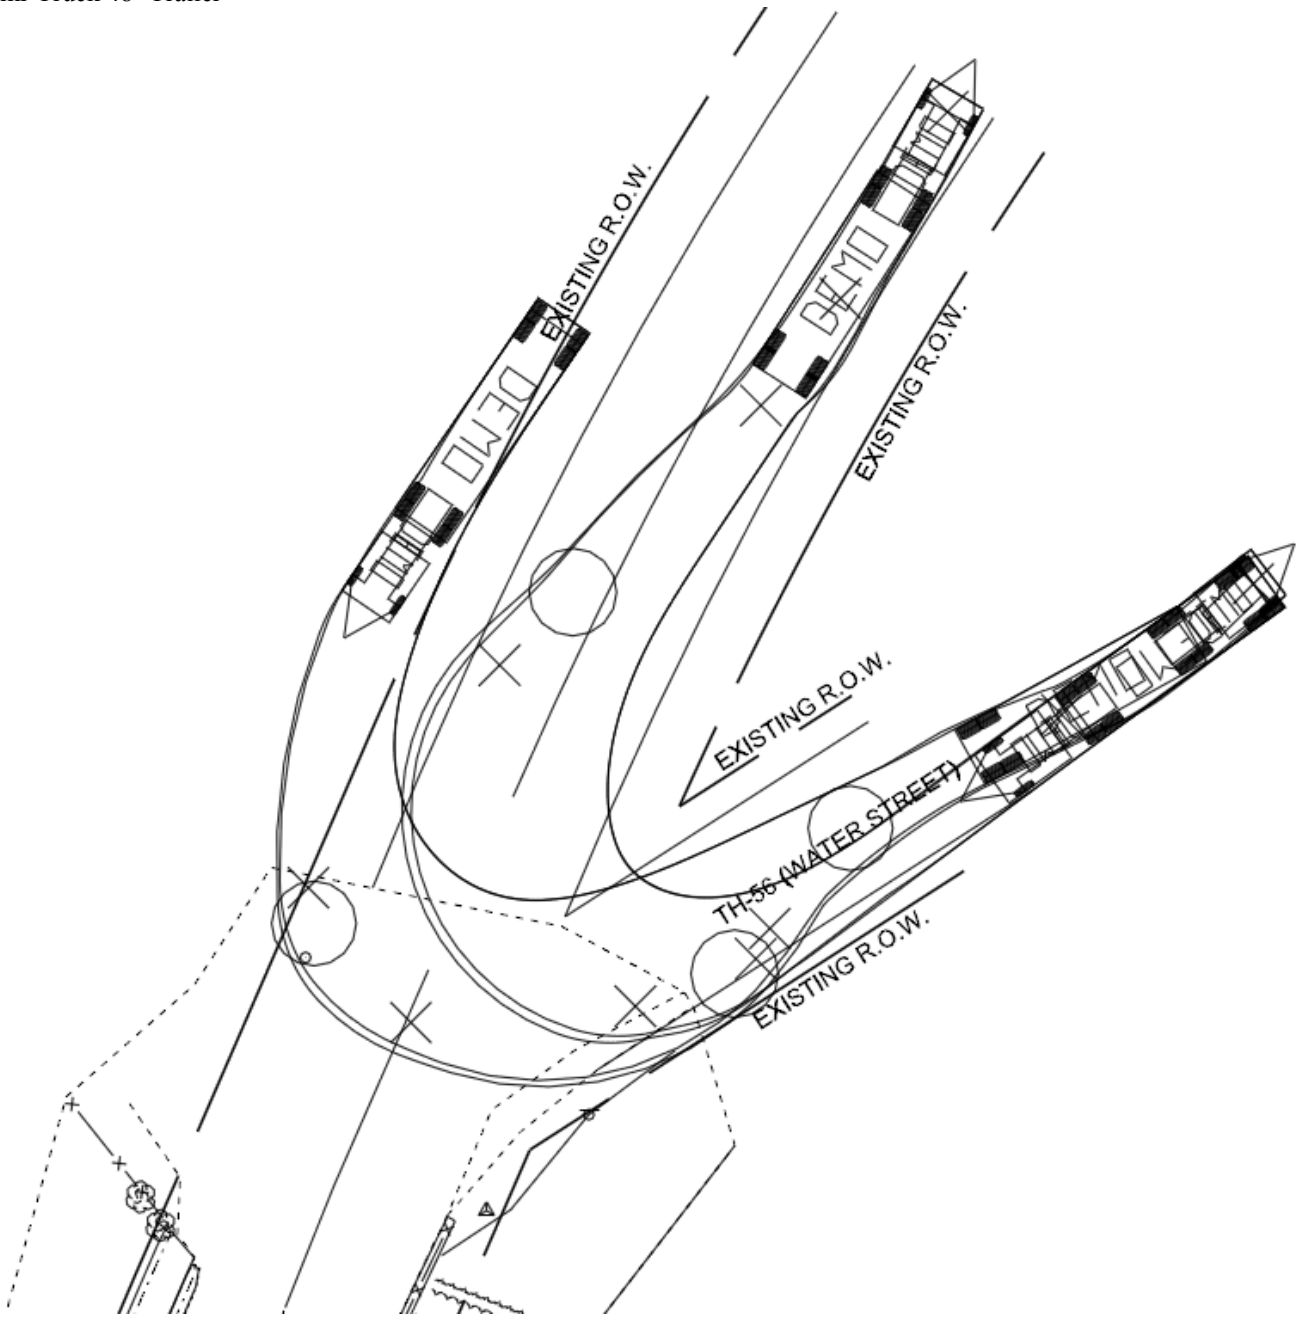
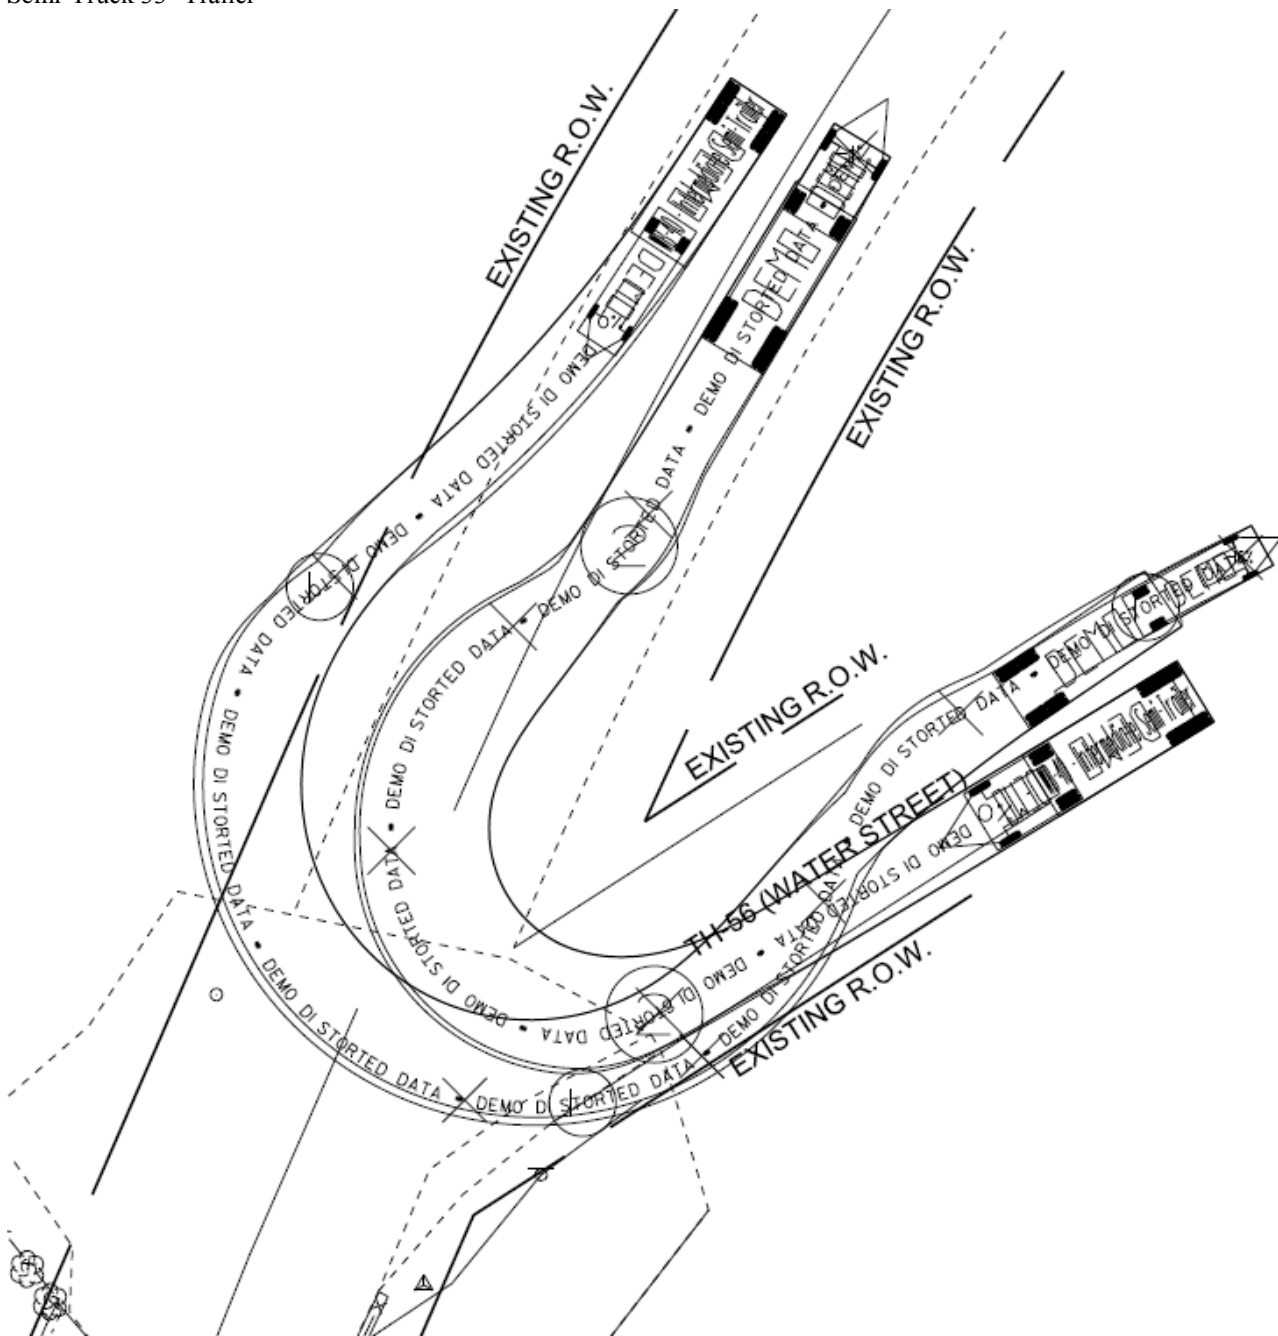
Turning Diagrams

One concern with the Off-Site Detour option is truck access for Water Street. The Vermont Agency of Transportation is aware that the company Soundview Vermont Holdings receives frequent deliveries from Semi Trucks towing 48 foot trailers. In order to determine if trucks could make the turn into Water St from the North (driving south) a model was created using Auto Track. From the analysis it was determined that it is possible to make the turn utilizing the commercial drive across from Water Street. However, several assumptions were made when running this analysis, the first was assuming no driver error, the second was assuming some small site modifications can be made, and the third was assuming the contractor or other private entities

would not be in conflict during the turning movement. A diagram showing the model results can be seen in the attachments. If Soundview can utilize shorter trailers during the closure or suspend delivers this option is very feasible.

Semi-Truck 48' Trailer
