Chester BF 025-1(45)

Regional Concerns Meeting

**Vermont Route 103 – Bridge #14 over Williams River & The Green
Mountain Railroad**

August 29, 2019

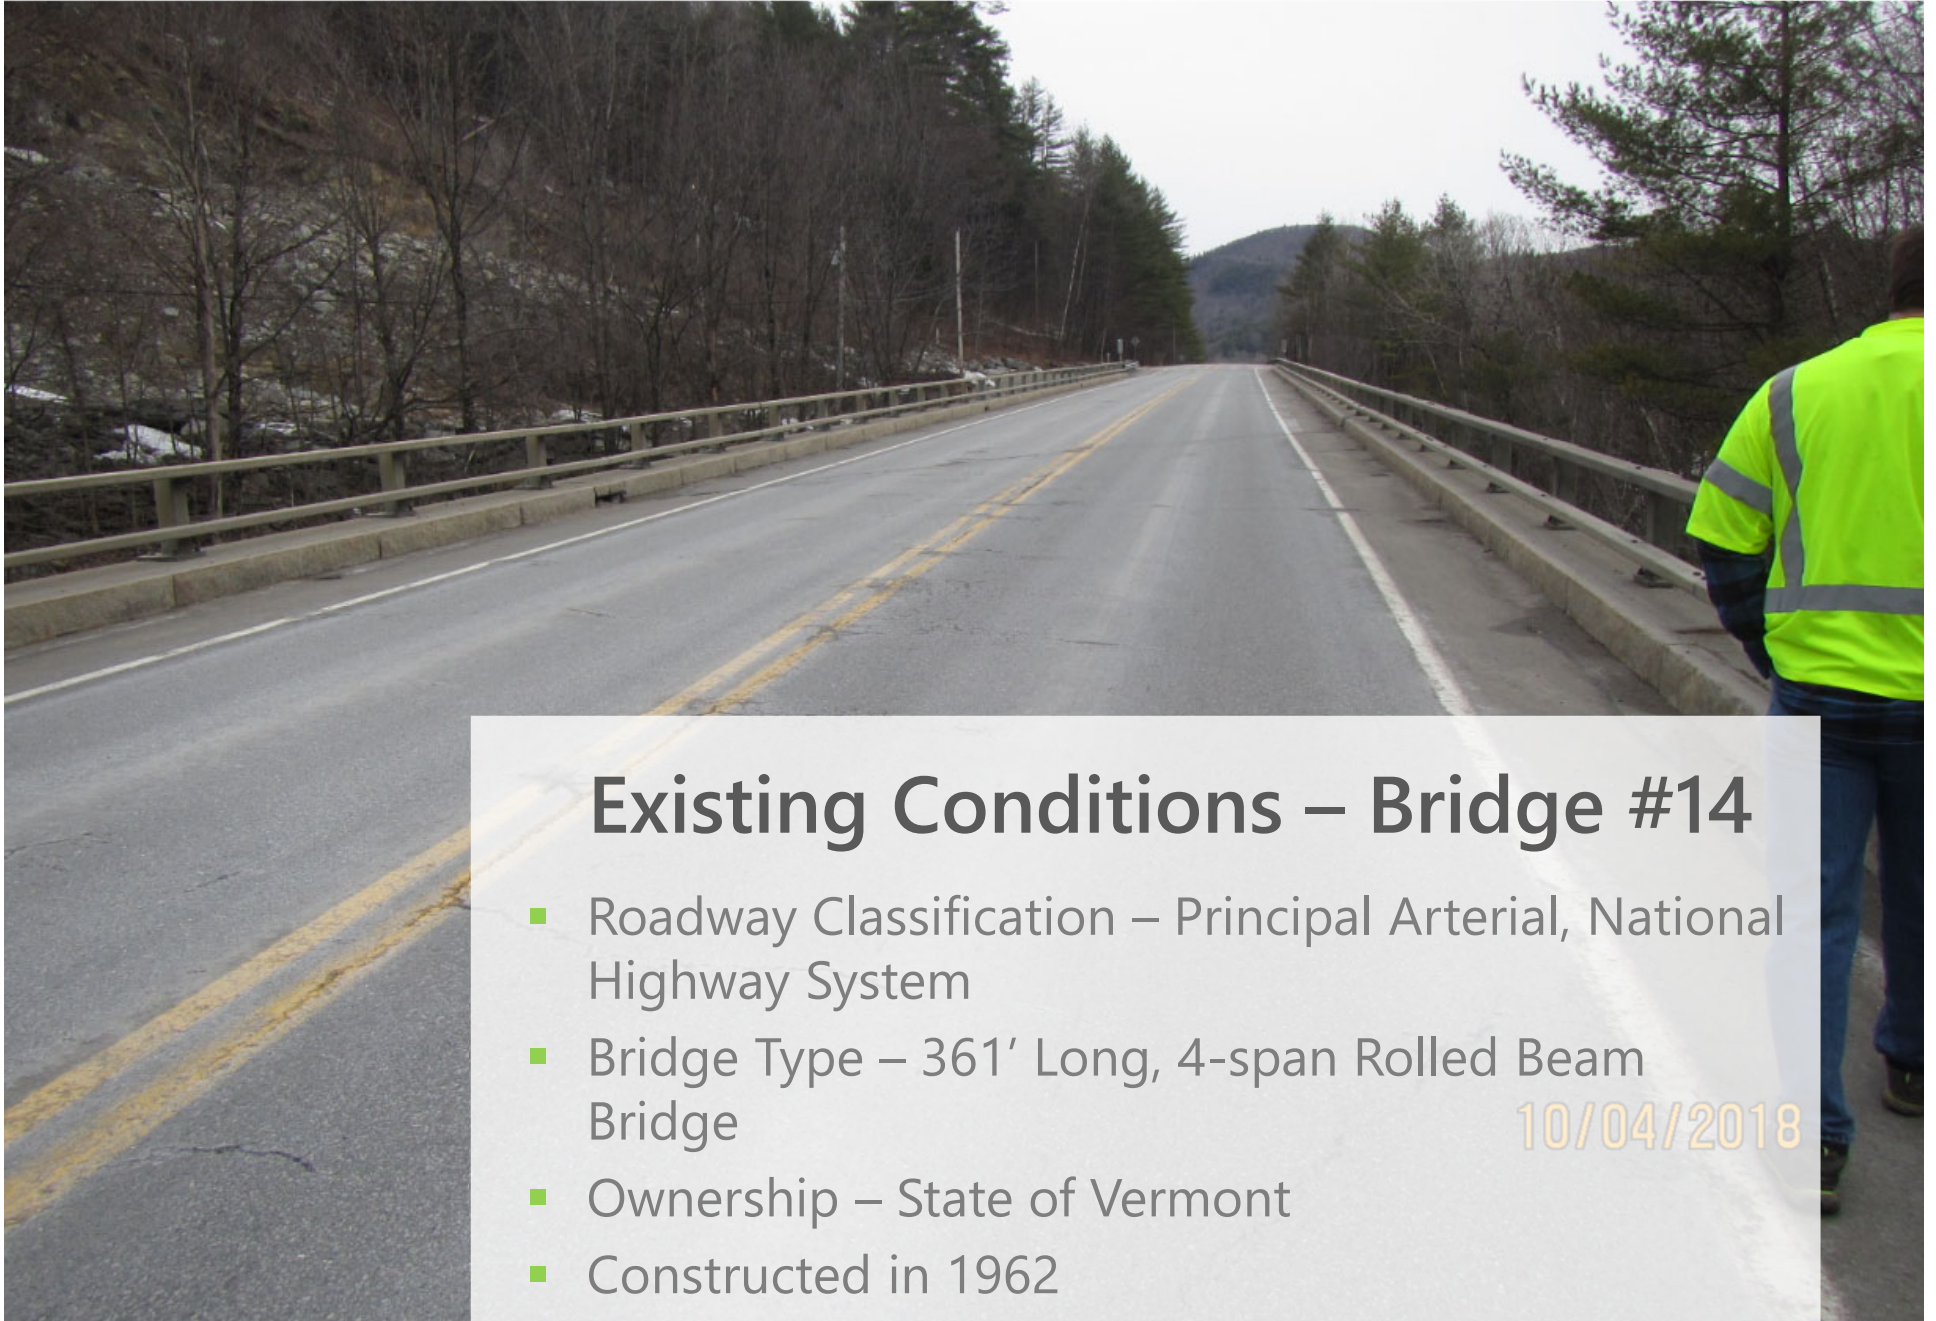
Looking North over Bridge 14

- Roadway Classification – Principal Arterial, National Highway System
- Bridge Type – 361' Long, 4-span Rolled Beam Bridge
- Ownership – State of Vermont
- Constructed in 1962

- The bridge is “structurally deficient”
 - Advanced deterioration of the deck
 - Joint failure with leakage
 - The beam ends have heavy rusting and corrosion due to years of leakage
 - The abutments have minor cracking
 - The pier caps/seats have heavy deterioration with cracking and delaminated concrete with many pop outs exposing corroded rebar
- The bridge has a substandard width (3'-12'-12'-3').
 - Standard is 10'-12'-12'-10'

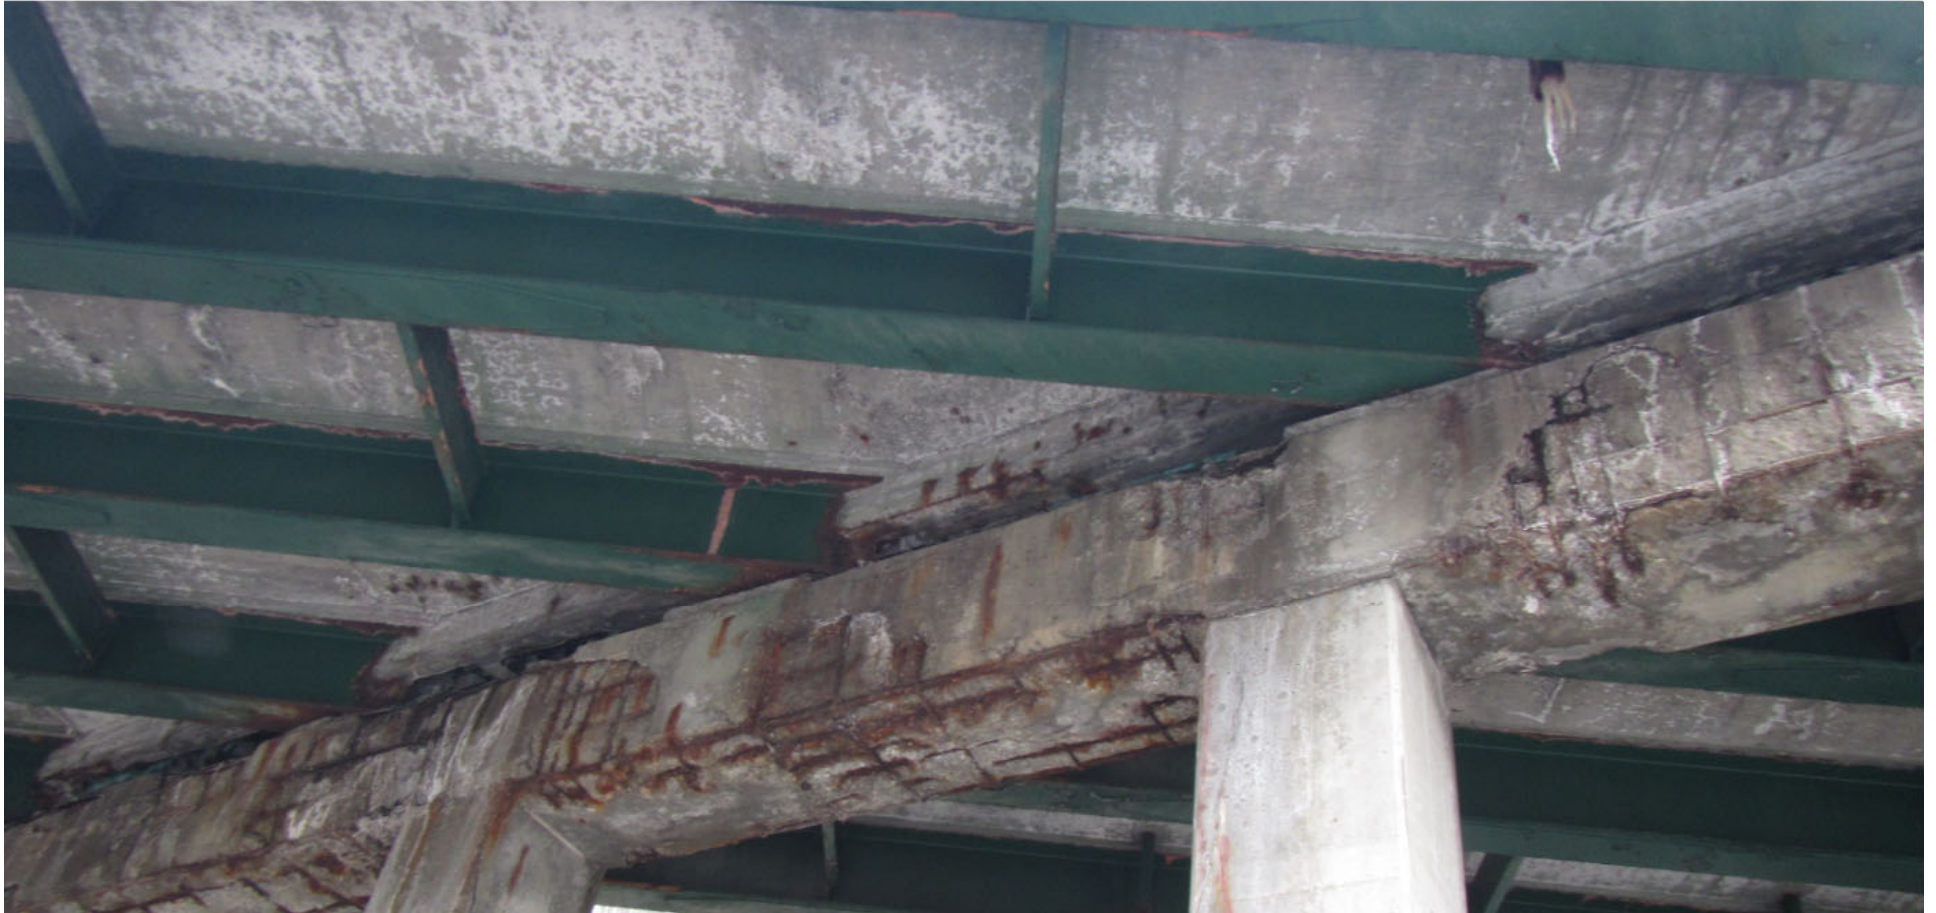
Condition Ratings

- Deck Rating 4 (Poor)
- Superstructure Rating 6 (Satisfactory)
- Substructure Rating 5 (Fair)

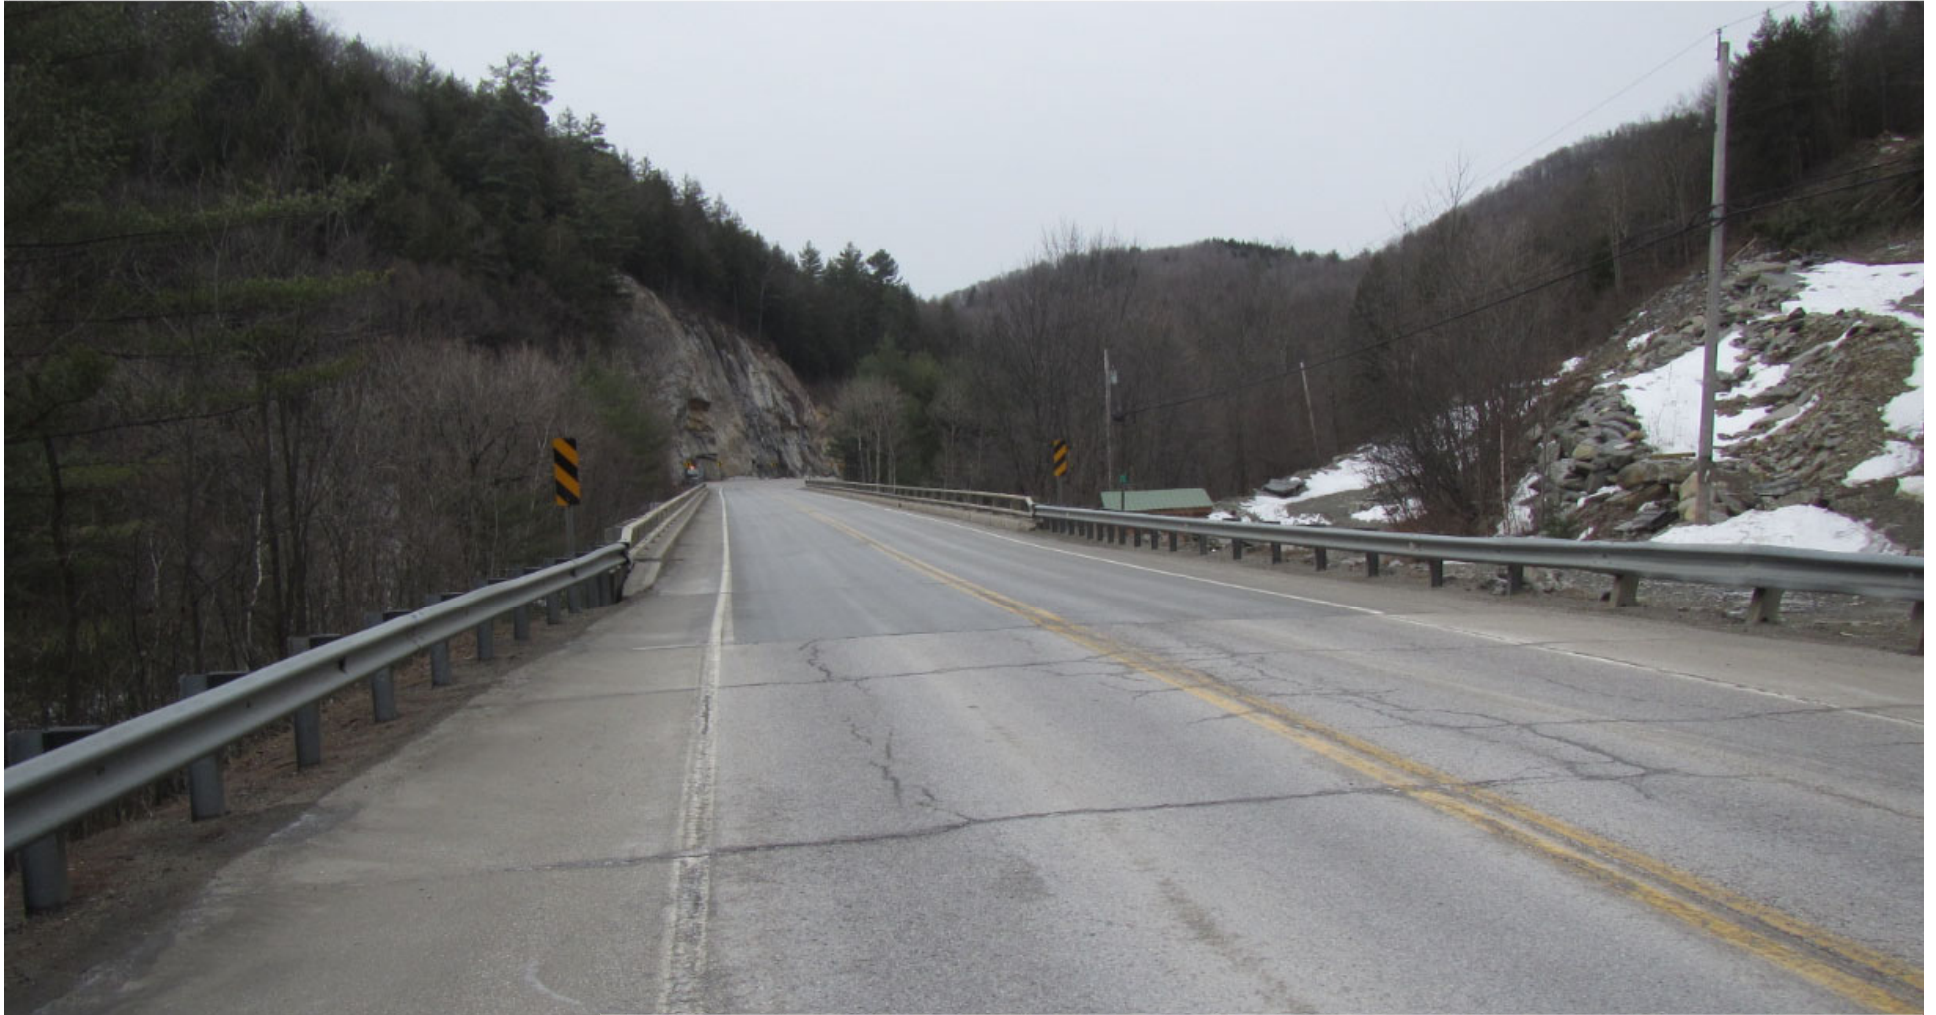
Looking South over Bridge 14

- Horizontal curve south of bridge
- Bedrock outcrop south of bridge

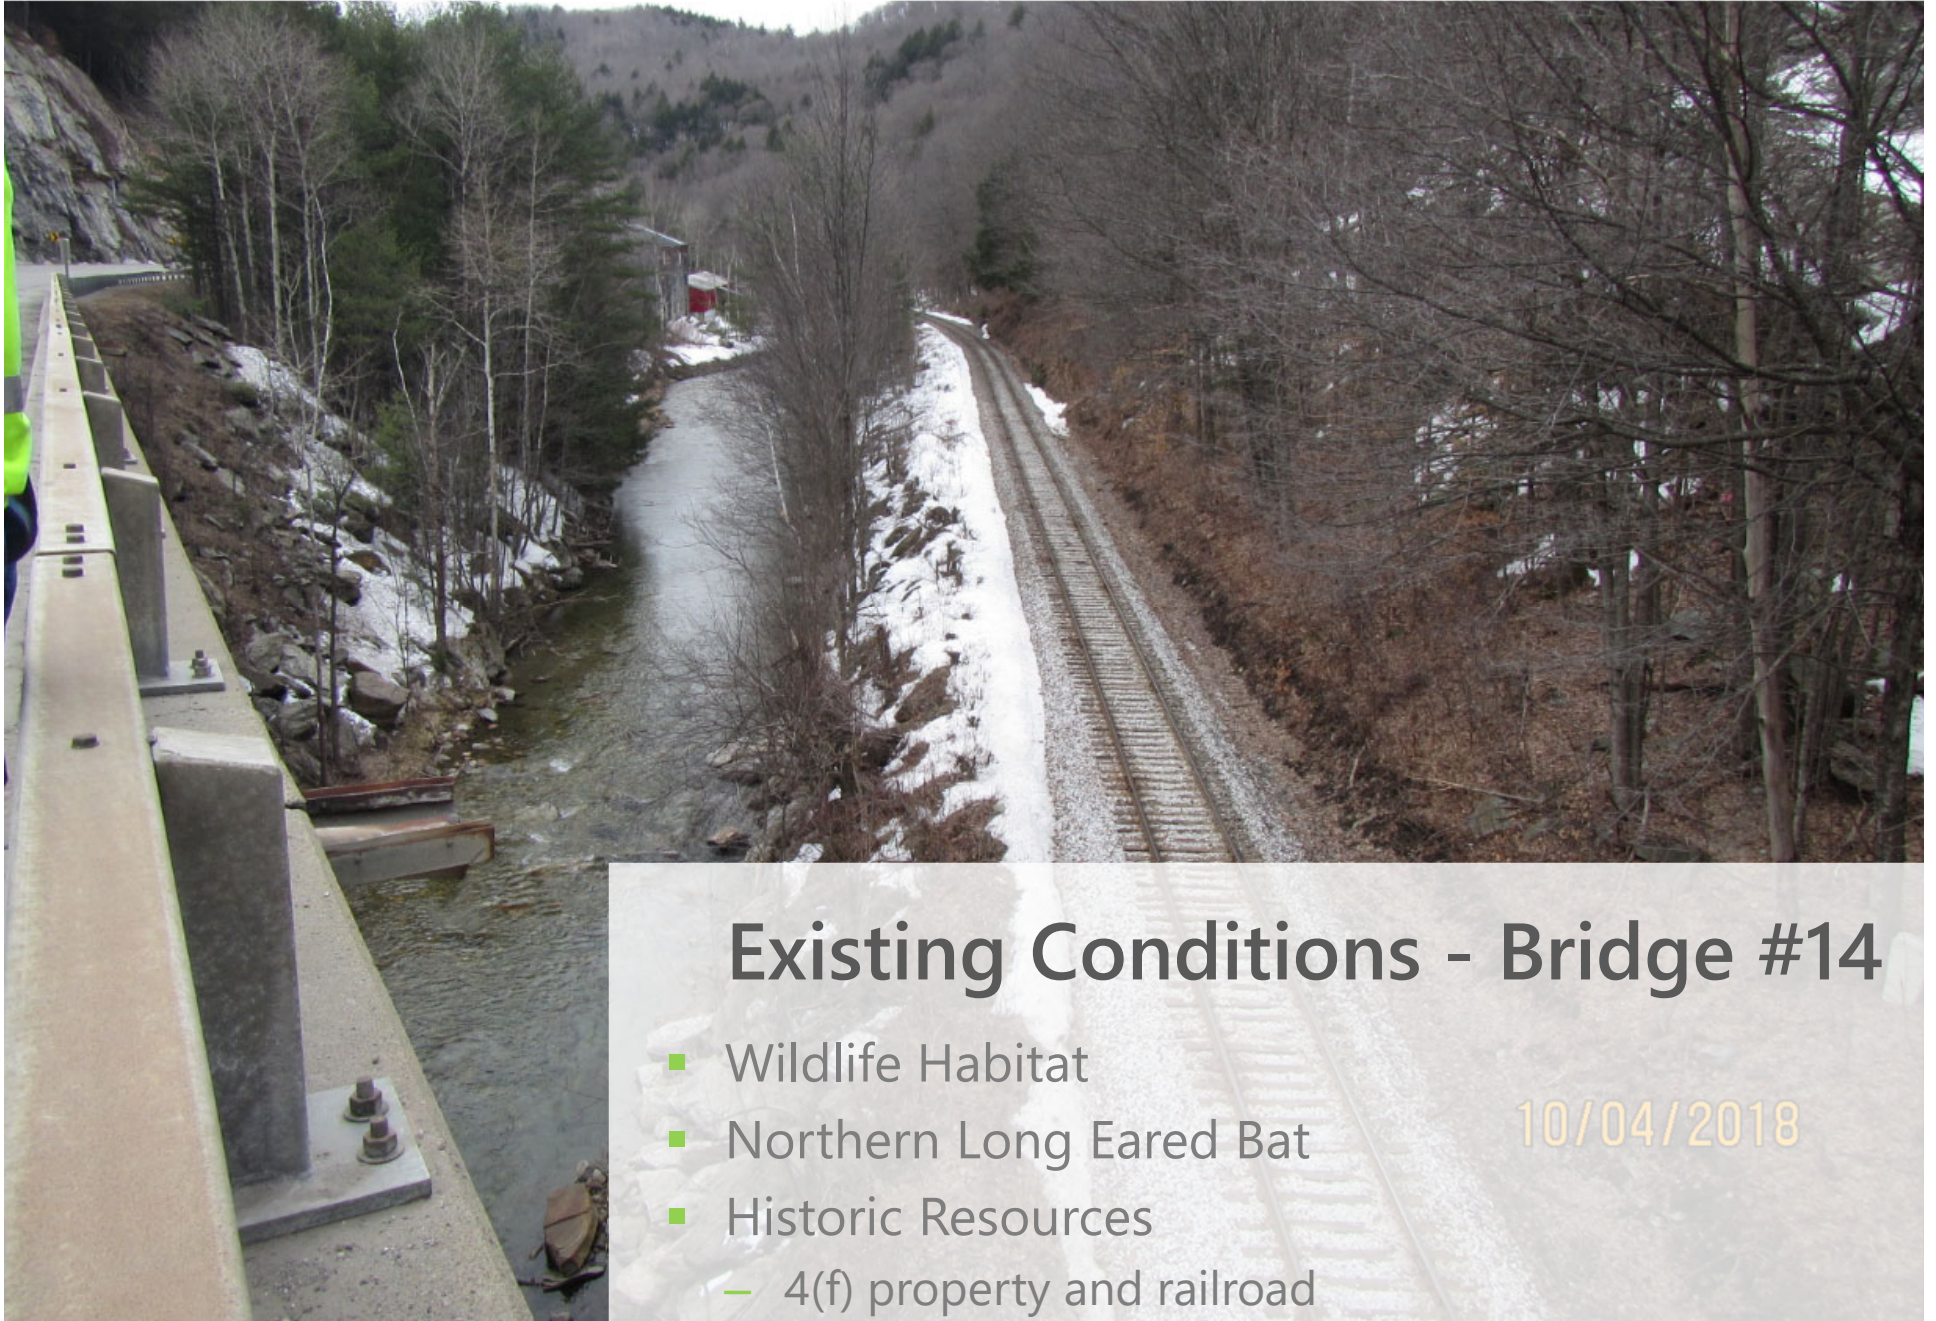
Resources – Looking Downstream

- Wildlife Habitat
- Northern Long Eared Bat
- Historic Resources
- 4(f) property and railroad

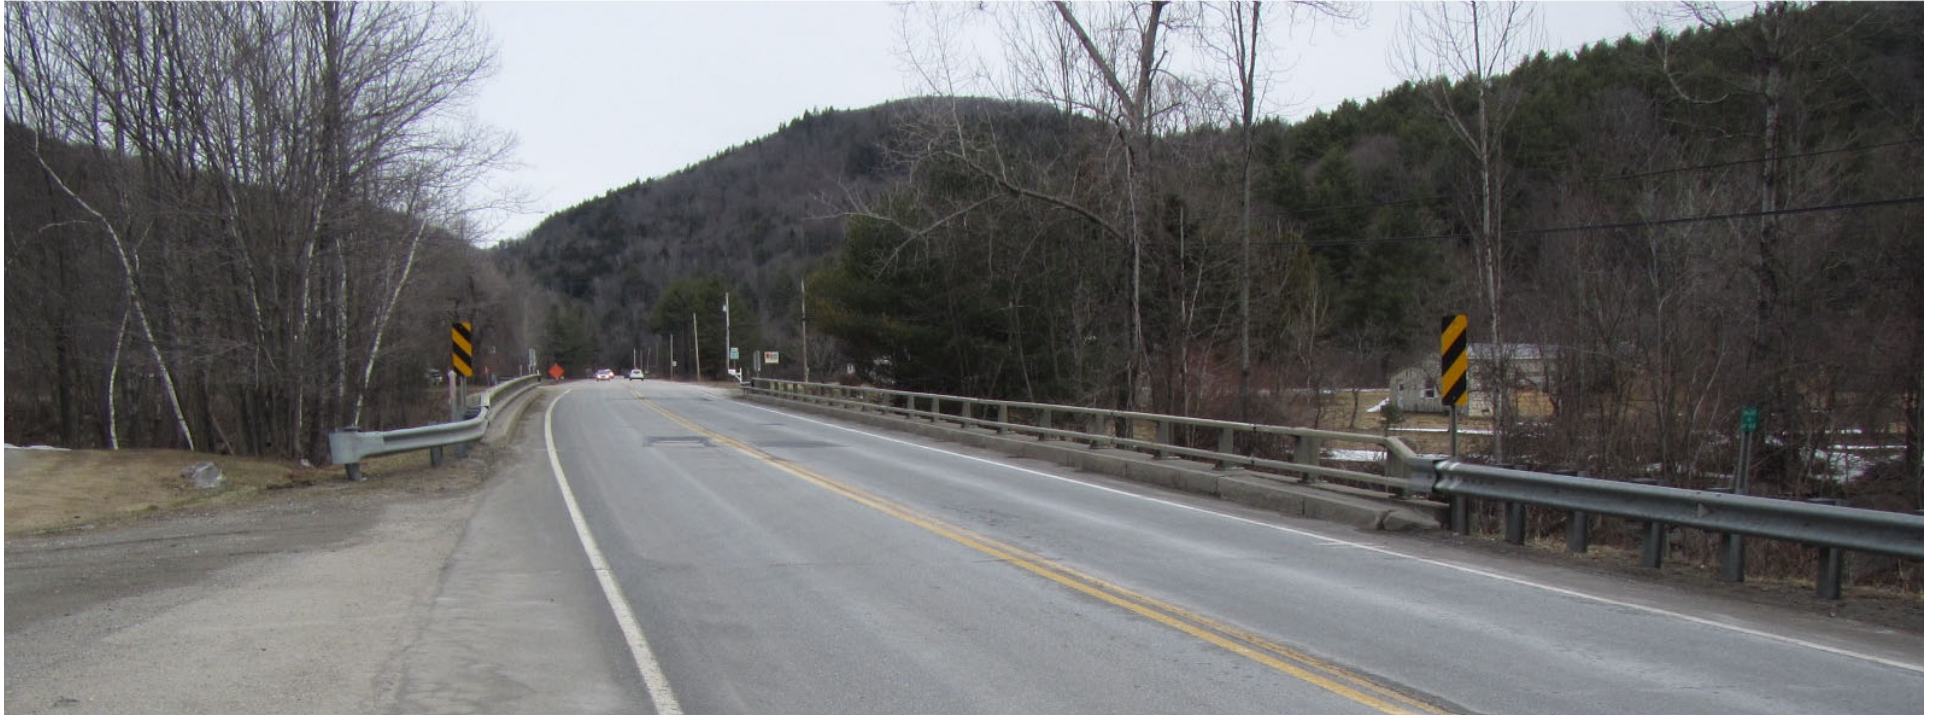
Looking North over Bridge

- Roadway Classification – Principal Arterial, National Highway System
- Bridge Type – 162' Long, Three span, Rolled Beam Bridge w/ Cast in Place Concrete Deck
- Ownership – State of Vermont
- Constructed in 1962

- The bridge is “structurally deficient”
 - Advanced deterioration of the deck
 - Steel plates have been placed over areas of deterioration.
 - Expansion joints have been replaced with asphaltic plug joints.
- The bridge has a substandard width (3'-12'-12'-3').
- The bridge railing is substandard.
- The abutments and piers have cracking and abrasion damage

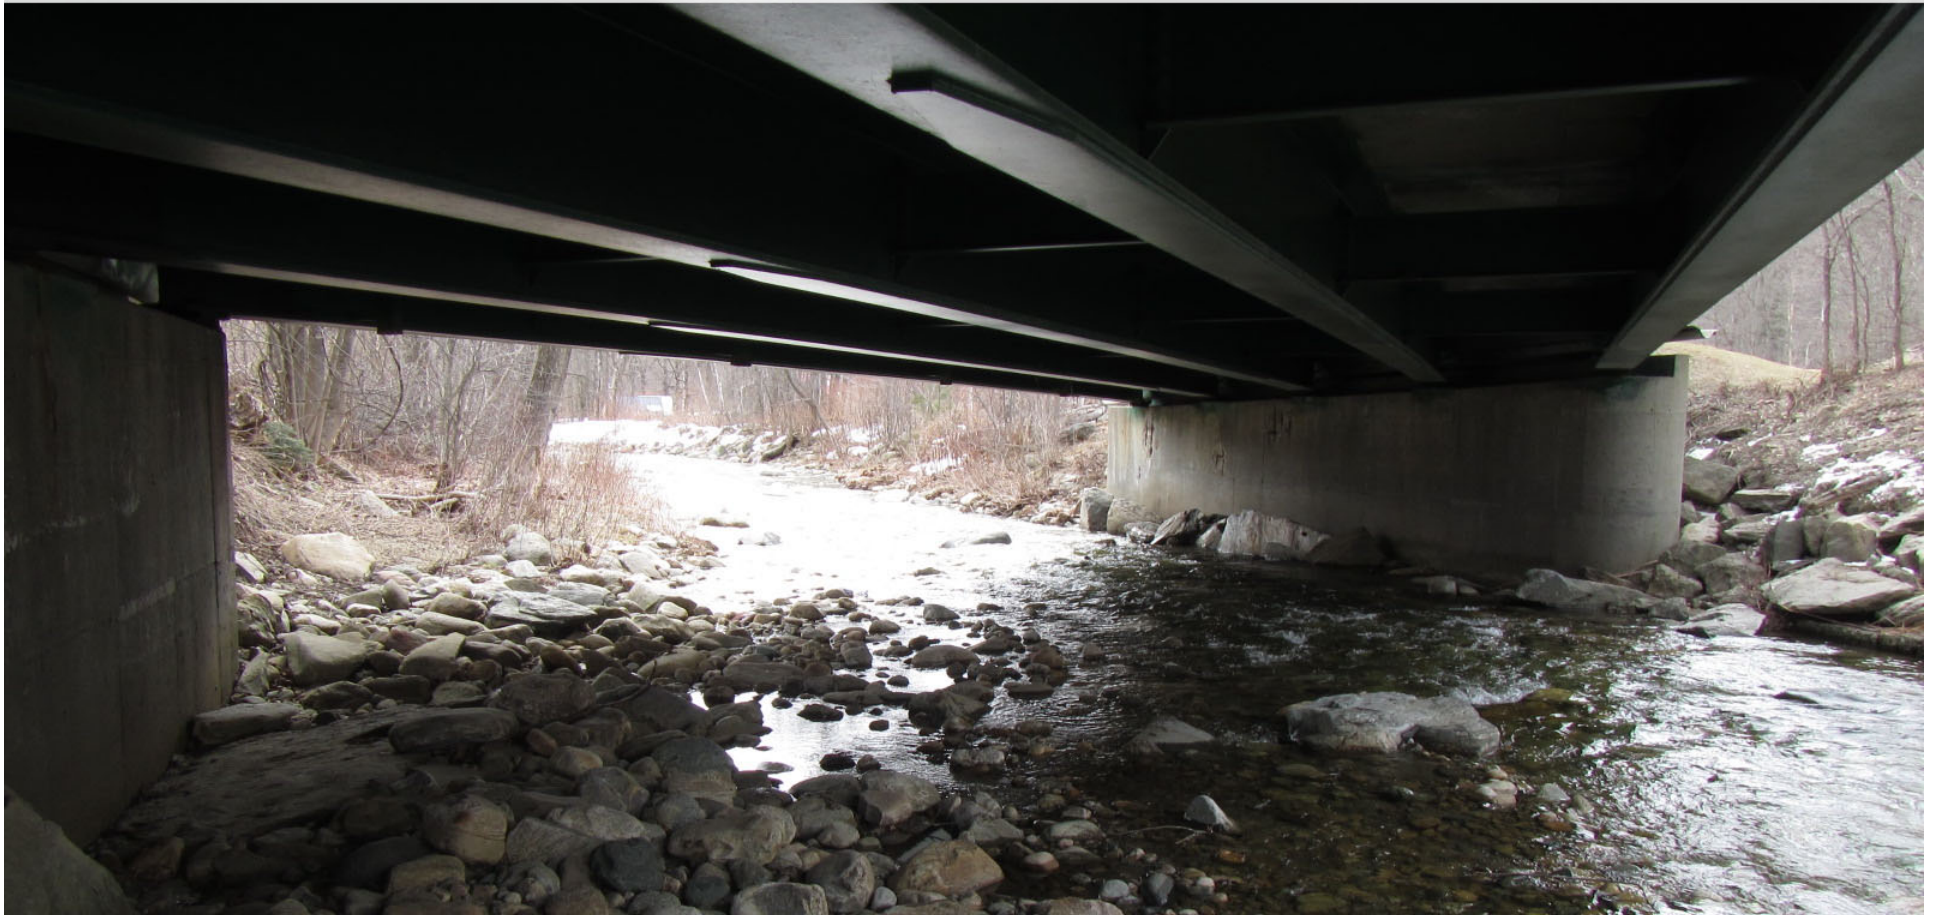
Condition Ratings

- Deck Rating 4 (Poor) 10/04/2018
- Superstructure Rating 7 (Good)
- Substructure Rating 6 (Satisfactory)

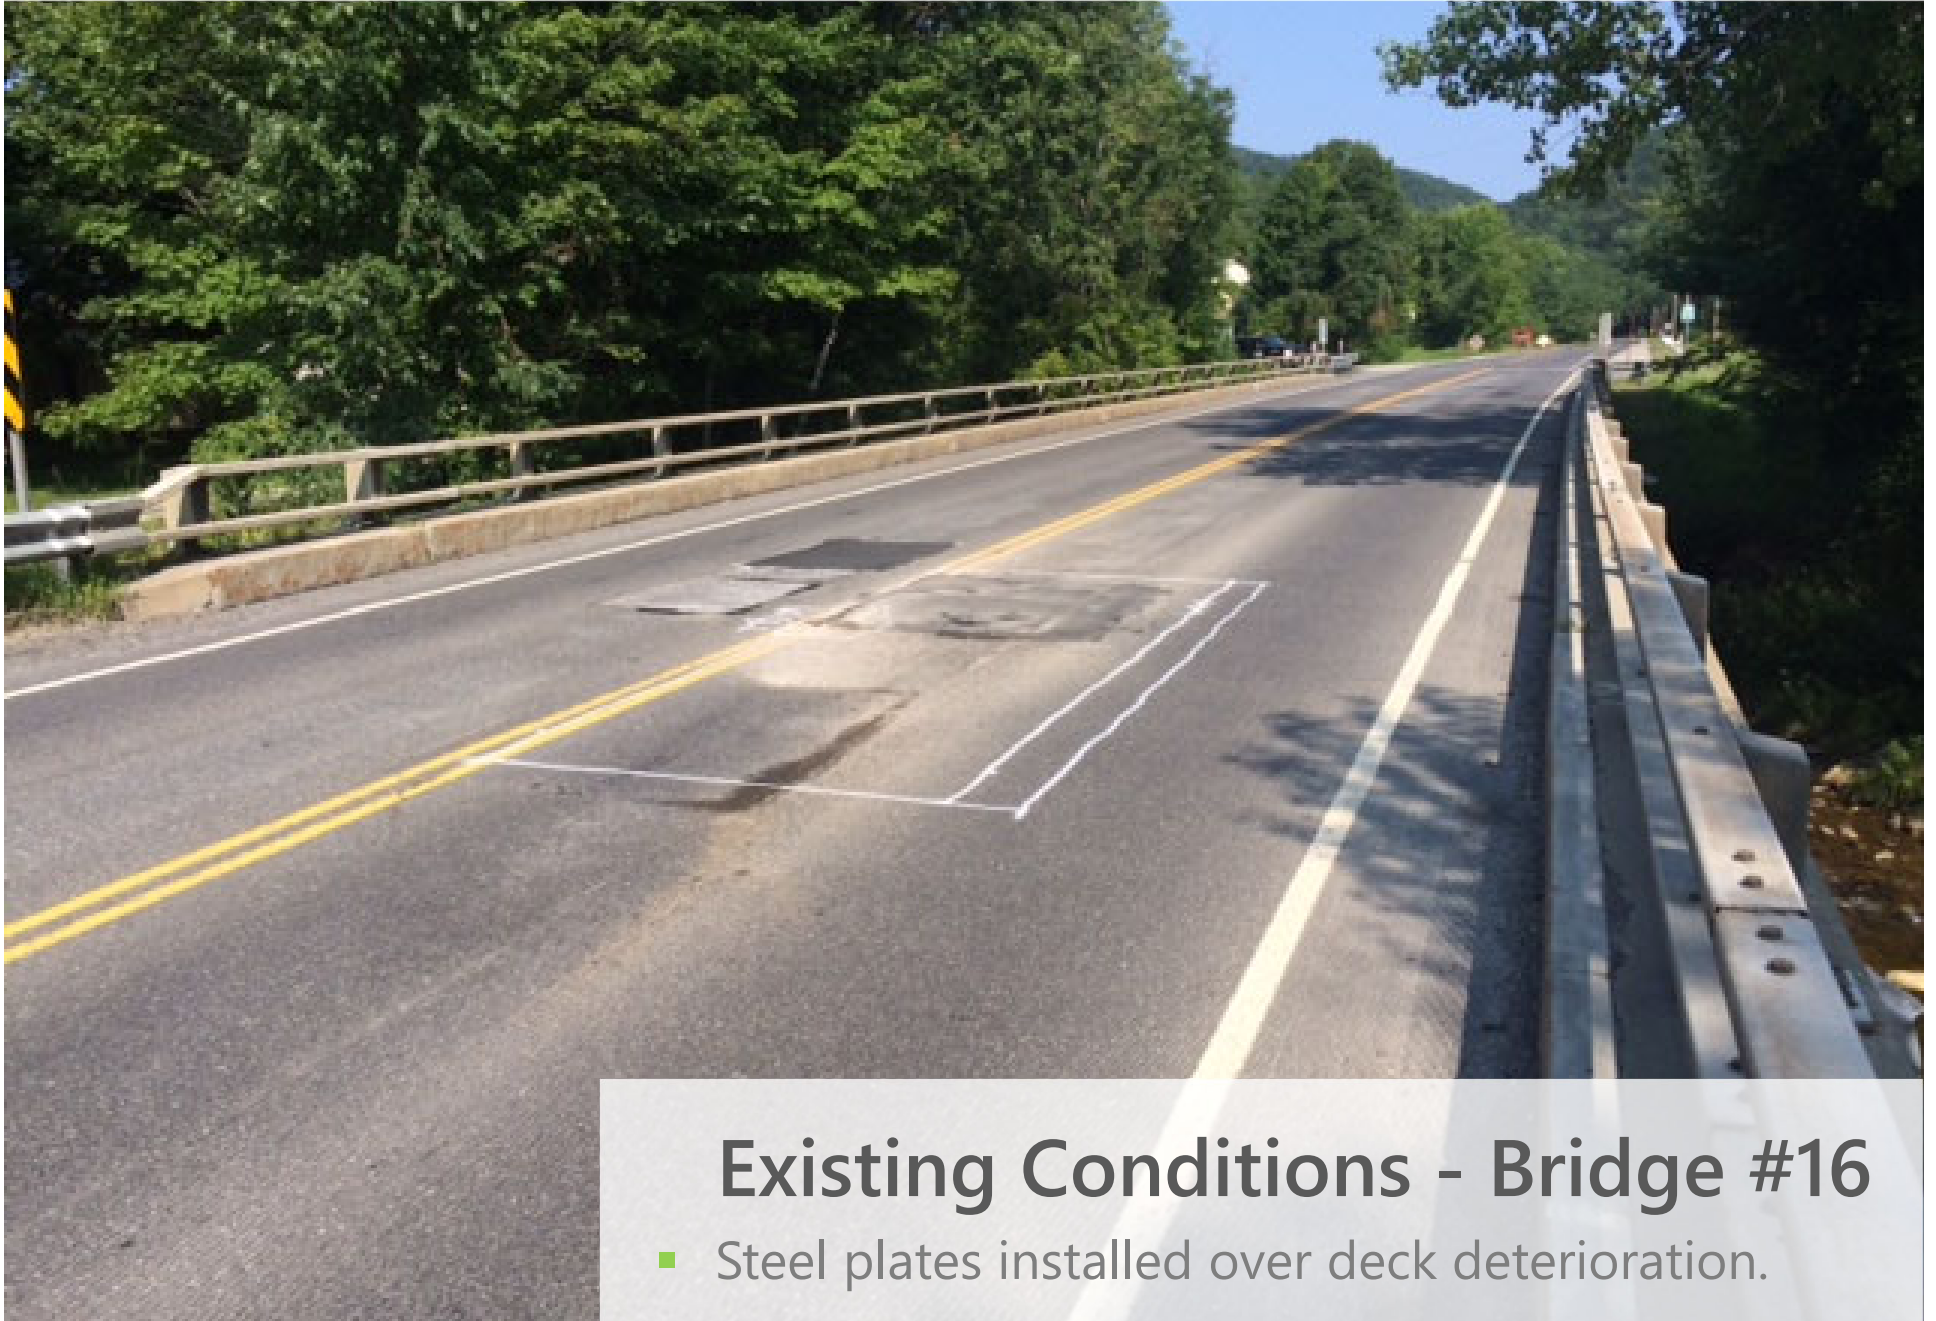
Deck Repairs

- Steel plates installed over deck deterioration.

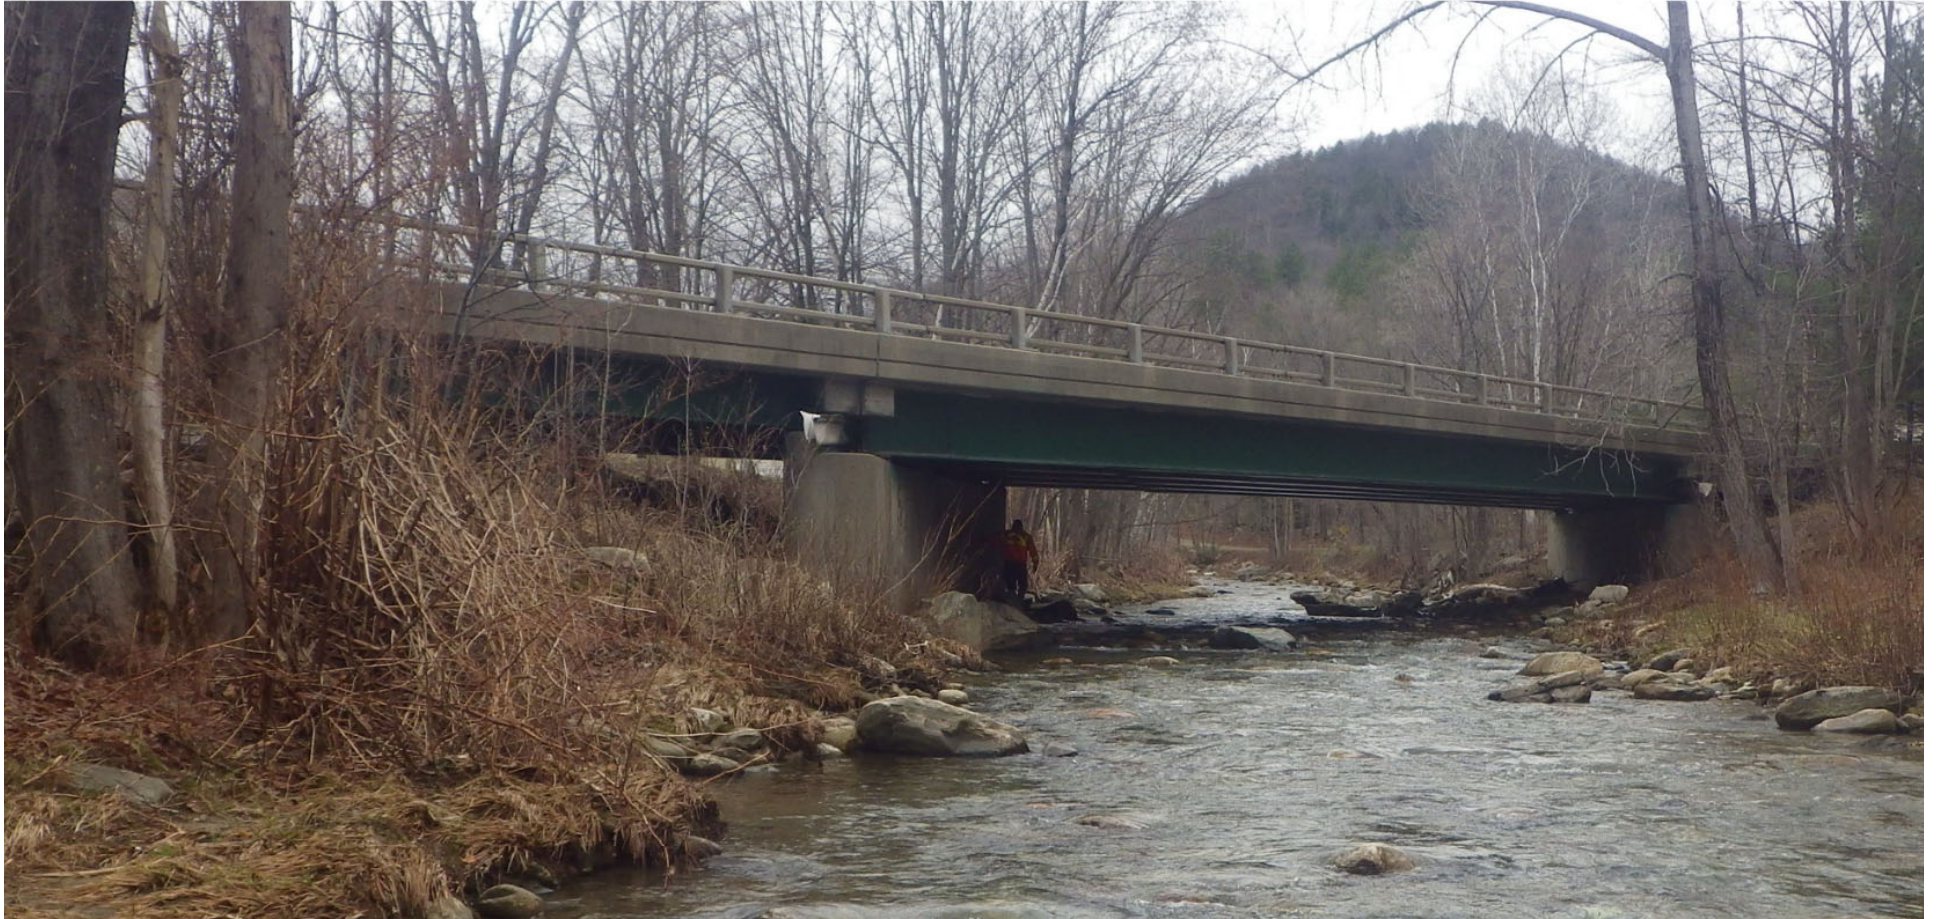
Resources – Looking Upstream

- Class III Wetland
- Historic Resources
- No Archaeological Resources found during phase I study

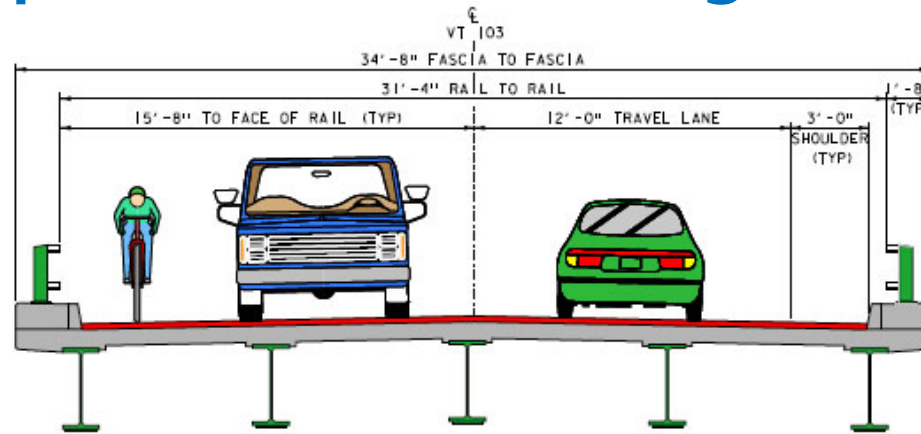
EXISTING BRIDGE 14 TYPICAL SECTION

BRIDGE RAILING, GALVANIZED
STEEL TUBING/CONCRETE COMBO
SEE STANDARD S-352A

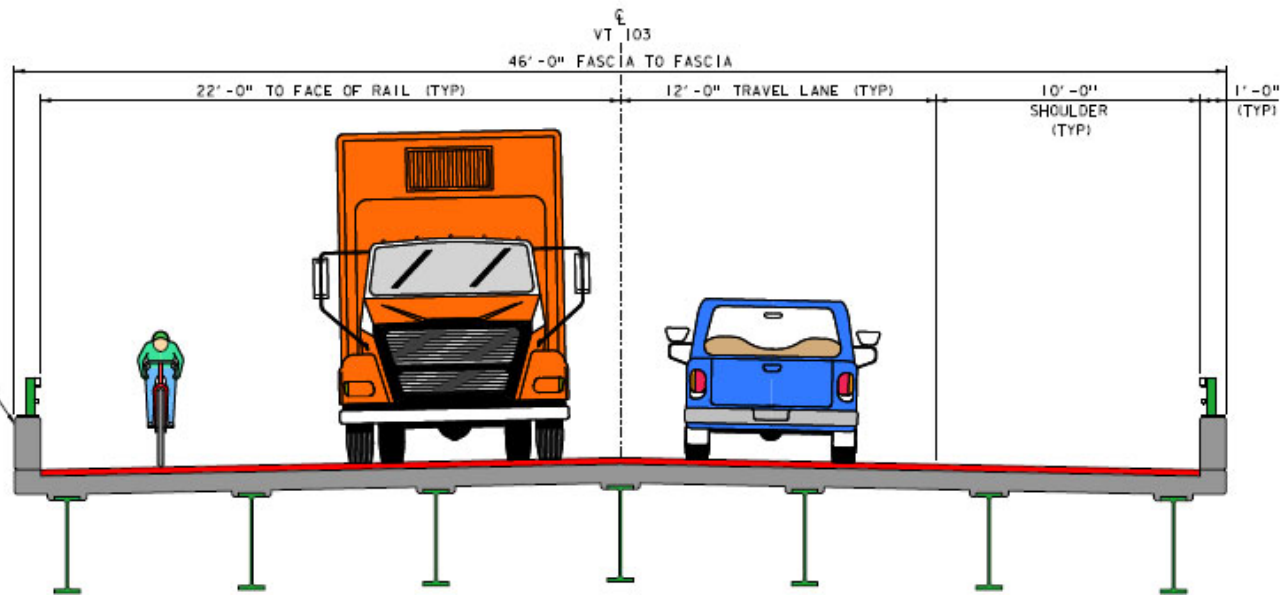
BRIDGE 14 REPLACEMENT TYPICAL SECTION

- Full Bridge Replacement
 - 10'-12'-12'-10' typical
 - 100-year design life
 - Existing configuration or reduced number of spans

SUPERSTRUCTURE TO BE DETERMINED

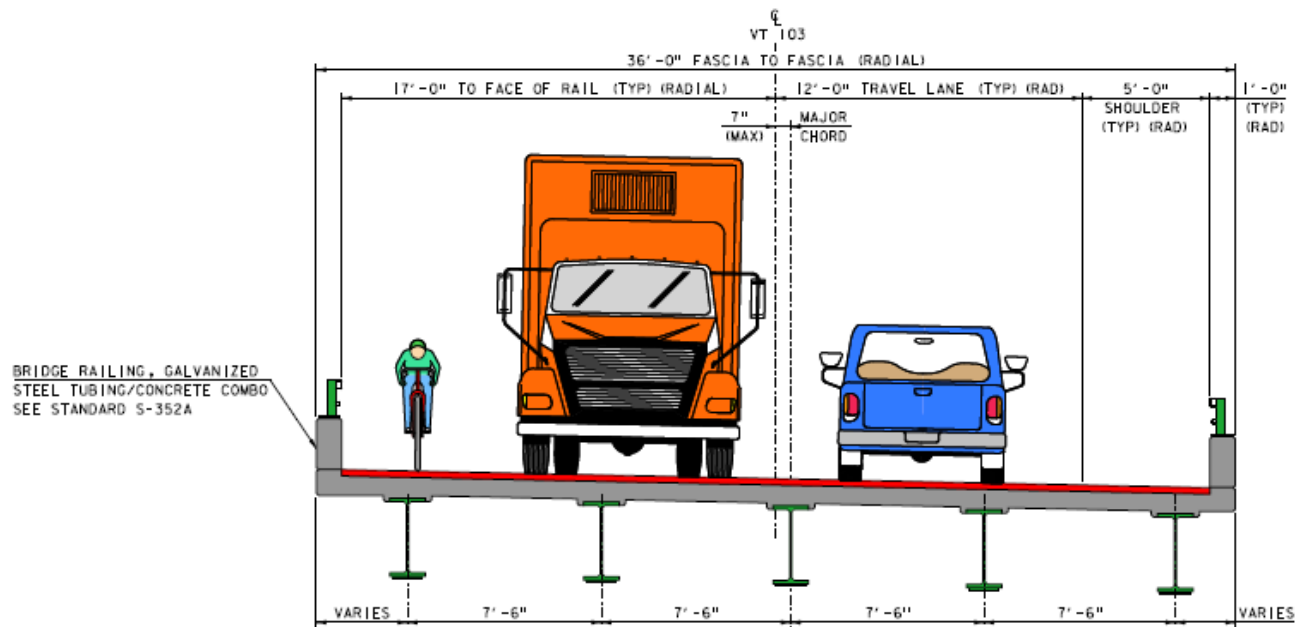
DECK REPLACEMENT TYPICAL SECTION

- Deck Replacement
 - 5'-12'-12'-5' typical
 - 40-year design life
 - Repairs to Abutments and Piers

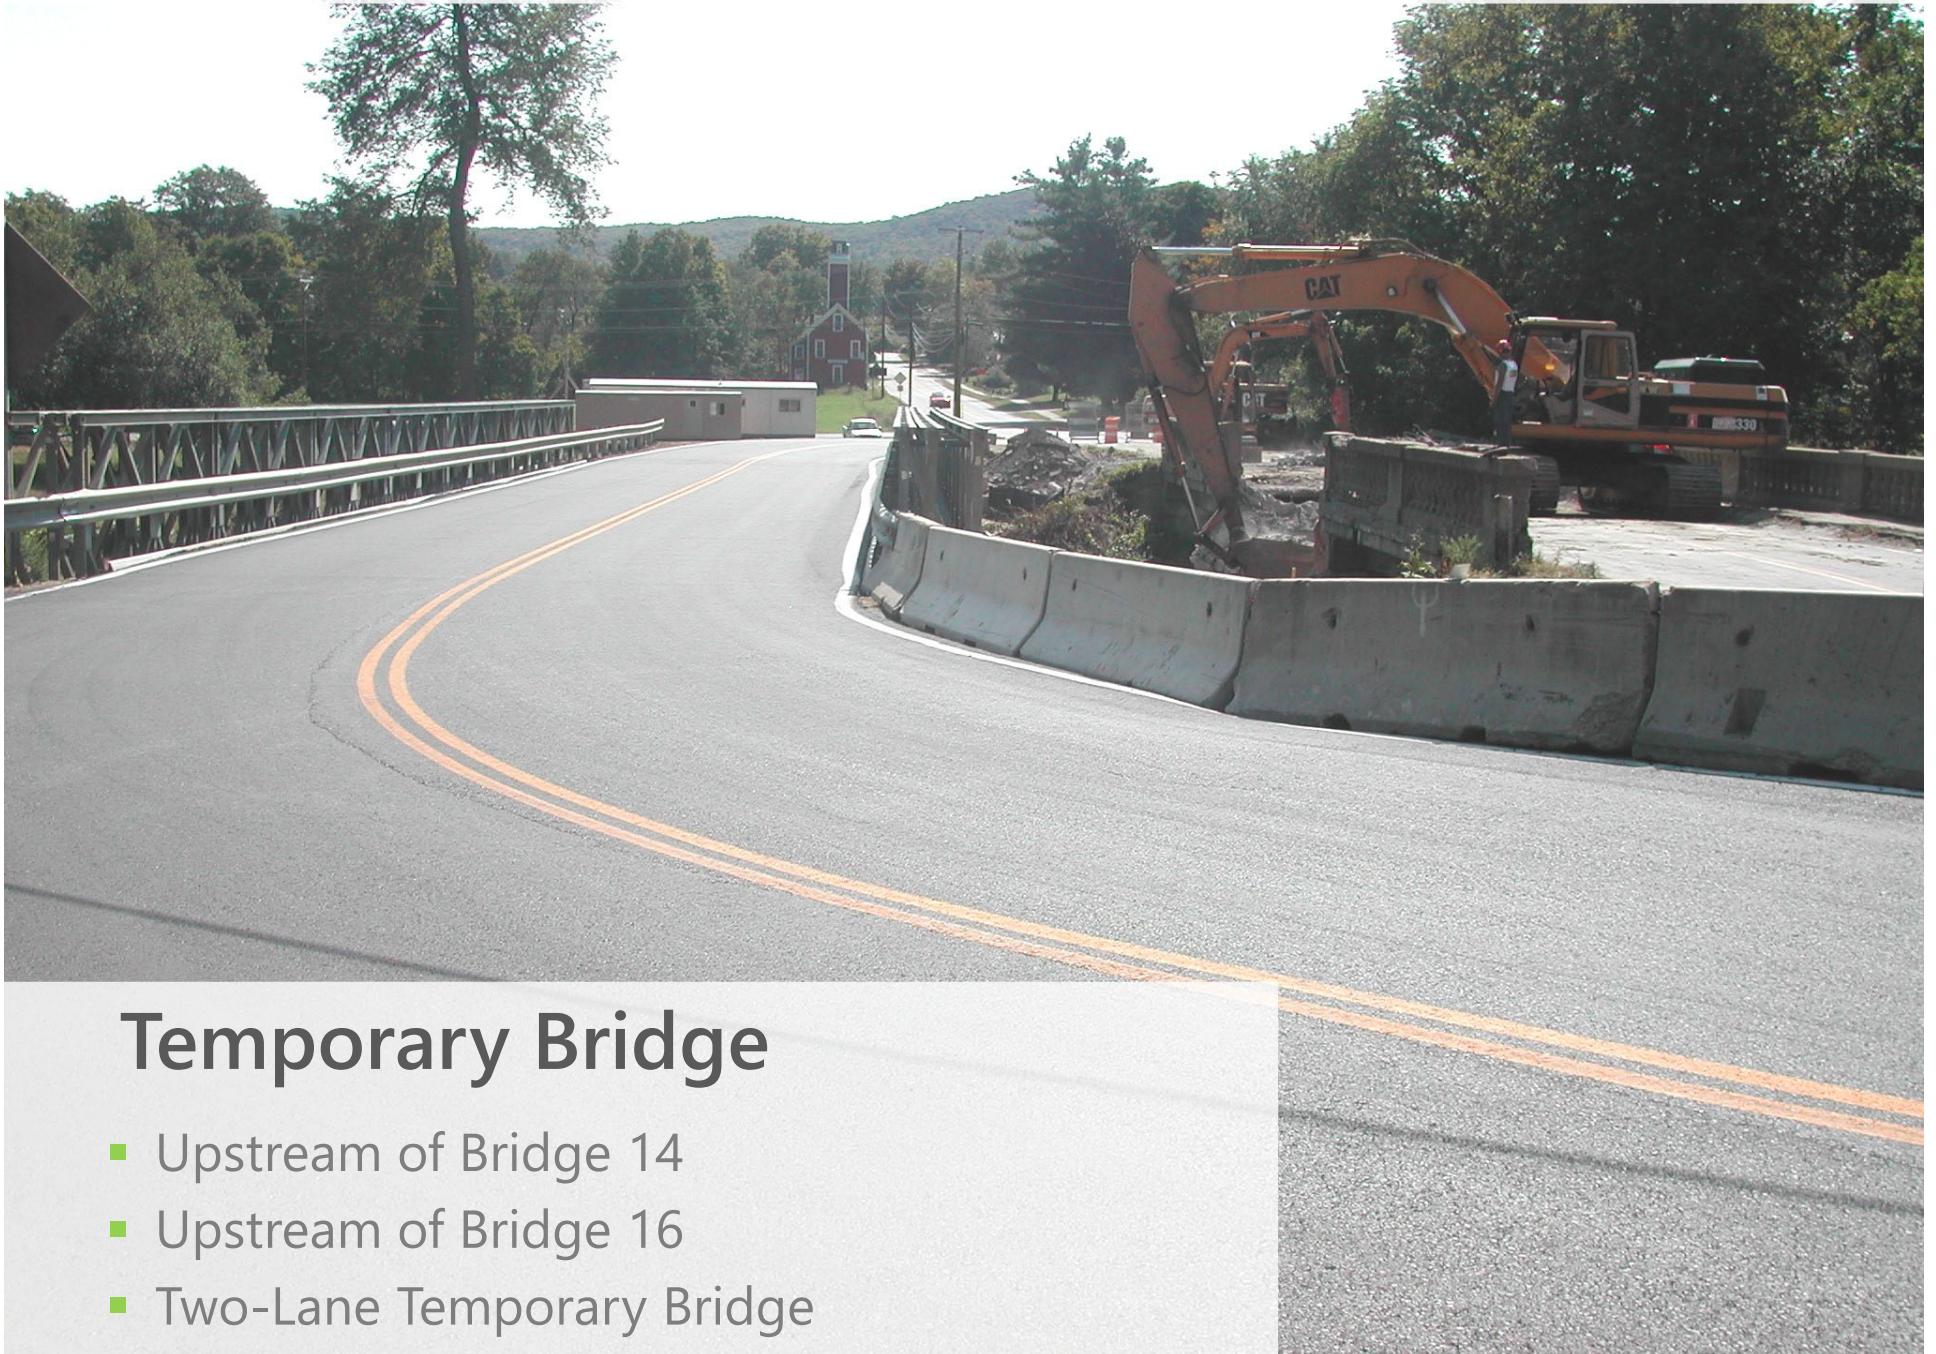
Selected Method of Traffic Maintenance

Temporary Bridge

- Upstream of Bridge 14
- Upstream of Bridge 16
- Two-Lane Temporary Bridge

- Deck Replacement with Traffic Maintained on a 2-way Upstream Temporary Bridge
 - 12'/5' typical
 - 40-year design life
 - Right-of-Way needed
 - Aerial utility relocation avoided
