Proctor BO 1443(54)

Public Informational Meeting

Town Highway 11 (North St.) – Bridge #3 over the Vermont Railway

November 27, 2017

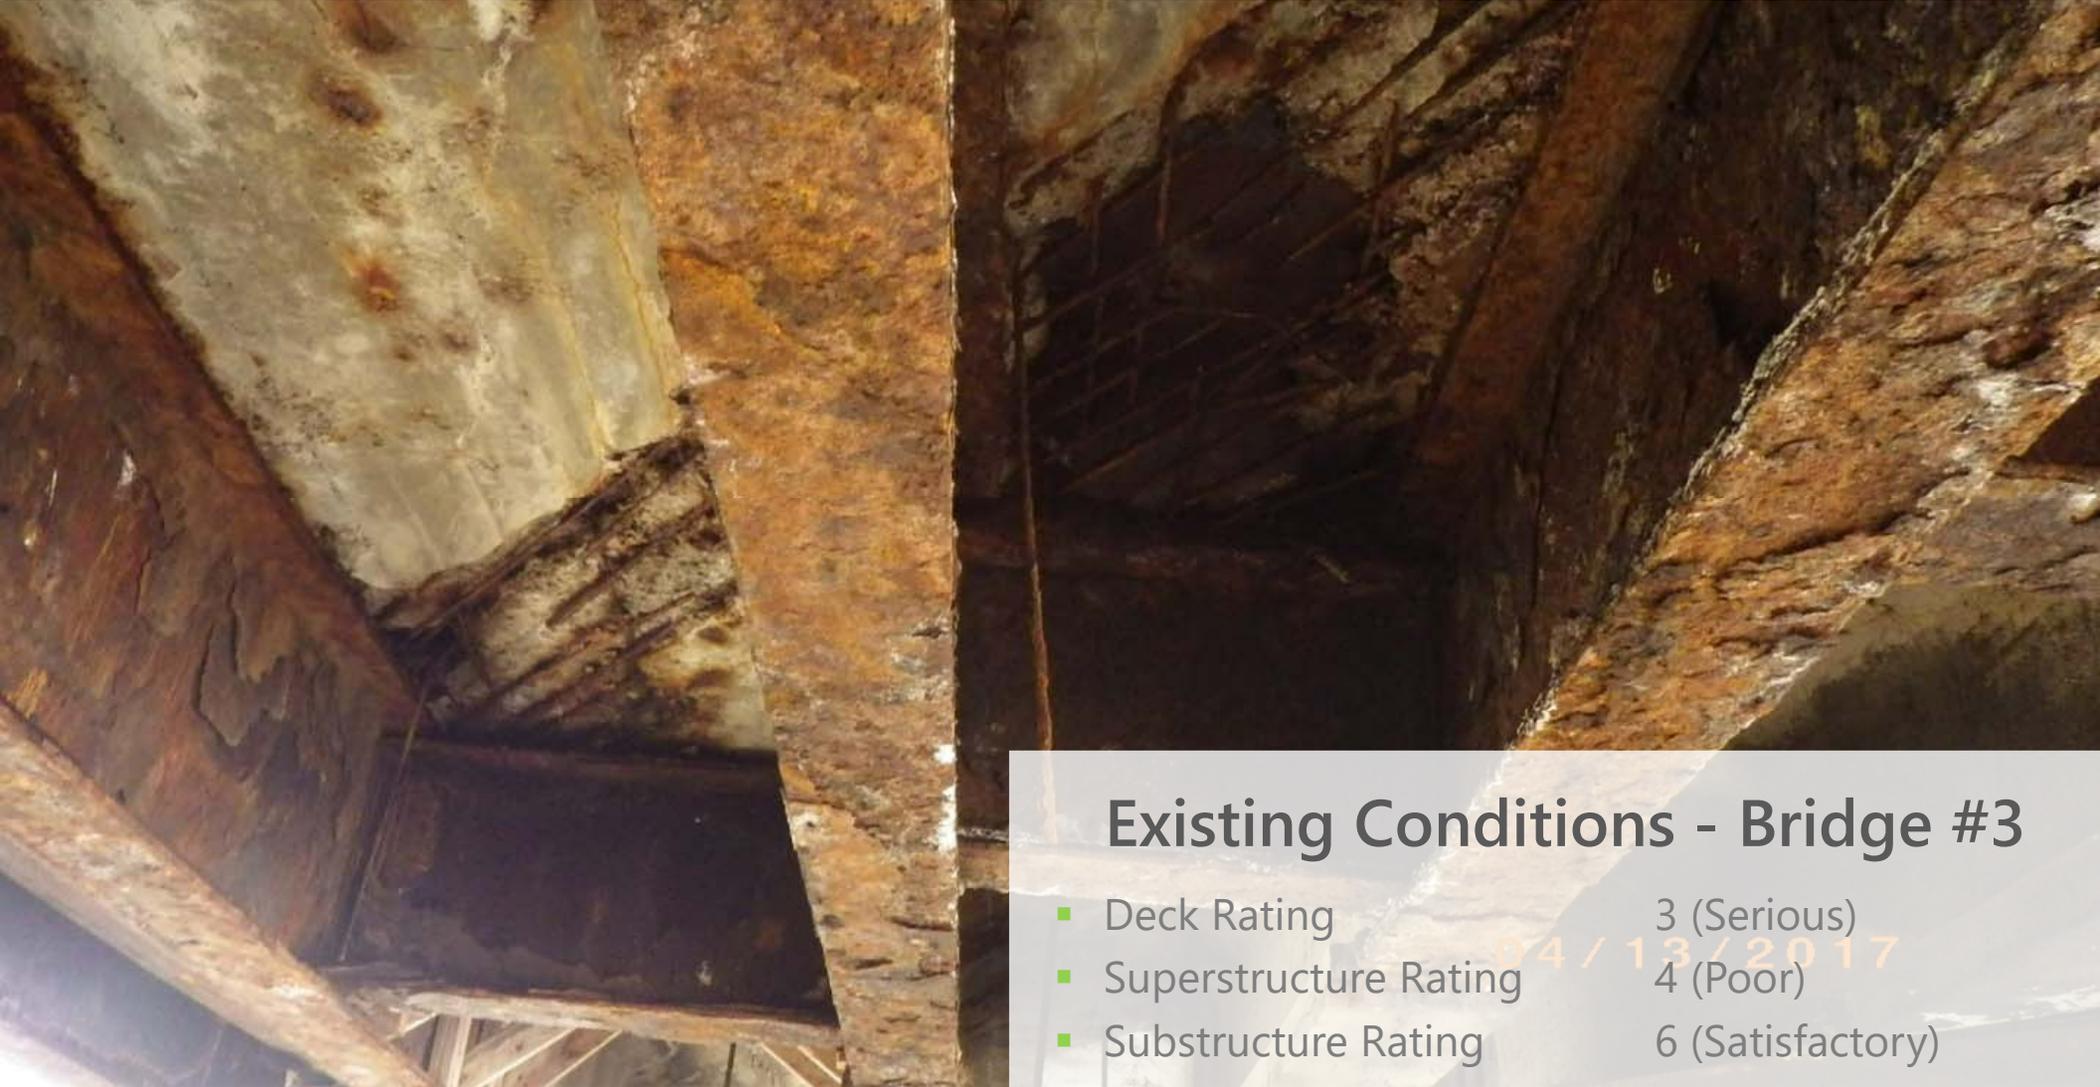
Deck and Superstructure Deterioration

- The deck is in serious condition
 - At risk for full depth pop outs
- The superstructure is in poor condition
 - Potential for beam crushing due to heavy corrosion and section loss
- There are delaminations and loose concrete at the stemwalls with some efflorescence.
- The shoulders on North Street are substandard by 1 foot throughout the project area.
- There is a substandard vertical crest curve over the bridge.
- The bridge does not meet the minimum vertical clearance for the railway.

- Deck Rating 3 (Serious)
- Superstructure Rating 4 (Poor)
- Substructure Rating 6 (Satisfactory)

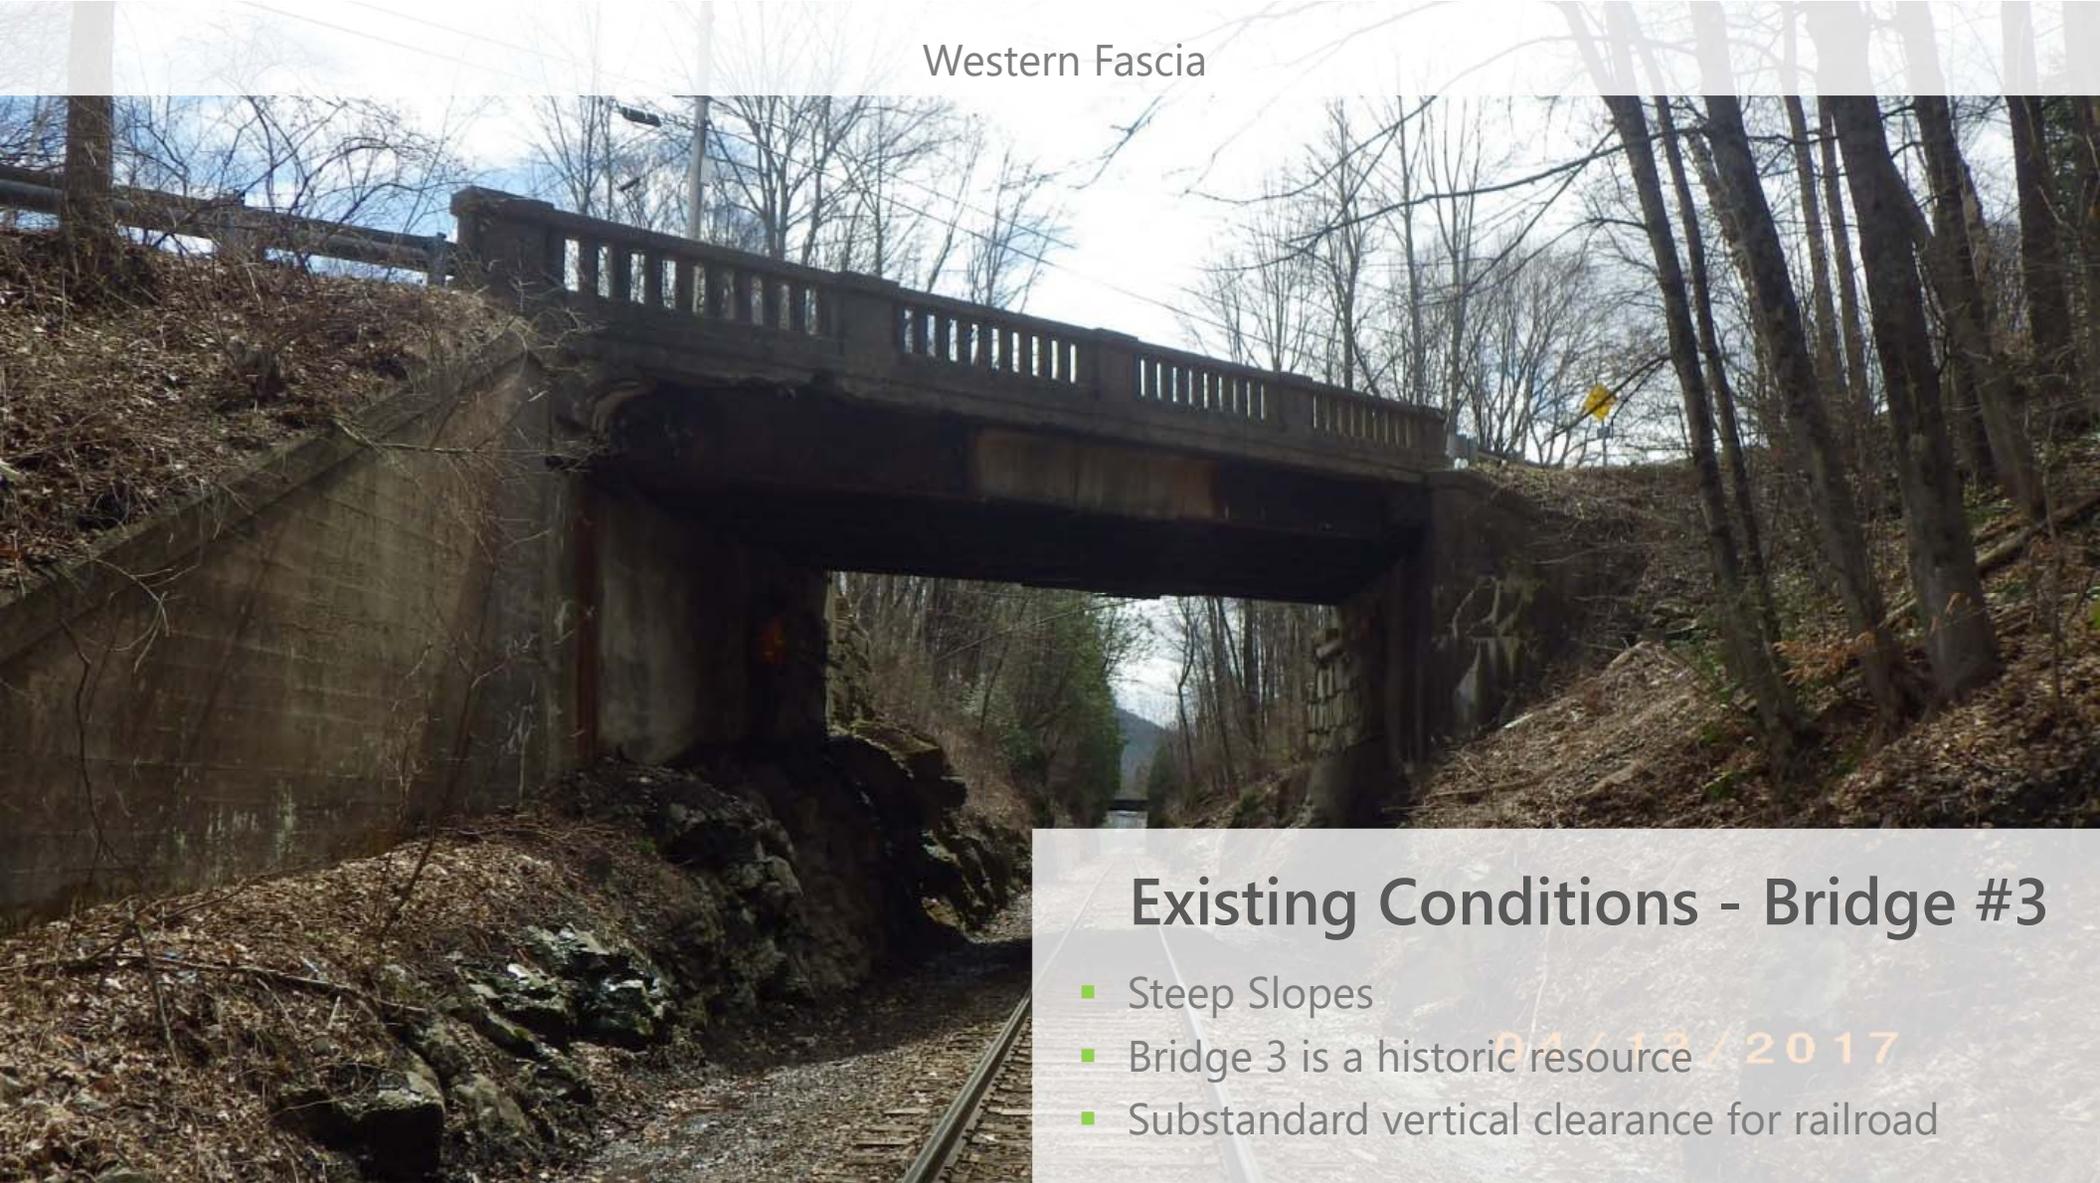
Western Fascia

- Steep Slopes
- Bridge 3 is a historic resource
- Substandard vertical clearance for railroad

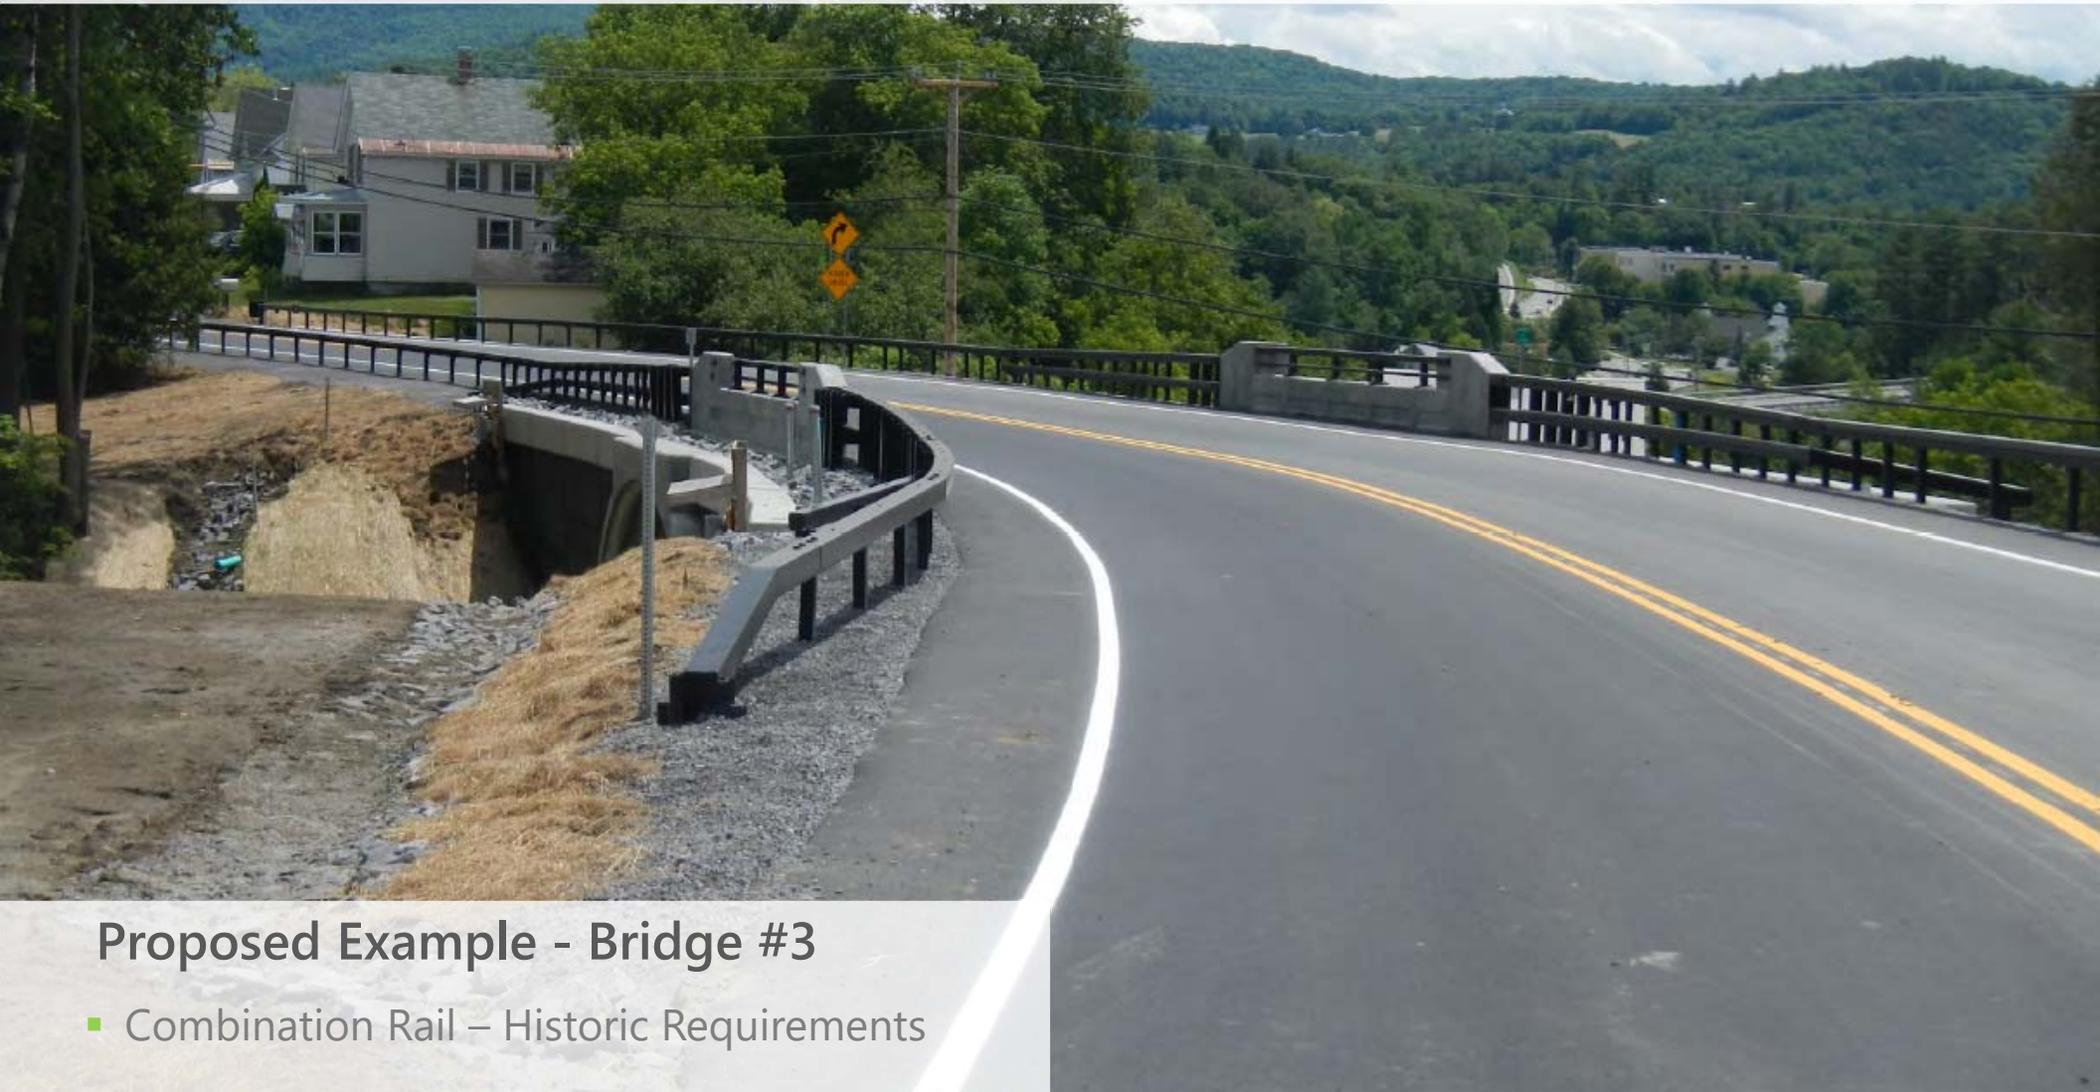
What Will the New Bridge Look Like?

Proposed Example - Bridge #3

- Combination Rail – Historic Requirements
