**STATE OF VERMONT
AGENCY OF TRANSPORTATION**

**Scoping Report
FOR
Eden BO 1448(44)**

**TOWN HIGHWAY 13, BRIDGE 23 OVER THE WHITE BRANCH OF GIHON
RIVER**

October 23, 2017

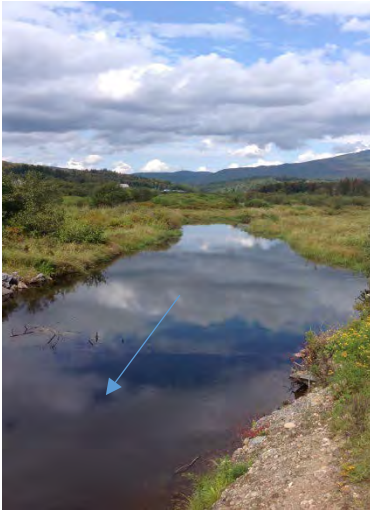
Figure 1 Wetland adjacent to White Branch of Gihon River

A class II wetland complex (Figure 1) comprises the majority of the project area. Wetlands were identified at a resource planning level using USCOE wetland indicators. The wetland complex was populated primarily with speckled alder, goldenrods and asters. Soils within the wetland are mapped as Histic Fluvaquents, a hydric soil. Field conditions confirmed this as the soils consisted of 15" of dark, organic soils with a mucky texture, underlain by grey silty loam. Several wetland hydrology indicators were met. The wetland is a large wetland complex (roughly 100 acres) that has several functions and values: flood storage; wildlife habitat; fisheries habitat; erosion control; water quality; education and research; recreation and open spaces.

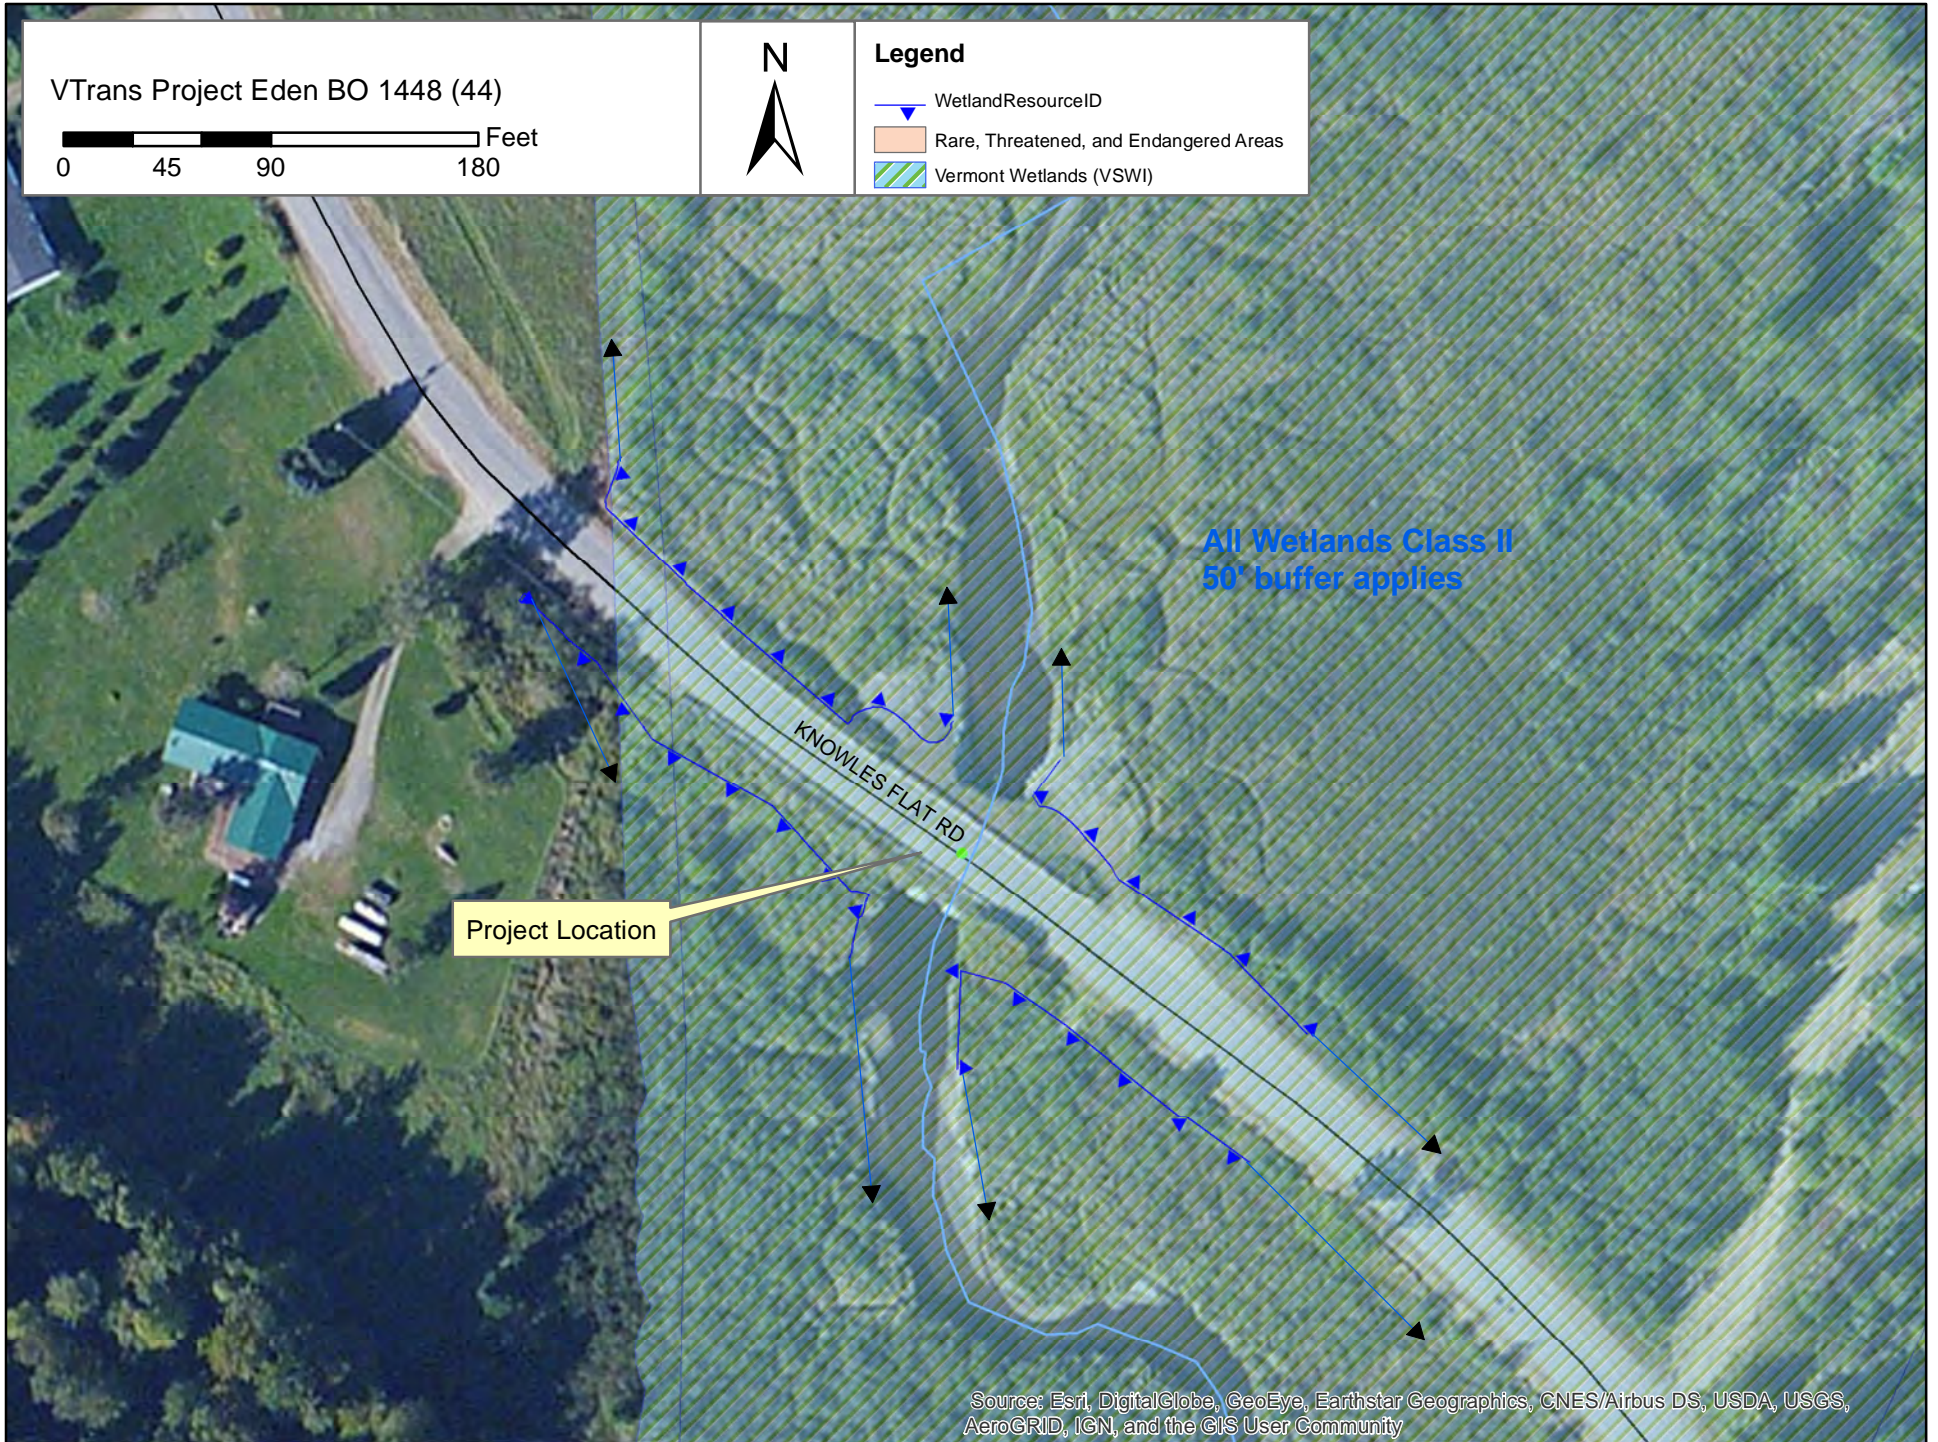
All Wetlands Class II
50' buffer applies

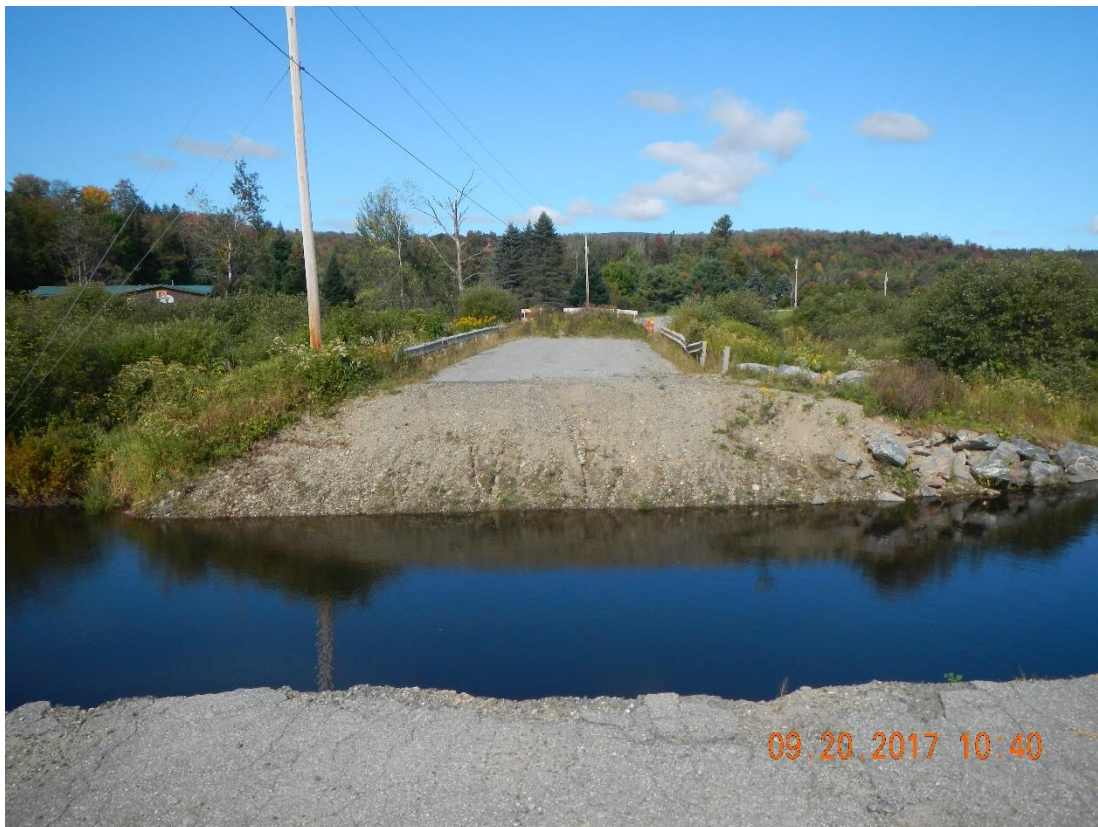
Figure 2: Looking northwest across river; visible are overhead wires running parallel to roadway and large stone fill on river bank.

A preliminary site visit was conducted on September 20th, 2017 to determine possible obstructions inhibiting boring operations and to make any other pertinent observations about the project. The road is currently closed and the previously existing structure has been removed, however some larger sized stone fill remains on the river banks, as seen in Figure 2. Overhead wires run along Knowles Flat Road in a northwest-southeast direction over the southern edge of the roadway and can be seen in Figure 2. There was no visible bedrock within the river but small cobbles were visible. The river banks are primarily vegetated in the upstream and downstream directions however cobbles and small sized boulders were visible along the river banks in the immediate vicinity of the former culvert location, as seen in Figures 3 and 4.

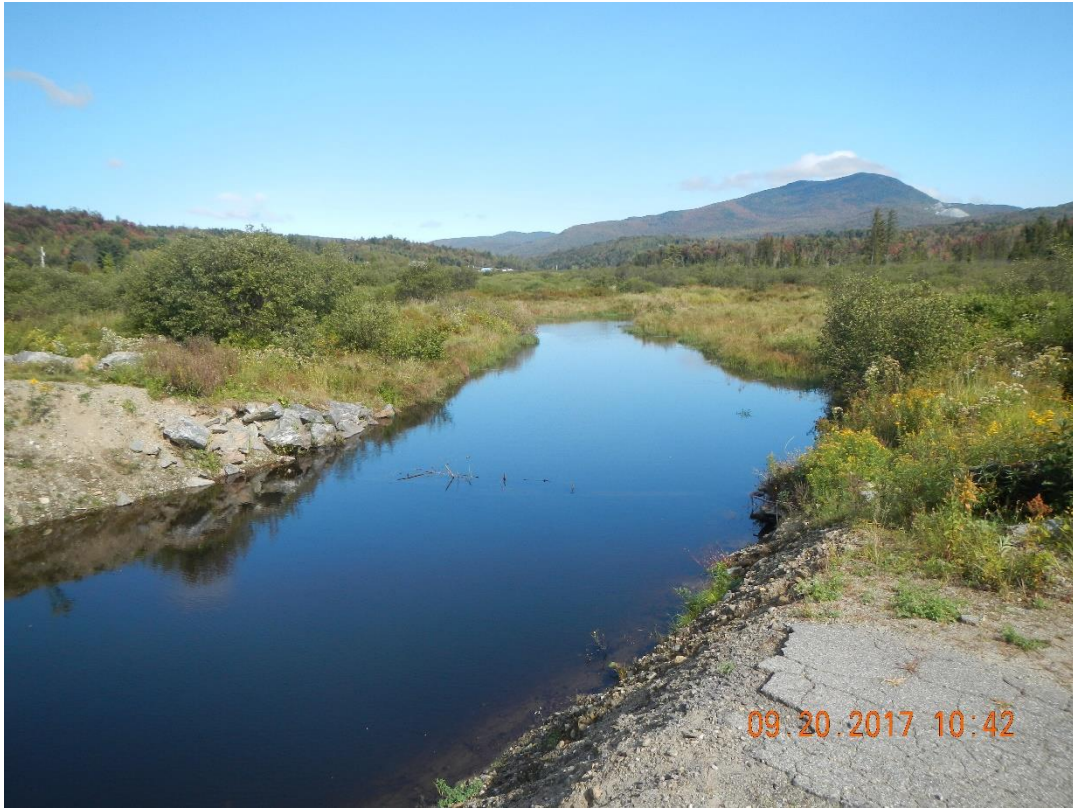
Figure 3: Facing north; stone fill, cobbles, and small boulders visible on river banks on upstream side.

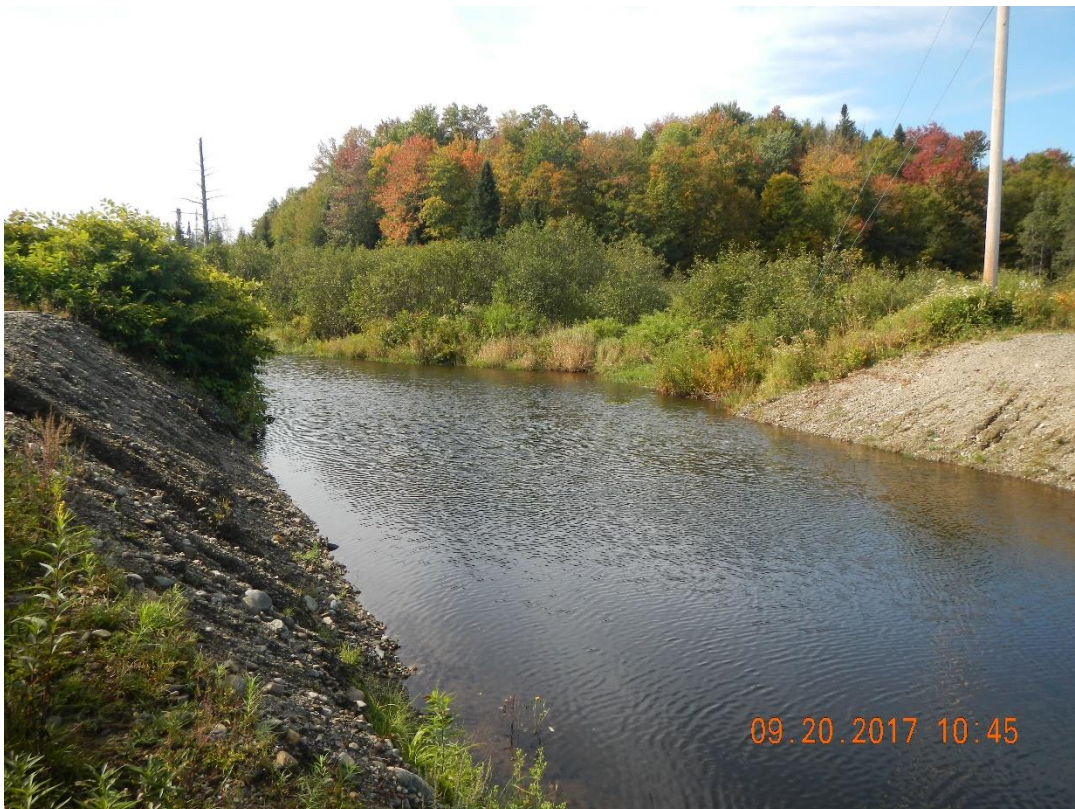
Figure 4: Facing south; cobbles and small boulders visible on river banks on downstream side.
