Newbury BO 1447(32) Alternatives Presentation Meeting

Town Highway 3, Bridge 15 over Wells River

June 26, 2019

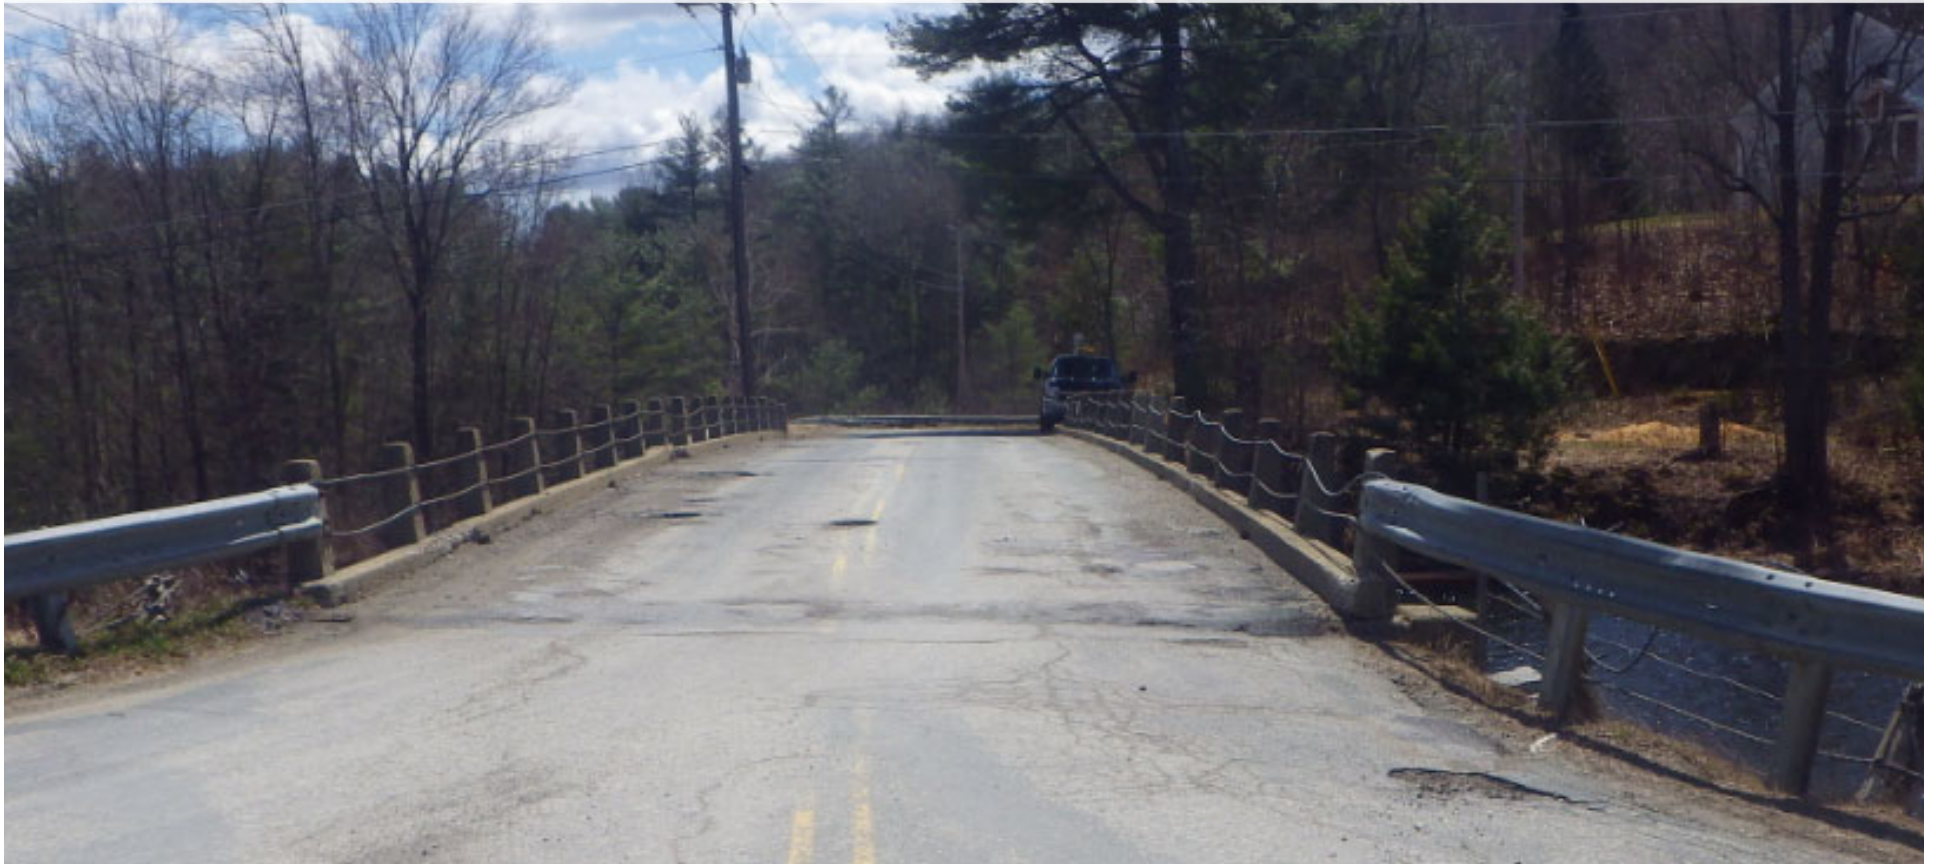
- Roadway Classification – Minor Collector (Class 2 Town Highway)
- Bridge Type – 113' Long 2-Span Rolled Beam Bridge
- Ownership – Town of Newbury
- Constructed in 1946

- Narrow
 - 9'/1' typical
 - Standard is 9'/3'
- Aerial Utilities

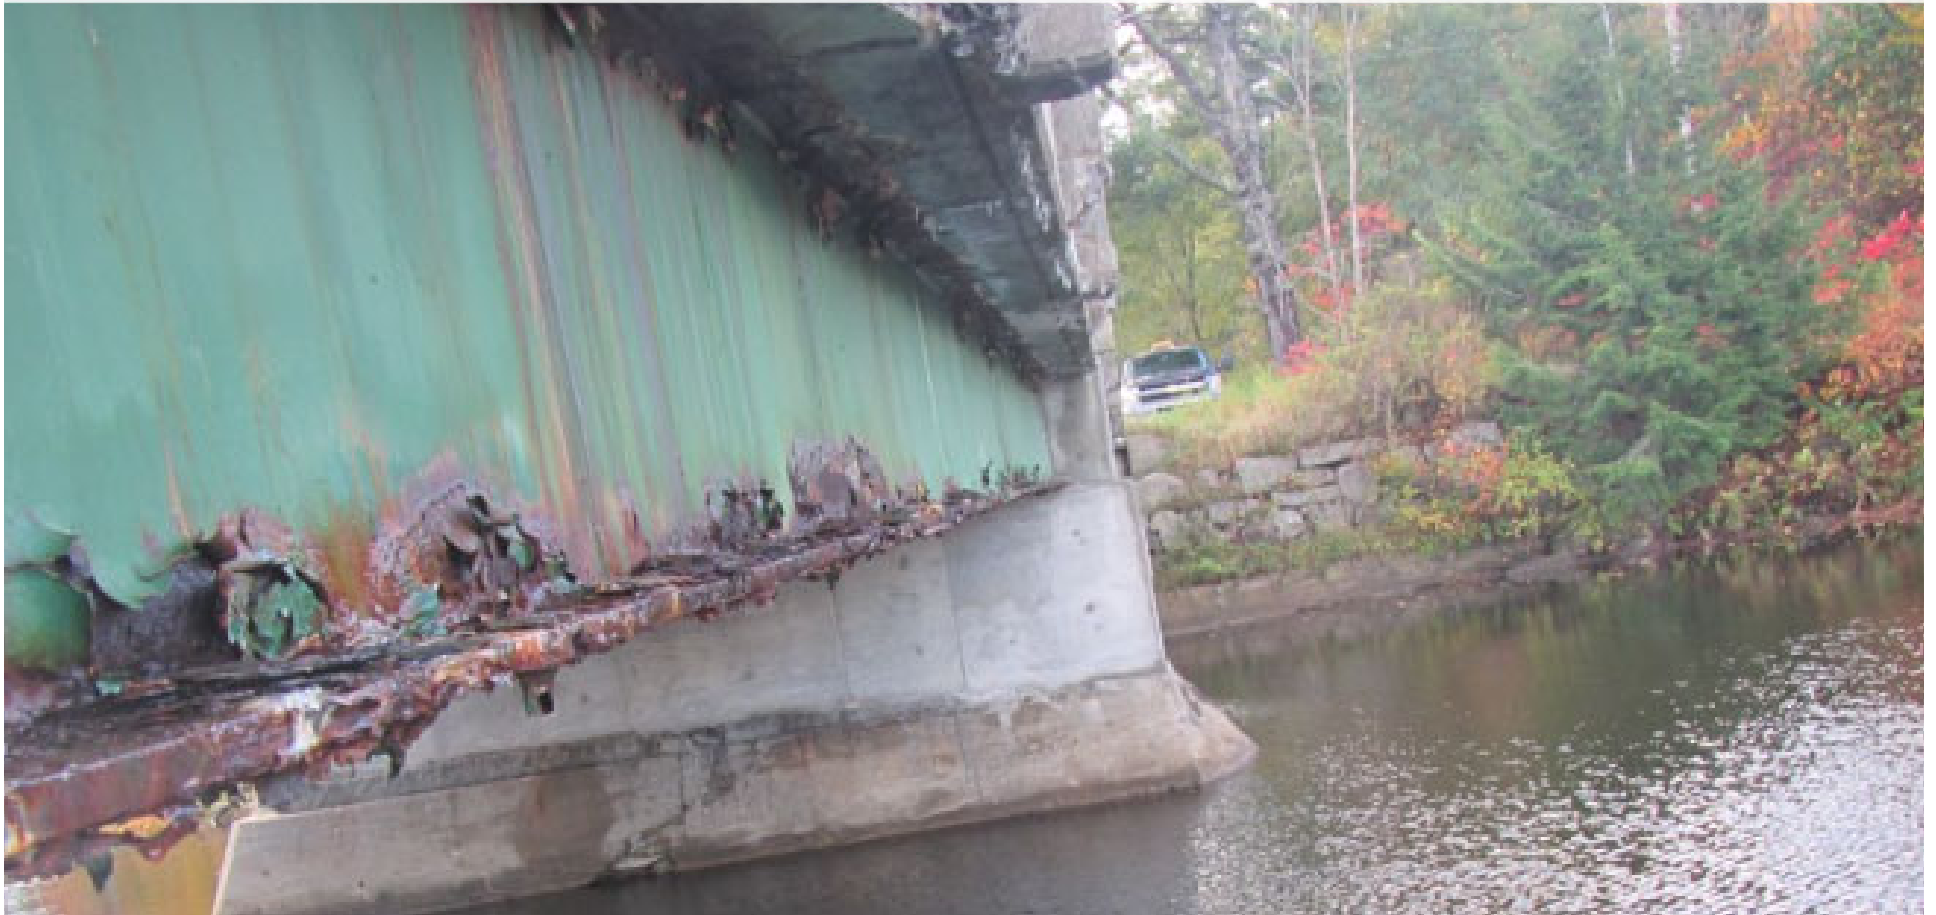
Condition Ratings

- Deck Rating 5 (Fair)
- Superstructure Rating 5 (Fair)
- Substructure Rating 6 (Satisfactory)

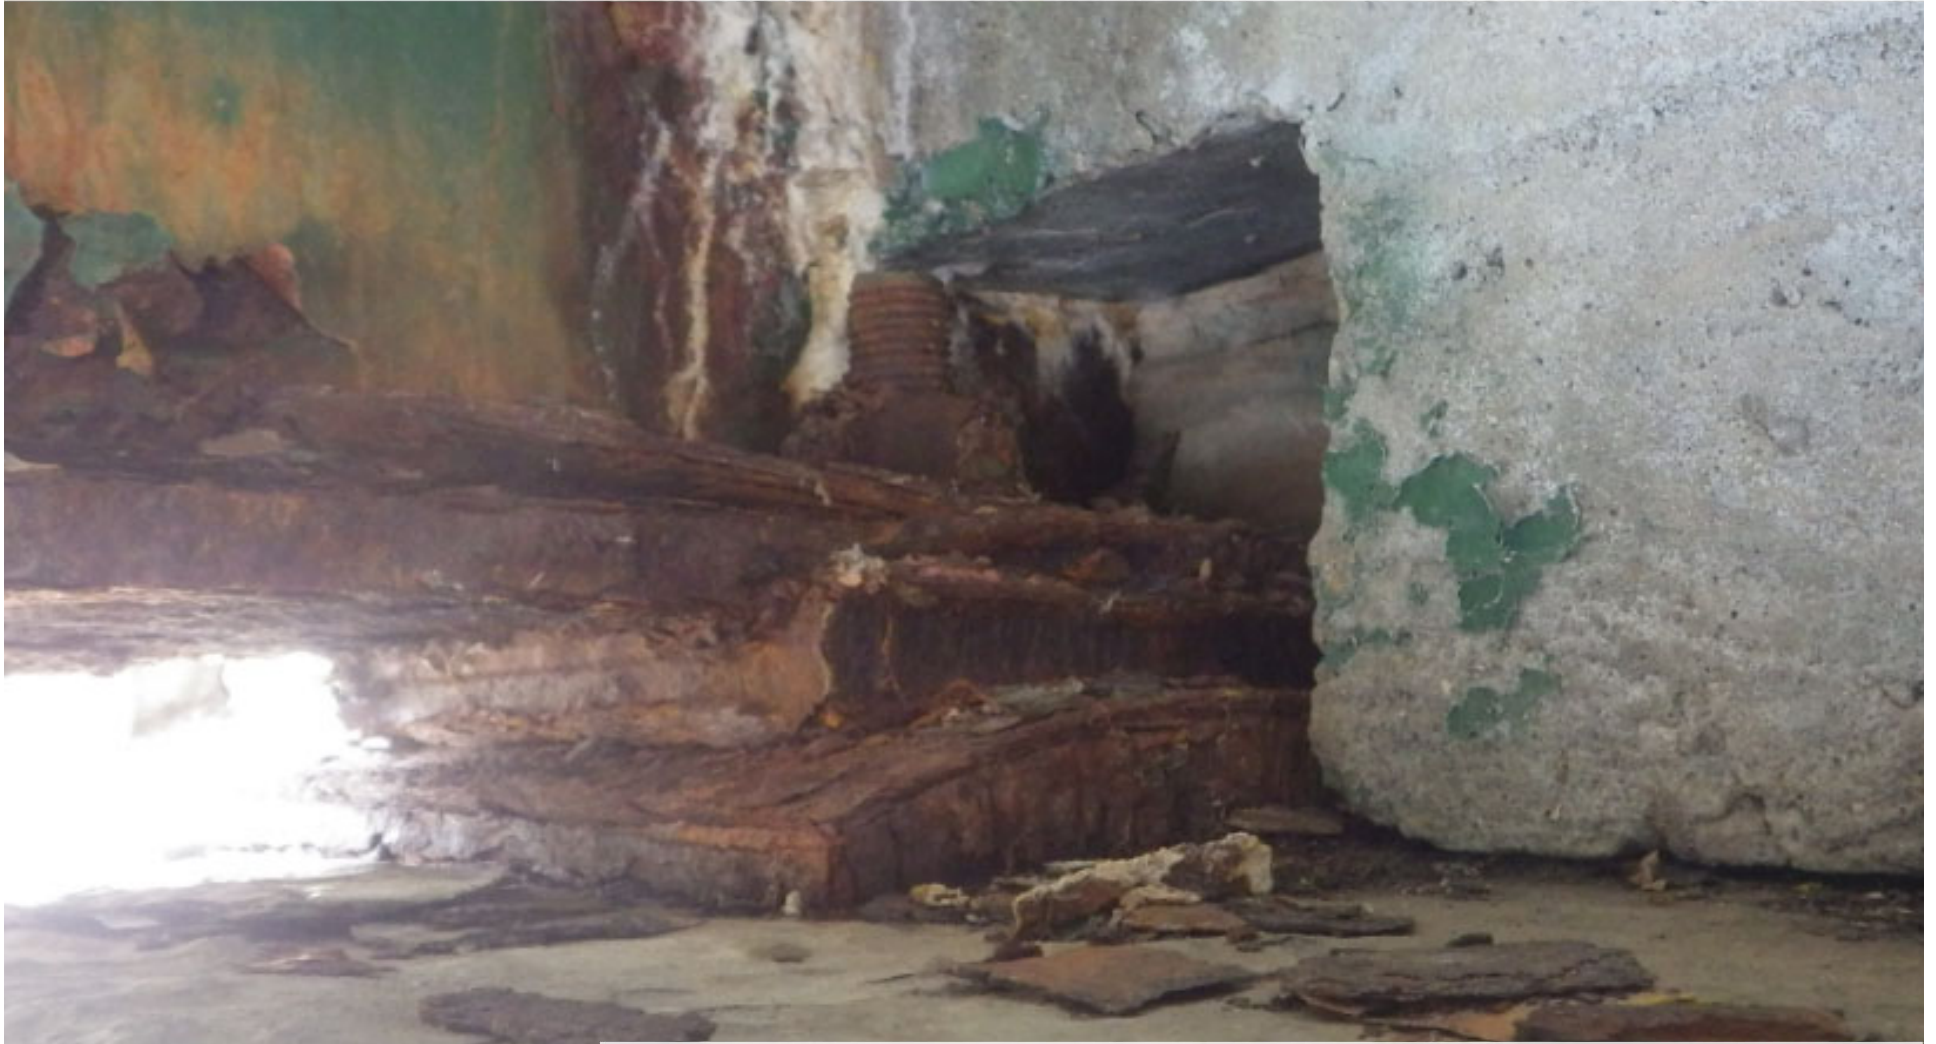
Superstructure – Prior to 2016 Rehabilitation

- heavy section loss in the steel beams at the ends near the pier

- In September of 2016, the superstructure was given a rating of 3 (serious) due to heavy section loss in the steel beams at the ends near the pier. The beam ends were encased in concrete to extend the life of the bridge and prevent beam crushing. Even though the beams are encapsulated in concrete, they will still will continue to rust.

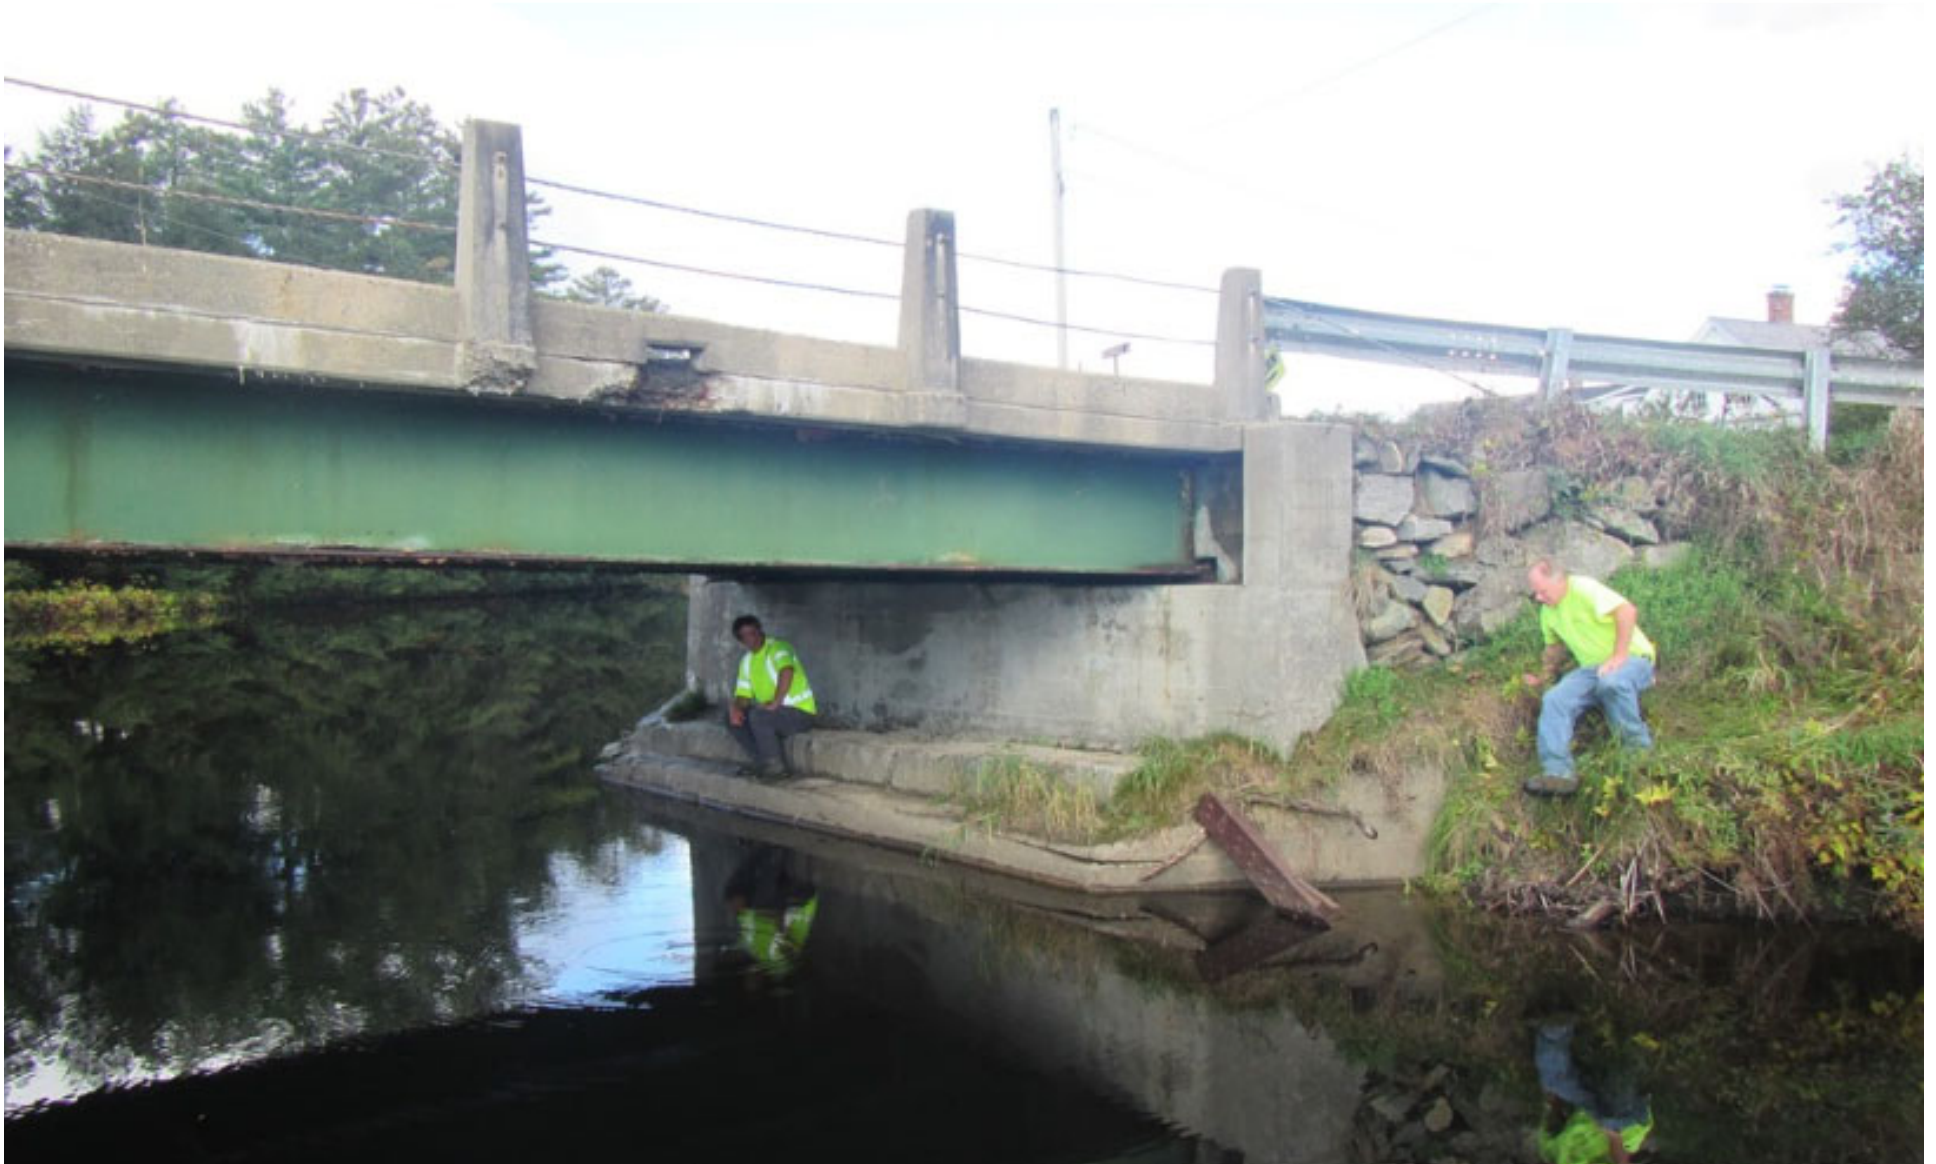
Northern Abutment

- Abutment 2 has some heavy scaling along the upstream knee wall and a minor vertical crack below beam 2.
- The bridge railing is in poor condition
- The bridge and roadway approaches are too narrow for the speed and traffic volumes present.

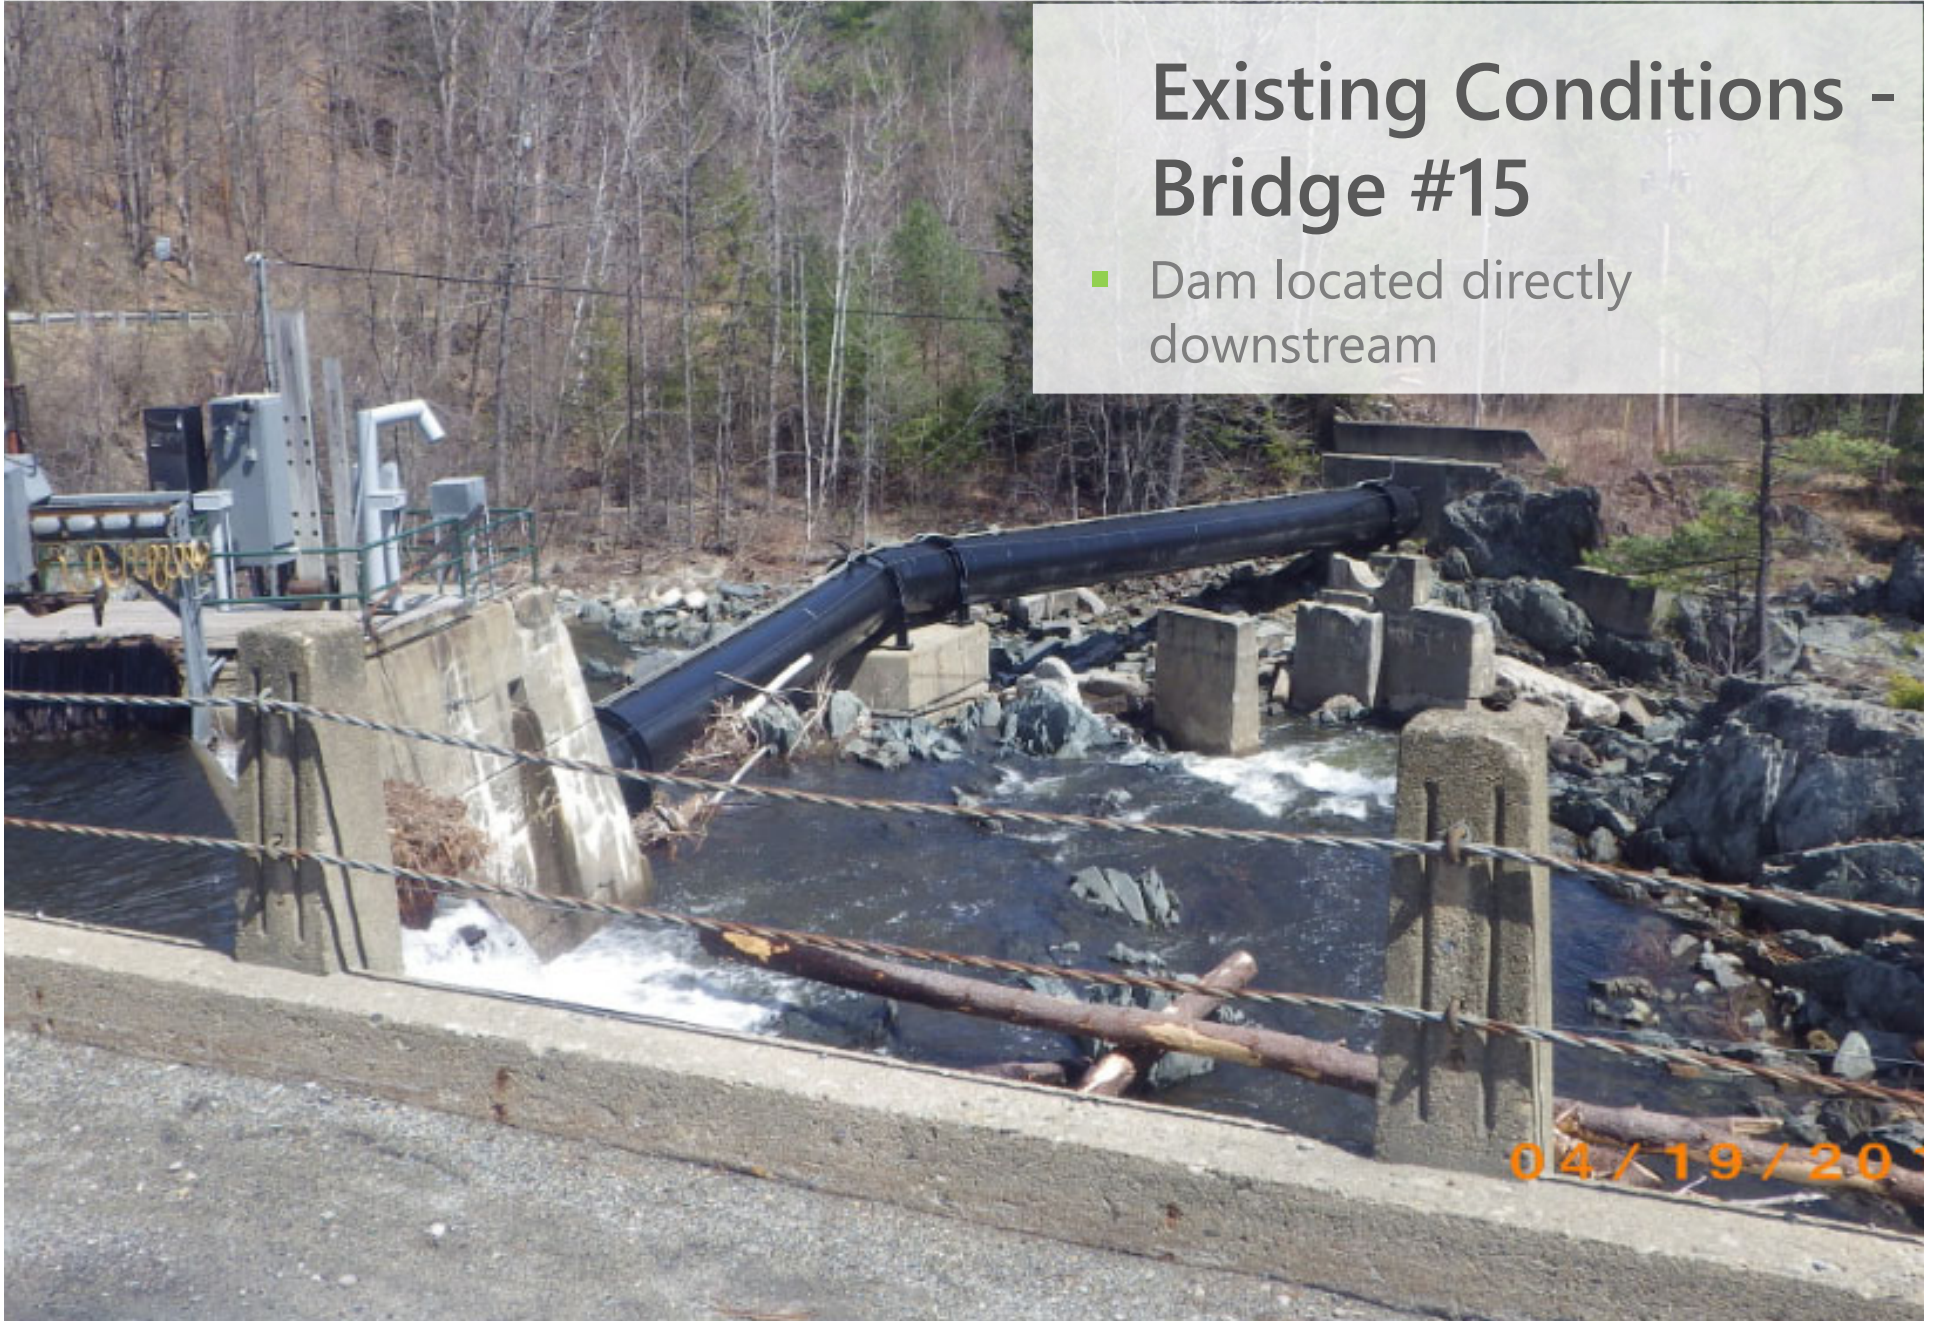
Looking Downstream

- Dam located directly downstream

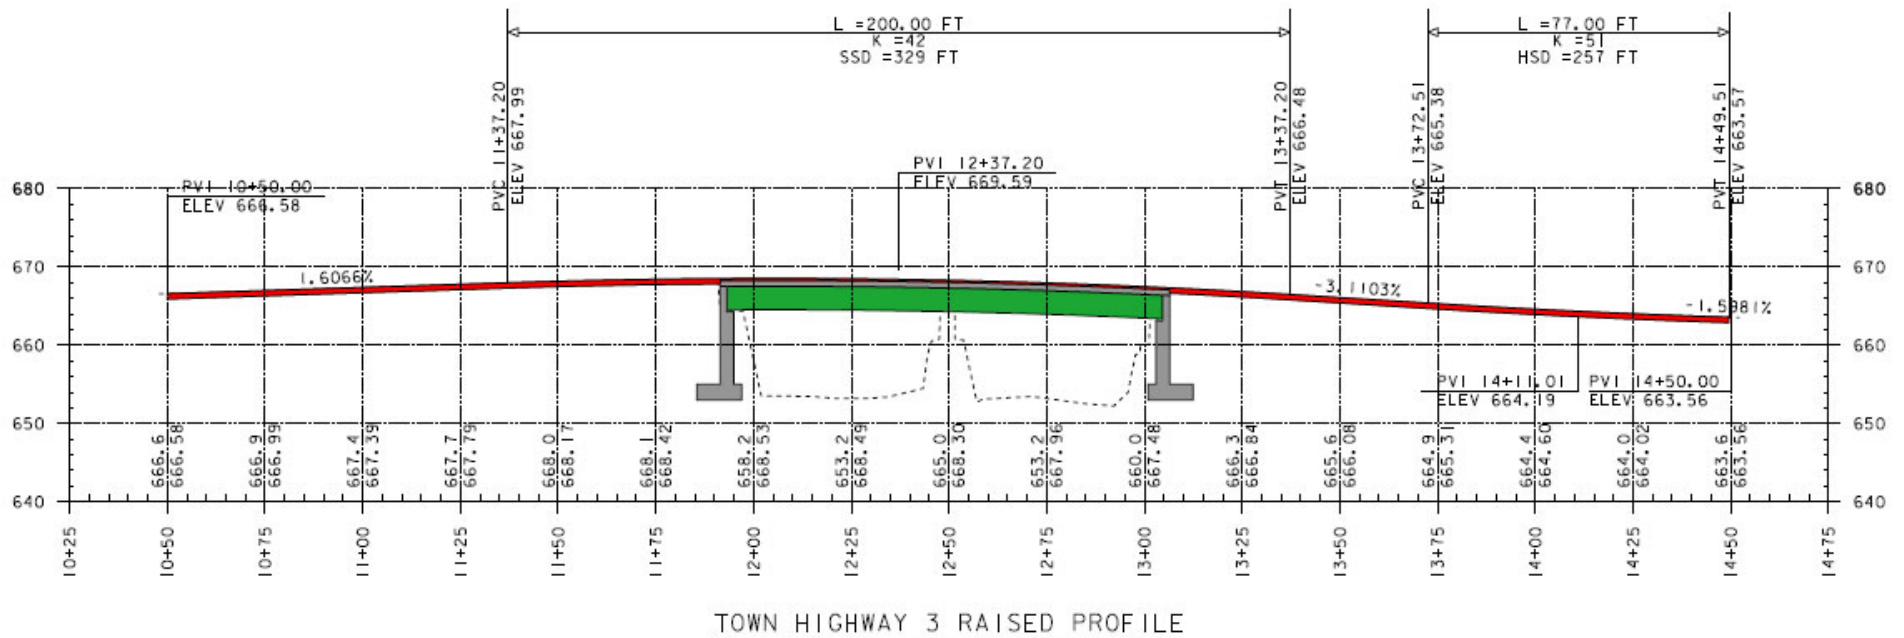
Proposed Profile

- Bridge slightly raised to meet minimum hydraulic requirements

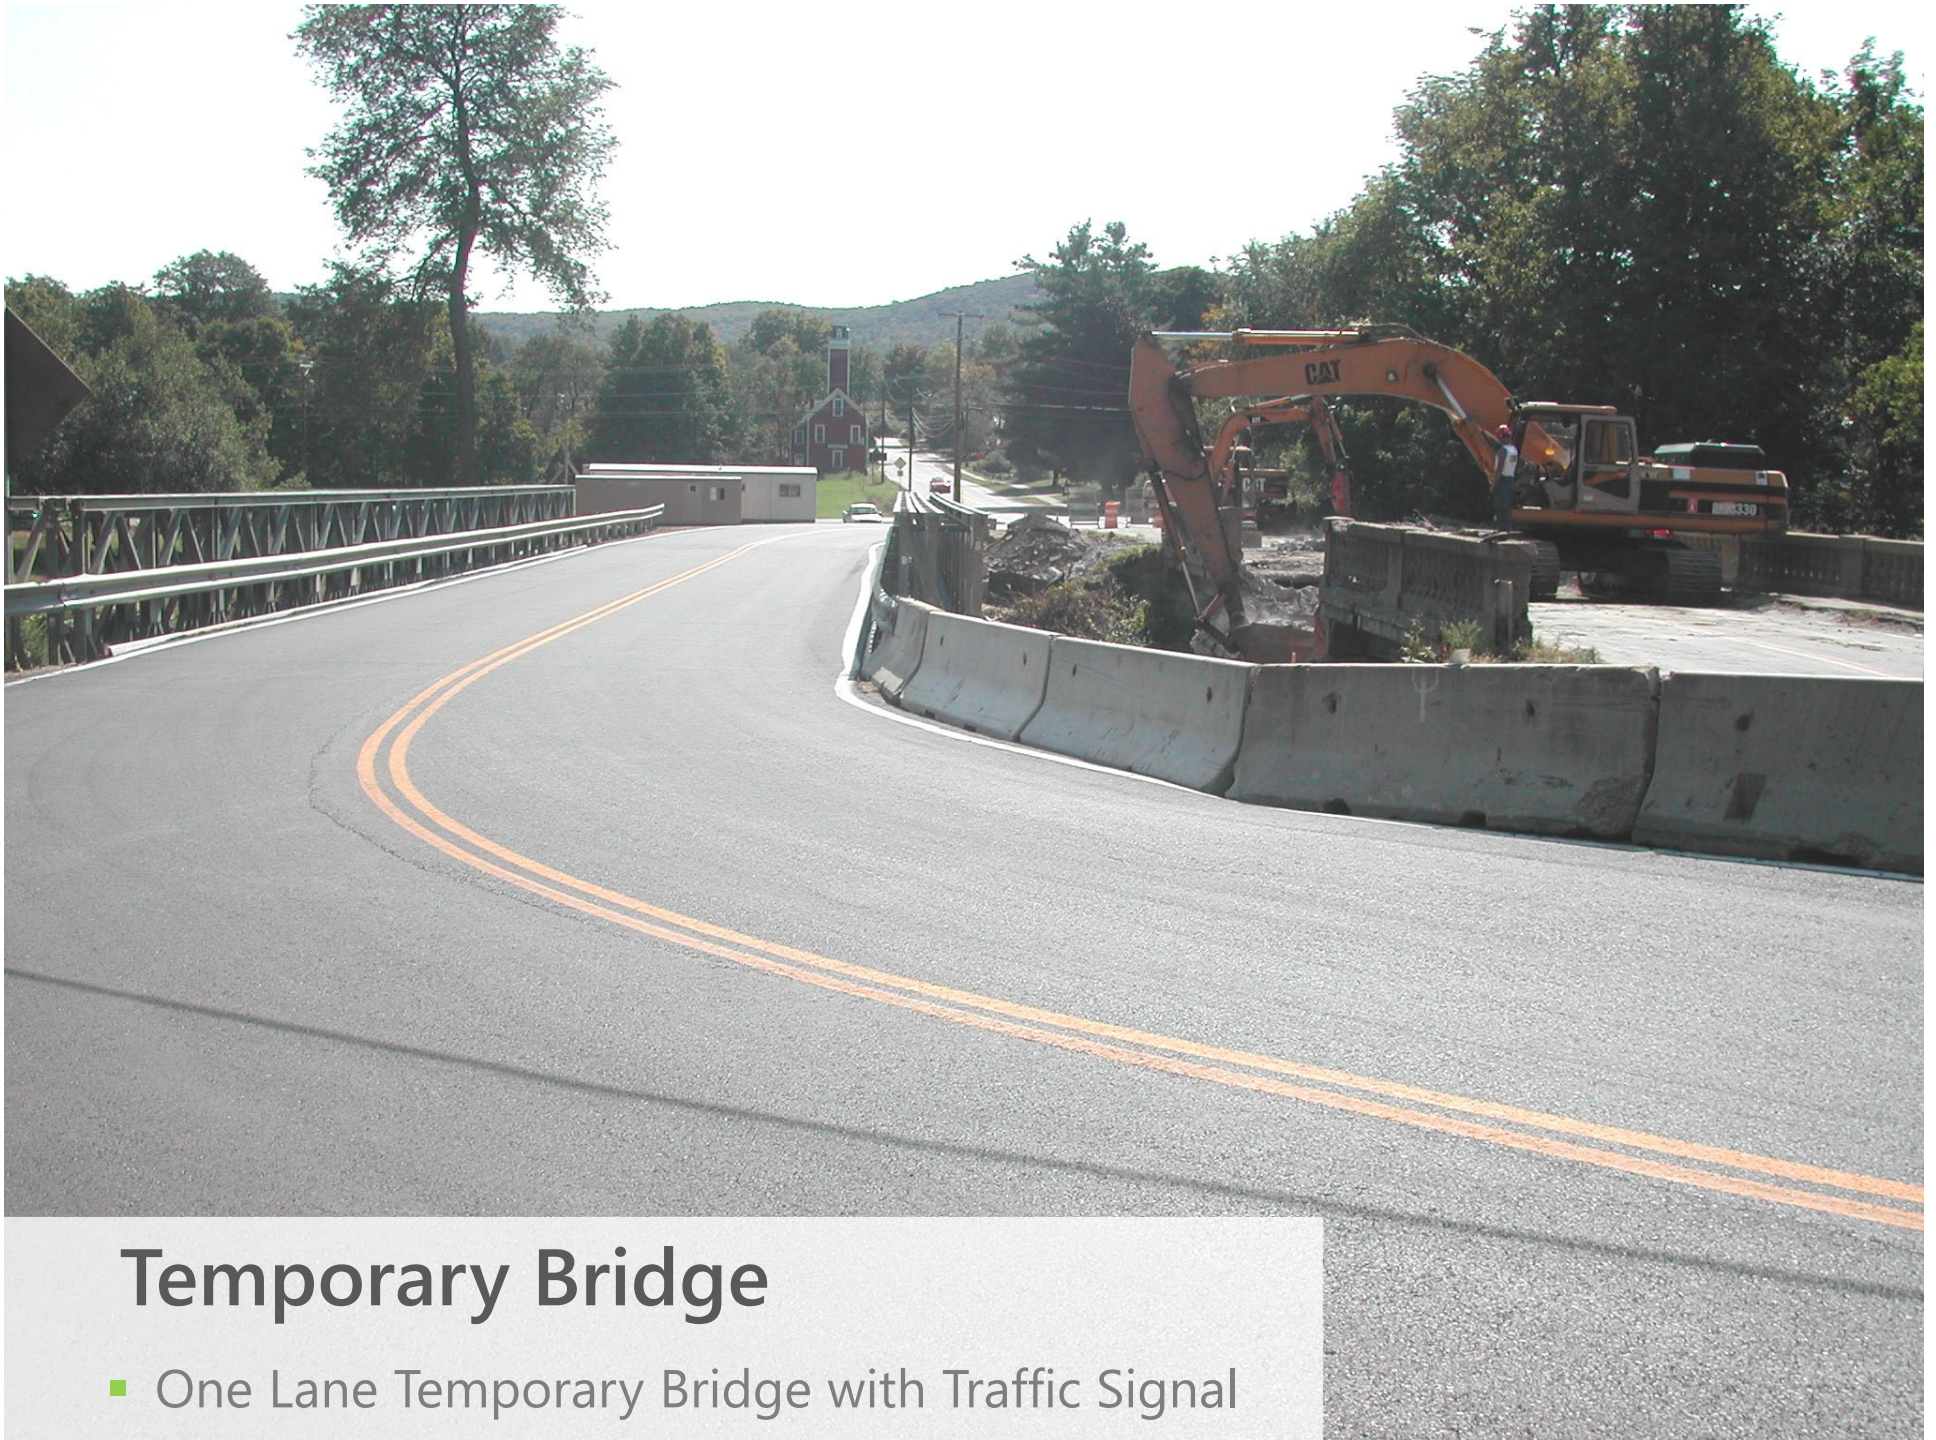
Traffic Control – Offsite Detour

- Detour chosen and signed by Town
- Shortest route is 8 miles end-to-end
- 30 to 60 day closure
- Coordination with Ryegate
- Per Act 153, the local share is reduced by 50% for closing the road to traffic during construction

- Local Detour:
8.1 miles end-to-end
