# Poultney BO 1443(53) Alternatives Presentation Meeting

**Town Highway 6 – Bridge #7 over Poultney River**

April 8, 2019

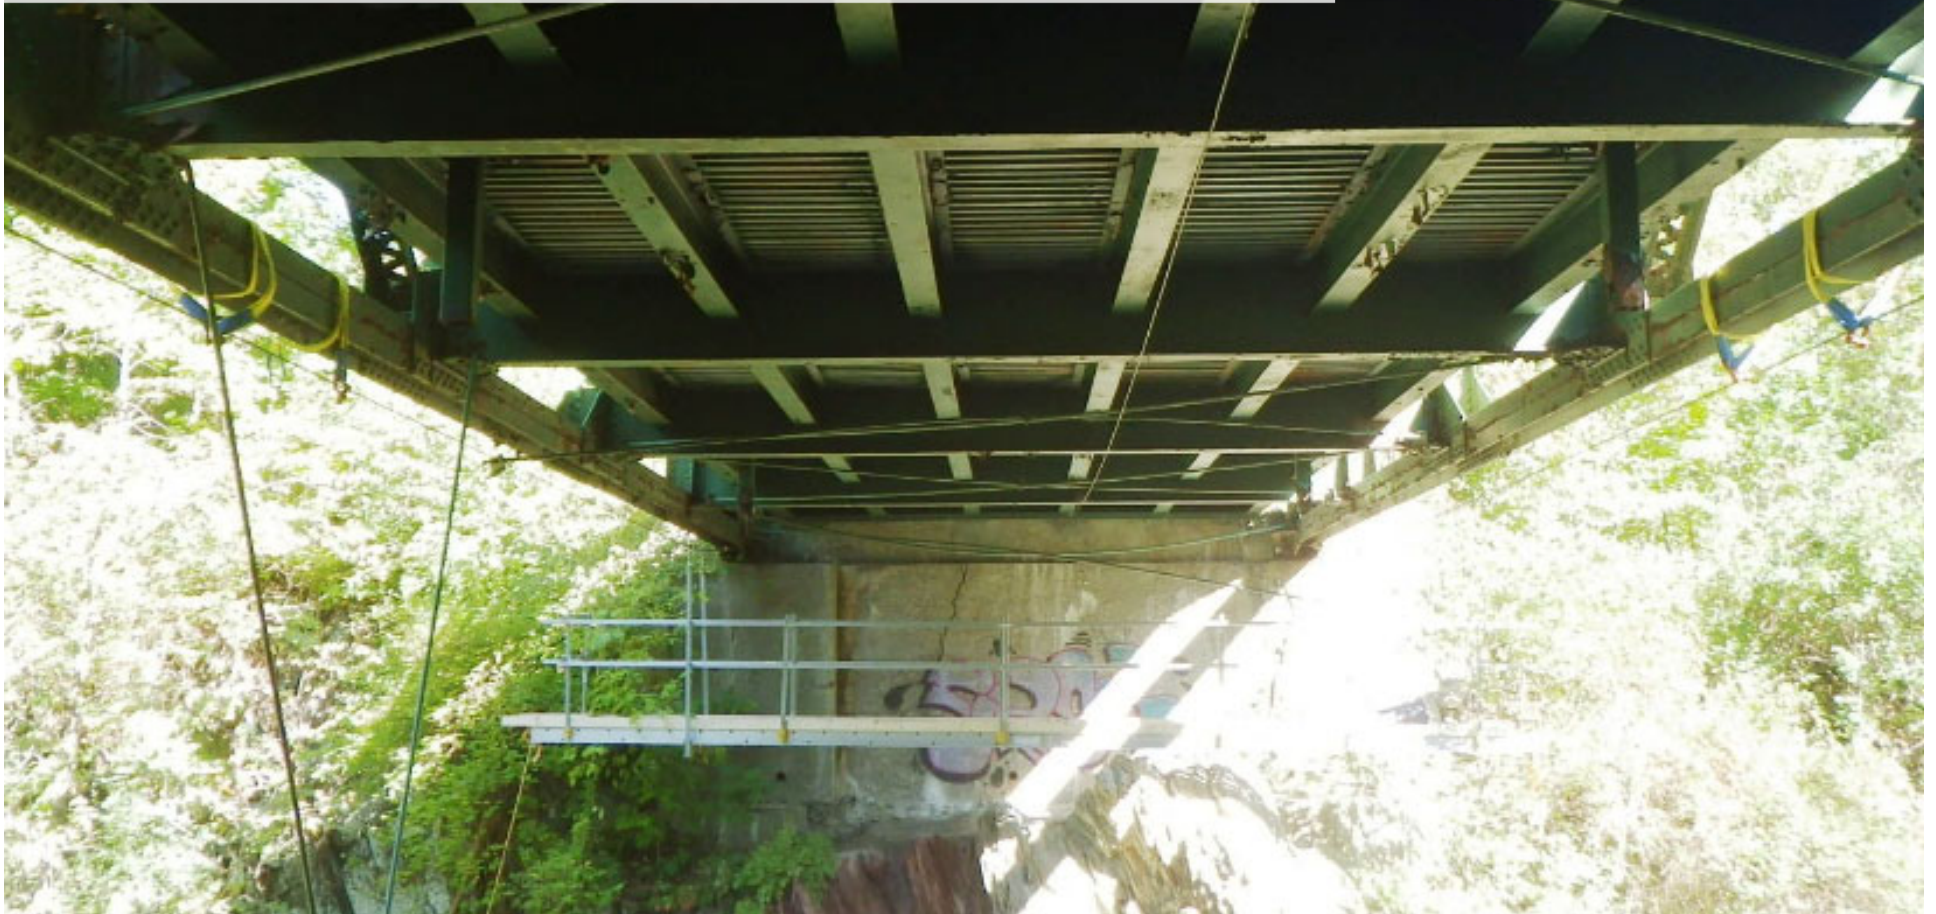
Steel Condition

A close-up photograph of a green-painted steel bridge beam. The paint is heavily chipped and peeling, revealing a dark, rusted metal surface underneath. The beam is part of a larger structure, with other beams and rivets visible in the background. The lighting is bright, suggesting a sunny day.

- Paint failure and minor section loss

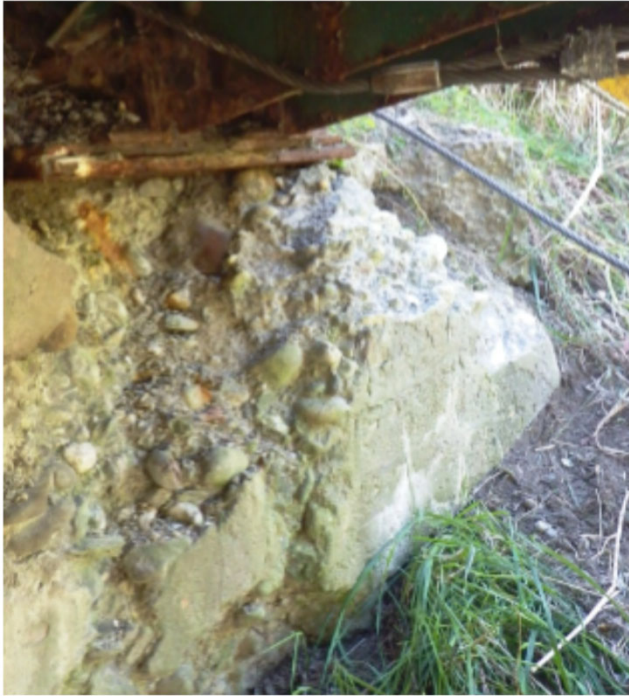
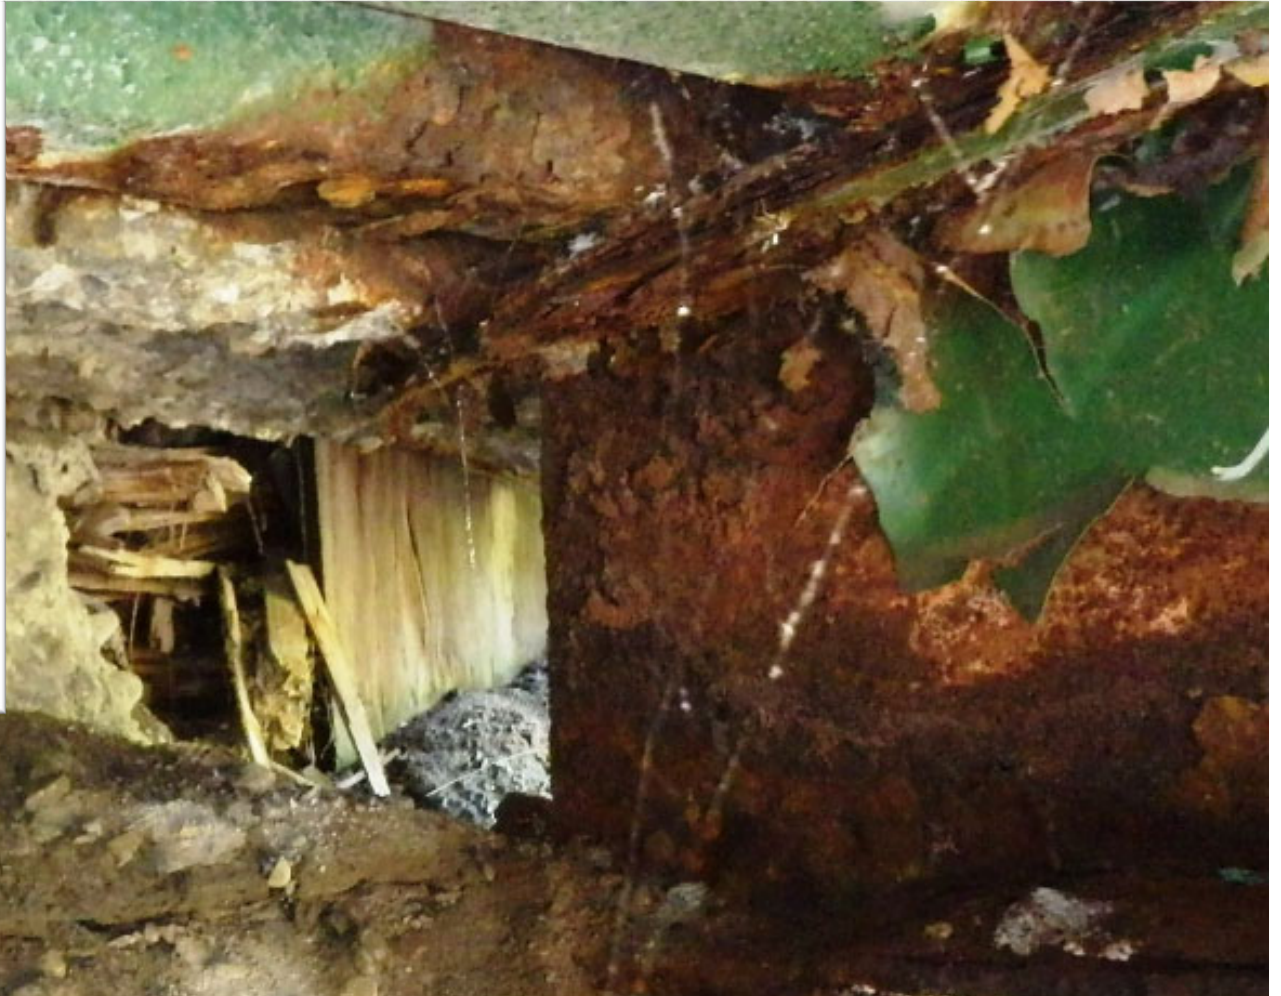
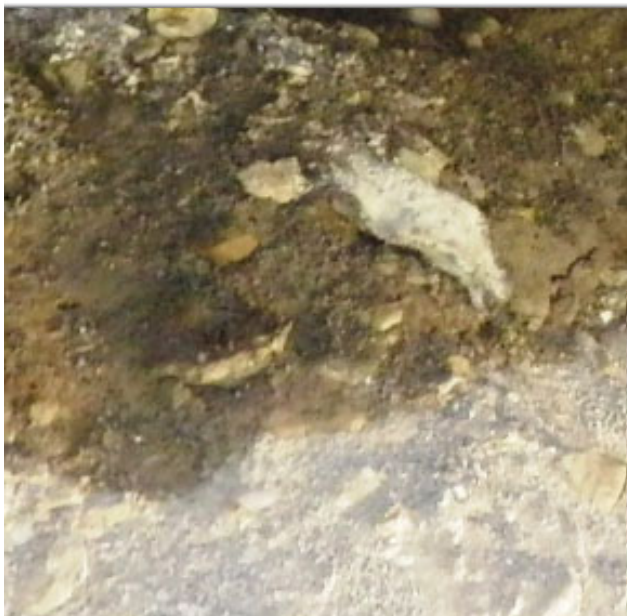
## Southern Abutment

- Significant spalling
- Failed backwall

- Bridge 7 is Functionally Deficient due to substandard rail to rail width.
  - One lane bridge with a curb to curb width of 18-feet
- The bottom chords and lateral bracing of the truss have section loss and there is a hole in the 3rd floor beam
- The southern abutment concrete, especially at the bridge seat, is deteriorating
- The Bridge is posted for 9 tons.

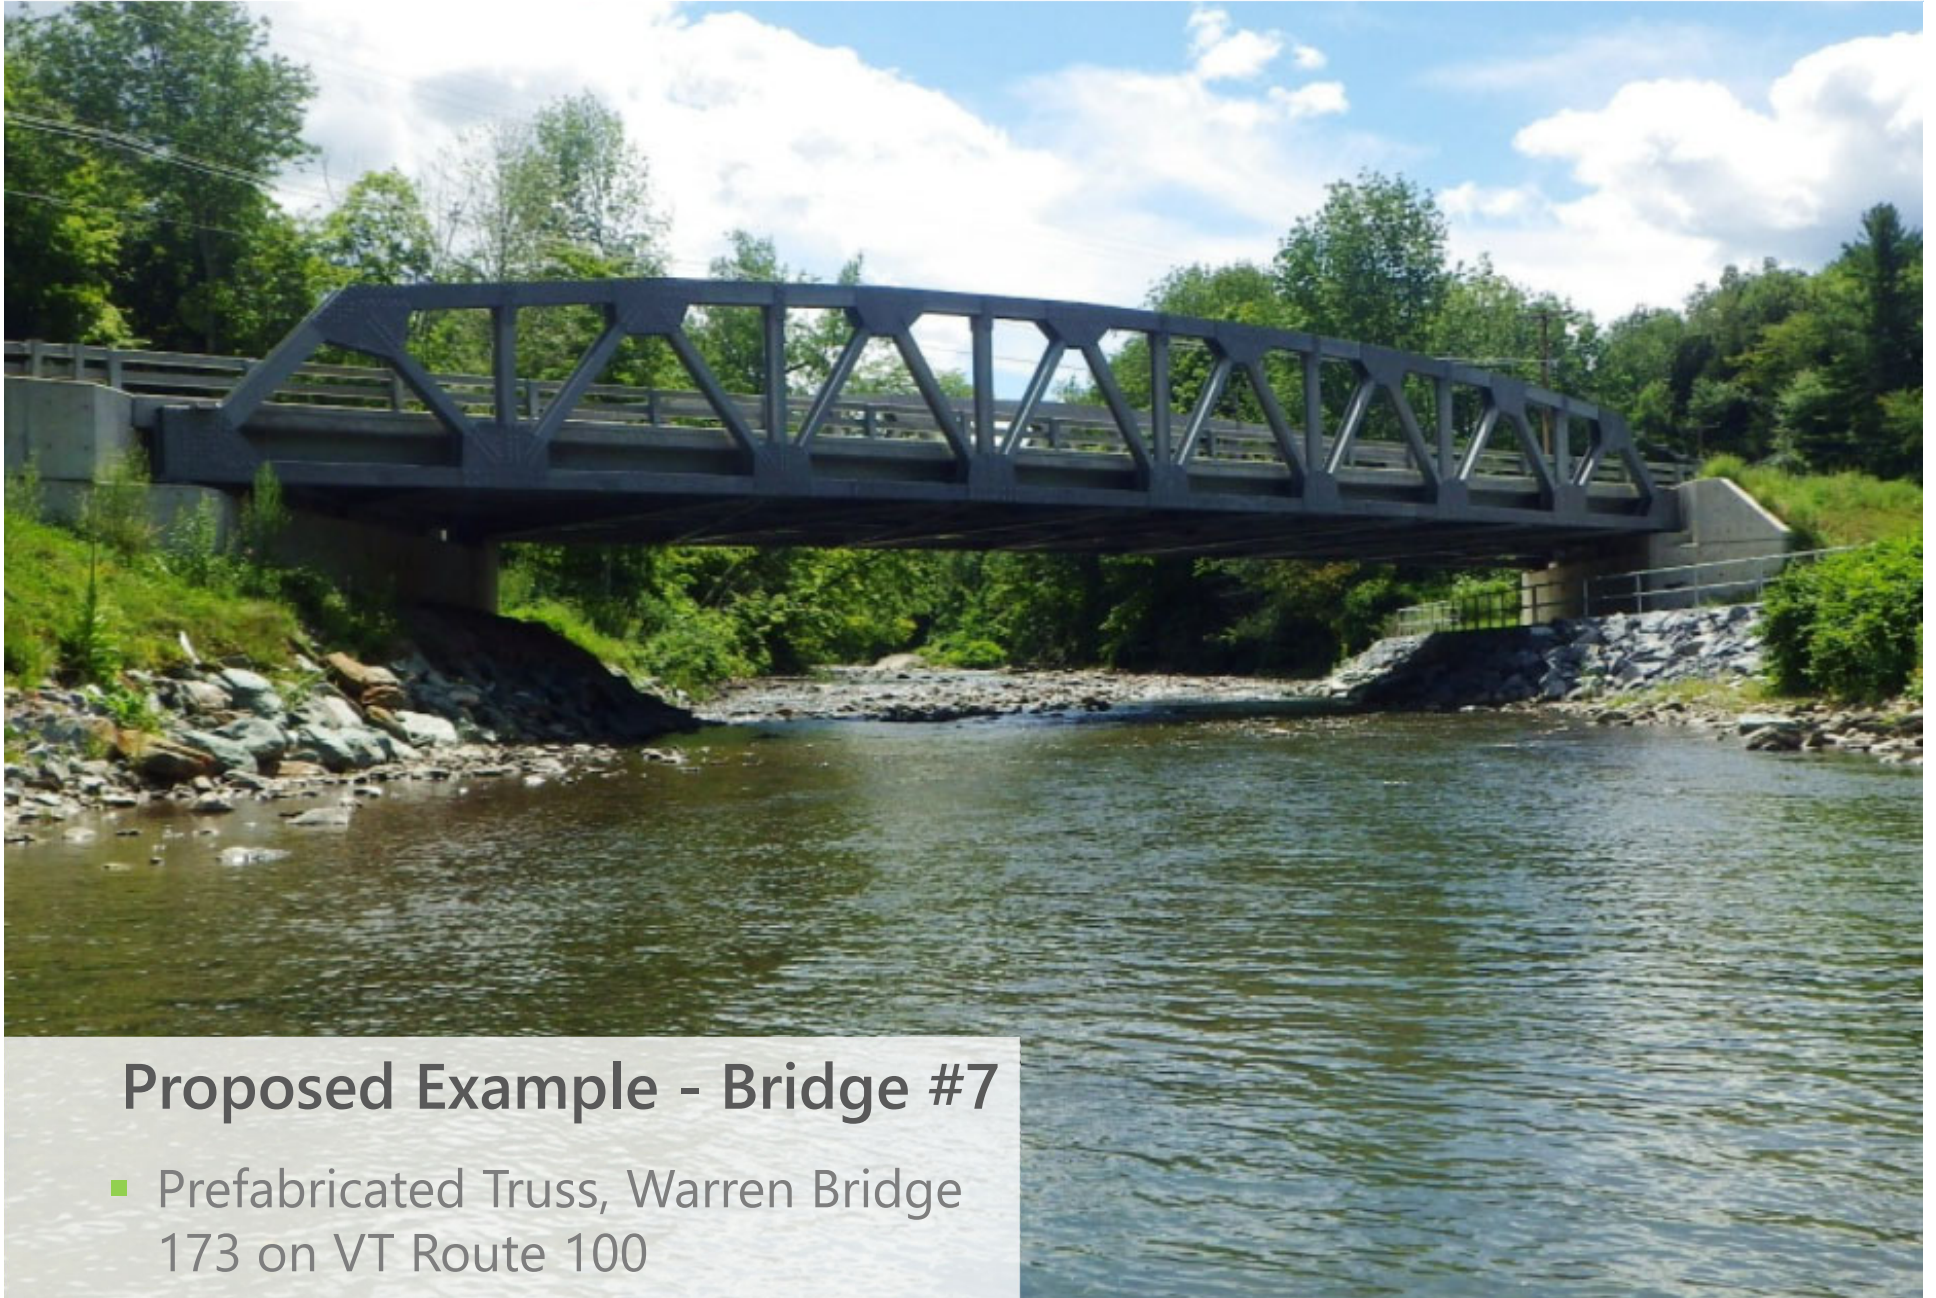
What Will the New Bridge Look Like?

- Prefabricated Truss, Warren Bridge 173 on VT Route 100

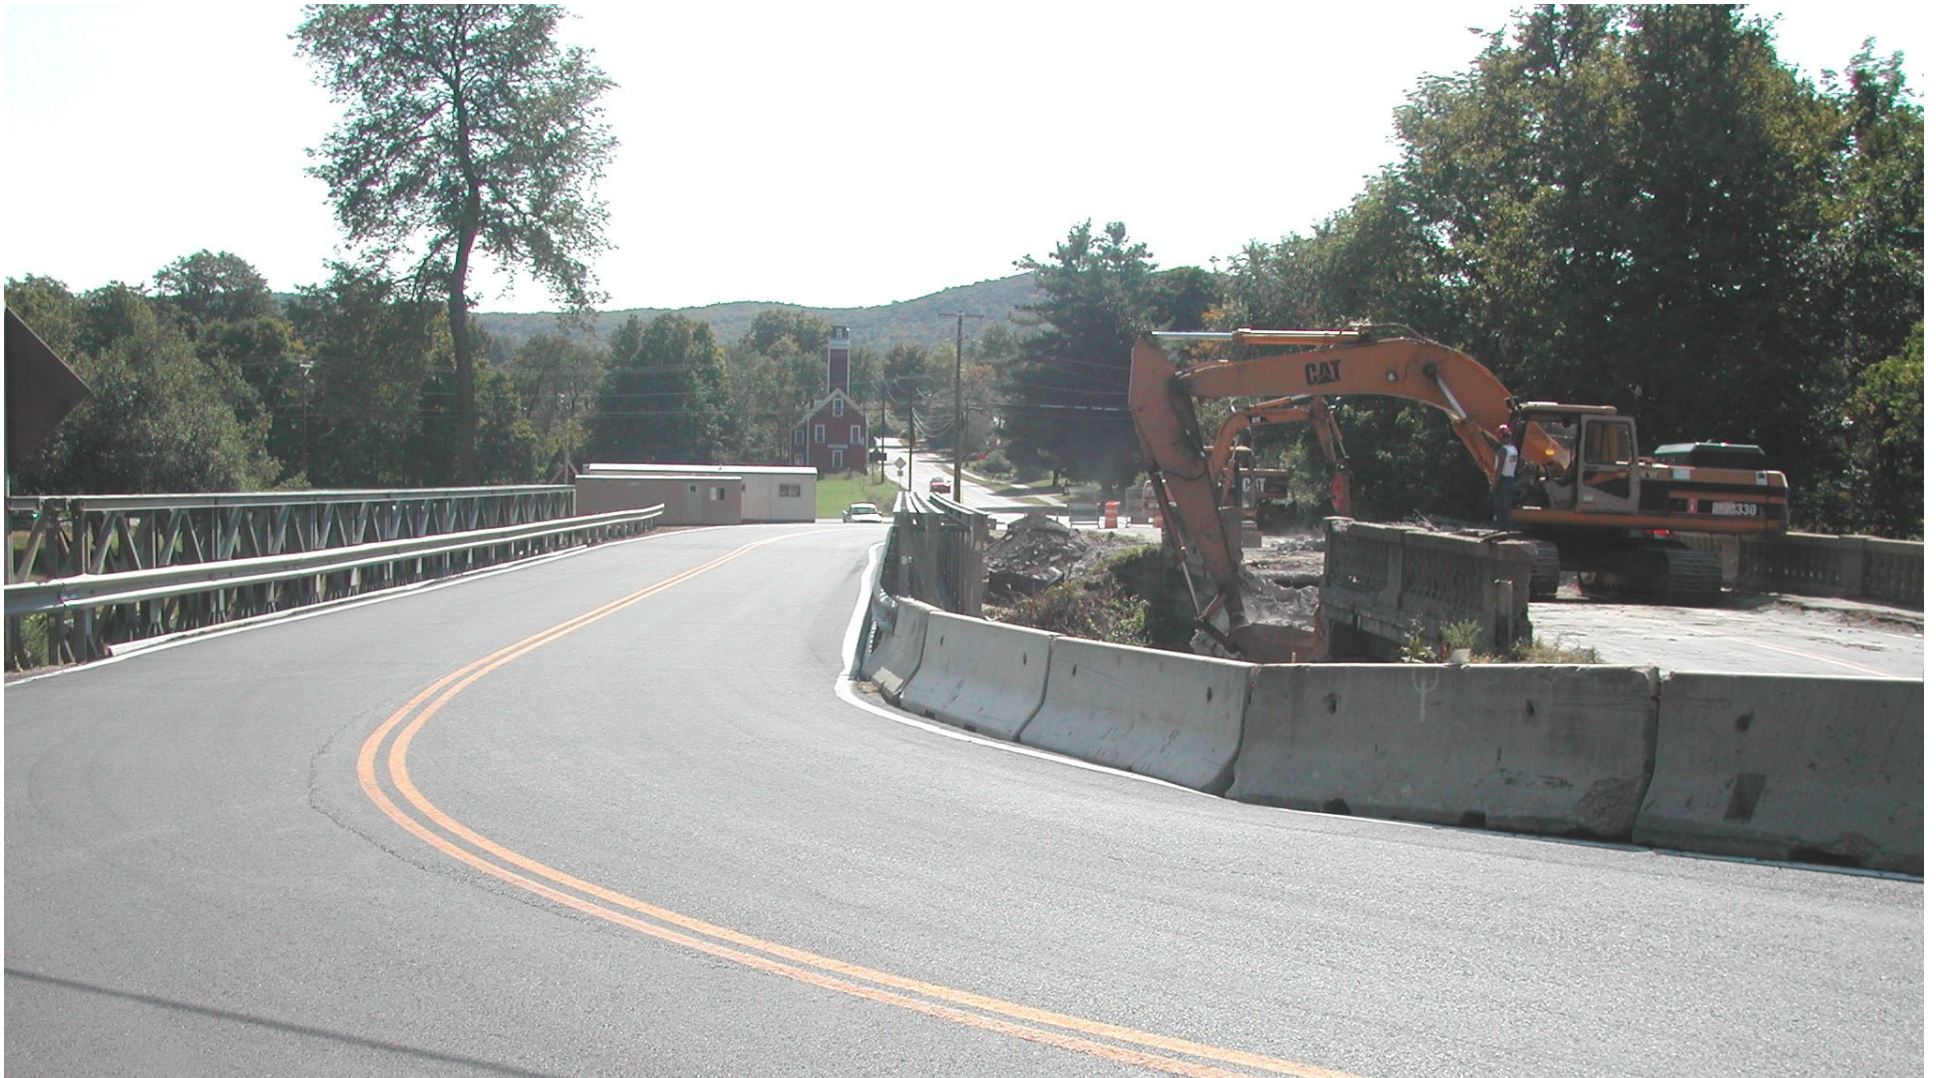
## Temporary Bridge

- One Lane Upstream Temporary Bridge with Traffic Signal
  - Would require temporary garage move
- Downstream temporary bridge would go through house
