**STATE OF VERMONT
AGENCY OF TRANSPORTATION**

Scoping Report

**Salisbury-Cornwall 1445(39)
Town Highway 1/3, Bridge 8 over Otter Creek**

September 20, 2021

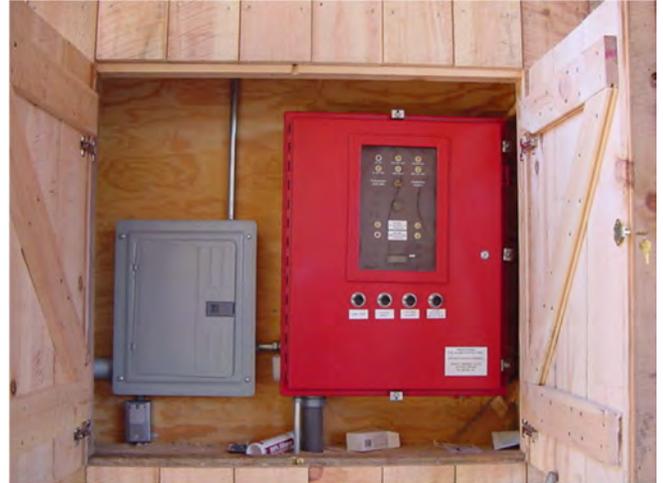
Fire Detection System (Protectowire)

If a fire is started, it is advantageous to notify the local fire department as soon as possible. The “Protectowire” is a proprietary alert system that works by running a small wire through key locations in the bridge. The sensor cable is comprised of steel conductors individually insulated with a heat sensitive polymer. The insulated conductors are twisted together to impose a spring pressure between them and wrapped with a protective tape. If a rapid rise in temperature is detected or if a wire is cut, the system alerts the local mutual aid or fire department. This advanced warning can greatly reduce fire damage to a bridge and hopefully prevent the fire from making the bridge a total loss.

It should be noted that there is an annual maintenance cost associated with this system. The system requires power and a phone line (land or cell) to contact mutual aid. In addition, the control box contains batteries that have small electric strip heaters on them to prevent damage from freezing during cold weather. The control box is typically hidden at the end of the bridge in siding and can be well insulated to reduce electrical costs.

The fire detection system has an upfront cost of approximately \$40,000, which would be a participating cost for the project.

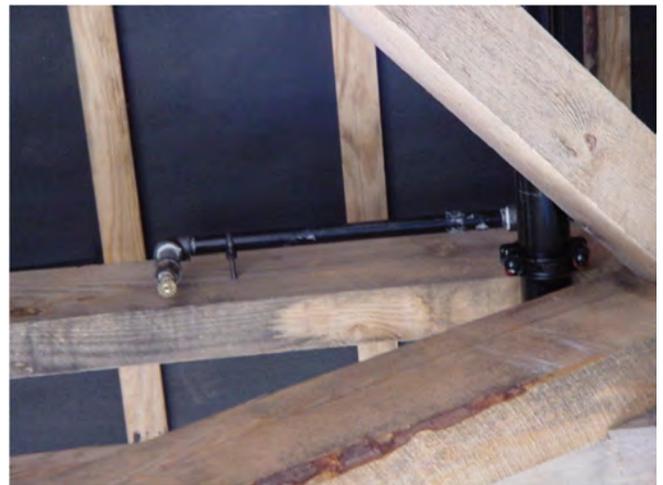
Dry Deluge Sprinkler System

The purpose of a deluge sprinkler system is to prevent the spread of fire by wetting down the entire fire area. The sprinkler system typically used includes dry pipes with a fire department connection away from the ends of the bridge. During a fire, the fire department feeds the system which directs water to the source of the fire. The majority of the piping and heads are in the roof; however, coverage is also provided under the bridge at the abutments. These systems are typically used in long or multi-span bridges where the fire department cannot effectively fight the fire near the center of the bridge.

The sprinkler system has an upfront cost of approximately \$100,000, which would be a participating cost for the project.

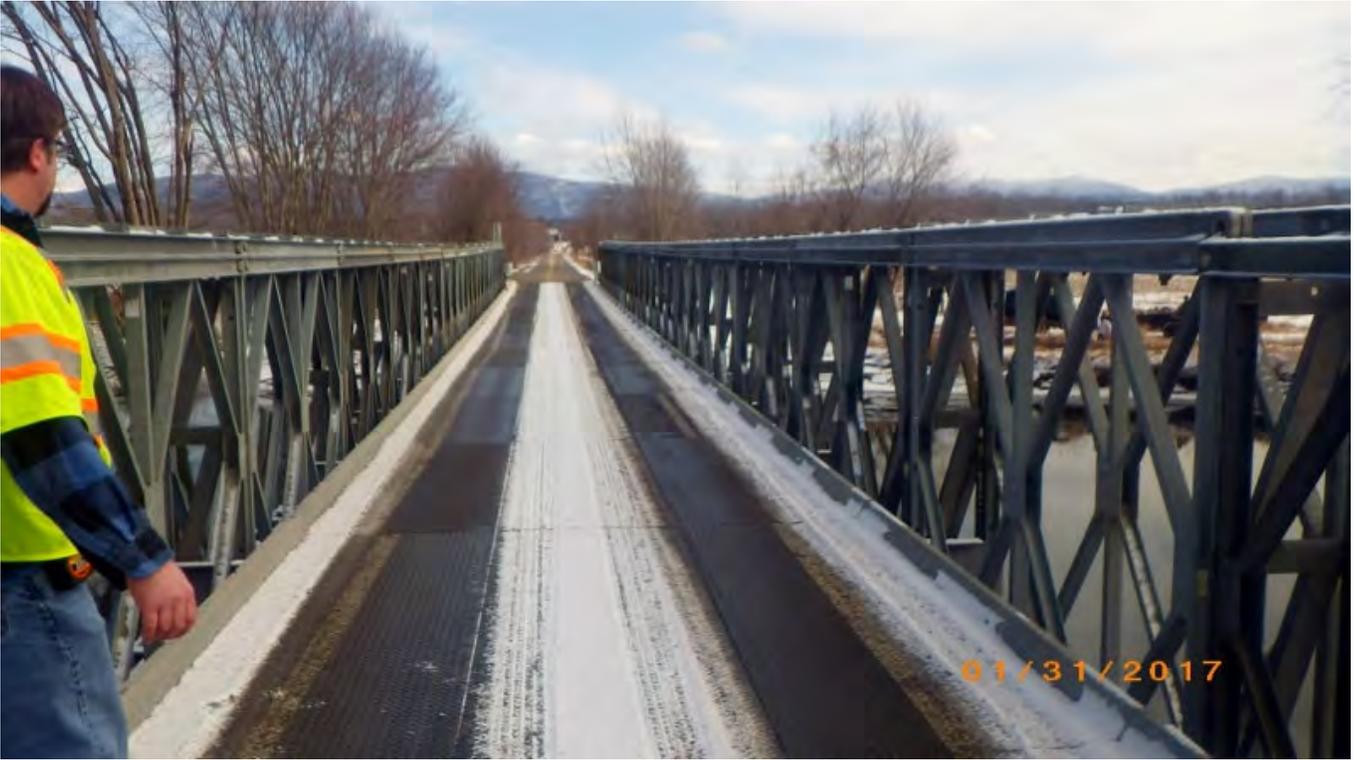
Picture one: Looking East over temporary bridge

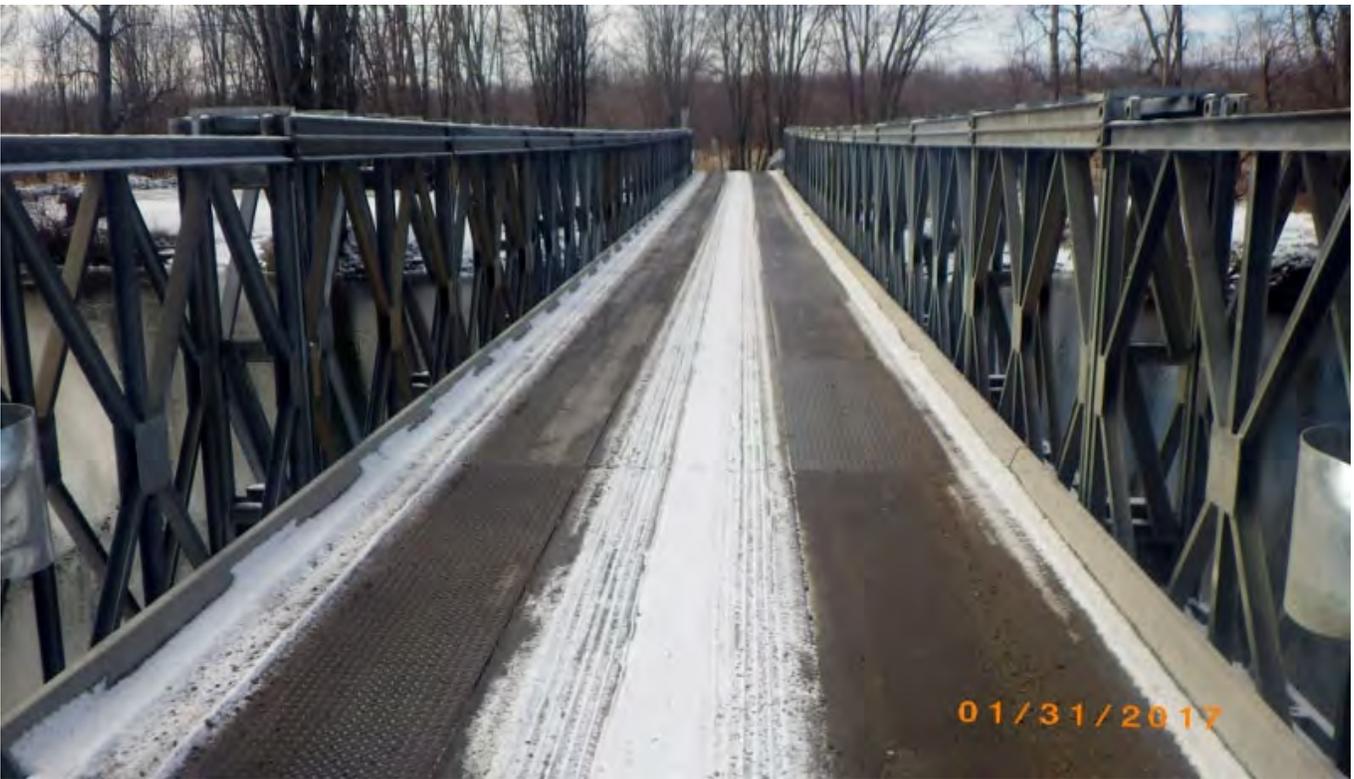
Picture two: Looking West over temporary bridge

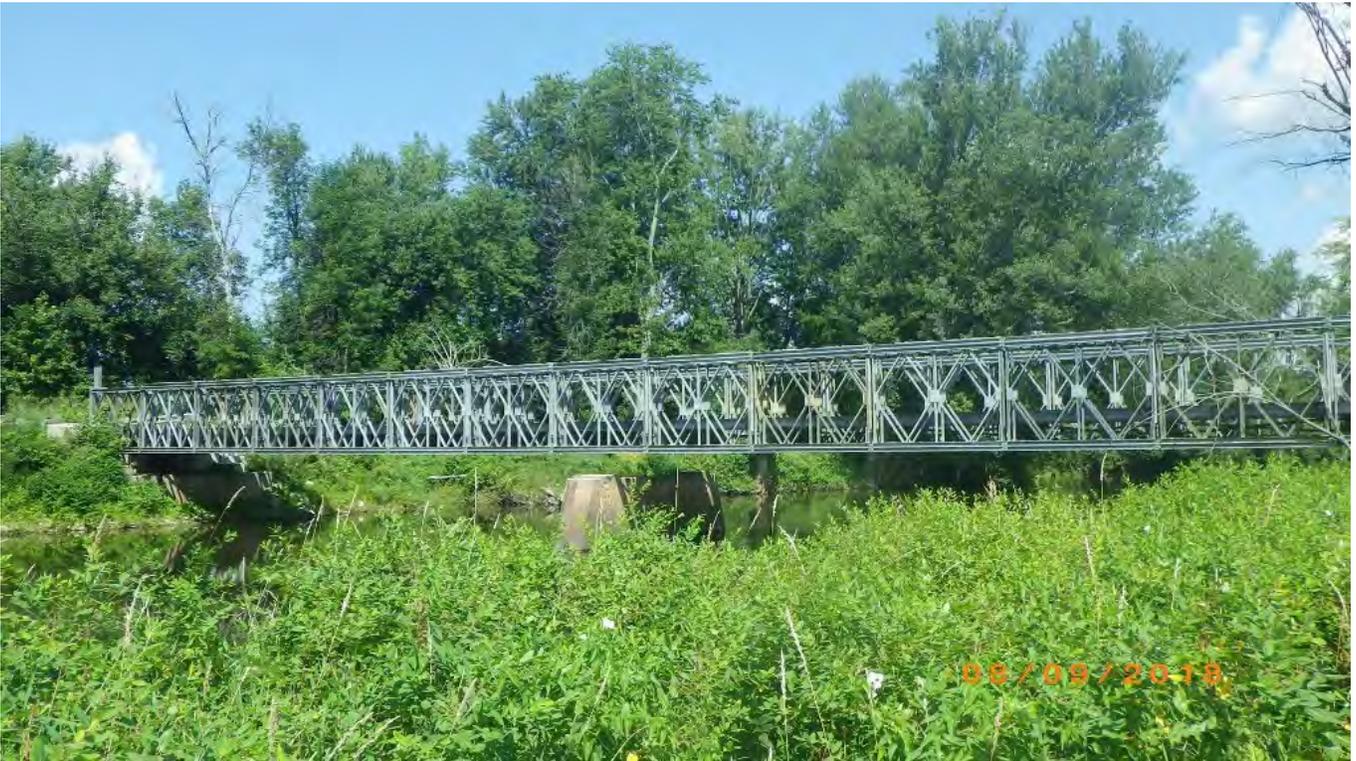
Picture three: Existing temporary bridge

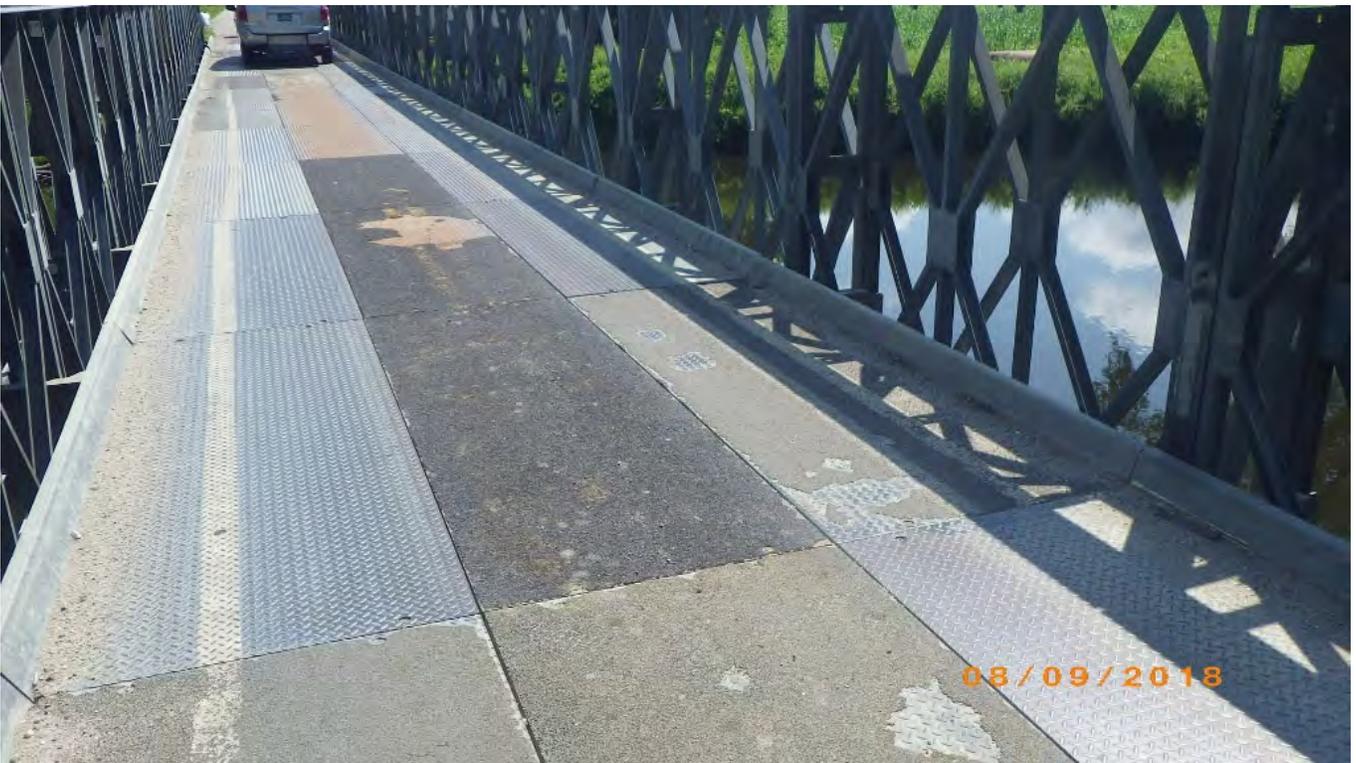
Picture four: Existing deck

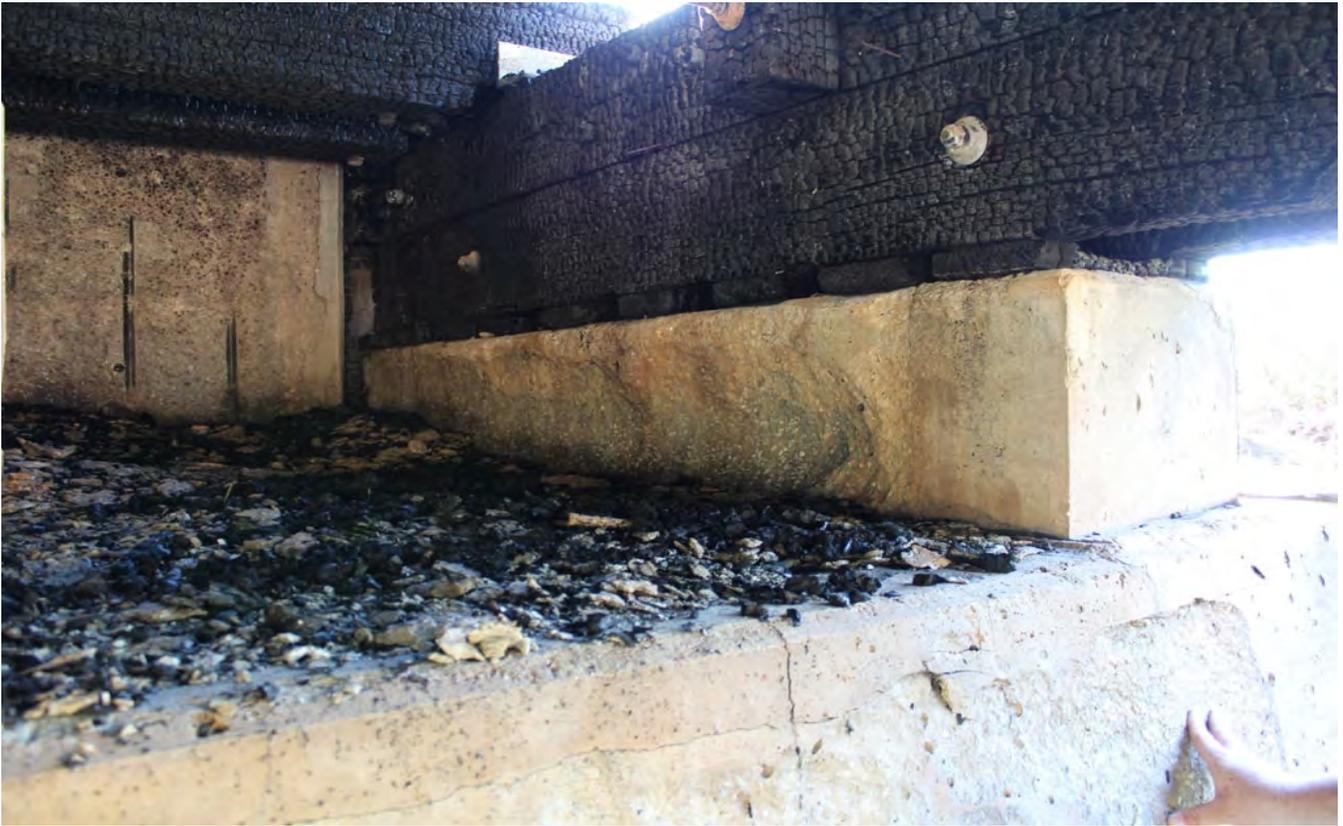
Picture five: Fire damage to existing abutments

Rehabilitation is not possible for this project. The superstructure has been completely destroyed and the existing abutments have likely suffered fire damage as well and therefore would not be viable for recovery.

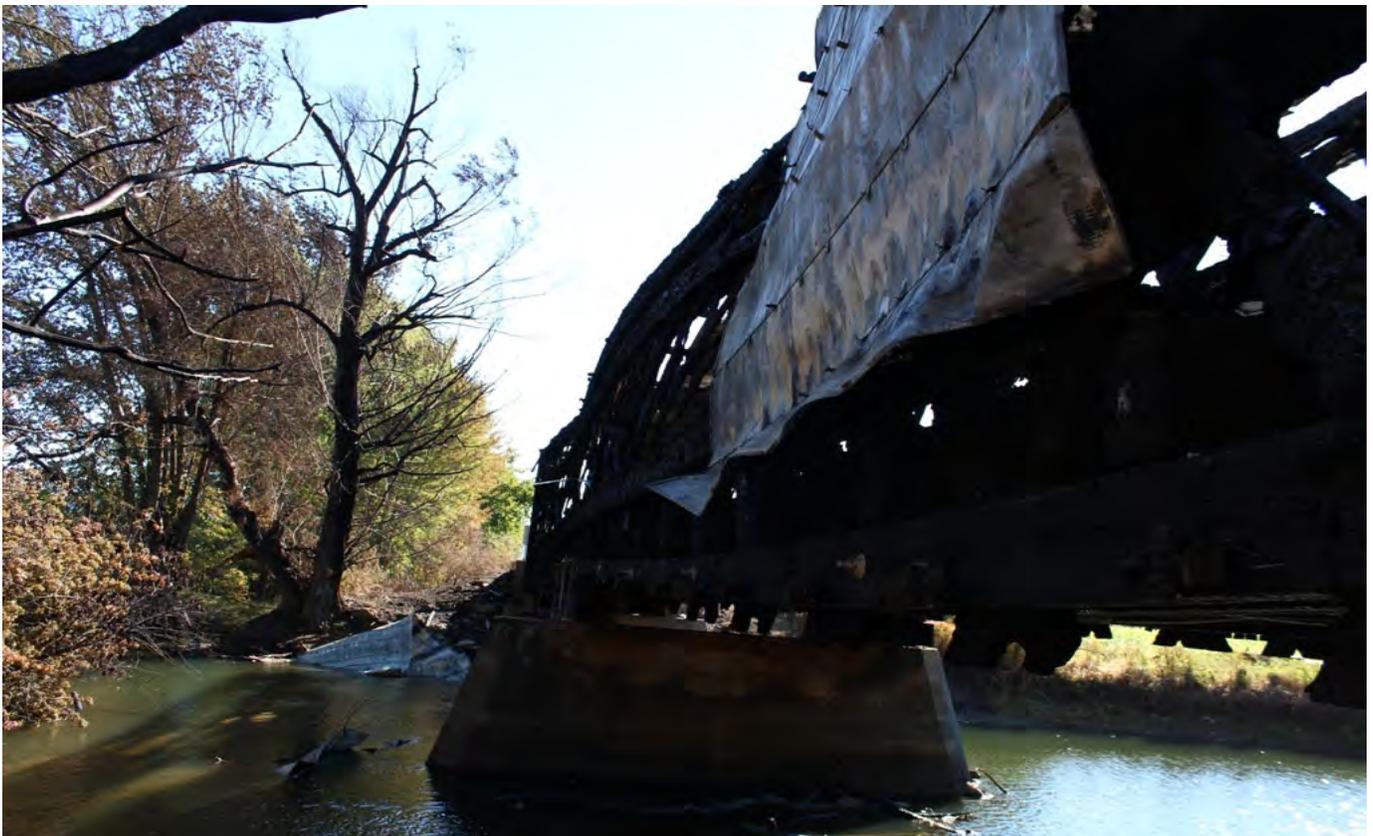
Picture six: Fire damage to existing center pier

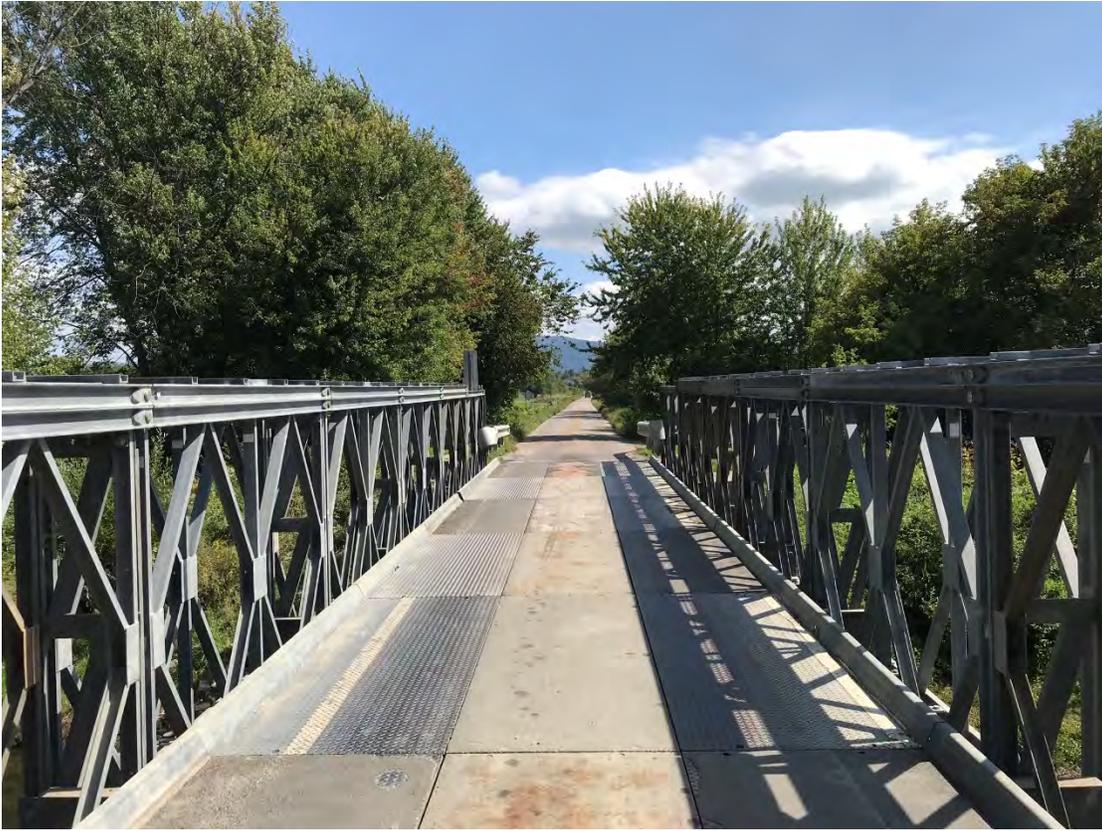
Figure 3.1: *Facing east; note steel plate deck on temporary bridge.*

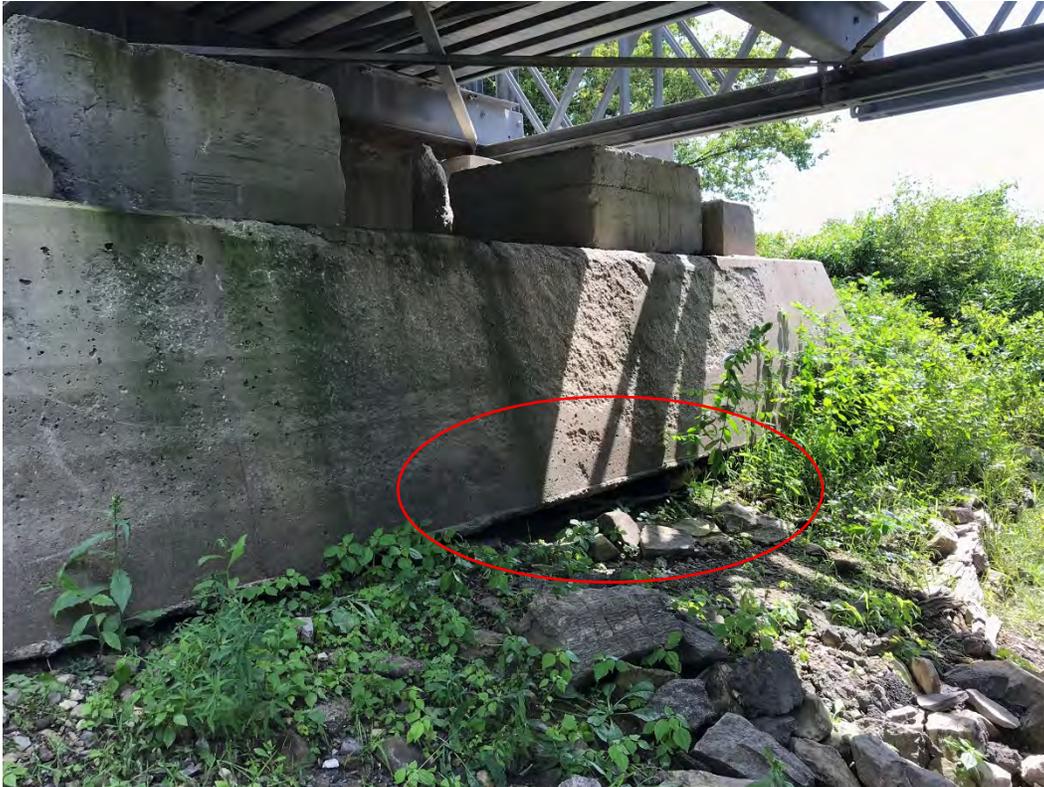
Figure 3.3: Facing eastern abutment; note material loss exposing bottom of abutment and spalling of concrete.

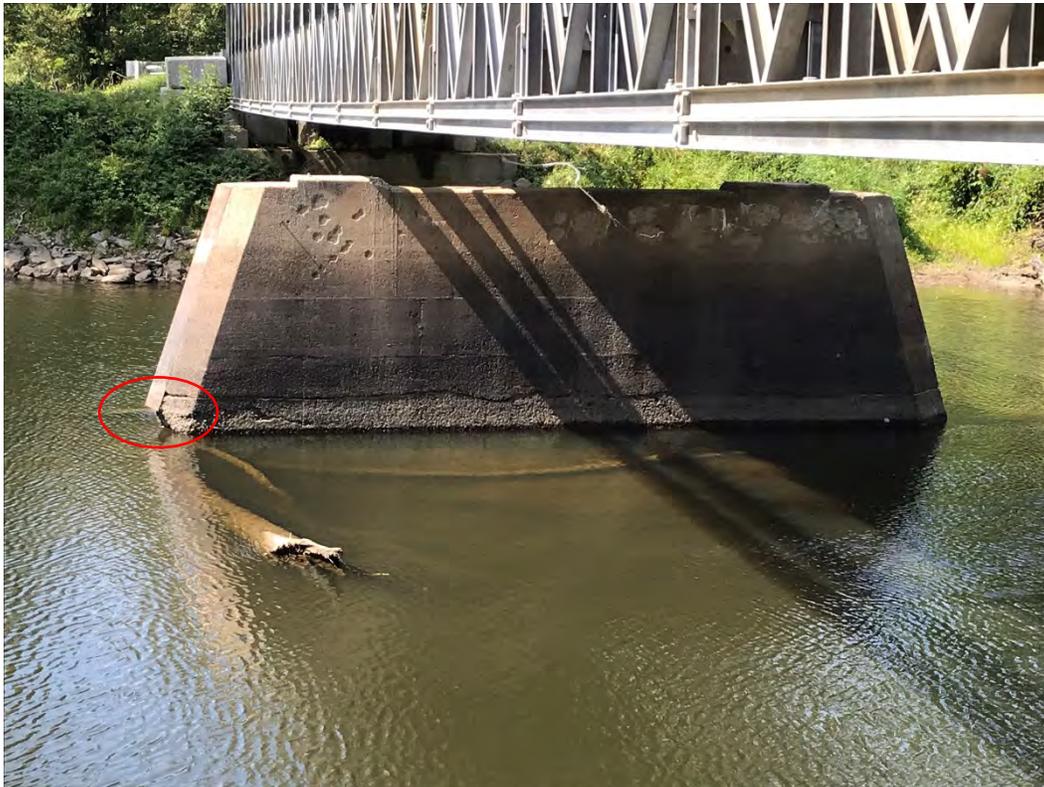
Figure 3.4: Facing west towards center pier; note spalling of concrete and exposure of bottom of pier. Temporary bridge is not connected to or bearing on pier.

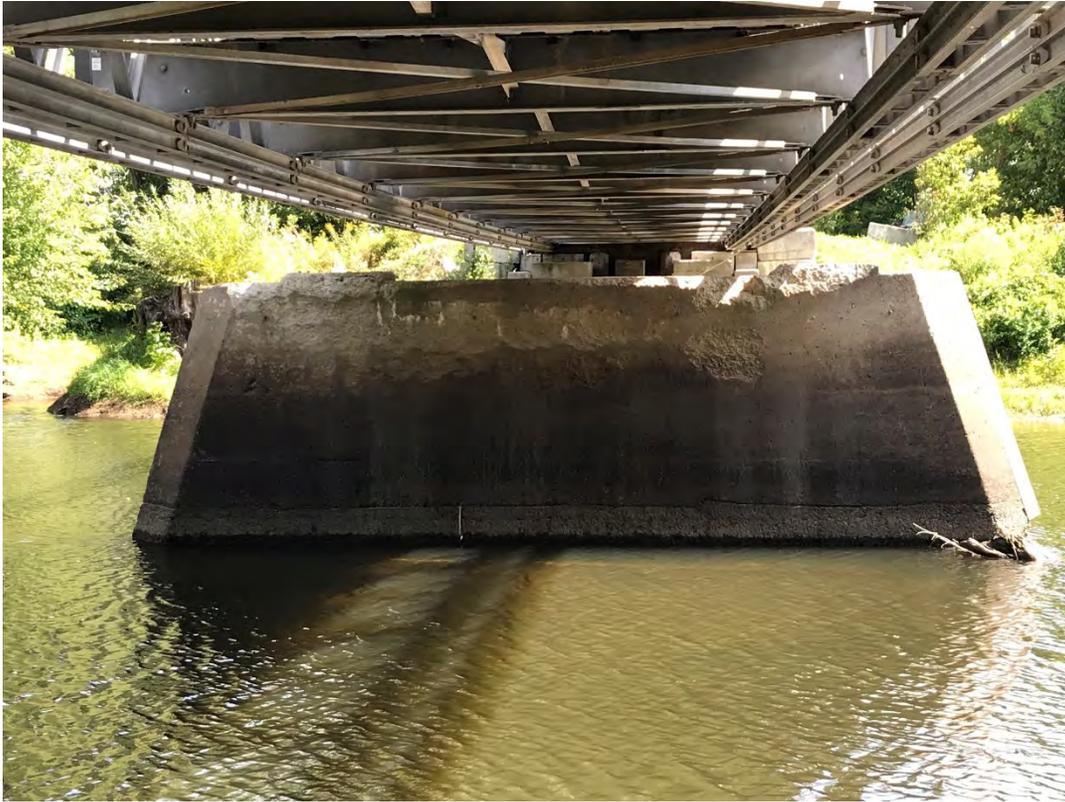
Figure 3.5: *Facing east towards center pier; note spalling of concrete.*
