Topsham BF 031-1(13)
Regional Concerns Meeting
Vermont Route 25 – Bridge #23 over Waits River

November 23, 2020

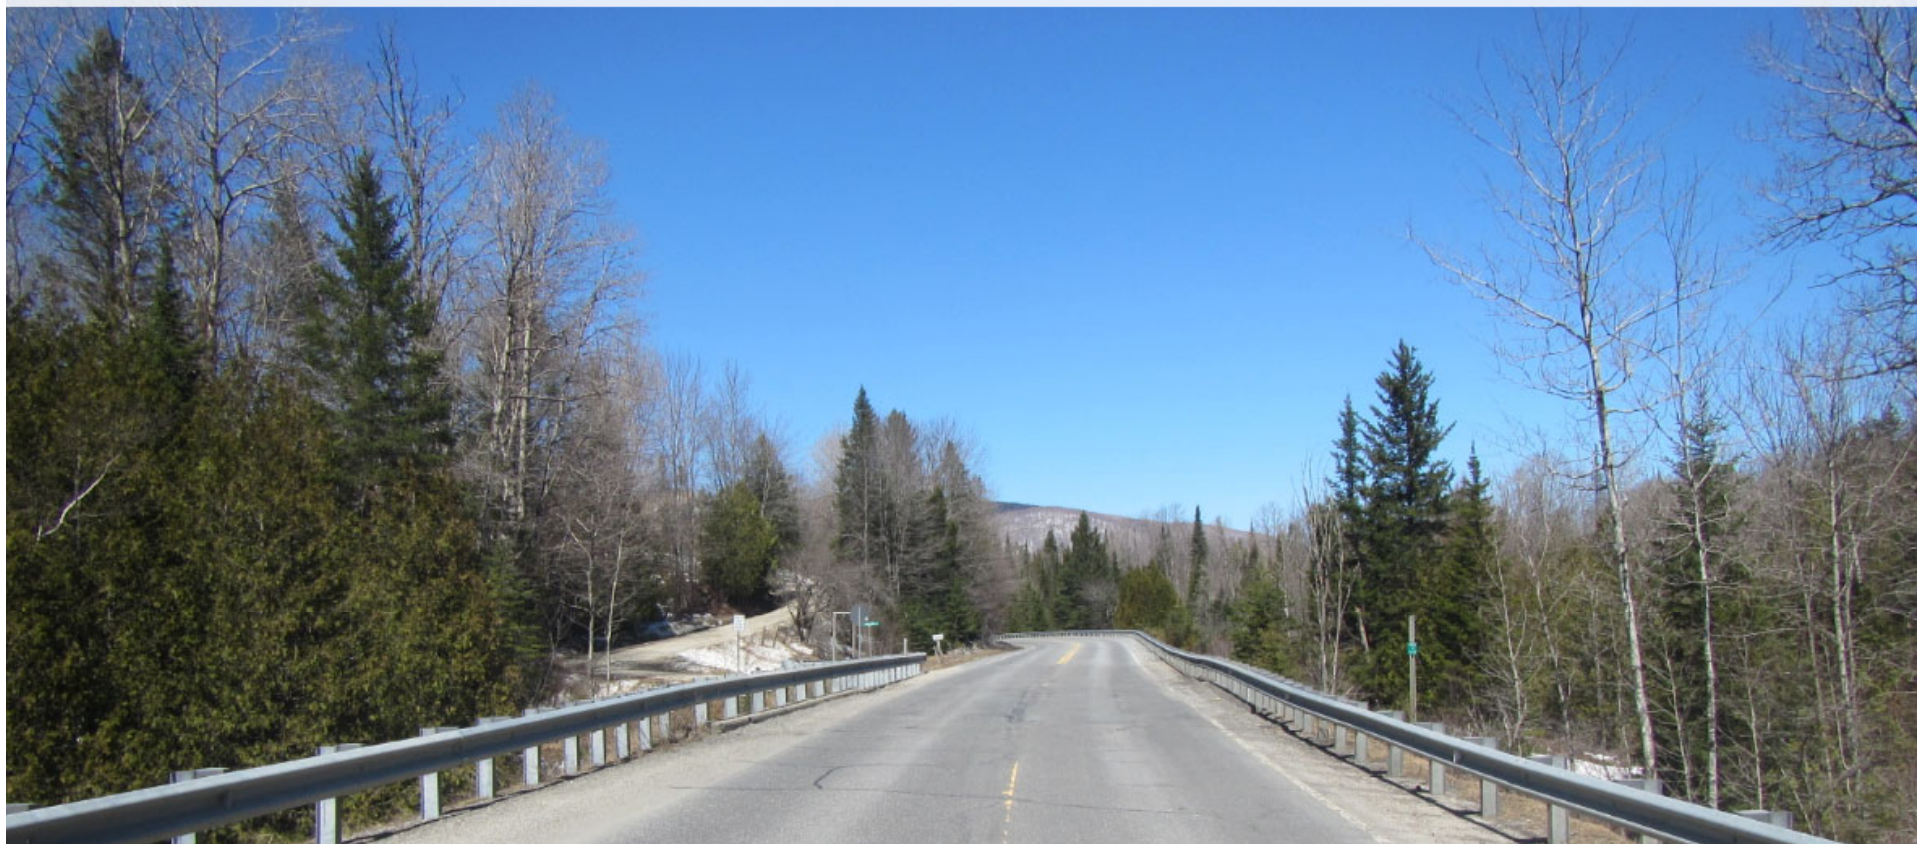
Looking South over Bridge 23

Existing Conditions – Bridge #23

- Large Skew

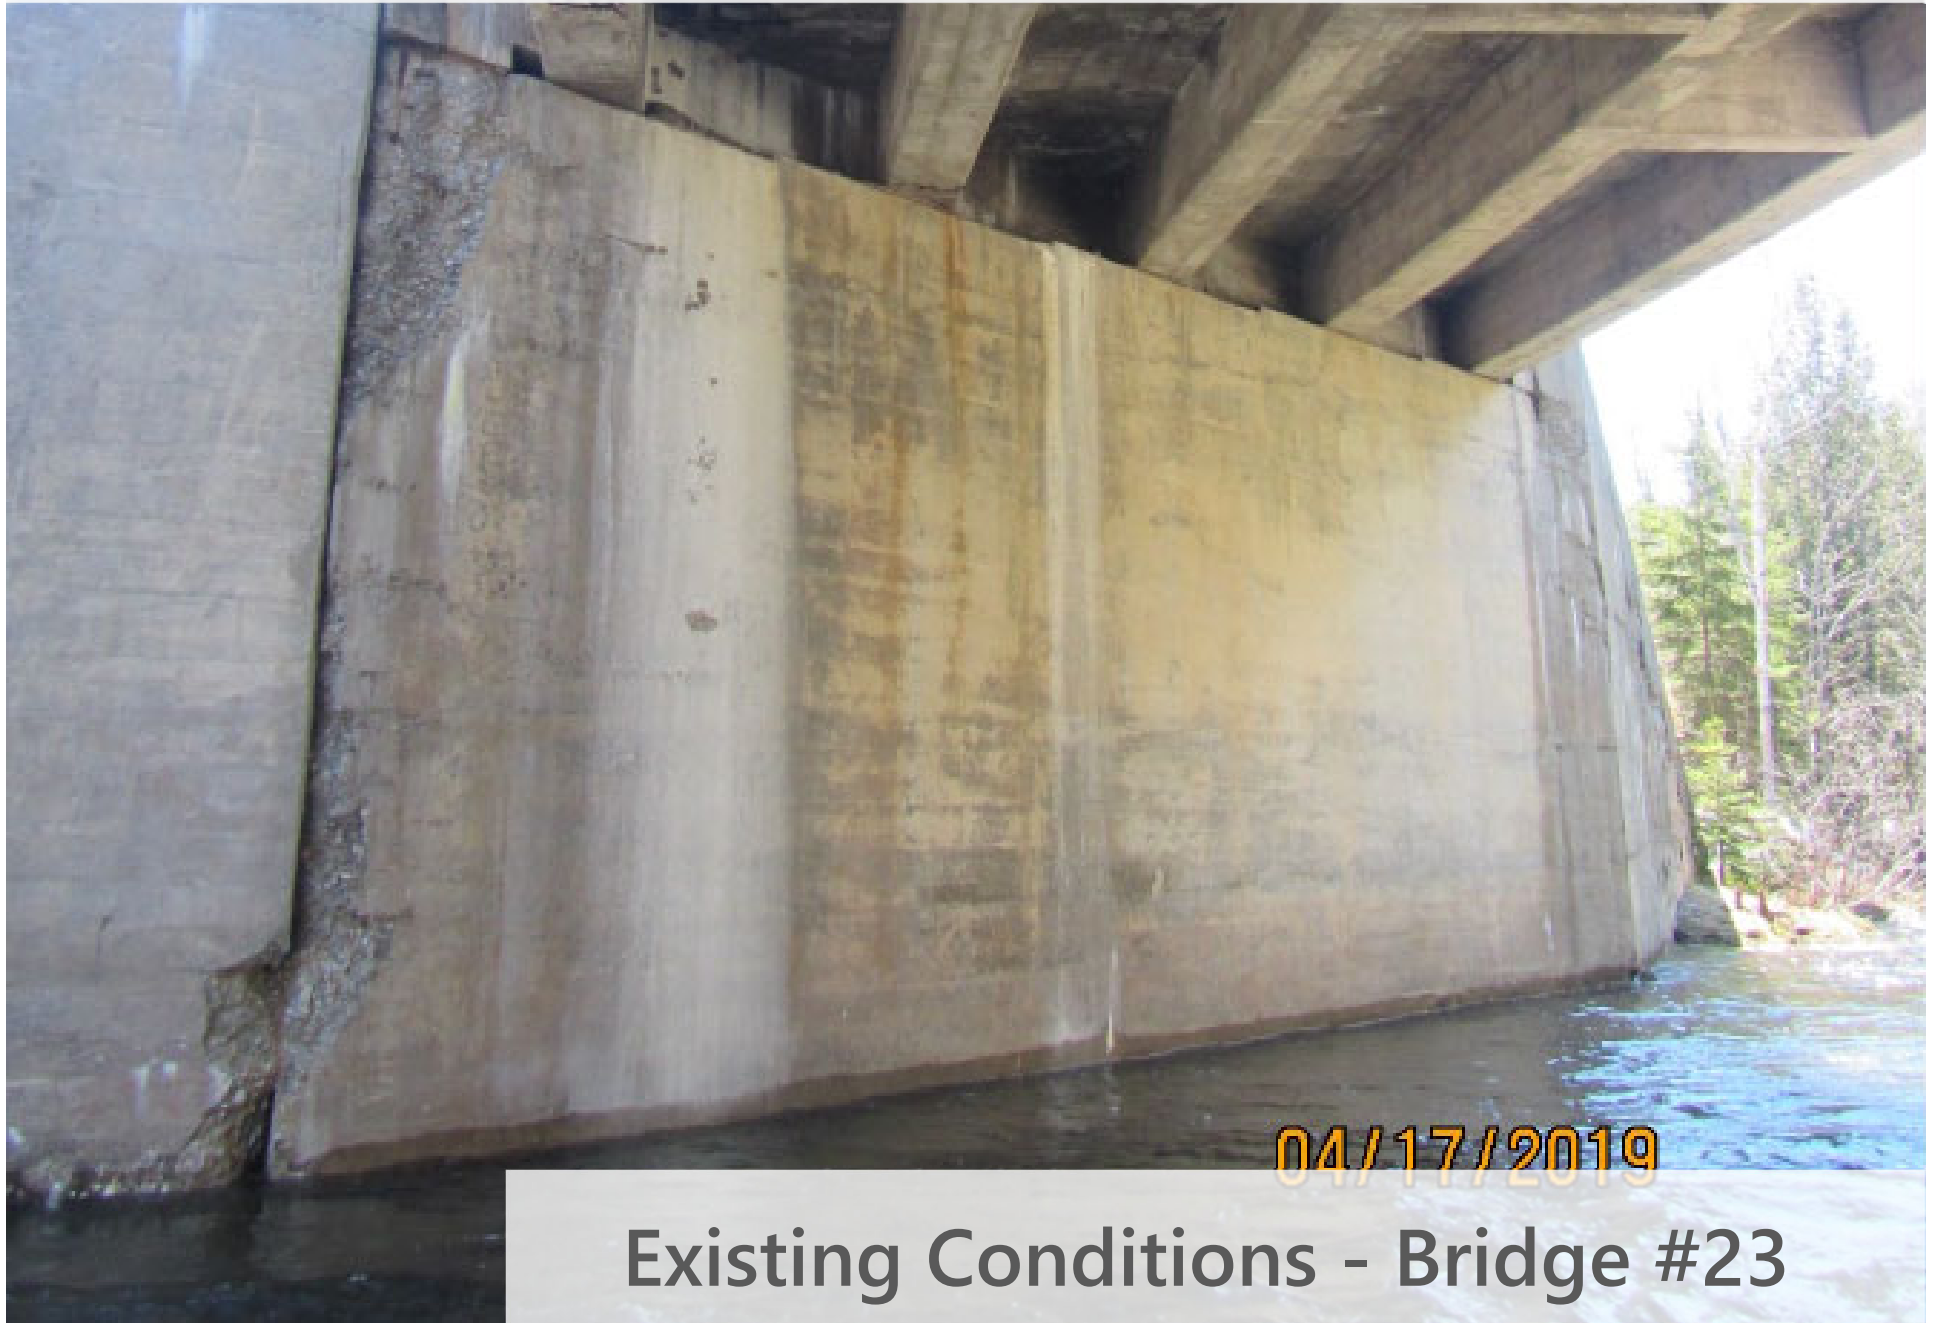
Southern Abutment

- The reinforced concrete deck is in poor condition.
 - Impending full depth holes with areas of large spalls with exposed and rusting reinforcing steel.
- Beams have progression in deterioration from Beam 1 to Beam 5.
 - Beams 3 through 5 have delaminations and spalling present with exposed reinforcing steel
- Abutments have minor concrete scaling, and minor vertical cracking.
- The wingwalls are in fair condition with localized heavy concrete scaling with large delaminations
- The bridge is narrow.
- The bridge does not meet the minimum standard for bankfull width.

- Deck Rating 4 (Poor)
- Superstructure Rating 5 (Fair)
- Substructure Rating 6 (Satisfactory)

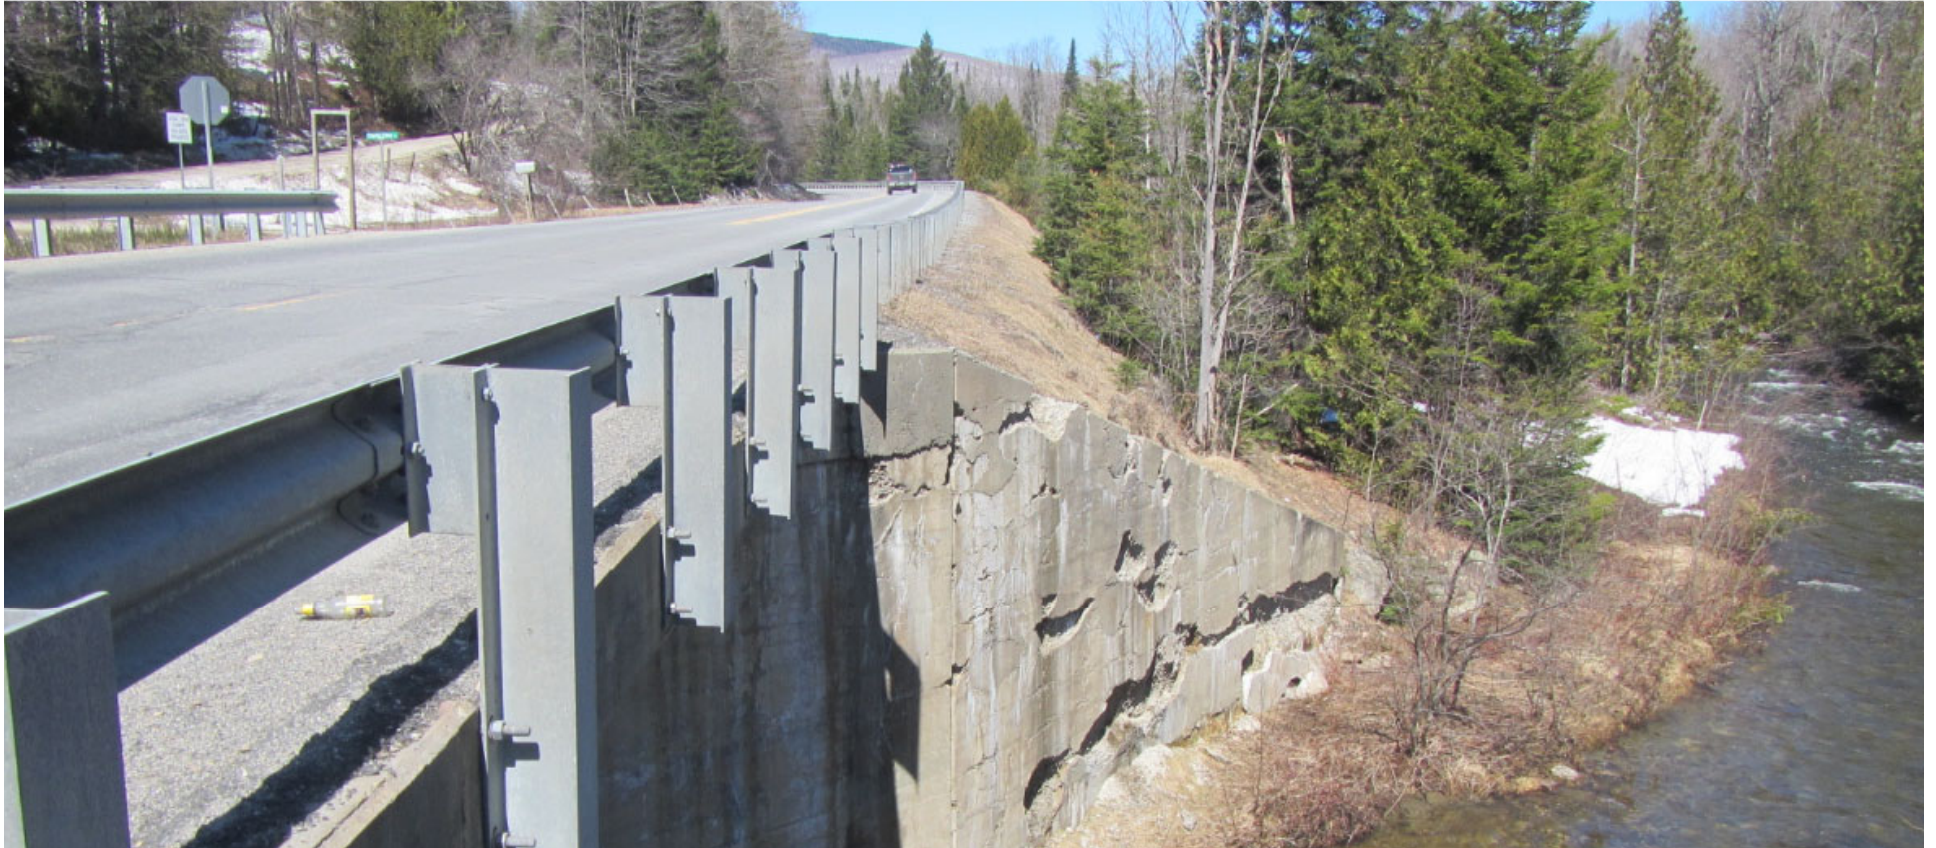
Resources

Existing Conditions - Bridge #23

- Wetlands
- Two historic properties:
 - Farm complex on Charles Cilley Road
 - Home at 558 VT Route 25

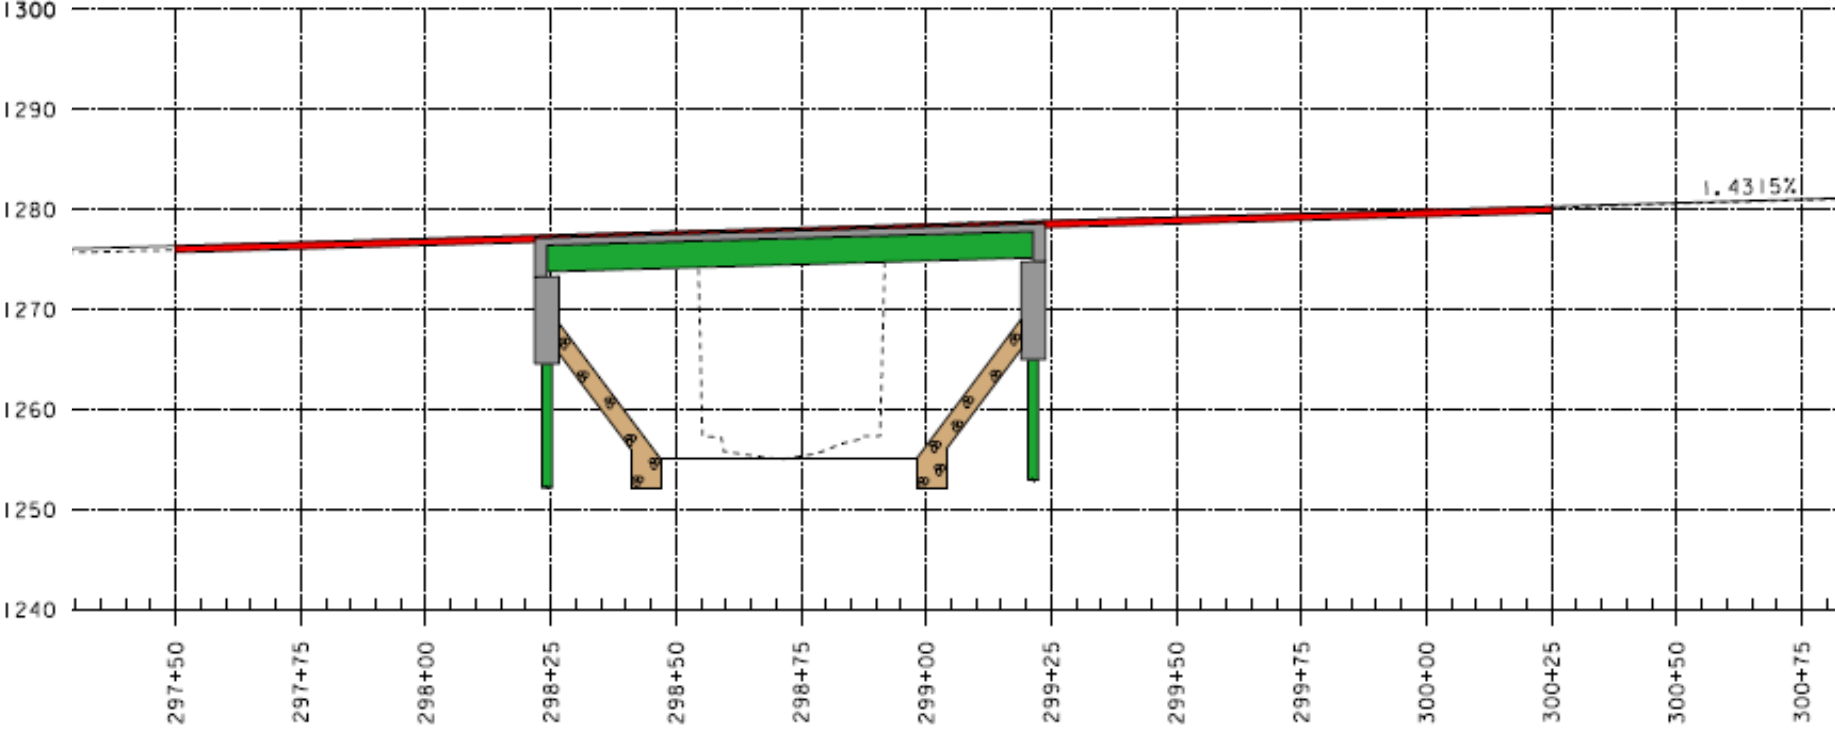
Proposed Profile

VT ROUTE 25 NEW BRIDGE PROFILE

SCALE: HORIZONTAL 1"=20'-0"
VERTICAL 1"=10'-0"

- Match Existing vertical alignment

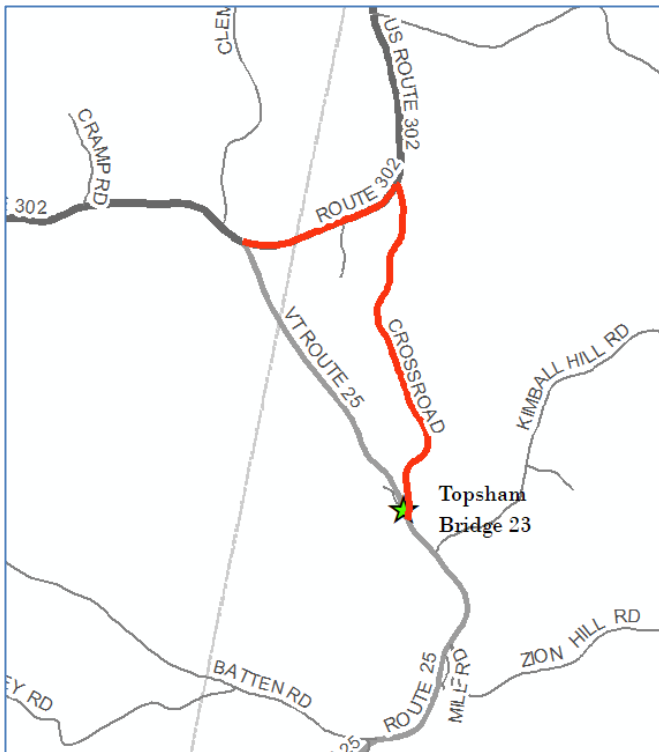
- VT Route 25, to Crossroad (Legal Load Limit: 24,000 lbs), and US Route 302, back to VT Route 25
 - 1.1 Miles Through-Route
 - 1.8 Miles Detour Route
 - 2.9 Miles end-to-end
 - 0.7 Miles Added

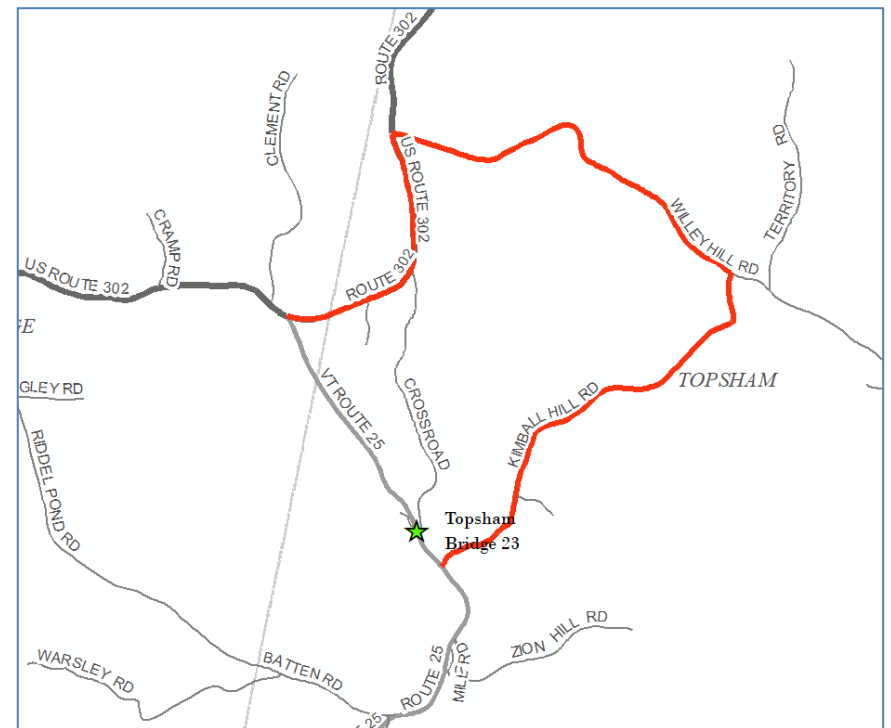
- VT Route 25, to Kimball Hill Road, Willey Hill Road, and US Route 302, back to VT Route 25
 - 1.3 Miles Through-Route
 - 4.9 Miles Detour Route
 - 6.2 Miles end-to-end
 - 3.6 Miles Added
