Fairfield STP DECK(51) Public Information Meeting

VT Route 36 – Bridge #6 over Fairfield River

May 28, 2024

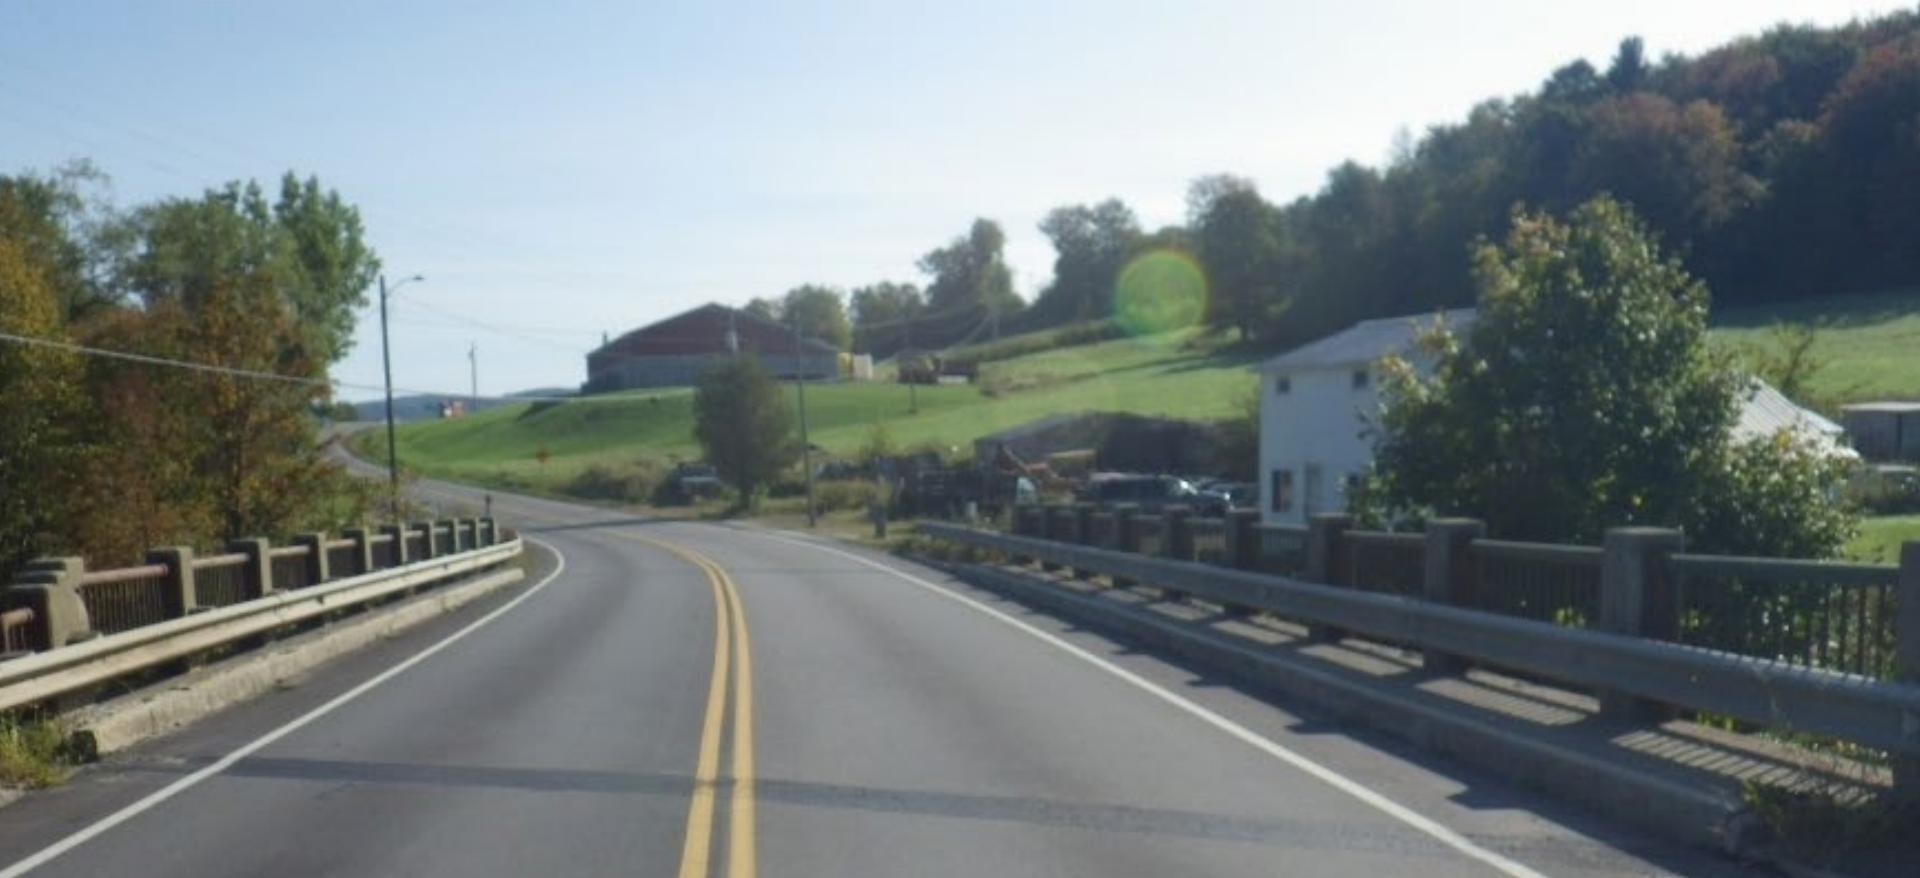
Existing Conditions – Bridge #6

- Aerial Utilities
- The Fairfield Town garage and fire department are located 0.2 miles to the east on VT Route 36

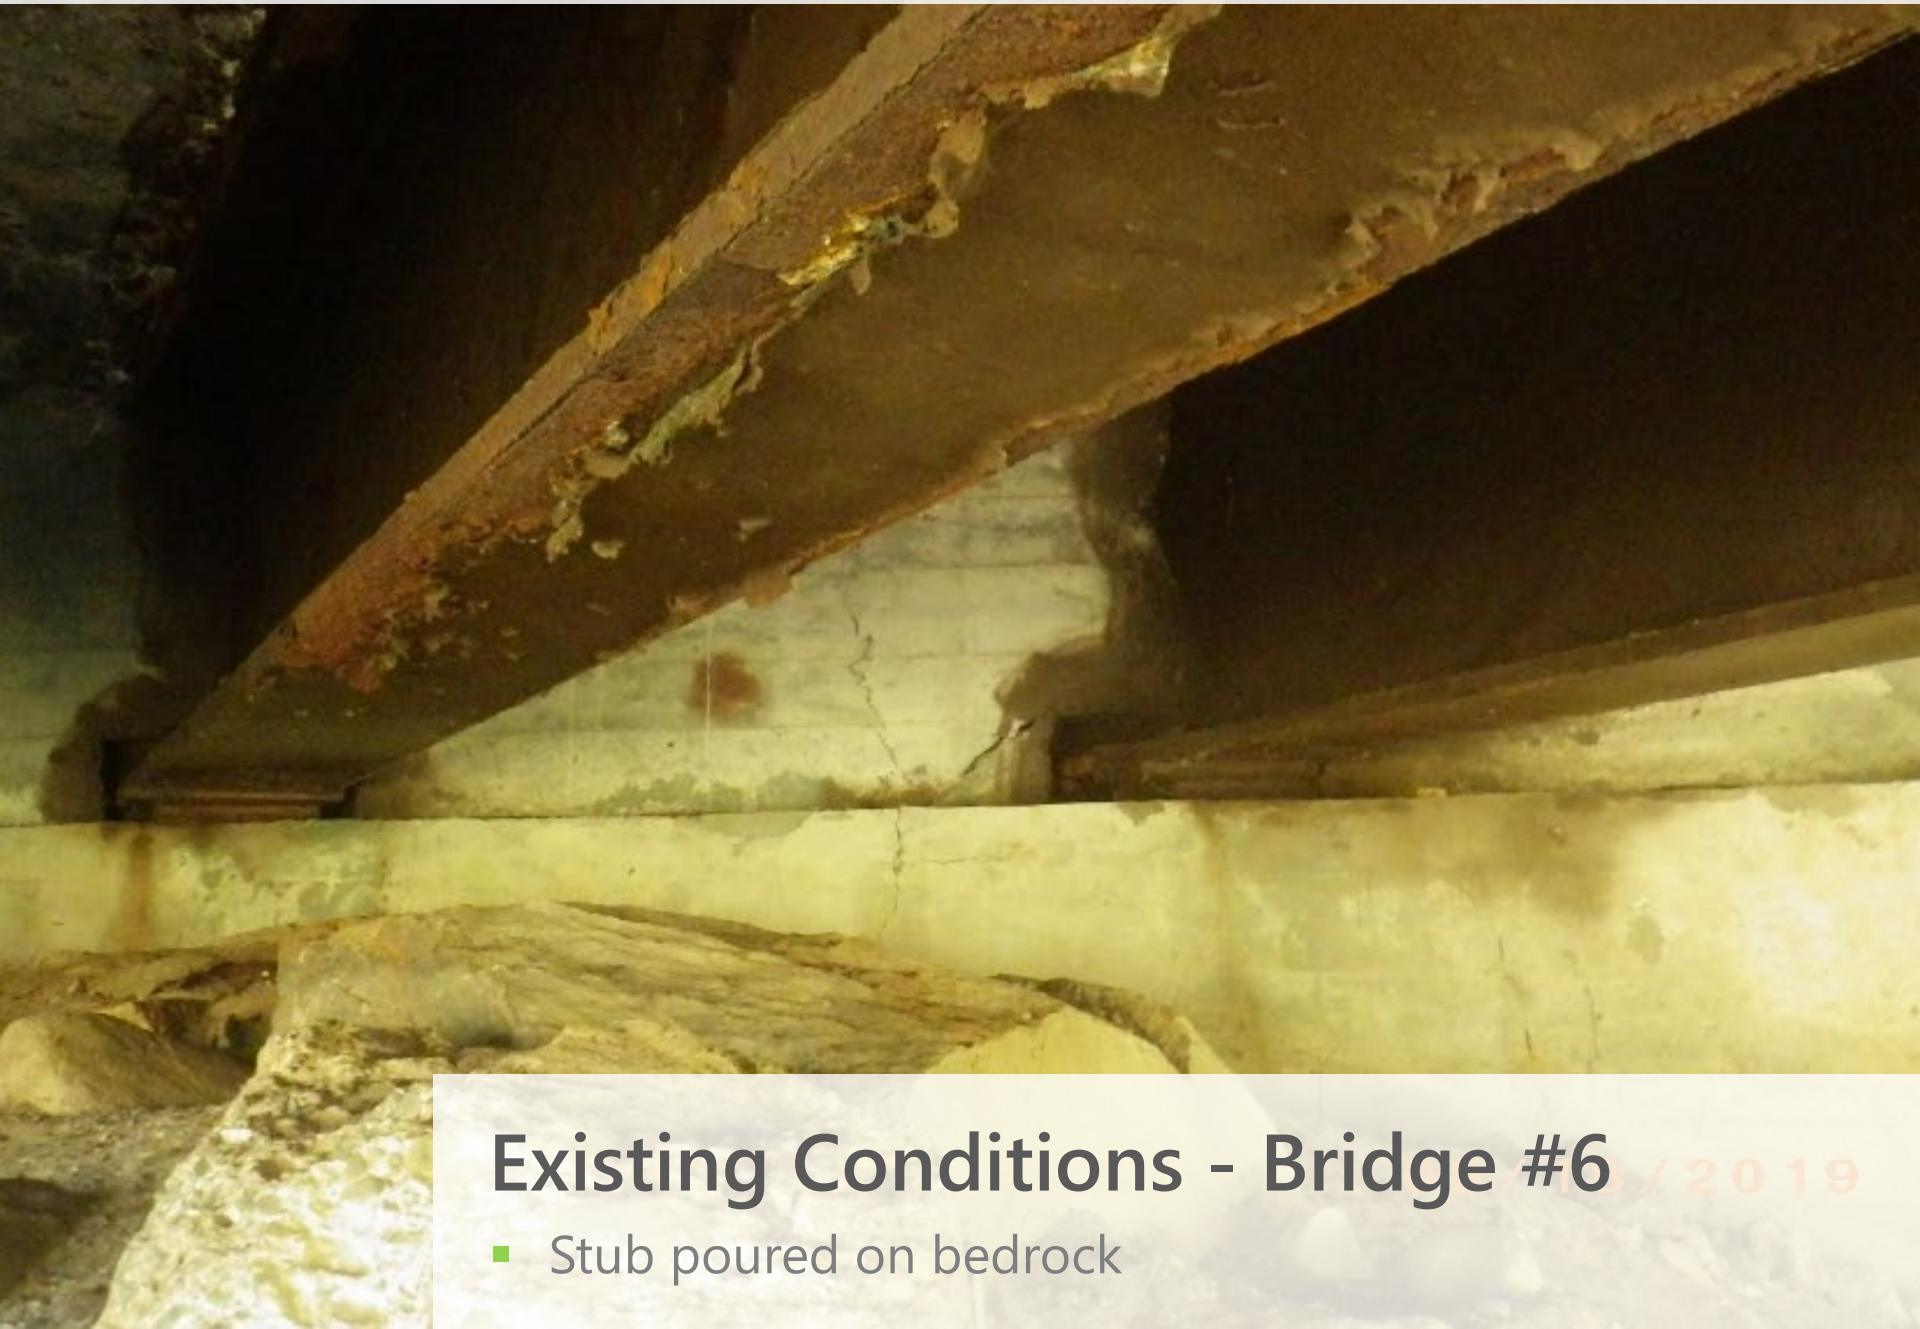
Southern Abutment

- Stub poured on bedrock

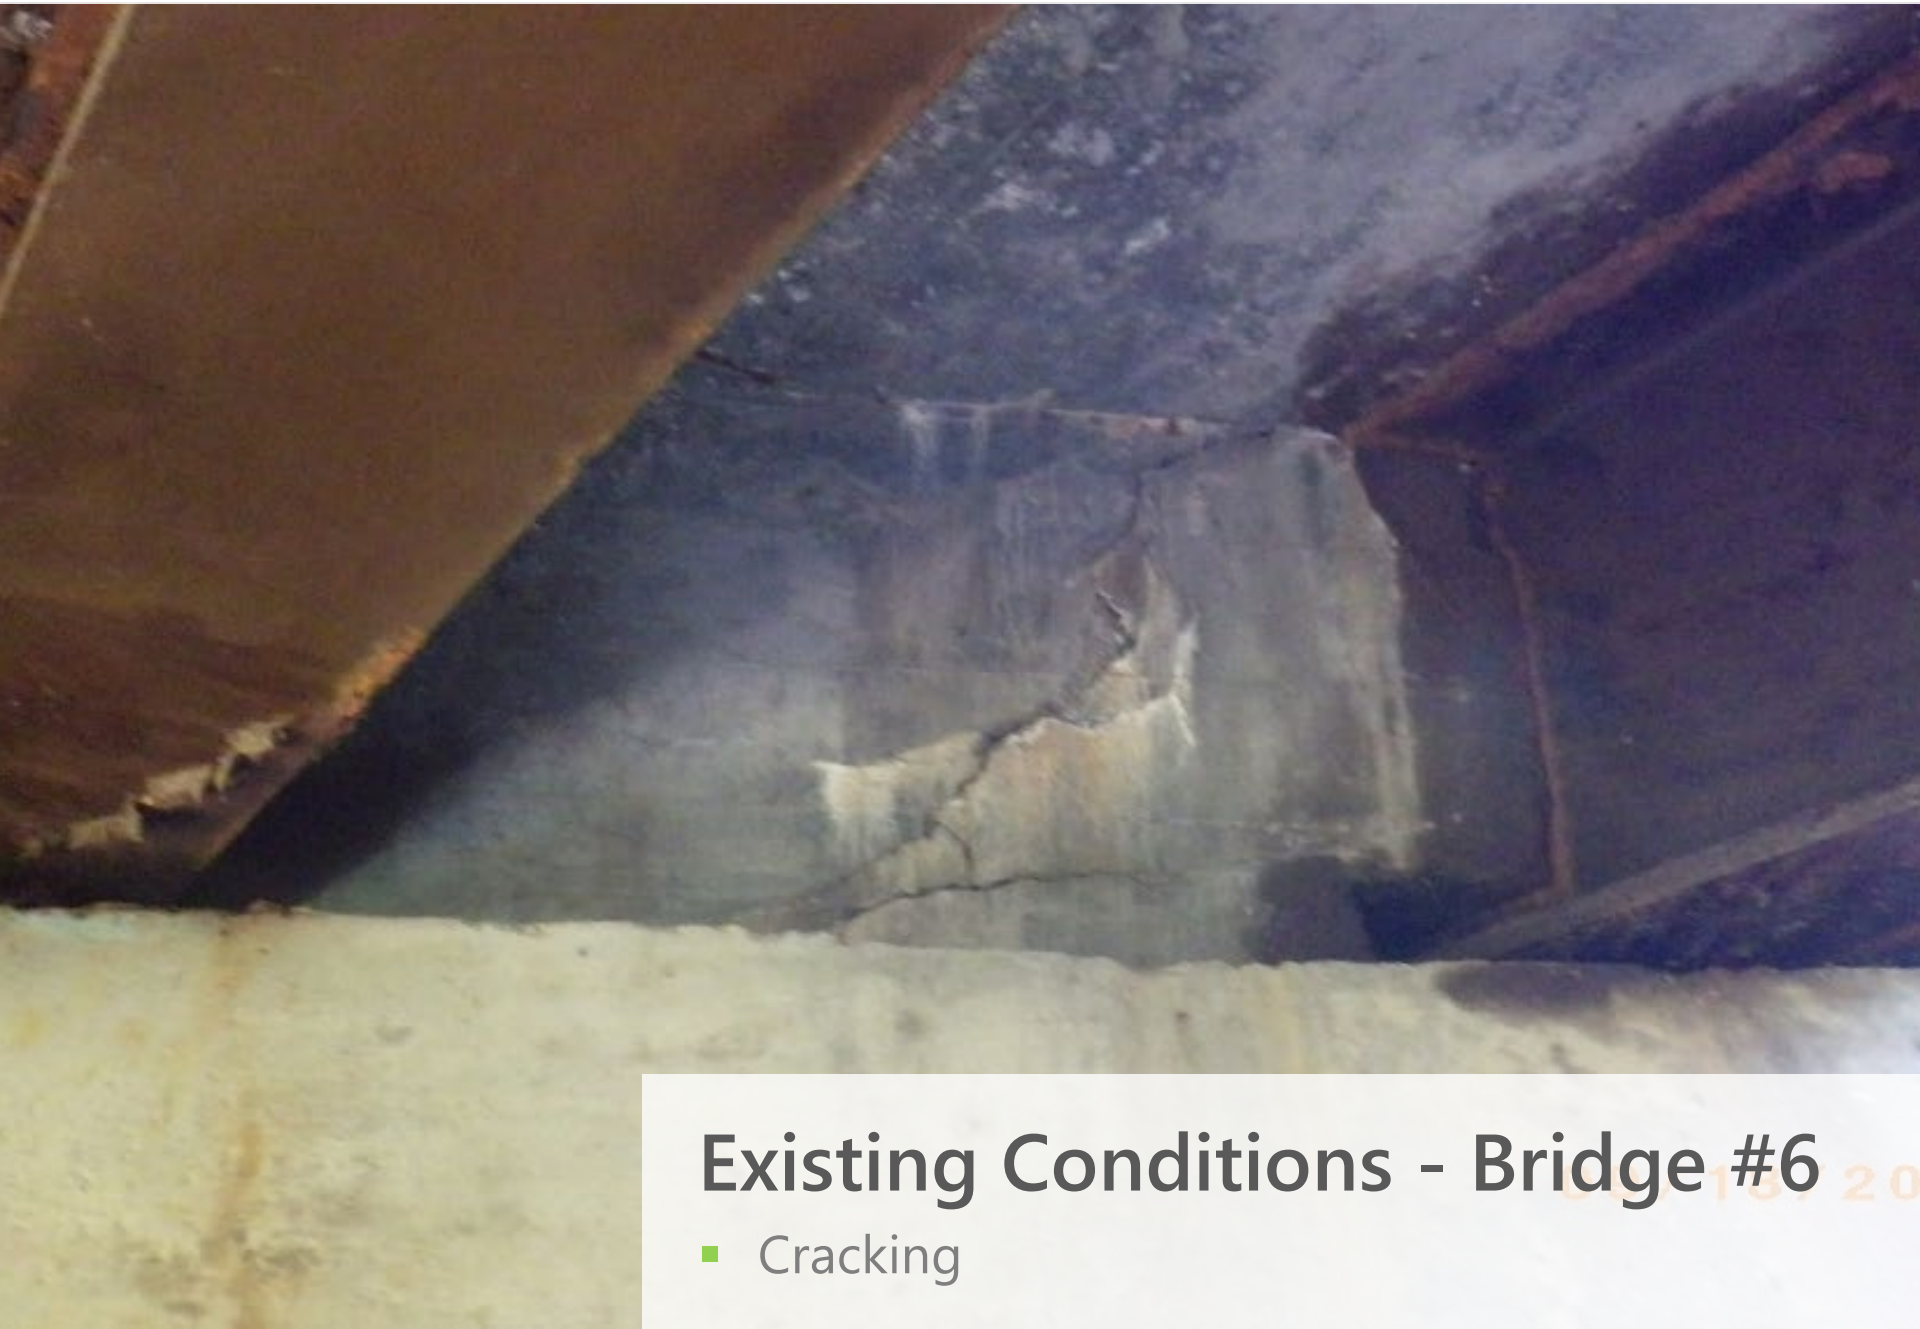
Backwall

- Cracking

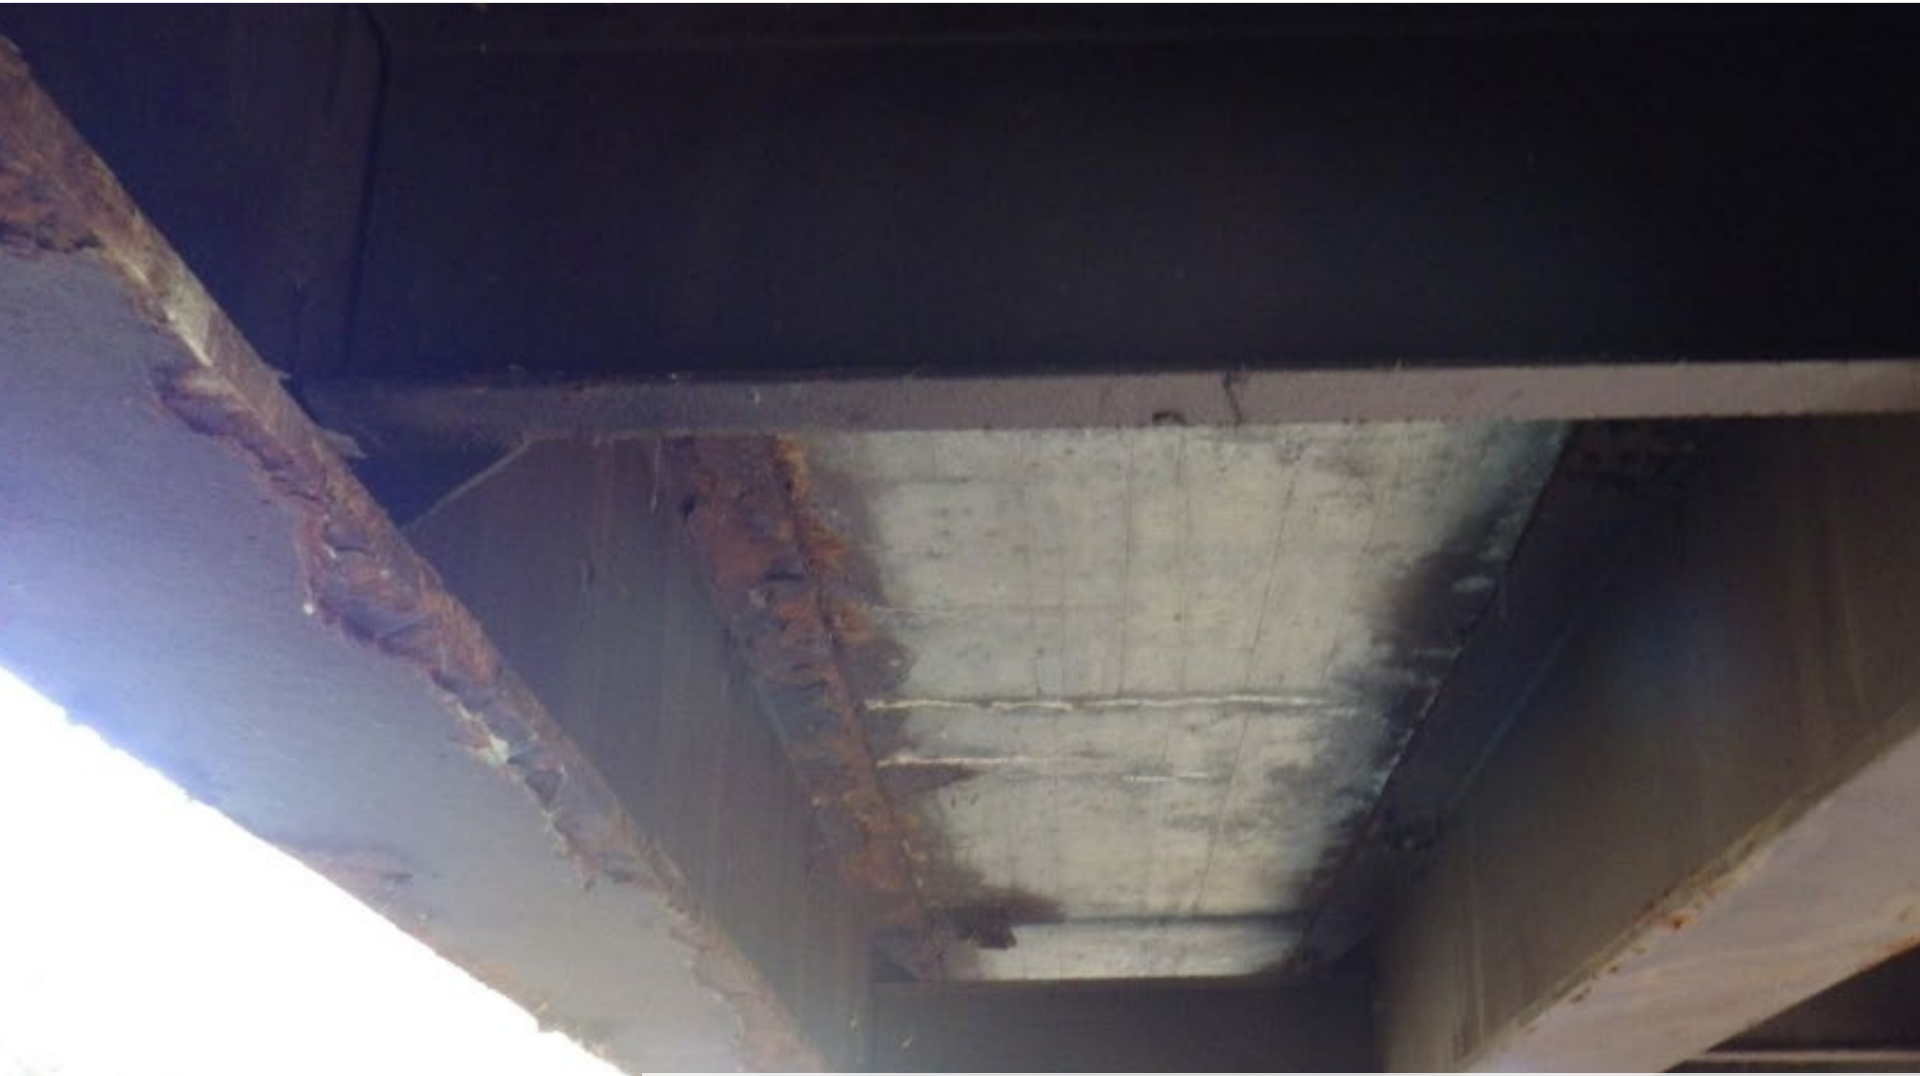
Underside of Deck

- Beams have paint peel

- The reinforced concrete deck is in fair condition. There is extensive saturation throughout with map cracking, light scaling, scattered delaminations, and scattered small spalls along the beam flanges. Additionally, a 1-foot x 2-foot full depth hole has developed.
- The existing rolled beams have moderate paint distress with rusting. There is paint peel and areas of rust scale with minor pitting and section loss along the flanges, beam ends, and fascias.
- The reinforced concrete curtain wall at abutment 2 has a full height vertical shrinkage crack with surrounding delaminations. The reinforced concrete curtain wall at abutment 1 has a full height settlement crack with large surrounding delaminations.

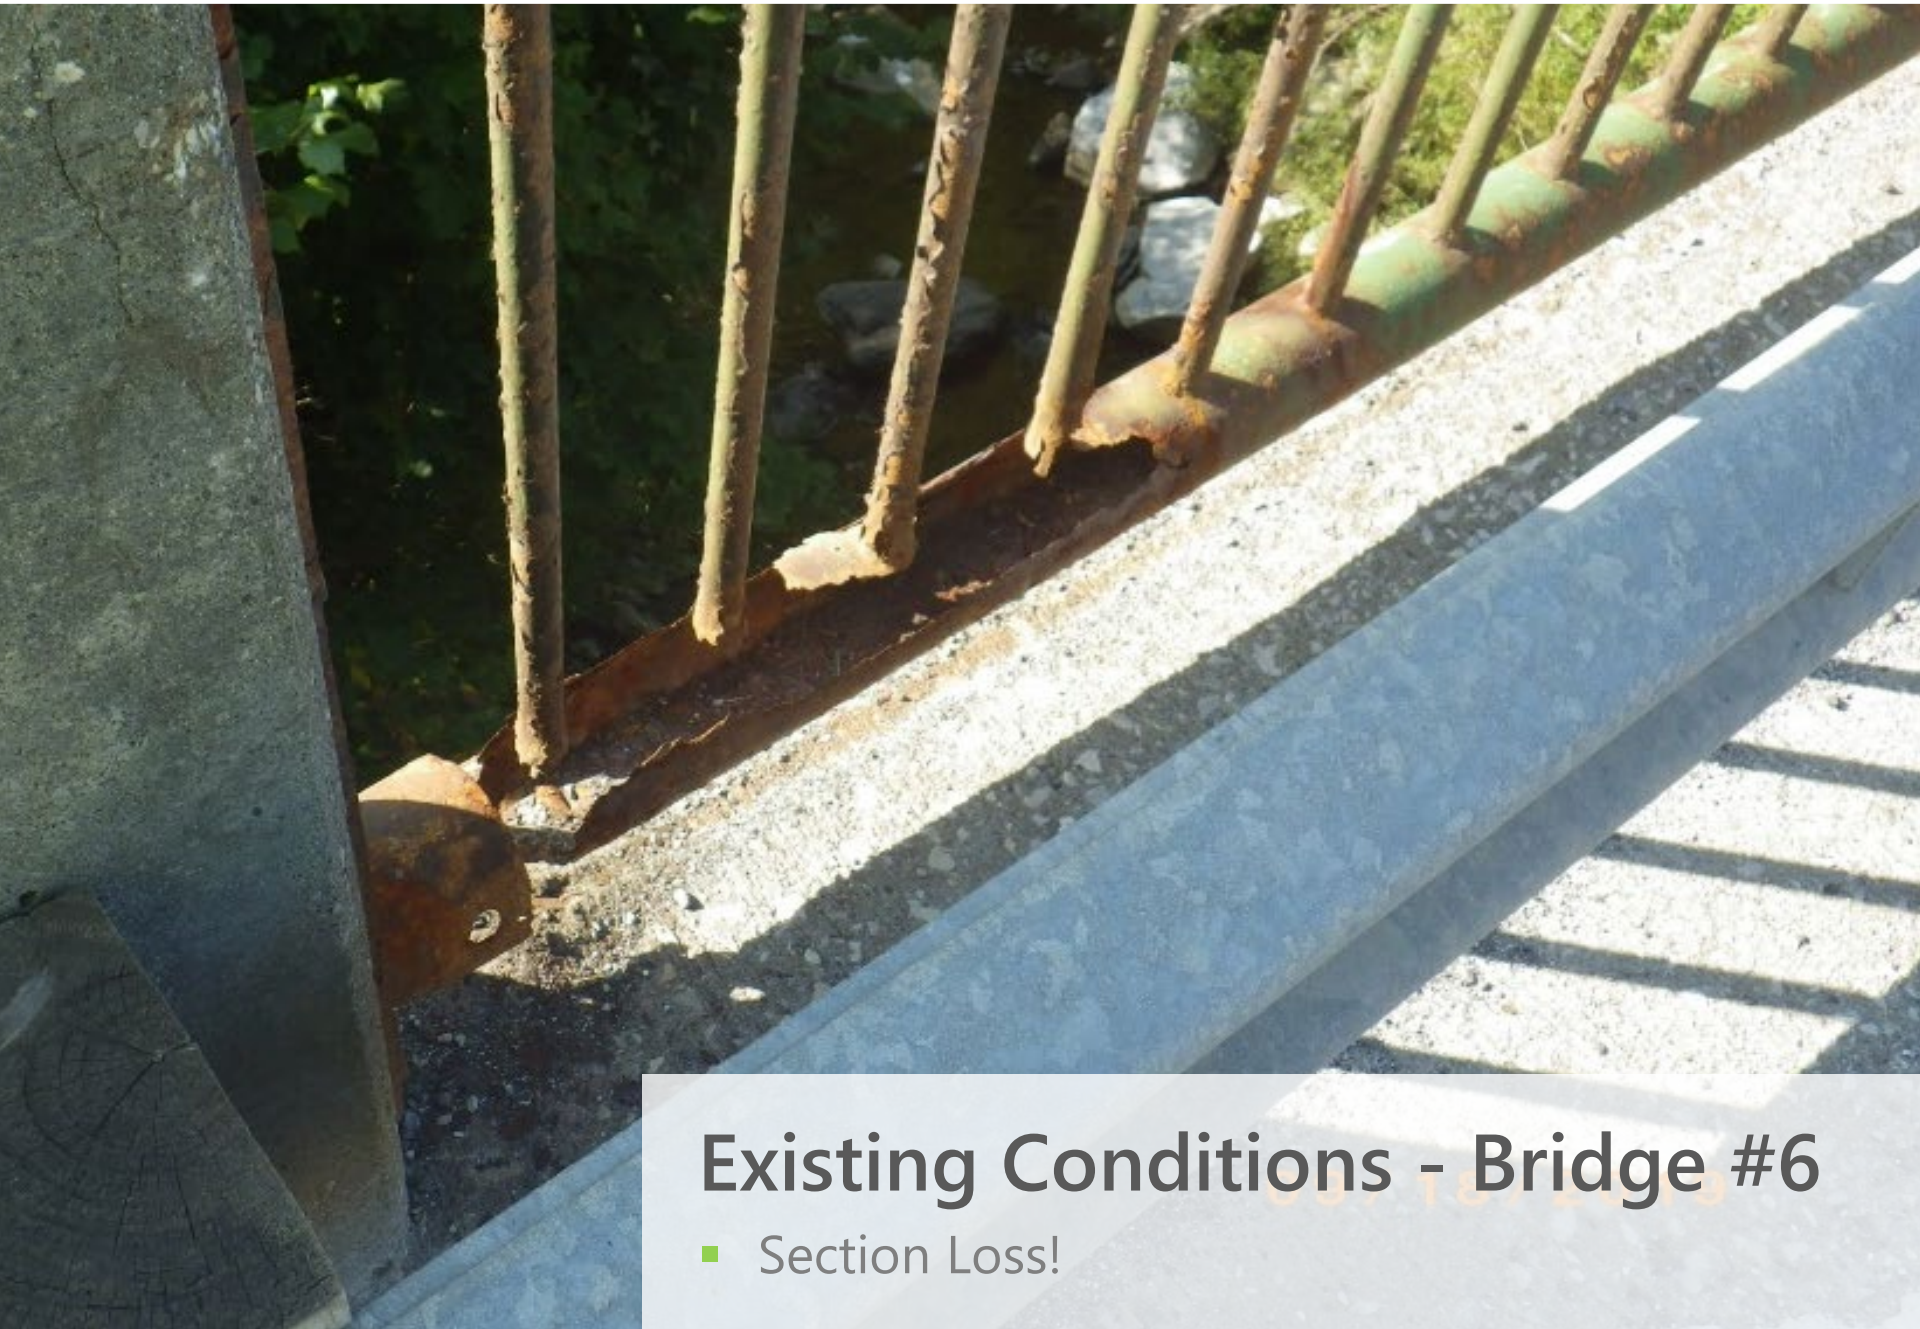
Railing

- Section Loss!

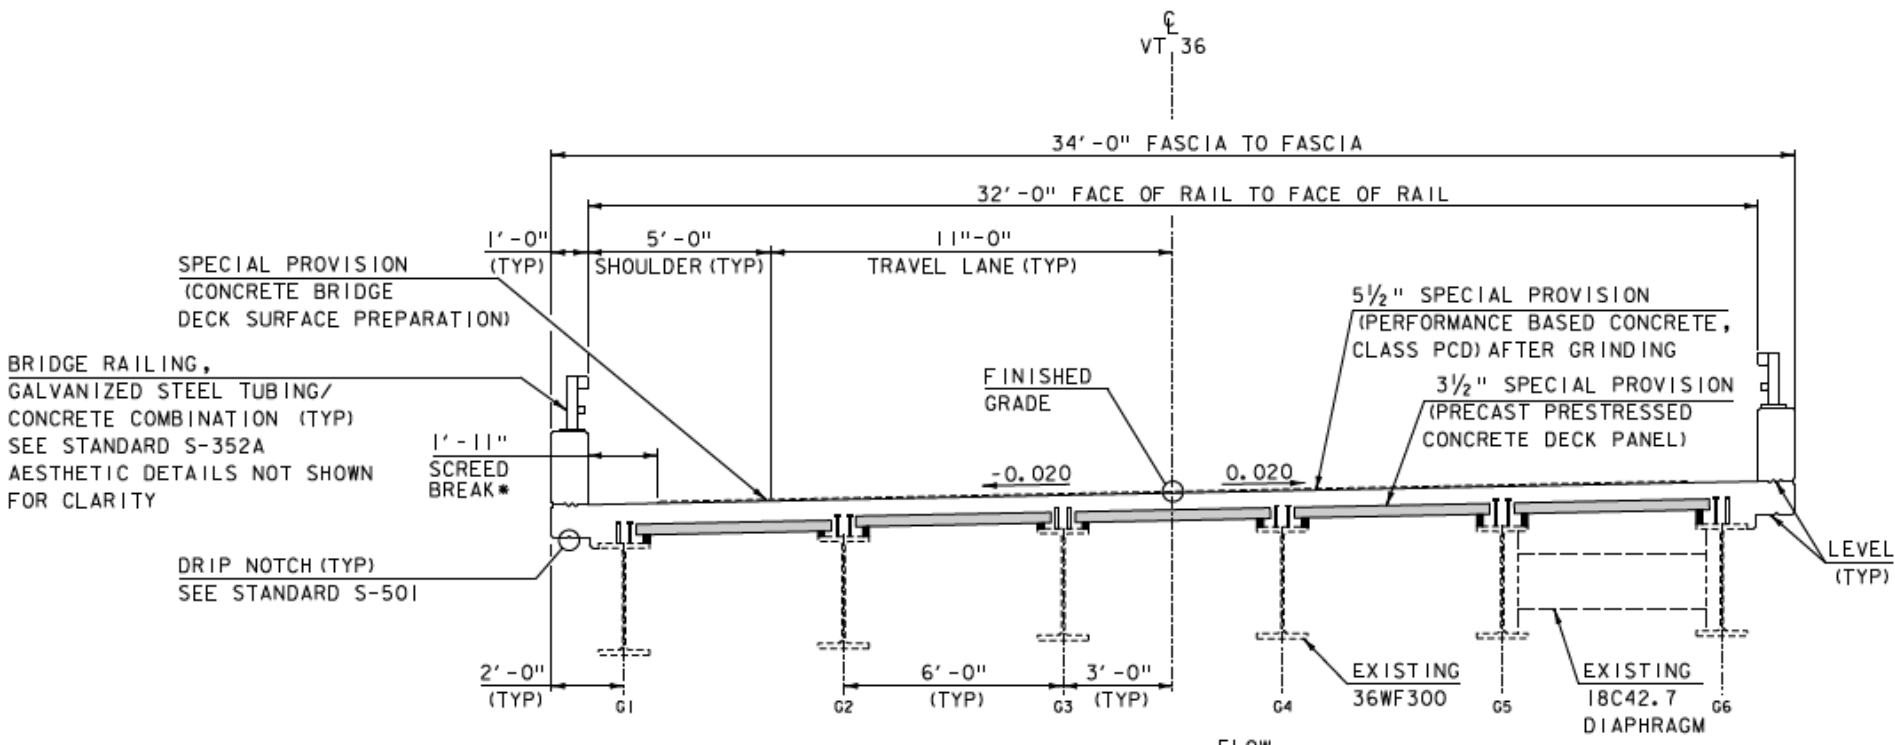
Proposed Bridge Typical Section

- Deck Replacement
 - Replace the existing deck, curtain walls and bridge railing
 - Replace bridge bearings
 - Improve Bridge Typical: 11'/5' typical section – wider shoulder for bike/ped safety
 - New Combination Concrete and Steel Bridge Railing – 42" high for bike/ped safety
 - 40-year design life
 - Project Construction Cost - \$1,531,955

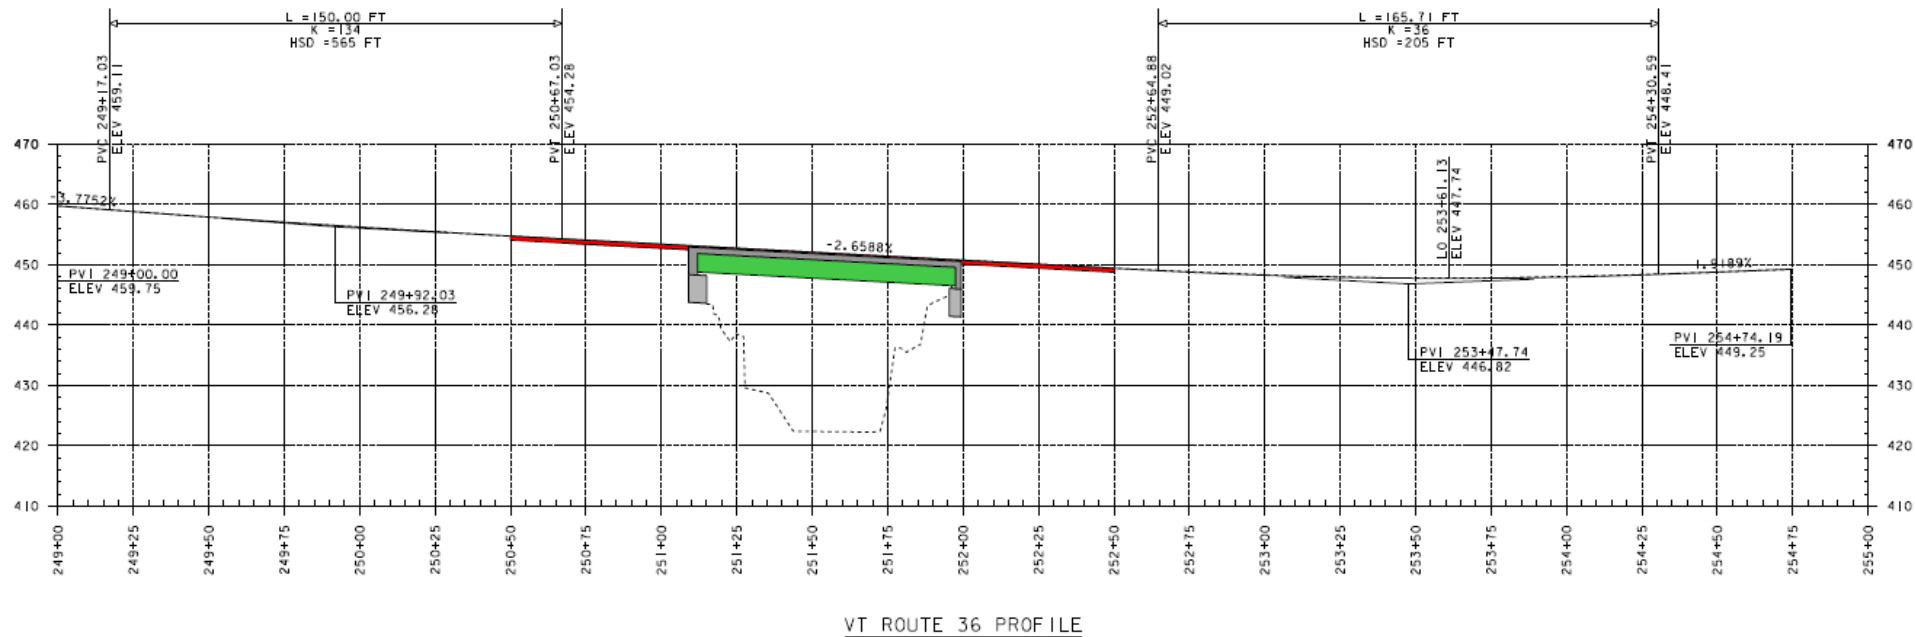
Proposed Profile

- Match Existing vertical alignment

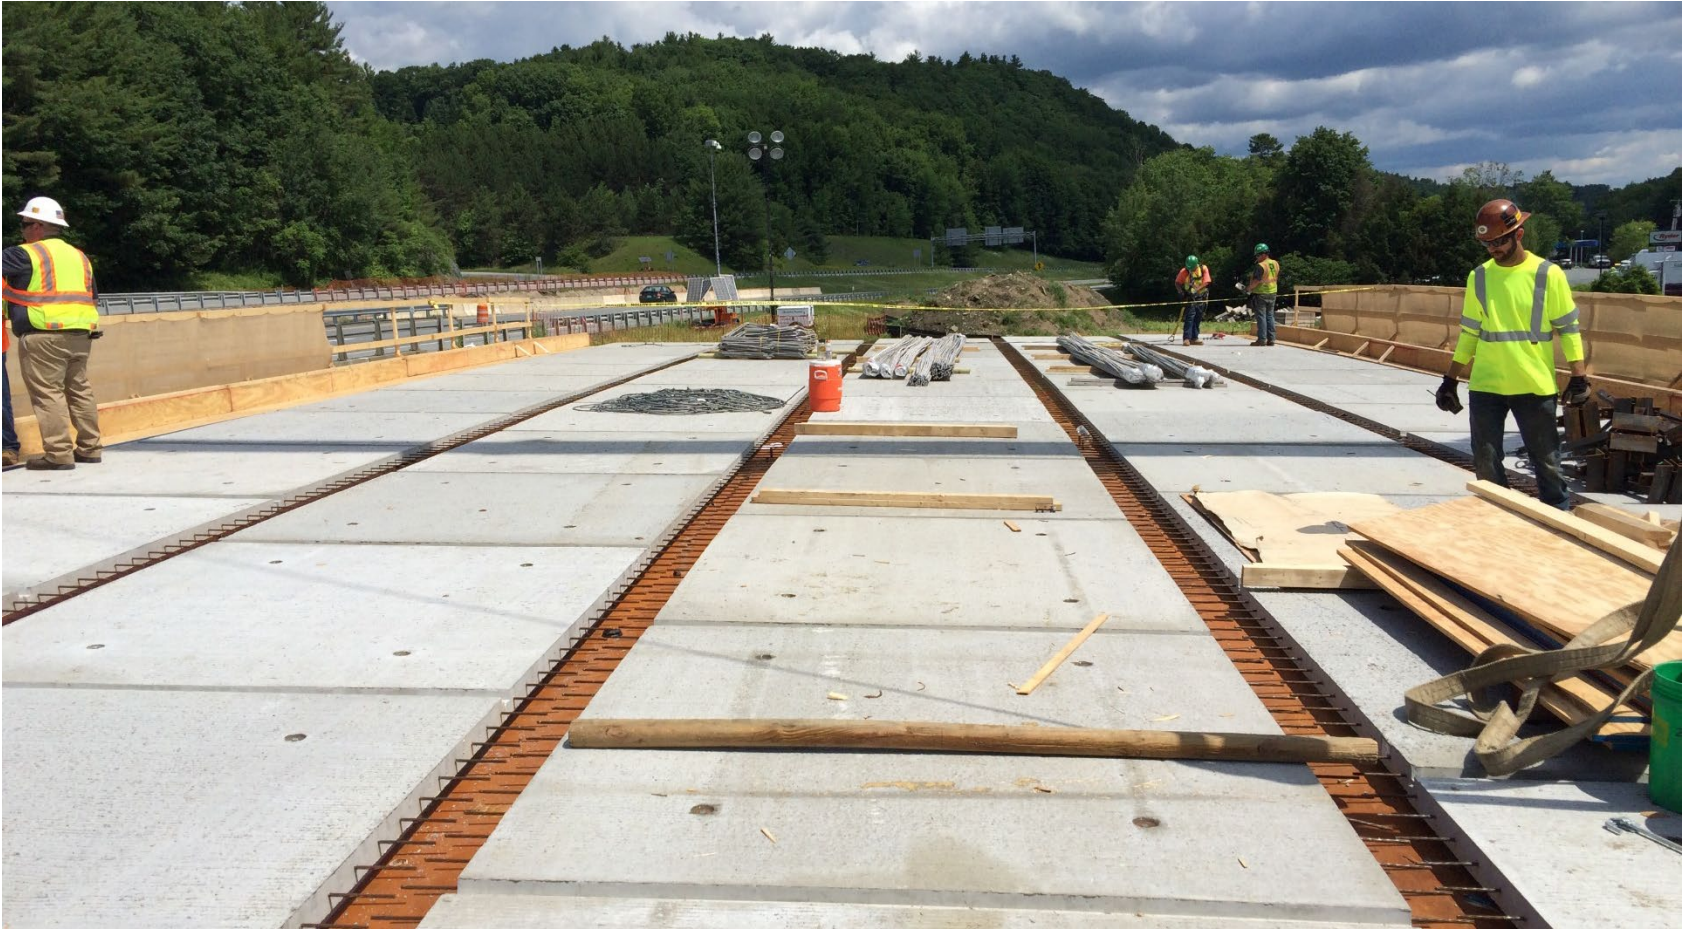
Precast Deck Panels

- Accelerated Elements
 - Precast Prestressed Deck Panels – quicker forming of the deck
- Conventional Components
 - Cast in Place Deck for smooth finish and better ride
 - Curtain walls – due to complexity around the end of the bridge
