**Wolcott BF 1446(38)**  
**Alternatives Presentation Meeting**  
**Town Highway 3 – Bridge 6 over Lamoille River**

December 1, 2021

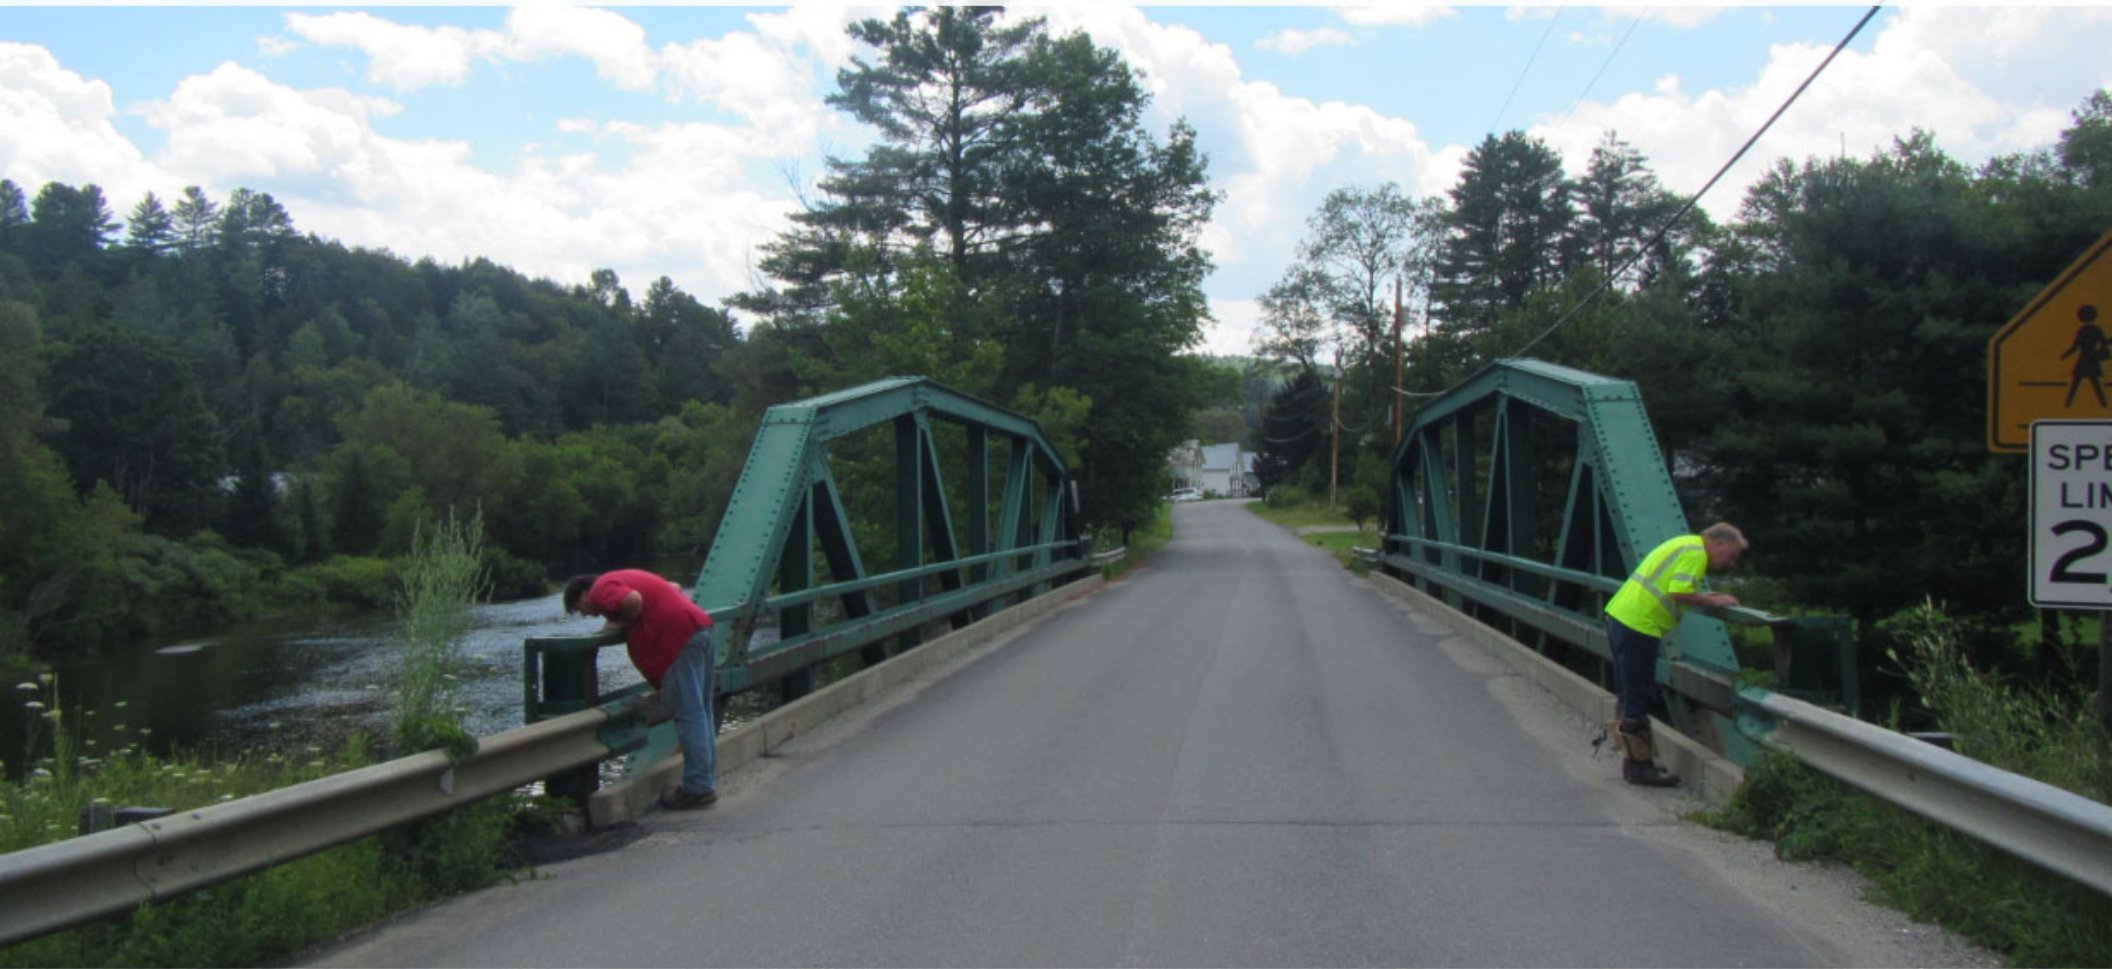
## Looking South over Bridge 6

## Existing Conditions – Bridge #6

- Roadway Classification – Local Road
- Bridge Type – 100' Span Parker Pony Truss
- Ownership – Town of Wolcott
- Constructed in 1928, reconstructed in 2004

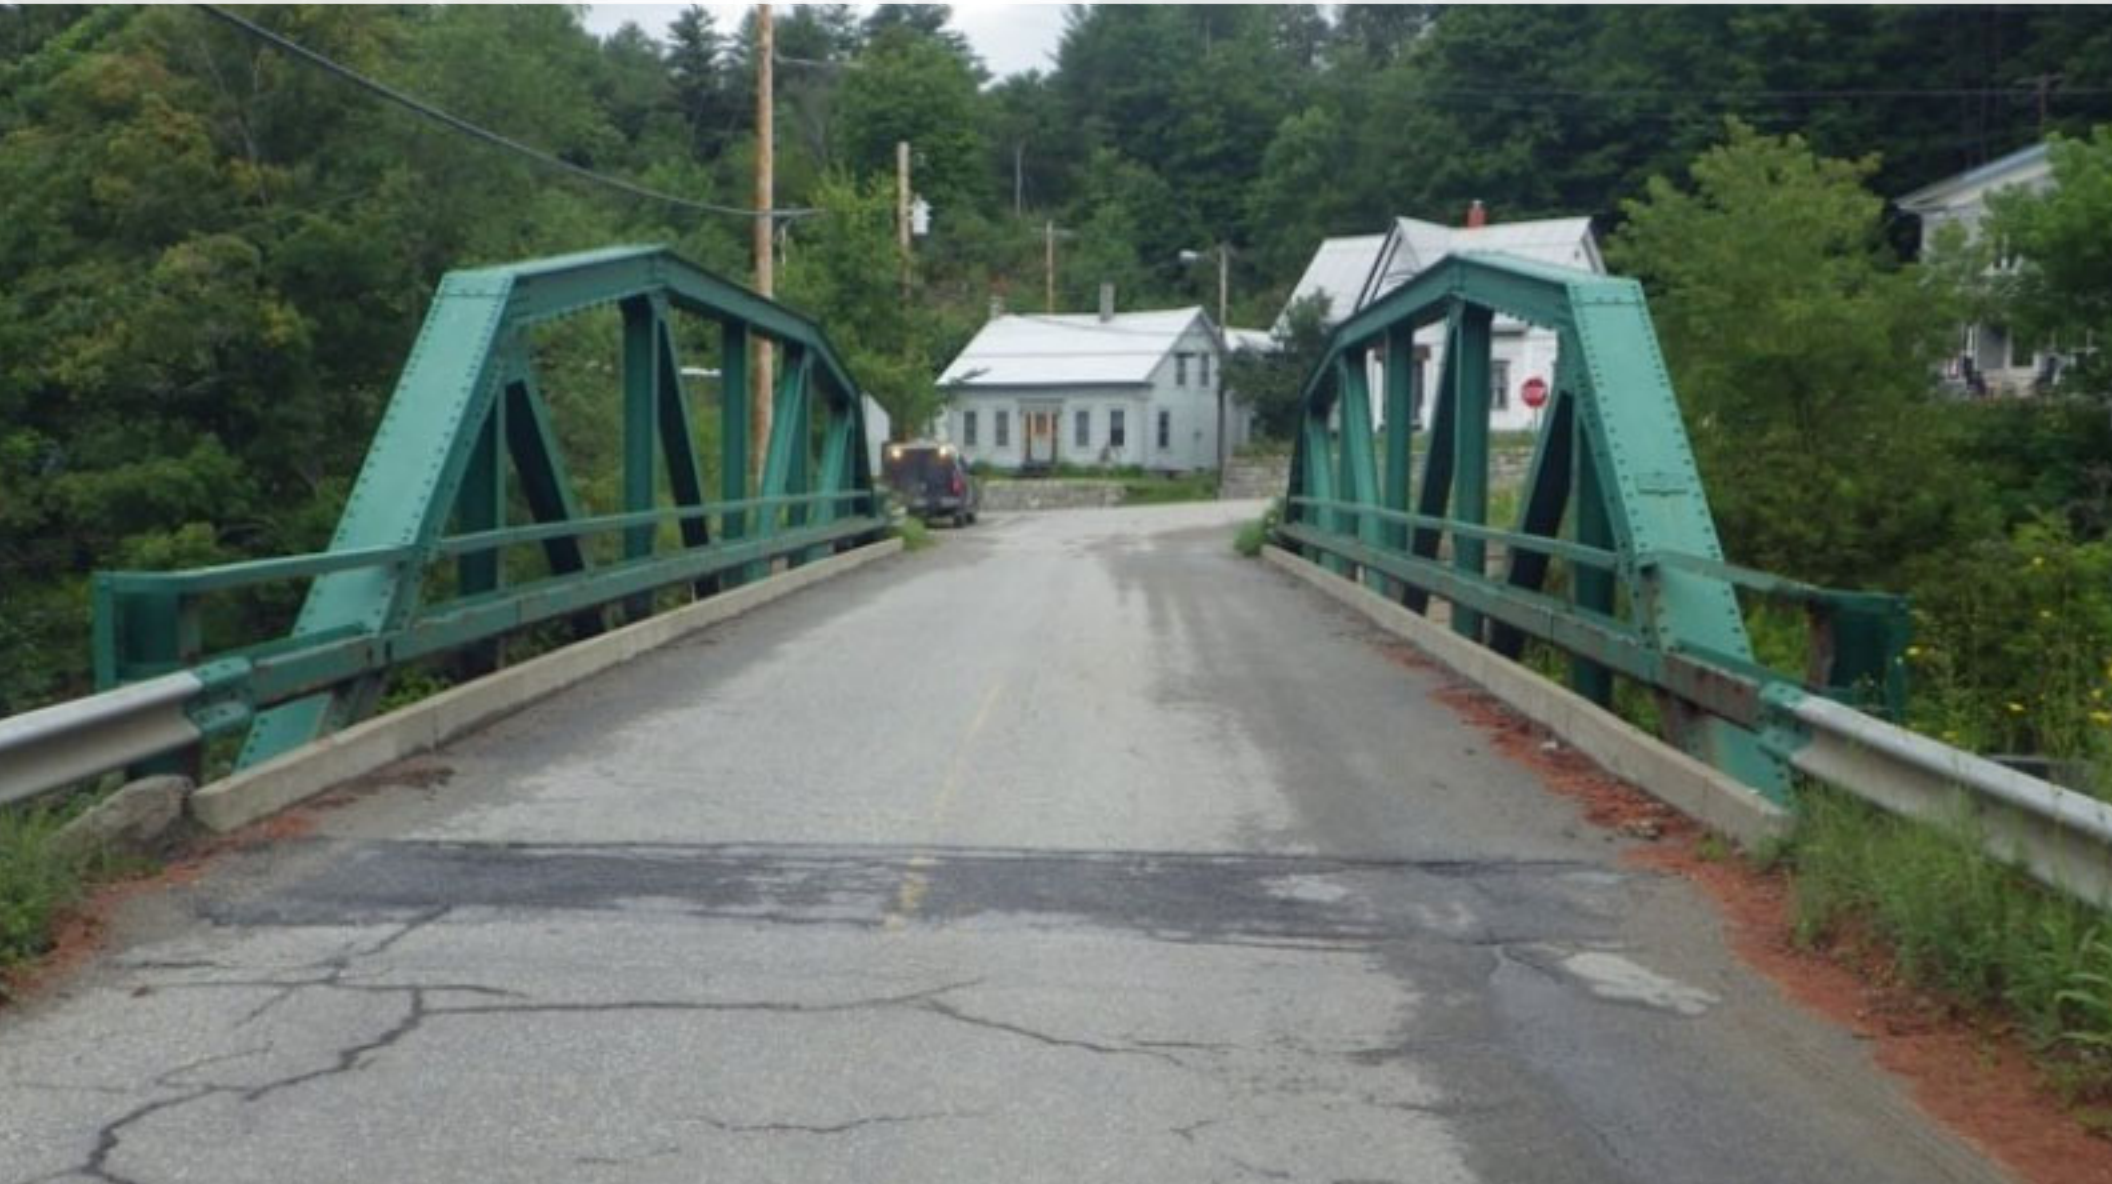
Looking North over Bridge 6

## Existing Conditions – Bridge #6

- Utilities (aerial and future sewer)

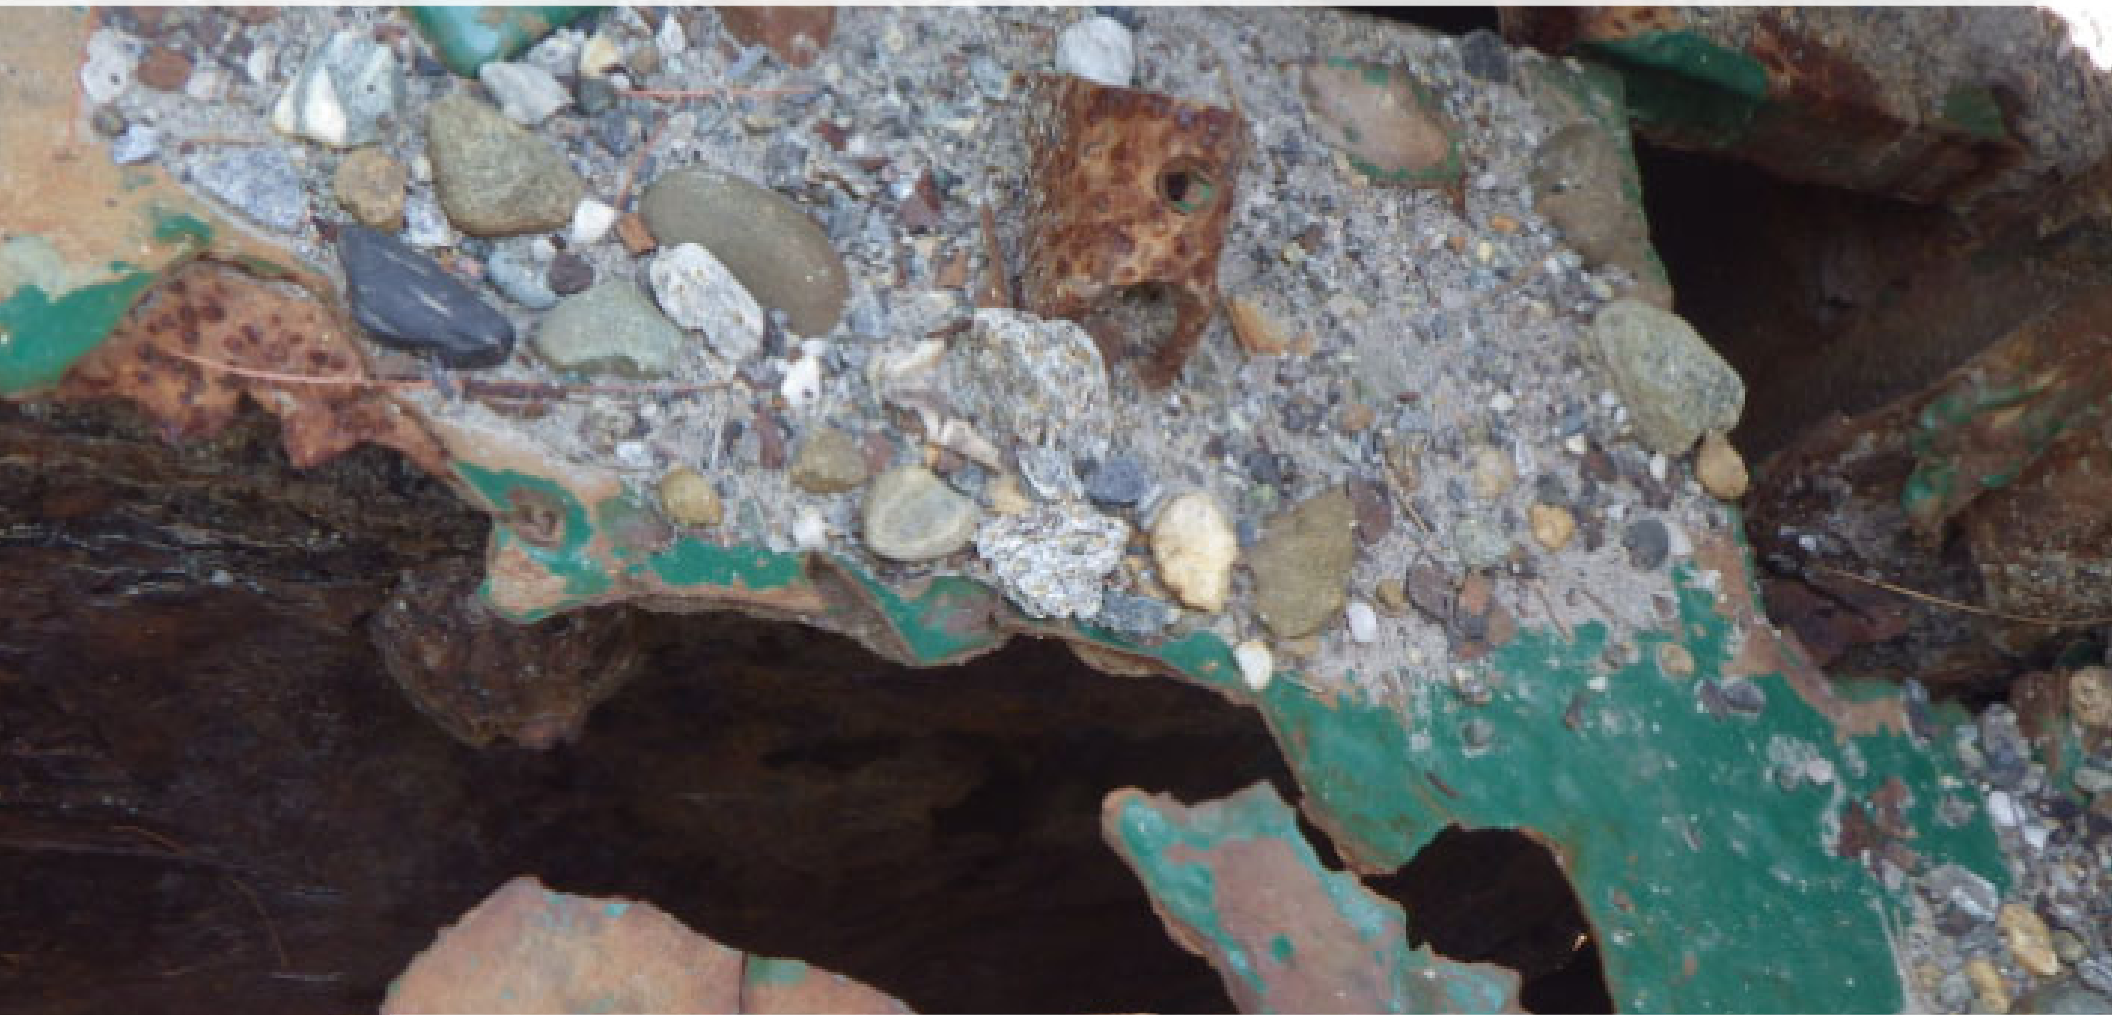
## Condition Ratings

### Existing Conditions - Bridge #6

- Deck Rating 8 (Very Good)
- Superstructure Rating Failed – Temporary in place
- Substructure Rating 6 (Satisfactory)

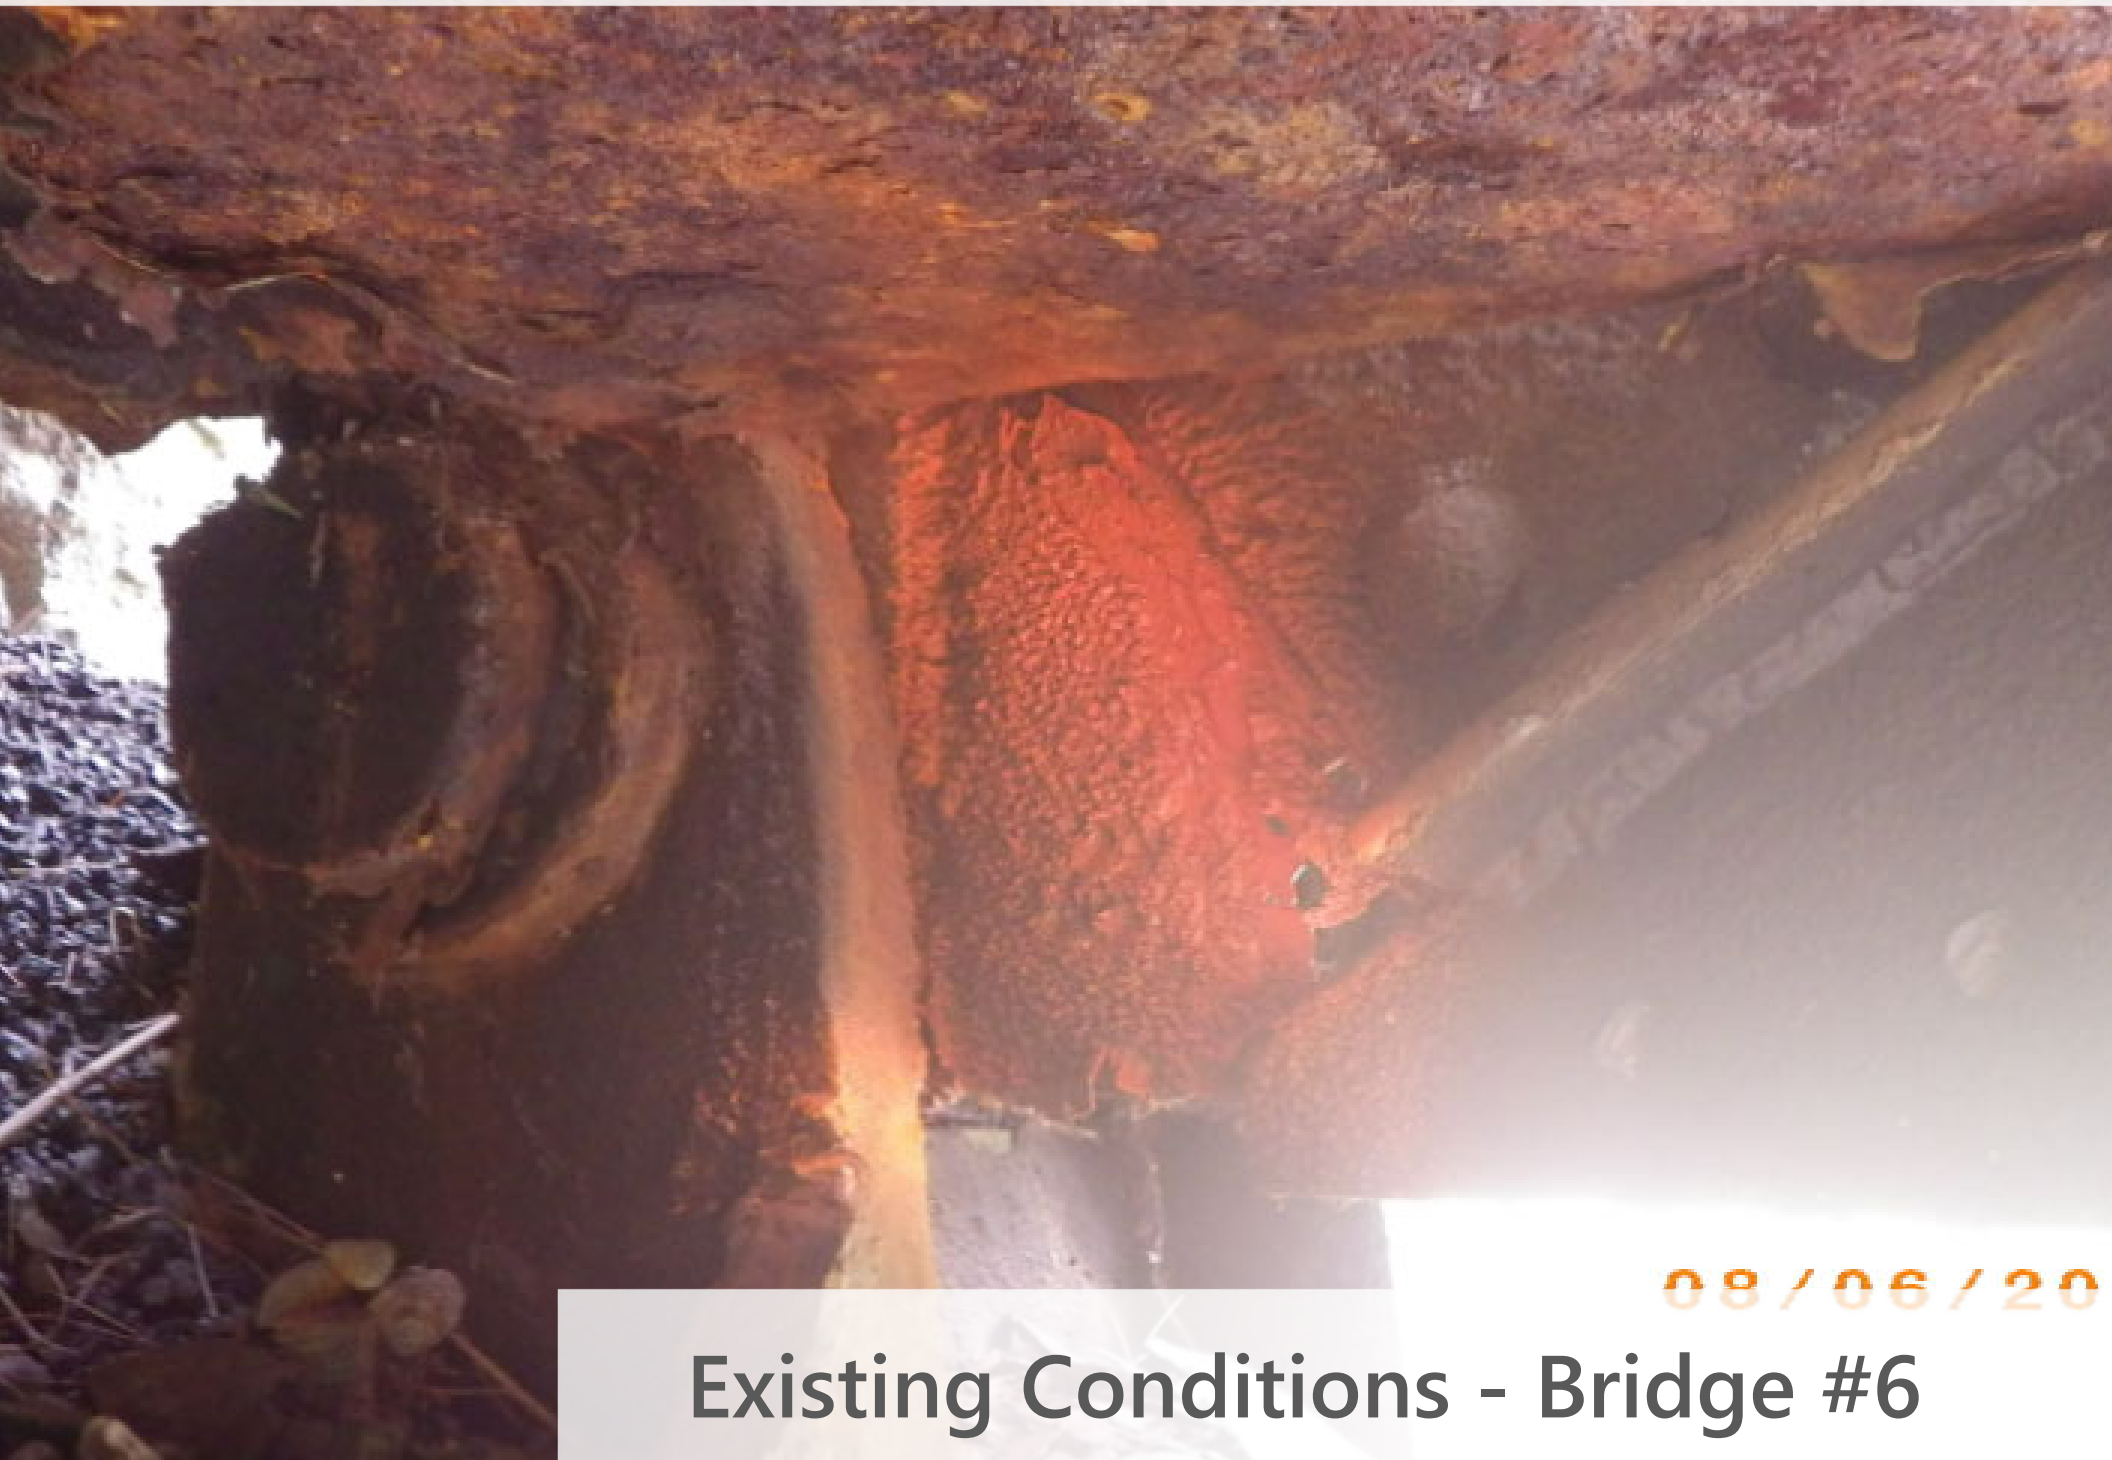
2018 Inspection Finding Photo

- The bridge was closed to traffic in 2018 and a temporary bridge was placed on top of the existing pony truss. During the annual inspection, it was discovered that the gusset connection, located at the bottom chord end of abutment #1 upstream bearing, had deteriorated to the point where it completely cracked through with some deformation seen.
- The shoulder width on Bridge 6 is substandard.
- Bridge 6 does not span bank full width.

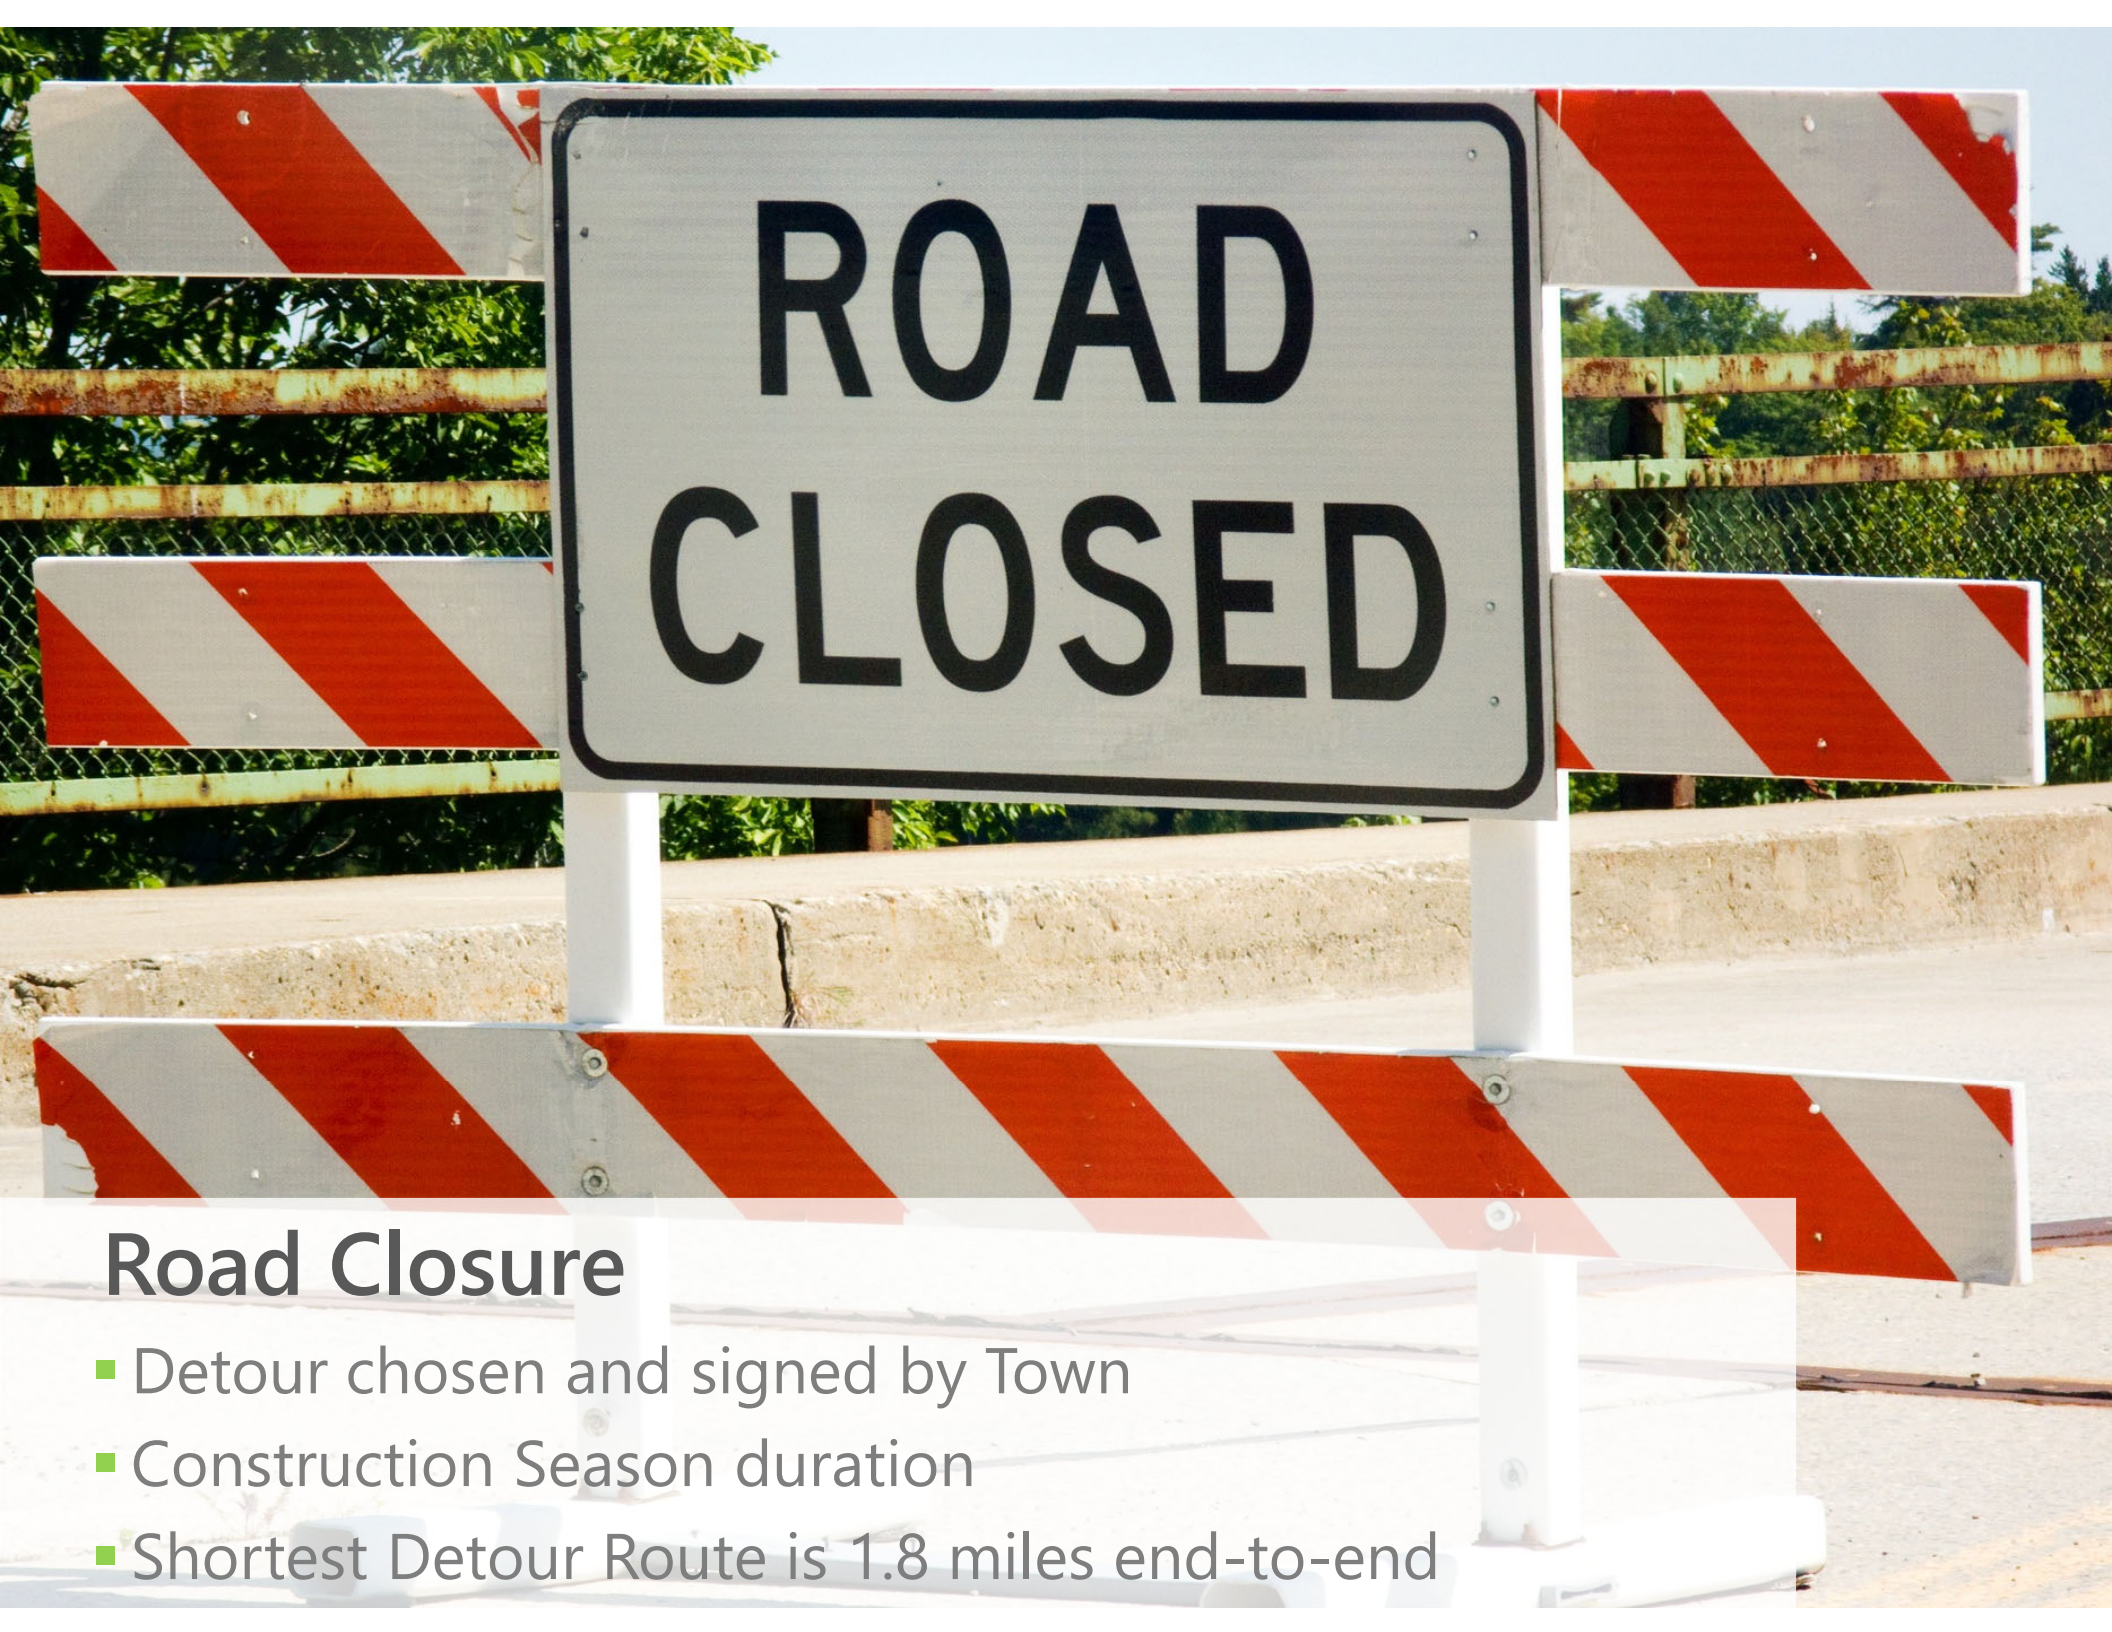
A photograph of a road closure. In the center, a white rectangular sign with a black border and the words "ROAD CLOSED" in large, bold, black capital letters is mounted on a white post. The sign is flanked by two horizontal barriers with red and white diagonal stripes. In the background, there is a concrete wall, a chain-link fence, and green trees under a clear blue sky.

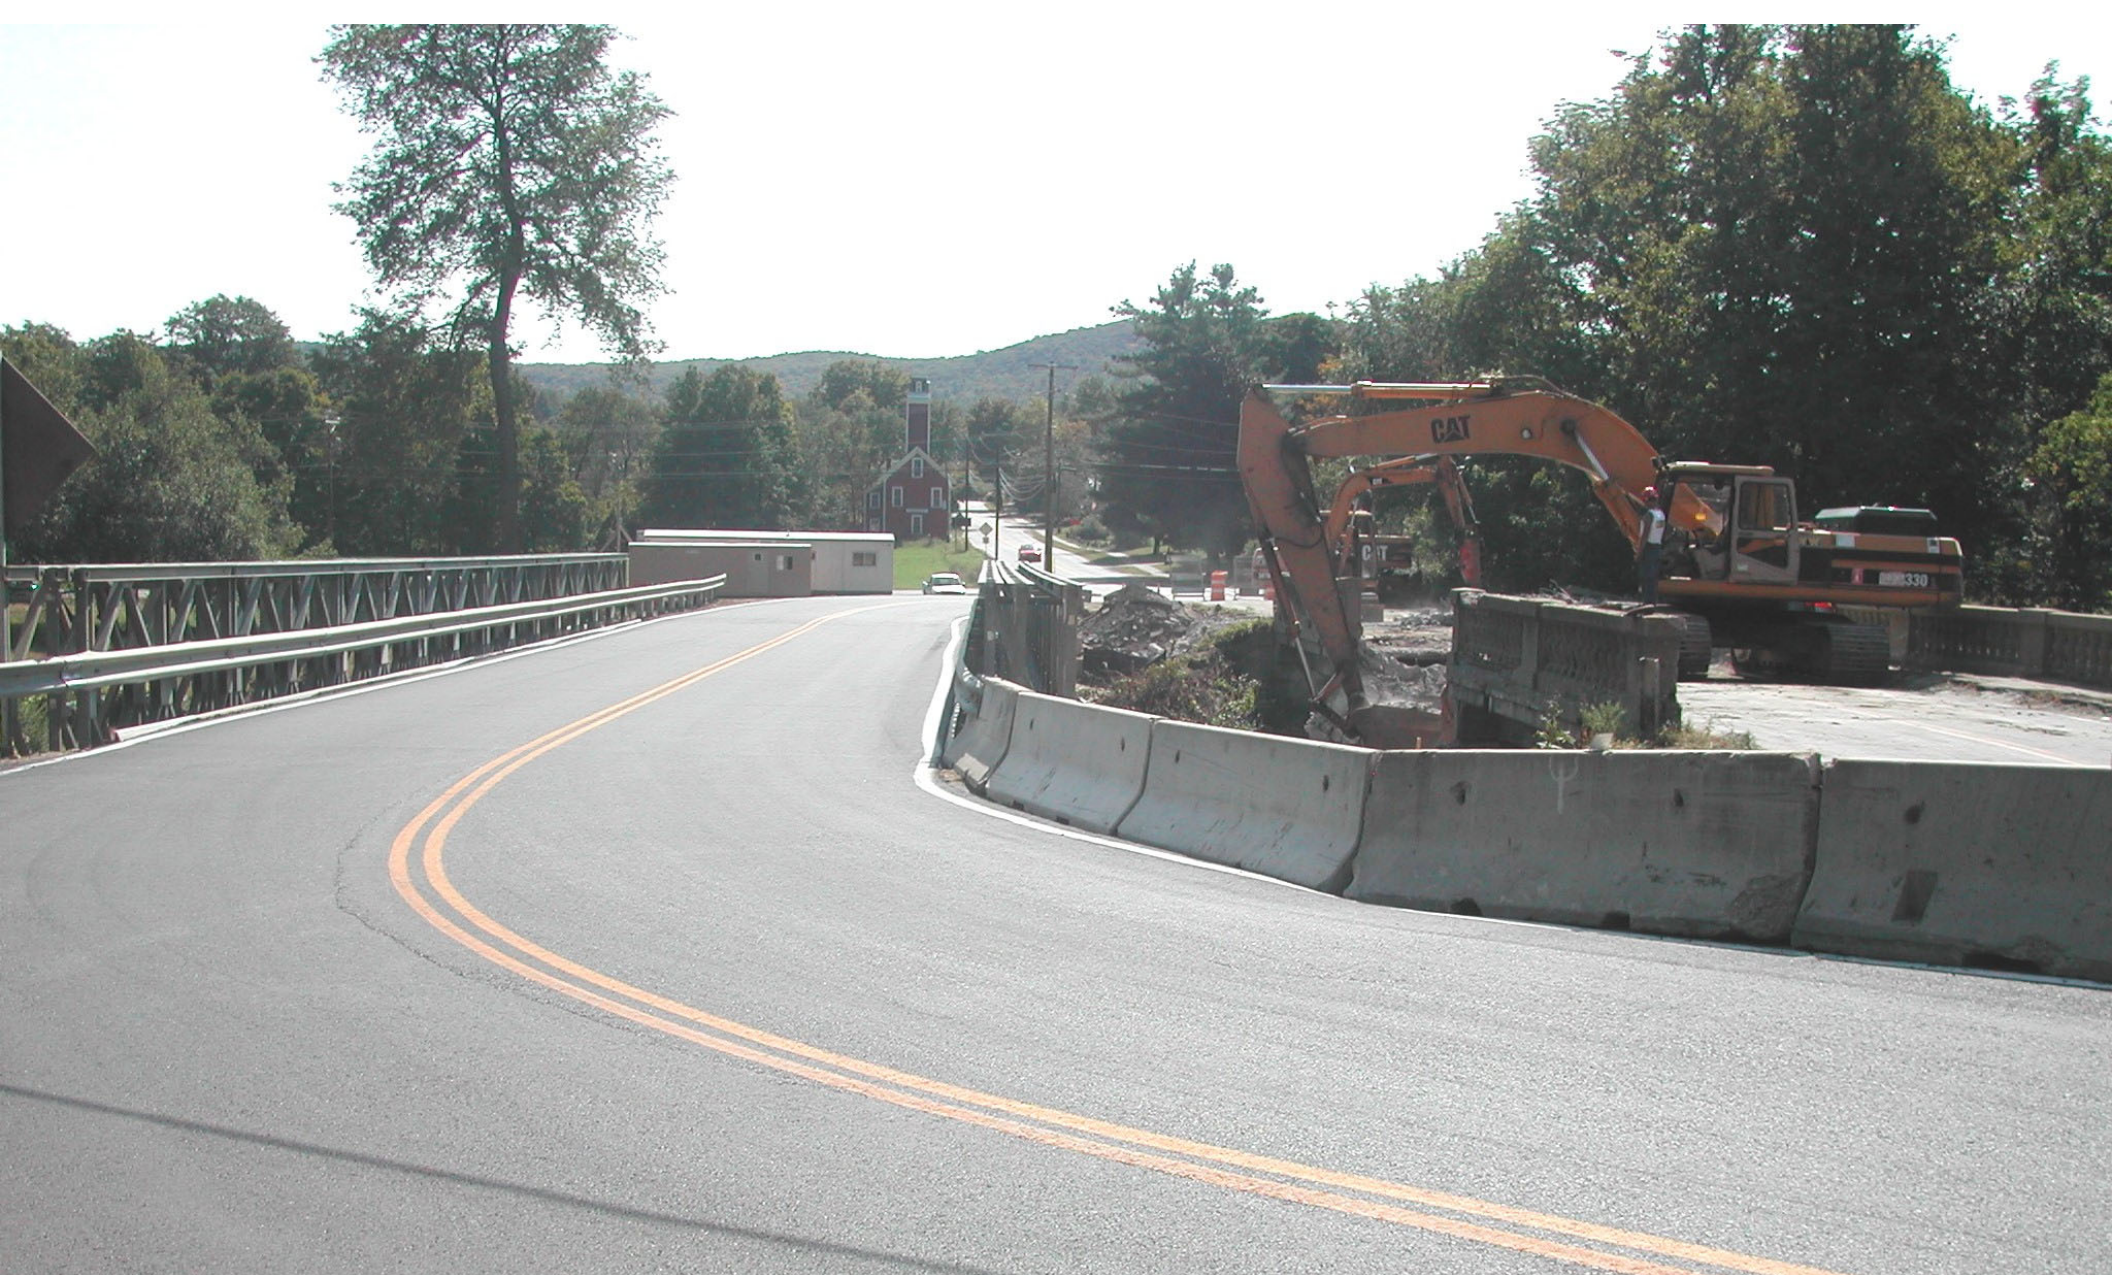
## Temporary Bridge/Roadway

- One Lane Temporary Bridge constructed either Upstream or Downstream side of School Street
