# Northfield Village BF 0241(58) Alternatives Presentation Meeting

**Vermont Route 12 – Bridge #60 over Dog River**

February 9, 2021

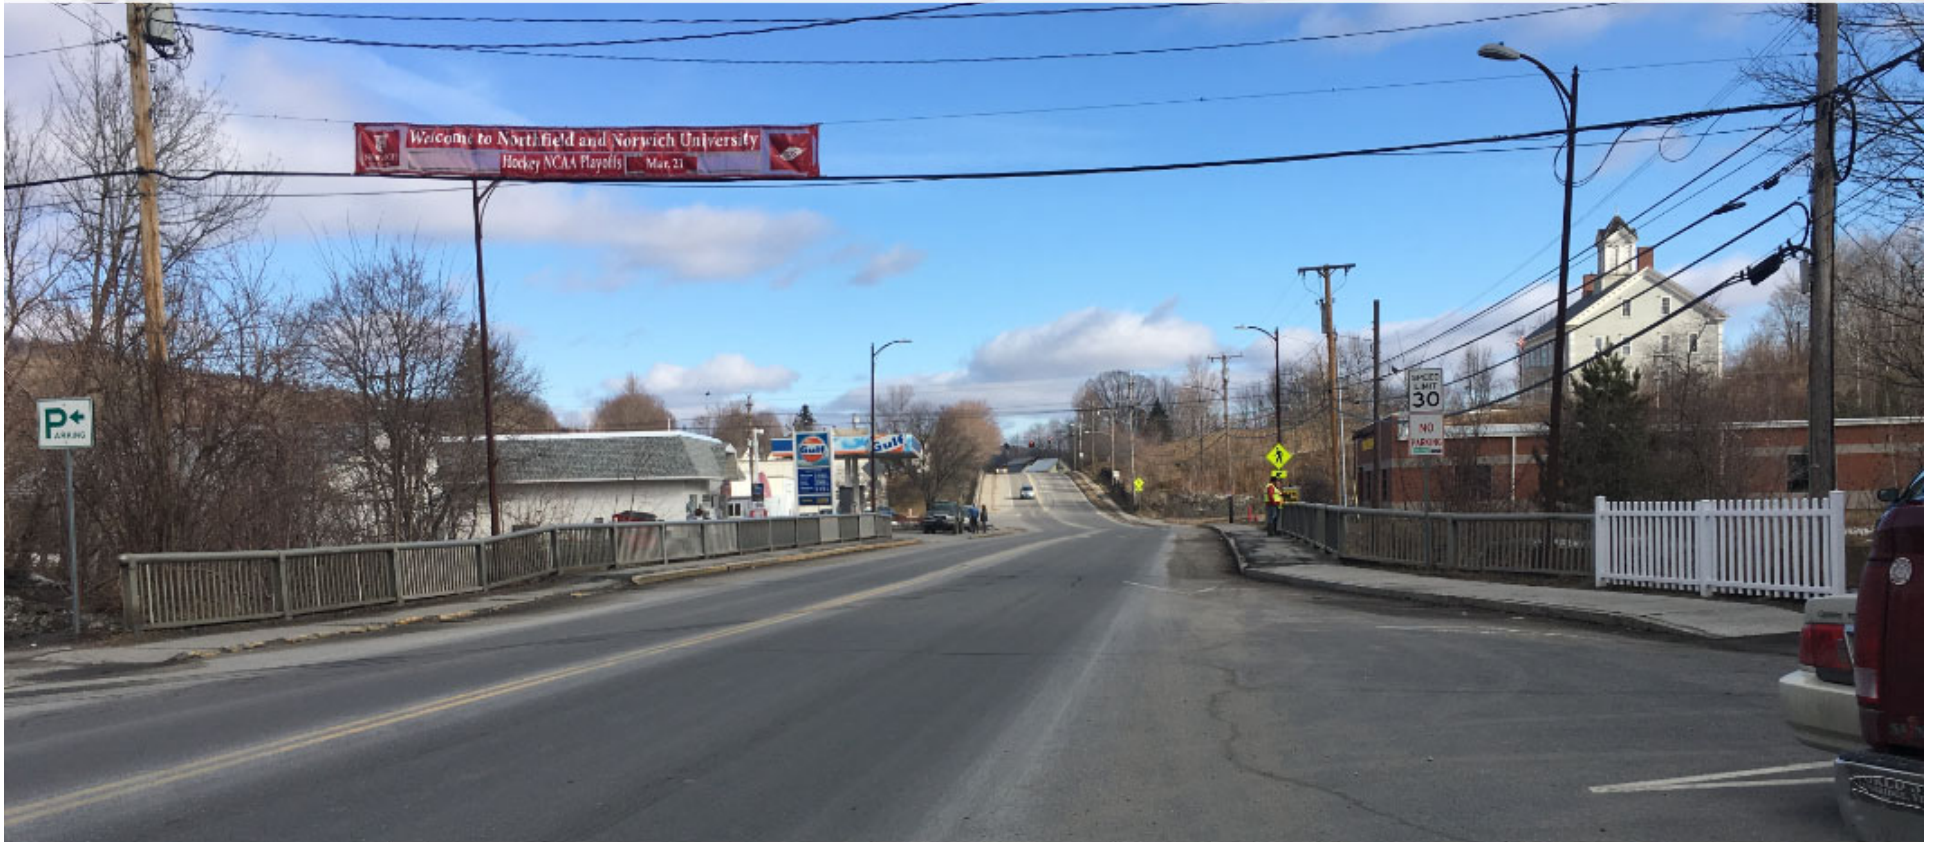
## Looking North over Bridge 60

- Roadway Classification – Major Collector (Class 1 TH)
- Bridge Type – 111' Long 3-Span Concrete T-Beam Bridge
- Ownership – Town of Northfield
- Constructed in 1926, Reconstructed in 1958

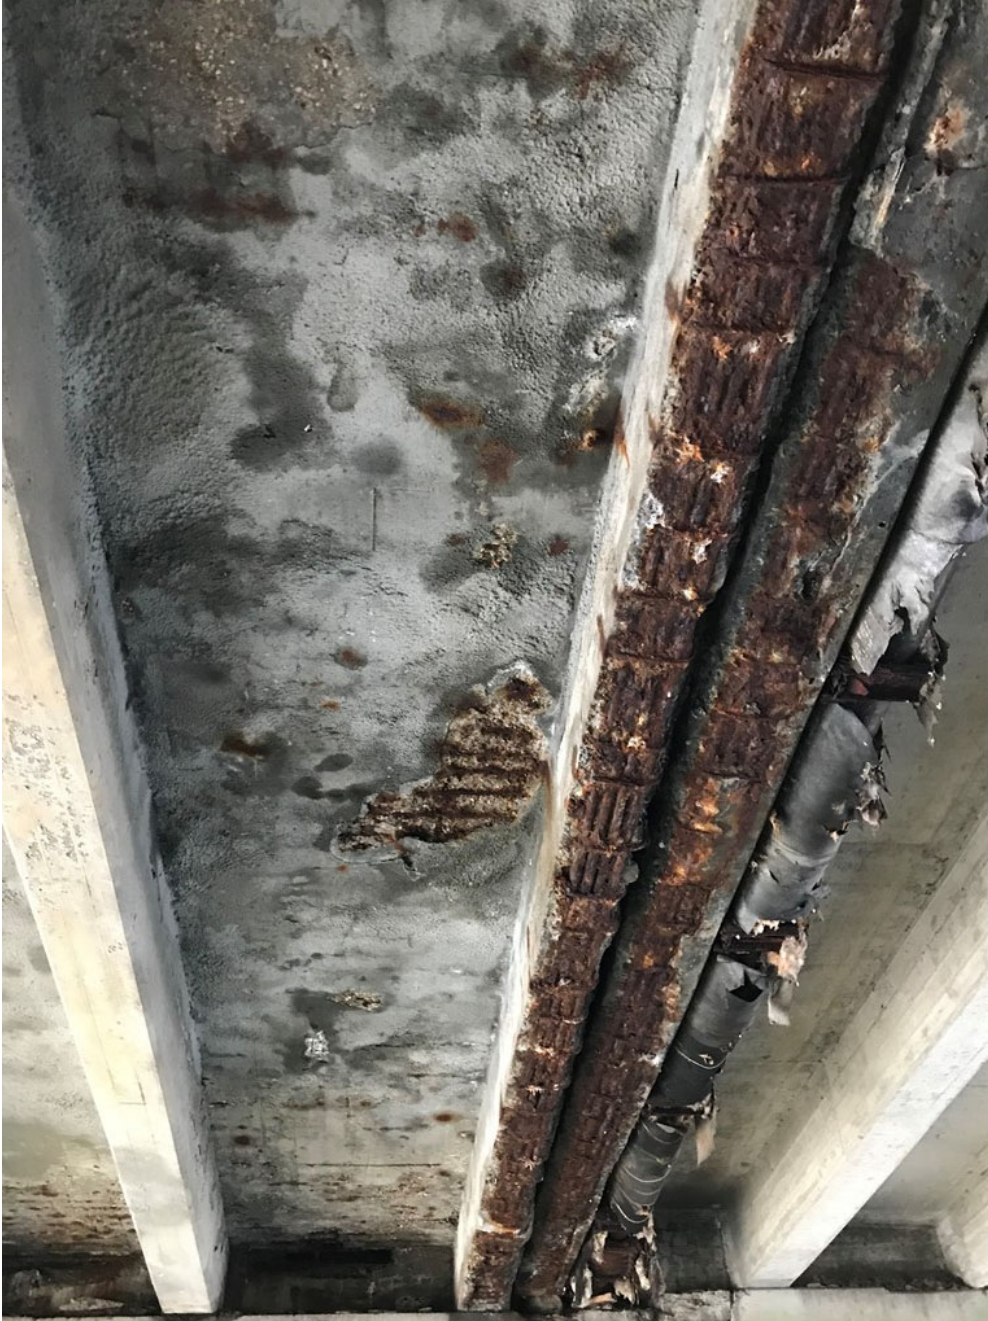
## Condition Ratings

- Deck Rating (Poor) 4
- Superstructure Rating (Fair) 5
- Substructure Rating (Satisfactory) 6

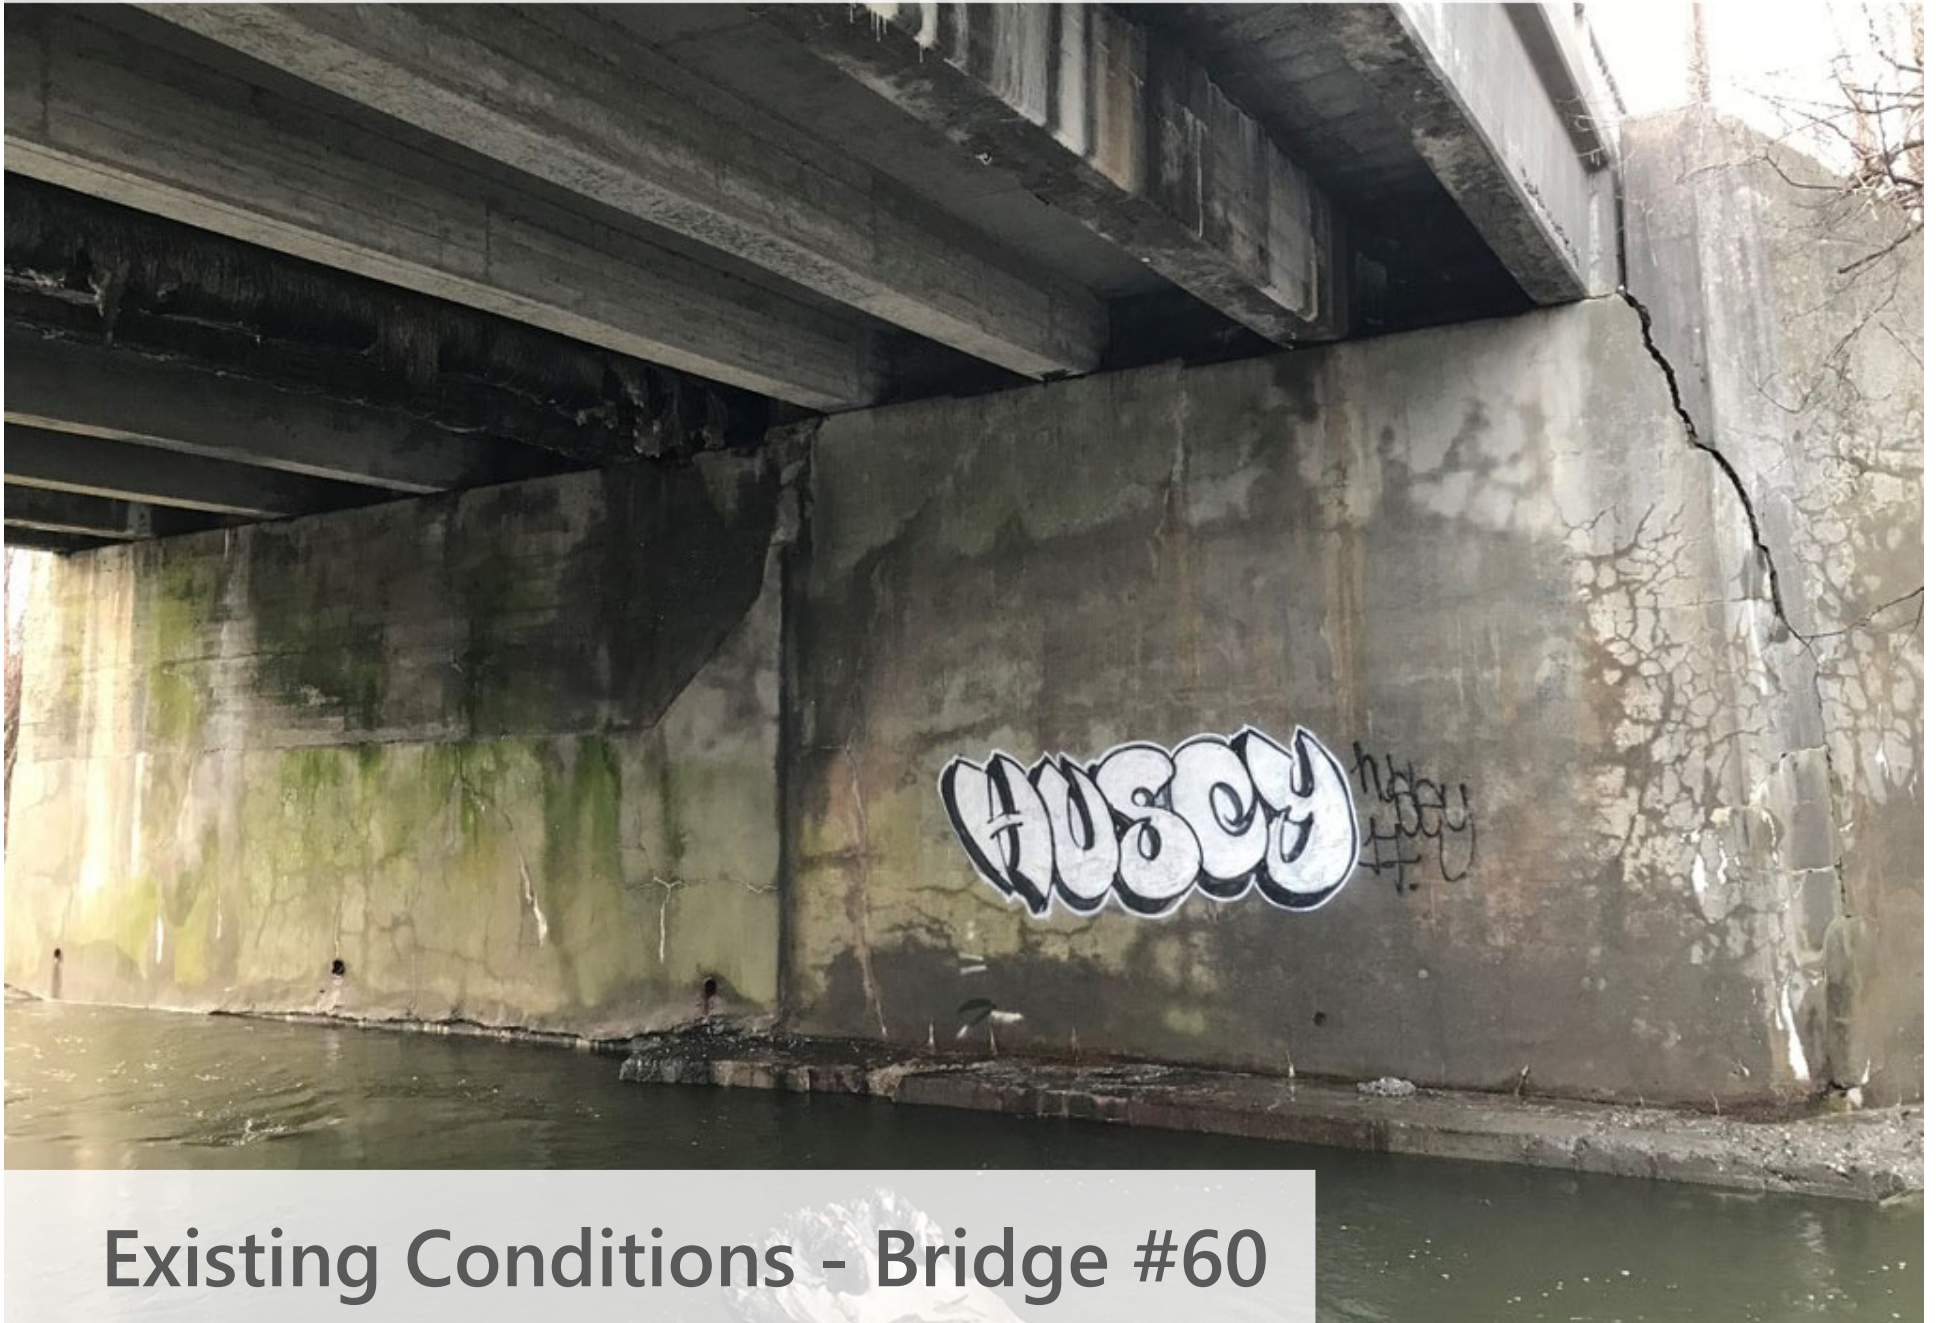
Abutment

- Both abutments have moderate to heavy cracking with efflorescence leakage due to saturation from above. Additionally, small spalls are present in the bridge seat area below the fifth and sixth beams.

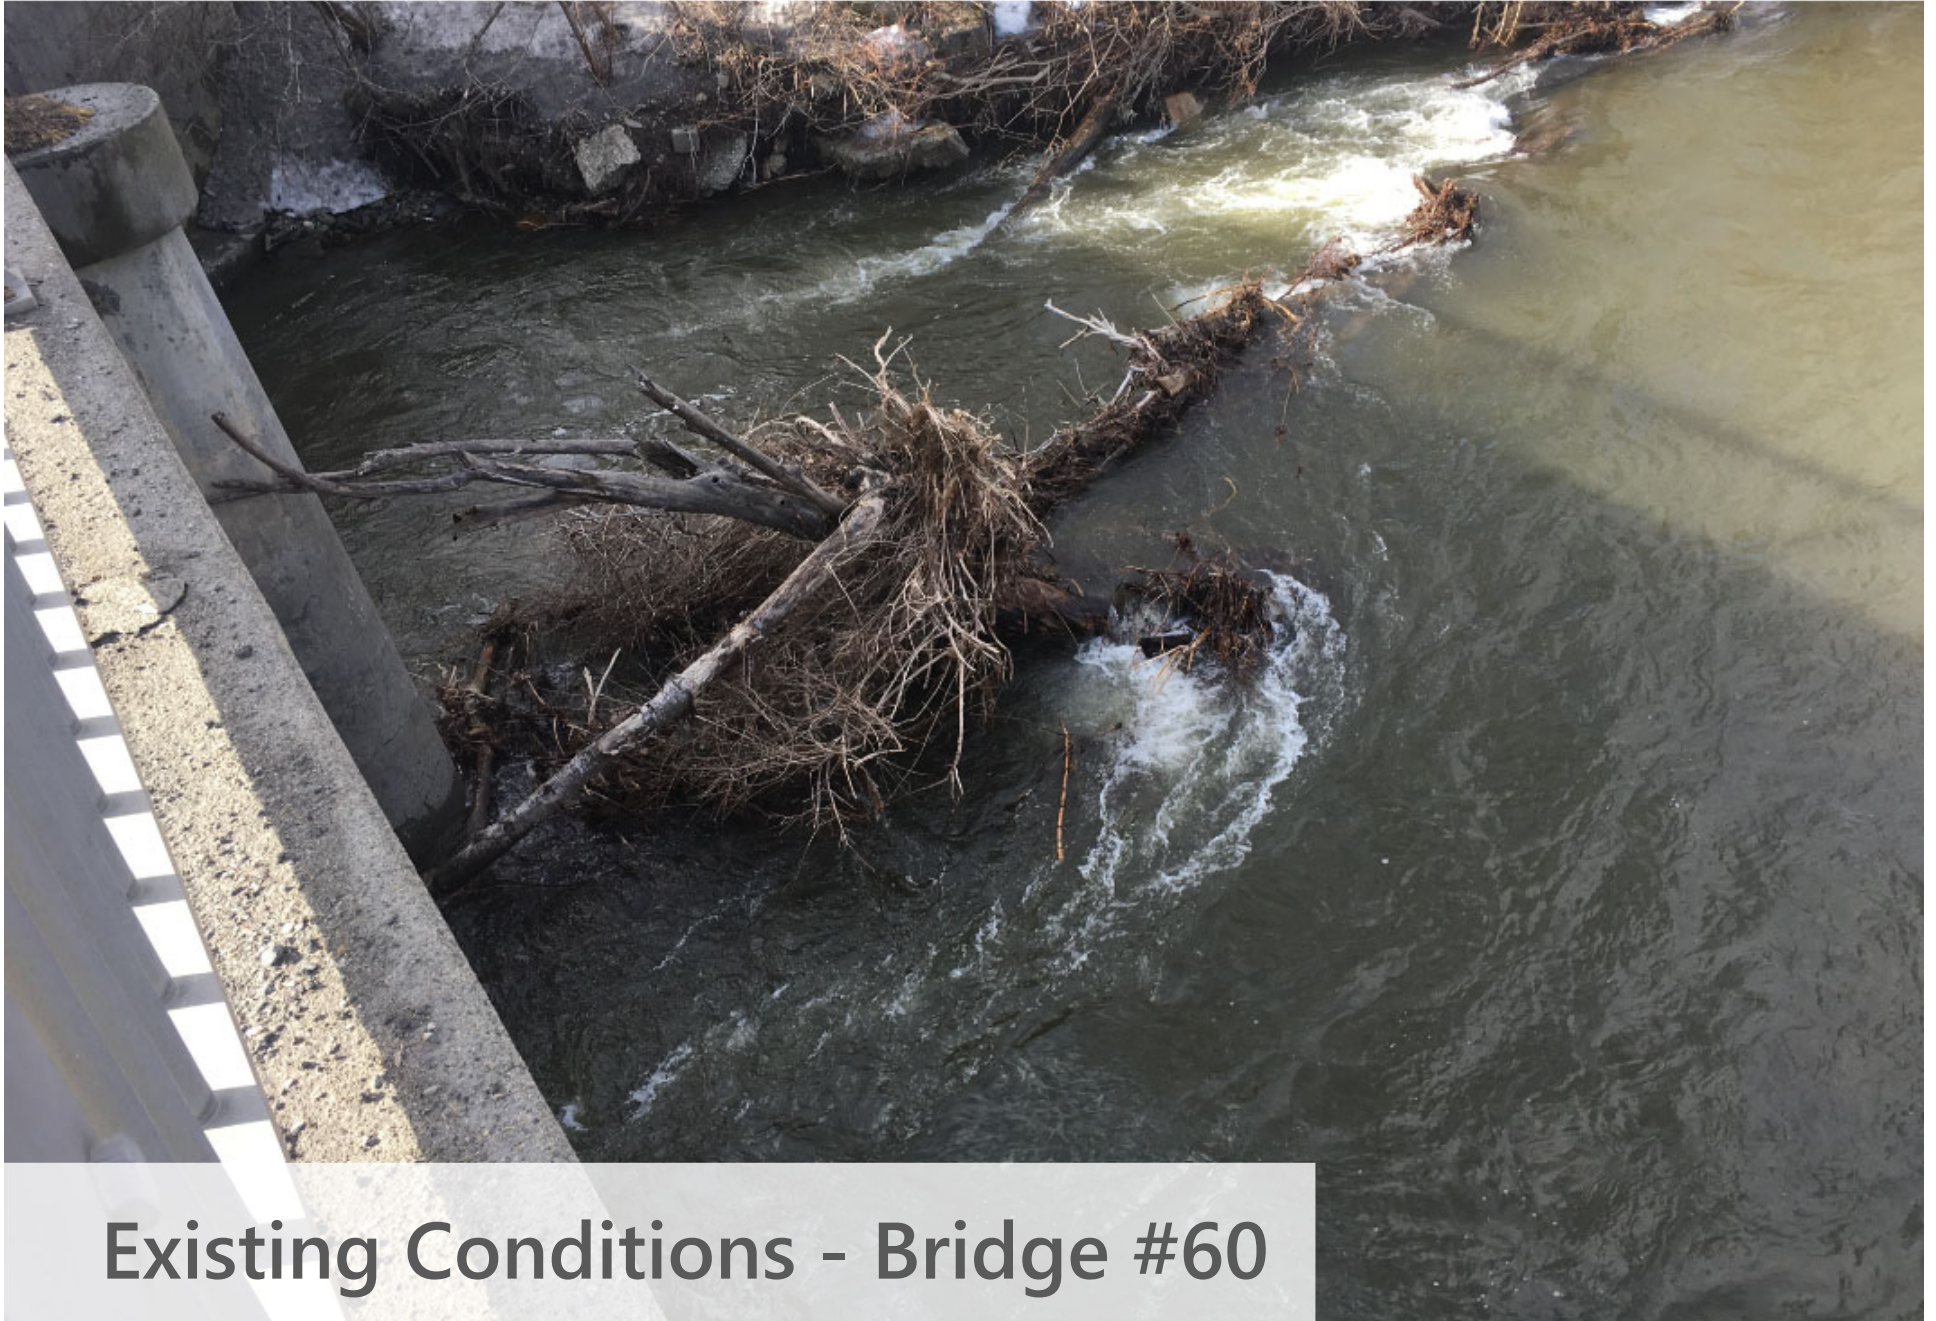
Typical Debris Jams at Pier

- The Dog River is prone to high debris, and debris gets caught on the existing piers on a regular basis.

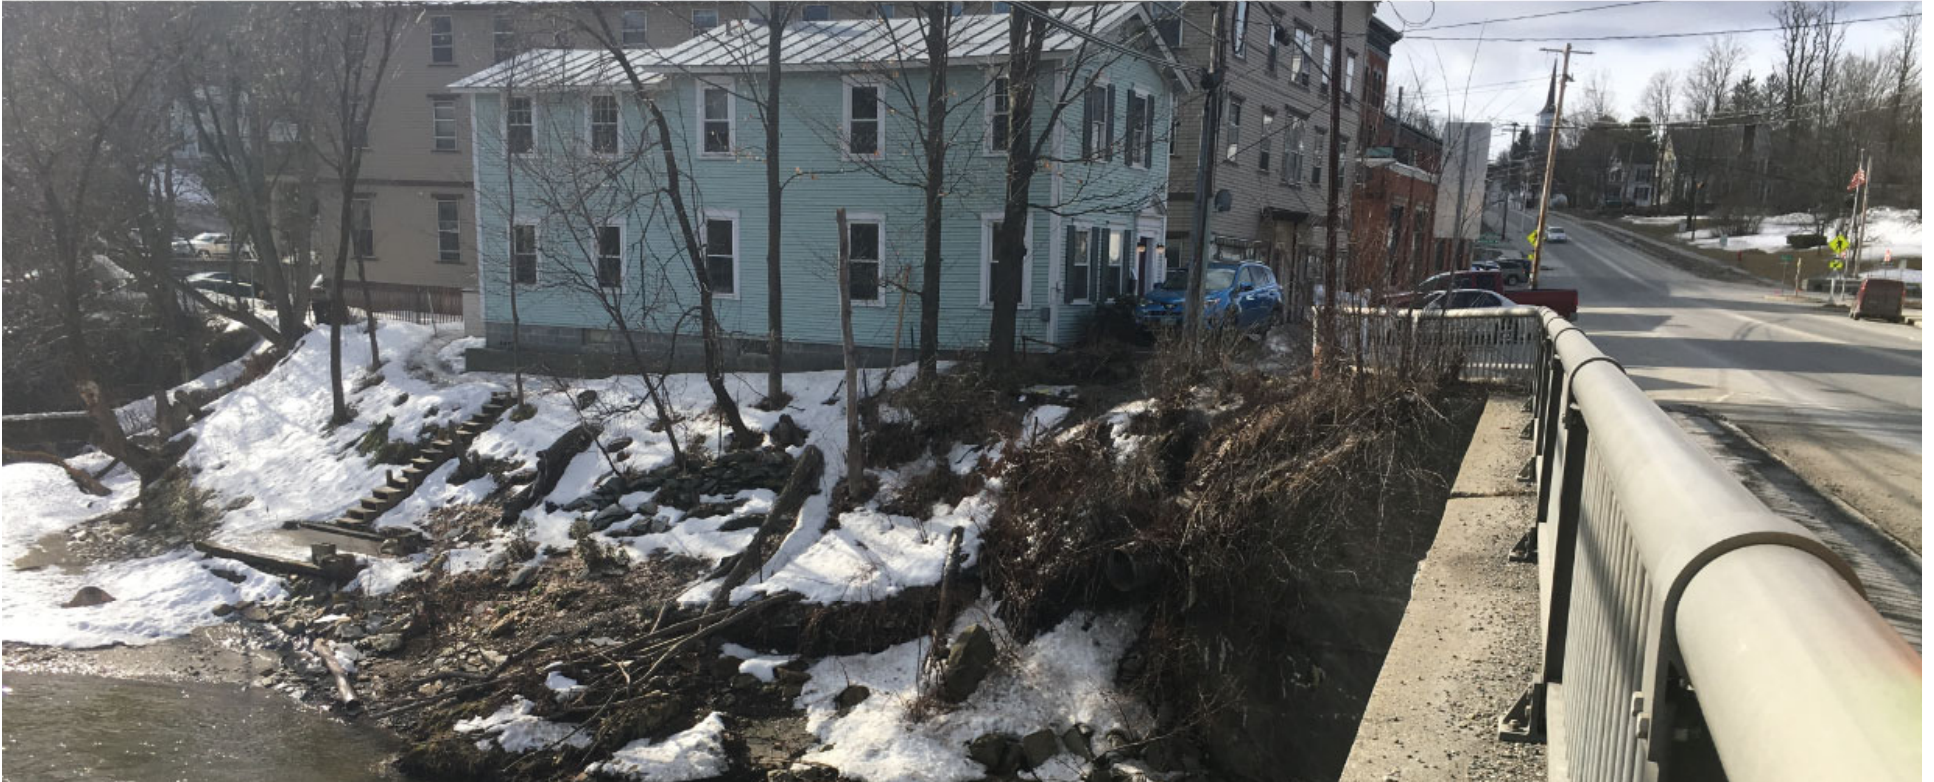
- Bridge is NOT Historic but is located within the Vermont State Register-listed Depot Square Historic District.
- Three contributing buildings to the Depot Square Historic District are located at the southeastern corner of Bridge No. 60 and are as follows: 38 North Main Street, 28 North Main Street, and 9 East Street.

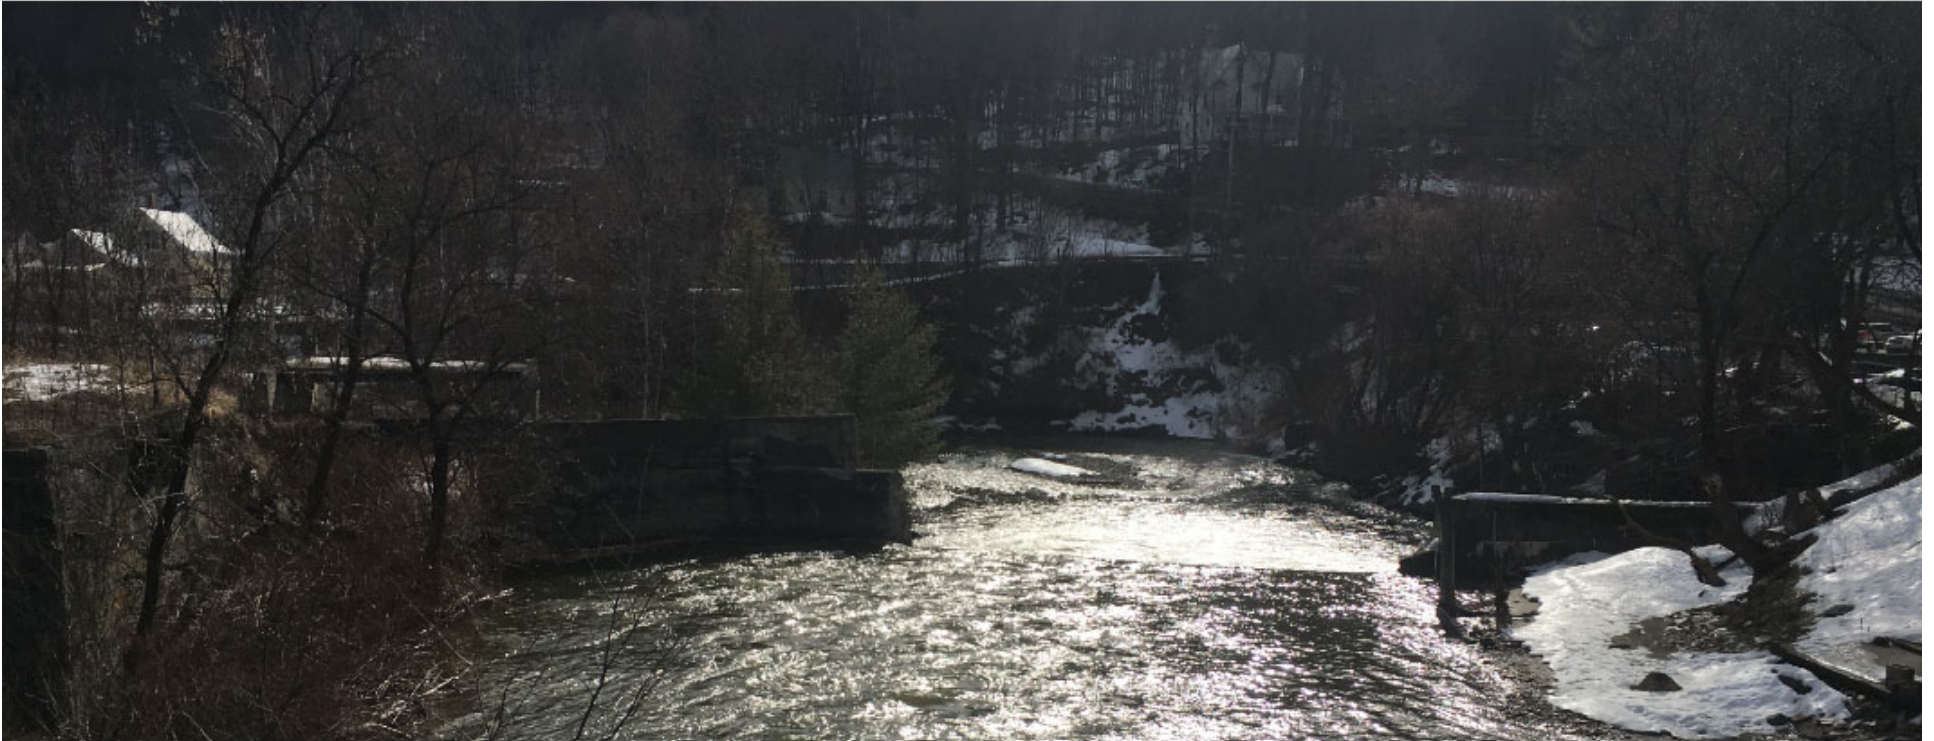
## Resources – Looking Downstream

- Northern Long Eared Bat
  - Potential Habitat under bridge (acoustic survey or time of year restrictions may be required)
- The northeast quadrant of the bridge may retain elements related to series of mills that were a prominent fixture on the Northfield landscape in the nineteenth century.

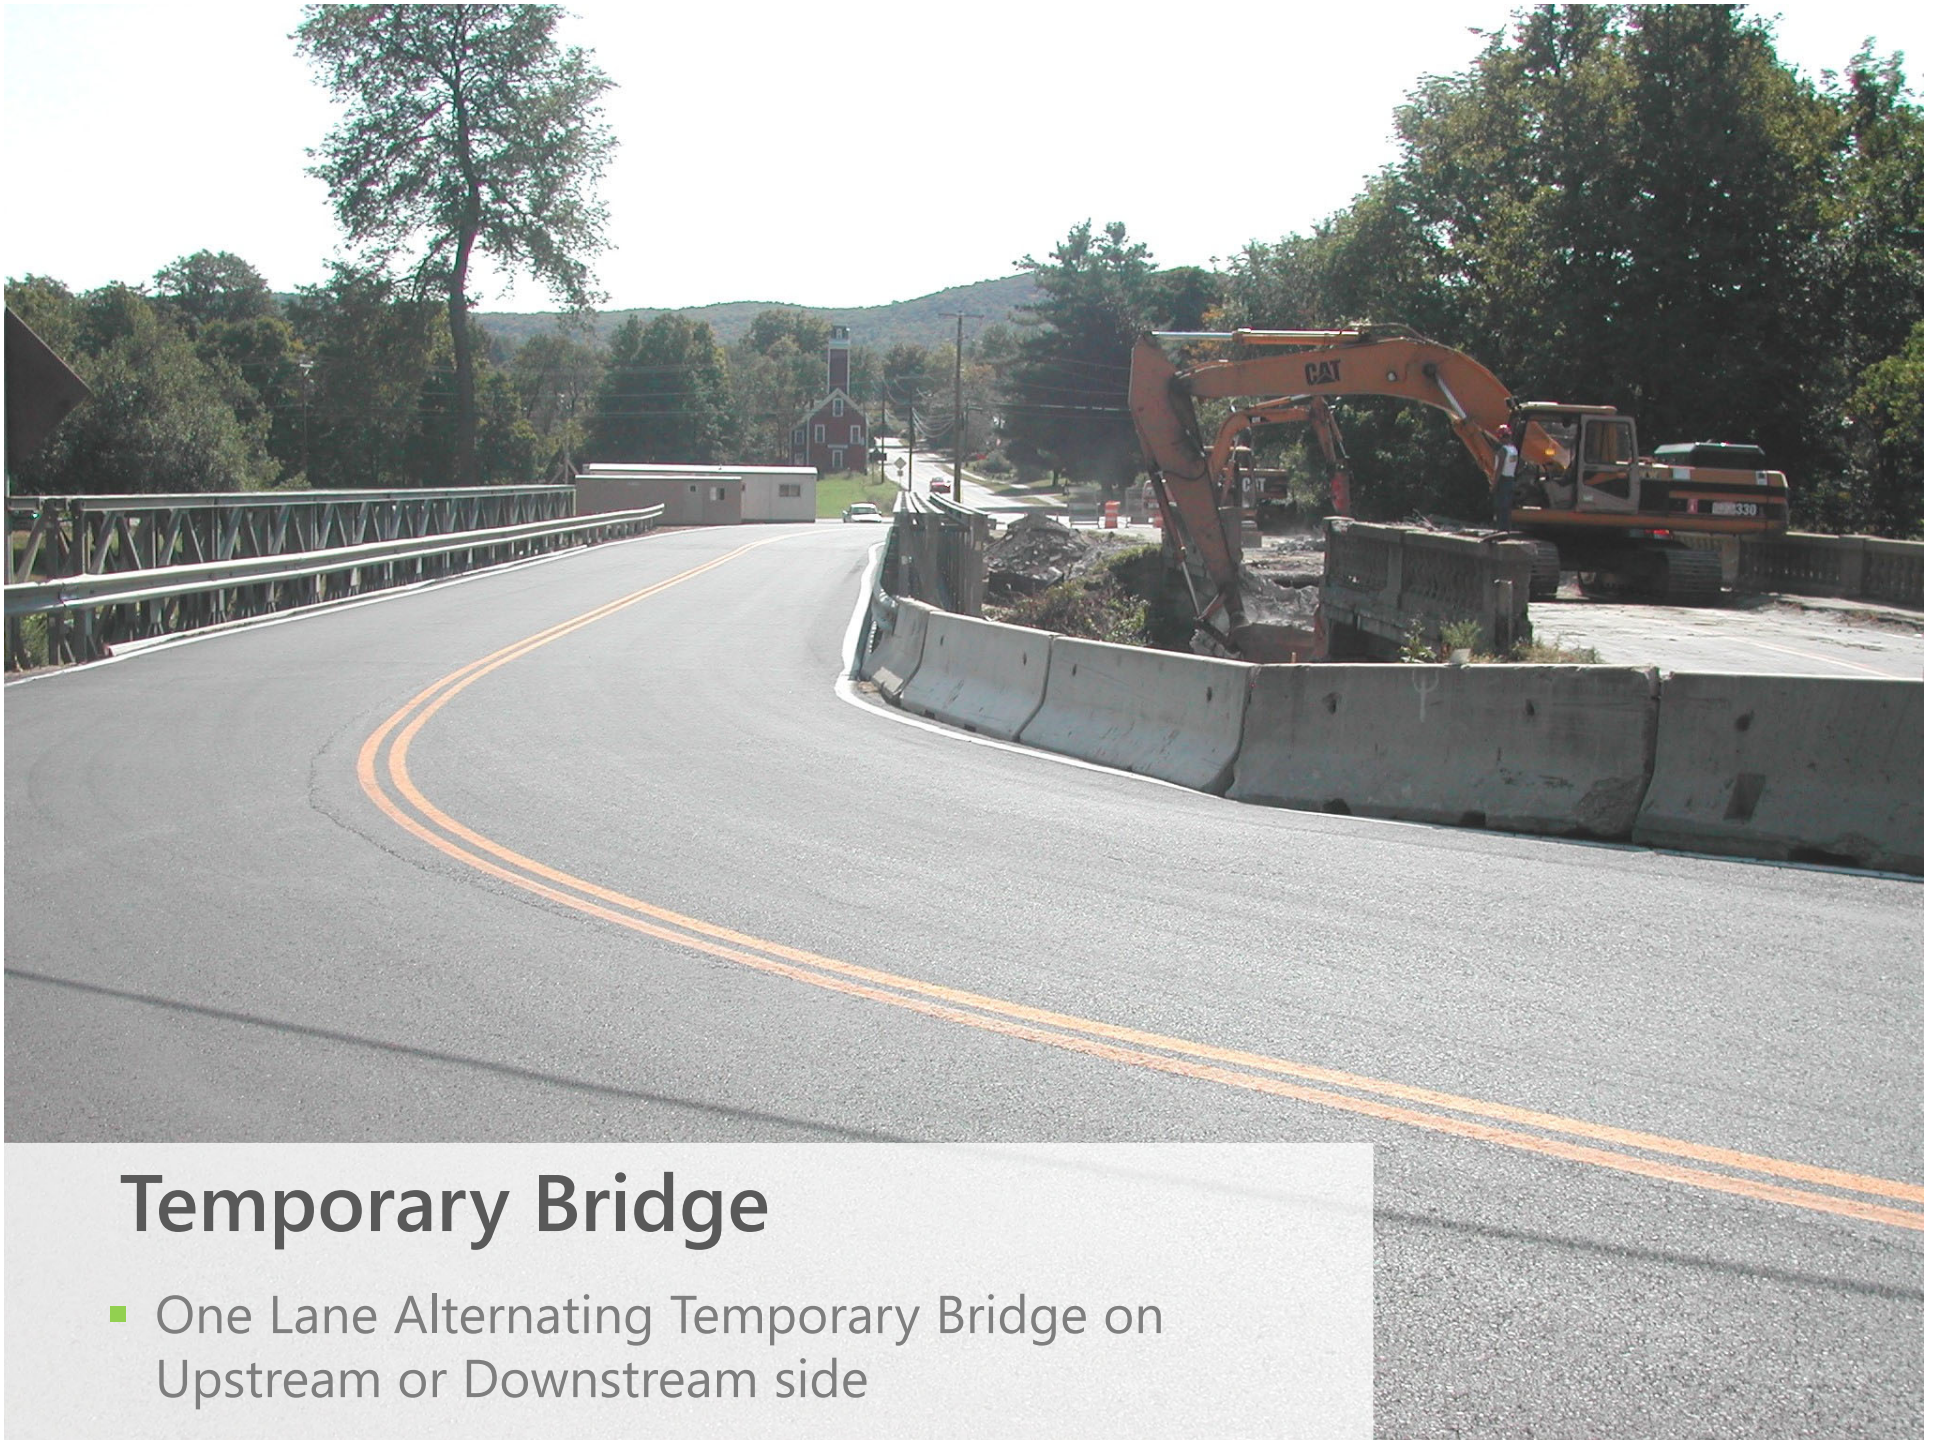
## Temporary Bridge

- One Lane Alternating Temporary Bridge on Upstream or Downstream side

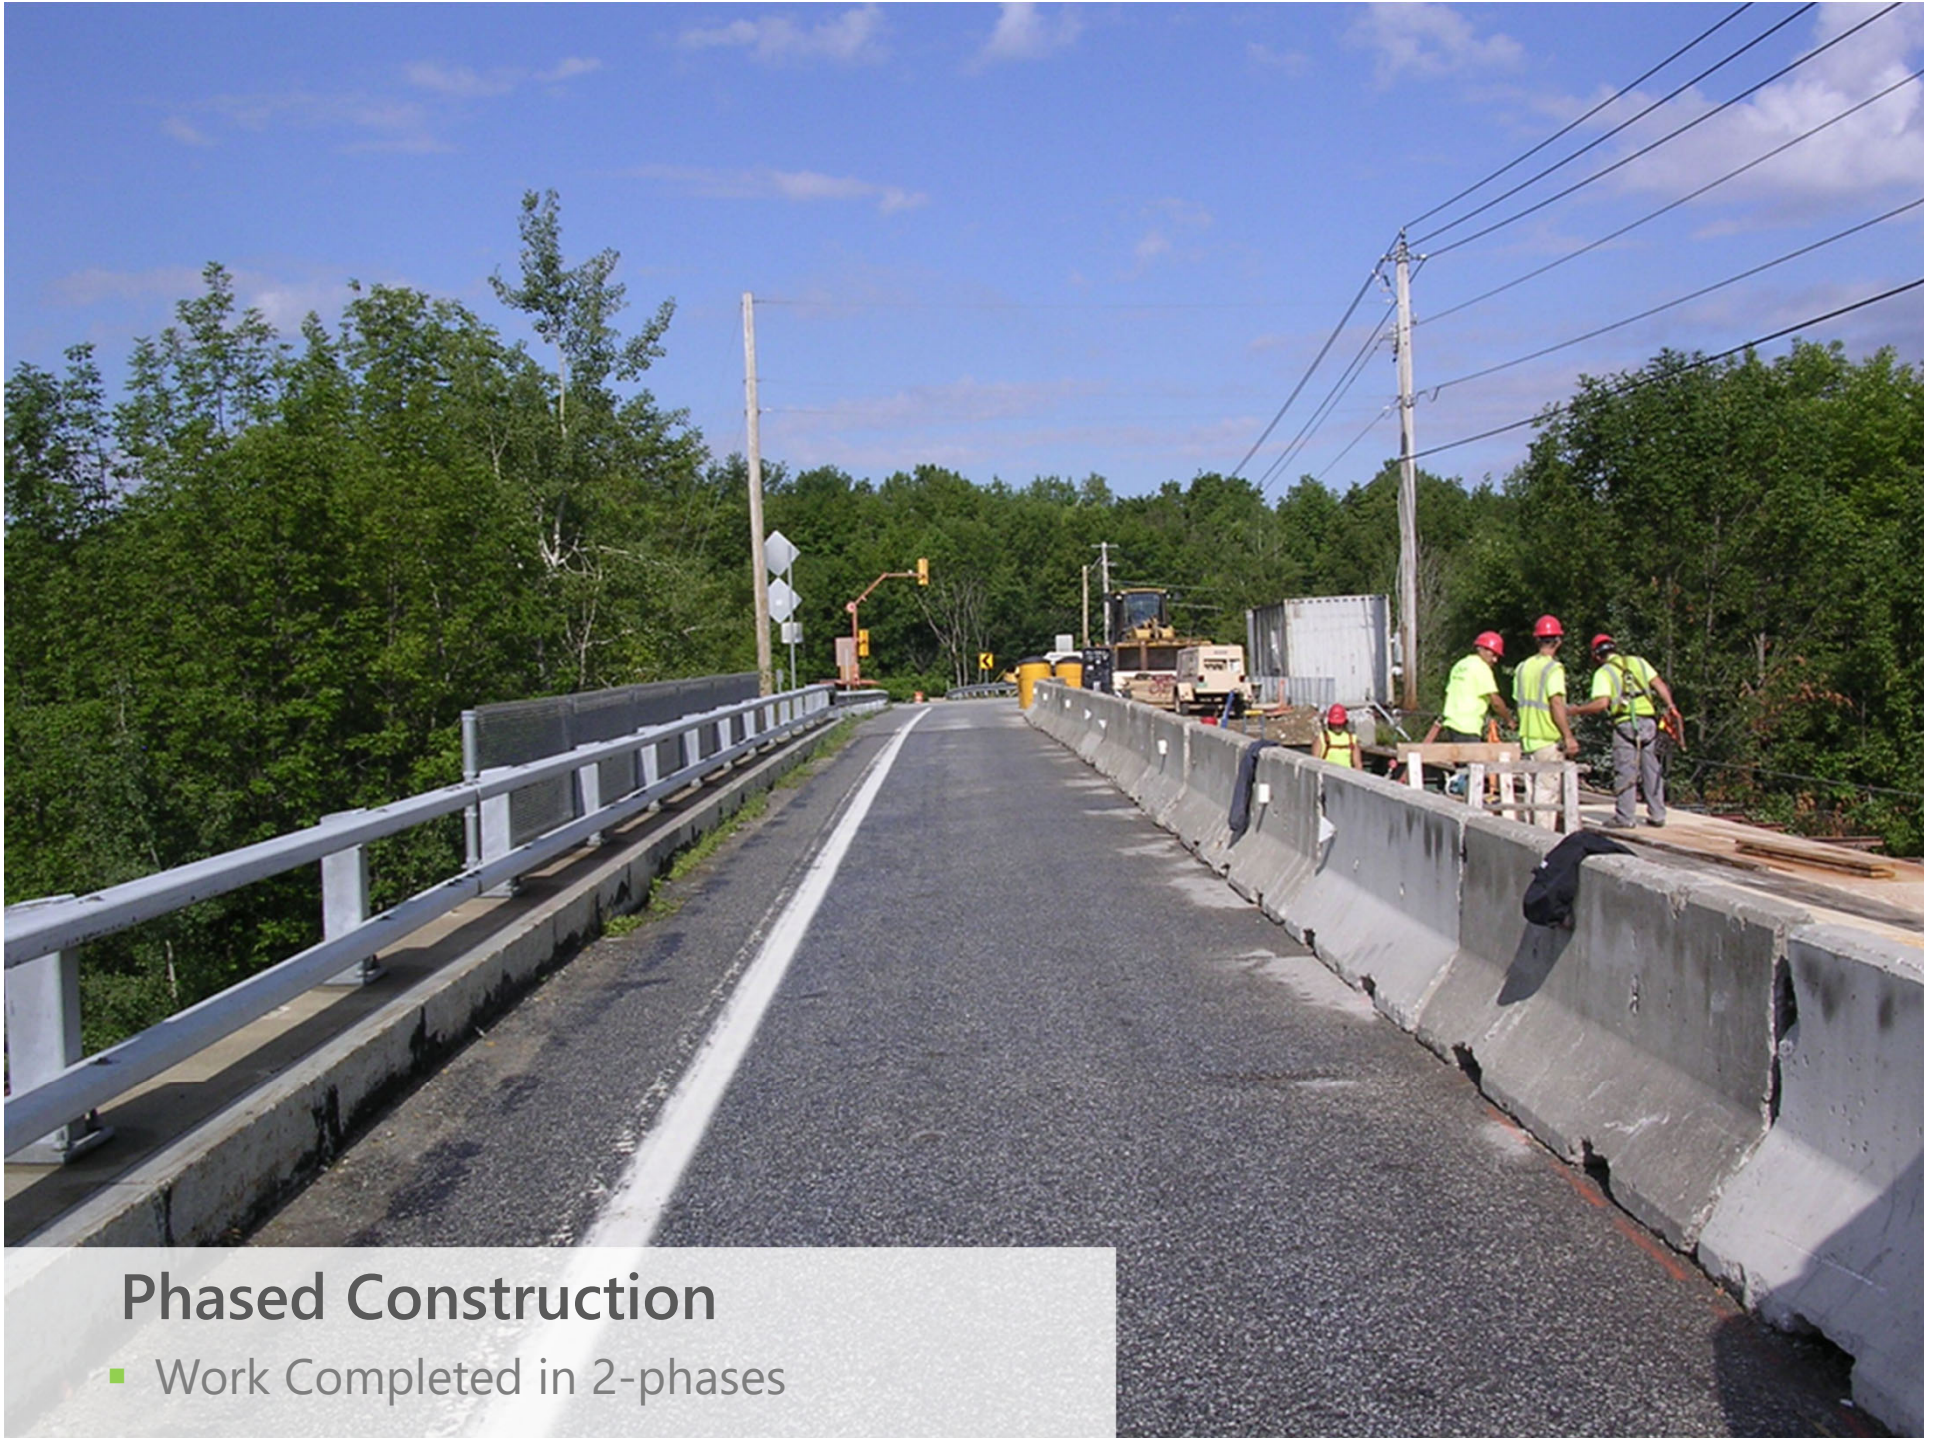
## Phased Construction

- Work Completed in 2-phases
