Enosburgh BO 1448(45)
Alternatives Presentation Meeting
Town Highway 4 – Bridge #50 over Tyler Branch

June 15, 2020

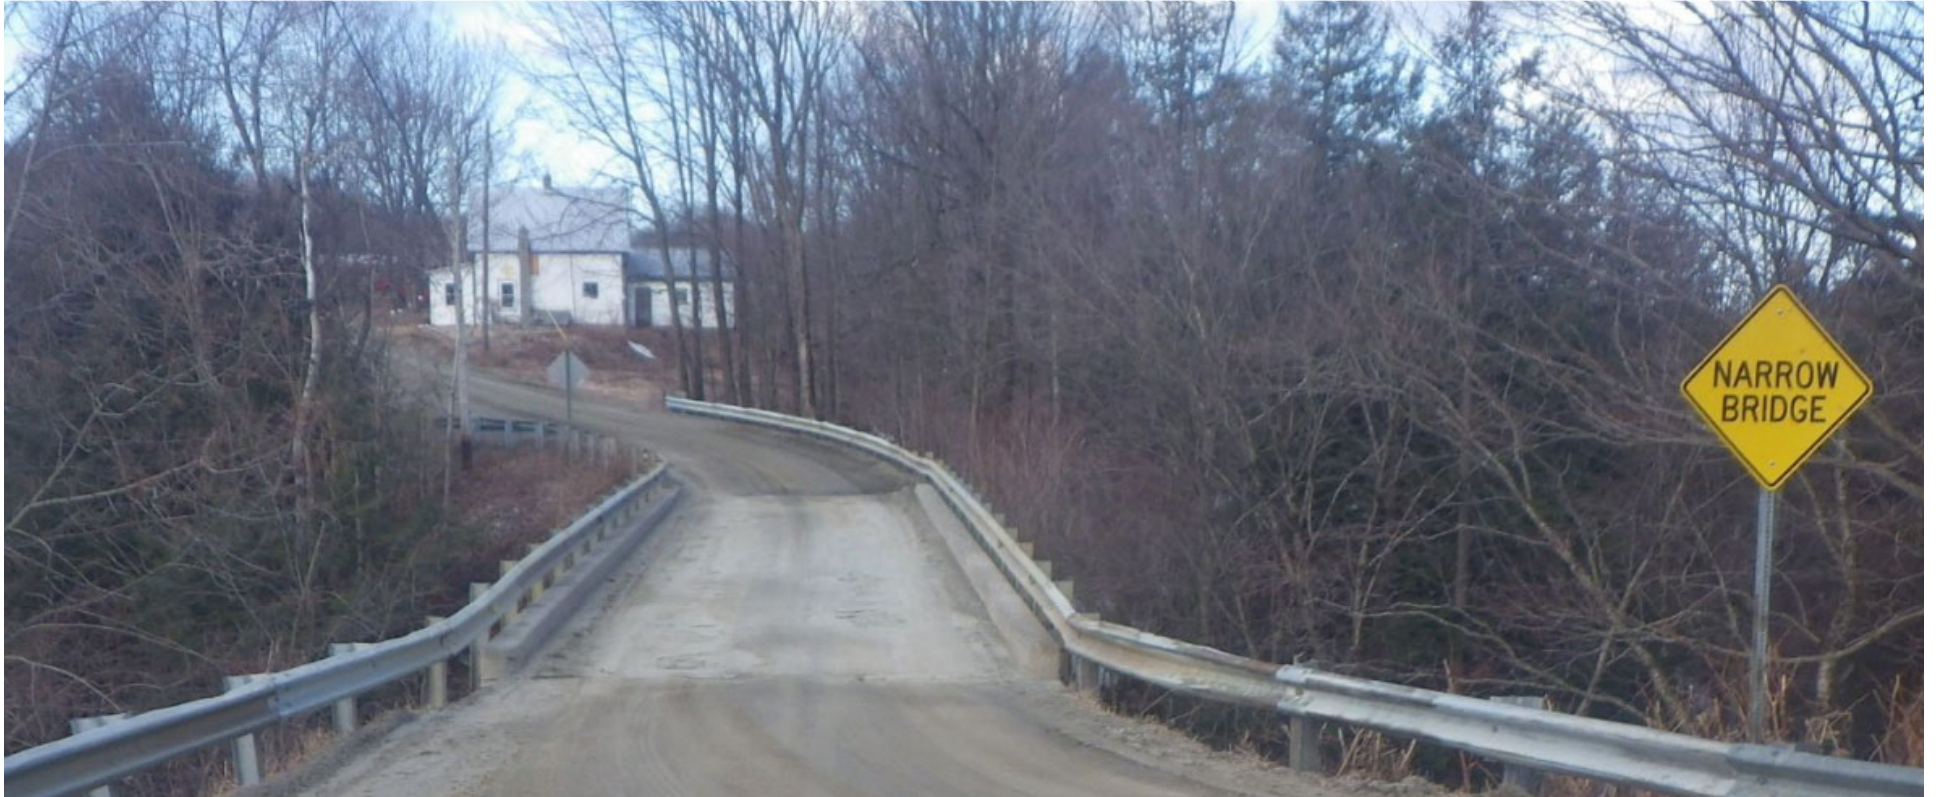
Looking West over Bridge 50

- Roadway Classification – Local Road (Class 2 Town Highway)
- Bridge Type – Single Span Rolled Beam Bridge
- Bridge Length – 74 feet
- Ownership – Town of Enosburgh
- Constructed in 1918, Reconstructed in 1975

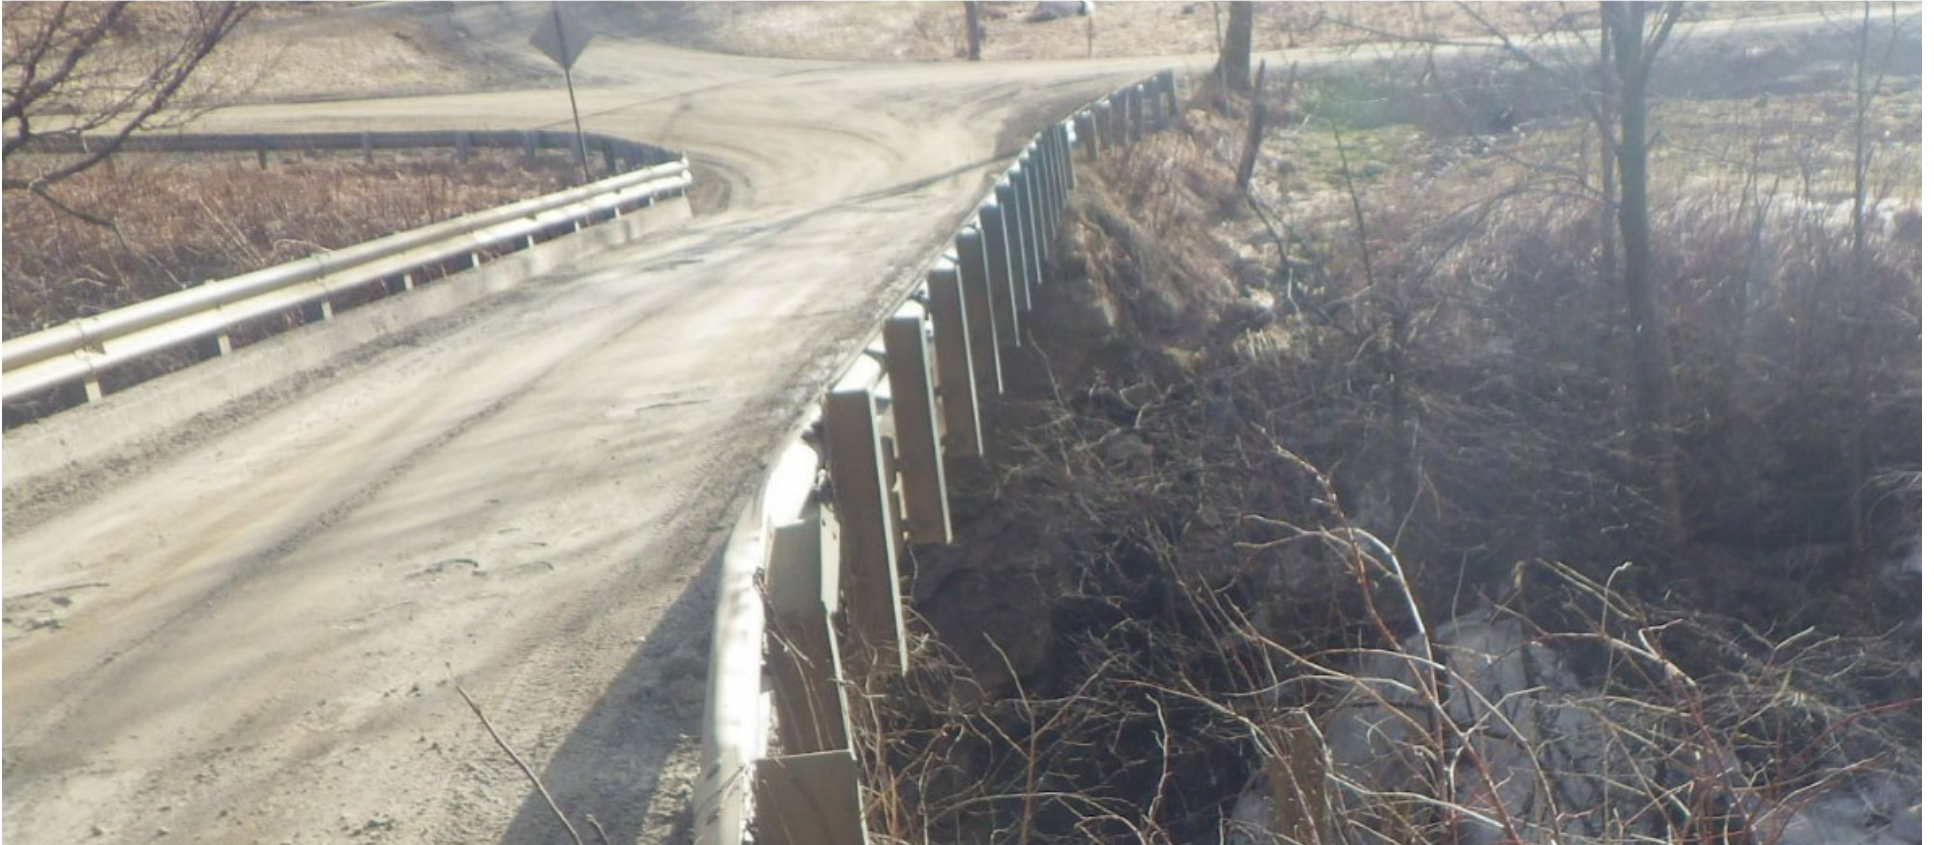
Looking East over Bridge 50

- Complicated Intersection on East Approach
- Narrow Bridge
 - Typical Section: 14' Rail-to-Rail
 - Standard Typical: 9'/1'

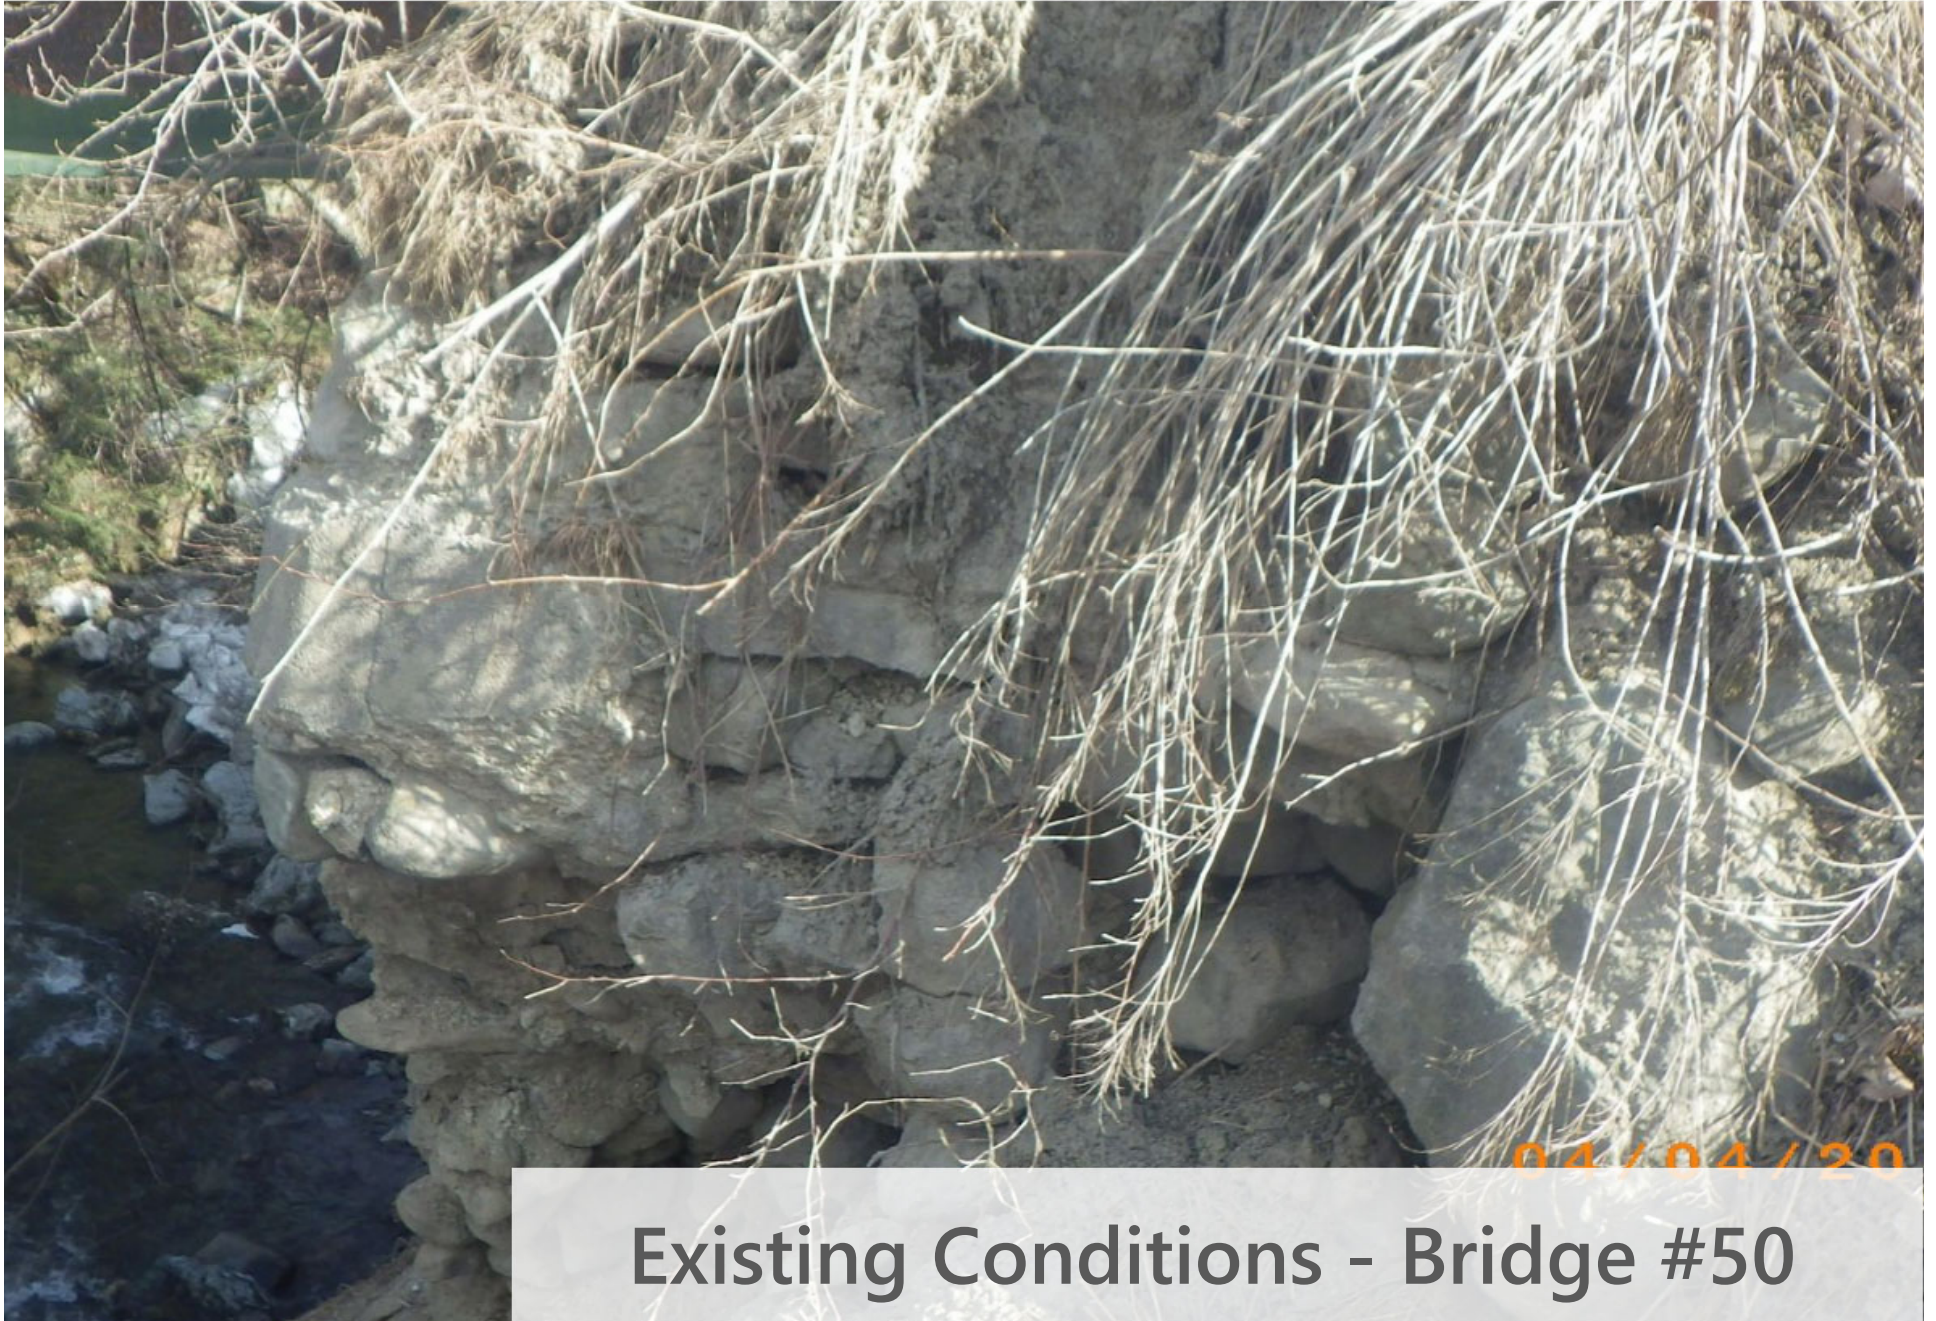
Eastern Abutment

- The bridge was closed on 3/16/2020 due to the heavy deterioration of the eastern abutment. This abutment is comprised of rough rubble cobble aggregate and concrete mix with no rebar and poured onto a steep inclined ledge cut. This abutment is not considered stable and could potentially come apart along its lower portion and fail along the ledge interface.
- The deck has some random shallow potholes with exposed rebar along the wheel line areas
- The existing bridge is narrow for the traffic volumes present.

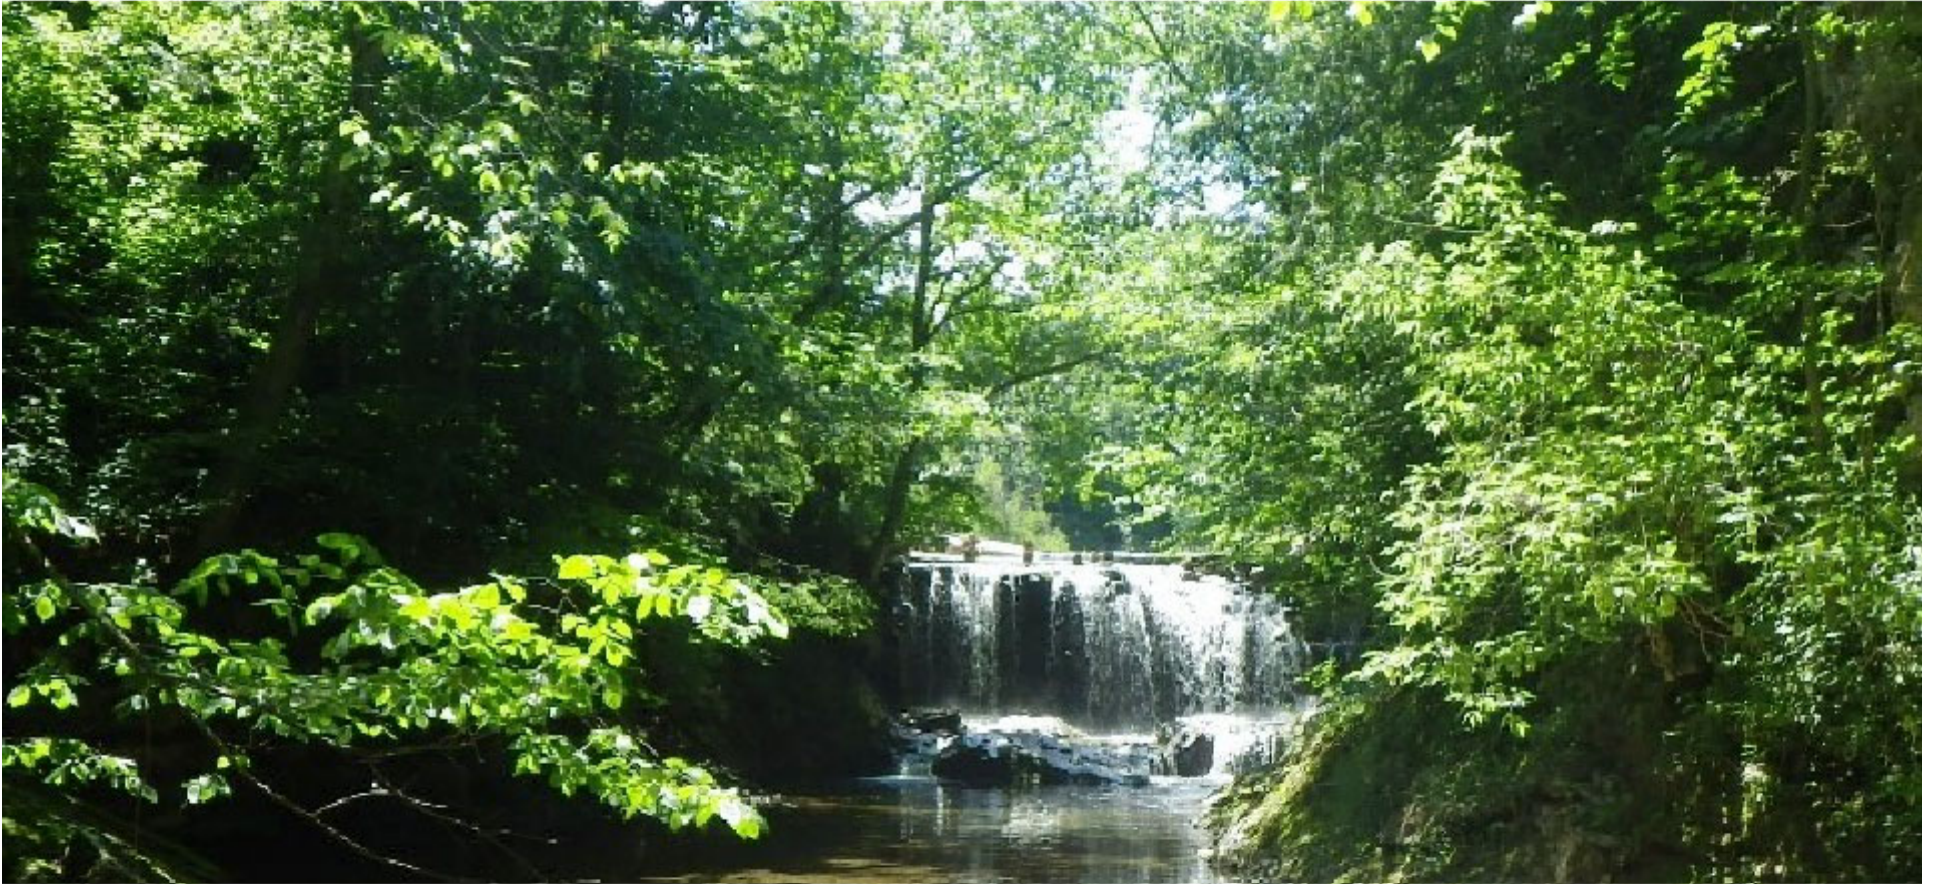
Resources – Looking Upstream

- Northern Long-Eared Bat
- Historic Resource
 - Farm complex at 1811 Horseshoe Cir
- Archaeological Resources
 - Old Sawmill Foundation in SE quadrant
- Primary agricultural soils

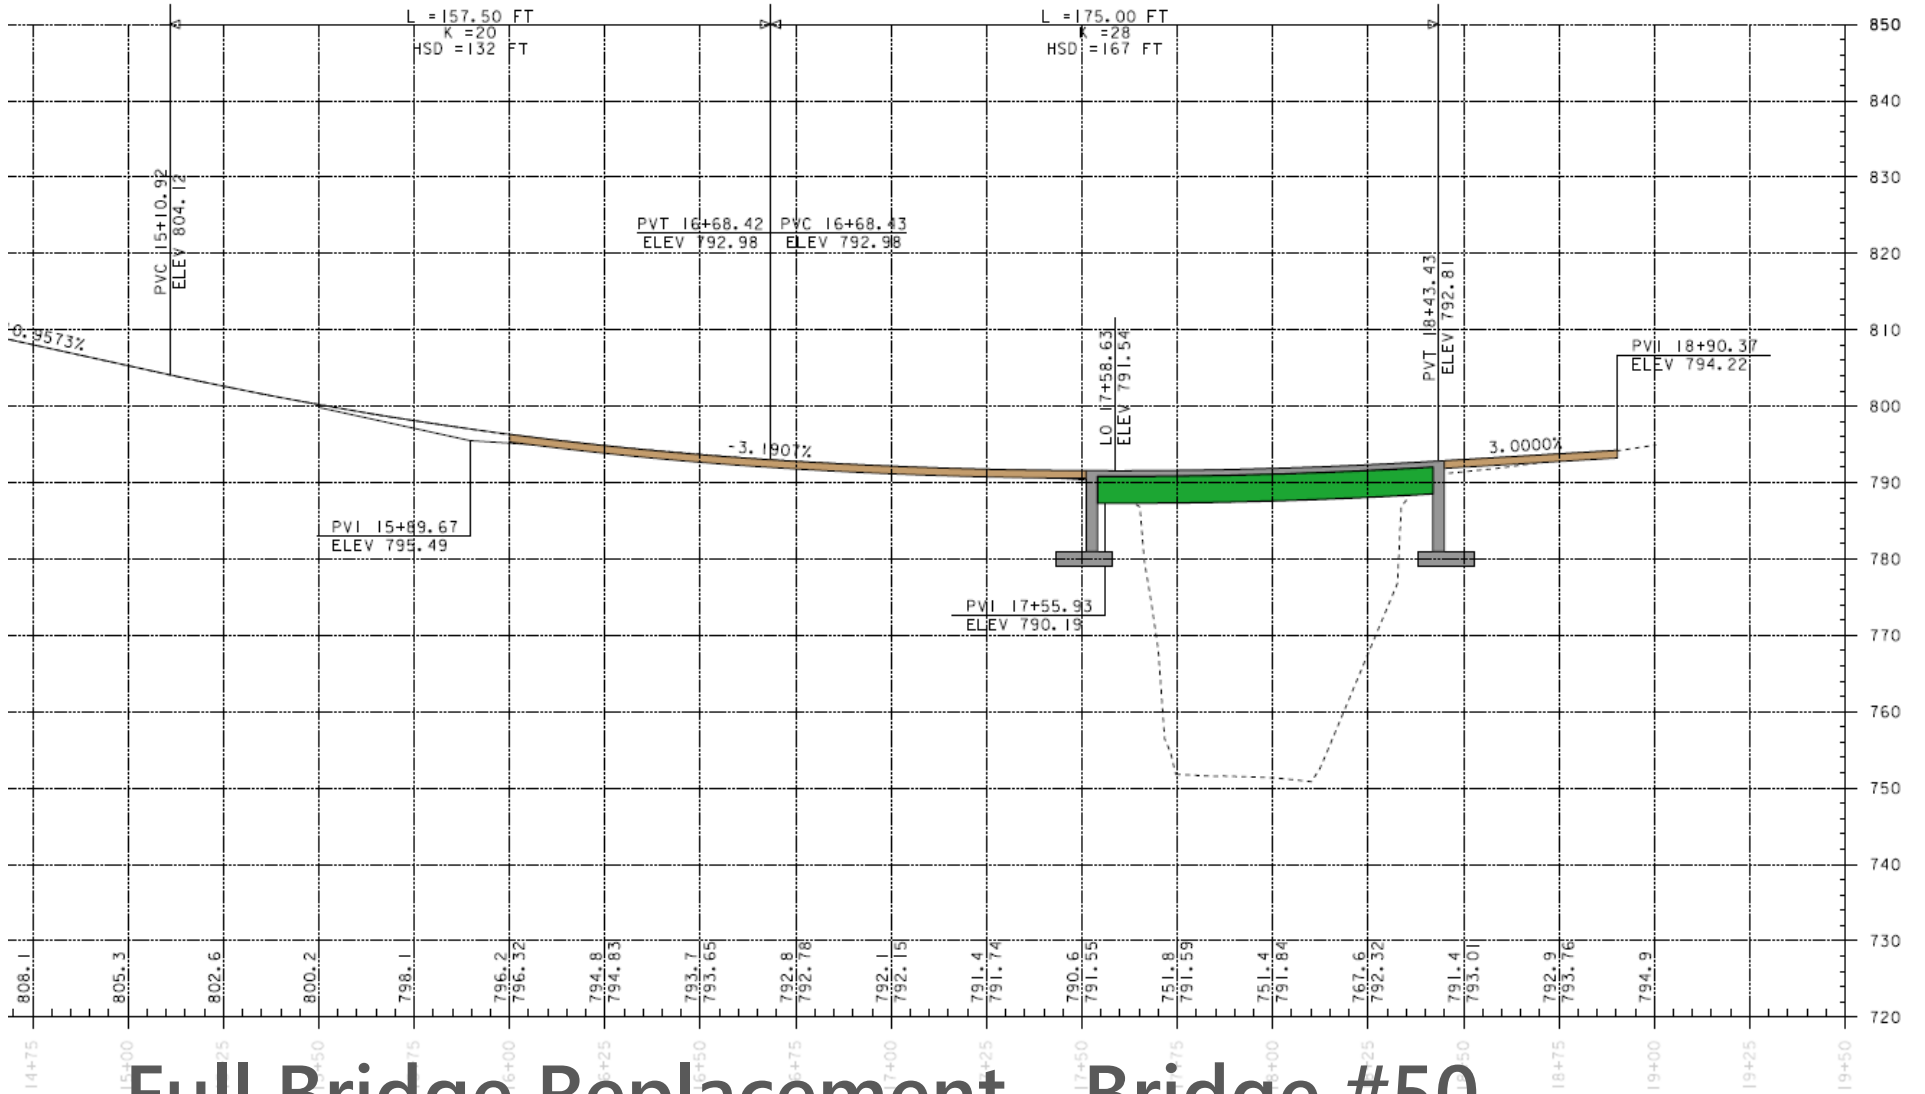
TH-4 Profile

- Potential Grade Raise
