ALTERNATIVES PRESENTATION MEETING

DEPOT STREET BRIDGE JAMAICA BO 1442(42) TH 19, BRIDGE NO. 32 OVER WEST RIVER

JUNE 28, 2021

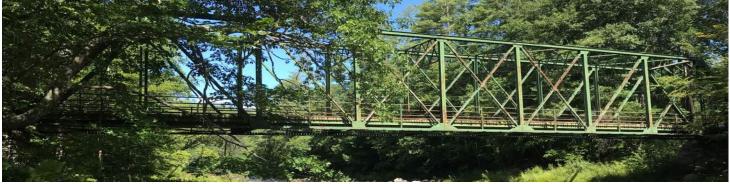
ELEVATION VIEW

- Bridge No. 32 constructed in 1926
- Fabricated by the Berlin Construction Company
- Kittredge Bridge Company as the contractor
- Pratt Through-Trusses:
 - 165' Total Span Length
 - 15'-4" On Center, 13'-6" Between Curbs
 - 14'-7" Vertical Clearance
 - Posted Weight: 8 Tons

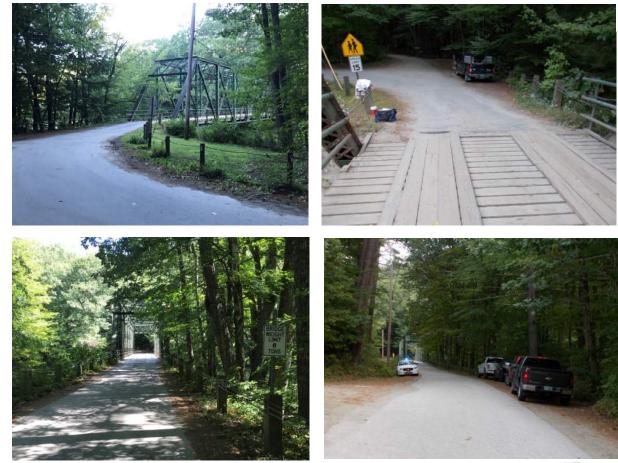
APPROACHES

Limited sightlines north approach

Satisfactory sightlines south approach

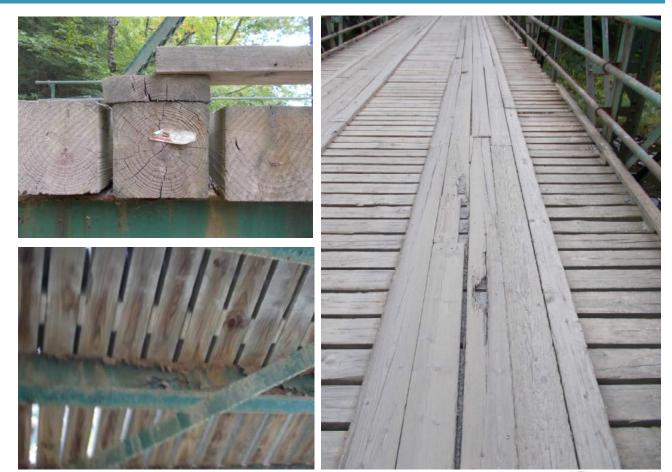
DECK

Transverse deck planks are in fair condition

- Recommended Alternative H20 Rehabilitation:
 - Only Rehabilitation Alternative that Accommodates Town Fire Truck.
 - New Floor System Deck, Stringer, Floor Beams
 - Truss Member Repair or Replacement (Portion of Lower Chord)
 - Cleaning and Painting of all Remaining Truss Members
 - Approach Work Including New Guardrail
 - Abutment Work Concrete Repair and Chinking

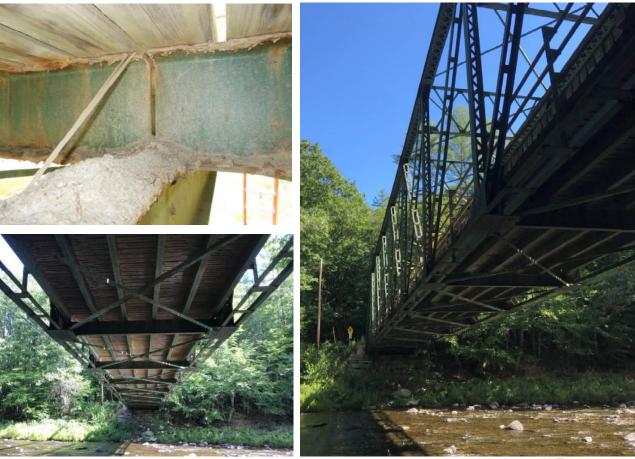
FLOOR SYSTEM

Stringers and floorbeams have some section loss

Debris collecting on floor system members from gaps in deck

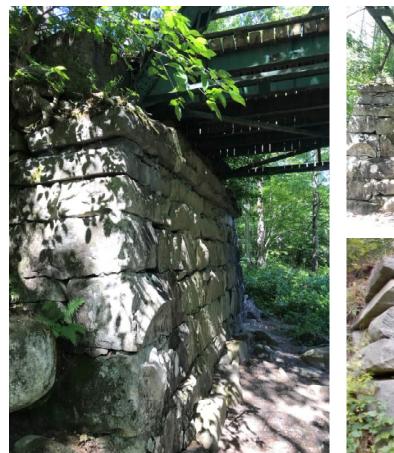
SUBSTRUCTURE

Some smaller stones have fallen outward from abutment faces
