PROJECT UPDATE – PRELIMINARY PLANS

DEPOT STREET BRIDGE

JAMAICA BO 1442(42)

TH 19, BRIDGE NO. 32 OVER WEST RIVER

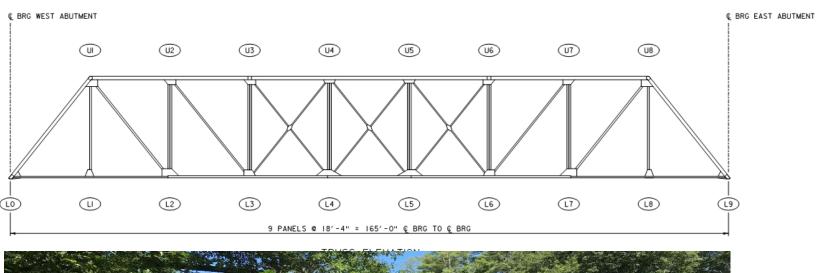
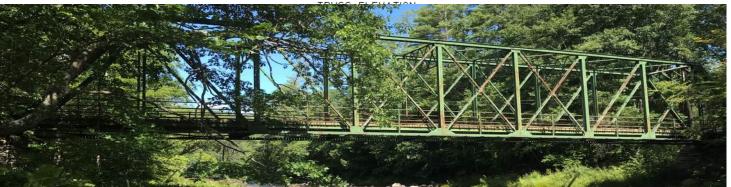
ELEVATION VIEW

- Bridge No. 32 constructed in 1926
- Fabricated by the Berlin Construction Company
- Kittredge Bridge Company as the contractor
- Pratt Through-Trusses:
 - 165' Total Span Length
 - 15'-4" On Center, 13'-5" Between Curbs
 - 14'-7" Vertical Clearance
 - Posted Weight: 8 Tons

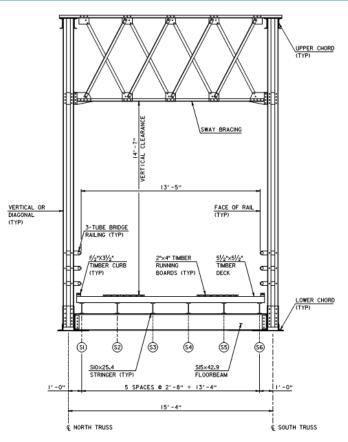
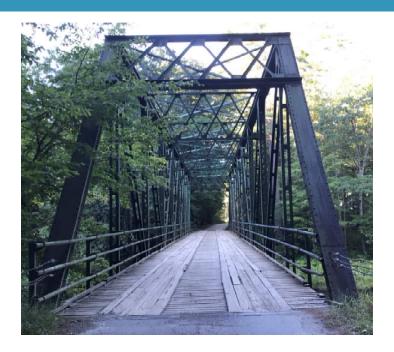
TYPICAL SECTION

EXISTING BRIDGE SECTION

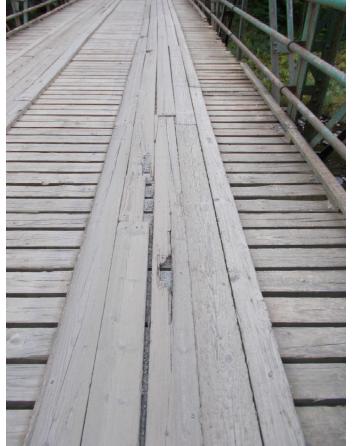
DECK

Transverse deck planks are in fair condition

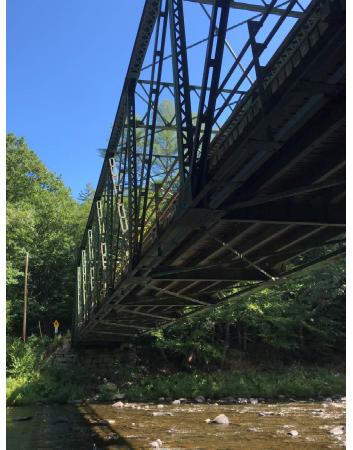
FLOOR SYSTEM

Stringers and floorbeams have some section loss

Debris
collecting on
floor system
members from
gaps in deck

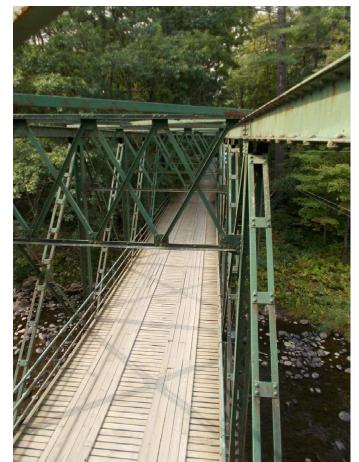
TRUSS MEMBERS

Minor section loss observed on lower portions of trusses

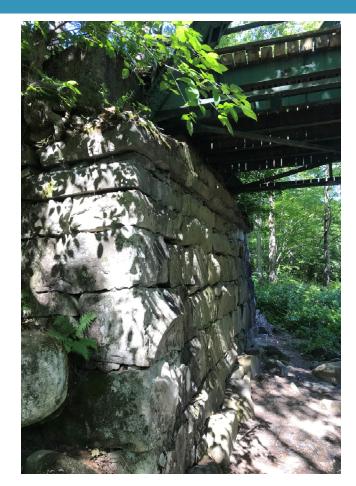
SUBSTRUCTURE

Some smaller stones have fallen outward from abutment faces

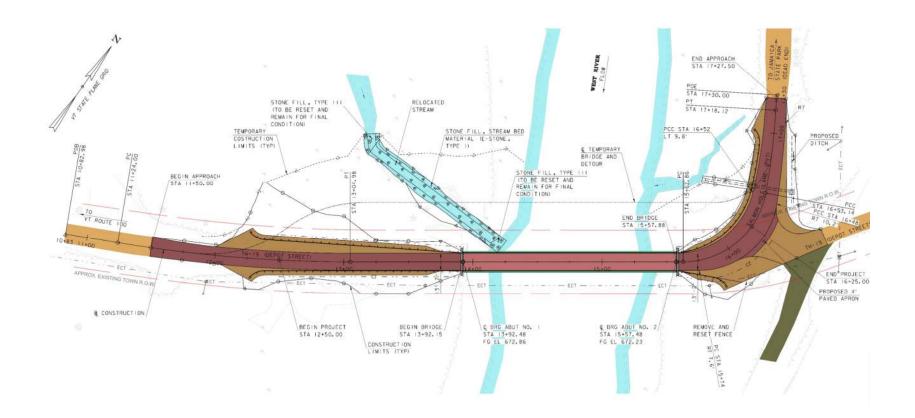
- Site Layout
 - Roadway Approach Layout Retained
 - Width Varies from 13'-4" (At Bridge) to 22'-5"
 - Existing Roadway Profile Will be Maintained
 - New Guardrail on All Four Corners of the Bridge
 - Slight Stream Relocation NE Quadrant
 - Additional Drainage at Park Entrance

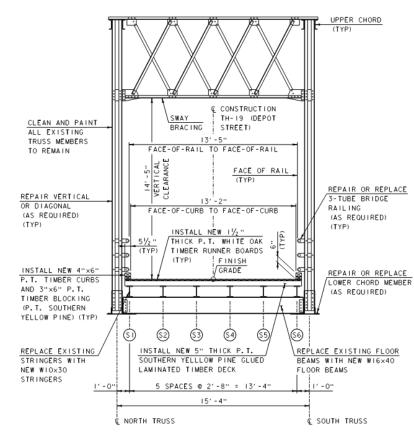
- Typical Section
 - Painting of All Steel Members
 - Partial Replacement of Lower Chord at Each Bearing
 - New Glulam (Wood) Deck with White Oak Wearing Surface
 - Replacement for Floor Beams and Stringers
 - Bearings Replaced/Rehabilitated
 - Partial Lower Lateral Bracing Replacement
 - New Concrete Backwalls and Bearing Pad

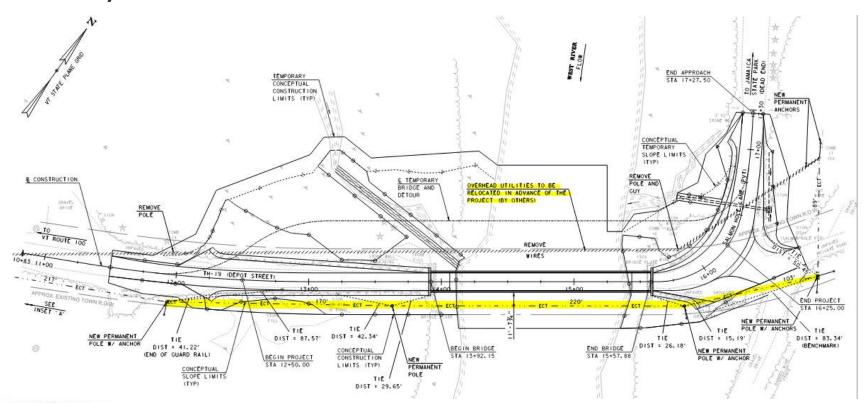
- Utility Relocation
 - Overhead Utilities are Located Upstream of Exist. Bridge.
 - Green Mountain Power, Consolidated Comm., Comcast
 - Will be Relocated Downstream of Exist. Bridge.
 - Initial Coordination with Utility Companies Completed.
 - No Underground Utilities.

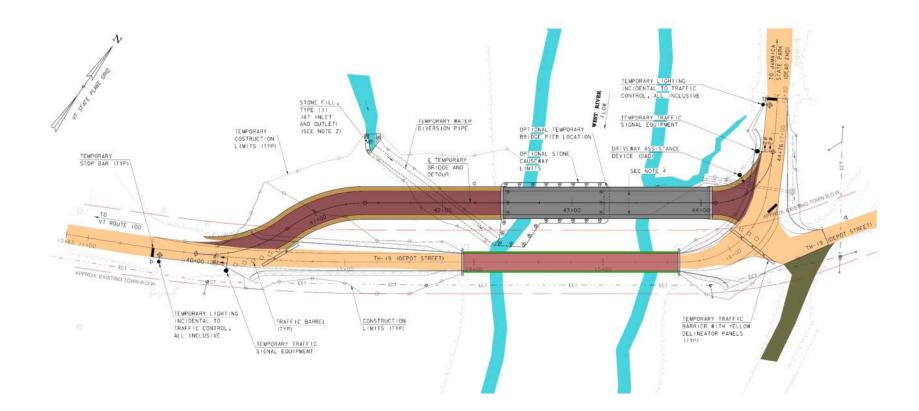
MAINTENANCE OF TRAFFIC

- Maintenance of Traffic
 - A Temporary Bridge and Approach Road Will be Installed Upstream of the Bridge.
 - One Lane of Traffic Will be Maintained at all Times.
 - Temporary Lighting and Signals will be Installed at Each End of the Detour.
 - Detour Area Reviewed for Archaeological Concerns and Cleared.
 - Army Corps of Engineers (ACOE) Project Coordination
 - Ball Mountain Project Schedule TBD
 - ACOE Use and Removal of Temporary Bridge TBD
