**STATE OF VERMONT
AGENCY OF TRANSPORTATION**

**Scoping Report
FOR
Coventry BF 0251(49)**

VT Route 14, Bridge 132 over Stony Brook

October 14, 2021

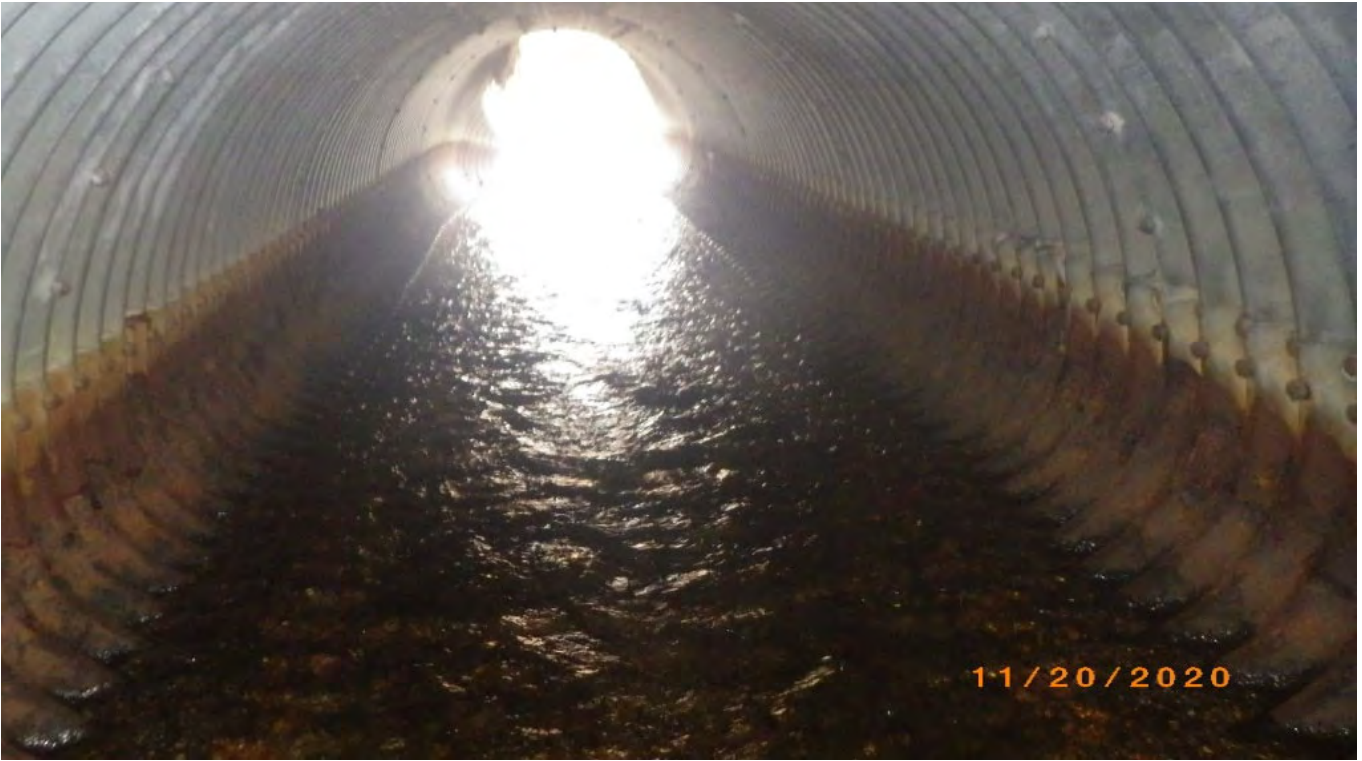
Culvert Barrel

1. The culvert is in serious condition. There are large holes throughout the culvert invert, with the worst area being in the center of pipe where what remains of the invert has broken off and resulting in no support for the barrel above. There is heavy rusting throughout the culvert barrel above the haunch line. The outlet end of the pipe has heavy undermining resulting in minor settlement of the pipe.
2. The existing culvert does not meet the minimum hydraulic standard or the calculated bank full width.
3. VT Route 14 though the project area is substandard in width for the speed and traffic volumes present.

11/20/2020 Pipe is in very poor condition with invert completely rusted through at approx. mid span and support has been lost. Rest of invert has holes and slotted holes throughout with piping surprisingly roadway doesn't show settlement yet. Holes are also outside of invert along haunches and outlet end south miter end is pushed in with settlement. Pipe needs repairs or replacement as sinkhole are imminent. MJK

11/21/2019 - Pipe remains in poor condition and should be replaced soon. Large holes throughout, with worst area being in the center of pipe where what remains of the invert has broken off and resulting in no support for the barrel above. - ABC/JAS

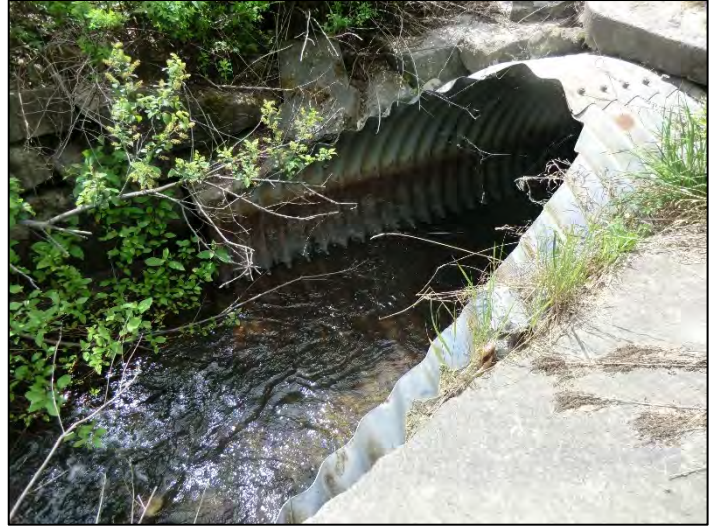
Figure 2. VT Route 14 culvert inlet

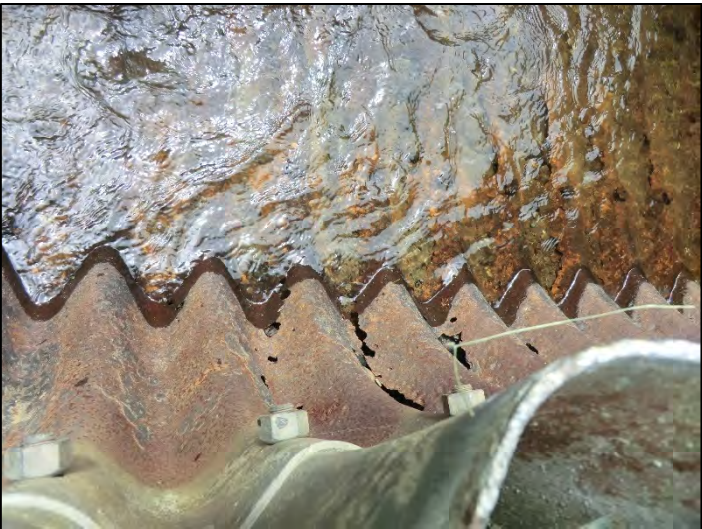
Figure 3. Deteriorated VT Route 14 culvert inlet

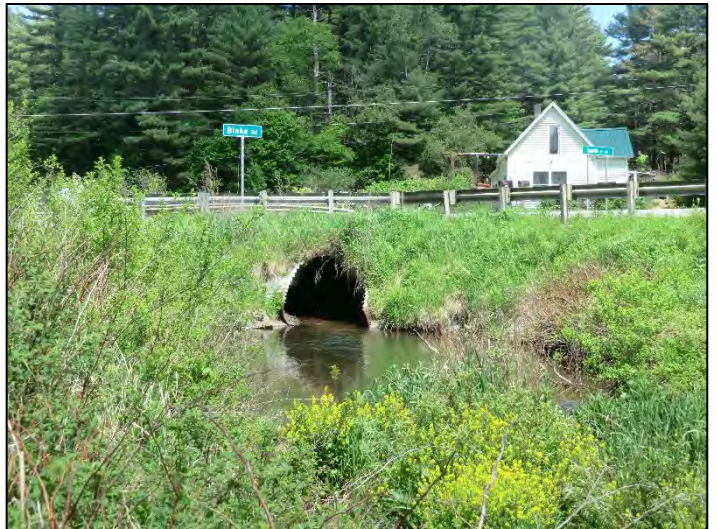
Figure 4. VT Route 14 culvert outlet

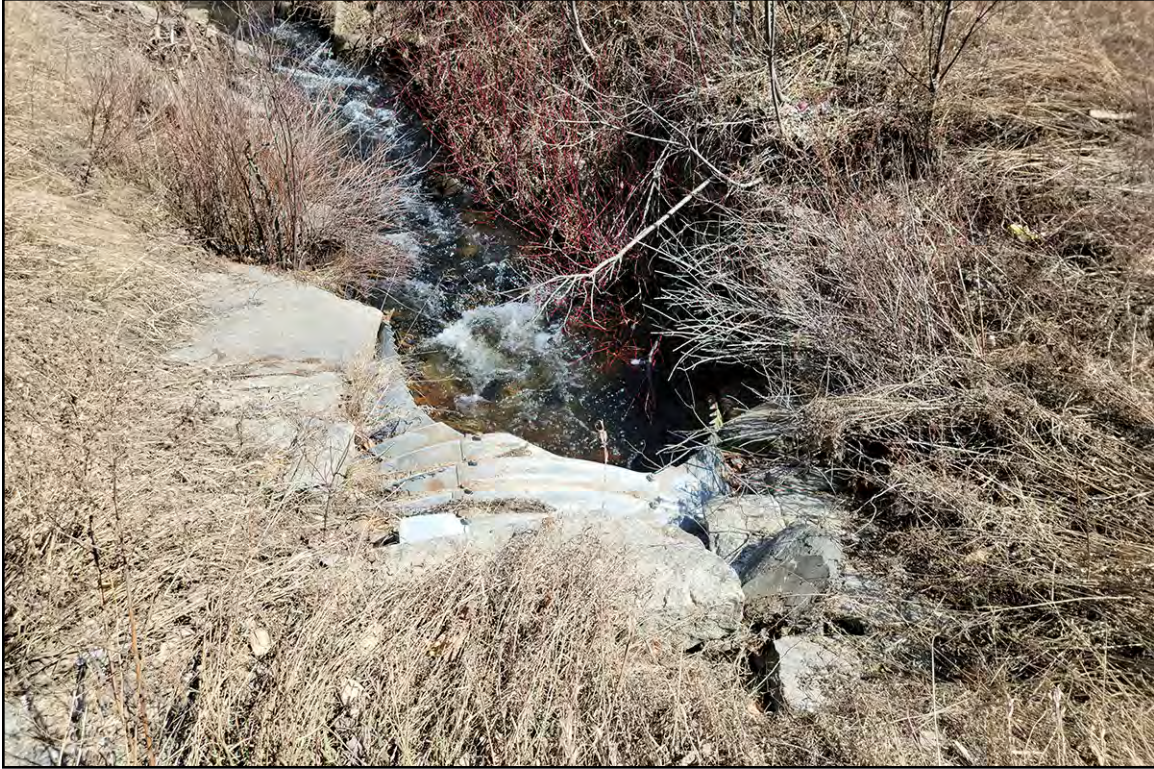
PLATE 2: North End of Culvert with Modern Ditch Used to Direct Stream/Runoff Water, View East

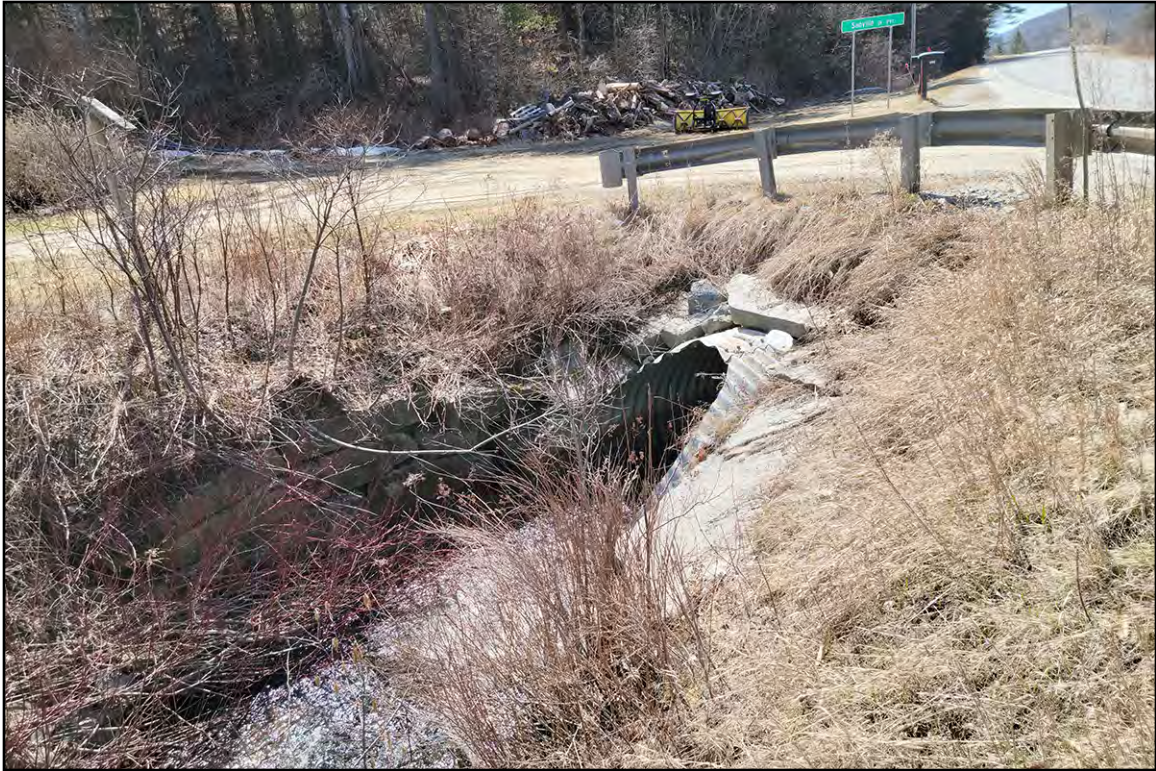
PLATE 1: Coventry Culvert No. 132, Facing South

The structure does not meet any NRHP Criterion C registration requirements as it is a common culvert type that lacks distinction. It is WSP's opinion that the Coventry Culvert No. 132 is not eligible for listing in the SRHP/NRHP.

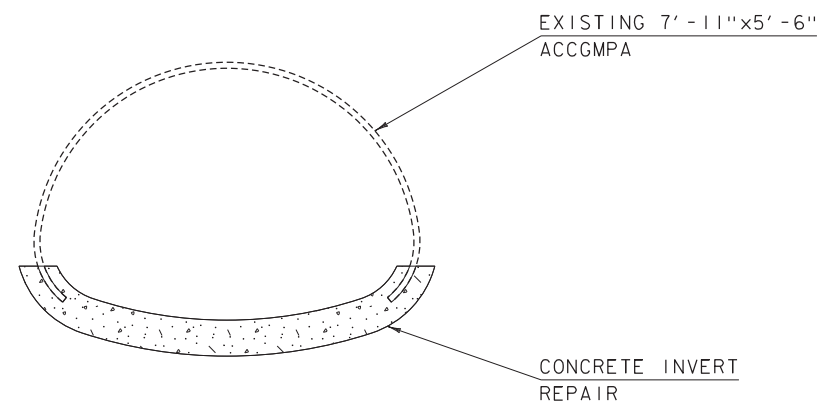
INVERT REPAIR TYPICAL SECTION

a. Invert Repair

In many cases, invert repair is used to rehabilitate reinforced concrete pipe where the invert has eroded. Invert repair can be utilized on corrugated steel pipe, and typically consists of paving the invert or pouring a concrete invert. There is significant rusting in the pipe that extends to the haunch located almost halfway up the pipe. Additionally, an invert repair offers little additional structural integrity to the current structure. As such an invert repair is not recommended.
