**Coventry BF 0251(49)**  
**Regional Concerns Meeting**  
**VT Route 14 – Bridge 132 over Stoney Brook**

January 3, 2022

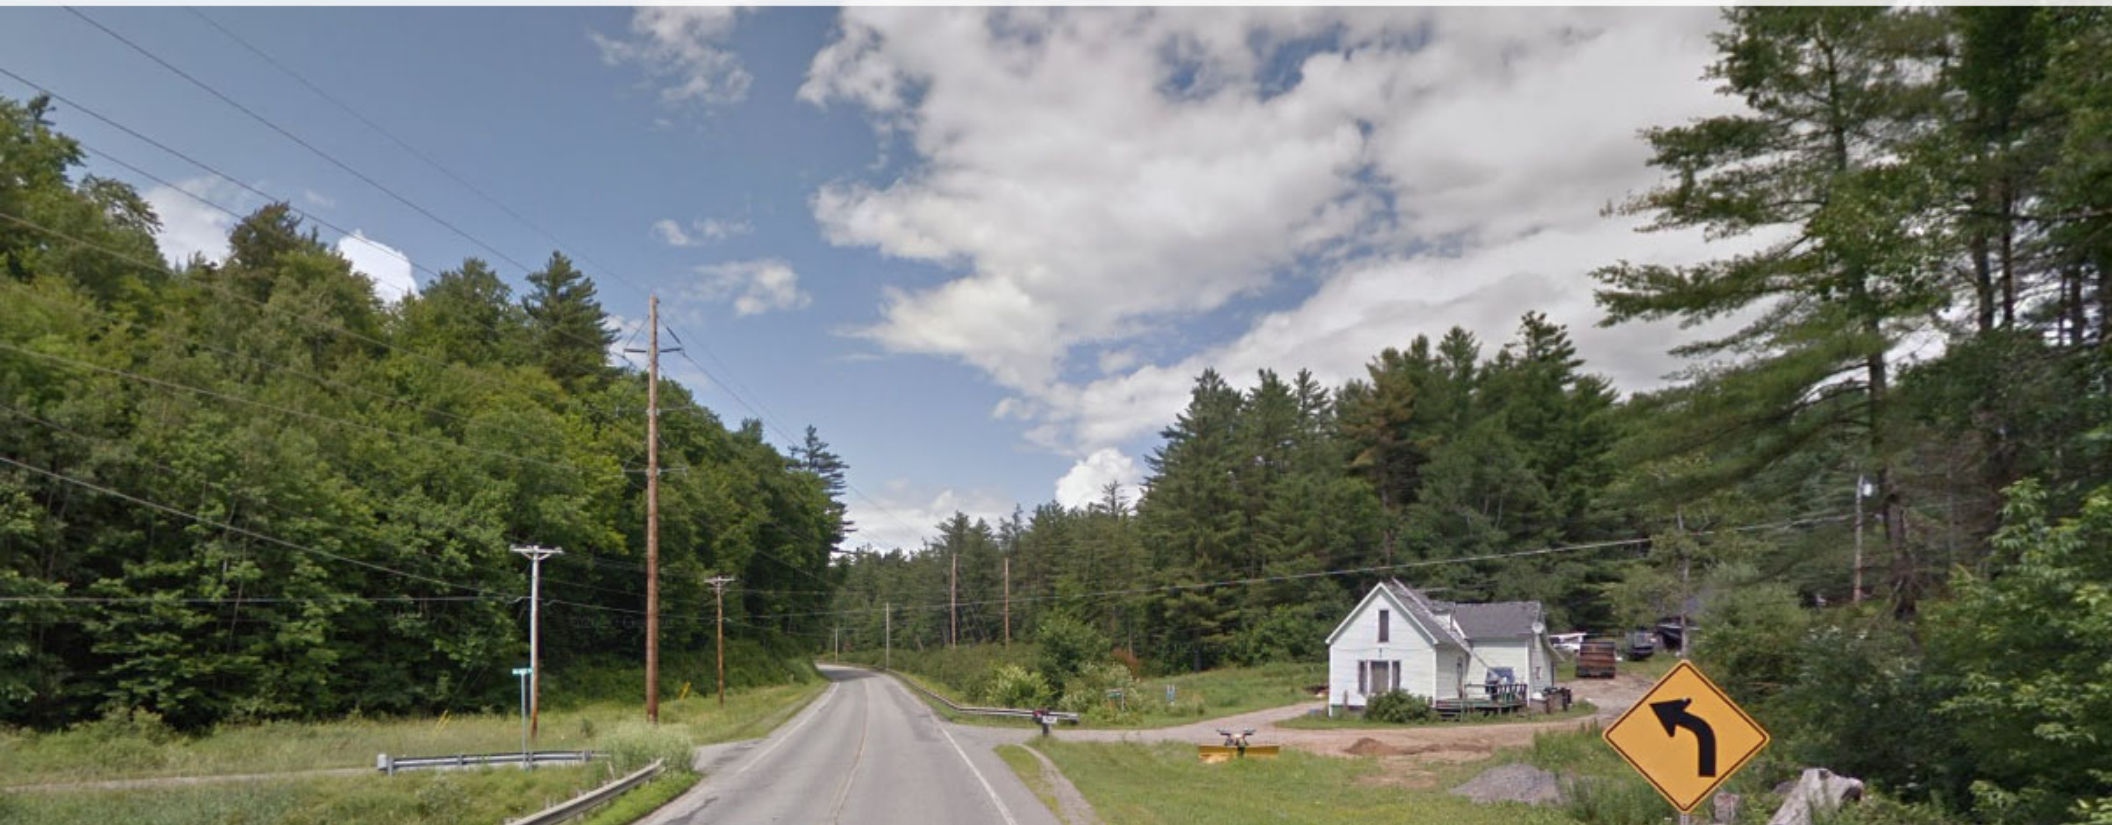
## Looking North over Bridge 132

## Existing Conditions – Bridge #132

- Roadway Classification – Major Collector
- Bridge Type – 8' Span CGMPPA (Corrugated Galvanized Metal Plate Pipe Arch)
- Culvert Length – 108 feet
- Fill Over Culvert – 4 feet
- Ownership – State of Vermont
- Constructed in 1959

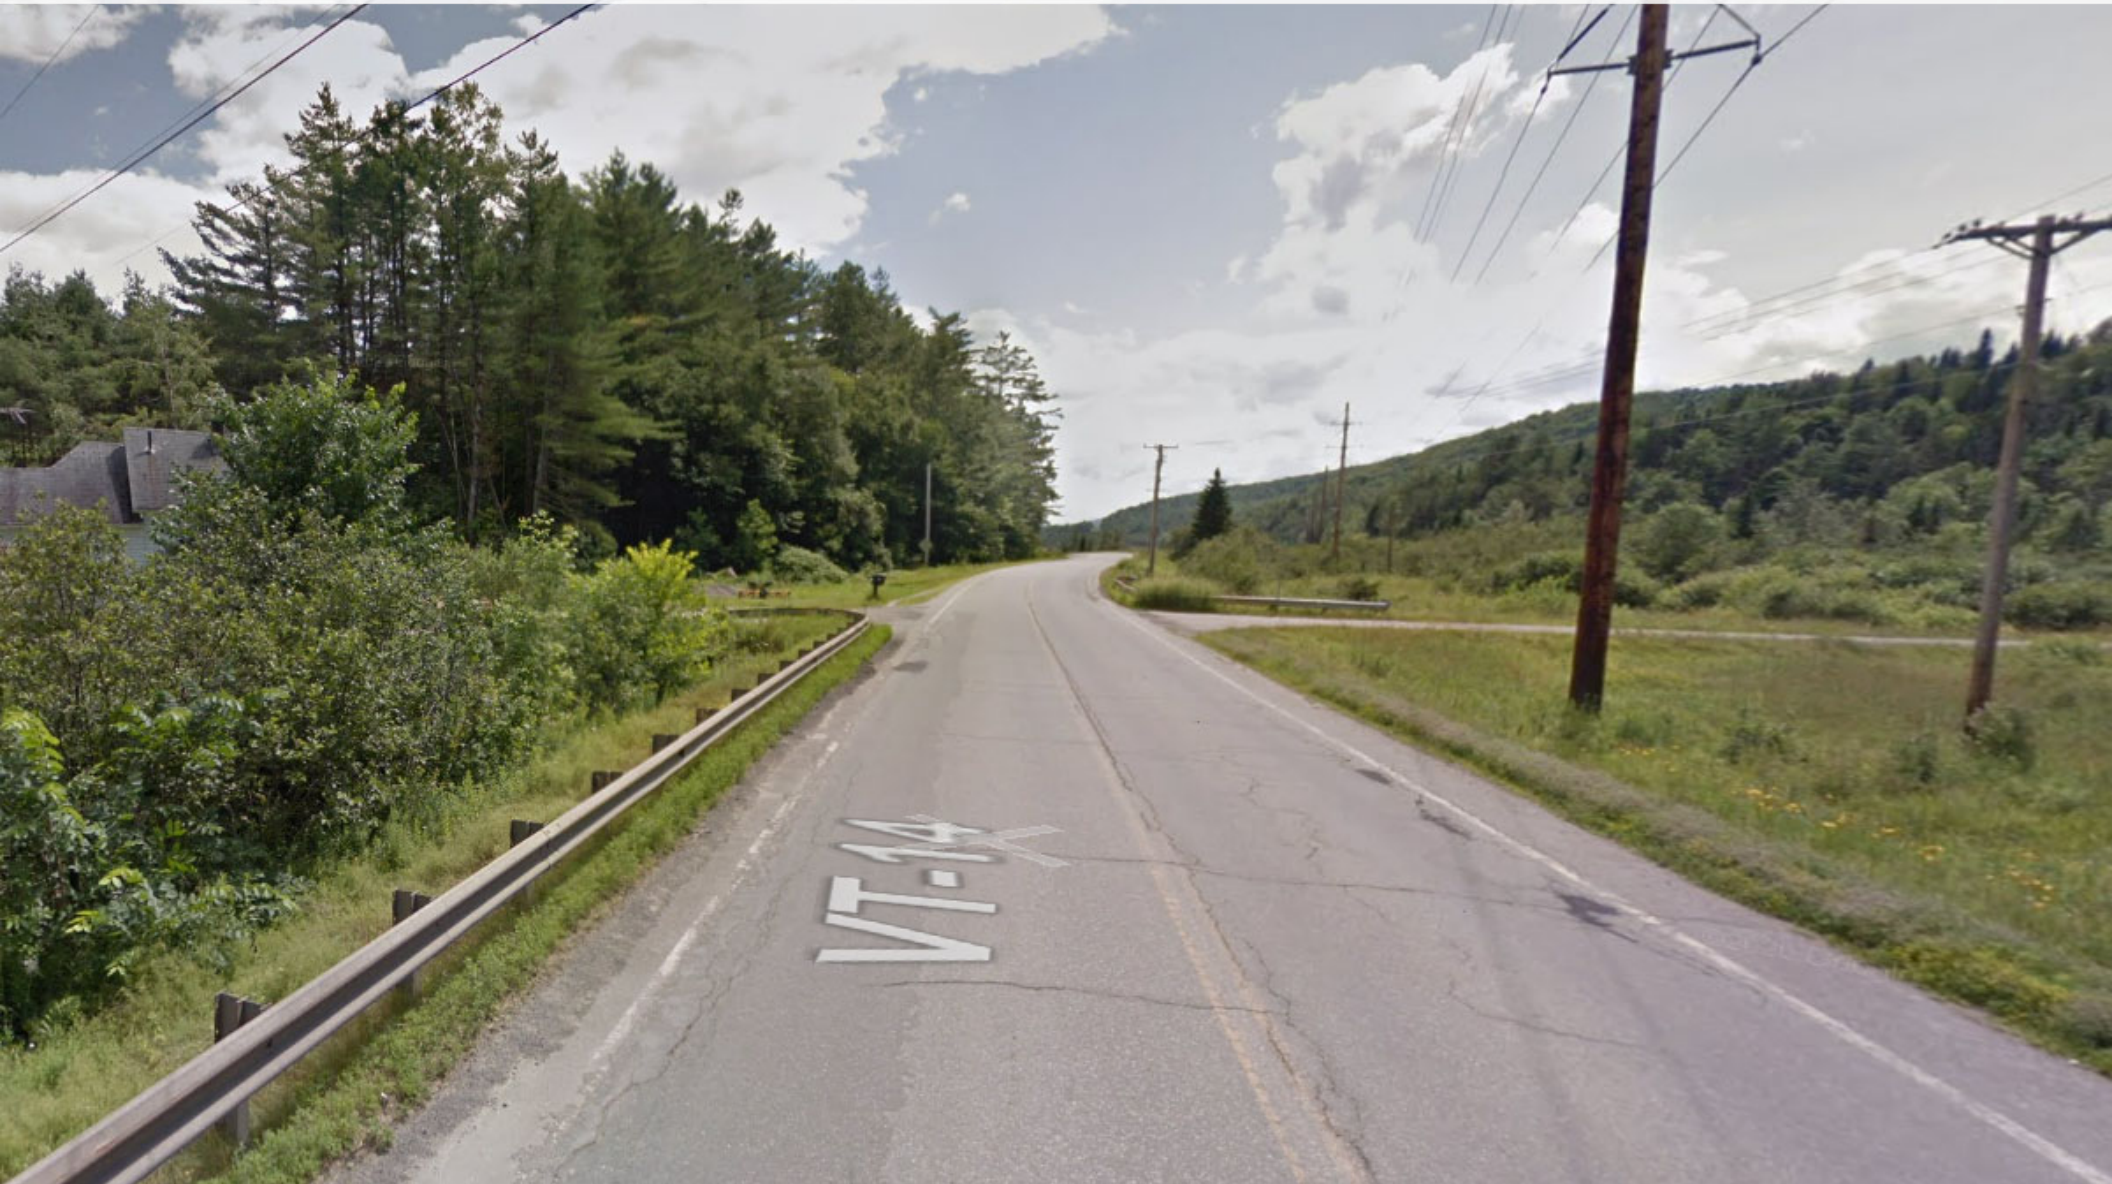
Looking South over Bridge 132

## Existing Conditions – Bridge #132

- Aerial Utilities

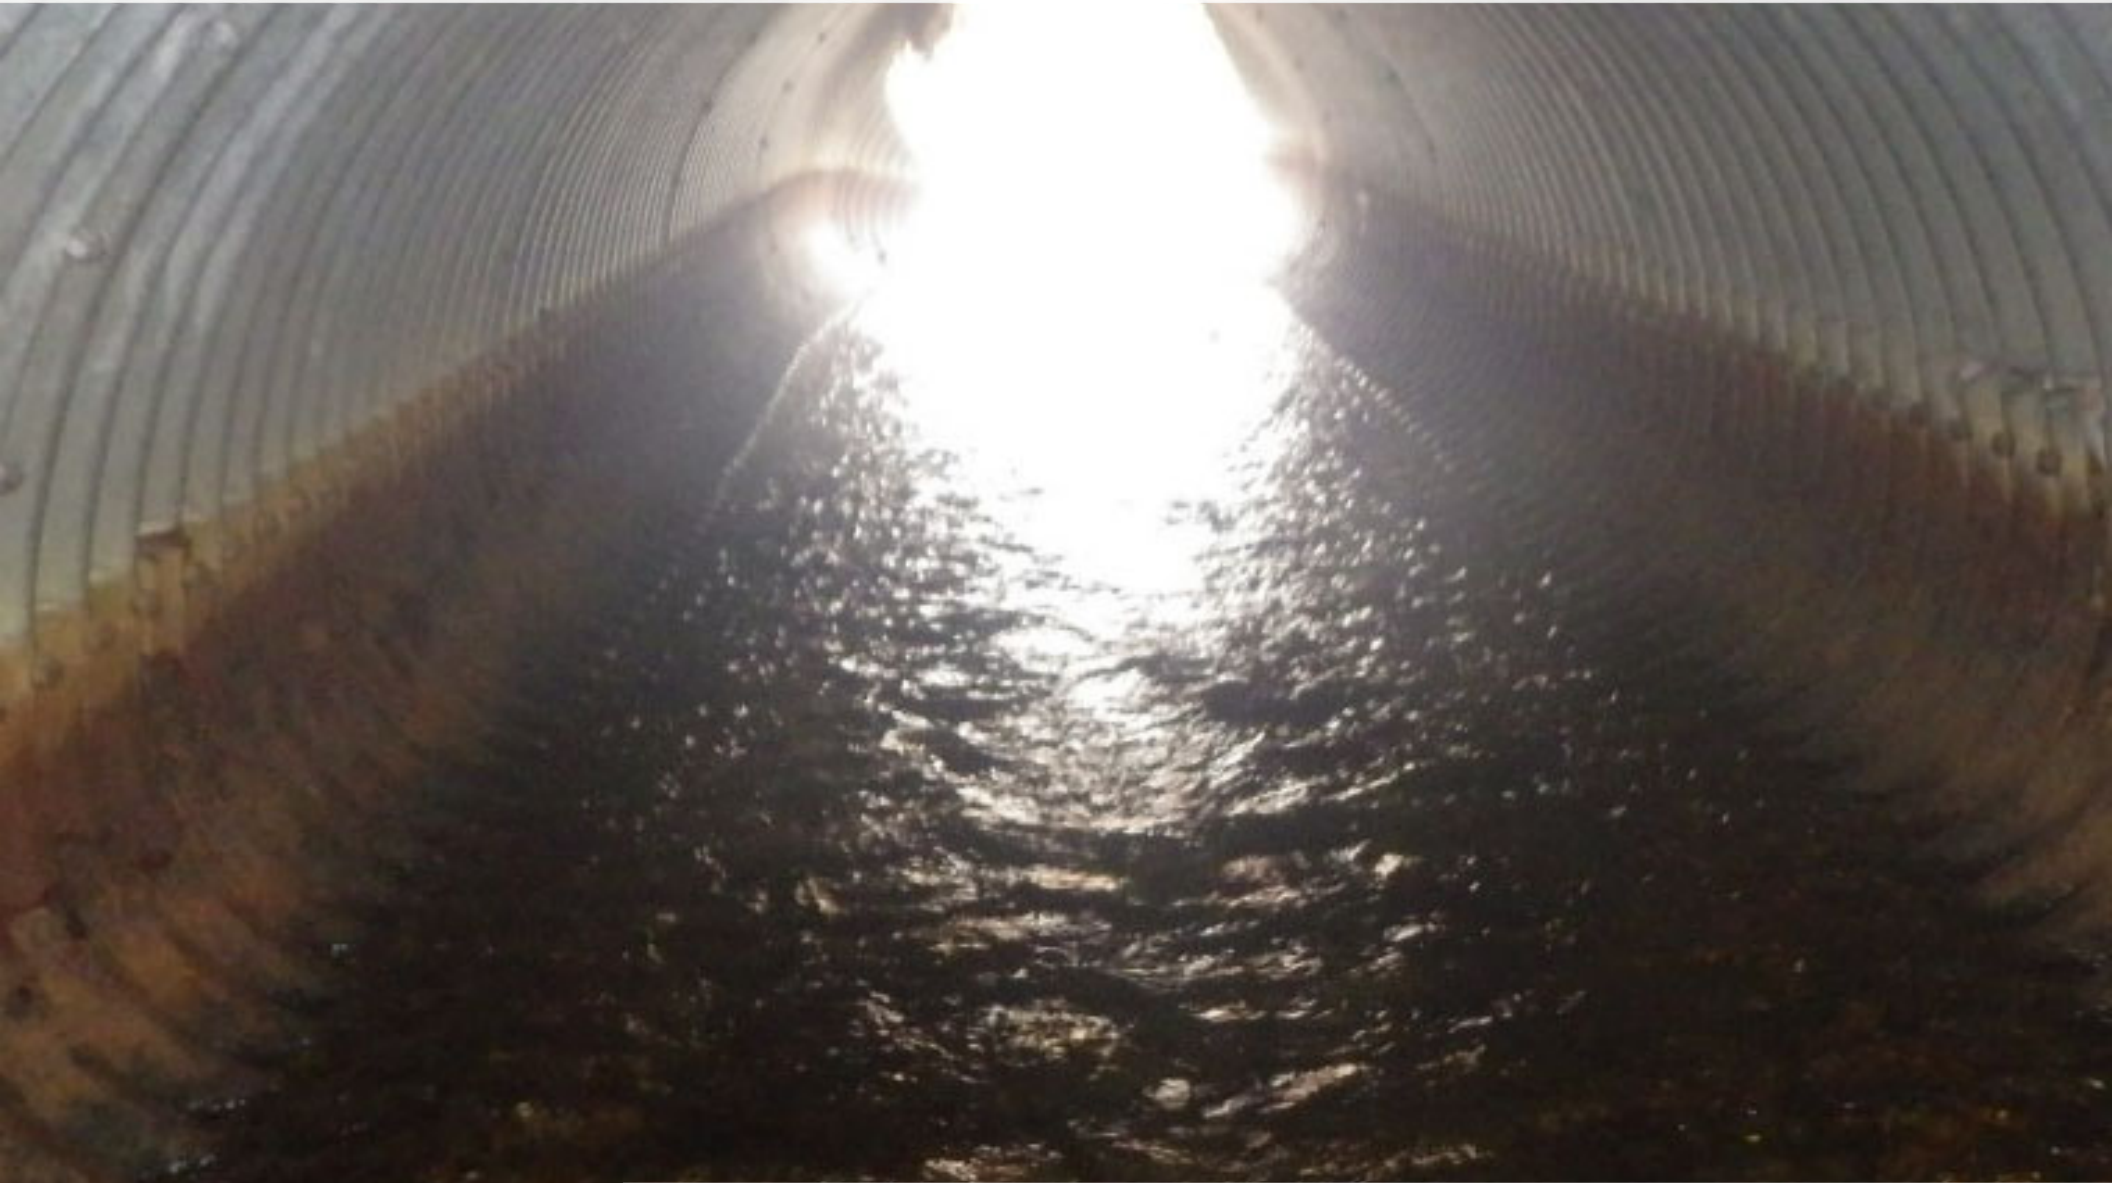
## Existing Conditions - Bridge #132

■ Culvert Rating 3 (Serious)

- The culvert is in serious condition. There are large holes throughout the culvert invert, with the worst area being in the center of pipe where what remains of the invert has broken off and resulting in no support for the barrel above. There is heavy rusting throughout the culvert barrel above the haunch line. The outlet end of the pipe has heavy undermining resulting in minor settlement of the pipe.
- The existing culvert does not meet the minimum hydraulic standard or the calculated bank full width.
- VT Route 14 though the project area is substandard in width for the speed and traffic volumes present.

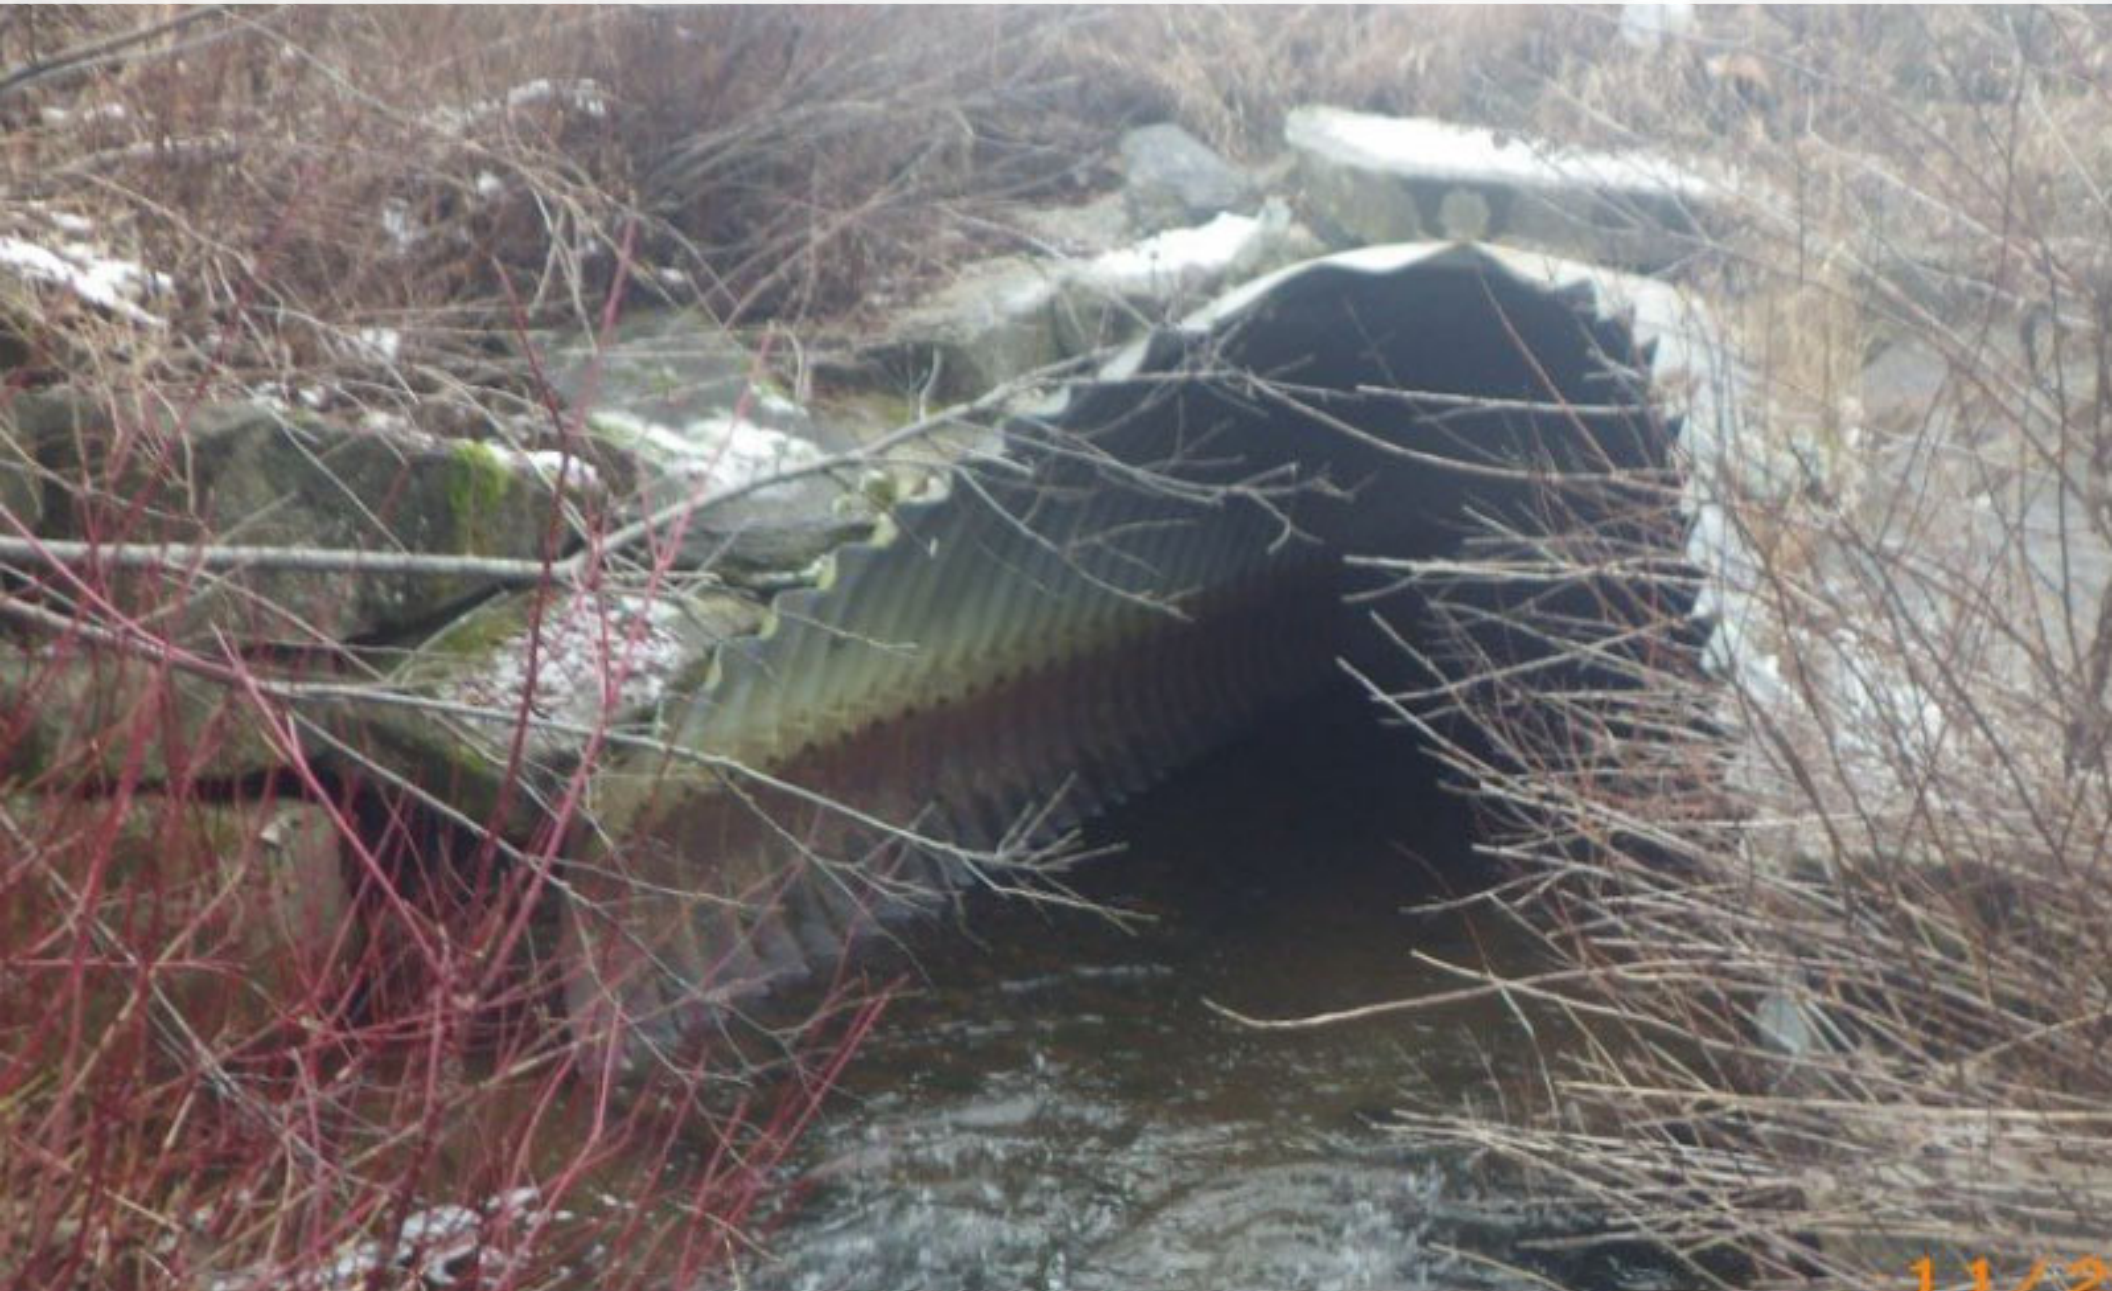
Inlet

Existing Conditions - Bridge #132

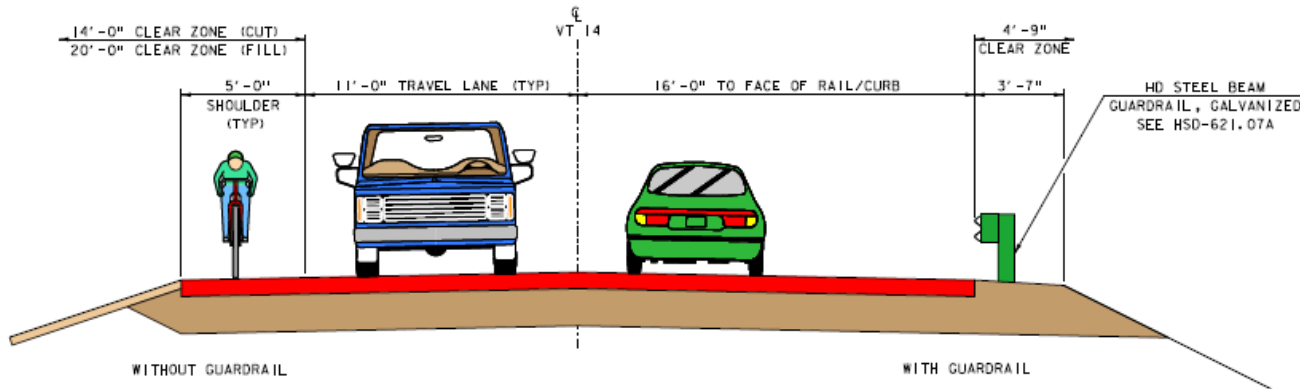
PROPOSED VT ROUTE 14 TYPICAL SECTION

# Proposed Typical Section

- Precast Concrete Box
  - 12' x 9.75' box with invert buried 3' for AOP
    - 12' x 6.75' waterway opening
  - 11'¼' typical to meet minimum standards
    - 11'½' is current typical section
  - 75-year design life

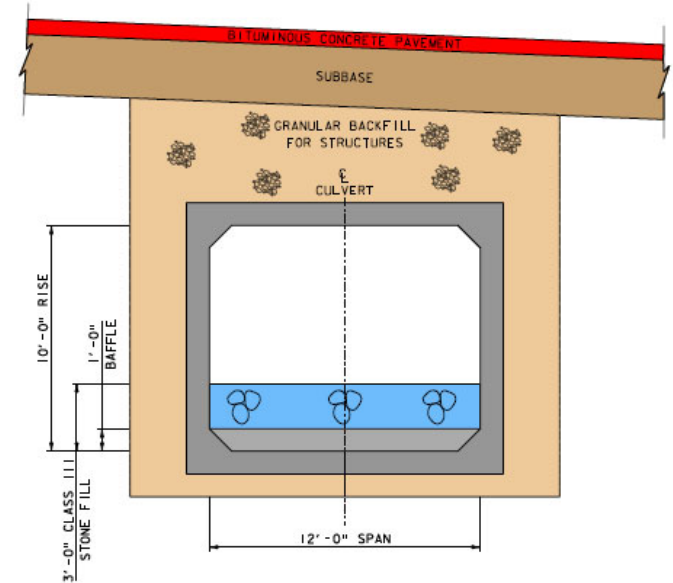
CULVERT TYPICAL SECTION

## New Precast Concrete Box - Bridge #132

- 11'¼' typical section
